◀ HEALTH & SAFETY ALERT ▶

Falling Objects in Excavations

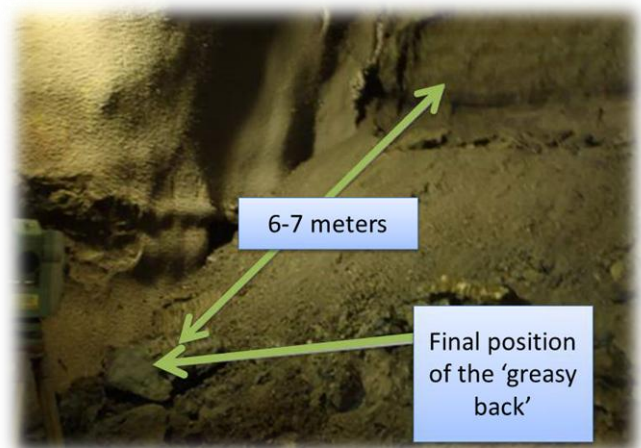
On Friday the 18th October at 20.40 in the Rounton Road shaft adit (entrance), a piece of clay from the roof of the tunnel broke away and rolled from the exclusion zone down the ramp of excavated clay and struck an operative. Such pieces of clay are known as 'greasy backs'.

- The Injured Person (IP) was the operator of the road header excavating machine.
- The IP was awaiting further instruction, left the machine and was sitting in the adit.
- The IP was sitting with his back to the face of the excavation and was struck on his legs and back after the clay had rolled down the ramp.
- The IP attended hospital and had suffered heavy bruising. He later returned to work.
- The works area was made safe by spraying the open areas of the excavation and all works were suspended pending a review of the work procedures.

- Eliminate the potential for open areas of excavation as far as possible
- Ensure that the method of the excavation including profile specifications are designed and communicated to all those involved in the works
- Ensure that works are continually supervised and monitored to ensure that the design, risk assessment, method statements and associated specifications are followed
- Check that emergency arrangements are in place, relevant for the risks involved and communicated to all personnel involved
- Use of defined extensive exclusion zones in such areas to further protect against the potential for unstable ground and prohibit sitting / resting in such work areas
