◀ HEALTH & SAFETY ALERT ▶

Breaker Attachment Failure

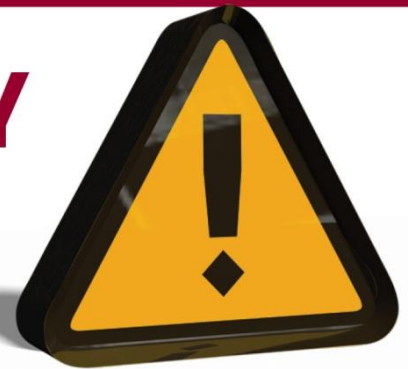
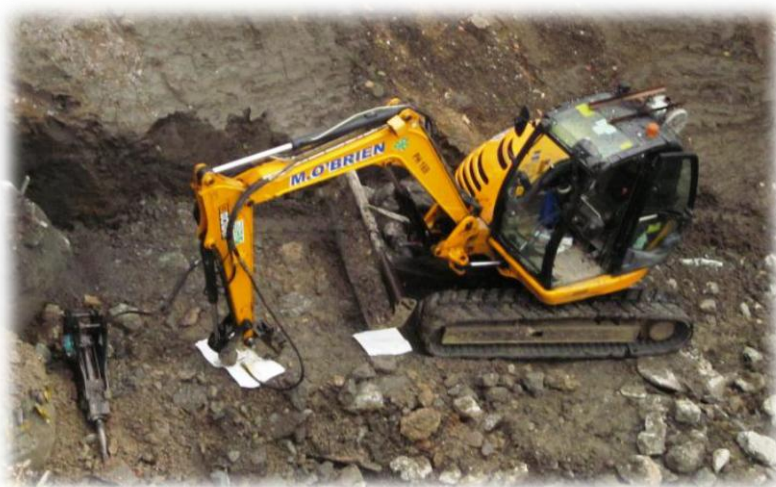
Following the change of attachment on a 360 excavator which was being used for BFK pile breaking activities, the breaker became detached from the quick hitch mechanism of the excavator falling approximately 3 metres into an unoccupied exclusion zone.

Picture shows 360 excavator and breaker and detached breaker attachment.

- Fully automated double locking quick hitch showing signs of wear and tear.
- Breaker attachment not specifically designed for the make/model of quick hitch assembly and had been modified to fit (independent inspection ongoing)
- Evidence of damage to hydraulic hose of the internal quick hitch mechanism (unclear if damage was prior to incident or sustained as a result).
- No operator's manual for the excavator (to include quick-hitch) or breaker attachment assembly were available on site.
- Evidence was available to demonstrate operators' pre-use checks.

Plant selection: Review plant selection process to ensure compatibility and all safety issues are adequately controlled and inspected in accordance with agreed testing and inspection regimes.

Documentation: All site management are to ensure plant under their control is accompanied with the relevant user manuals that are referred to by the operator.
