C336-COS-T1-RGN-CR076_SD006-50056 Rev 1.0 C336 PADDINGTON NEW YARD - BORED PILING VIBRATION MONITORING REPORT

C336 - Paddington New Yard

BORED PILING VIBRATION MONITORING REPORT

SUBJECT: C336 PADDINGTON NEW YARD - BORED PILING VIBRATION MONITORING REPORT

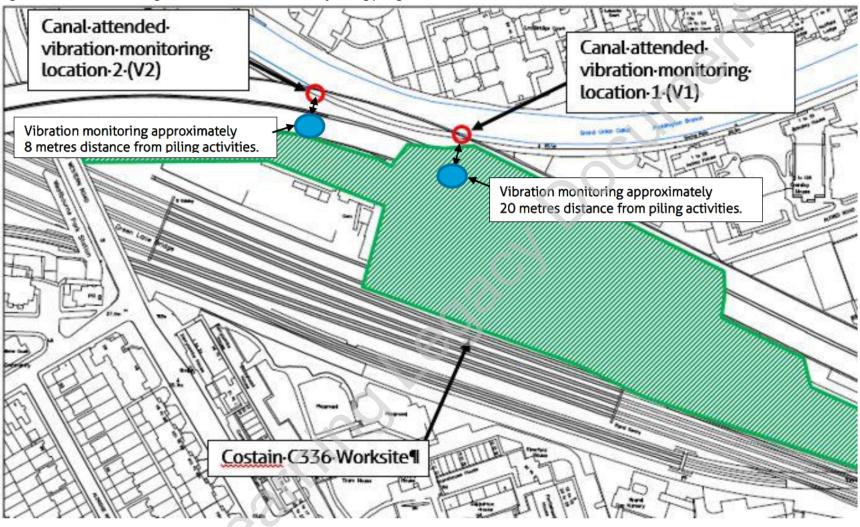
Figure 1: Vibration Monitoring and Works Locations for survey during piling works

This report presents results of the attended vibration monitoring on 11th November 2015. Figure 1 in Appendix A shows both vibration monitoring locations and the locations of the works (highlighted in blue).

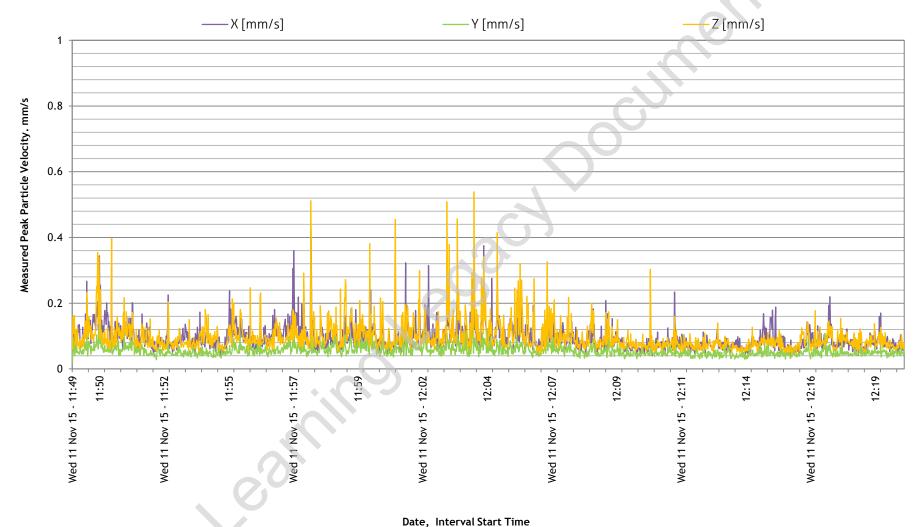
Figure 3: Vibration Monitoring for survey during piling works – Time History (11/11/2015)

Table 3 details the 10 highest one-second PPV measurements that occurred as a result of the works during the attended vibration monitoring at location 1 (V1) between 11:49 to 12:20 on 11th November 2015.

Vibration Location 1 (V1) - 11:49 to 12:20:

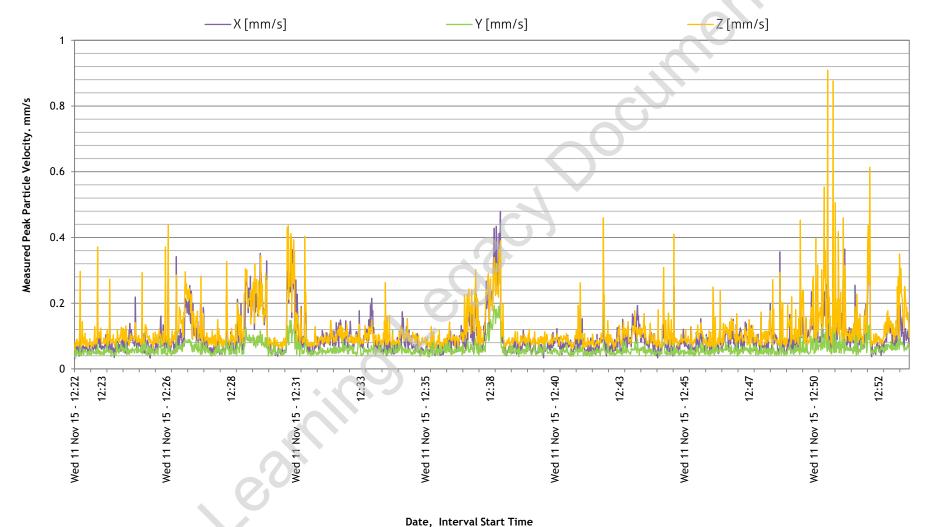
Figure 4: Vibration Monitoring for survey during piling works – Time History (11/11/2015)

Table 4 details the 10 highest one-second PPV measurements that occurred as a result of the works during the attended vibration monitoring at location 2 (V2) between 12:22 to 12:53 on 11th November 2015.

The vibration levels measured fell below the BS 5228-2 limits. It may be concluded that it is unlikely that any damage will have occurred to the surrounding structures as a result of vibration emissions from these works.

Vibration Location 2 (V2) - 12:22 to 12:53:
