C435 Farringdon Main Station

Monitoring Close Out Report – Inground Monitoring Section A

CRL Document Number: C435-BFK-C2-RGN-M123-51049

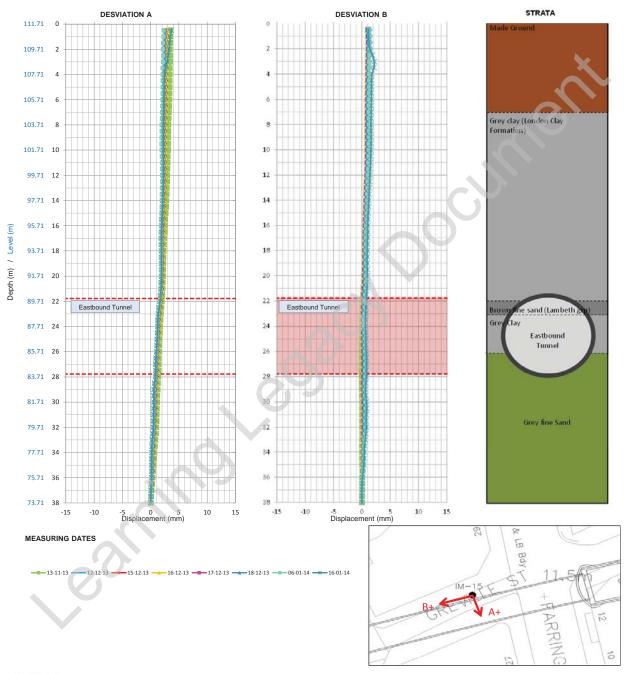
Inclinometer C435-IM00015 - READINGS BEFORE AND AFTER EASTBOUND TBM PASSAGE DEVICE:

Inclinometer C435-IM00015 show 1-2mm due the TBM passage. During the STW1, this inclinometer show another 2mm in A direction and 1.5mm maximum in B- direction. The total/maximum horizontal movement in inclinometer C435-IM00015 is 3.6mm in A+ direction and 1.83mm in B- direction.

Readings before and after Eastbound TBM passage did not show any significant displacement, maybe 1-2mm.

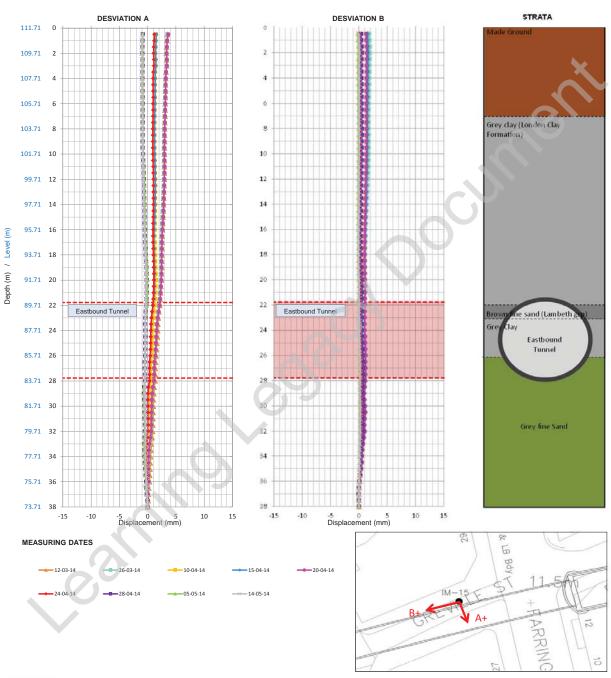
Inclinometer C435-IM00015 - READINGS BEFORE AND AFTER STW1 ENLARGEMENT DEVICE:

There is -2mm displacement on top during STW1 Enlargement works. There is 2mm maximun in B direction. STW1 start on 26-03-2014, and finish on 24-04-2014

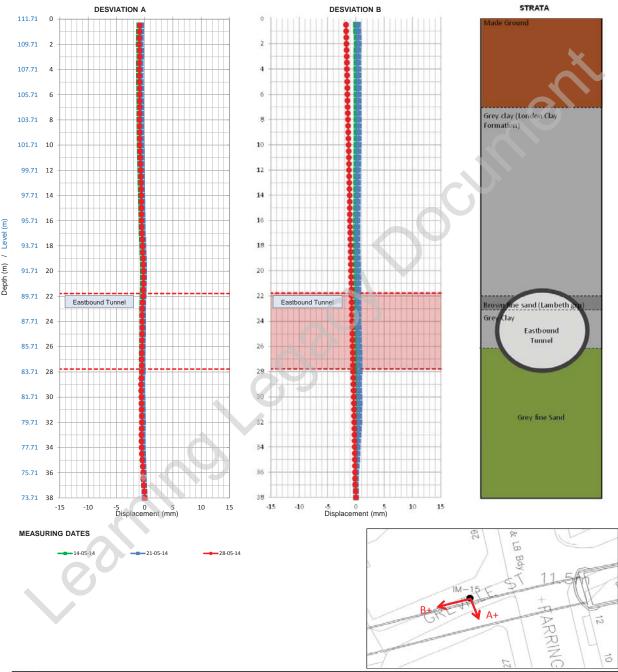
DEVICE: Inclinometer C435-IM00015 - READINGS AFTER WORKS

Readings after works do not show appreciable horitzontal displacements.

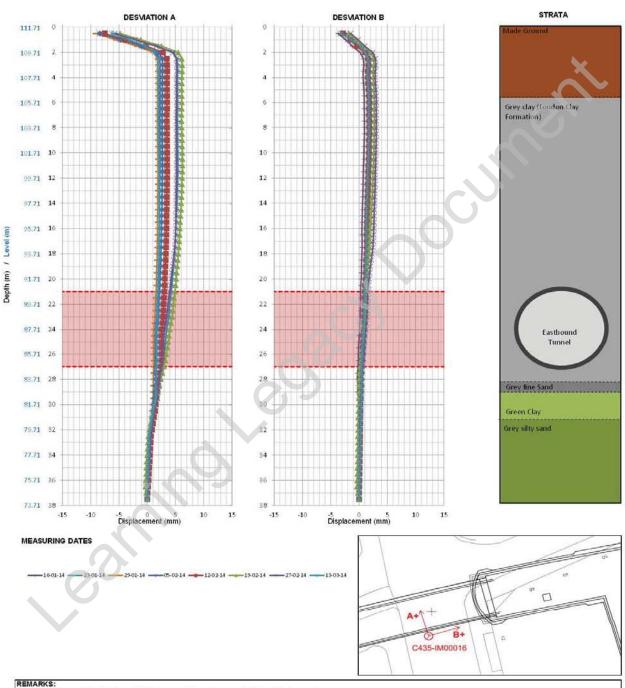
DEVICE: Inclinometer C435-IM00016 - READINGS BEFORE AND AFTER EASTBOUND TBM PASSAGE

Readings before and after Eastbound TBM passage did not show any significant displacement.

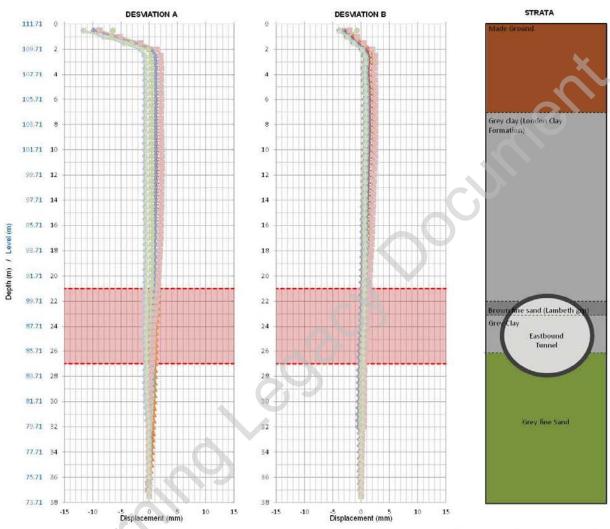
DEVICE: Inclinometer C435-IM00016 - READINGS BEFORE AND AFTER STW1 ENLARGEMENT

Readings during STW1 Enlargement works did not show any significant displacement.

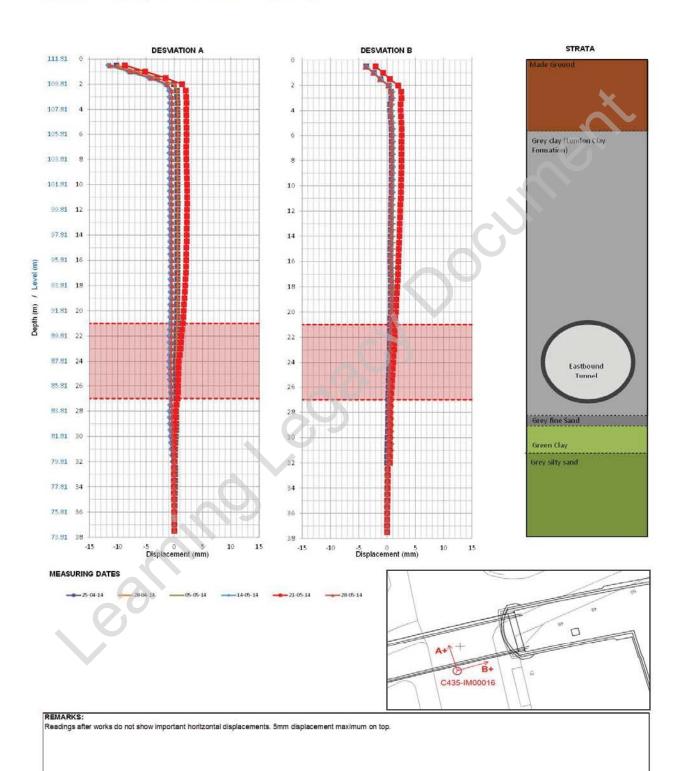
DEVICE: Inclinometer C435-IM00016 - ALL READINGS

Inclinometer C435-IM00016 shows a kink at the top in the graphs. The reason for this kink is a combination of issues. One of the issues is the top of the inclinometer is within made ground, this is made up of compacted type 1 which was used to backfill the Farringdon Road Water main replacement excavations, because this fill was place at the time the inclinometer was installed it is possible that the fill, reservation tube and inclinometer casing have move.

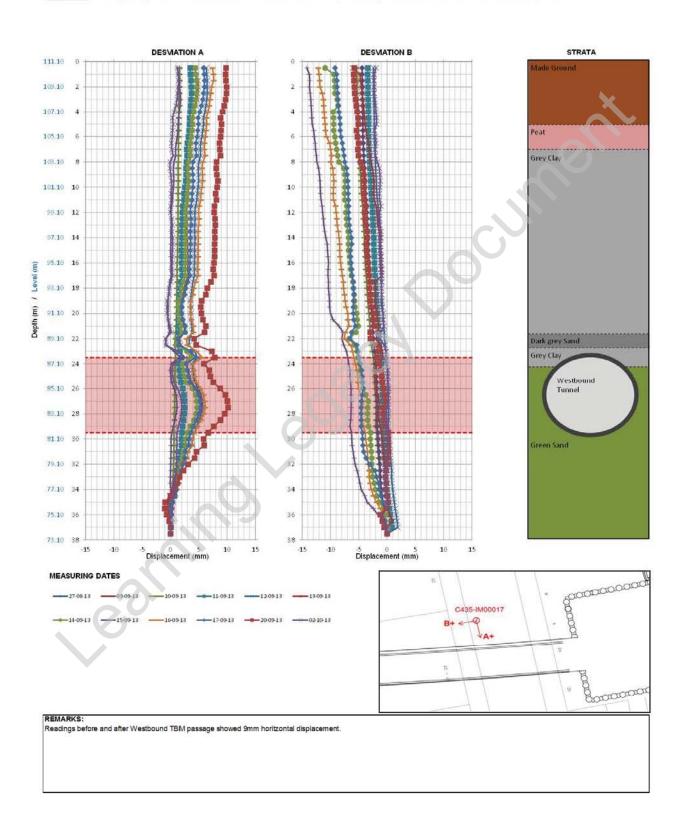
DEVICE: Inclinometer C435-IM00017 - READINGS BEFORE AND AFTER WESTBOUND TBM PASSAGE

The monitor data for the inclinometer located directly north of the WB TBM tunnel (C435-IM00017) is presented in Appendix B. The passage of the WB TBM tunnel is shown to have caused a maximum horizontal displacement of 9mm in the same level than tunnel, as expected. There is a reading taken on 15-10-13 that show maximum -15mm in B direction is a bad reading. During the enlargement of STW3 this inclinometer shows 4mm horizontal displacement, less than expected.

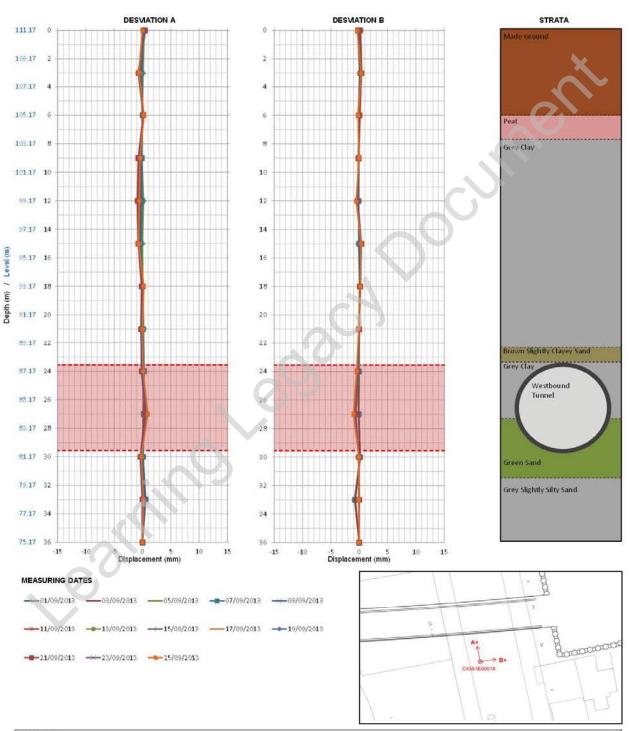
DEVICE: Inclinometer C435-IM00018 - READINGS BEFORE AND AFTER WESTBOUND TBM PASSAGE

Readings before and after westbound TBM passage do not shorw appreciable horitzontal displacement.

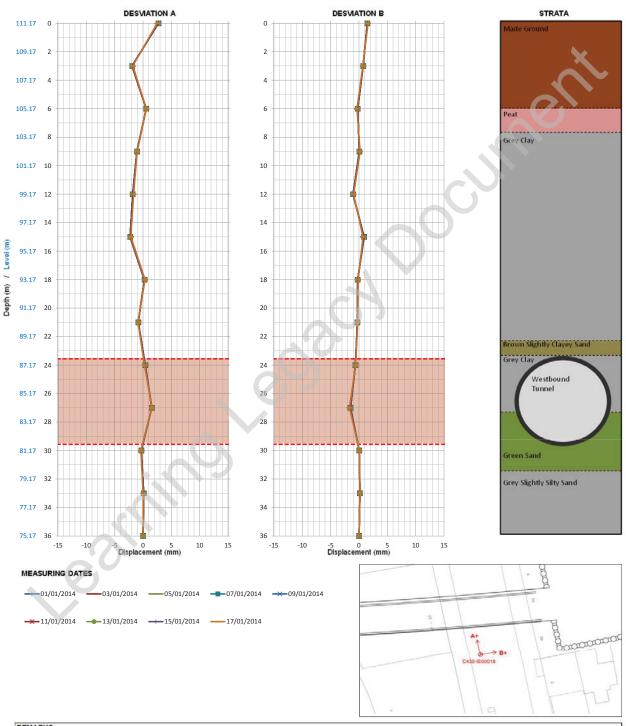
DEVICE: Inclinometer C435-IM00018 - READINGS BEFORE AND AFTER STW3 ENLARGEMENT

Readings before and after STW3 enlargement do not show any appreciable horizontal displacement.

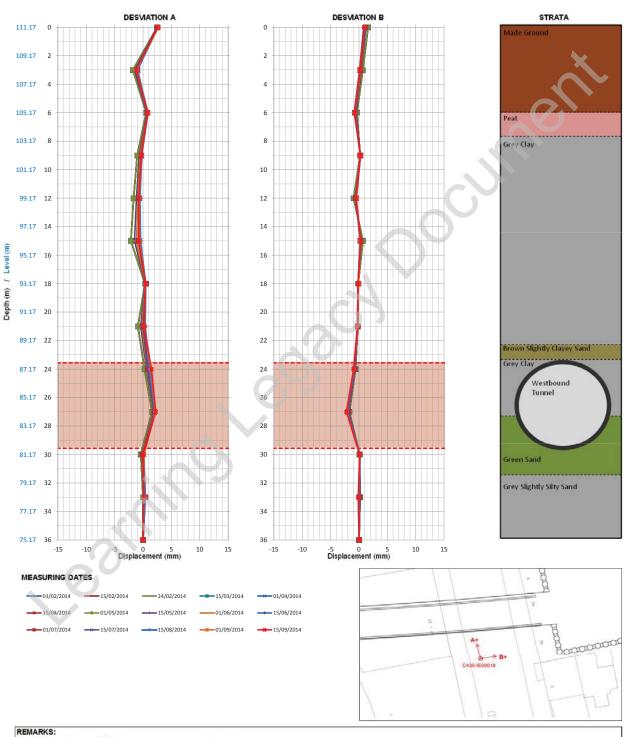
Inclinometer C435-IM00018 - READINGS BEFORE AND AFTER WESTBOUND TBM PASSAGE **DEVICE:**

Readings after works do not show appreciable horitzontal displacement.

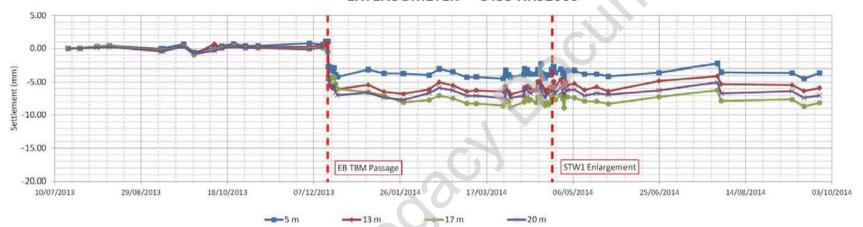
EXTENSOMETER C435-XR01000

The monitoring data for the extensometer at street level located directly above the crown of the EB TBM (C435-XR01000) is shown in Appendix B. The passage of the EB TBM is shown to have caused a maximum settlement of 7mm, recorded on the extensometer rod at 17m below

The settlement rate after all works is less than 0,5mm/year, so extensometer data is stable.

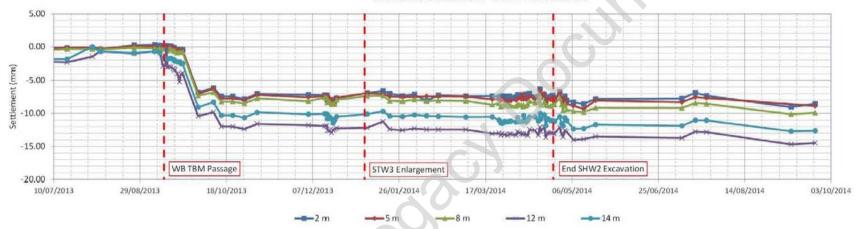
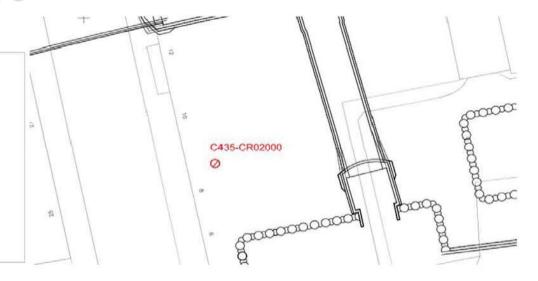
EXTENSOMETER C435-XR02000

The monitoring data for the extensometer within the WTH site located close WB TBM tunnel (C435-XR02000) is shown in Appendix B. The passage of the WB TBM is shown to have caused a maximum settlement of 9mm, recorded on the extensometer rod at 12m below surface level (around 3.5m above the crown of the tunnel). The settlement is shown to increase with depth from the surface, as expected, with only around 6mm recorded at 2m depth. During the enlargement of STW3 additional settlement of approximately 3mm was recorded on the extensometer rod at 12m depth.

The settlement rate after all works is less than 1,6mm/year, so extensometer data is stable.

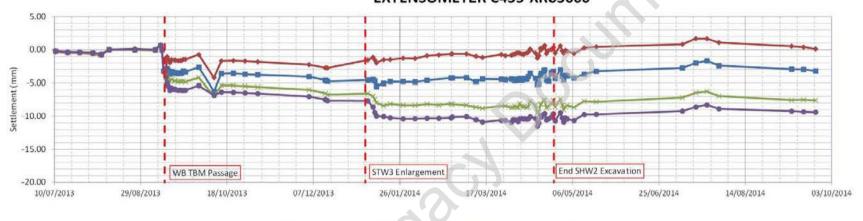
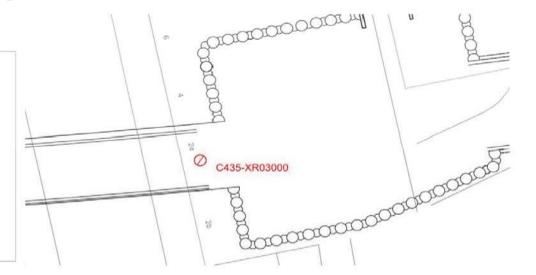
EXTENSOMETER C435-XR03000

The monitoring data for the extensometer within the WTH site located directly above the crown of the WB TBM tunnel (C435-XR03000) is presented in Appendix B. The passage of the WB TBM is shown to have caused a maximum settlement of 7mm, recorded on the extensometer rod at 12m below surface level (around 3.5m above the crown of the tunnel). The settlement is shown to increase with depth from the surface, as expected, with only around 2mm recorded at 2m depth. During the enlargement of STW3 additional settlement of approximately 3mm was recorded on the extensometer rod at 12m depth.

The settlement rate after all works is less than 1,0mm/year, so extensometer data is stable.
