C435 Farringdon Main Station

Monitoring Close-Out Report: Levelling Points Installed on St John St. CRL Document Number: C435-BFK-C2-RGN-M123-51637

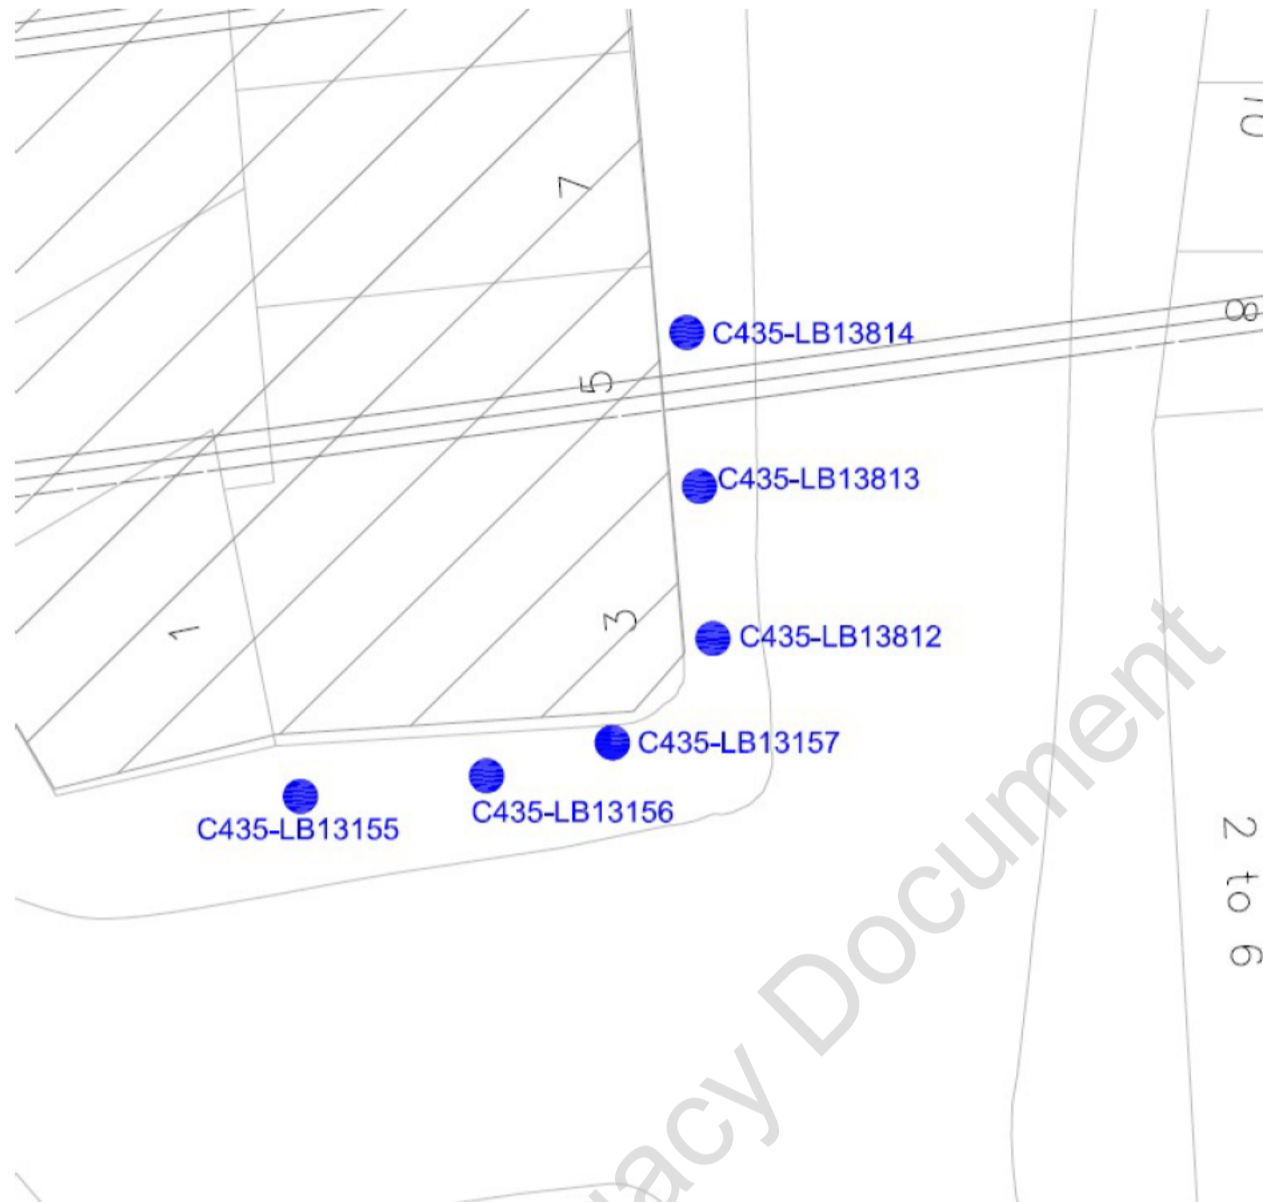
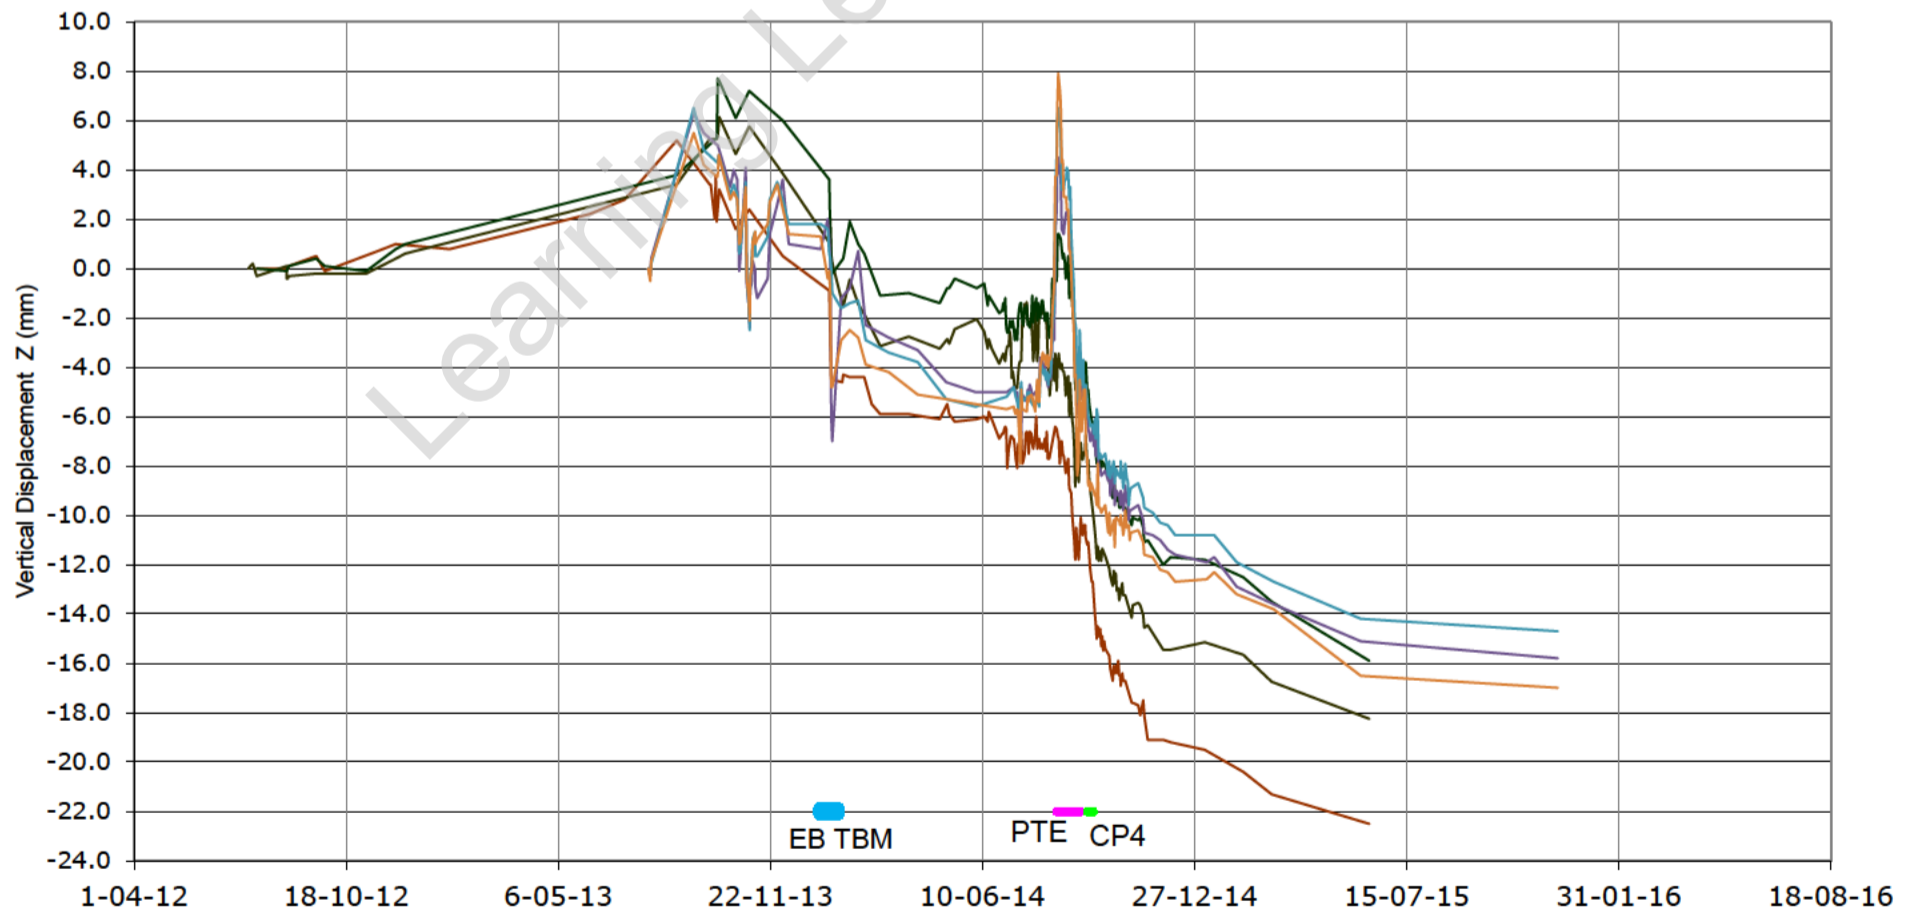
REPORT LEVELLING
AREA 3-5 ST JOHN STREET
DEVICE Precise Levelling Points

- In August 2013 compensation grouting caused 4mm maximum of heave.
- From 16-01-2014 to 17-01-2014 the EB TBM caused maximum 6mm of settlement.
- Residual settlement caused 1-2mm of settlement.
- During July and August 2014 compensation grouting caused 13-14mm maximum of heave.
- Between 19-08-2014 and 10-09-2014 PTE caused 6mm of settlement maximum.
- CP4 construction caused 8-10mm maximum of settlement from 10-09-2014 to 17-09-2016.
- Maximum settlement at the end of the works -23mm

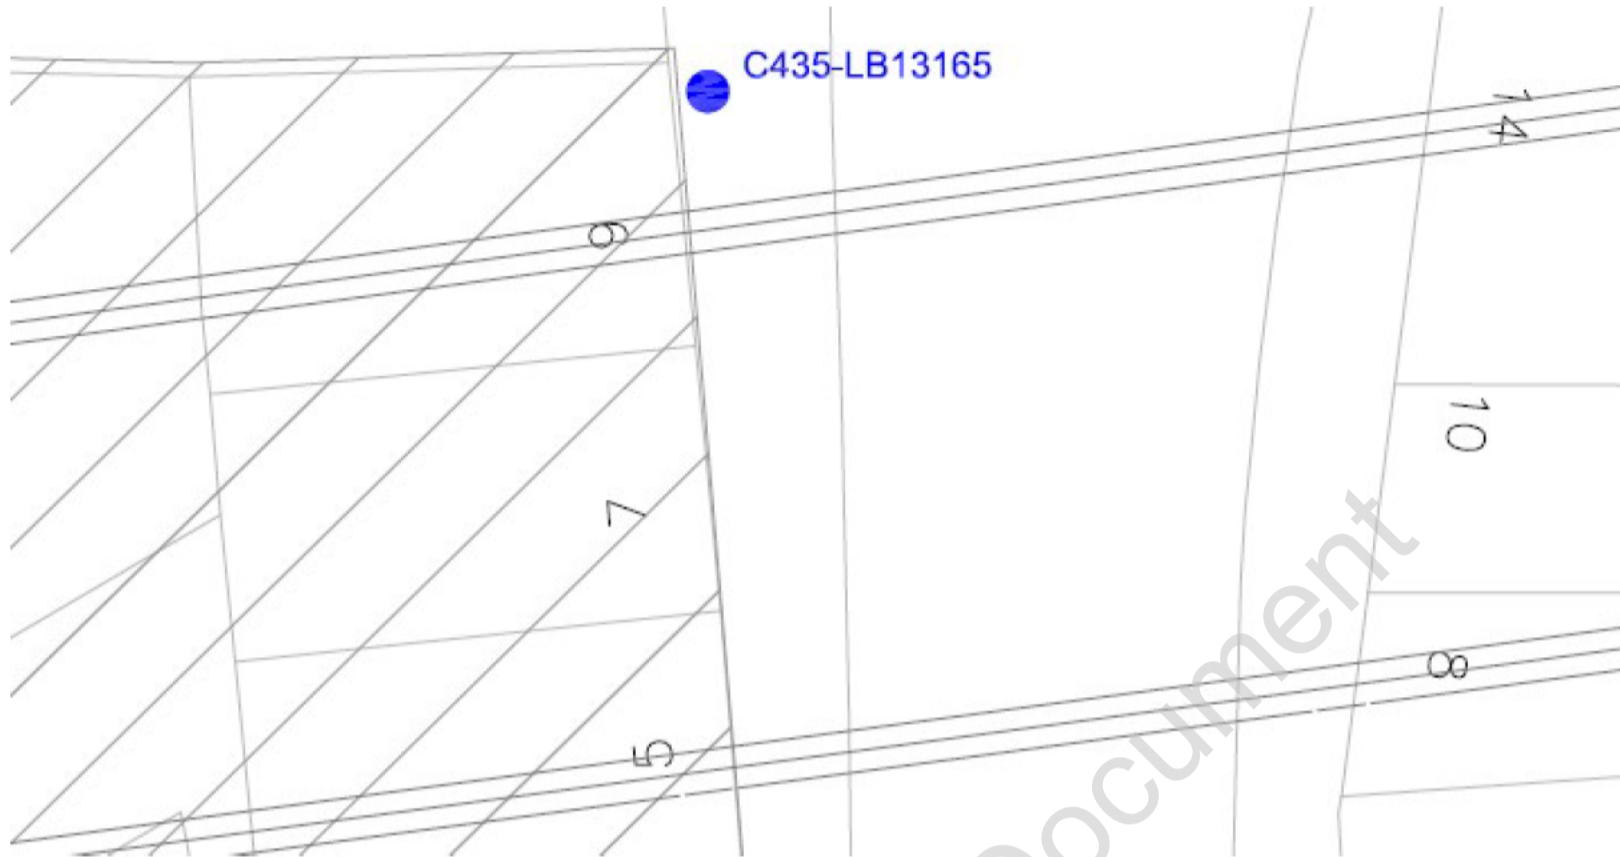
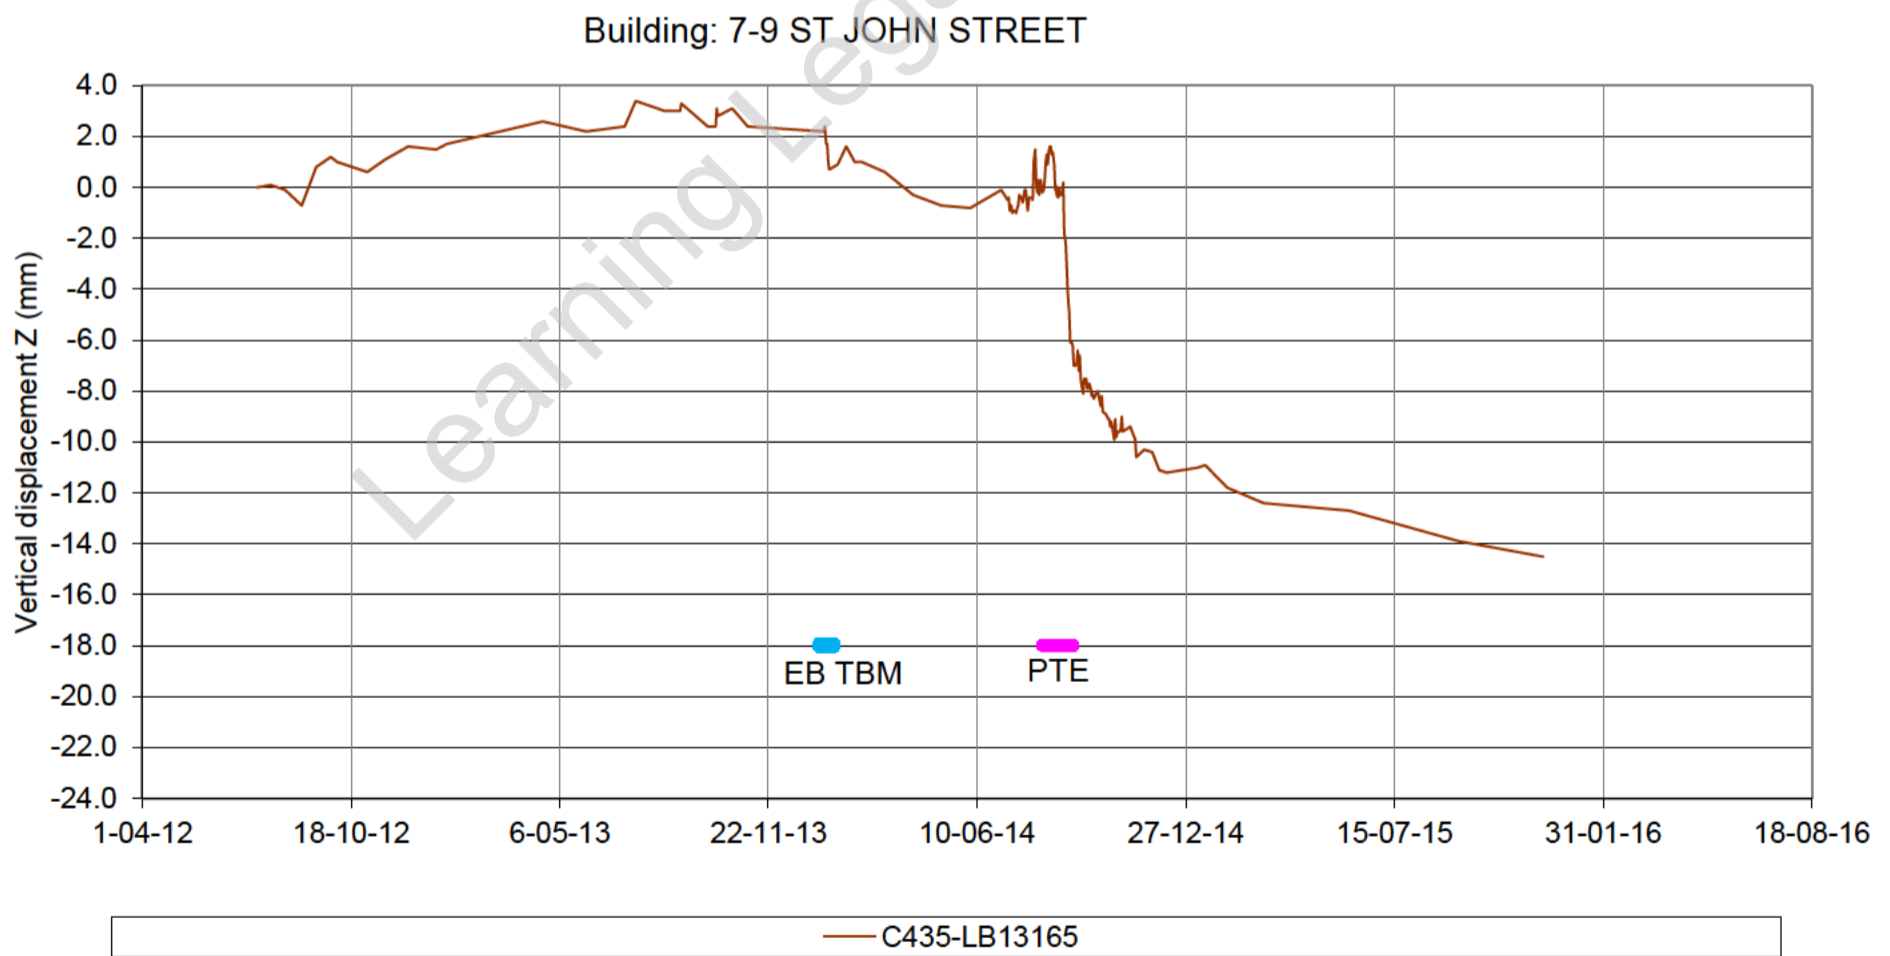
REPORT LEVELLING
AREA 7-9 ST JOHN STREET
DEVICE Precise Levelling Points

- On August 2013 compensation grouting caused 2-3mm of heave.
- On 16-01-2014 EB TBM caused 2mm maximum of settlement.
- On 05-08-2014 compensation grouting caused 2mm of heave.
- Between 19-08-2014 and 10-09-2014 PTE enlargement caused 8-10mm maximum of settlement.
- Maximum settlement at the end of the works -15mm

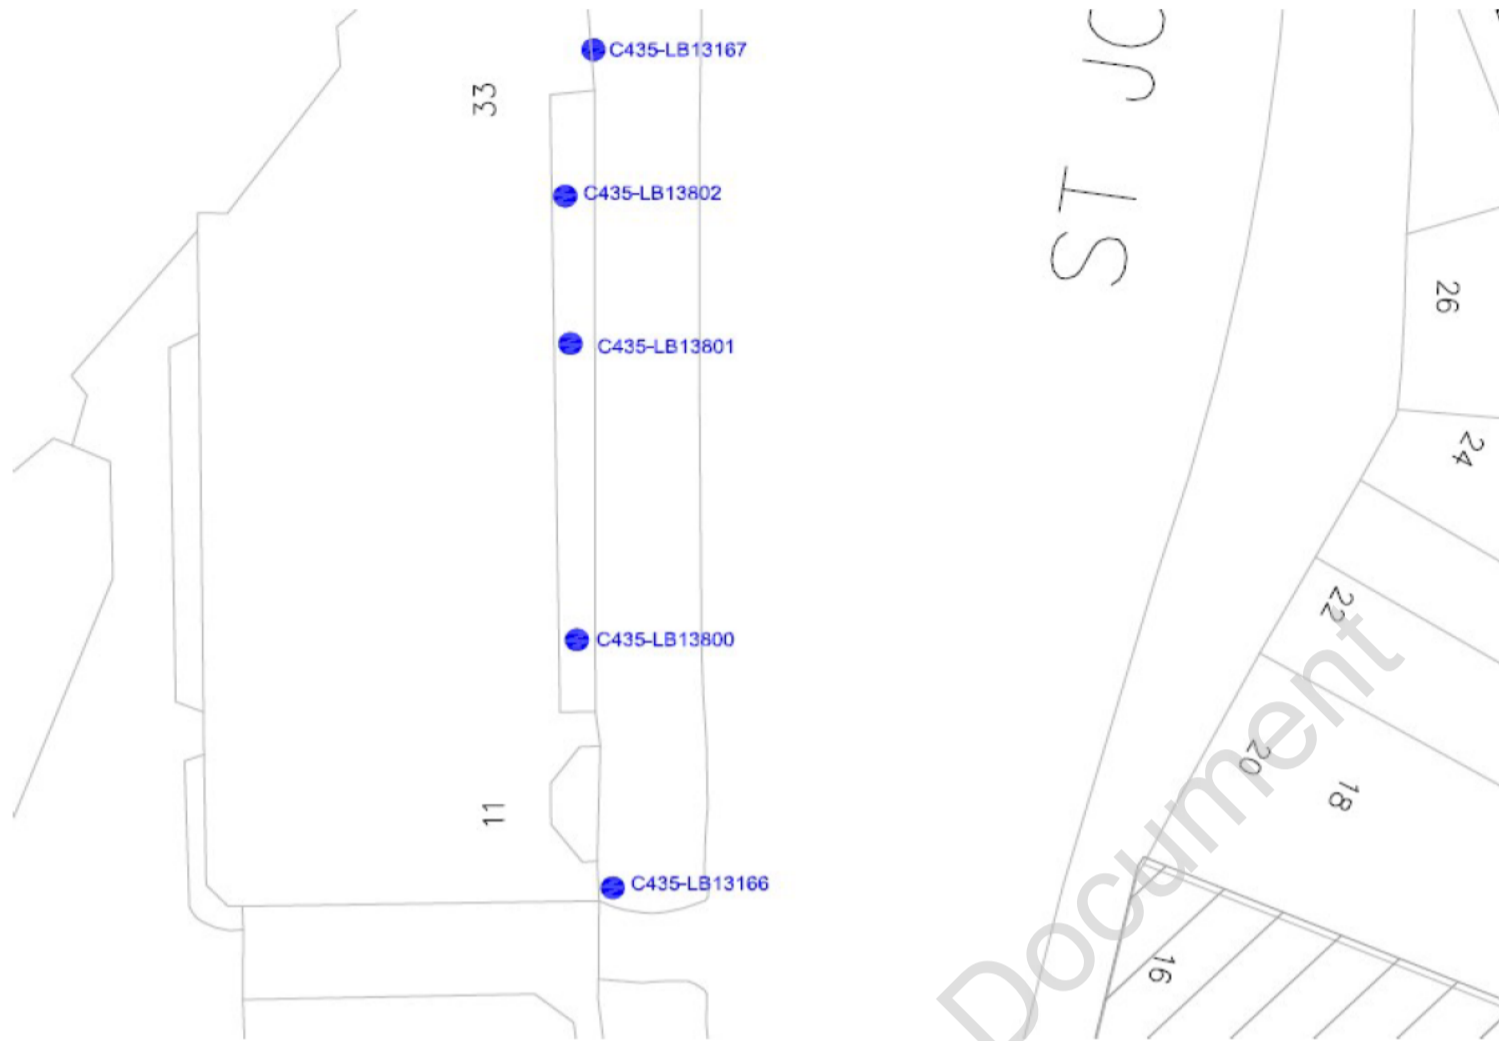
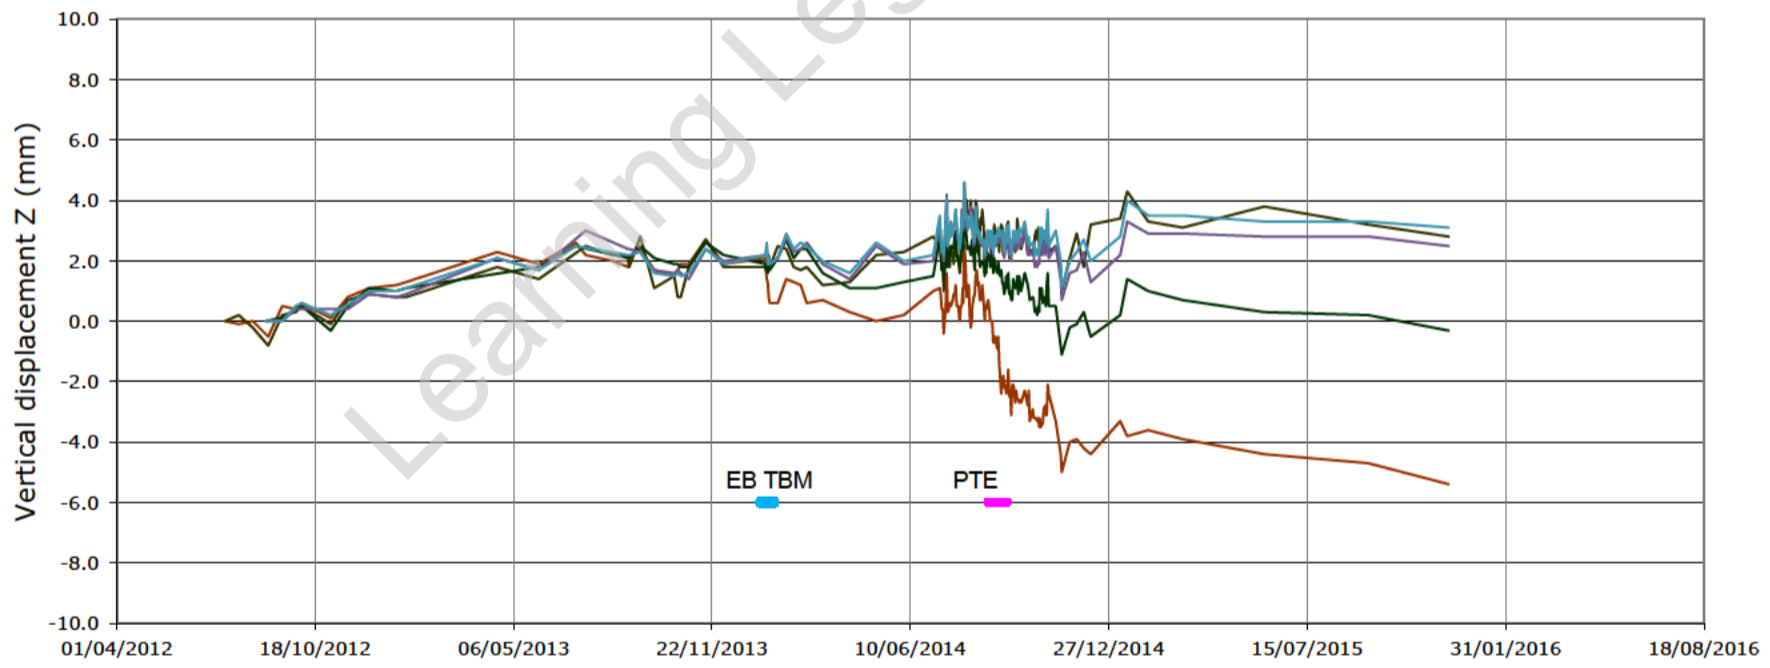
REPORT LEVELLING
 AREA 11-33 ST JOHN STREET
 DEVICE Precise Levelling Points

- On 16-01-2014 Eastbound TBM caused 1mm maximum of settlement.
- Between 02-09-2014 and 10-09-2014 PTE works caused 4-5mm maximum of settlement.
- Maximum settlement at the end of the works -5mm

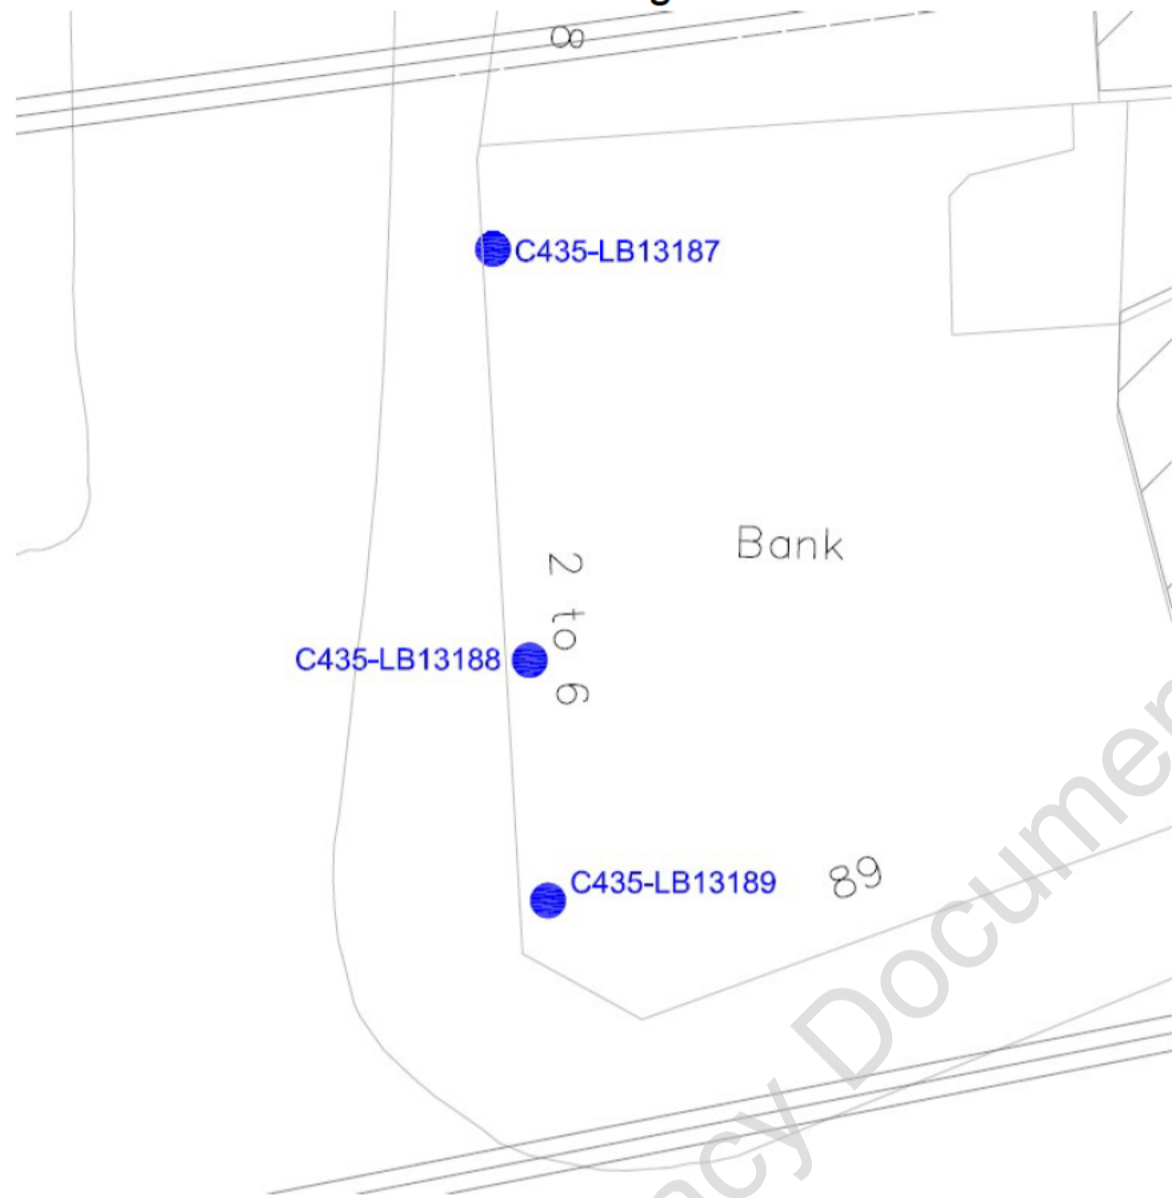
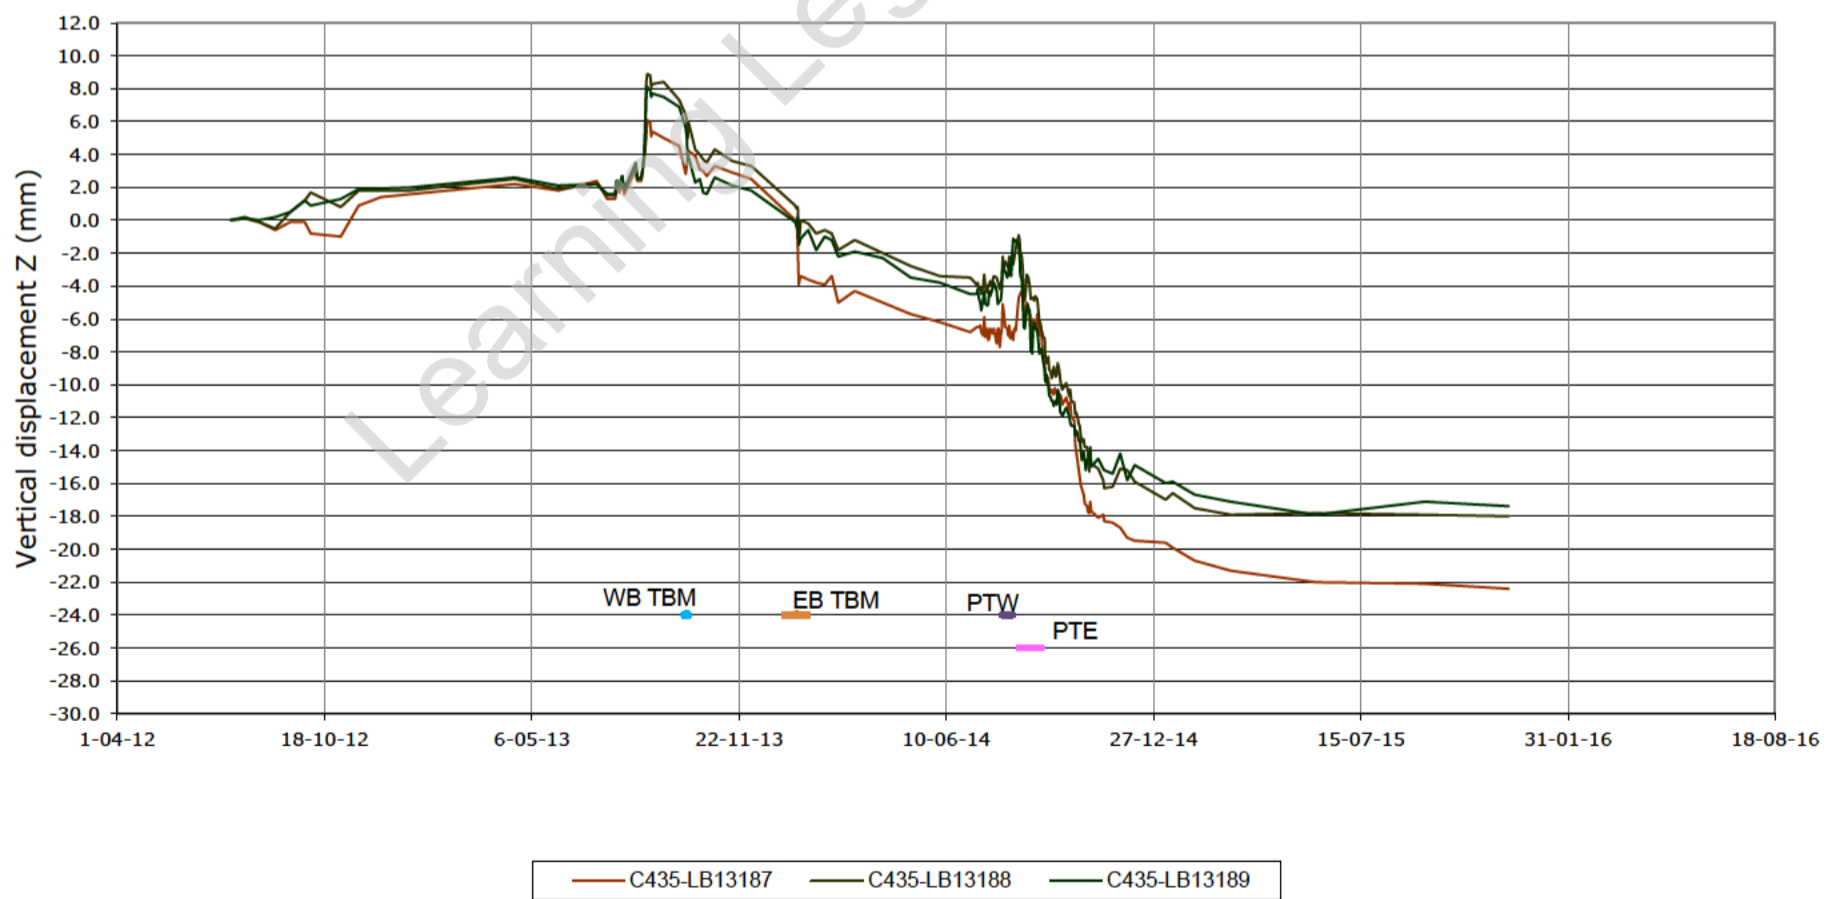
REPORT LEVELLING
AREA 2-6 ST JOHN STREET
DEVICE Precise Levelling Points

- On 23-08-2013 compensation grouting caused 6-7mm maximum of heave.
- From 01-10-2013 to 03-10-2013 Westbound TBM caused 2mm of settlement.
- Residual settlement caused 2mm maximum of settlement.
- Between 16-01-2014 and 17-01-2014 Eastbound TBM caused 4-5mm maximum of settlement.
- Residual settlement after EB TBM caused 3-4mm of settlement.
- Compensation grouting caused 2mm maximum of heave on 09-08-2014.
- Between 03-08-2014 to 13-08-2014 PTW enlargement works caused 10mm maximum of settlement.
- From 19-08-2014 to 10-09-2014 PTE works caused 7-8mm of settlement.
- Maximum settlement at the end of the works -22mm

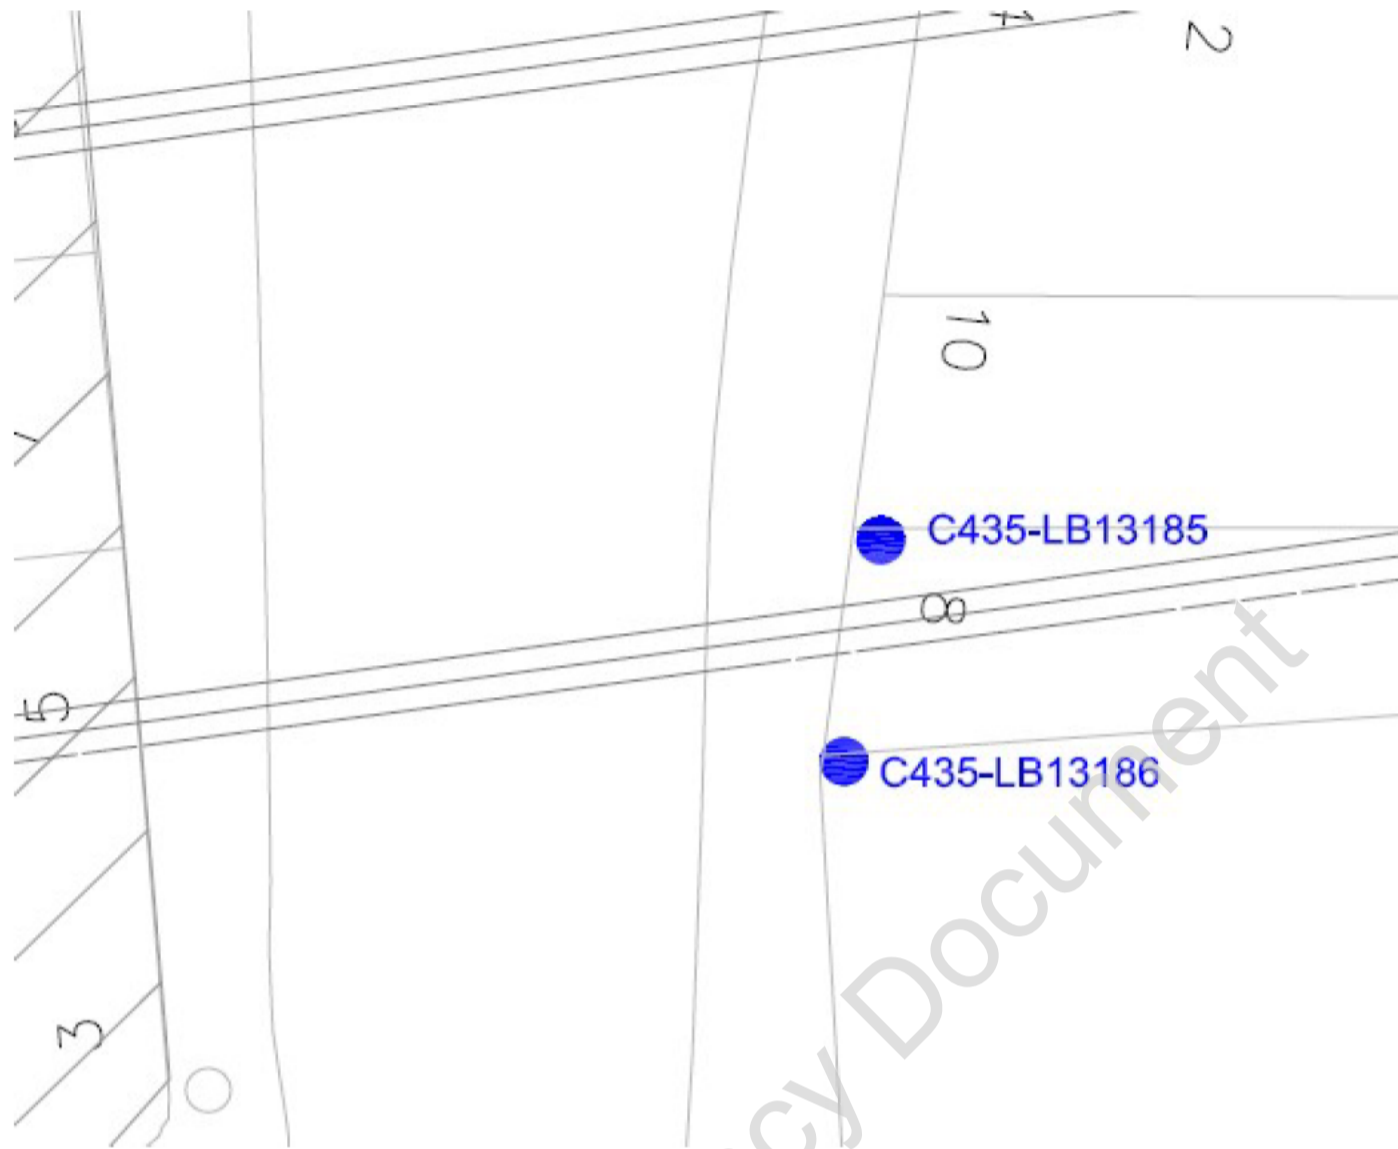
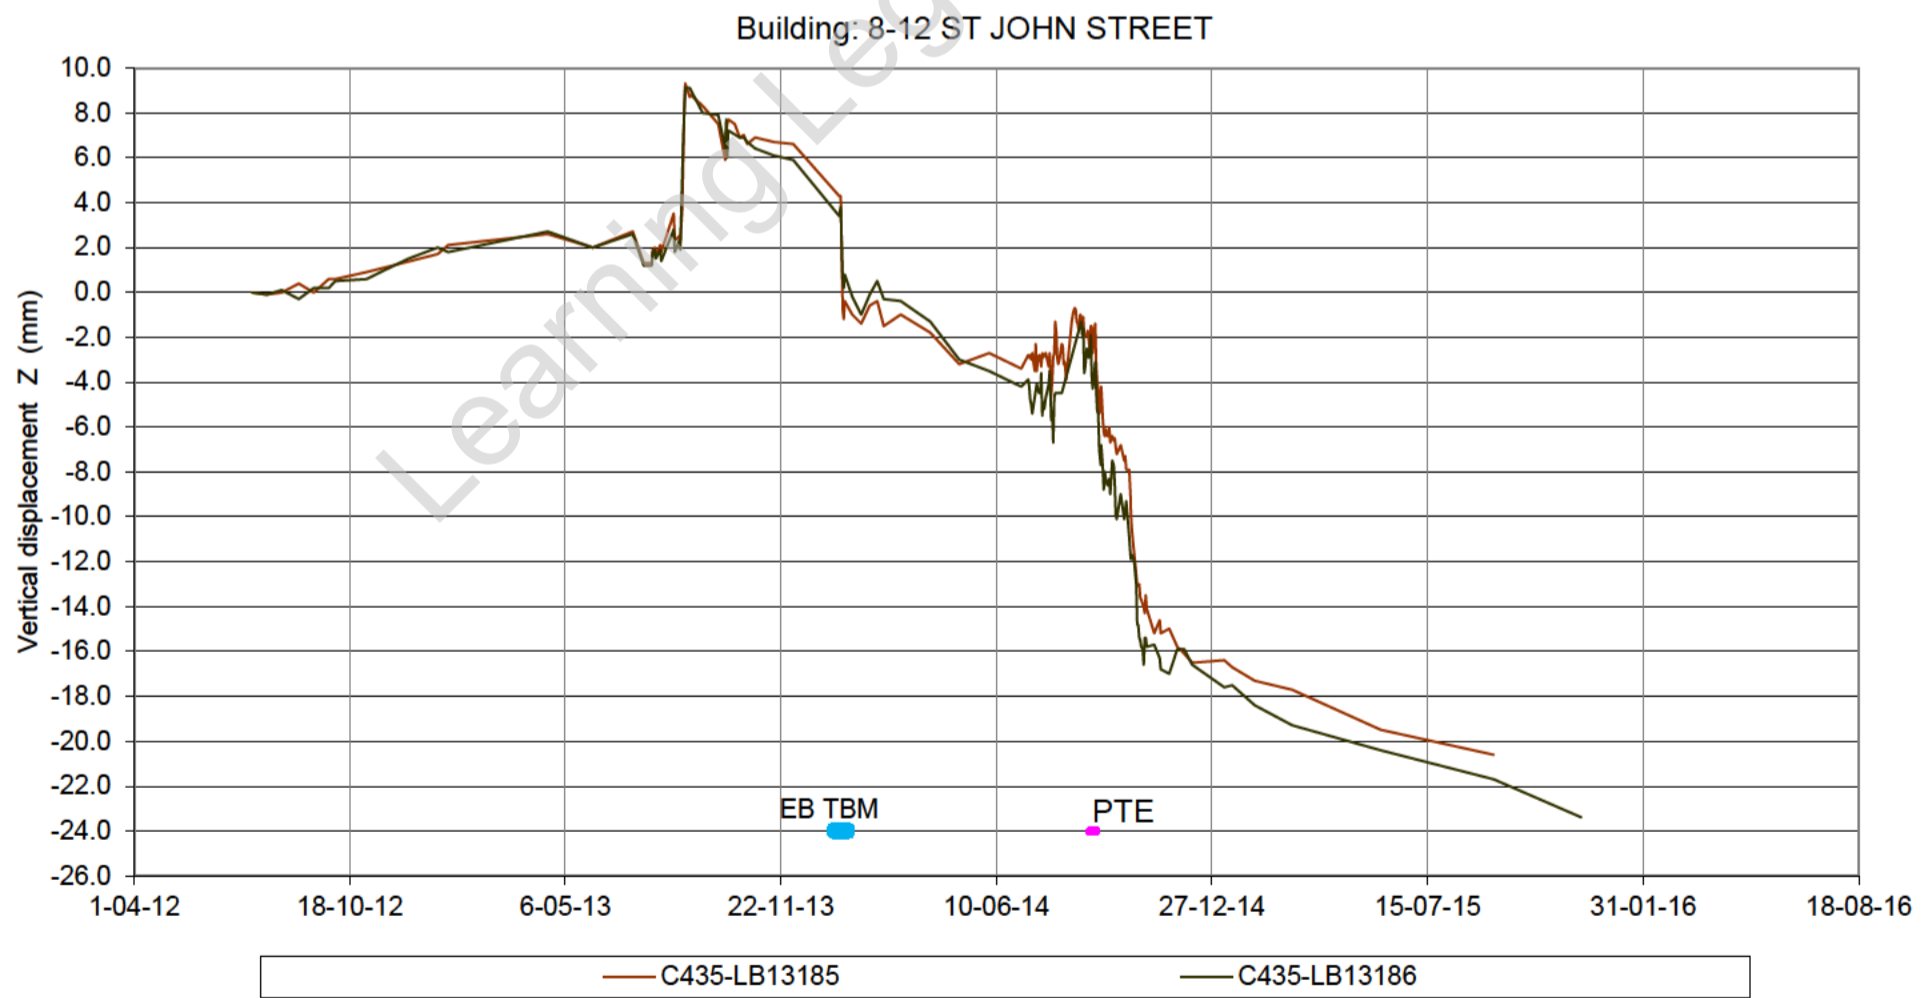
REPORT LEVELLING
AREA 8-12 ST JOHN STREET
DEVICE Precise Levelling Points

- On 25-08-2013 compensation grouting caused 6-7mm maximum of heave.
- From 16-01-2014 to 17-01-2014 EB TBM caused 4mm of settlement.
- Residual settlement caused 4mm maximum of settlement.
- On 03-09-2014 compensation grouting caused 2-3mm of heave.
- Between 05-09-2014 and 10-09-2014 PTE construction caused 14-16mm maximum of settlement.
- Maximum settlement at the end of the works -23mm

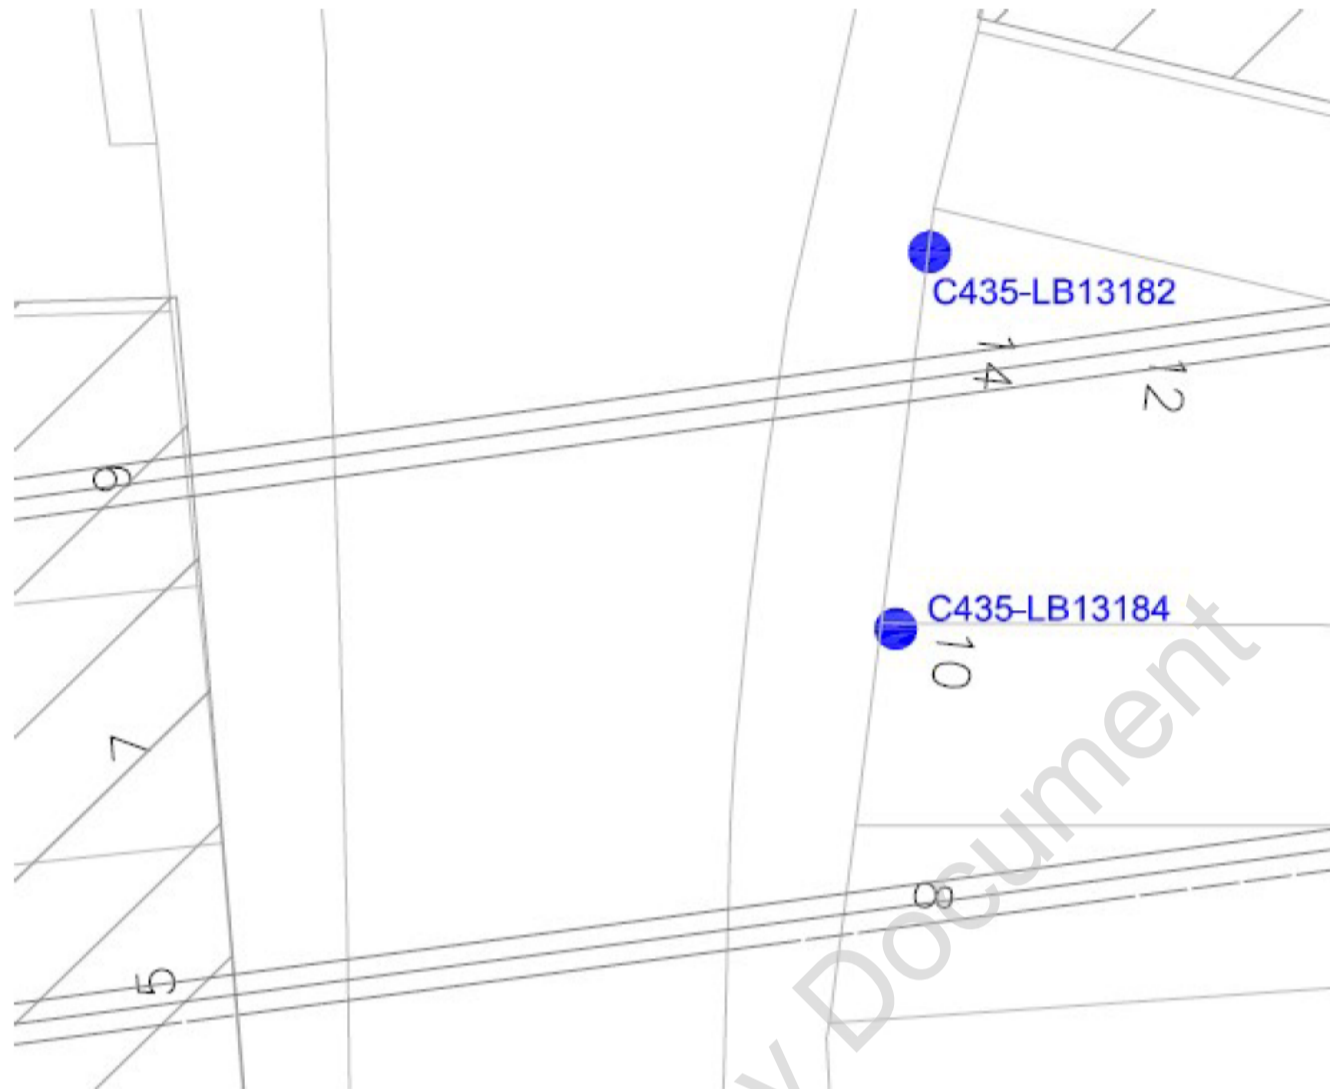
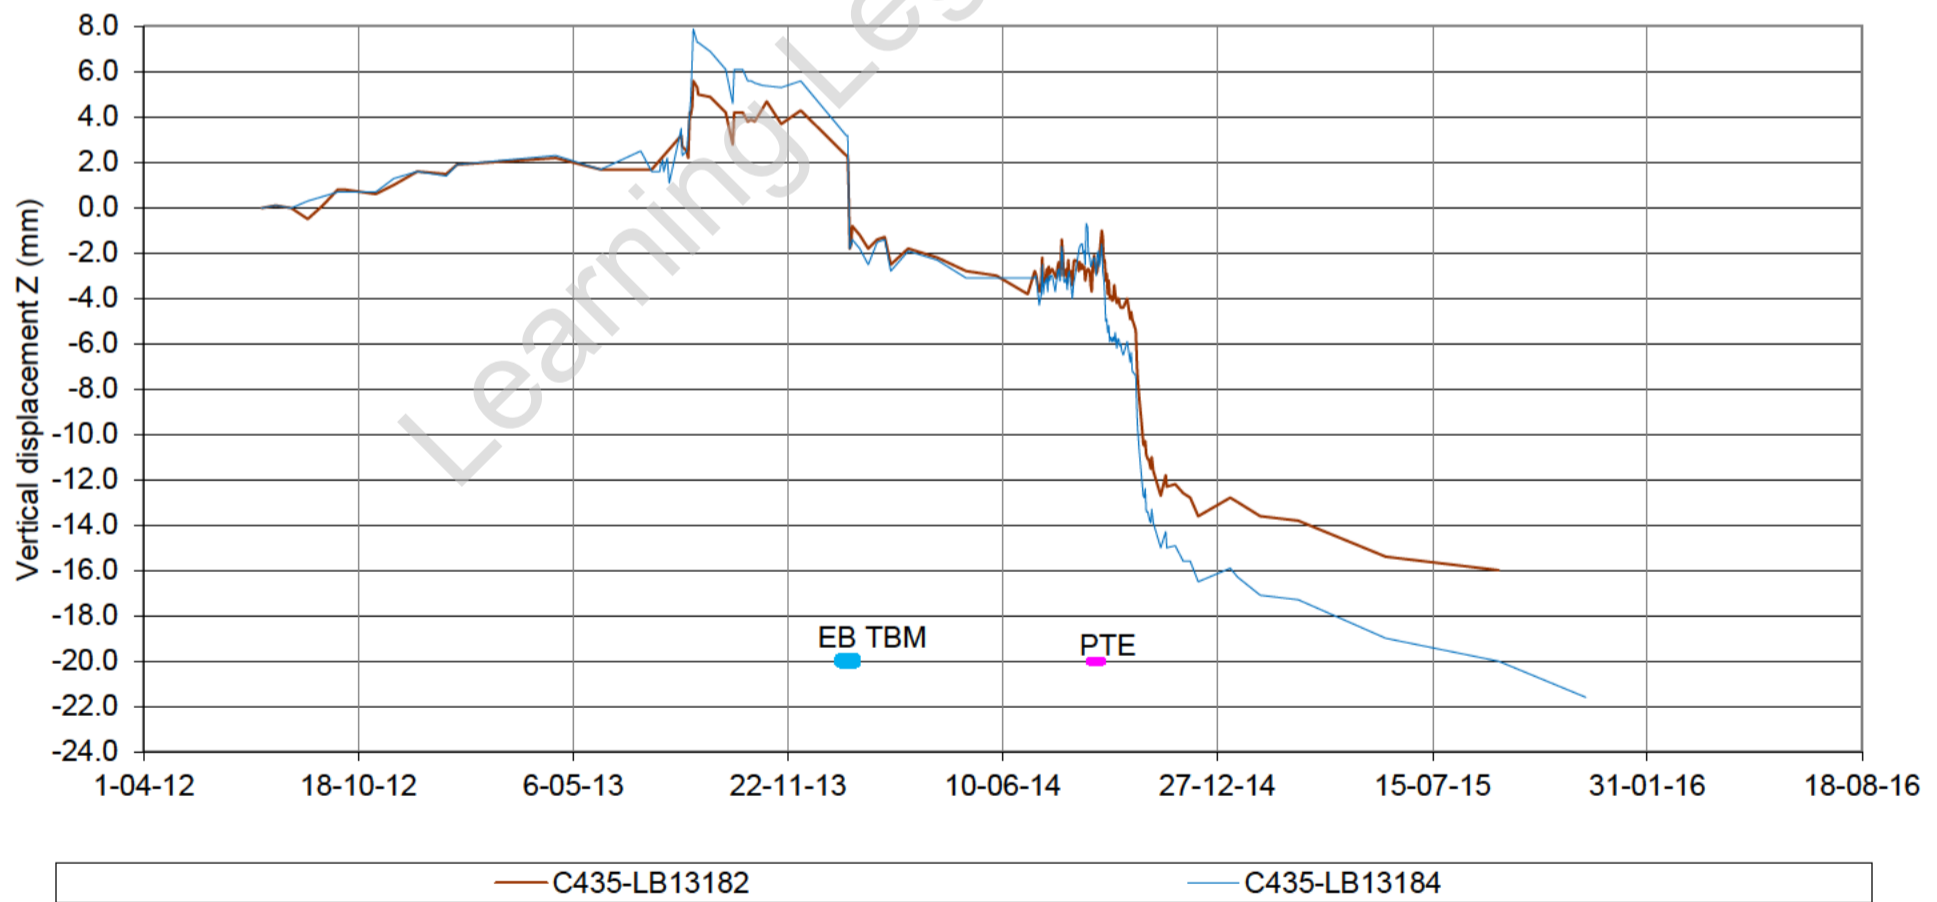
REPORT LEVELLING
AREA 12-14 ST JOHN STREET
DEVICE Precise Levelling Points

- Compensation grouting from Moorgate Shaft 1 caused 6-7mm of heave on 23-08-2013.
- On 16-01-2014 EB TBM caused 4-5mm maximum of settlement.
- Residual settlement caused 2mm of settlement.
- From 30-08-2014 to 10-09-2014 PTE works caused 14-15mm of settlement.
- Maximum settlement at the end of the works -22mm

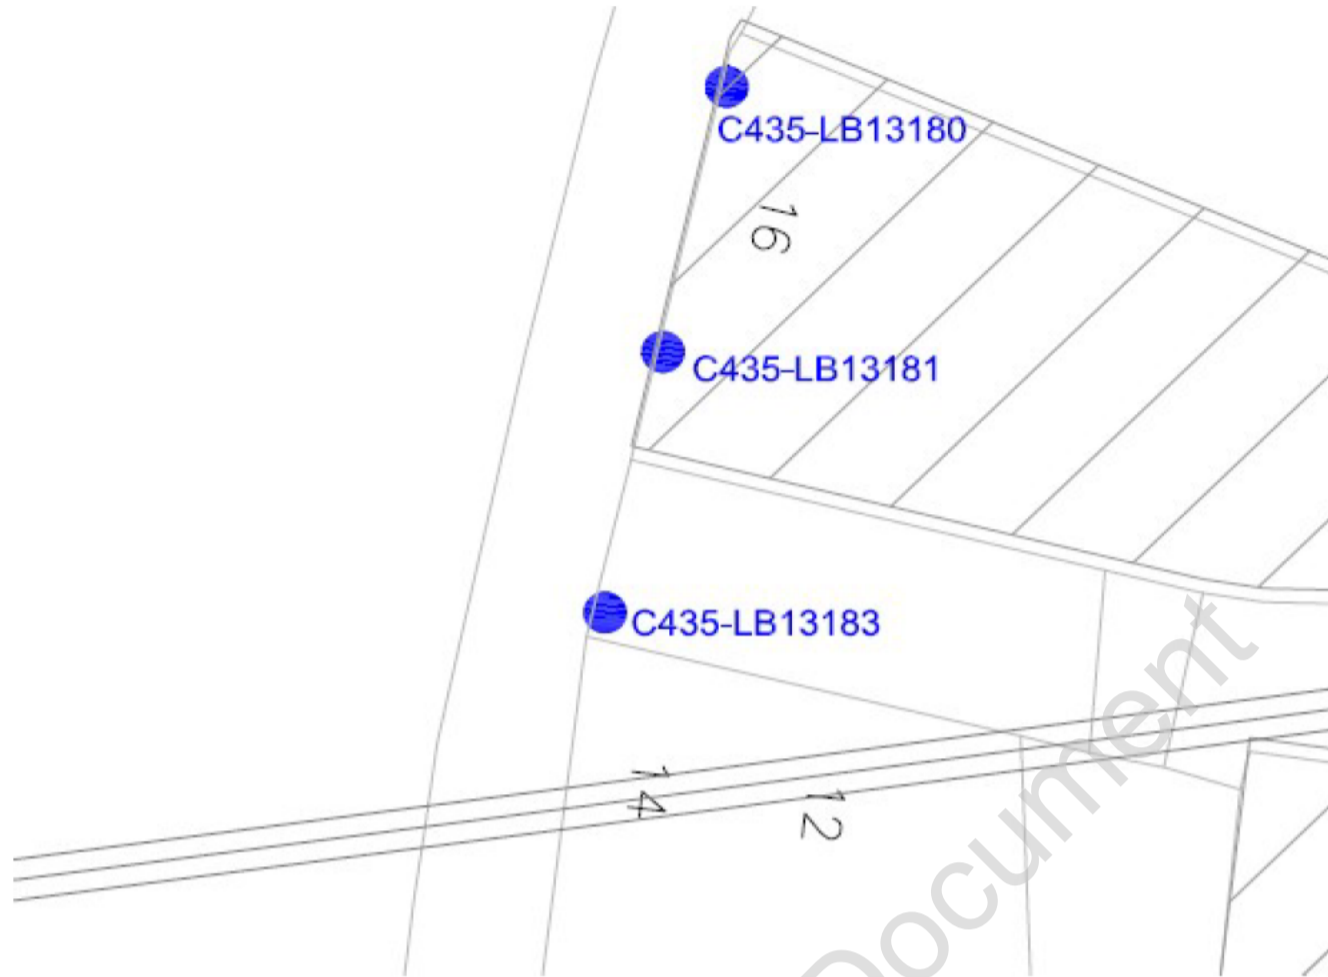
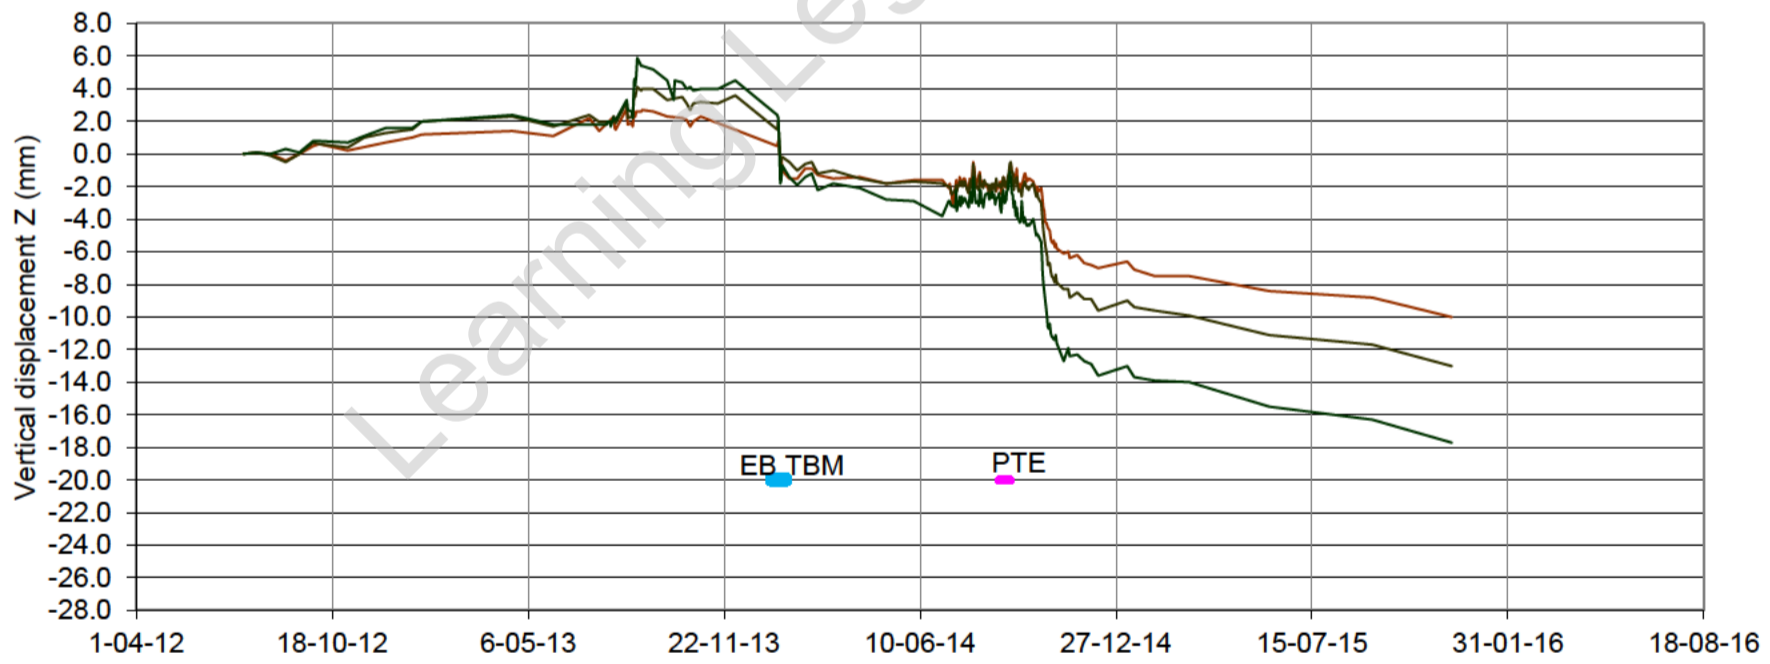
REPORT LEVELLING
AREA 16 St John St
DEVICE Precise Levelling Points

- Compensation grouting carried out on 22-08-2013 caused 4mm maximum of heave.
- On 16-01-2014 EB TBM caused 3-4mm maximum of settlement.
- PTE works caused 8-9mm maximum of settlement from 30-08-2014 to 10-09-2014.
- Maximum settlement at the end of the works -18mm
