C435 Farringdon Main Station

Monitoring Close-Out Report: Levelling Points Installed on St John St. CRL Document Number: C435-BFK-C2-RGN-M123-51637

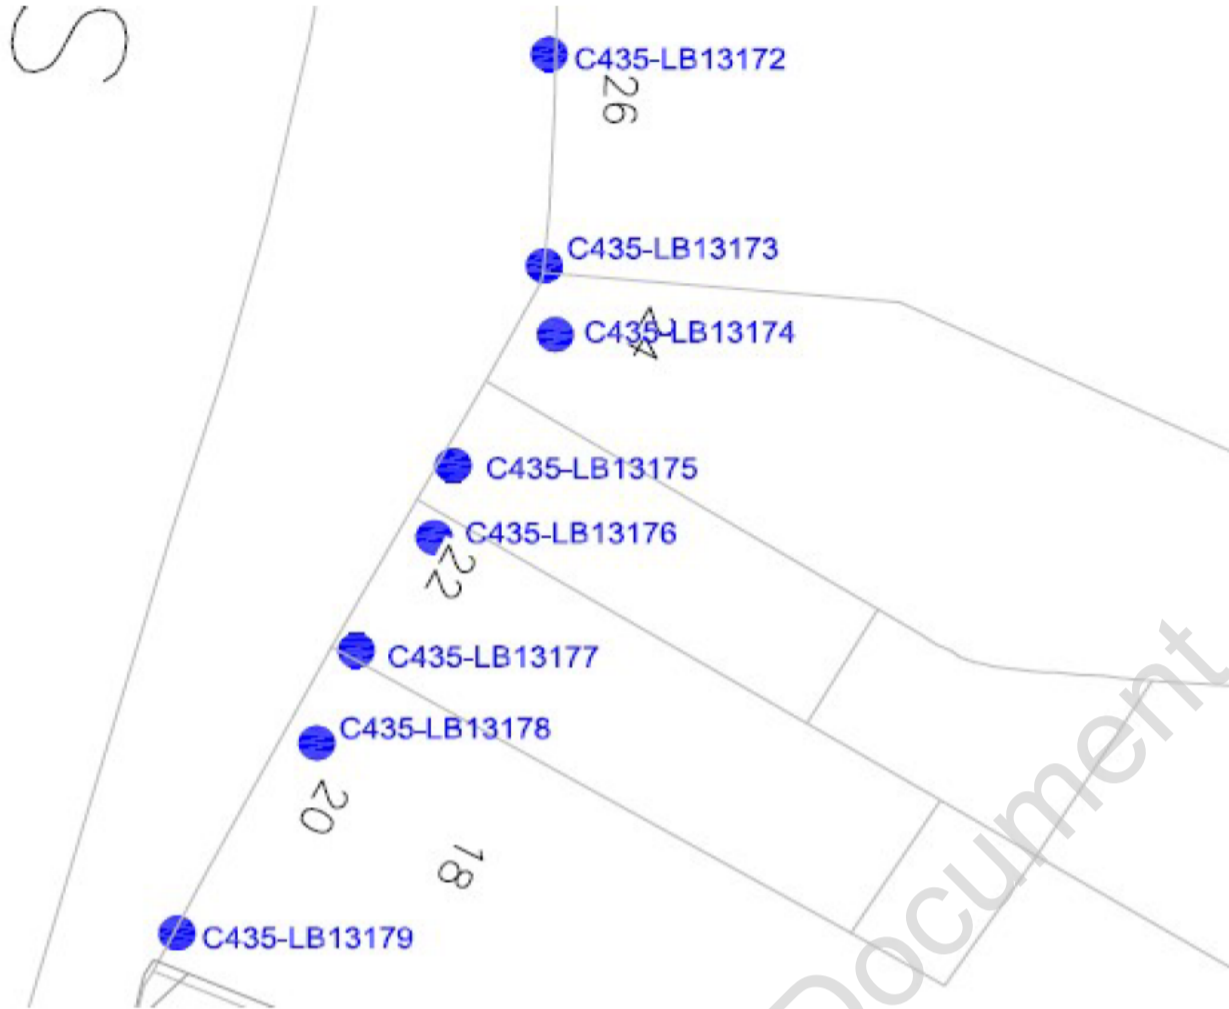
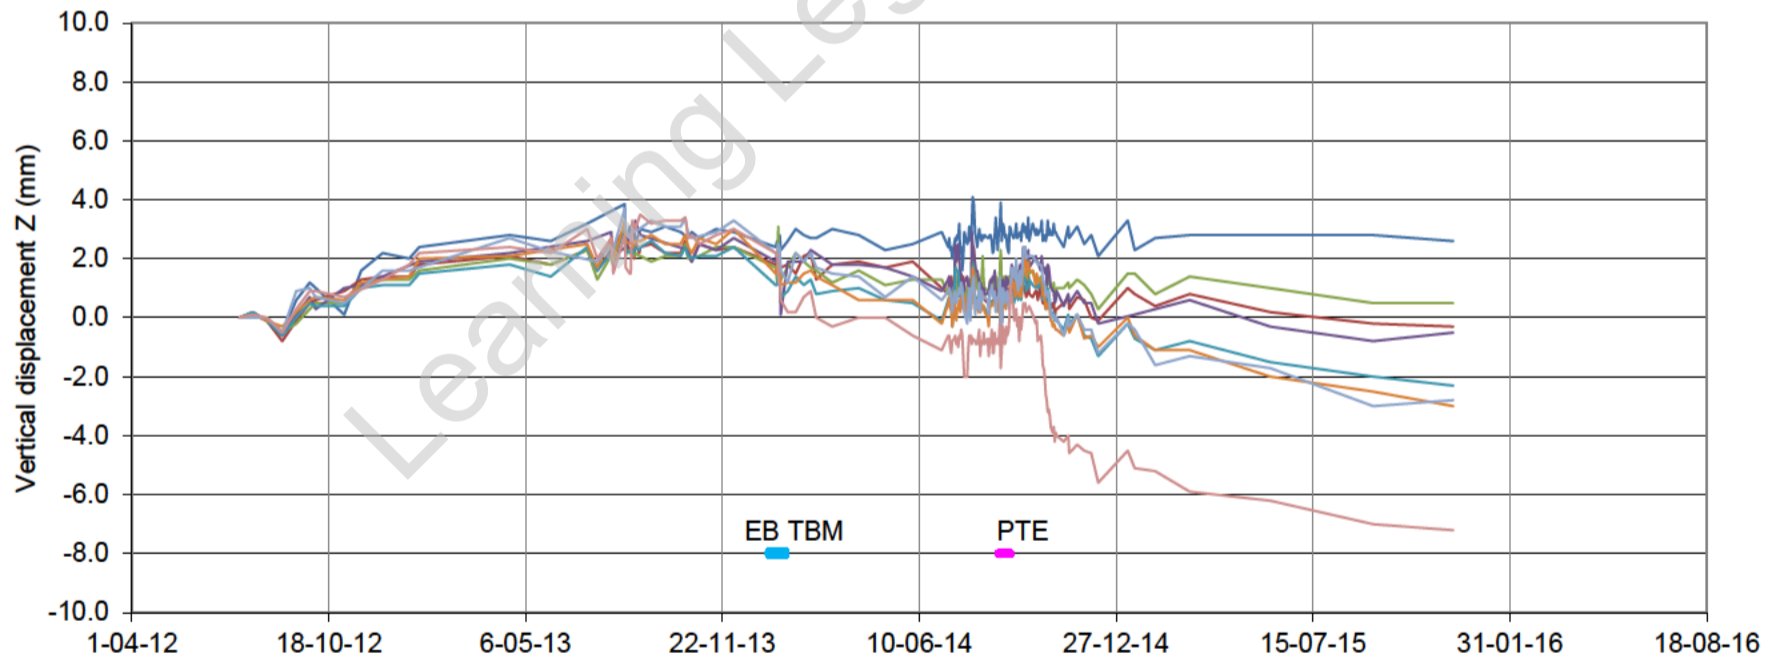
LEVELLING
20-26 St John St
Precise Levelling Points

- 2mm maximum of settlement caused by the EB TBM on 16-01-2014.
- From 30-08-2014 to 10-09-2014 PTE works caused 4mm maximum of settlement.
- Maximum settlement at the end of the works -7mm

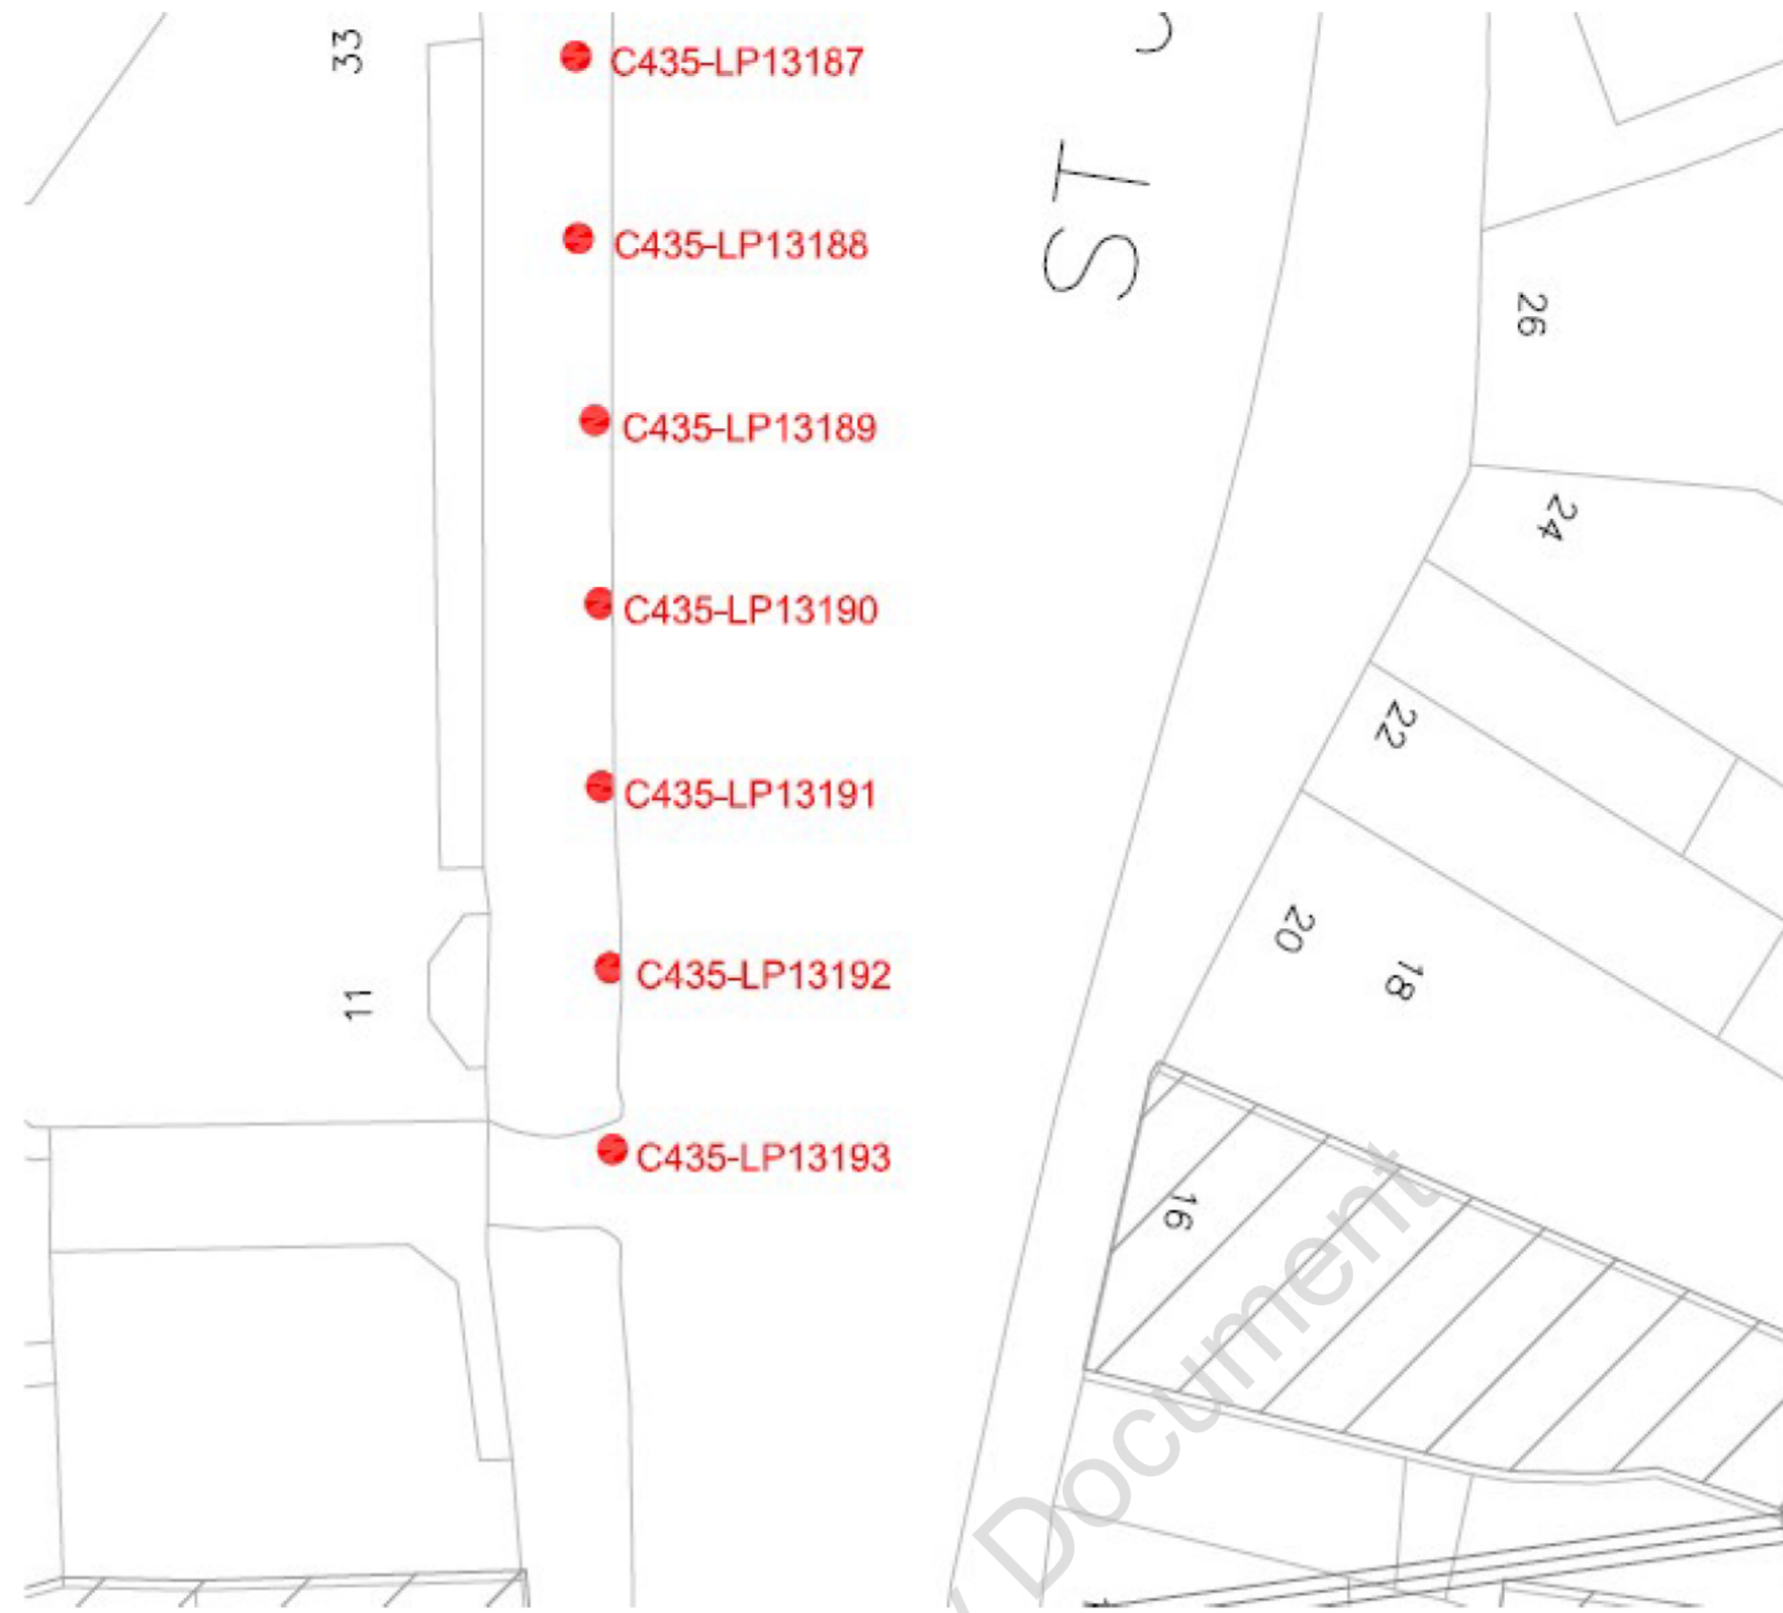
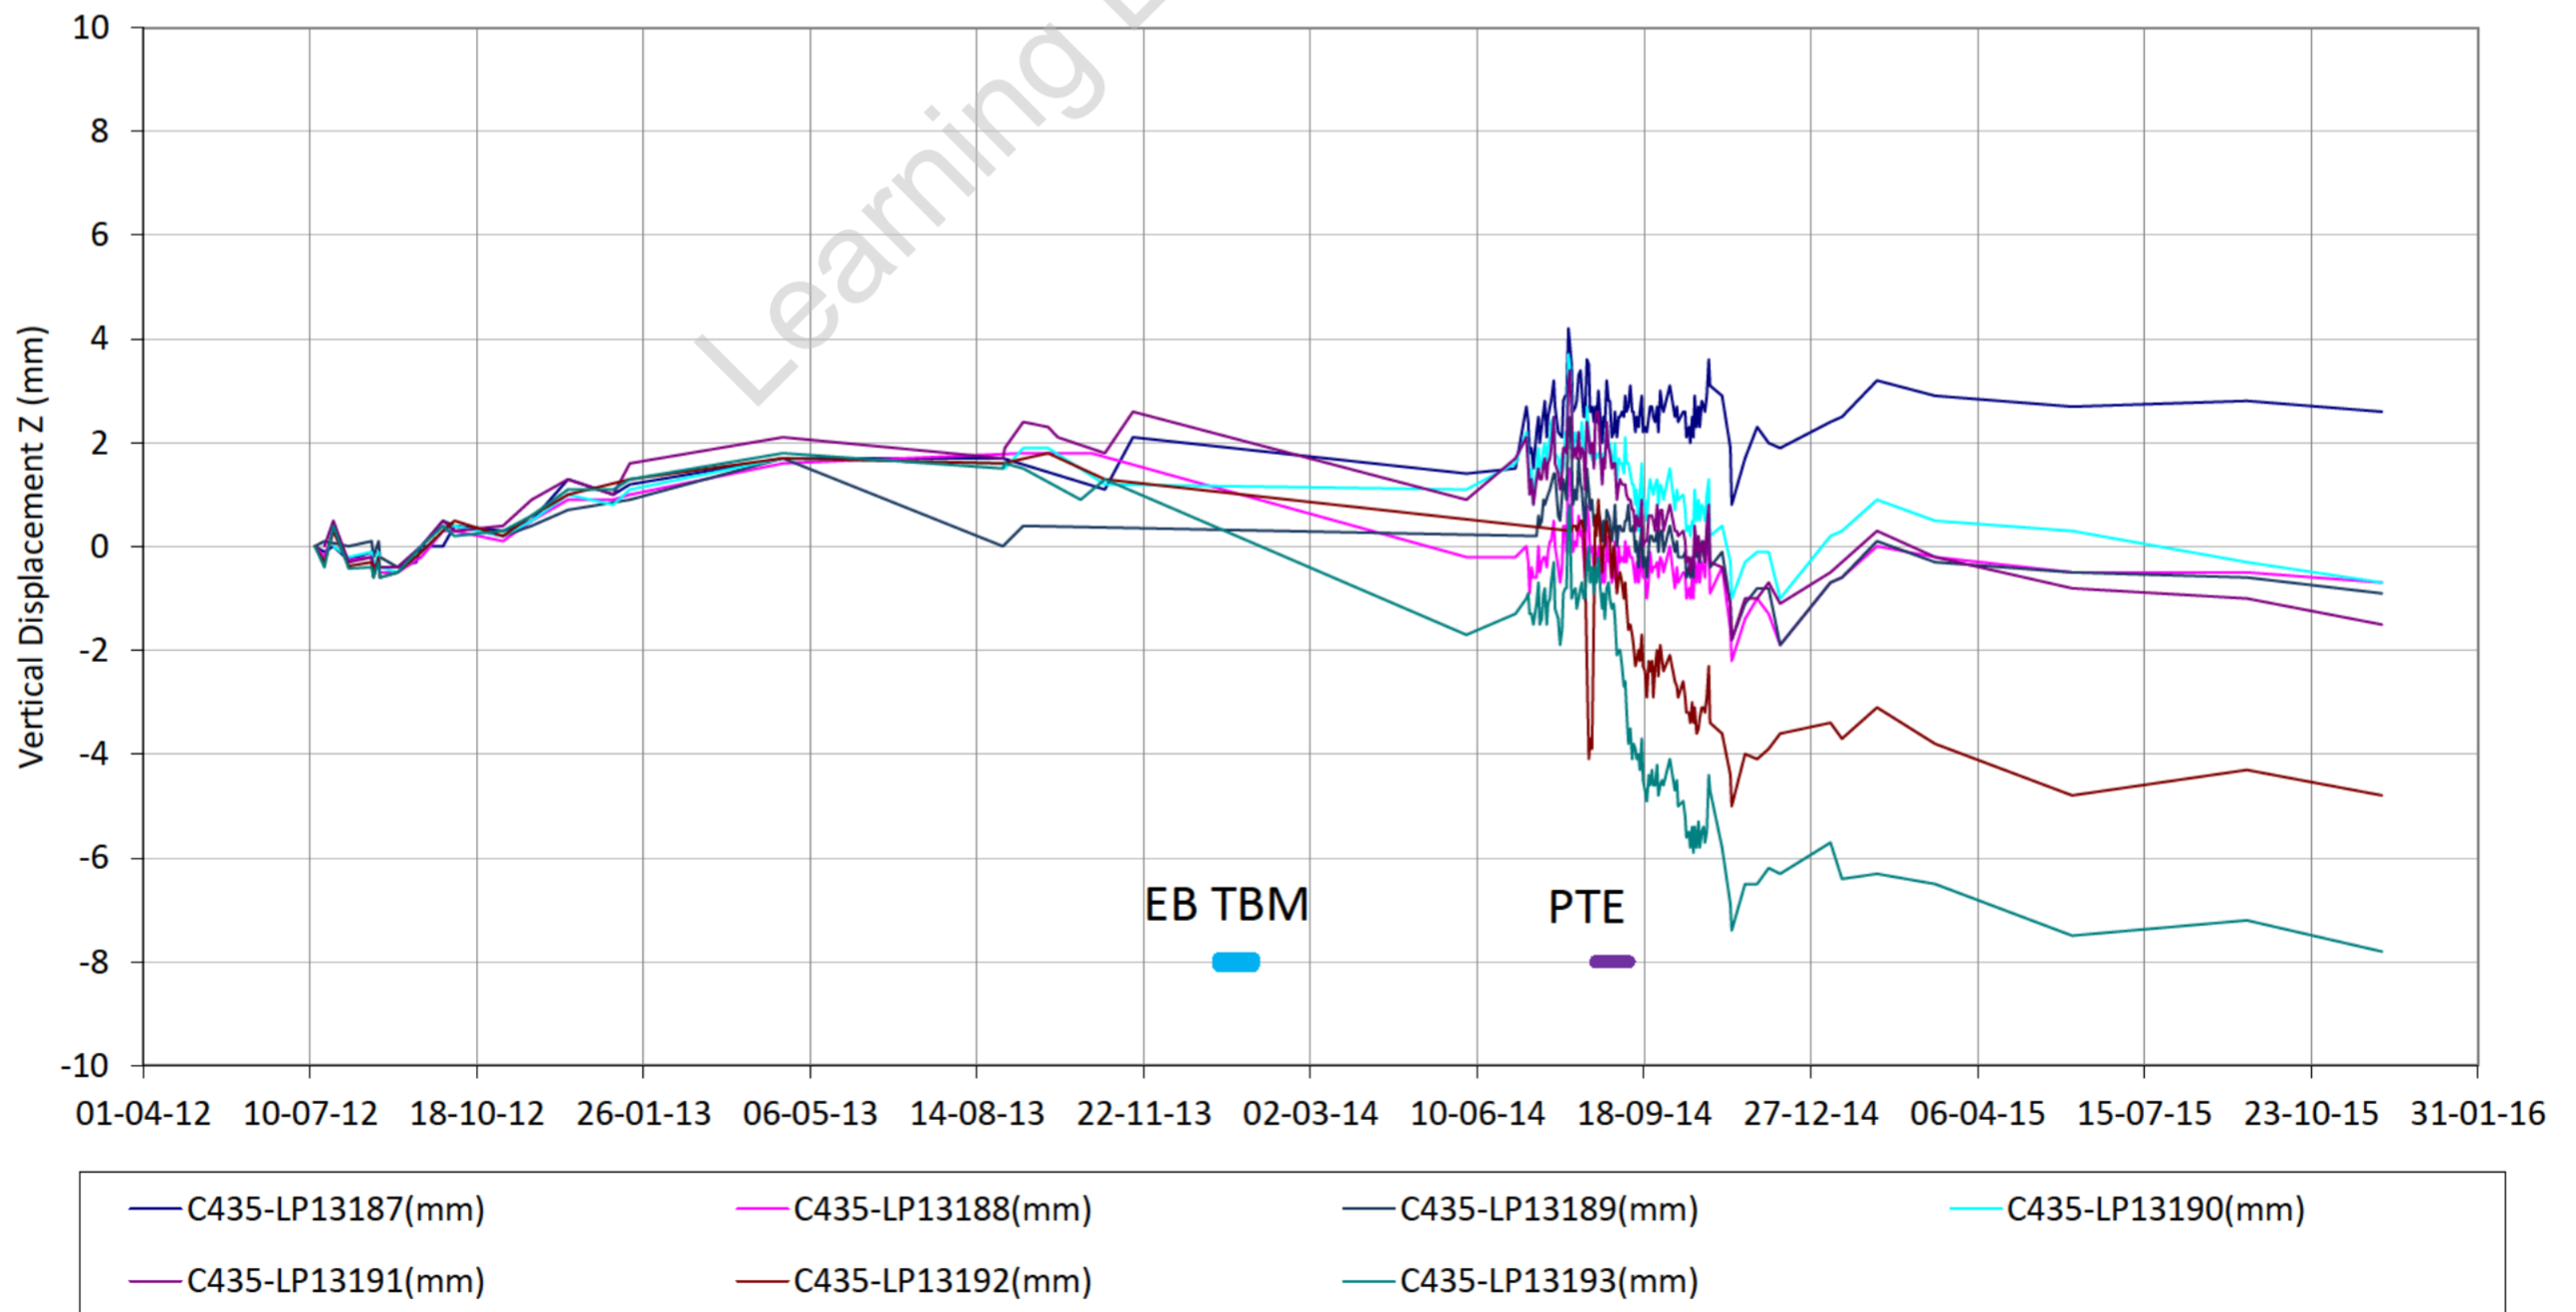
REPORT: LEVELLING
AREA: St John St
DEVICE: PLP'S

- On 16-01-2014 EB TBM caused maximum 2mm of settlement.
- Between 20-08-2014 and 09-09-2014 PTE works caused 4-5mm maximum of settlement.
- Maximum settlement at the end of the works -8mm

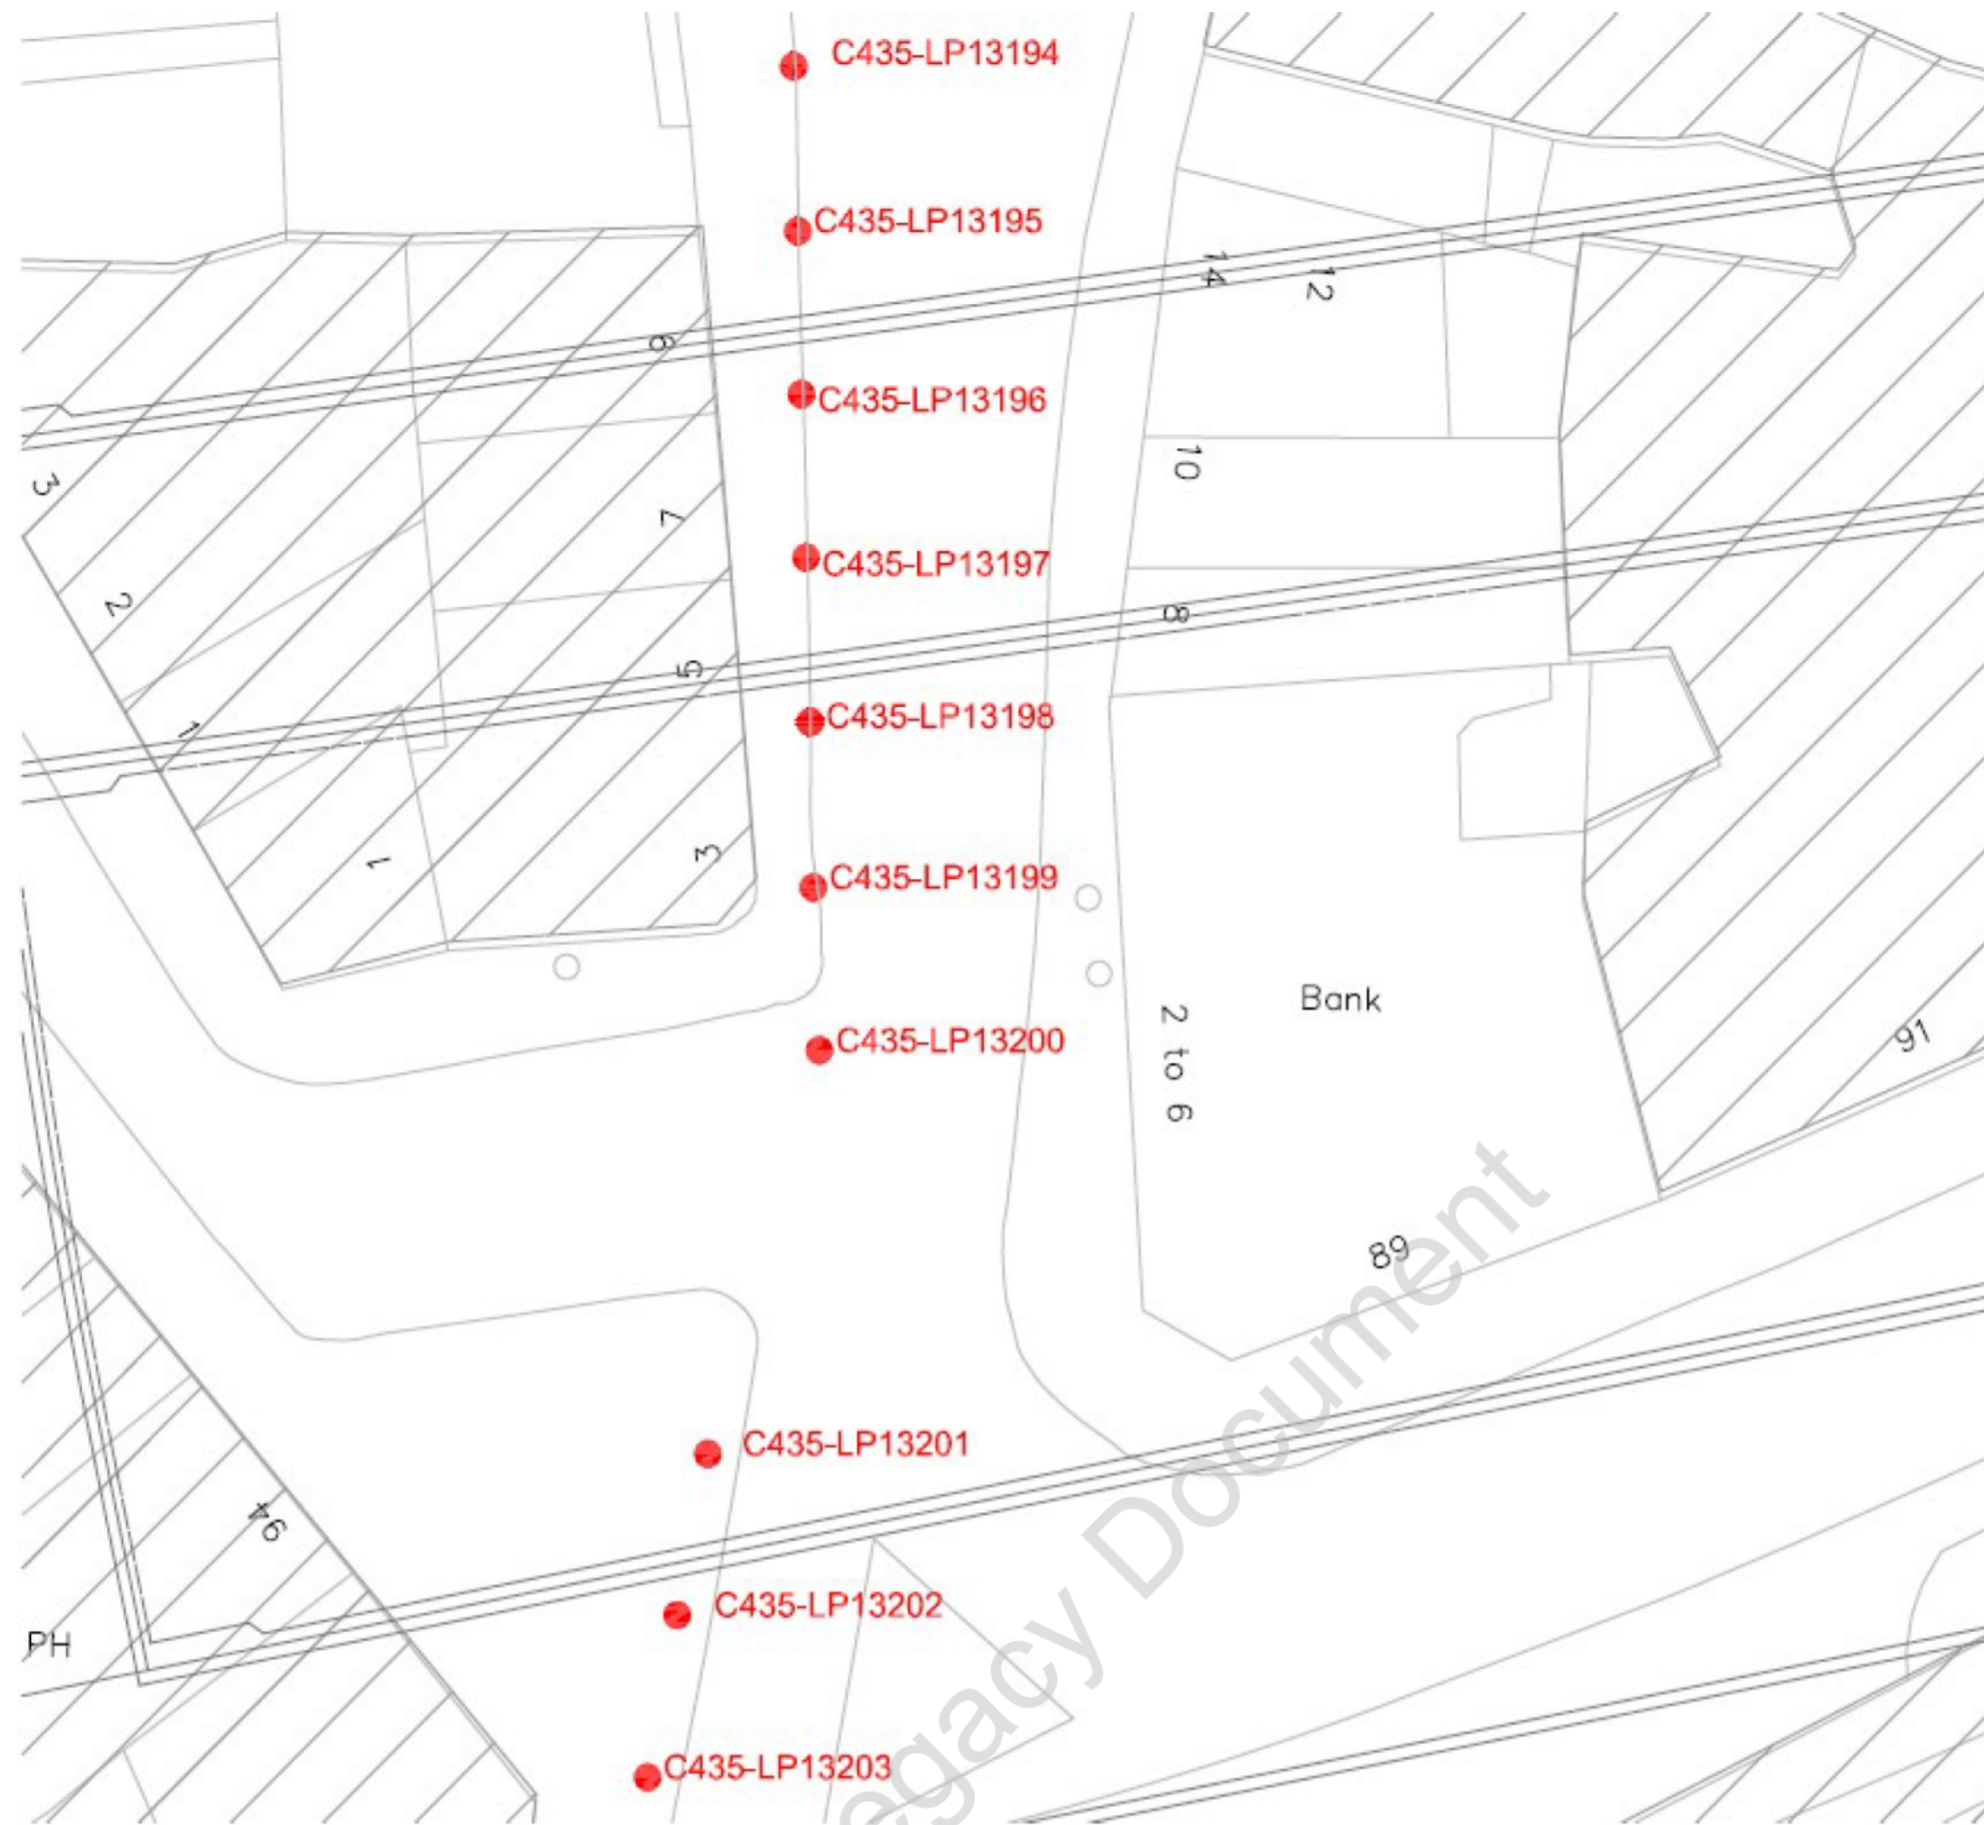
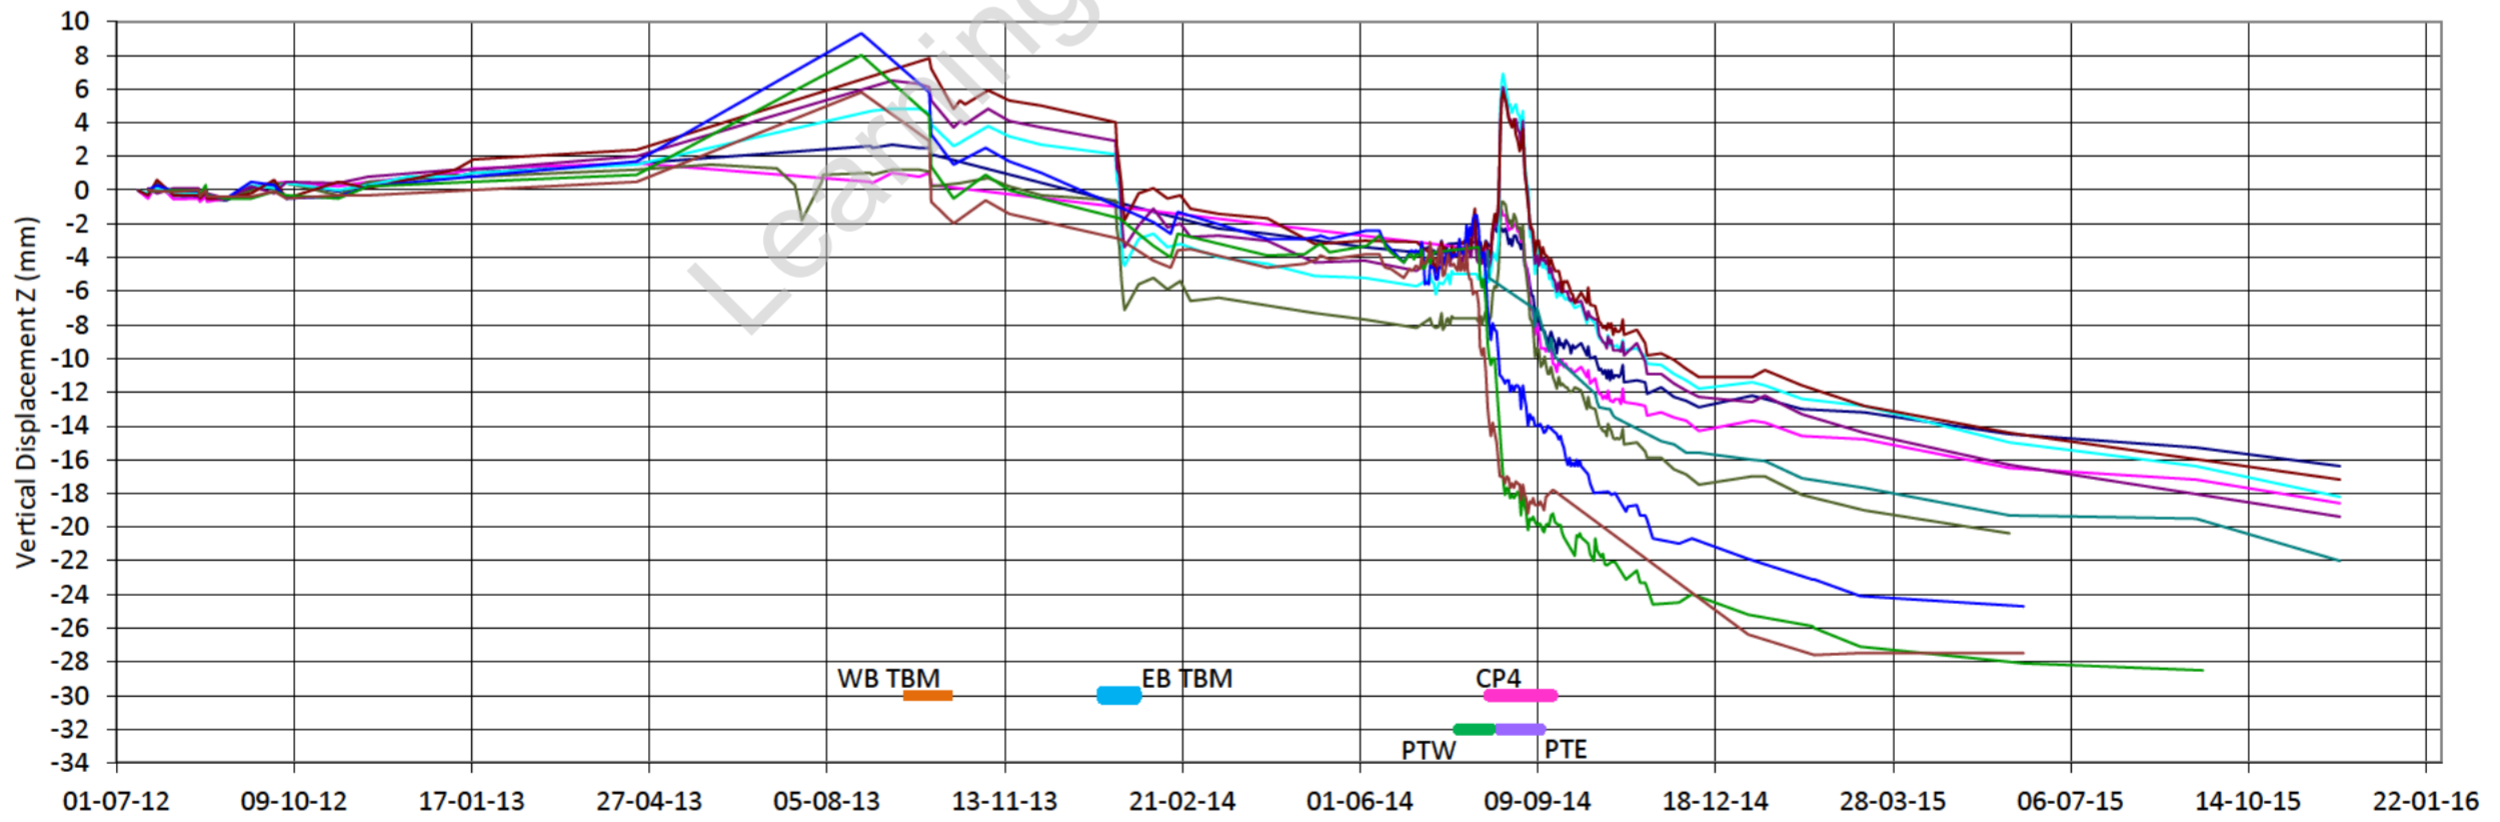
REPORT: LEVELLING
AREA: St John St
DEVICE: PLP'S

- On 24-08-2013 compensation grouting from Moorgate Shaft 1 caused 6-7mm maximum of heave.
- On 30-09-2013 WB TBM caused 4-5mm maximum of settlement.
- On 16-01-2014 Eastbound TBM caused 5-6mm of settlement.
- Residual settlement after the EB TBM caused 2-3mm of settlement.
- On 22-08-2014 compensation grouting caused 7-8mm of heave.
- From 27-07-2014 to 13-08-2014 PTW enlargement caused 10-12mm maximum of settlement
- Between 19-08-2014 and 10-09-2014 PTE works caused maximum 6-8mm of settlement.
- Maximum settlement at the end of the works -28mm

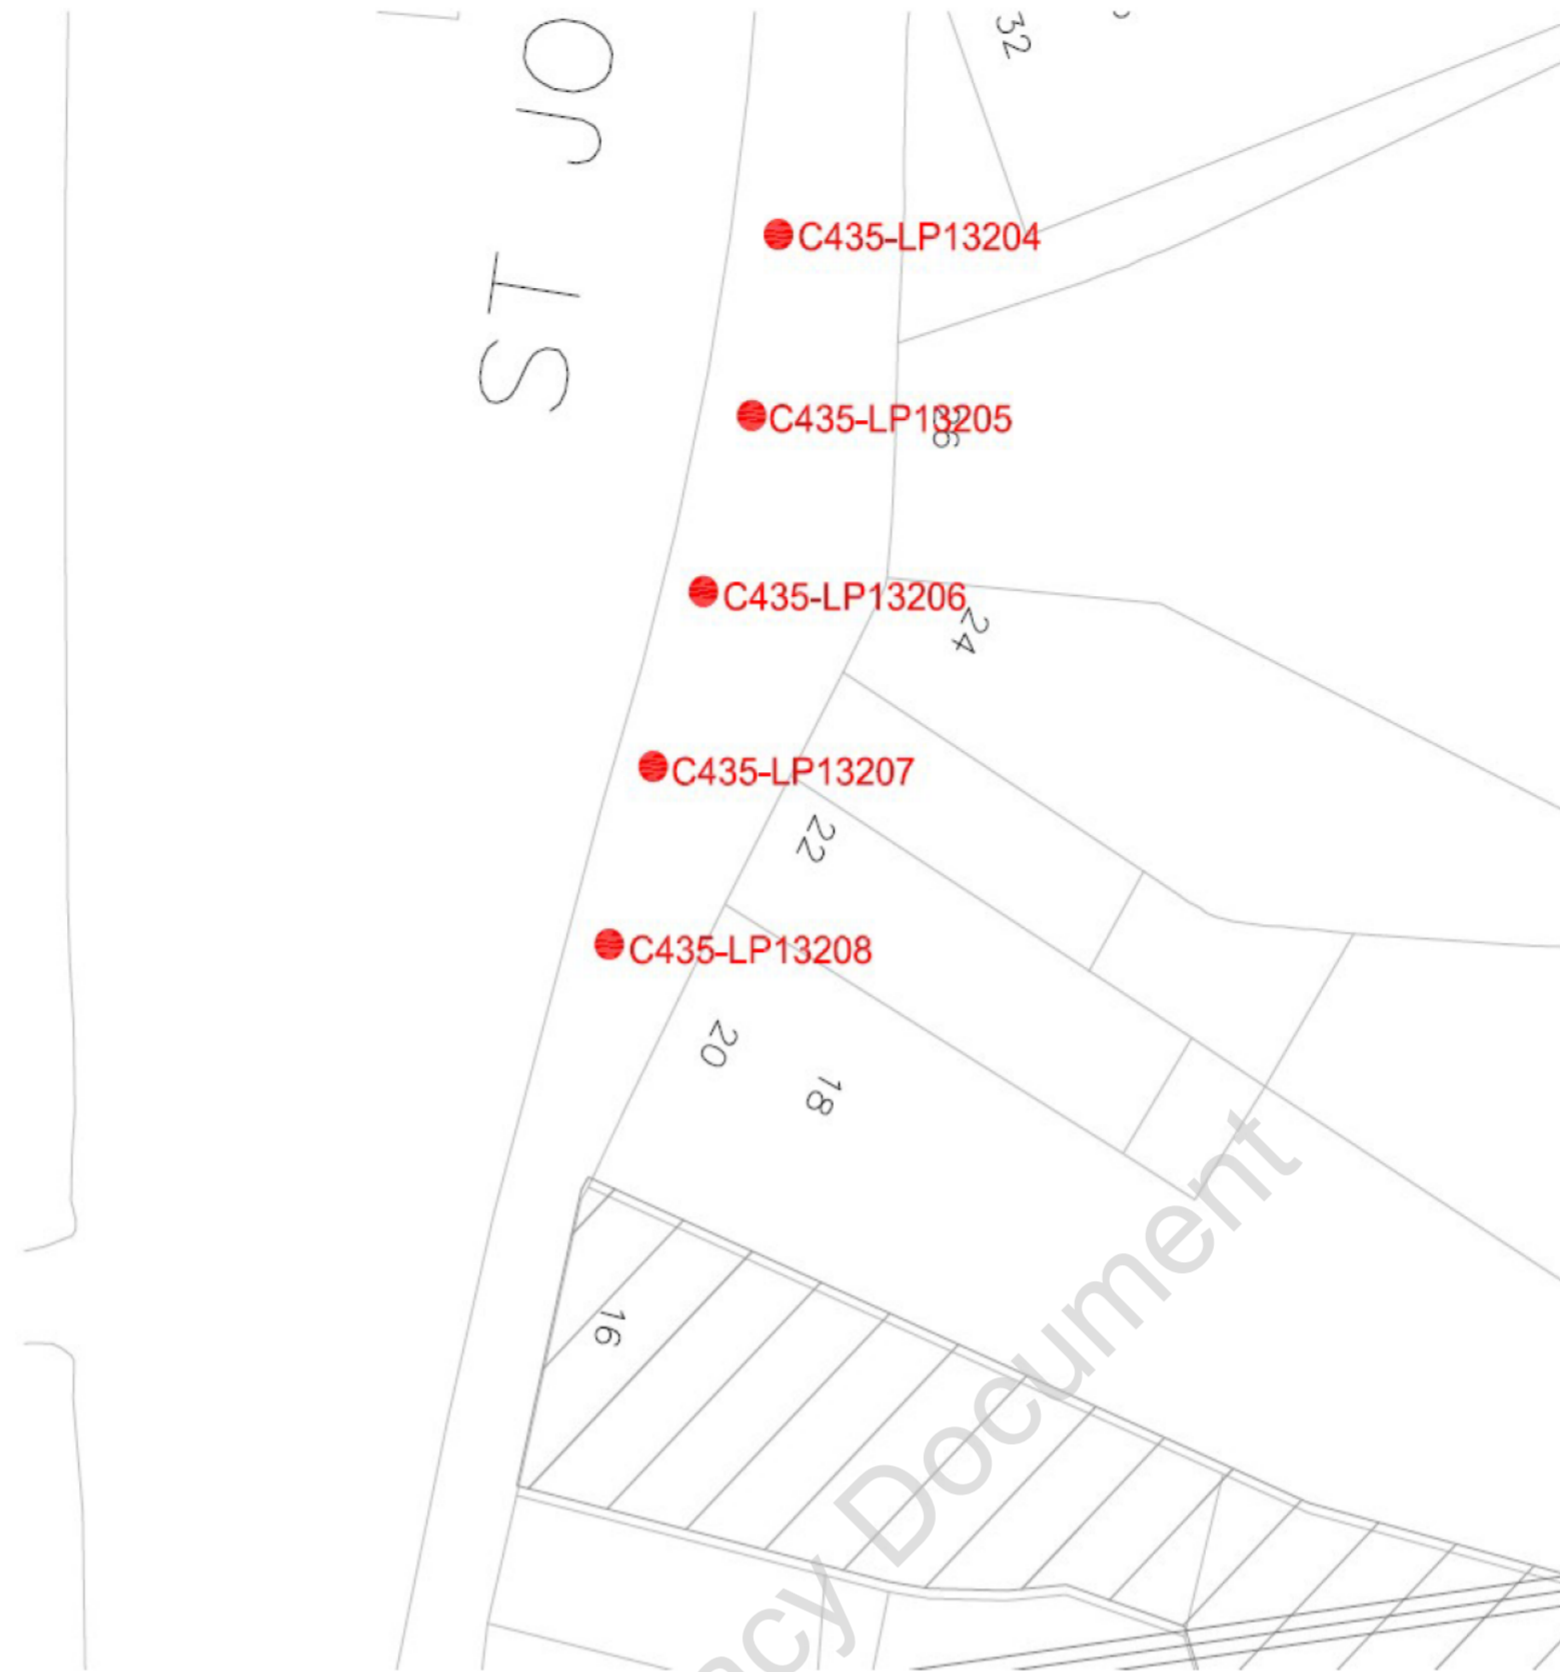
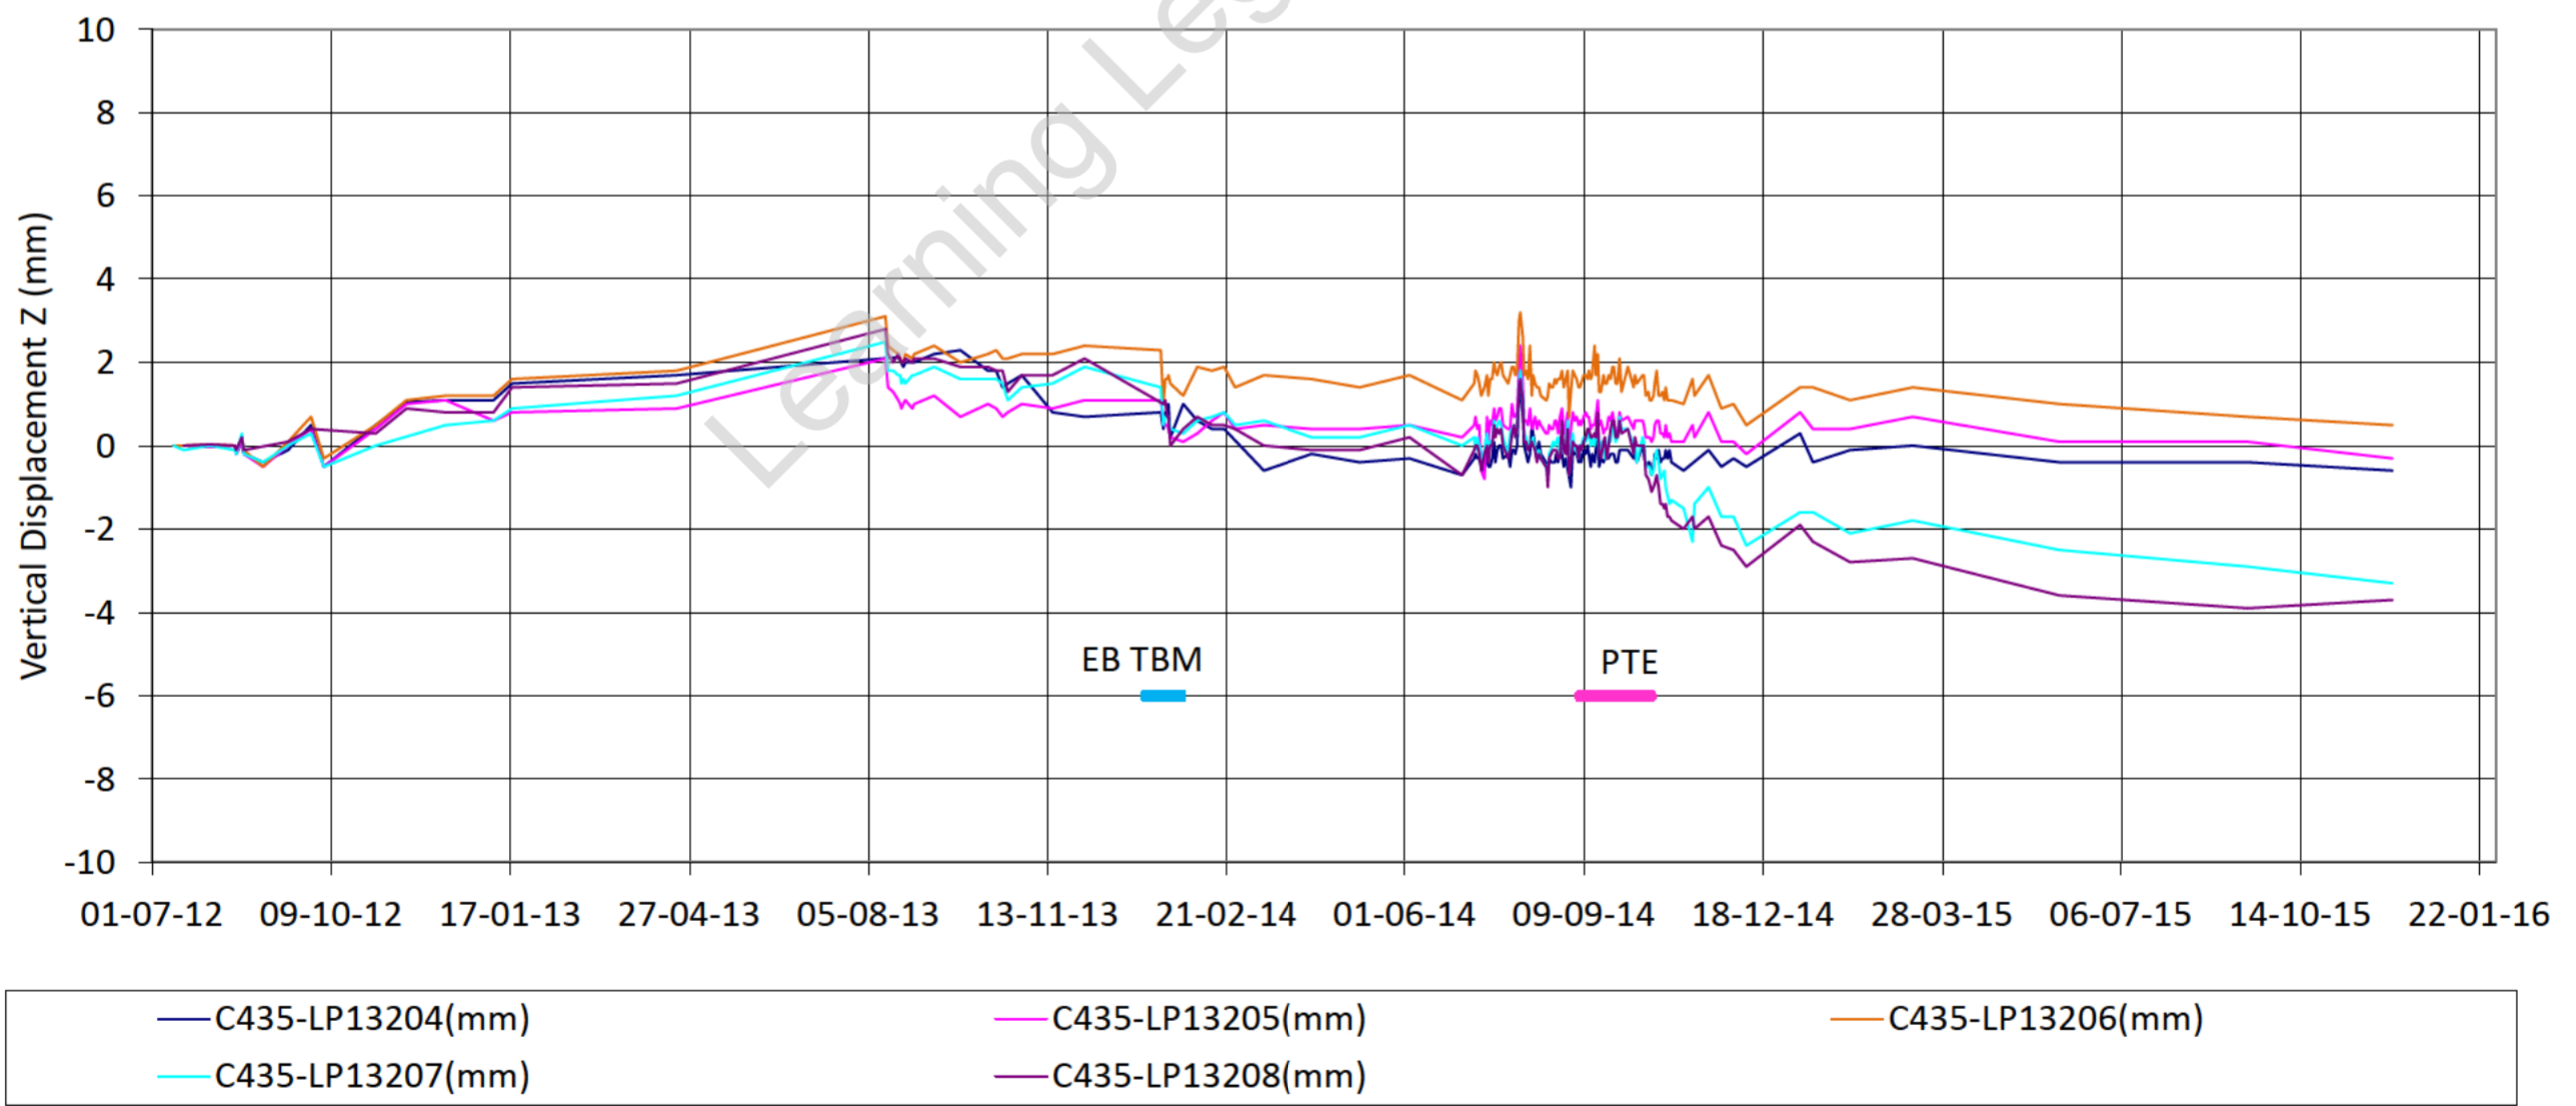
REPORT: LEVELLING
AREA: St John St
DEVICE: PLP'S

- On 16-01-2014 EB TBM caused maximum 2mm of settlement.
- From 01-09-2014 to 10-09-2014 PTE enlargement works caused 2mm maximum of settlement.
- Maximum settlement at the end of the works -4mm
