C435 Farringdon Main Station

Monitoring Close-Out Report: Levelling Points Installed on St John St. CRL Document Number: C435-BFK-C2-RGN-M123-51637

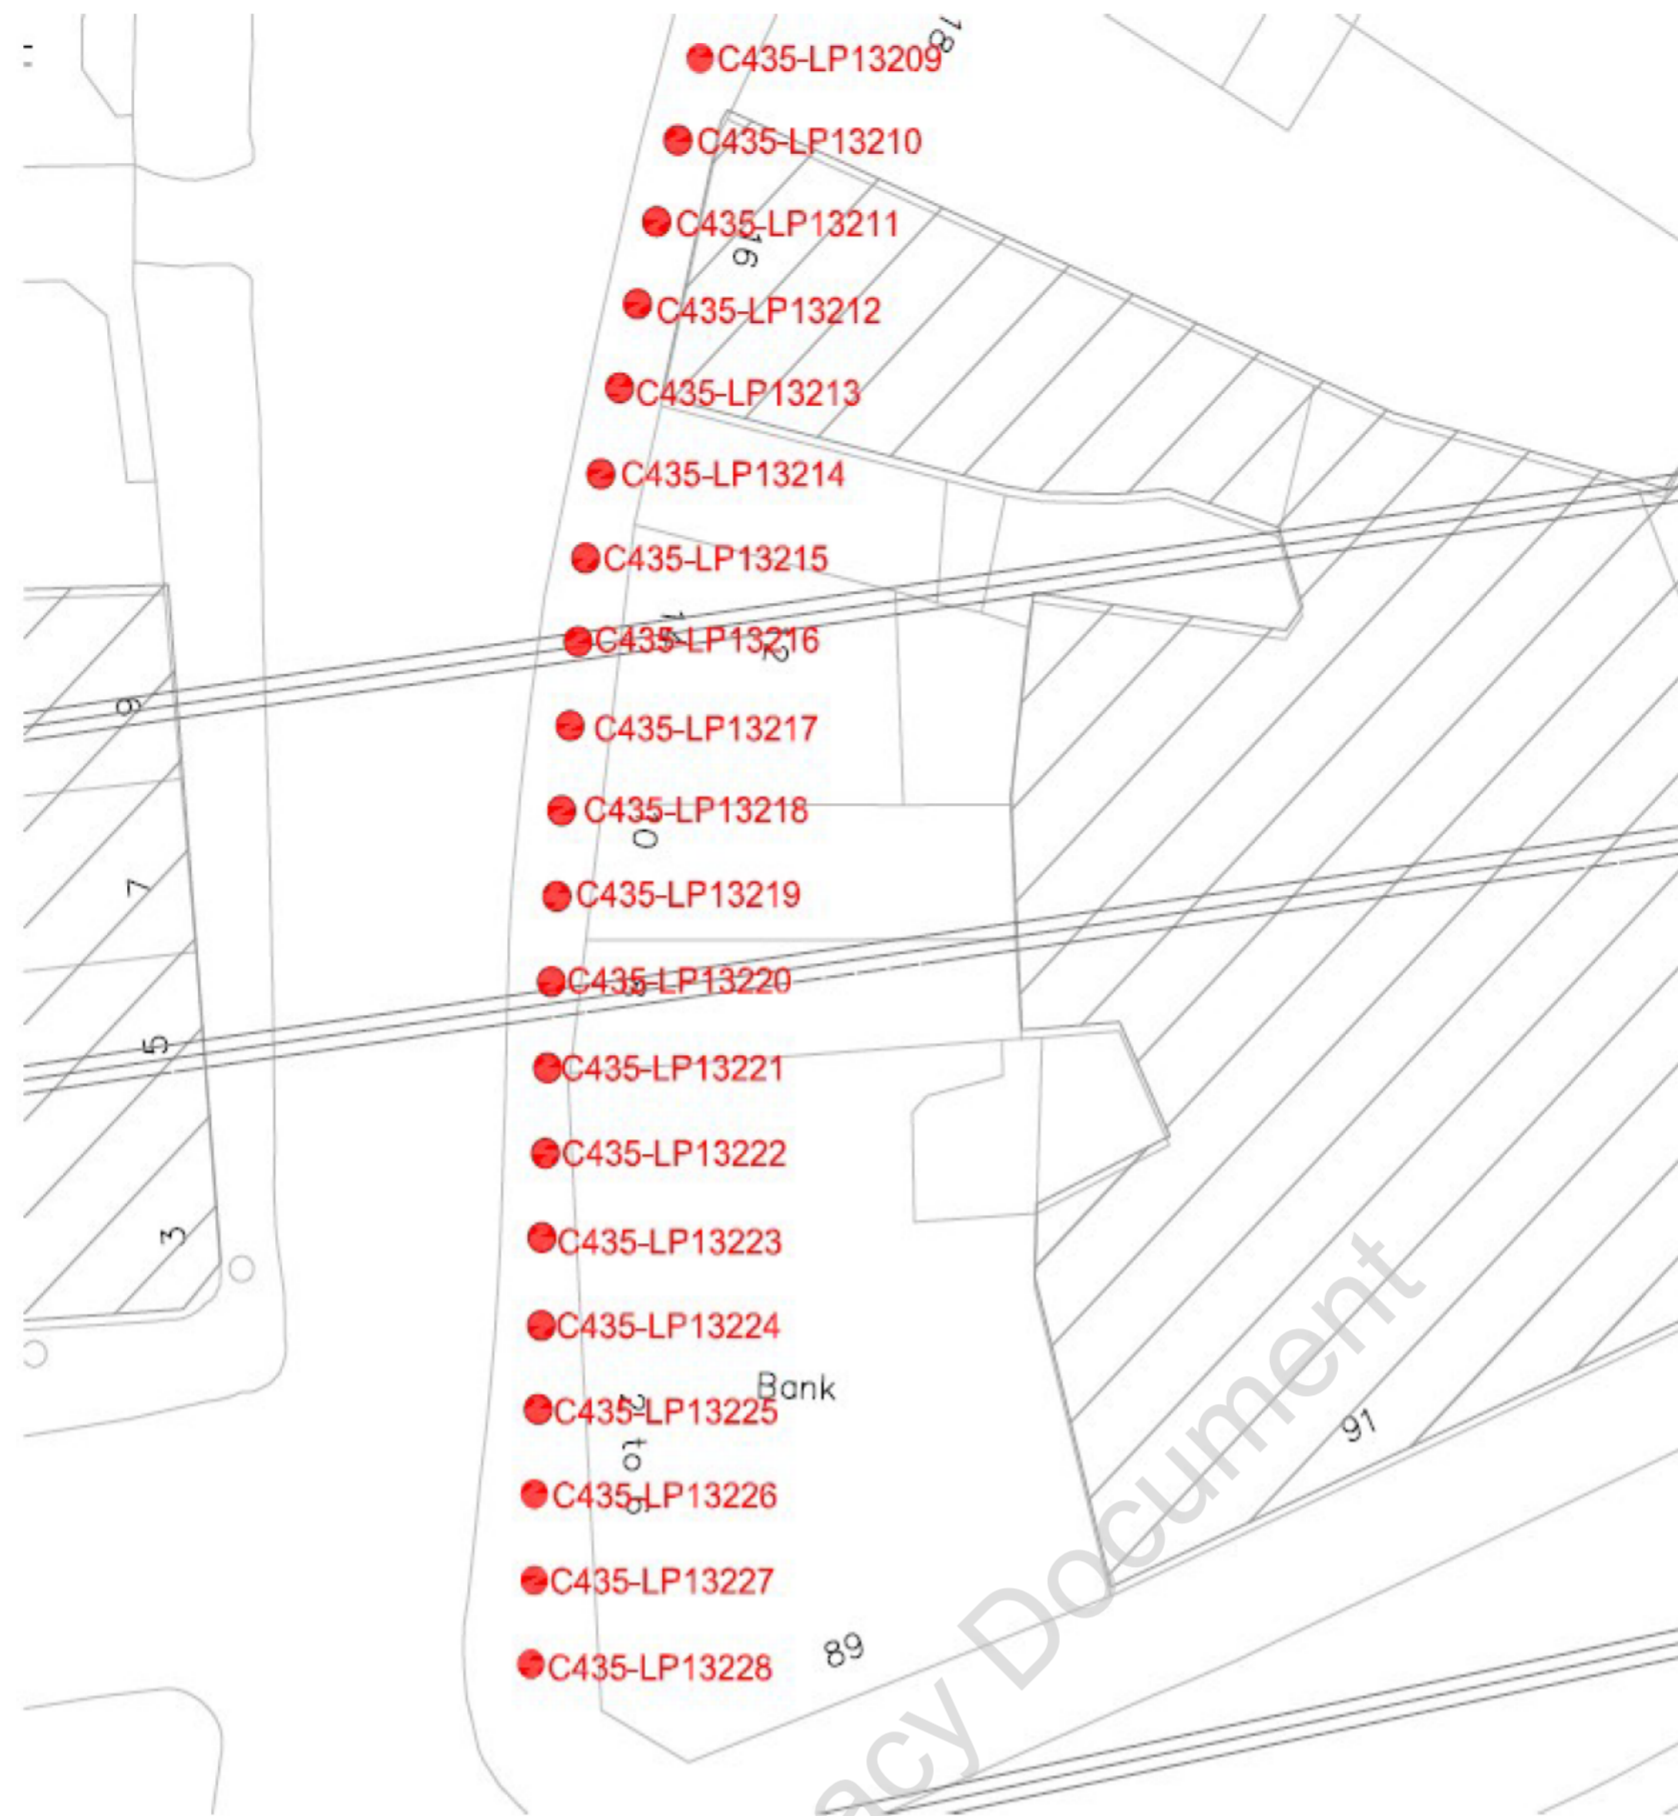
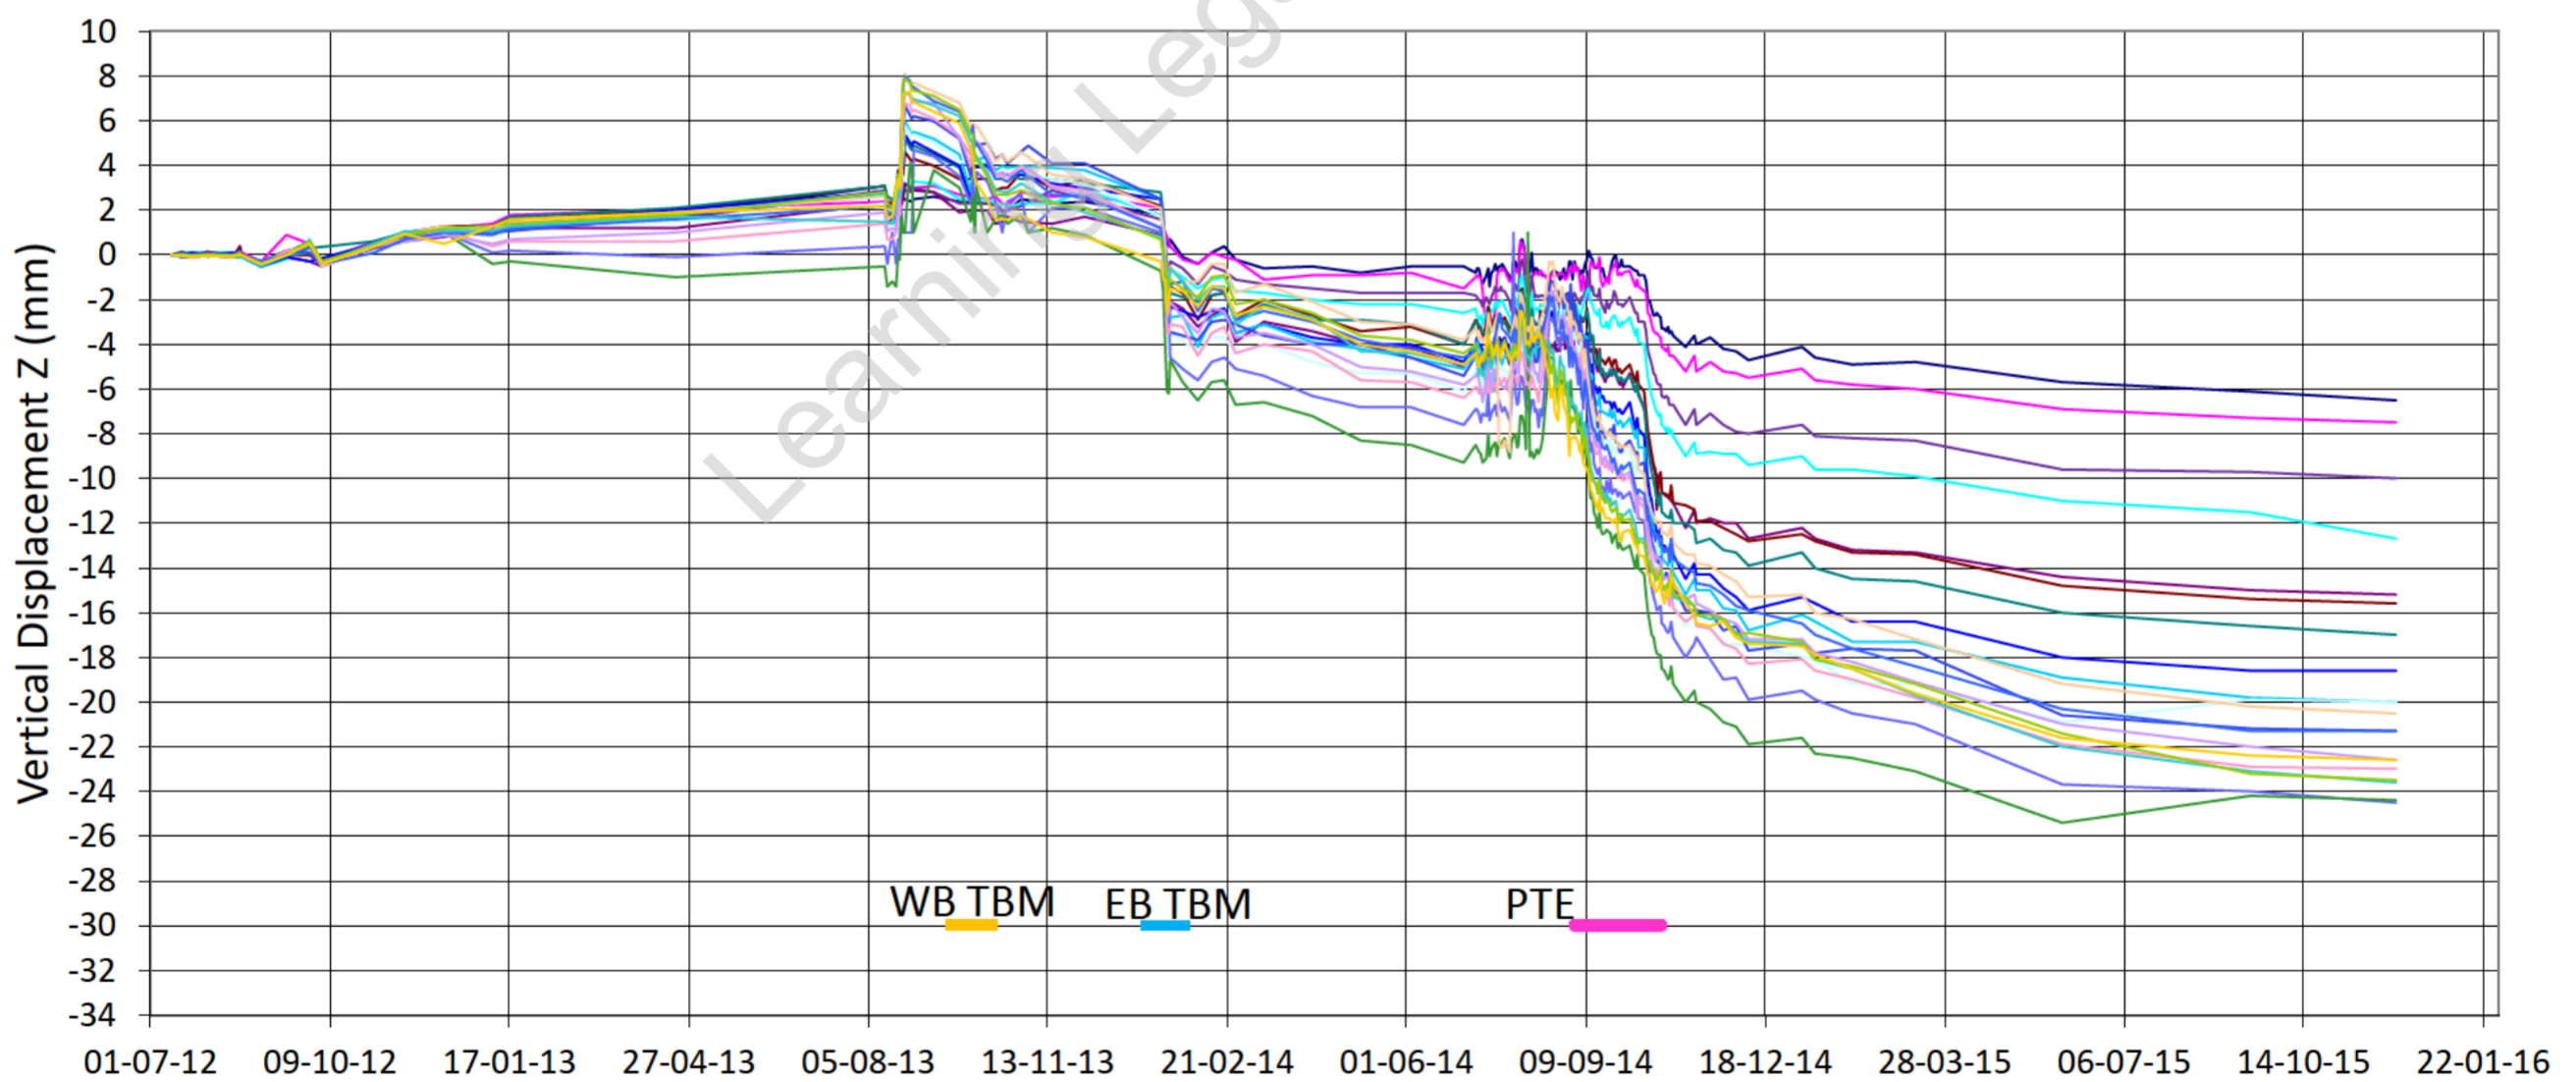
REPORT: LEVELLING
AREA: St John St
DEVICE: PLP'S

- Compensation grouting carried out on 24-08-2013 caused maximum 6-7mm of heave.
- On 02-10-2013 WB TBM caused 2mm of settlement.
- Residual settlement after WB TBM caused 1-2mm of settlement.
- On 15-01-2014 EB TBM caused 3-4mm of settlement.
- Compensation grouting carried out on 19-08-2014 caused 3-4mm of heave.
- From 30-08-2014 to 10-09-2014 PTE construction works caused 14-16mm of settlement.
- Maximum settlement at the end of the works -24mm
