C435 Farringdon Main Station

Monitoring Close-Out Report: Internal Monitoring: Sockets and Crackmeters

CRL Document Number: C435-BFK-C2-RGN-M123-51653

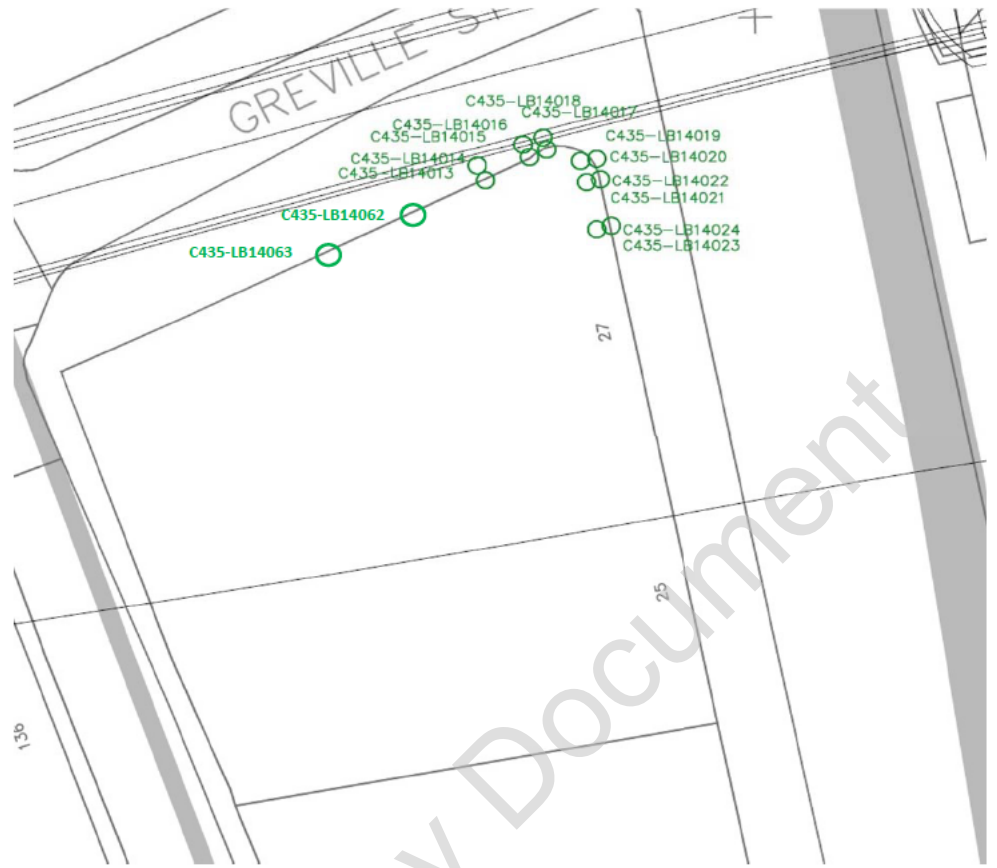
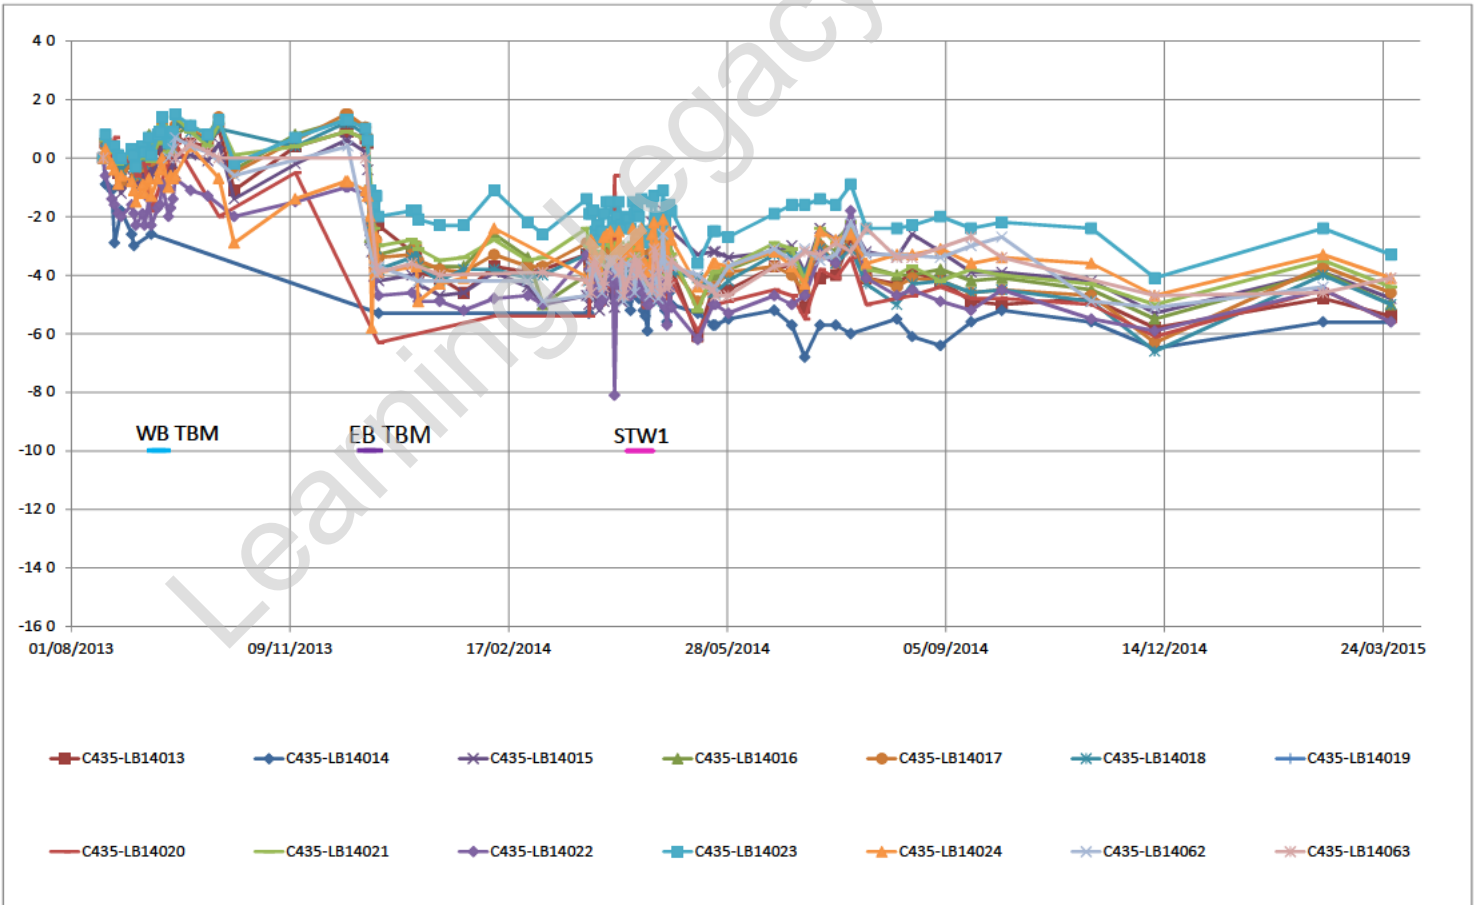
REPORT: LEVELLING
AREA: 25-27 Farringdon Rd
DEVICE: Precise Levelling Points

- WB TBM caused 2mm maximum of settlement from 09-09-2013 to 11-09-2013.
- EB TBM caused 5mm maximum of settlement between 14-12-2013 and 17-12-2013.
- No movement caused by STW1 construction.
- Maximum settlement at the end of the works 7mm

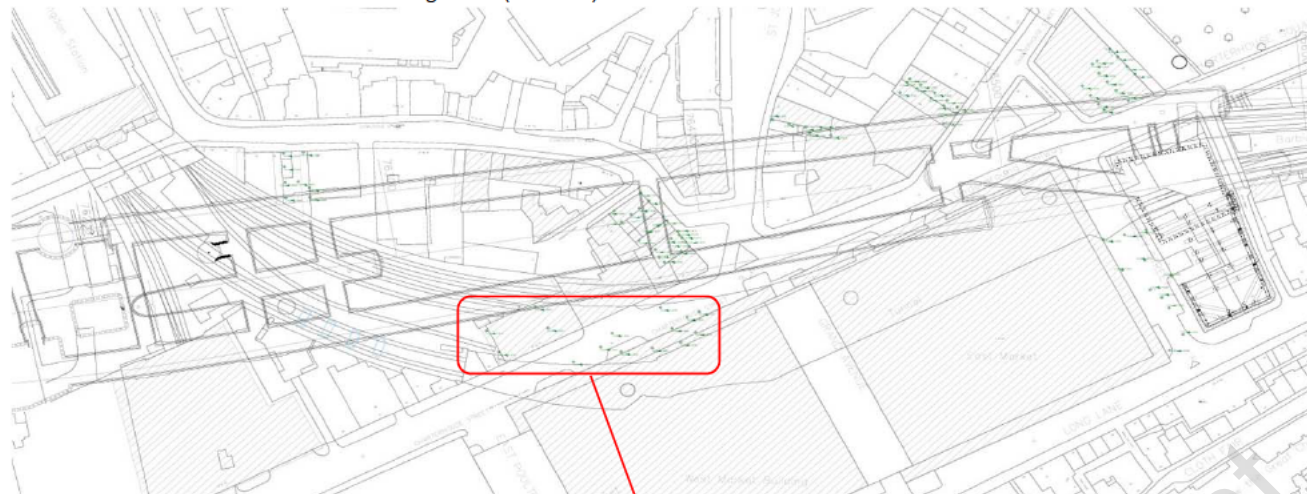
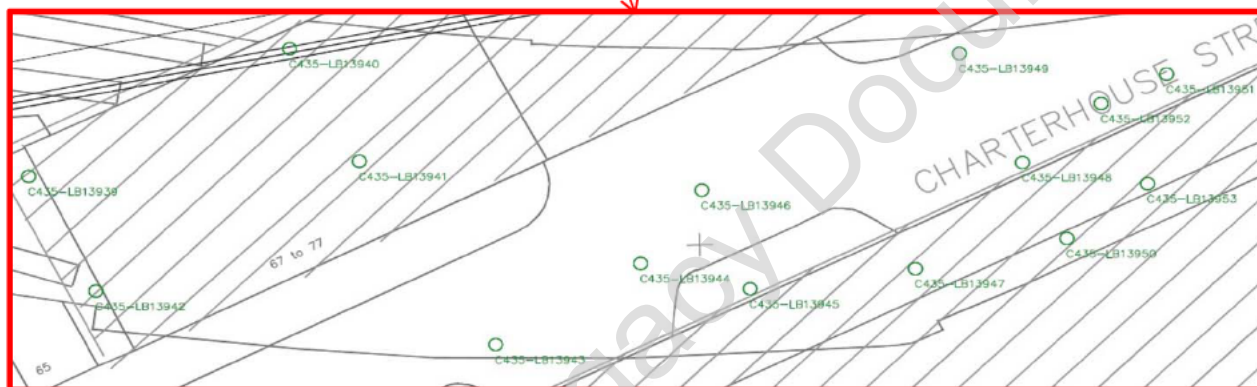
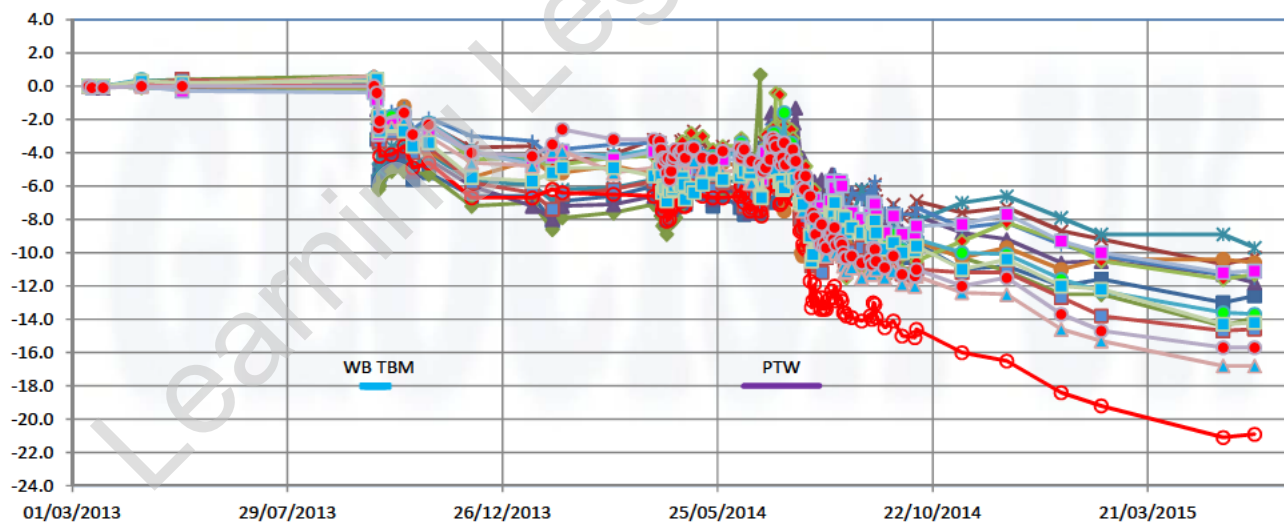
REPORT: LEVELLING
AREA: 77A Charterhouse St (Fabric)
DEVICE: Precise Levelling Point (Sockets)

- WB TBM caused maximum 6mm of settlement from 27-09-2013 to 30-09-2013.
- Compensation grouting from Moorgate Spur Shaft 3 caused maximum 4mm of heave on 04-07-2014.
- PTW enlargement works caused 8mm of settlement from 12-06-2014 to 04-08-2014.
- Residual settlement caused 2mm.
- CP4 caused maximum 2mm of settlement from 17-09-2014 to 16-10-2014.
- Residual settlement caused 5mm.
- Maximum settlement at the end of the works 21mm.

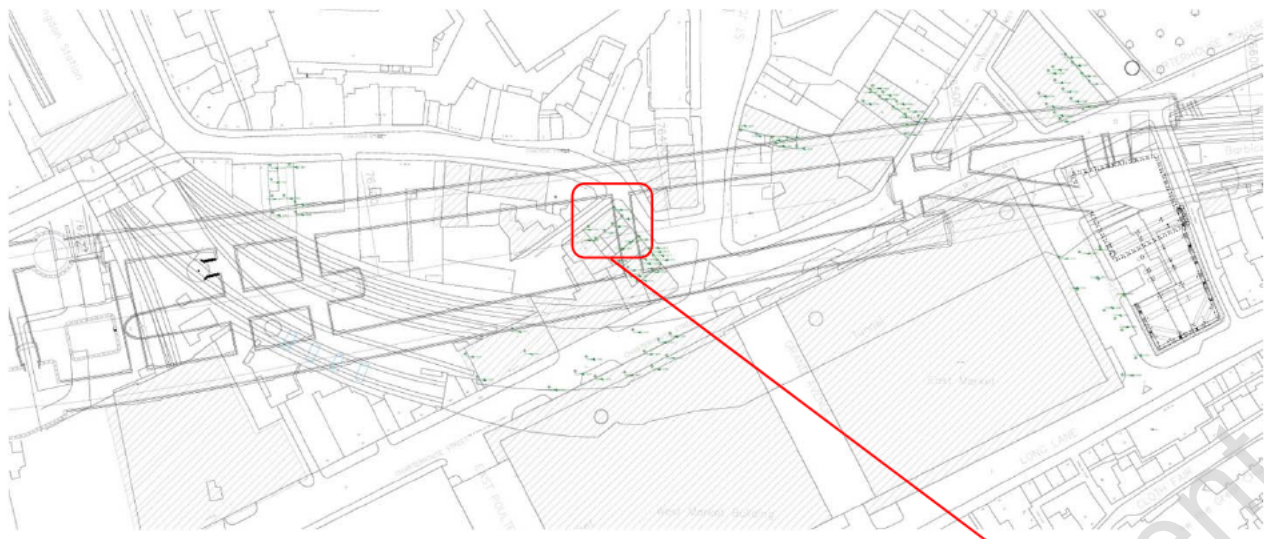
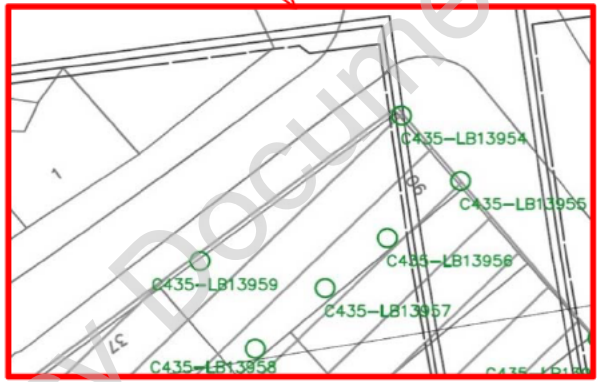
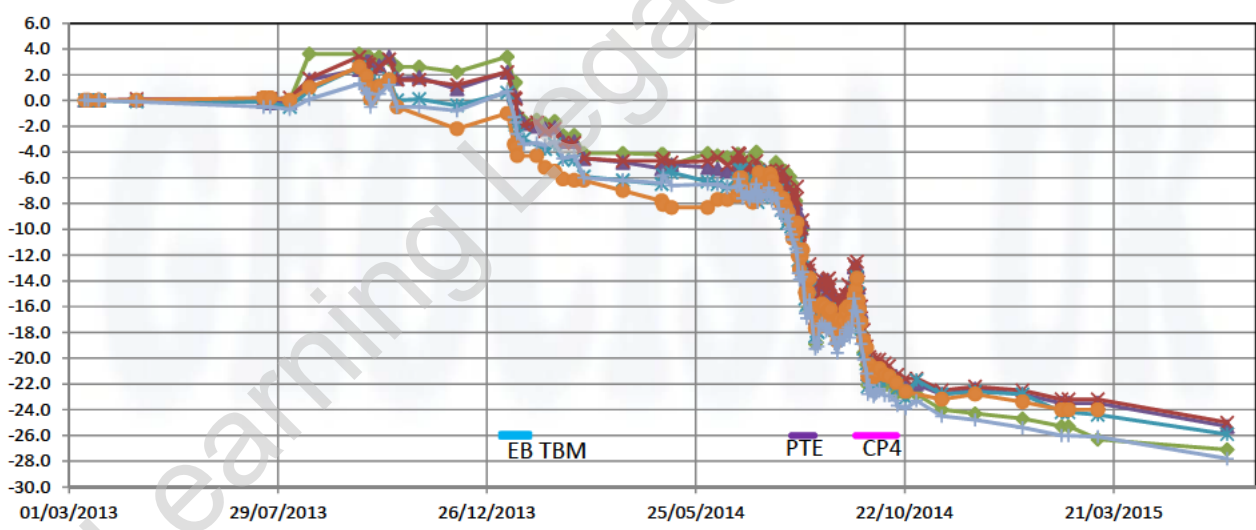
REPORT: LEVELLING
AREA: 90 COWCROSS (Nicolas)
DEVICE: Precise Levelling Point (Sockets)

- TAM's drilling for Moorgate Shaft 1 caused 4mm of heave from 06-08-2013 to 09-01-2014.
- EB TBM caused 3mm of settlement from 15-01-2014 to 16-01-2014.
- Residual settlement caused 2mm.
- PTE enlargement works caused 16mm maximum of settlement from 02-08-2014 to 18-08-2014.
- Compensation grouting from Moorgate Shaft 1 caused 4mm of heave from 03-09-2014 to 17-09-2014.
- CP4 construction caused maximum 10mm of settlement between 17-09-2014 and 16-10-2014.
- Maximum settlement at the end of the works 28mm

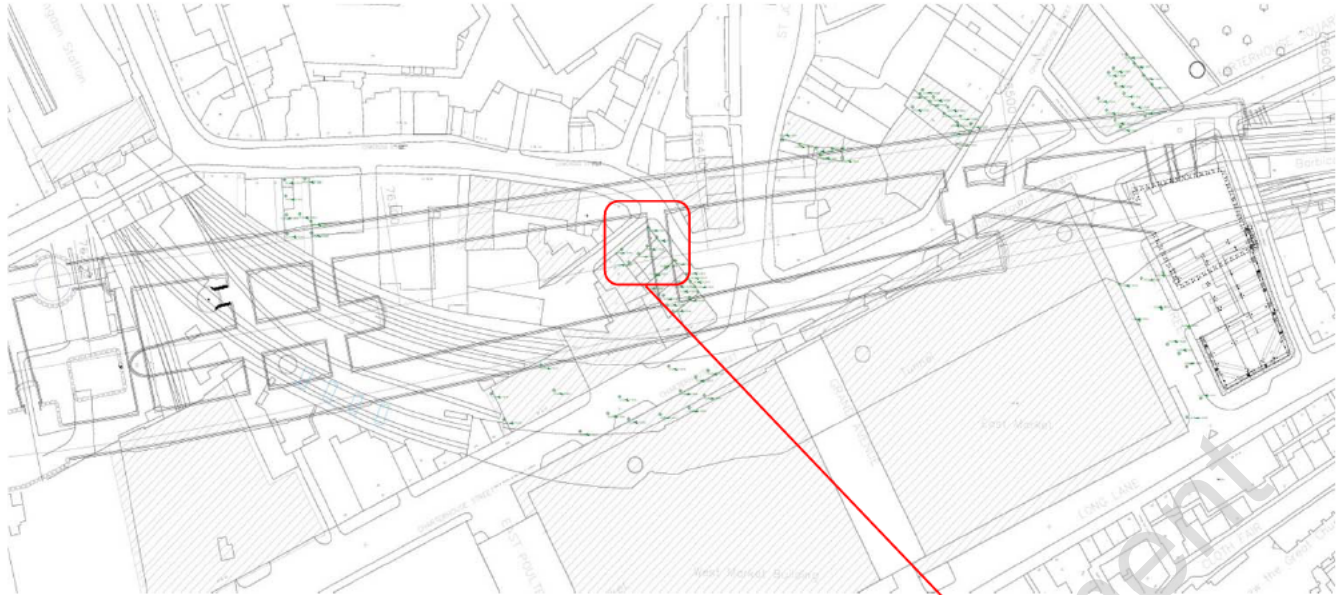
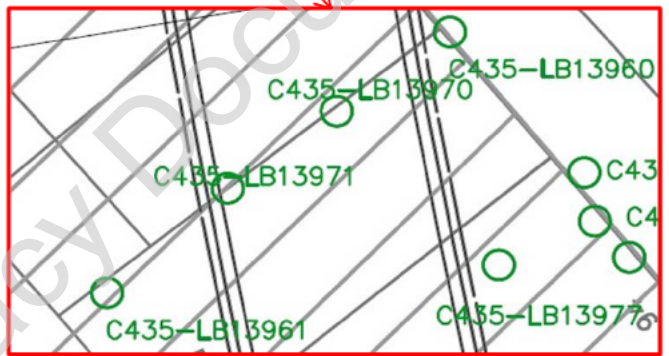
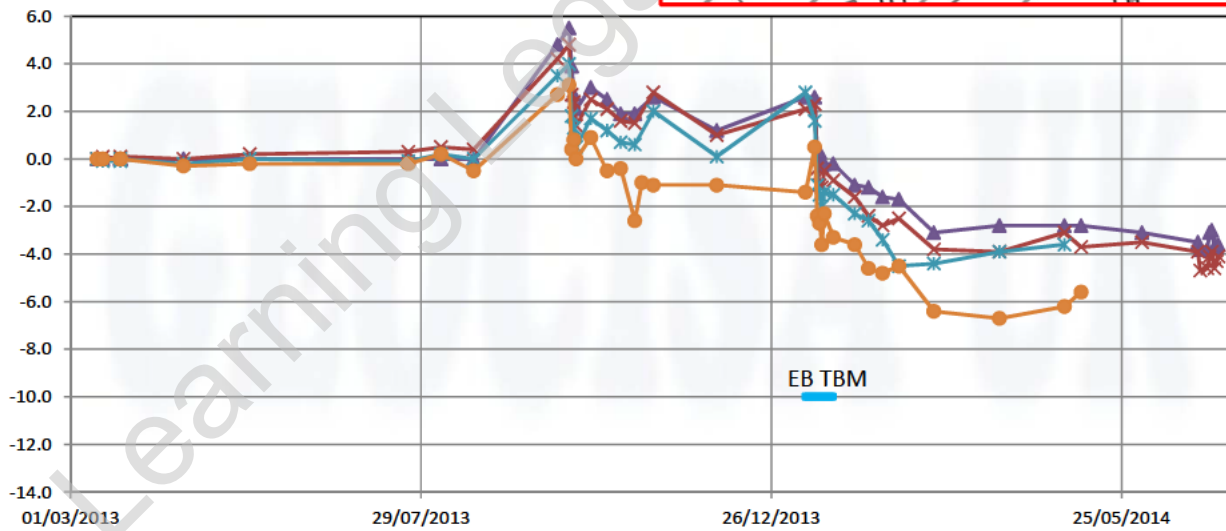
REPORT: LEVELLING
AREA: 90 COWCROSS (Jasmine)
DEVICE: Precise Levelling Point (Sockets)

- TAM's drilling for Moorgate Shaft 1 caused 6mm of heave on 30-09-2013.
- EB TBM caused maximum 5mm of settlement from 15-01-2014 to 16-01-2014.
- Residual settlement caused 3mm of settlement.
- Maximum settlement at the end of the works 7mm

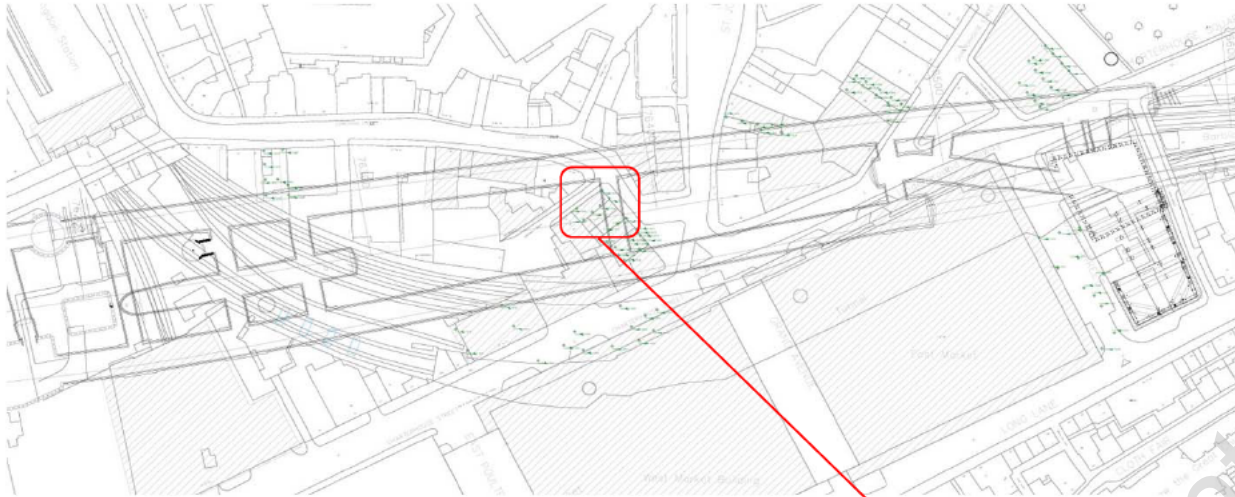
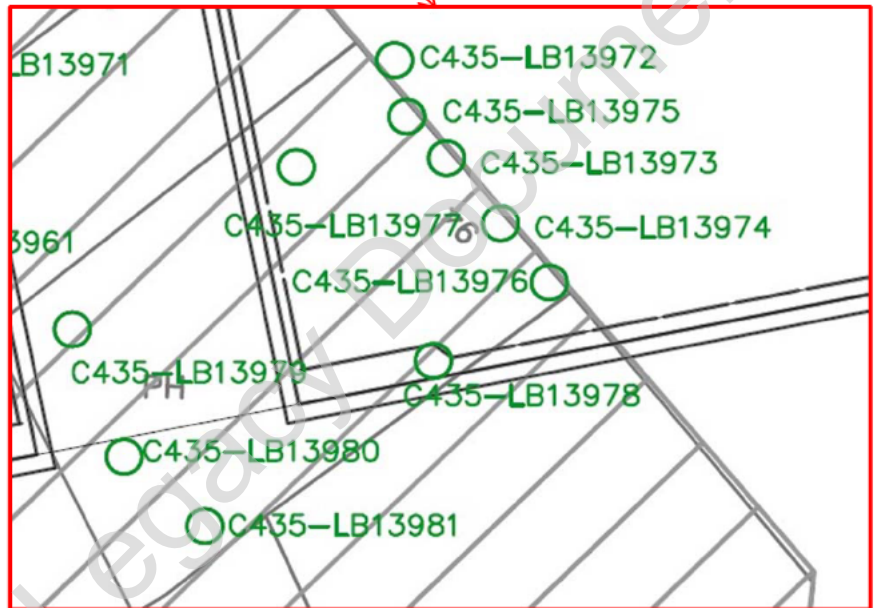
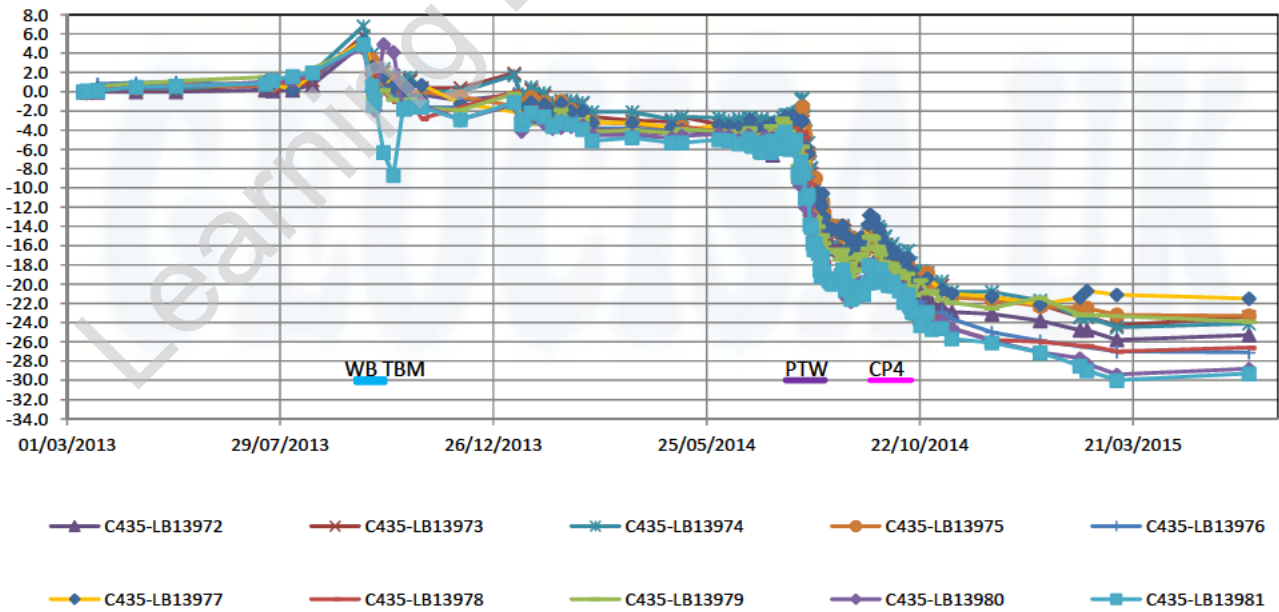
REPORT: LEVELLING
 AREA: 94 Cowcross St (The Hope)
 DEVICE: Precise Levelling Point (Sockets)

- TAM's drilling for Moorgate Shaft 1 caused 6mm of heave on 25-09-2013.
- Westbound TBM caused maximum 5mm of settlement from 30-09-2013 to 01-10-2013.
- Residual settlement caused 4mm of settlement.
- PTW works caused 18mm maximum of settlement between 20-07-2014 to 16-08-2014.
- Compensation grouting caused 2mm of heave from 04-09-2014 to 23-09-2014.
- CP4 construction caused 12mm of settlement from 17-09-2014 to 16-10-2014.
- Maximum settlement at the end of the works 30mm.

REMARKS:
 30-08-14. Bad readings

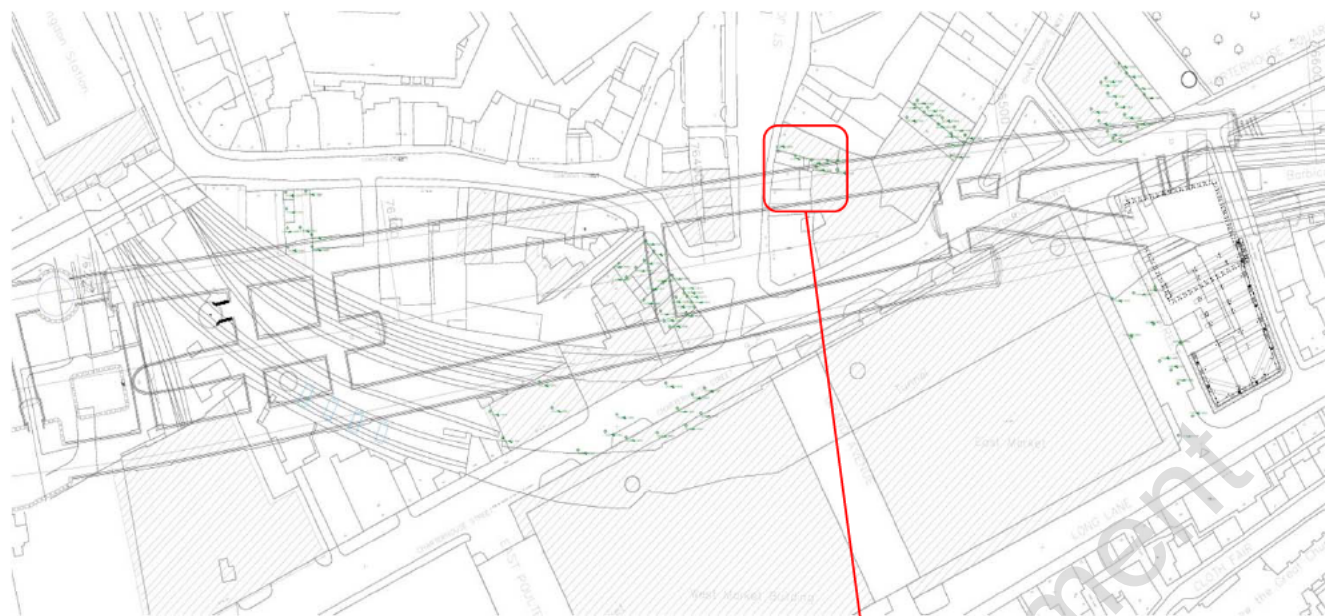
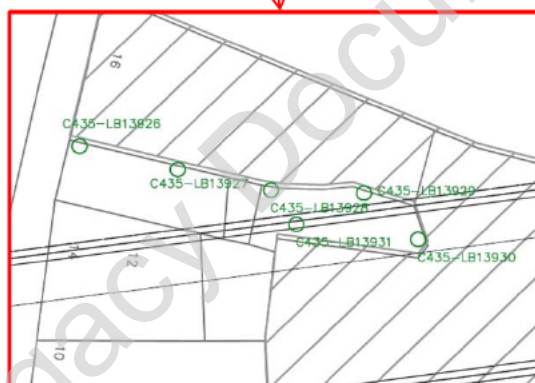
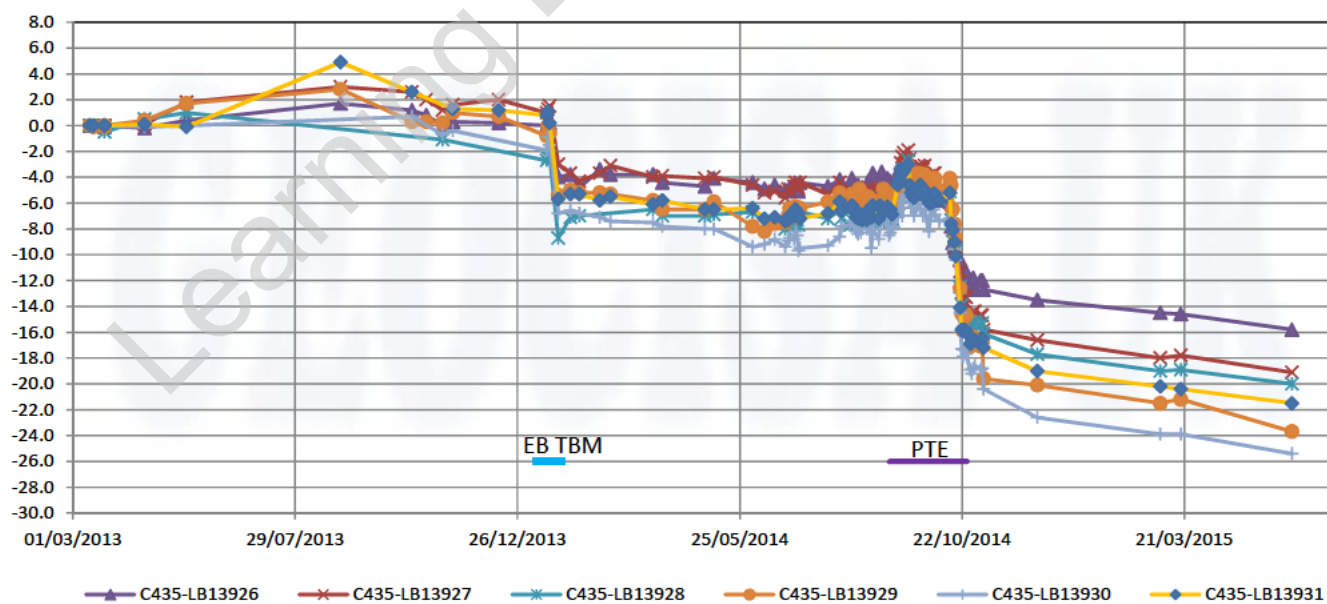
REPORT: LEVELLING
 AREA: 16 St John St (Clinic)
 DEVICE: Precise Levelling Point (Sockets)

- EB TBM caused maximum 9mm of settlement from 16-01-2014 to 17-01-2014.
- PTE enlargement works caused 15mm of settlement between 03-09-2014 to 25-10-2014.
- Maximum settlement at the end of the works 26mm

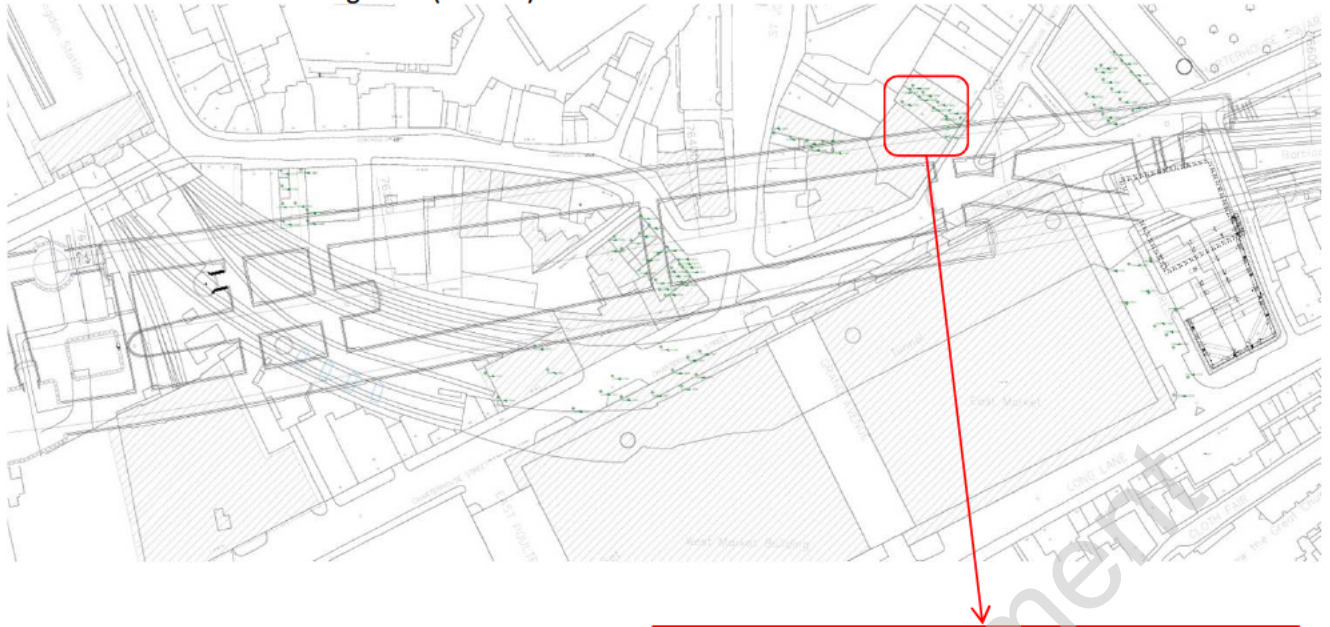
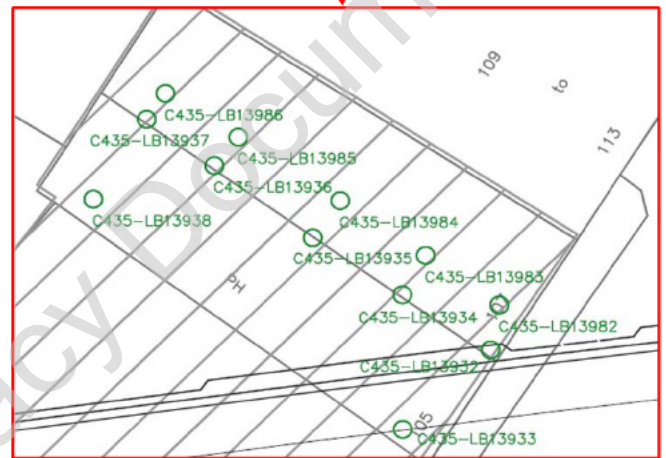
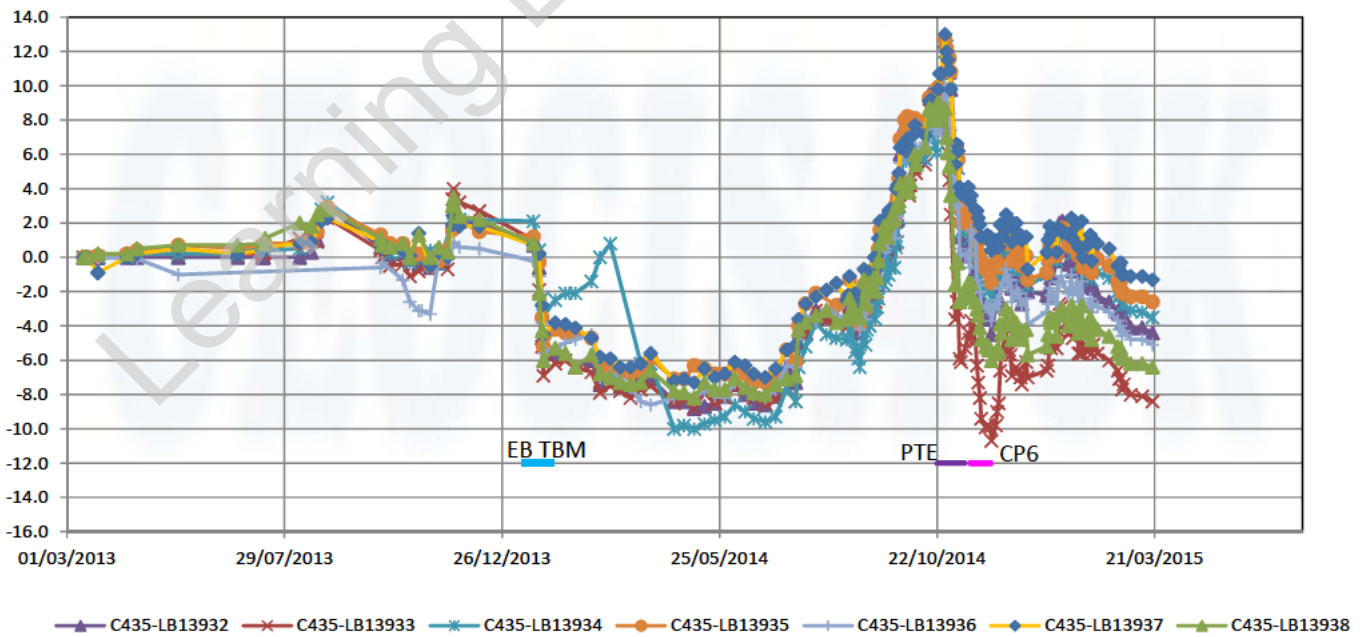
REPORT: LEVELLING
 AREA: 105 Charterhouse St (Smithfield Tavern)
 DEVICE: Precise Levelling Point (Sockets)

- TAM's drilling from Moorgate Shaft 2 caused 3mm of heave on 23-08-2013.
- Compensation grouting caused 4mm maximum of heave on 21-11-2013.
- EB TBM caused maximum 7mm of settlement from 19-01-2014 to 20-01-2014.
- Residual settlement caused 2mm.
- Ground treatment caused 15mm of heave from 10-07-2014 to 27-10-2014.
- PTE enlargement works caused 16mm of settlement between 22-10-2014 to 10-11-2014.
- CP6 construction caused 3mm of settlement from 20-11-2014 to 22-11-2014.
- Maximum settlement at the end of the works 11mm

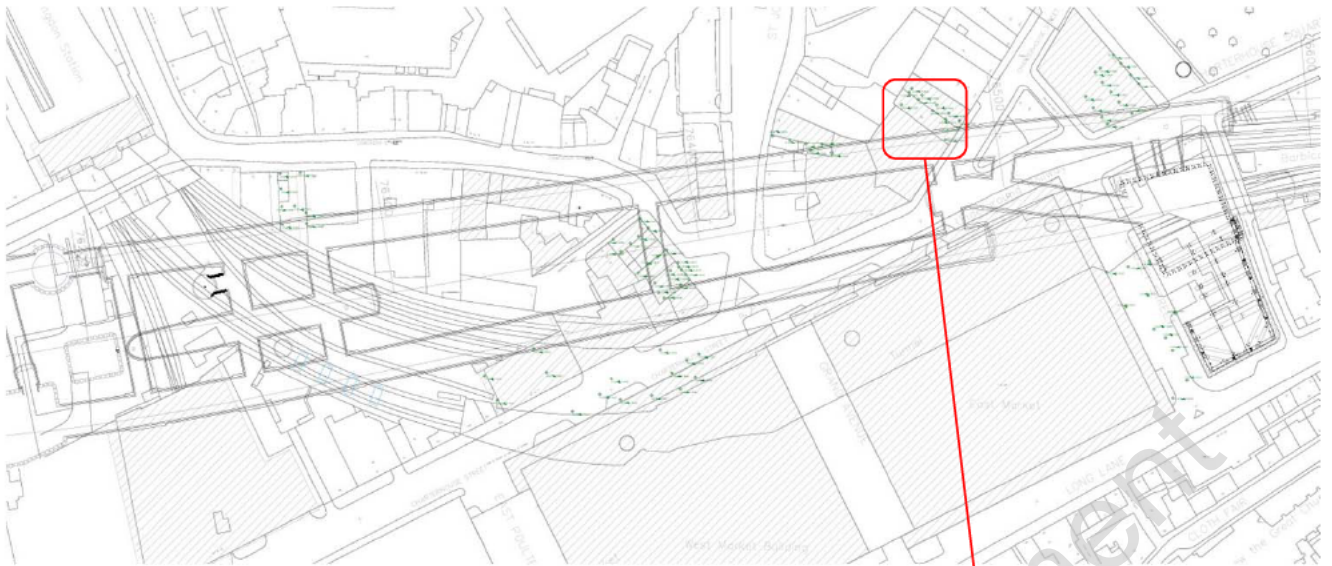
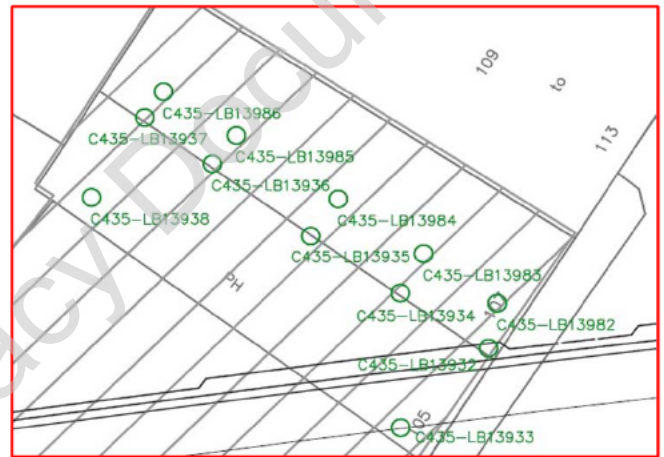
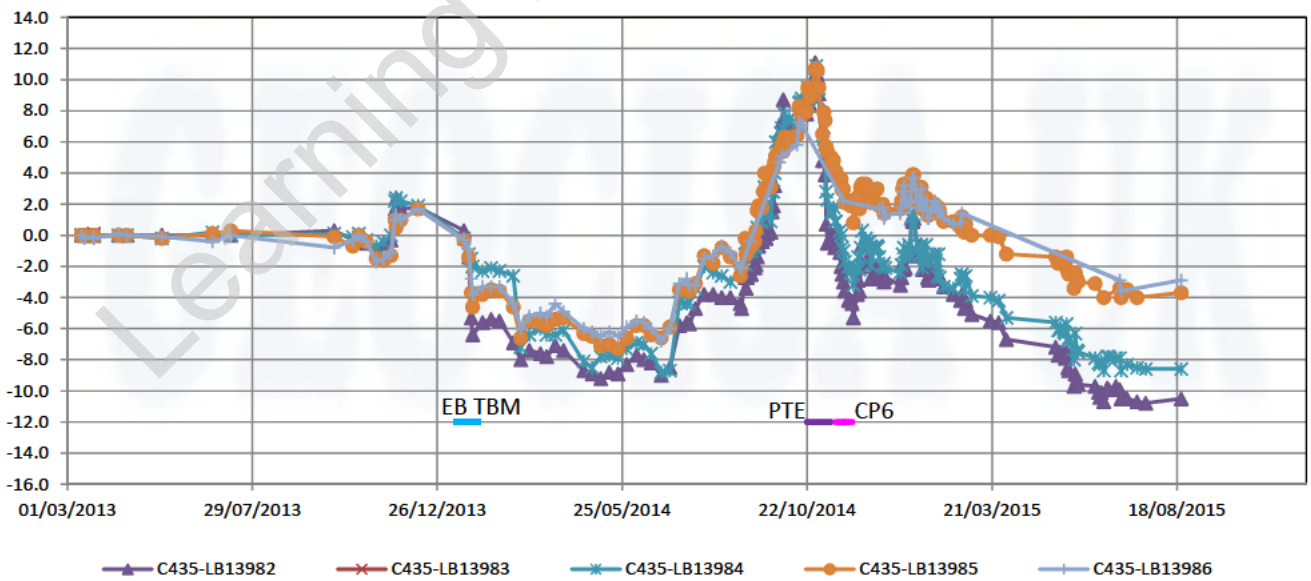
REPORT: **LEVELLING**
AREA: **107 CHARTERHOUSE**
DEVICE: **Precise Levelling Point (Sockets)**

- Compensation grouting from Moorgate Shaft 2 caused maximum 3mm of heave on 22-11-2013.
- EB TBM caused maximum 6mm of settlement from 19-01-2014 to 20-01-2014.
- Residual settlement caused 3mm.
- Ground treatment caused 14mm of heave from 02-07-2014 to 30-10-2014.
- PTE construction caused 15mm of settlement maximum from 22-10-2014 to 10-11-2014.
- CP6 works caused 3mm of settlement from 20-11-2014 to 22-11-2014.
- Maximum settlement at the end of the works 11mm

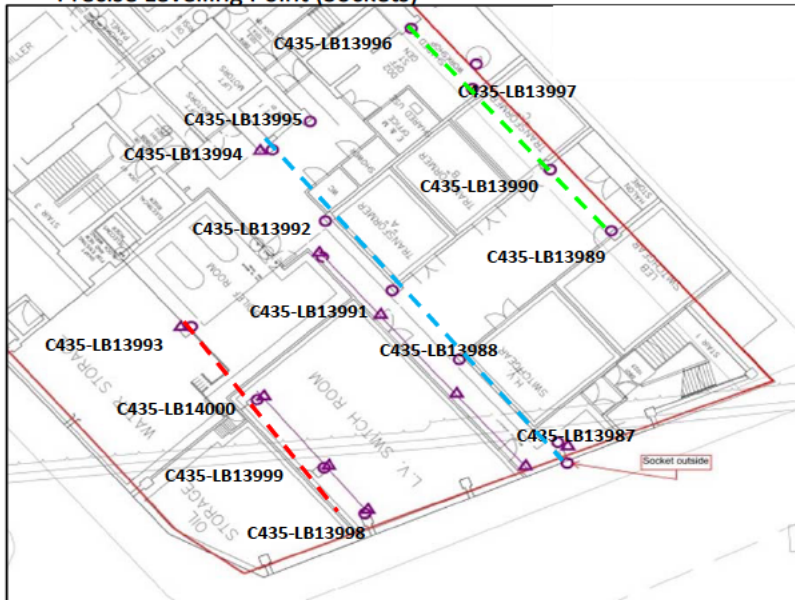
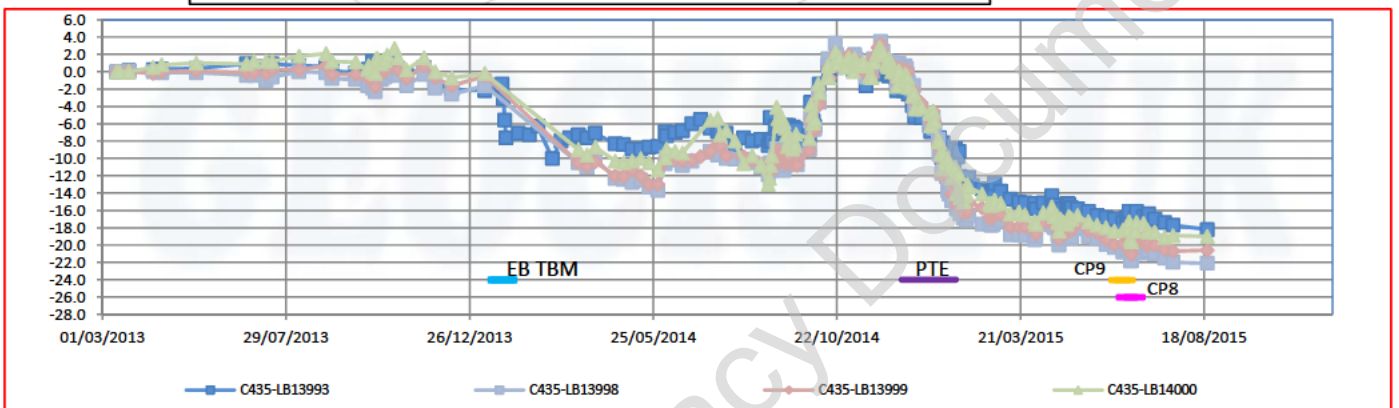
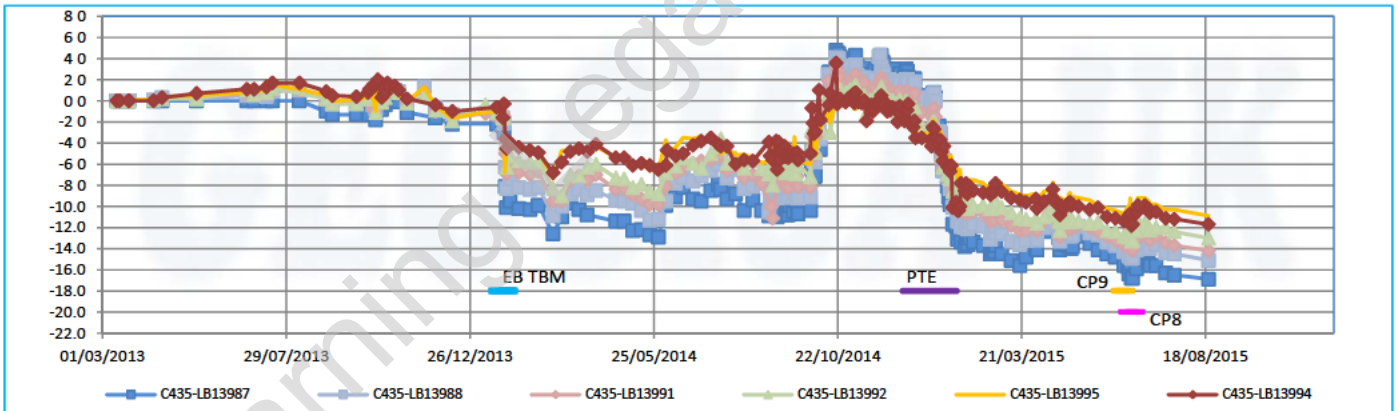
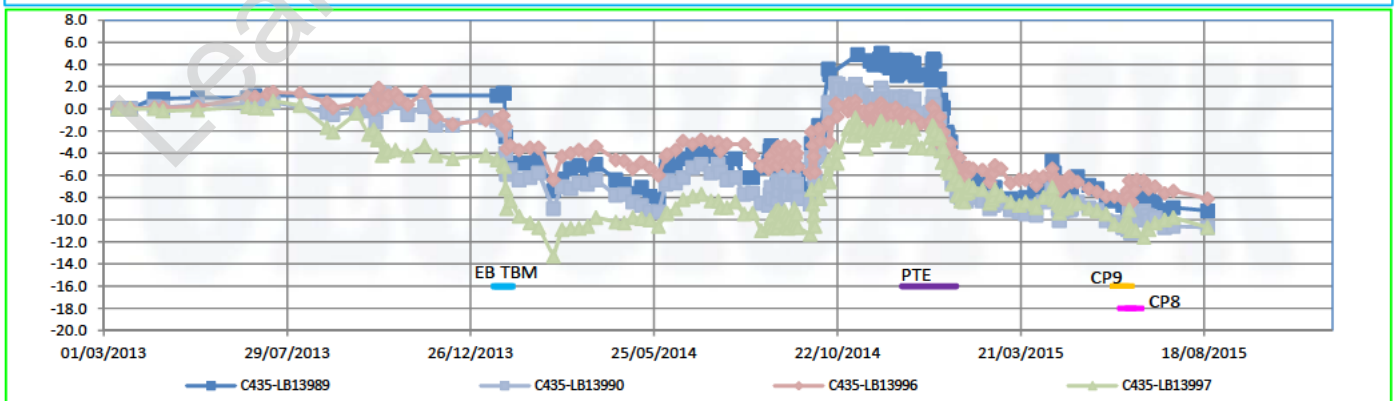
LEVELLING
23-28 Charterhouse Sq (Bank of Scotland)
Precise Levelling Point (Sockets)

- EB TBM caused maximum 10mm of settlement from 21-01-2014 to 23-01-2014.
- Ground treatment caused maximum 16mm of heave between 29-09-2014 to 07-11-2014.
- PTE construction works caused 20mm of settlement between 14-12-2014 to 27-01-2015.
- Residual settlement caused 2mm.
- CP8 and CP9 combination caused maximum 4mm of settlement from 10-06-2015 to 22-06-2015
- Maximum settlement at the end of the works 22mm

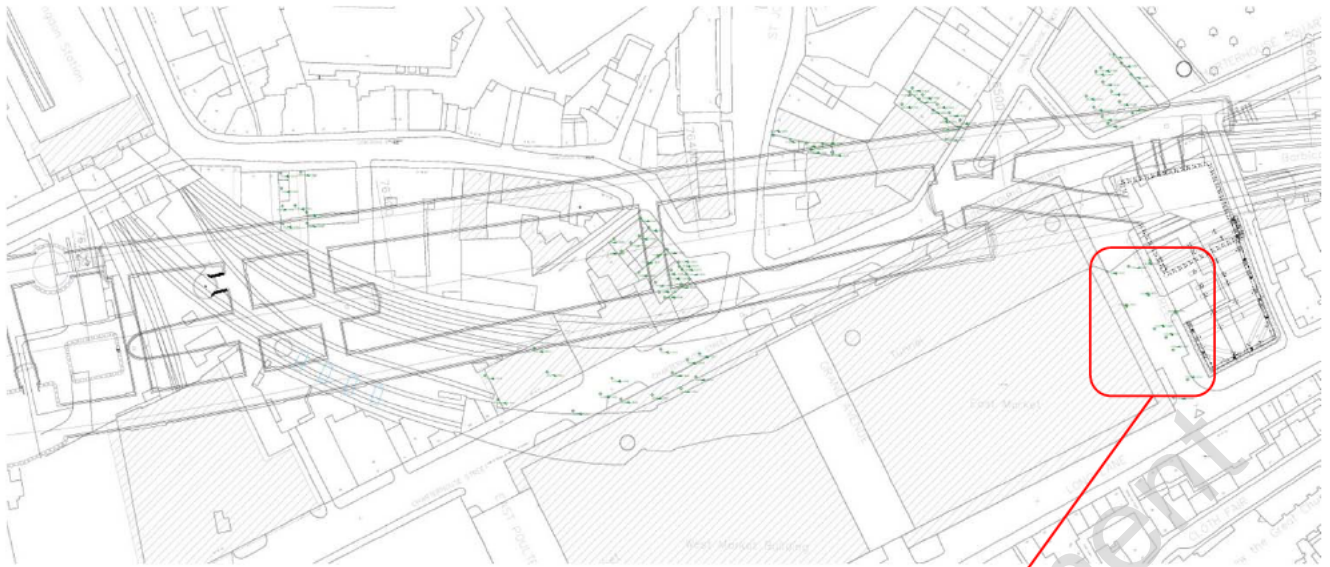
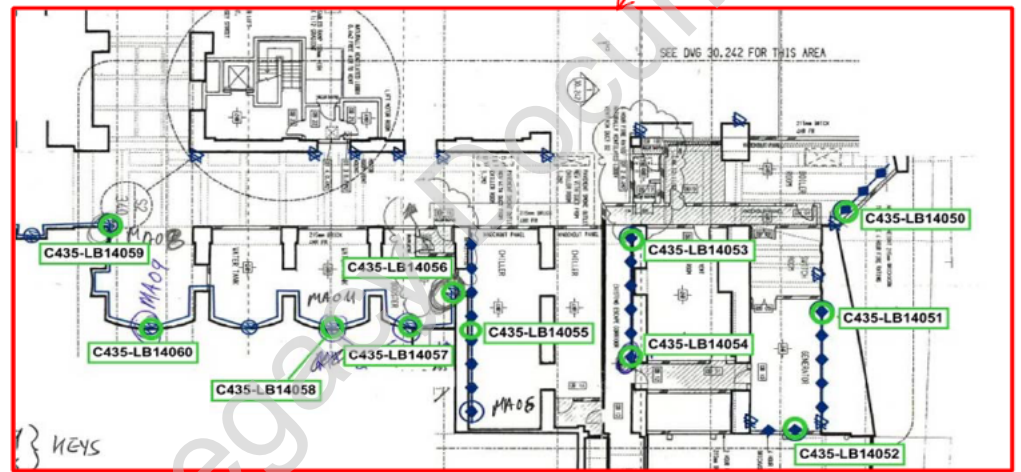
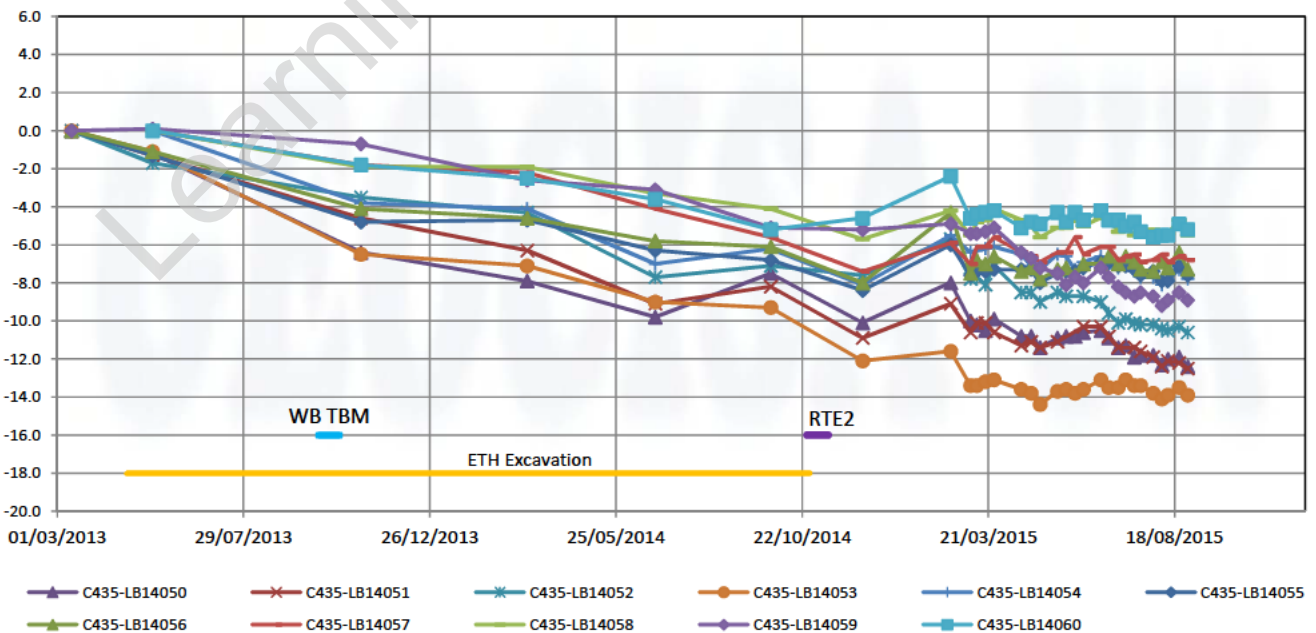
REPORT: LEVELLING
 AREA: Smithfield Market (east)
 DEVICE: Precise Levelling Point (Sockets)

- ETH excavation caused maximum 9mm of settlement from 26-04-2013 to 28-10-2014.
- RTE2 tunnel caused maximum 3mm of settlement between 26-10-2014 to 12-11-2014.
- Maximum settlement at the end of the works 14mm
