C435 Farringdon Main Station

Monitoring Close-Out Report: Internal Monitoring: Sockets and Crackmeters

CRL Document Number: C435-BFK-C2-RGN-M123-51653

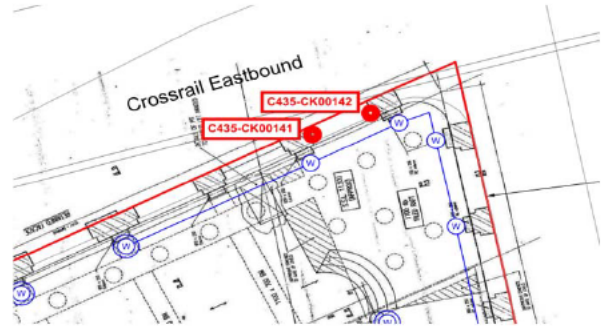
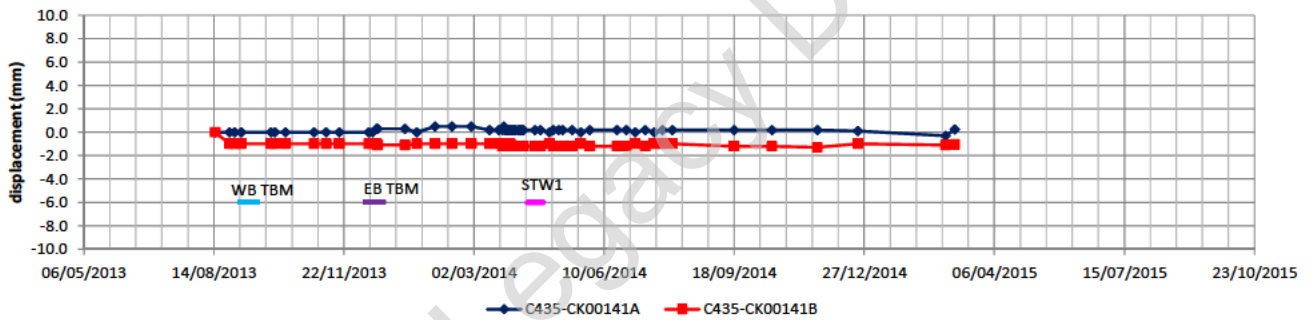
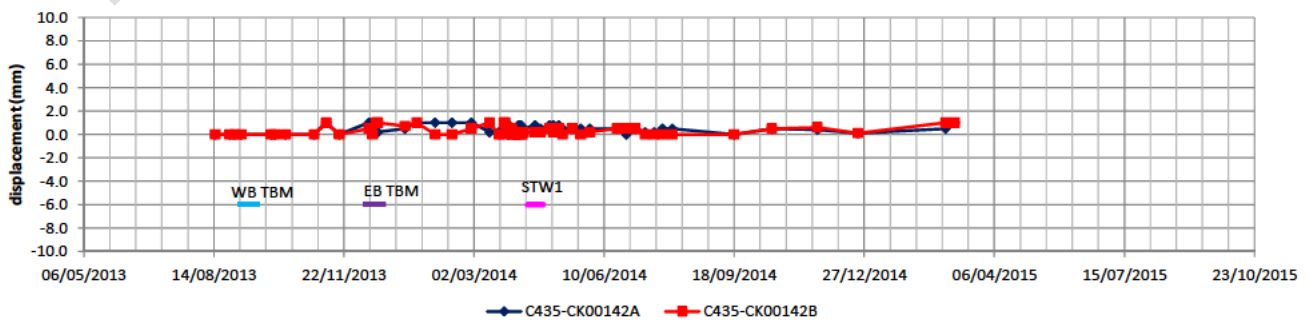
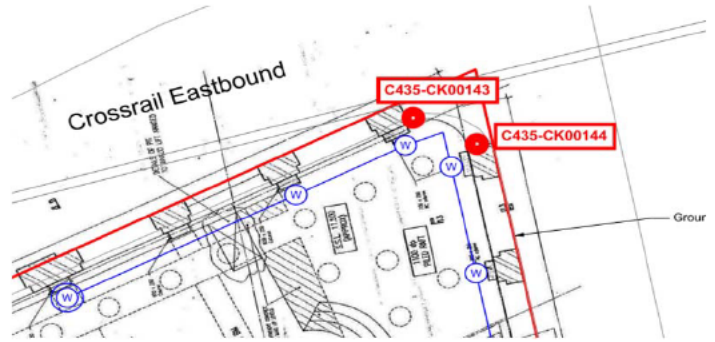
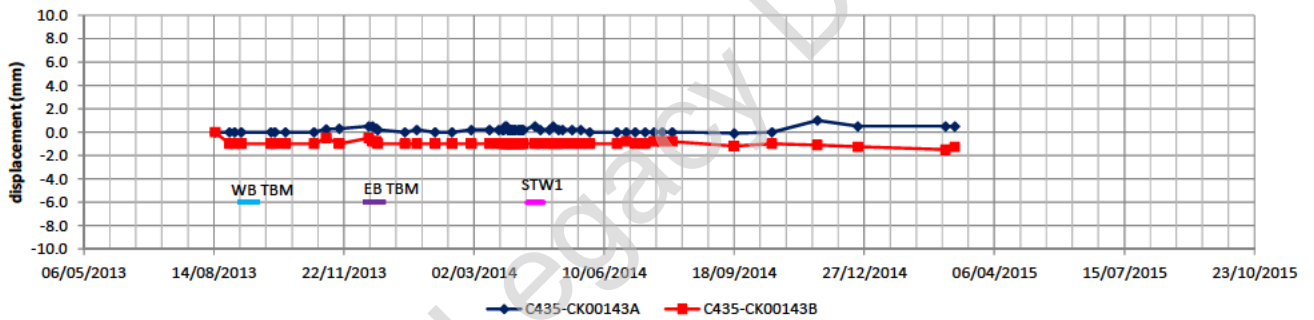
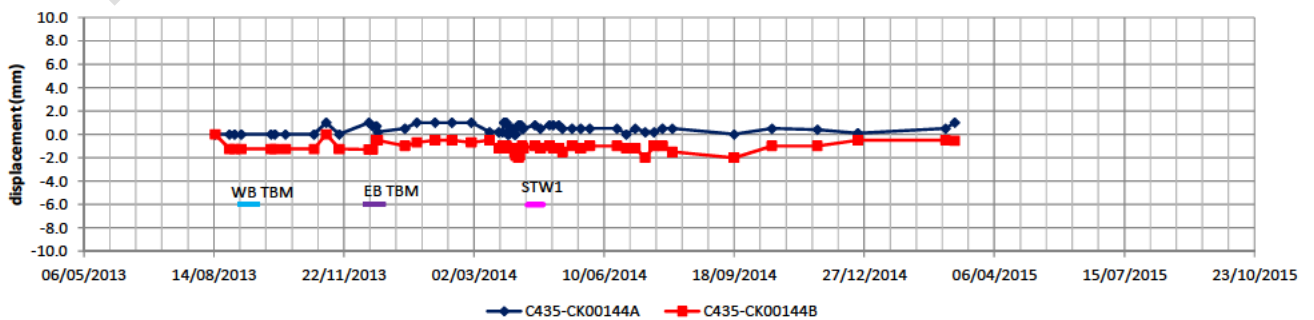
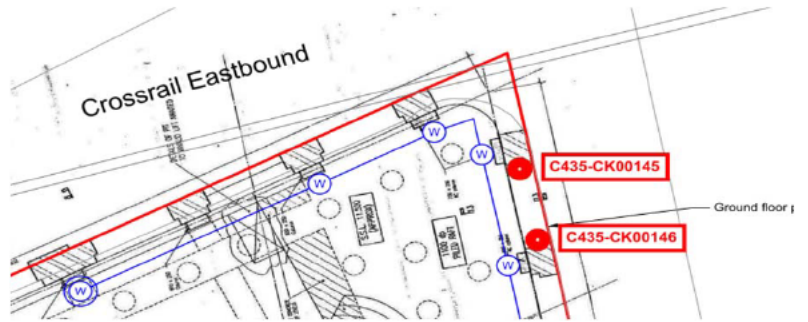
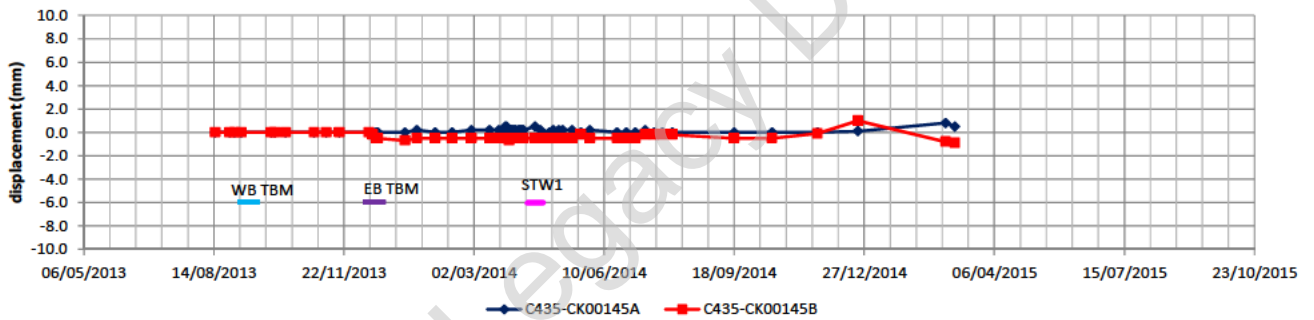
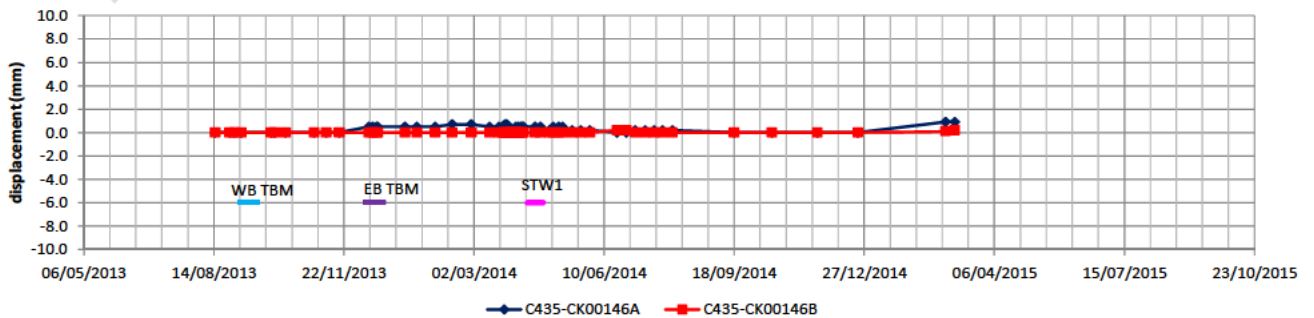
REPORT: Manual Crack monitor
AREA: 25-27 Farringdon Road
DEVICE: Calibrated Tell-Tales.

- The maximum movement captured by the crackmeters installed in this building was -2mm during the STW1 construction, from 12-04-2014 to 24-04-2014.
- No movements caused by the rest of the Crossrail works.

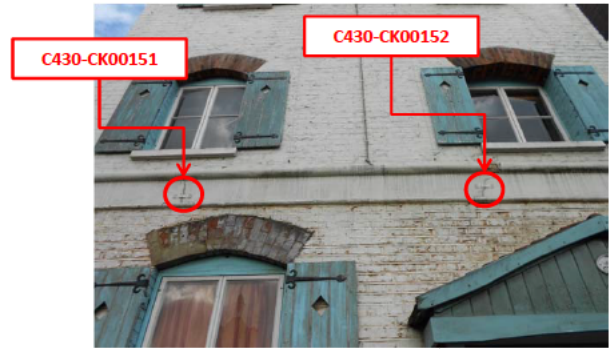
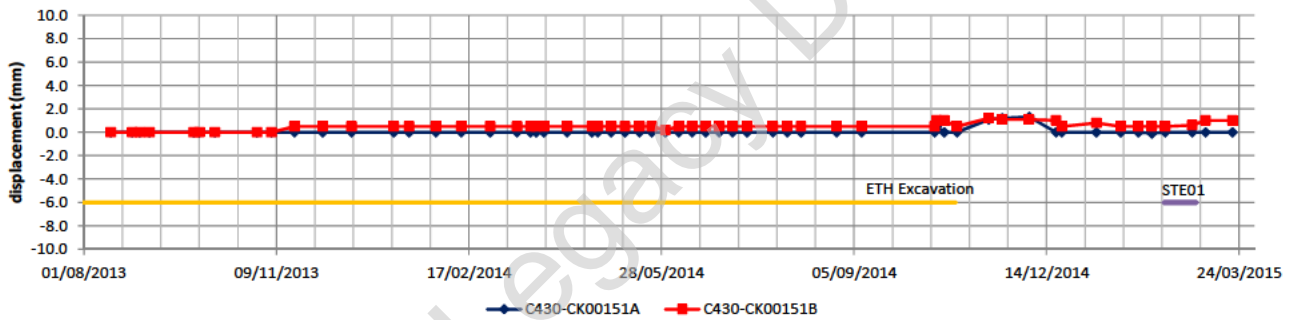
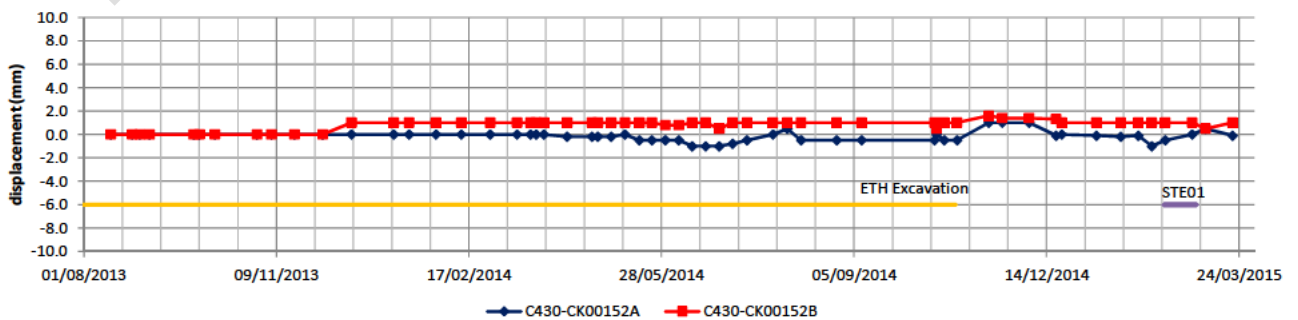
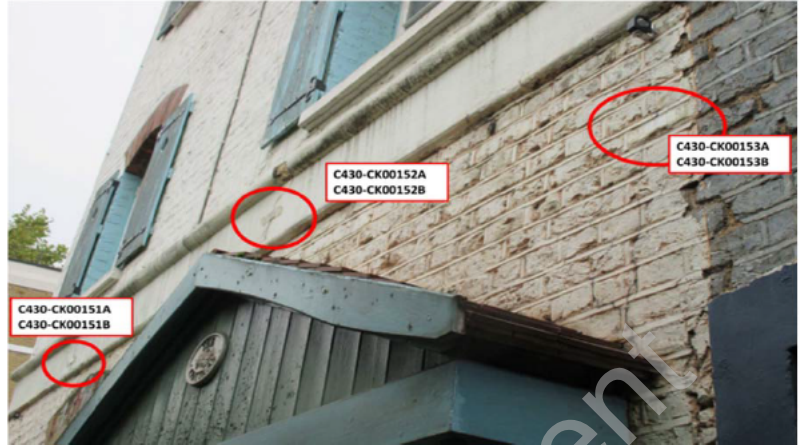
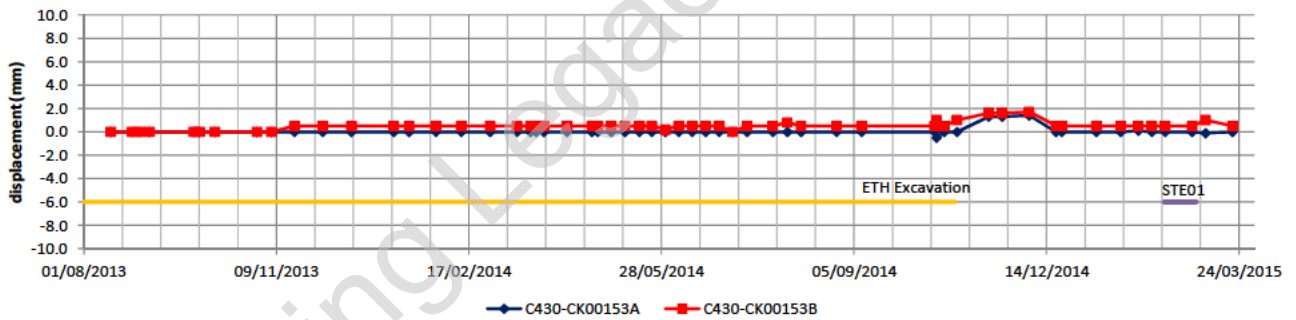
REPORT: Manual Crack monitor
AREA: 2-3 Hayne Street.
DEVICE: Calibrated Tell-Tales.

- Maximum movement captured by these crackmeters was 1.5mm during ETH excavation works.
- No significant movements for the rest of Crossrail works.

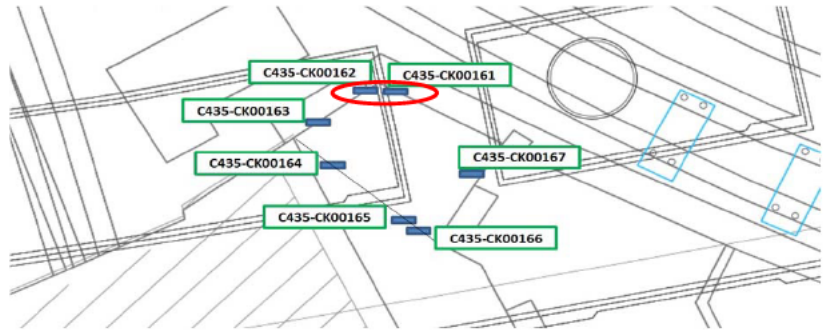
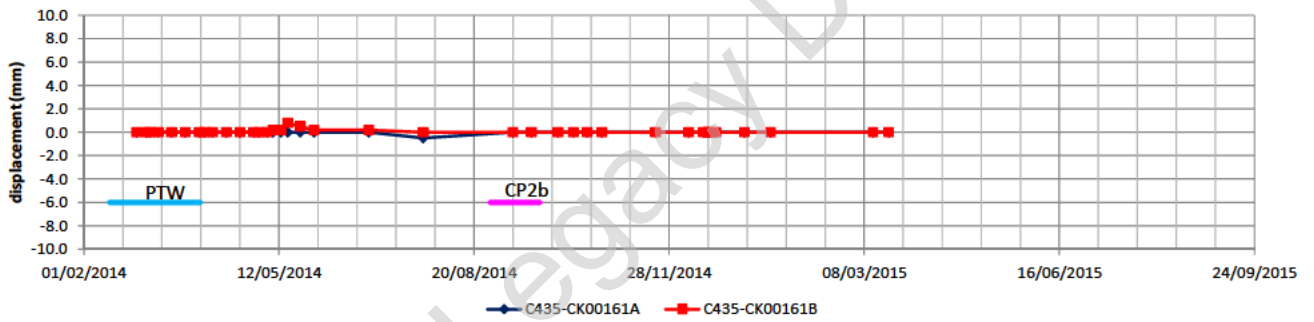
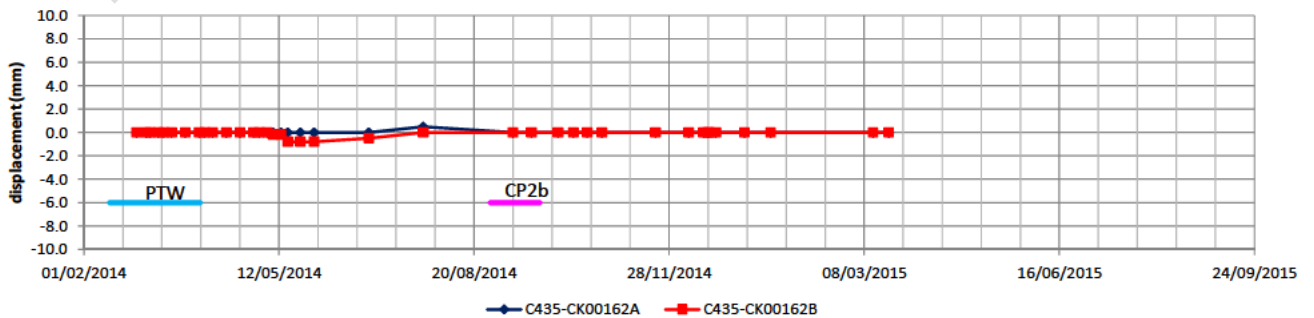
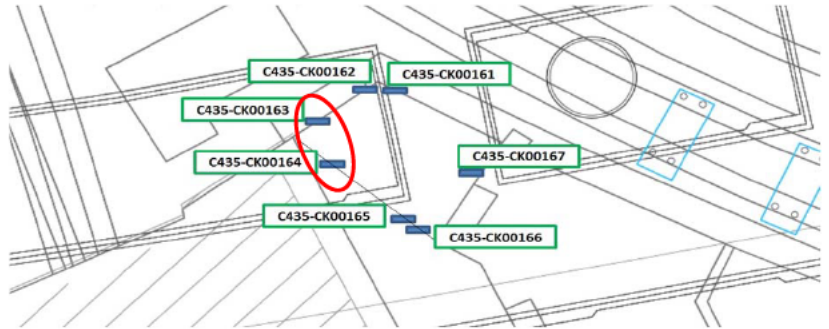
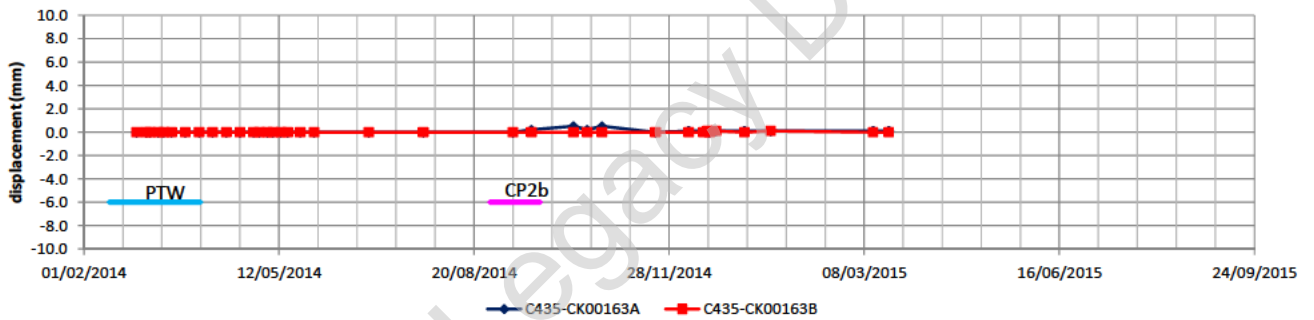
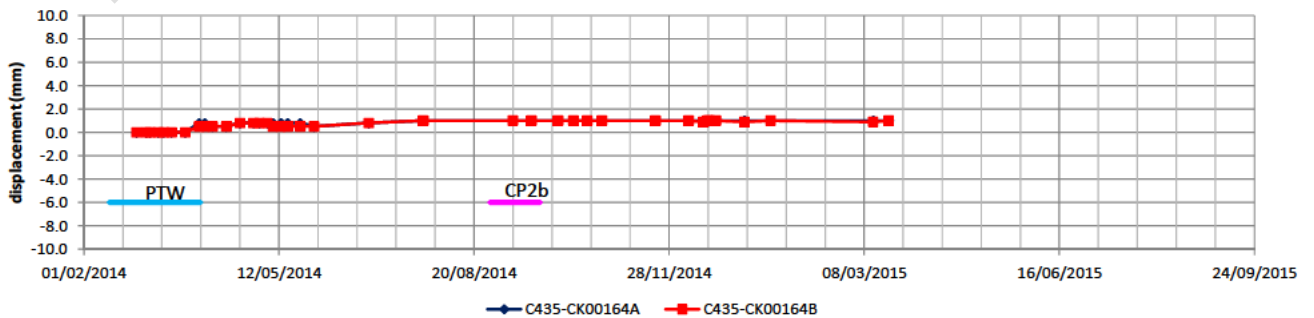
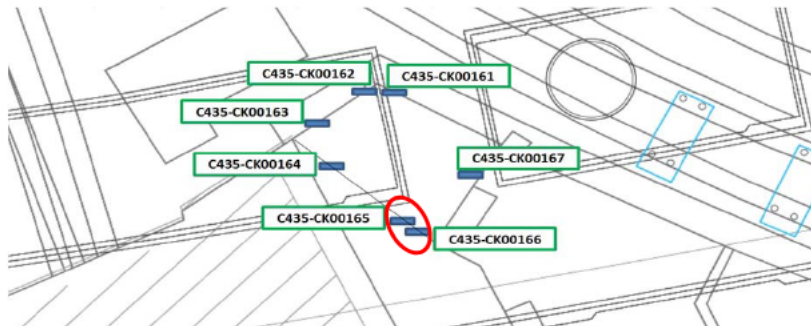
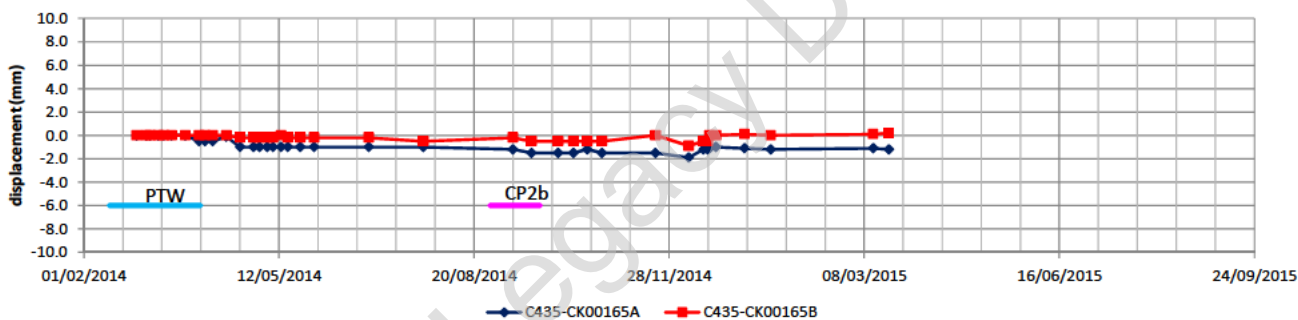
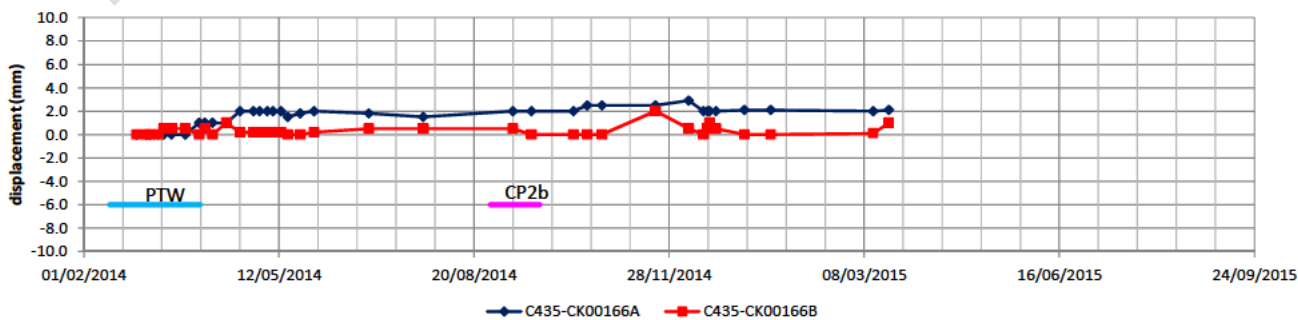
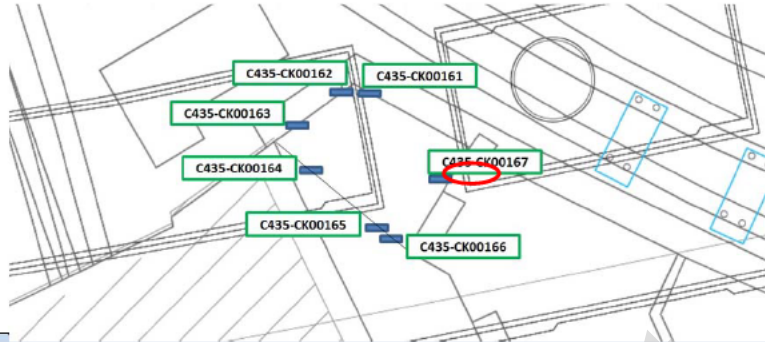
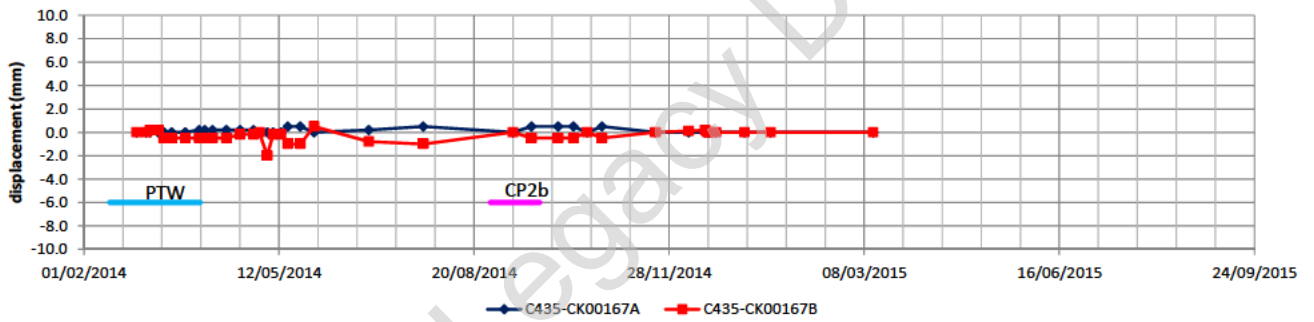
REPORT: Manual Crack monitor
AREA: 55 Charterhouse Street
DEVICE: Calibrated Tell-Tales.

- PTW works caused maximum 2mm of movement from 14-12-2014 to 02-04-2014.
- CP2b construction caused 1mm of movement from 28-08-2014 to 23-09-2014.

28-2-2014: These Crackmeters have been installed in vertical position.

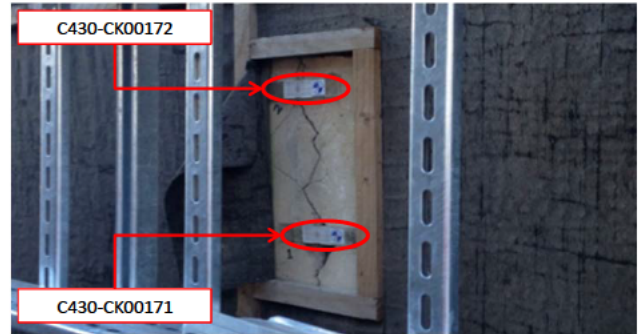
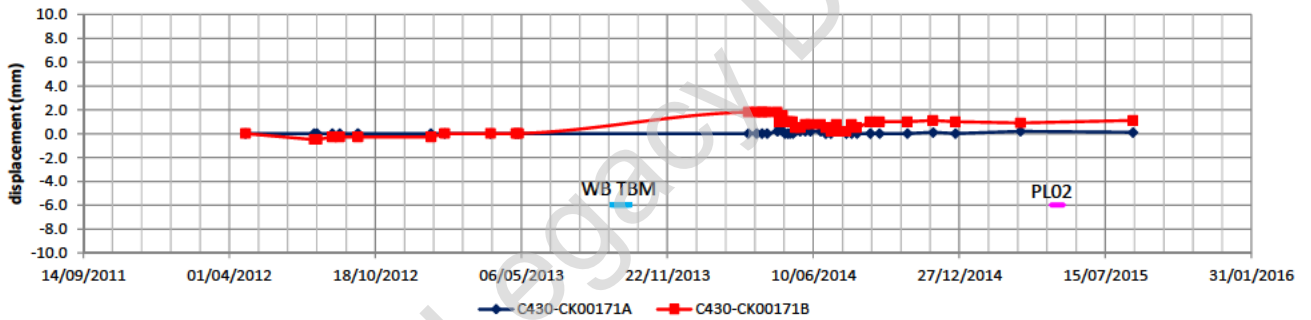
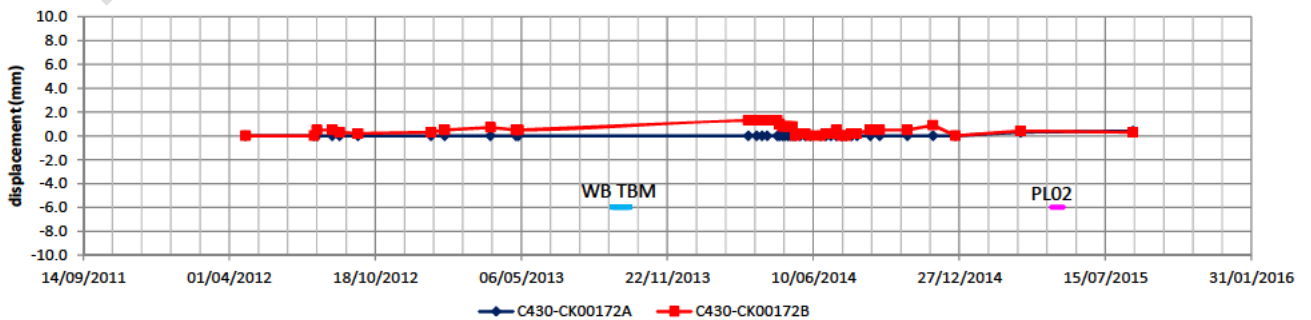
REPORT: Manual Crack monitor
AREA: 57 Charterhouse St
DEVICE: Calibrated Tell-Tales.

- WB TBM caused maximum 2mm of movement from 18-09-2013 to 22-09-2013.
- No movement caused by the PL2 tunnel.
