# C435 Farringdon Main Station

# Monitoring Close-Out Report:

# In-ground Monitoring Section E

CRL Document Number: C435-BFK-C2-RGN-M123-51655

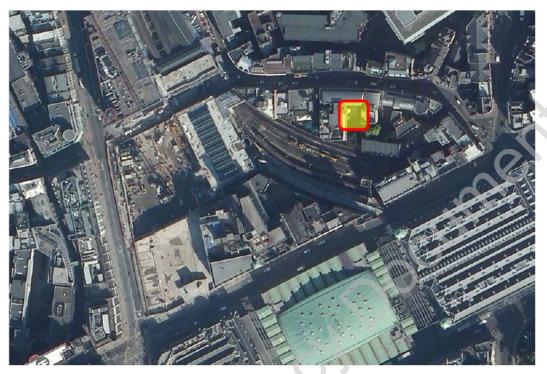
Figure 1 - Plan showing the Location for the device on Section E.

In ground device associated with Section E is located on the plan below highlighted in yellow.
