C435 Farringdon Main Station

Monitoring Close-Out Report: Section K

CRL Document Number: C435-BFK-C2-RGN-M123-51659

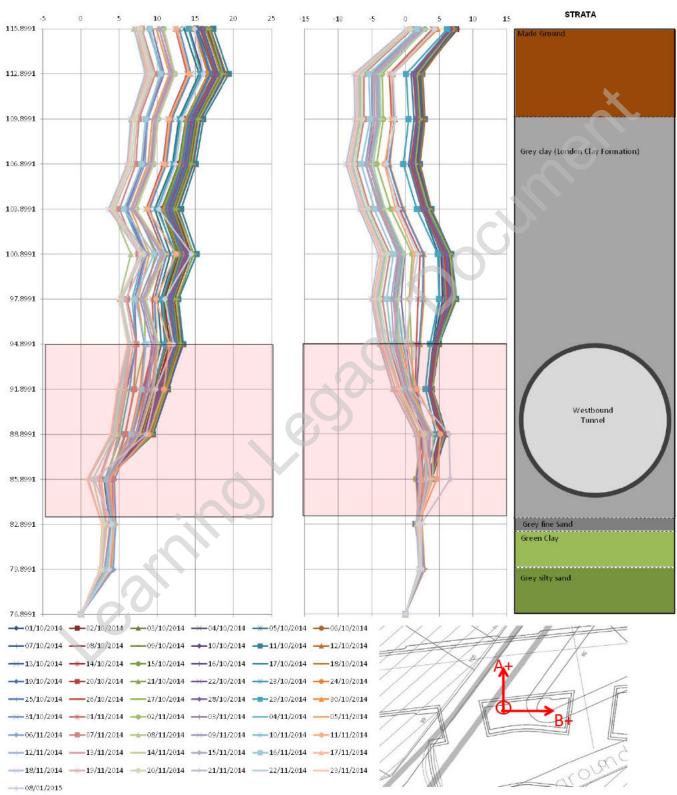
DEVICE: Inclinometer C435-IE00013

- PTE enlargement caused 14mm lateral displacement in A direction toward the tunnel and 5-6mm in B+ direction from October 2014 to November 2014.
- CP6 construction caused 16mm lateral displacement in A direction toward PTE tunnel and 8mm in B- direction between 01-11-2014 to 23-11-2014.

The inclinometer was inside of the influence area for PTE from 23-10-2014 to 16-12-2014

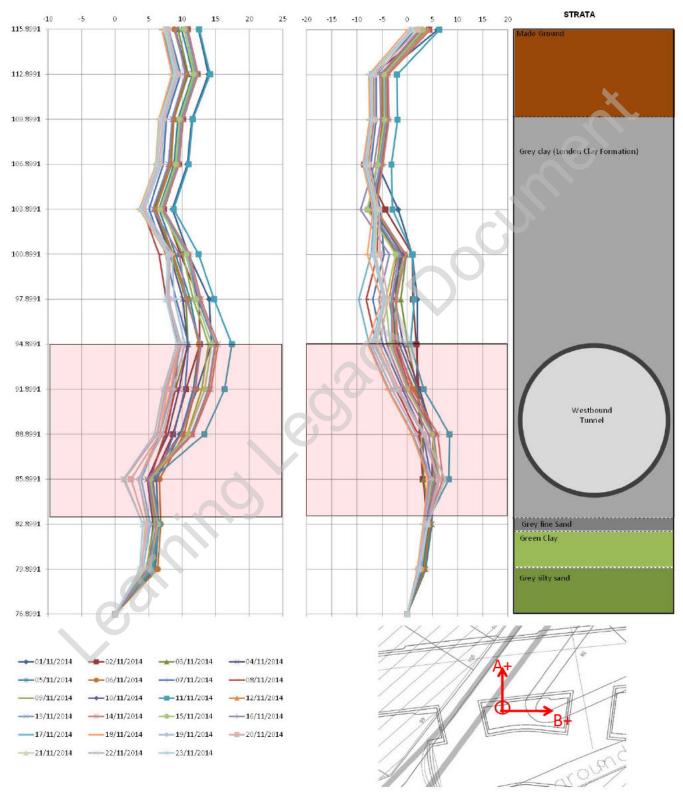
During CP6

The inclinometer was inside of the influence area for CP6 from 14-11-2014 to 22-11-2014

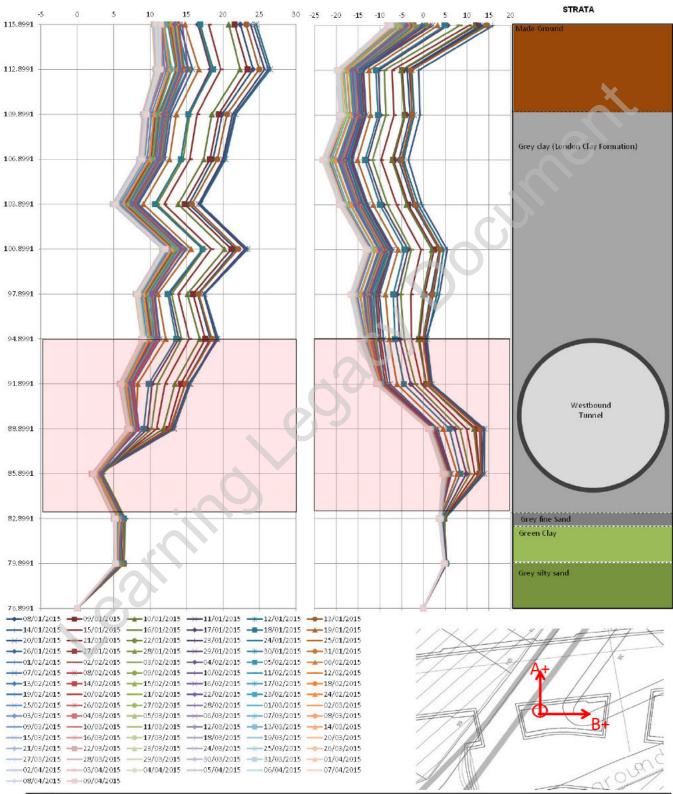
During CH2

- CH2 (combination of pilot and enlargement) construction works caused 14-15mm lateral displacement in A- direction and 14-15mm in B- direction from 08-01-2015 to 09-04-2015.

The inclinometer was inside of the influence area for CH2 from 30-01-2015 to 01-04-2015
