◀ HEALTH & SAFETY ALERT ▶

Slewing Plant Fatality – Hong Kong

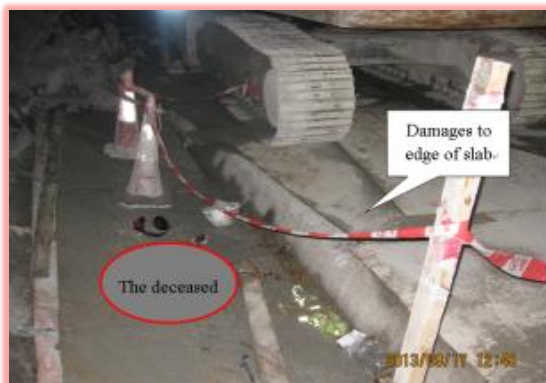
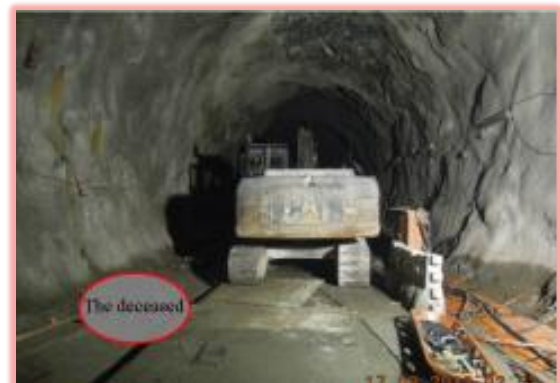
A ganger working on a tunnelling contract in Hong Kong was fatality crushed by an excavator during tunnel wall trimming operations. The deceased was positioned in the side of the excavator adjacent to the operator's cab. Whilst tracking backwards the excavator's rear track slipped off the invert slab causing the excavator to jerk. It is believed that either when the excavator slipping off the slab or during reverting to the slab, the deceased was crushed between the tunnel sidewall and the counterweight of the excavator.

Investigation revealed that the excavator operation zone was not barricaded off and warning bars/rods were not installed at the rear of the excavator.

1. Establish 'exclusion zone' for slewing plant by physical barriers with warning signs.
2. Appoint banksman to guide the plant and stop people from entering the 'exclusion zone'. The banksman should also stay outside the 'exclusion zone' during plant operation.
3. Provide adequate task specific lighting from at least two widely separated sources to avoid shadows.
4. Develop effective means of communication between the plant operator and the working gang, e.g. walkie talkie, whistle, flashlight, baton, etc.
5. Slewing plant should be installed with warning bars/rods at the rear, as well as side mirrors and reversing video device/CCTV.
6. Work area should be levelled off to avoid inadvertent plant movement.
7. Plant which has the counterweight inside its footprint of the track, whilst slewing, should be used at a work location where space is restricted.
