# ◀ HEALTH & SAFETY ALERT ▶

## Crawler Crane Auxiliary Jib Chain Detachment – Update

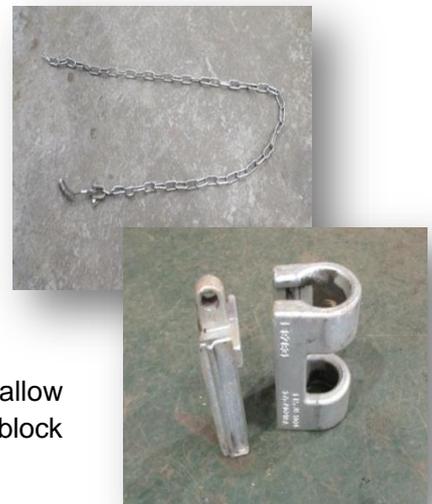
An incident occurred on the 30<sup>th</sup> August '14 at Crossrail Moorgate site involving a crawler crane, where an over hoist cut out chain became entangled in the sheave, causing both chain and block to fall free. No one was injured as a result of this incident.

As the speed of the hoist increased, it was observed that the over hoist block started to rotate. After several lifts, this rotation became sufficient to allow the chain to become entangled around the wire rope and the cut out block weight, to a point where it subsequently struck and damaged the sheave.

During this process, the over hoist chain remained taut, meaning the cut out switch was not activated and the crane continued to lift.

As soon as the line was lowered, the entanglement of the block and chain became released, causing the chain to snap, resulting in both block and chain to fall down the rope striking the auxiliary hook block. The trial effectively created an identical outcome to the incident which occurred on the 30<sup>th</sup> August '14.

**In advance of this solution and with immediate effect, Crossrail recommend that all contractors review the use single rope auxiliary lines until they get confirmation from their crane supplier / hirer that the configuration is safe and fit for use.**

**We request PC Project Manager to confirm to the CRL Project Manager by the 24<sup>th</sup> September '14 that the supplier / hirer has approved the crane set up and configuration as safe and fit for use.**
