C131 - PADDINGTON INTEGRATED PROJECT

HISTORIC BUILDING RECORDING – PIP TRIANGLE SITE

Document Number: C131-MMD-T1-RAN-B071-00002

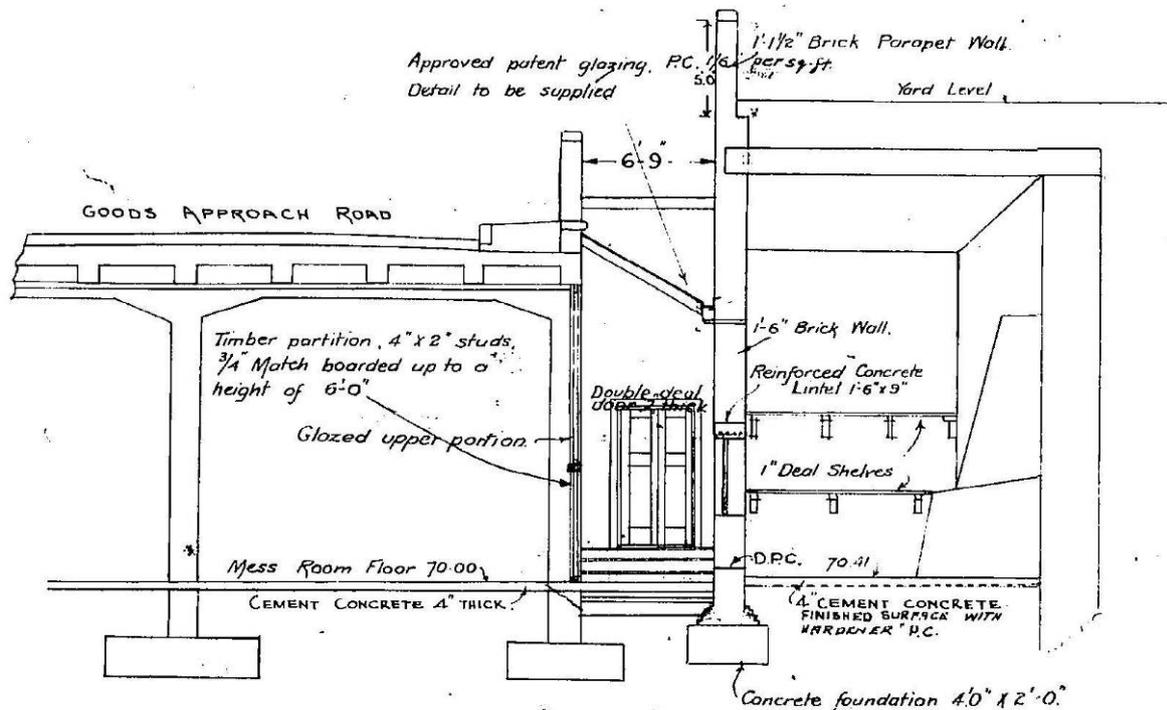
Figure 12- 1930s alterations showing a cross section of Vault 5 to the right

Vault 5 was a similar composition to Vault 2 being open with no central partition wall. At the northern end a vertical buttress surrounded by a horizontal buttress were visible (plate 58), a

section showing the form of these units is provided in figure 12. The western elevation showed exposed brickwork in the same bond and brick as those exposed in the other vaults (plates 59-60). Another set of four niches were visible in the room, all evidence of previous openings (plates 59-61). Further corbels were extant providing evidence of a previous ceiling structure (plates 59 & 61). An 18 paned metal fixed window was also visible within the room (plate 62).

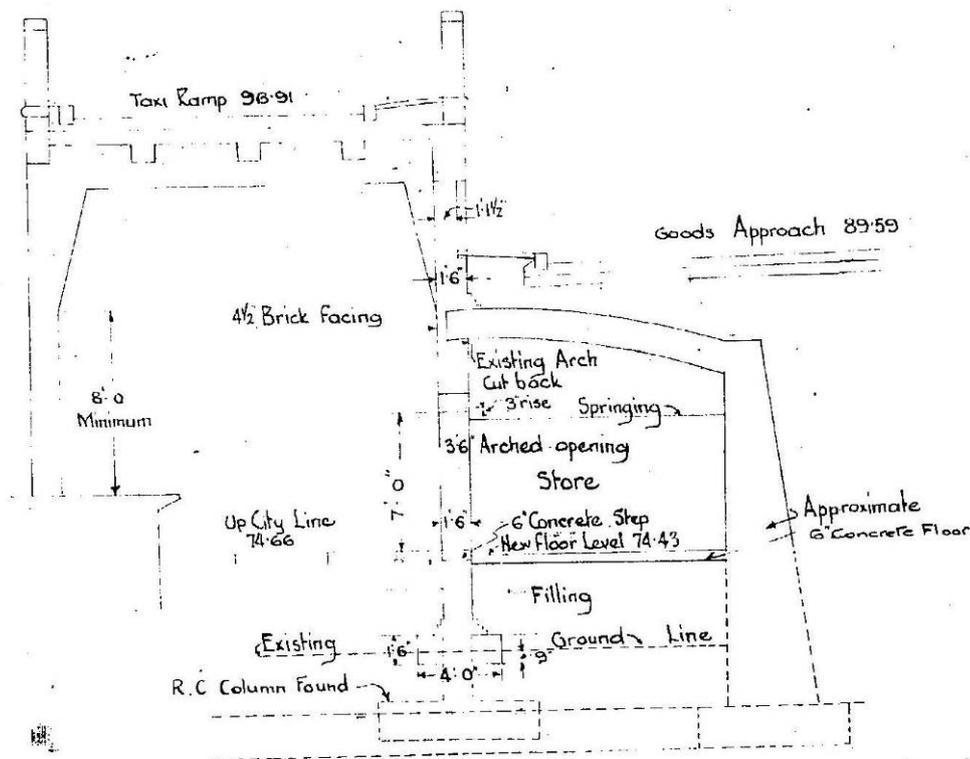
Figure 13 – Showing alterations to Vault 8 and its small scale (source: G.W.R Paddington Station Improvements: Bishops Road Station, Goods and Taxi Approach Roads, Foundation Plan and Sections, Contract No.11, Drawing No. 7)

Vault 8 is a relatively small vault that appears to have been originally constructed of two rooms, one to the north and one to the south (Figure 7), although the northern section was demolished as part of the 1930s alterations. The southern section has also been truncated to the south with a new 1930s façade inserted with plank and batten door (plates 76 & 77) as part of the reconstruction of Bishops Bridge Station and the expansion of both underground and suburban services works. The room is plain in character, being constructed of stock bricks with much efflorescence to the bricks and sulphur deposits (plates 75, 77 and 78). Numerous tables and hooks to the walls were also identified suggesting the room was used as some form of workshop after it was no longer used as a stable (plates 74 & 75). To the northern extent there is a boarded up opening which may have been used as a light well as the original layout of these stables would have had little natural light within them (Figure 14 & plate 74). The interesting thing of note here is that no corbels survive due to low height of the vaulted ceiling which was raised by 6 inches in the 1930s (Figure 13).

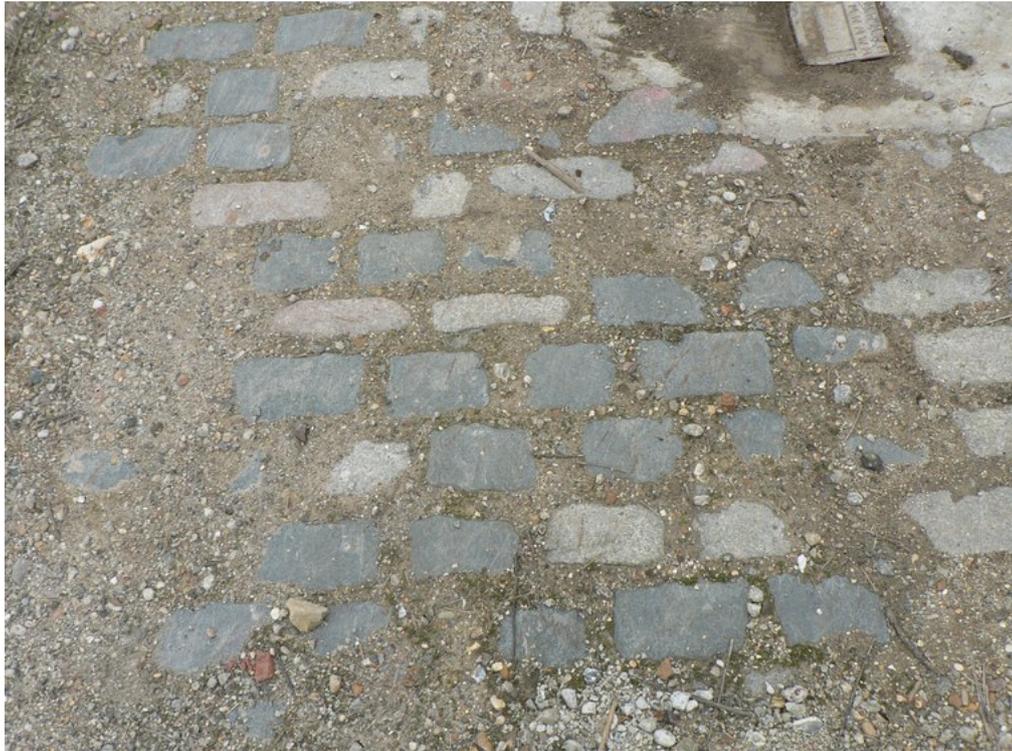
Plate 5 – Granite setts located on Upper Triangle site

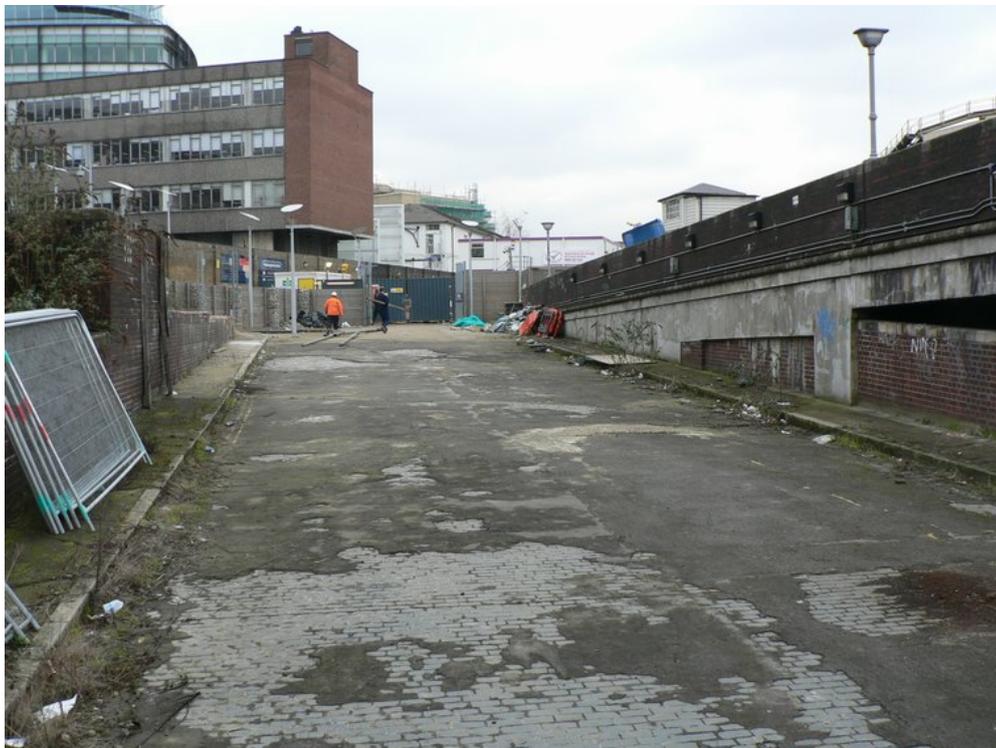
Plate 10 – View up Goods Ramp showing historic granite sett partially covered by tarmac

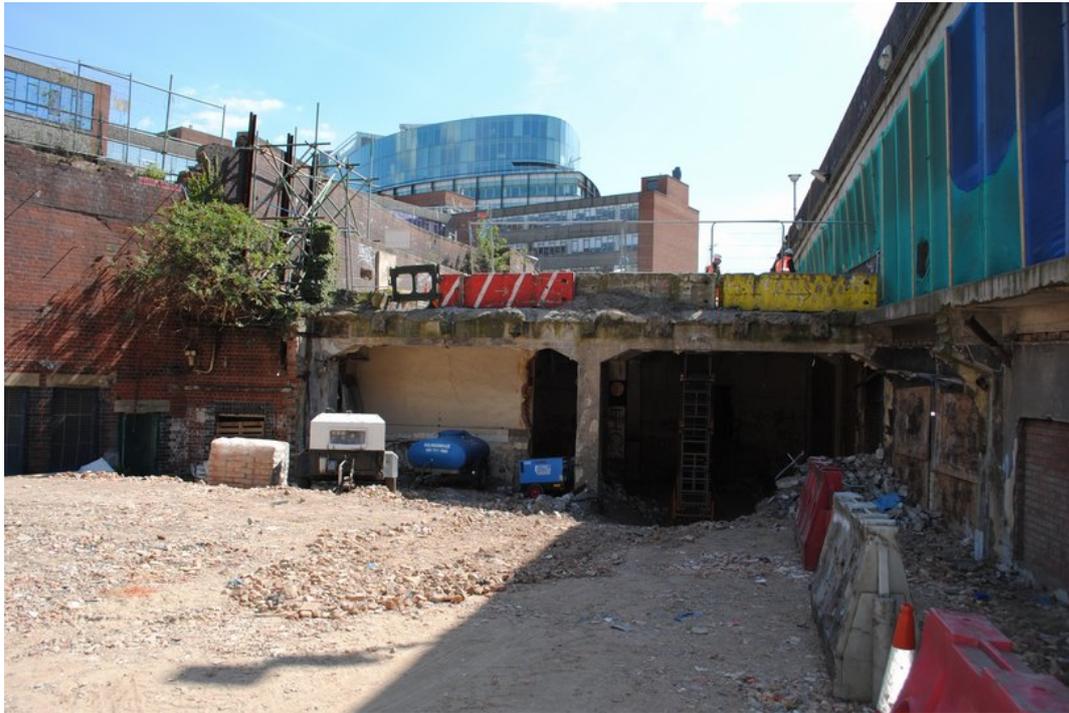
Plate 15 - View towards former dining rooms, note partial demolition to right permitting further access

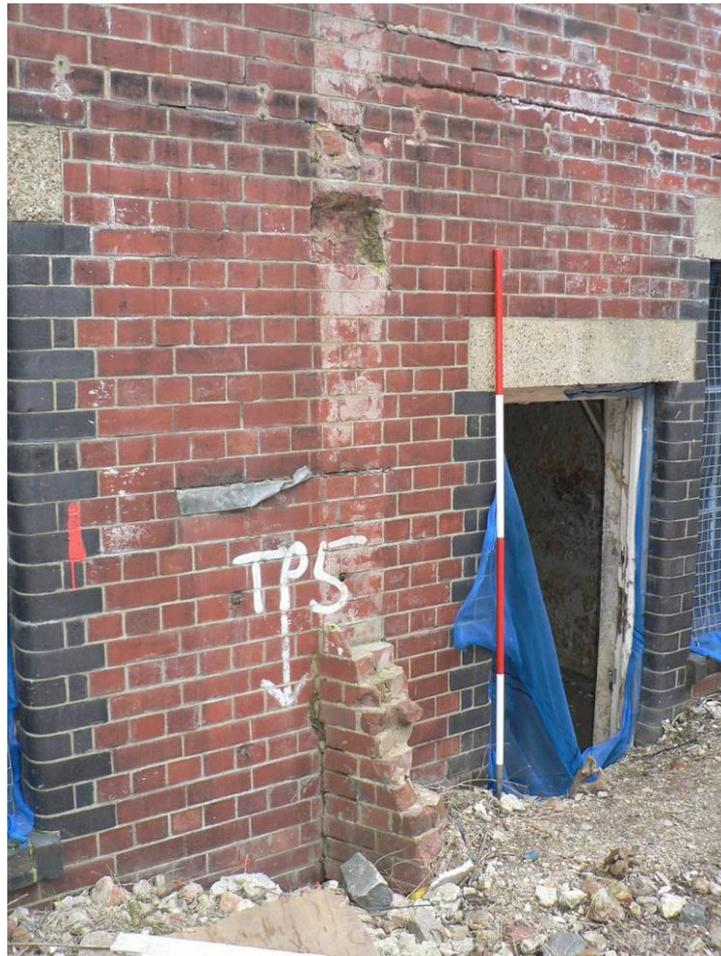
Plate 18 - Detail of former partition to brick vaults outside Vault 3

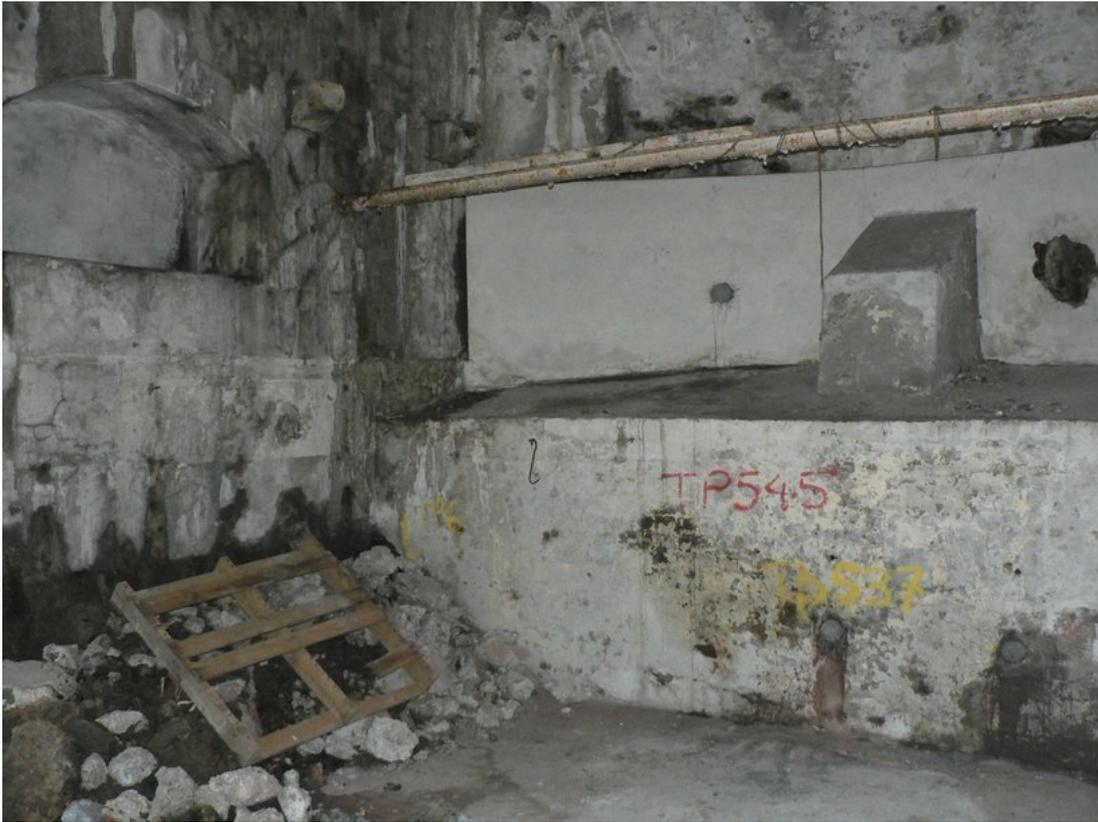
Plate 39 – Partially obscured vertical buttress and partially blocked niche to left

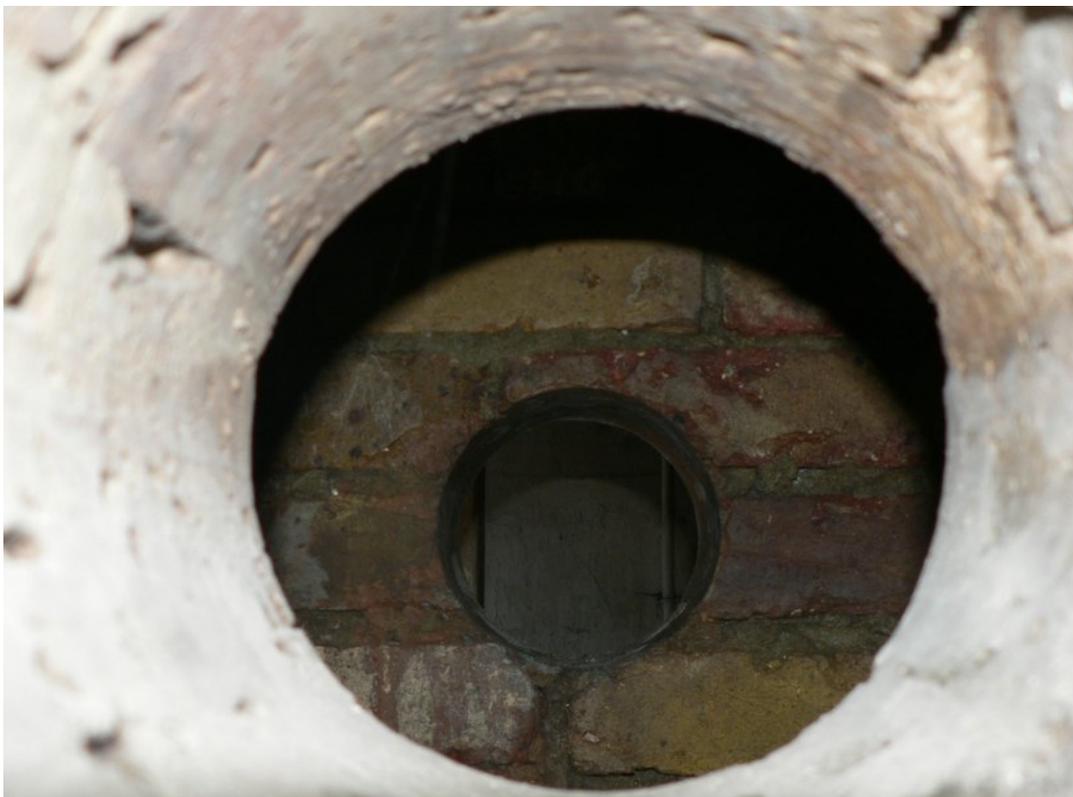
Plate 40 – Core hole showing blocked niche was originally hollow

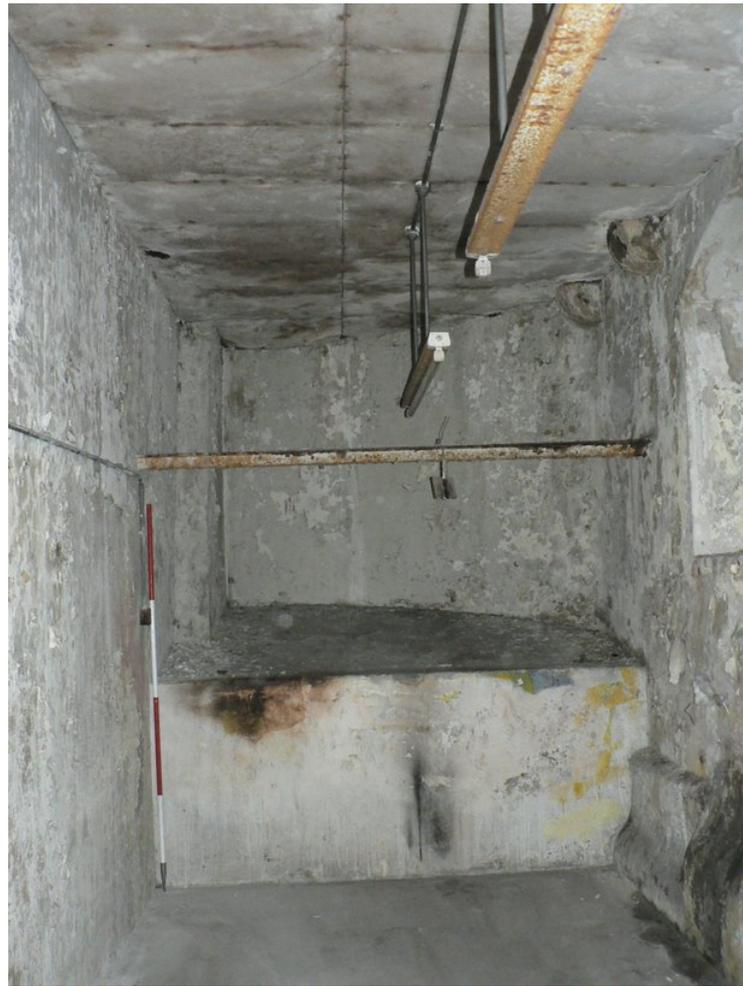
Plate 46- Obscured brackets, note corbels supporting roof above

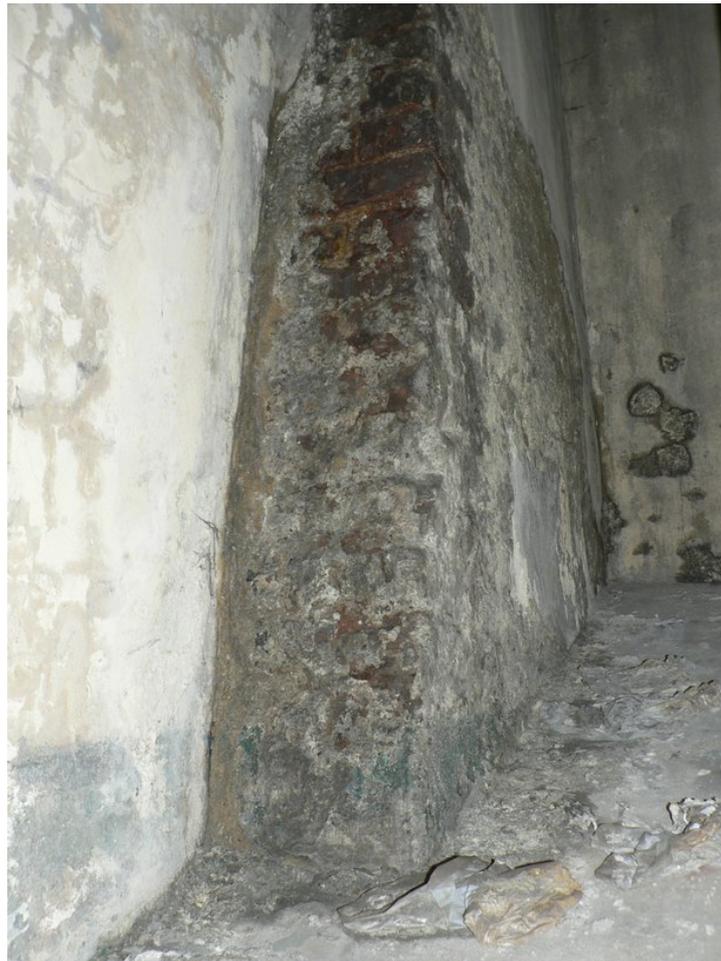
Plate 54 – Part of brick buttress obscured by partition wall

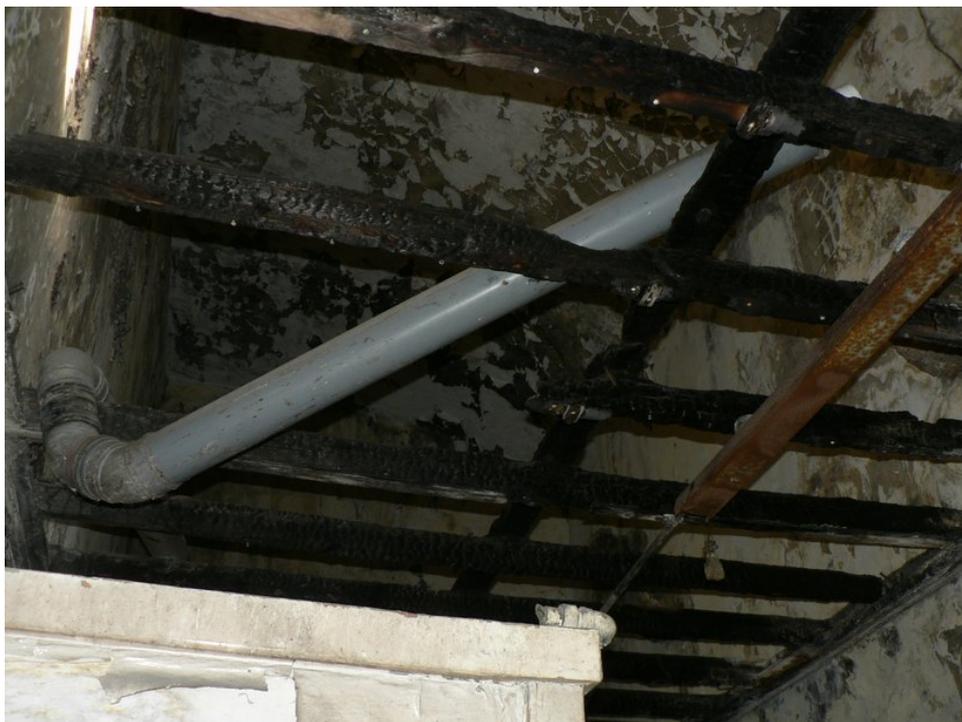
Plate 57 – Former ceiling detail, now charred

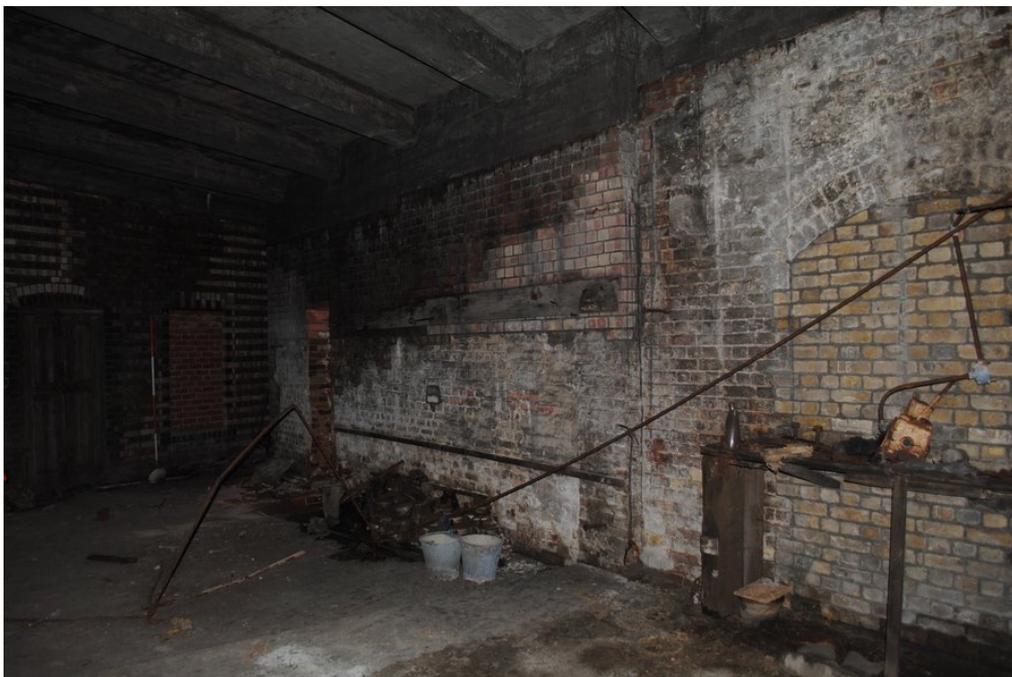
Plate 70 – Western elevation of vault, showing straight joint of wall to centre and change of floor level suggesting the room was originally divided into two.
