Crossrail Archaeology Framework

Archaeological Watching Brief - Sea Wall Breaching Wallasea Island Essex_ CNWA13_ Fieldwork Report

CRL Document Number: C254-OXF-T1-RGN-CRG04-50001rev2

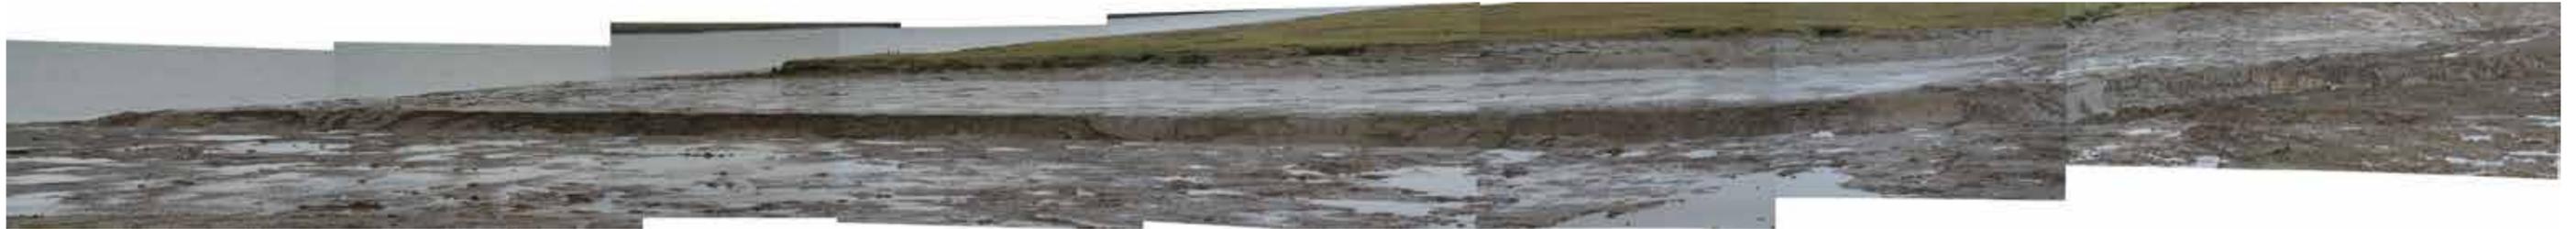
Plates 1-11: Montage showing north facing section through the sea wall in Breach 1

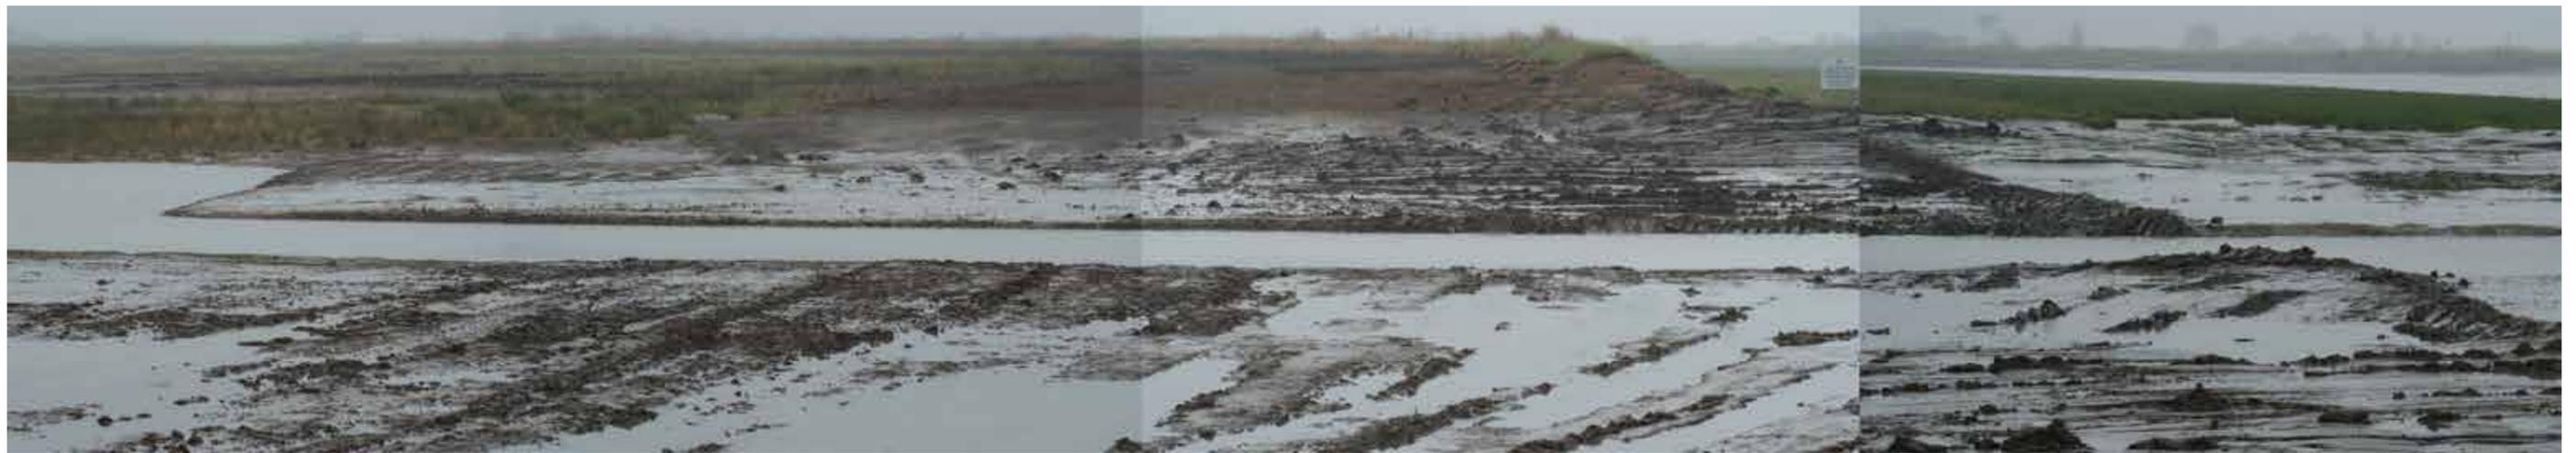
Plates 12-16: Montage showing east facing section through sea wall in Breach 3

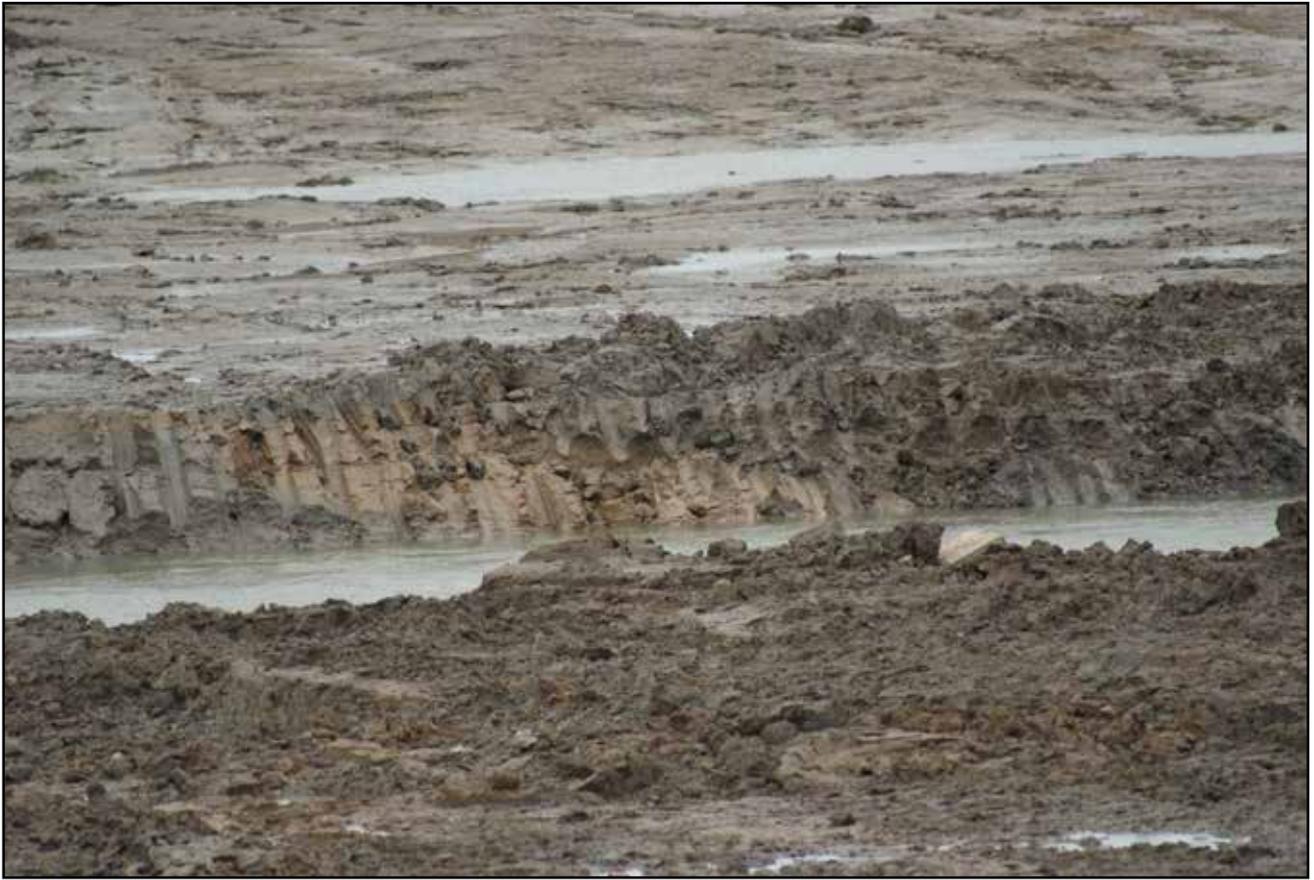
- 4.1.5 In the breach's southern face, a distinct orange brown deposit (101) was observed ca. 1-1.5m below the level of the former sea wall (Plate: 17). This deposit, which was c. 0.6m thick, lay within the grey marine clays and appeared to be an oxidised layer of clay which clearly sloped down from east to west. To the west and sealing the oxidised clay was a dark brown-black "organic" deposit (102) which appeared to be the fill of an infilled former ditch (111). The "organic" deposit was at least 1.5m thick (it appeared to continue below the sea level) and was at least 2.5m wide.

6.6.3 The remains of undated ditch and the truncated remains of a possible bank 111/101/102 were observed in the section of the southern bank of Breach 1 beneath the recently removed sea wall. Although no dating material was obtained from the ditch fills. This ditch and truncated bank was almost certainly the remains of part of the sea defences shown on Chapman and Andre's 1777 map of the island and are possibly much earlier in date.

6.6.6 In Breach 1, the in filled ditch (111) observed beneath the present sea wall on western (landward) side of the present sea wall and the associated oxidised clay of a probable truncated bank seems to be part of an earlier 18th century sea embankment.

Plate 17: Southern side of Breach 1. Detail of possible ditch 111 and organic fill and bank material 101/102

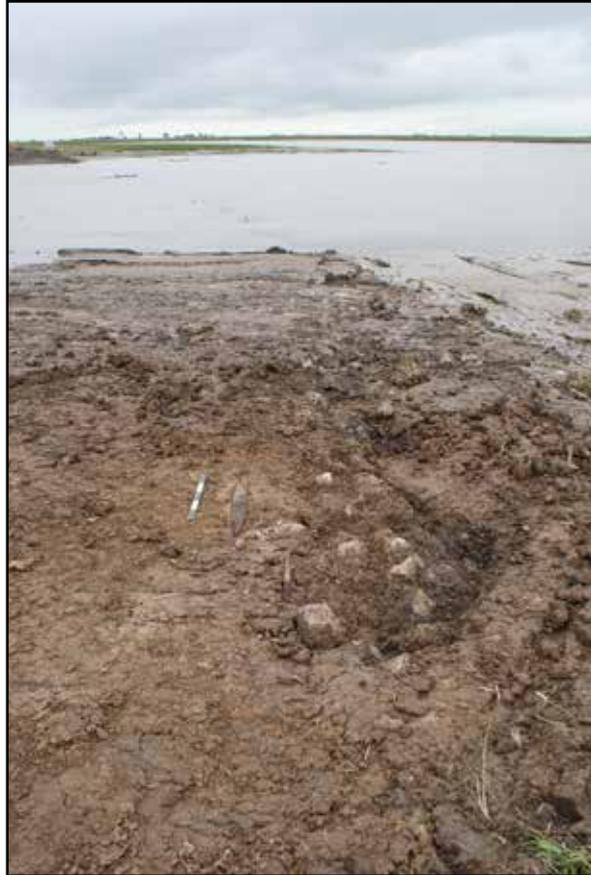
- 4.4.9 Dry stone “wall” (103 - Plates 18-21) has been assigned to this phase of the site. No dating material was found in association with this structure but the fact that “wall” 103 does not follow the same alignment as the still partly extant sea wall suggests that it pre-dates the construction of the present sea defences. Although without secure dating material it is difficult to say by how long. Several alternative dates suggest themselves;

Plate 18: Breach 3. Stone structure 103. Looking west

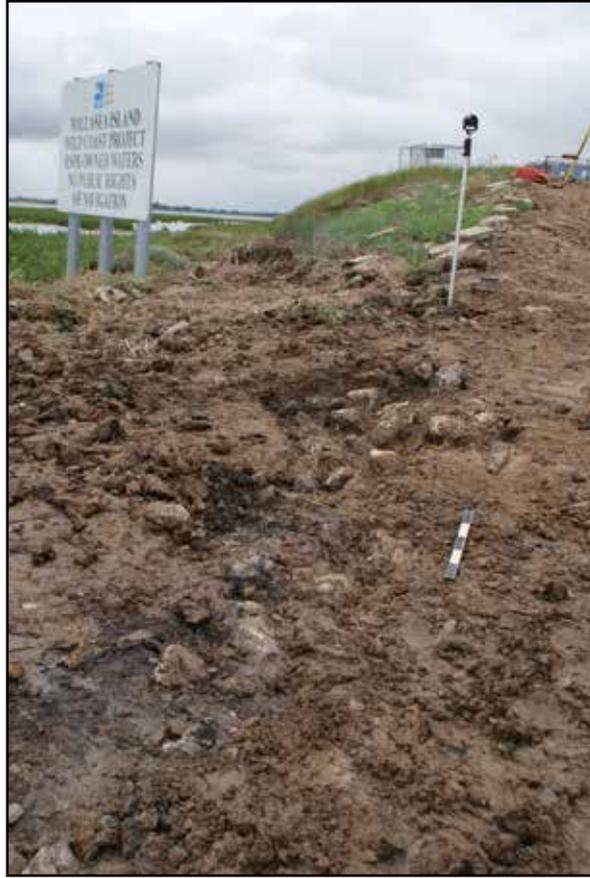
Plate 19: Breach 3. Stone structure 103. Looking east

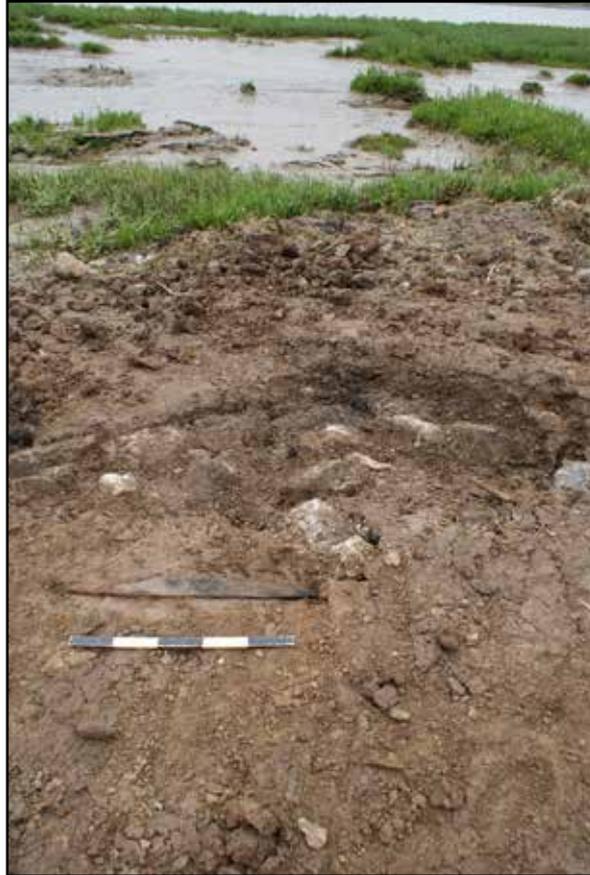
- 4.1.10 Three cut timber posts were found along the back of (103) two lay flat seeming pulled out of place, possibly by the breaching works, and a third was driven into the ground at a 45° angle. The posts which were machine cut, very regular and in good condition and were most likely recent in origin (Plates: 20 and 21).

Plate 20: Breach 3. Stone structure 103. Looking south

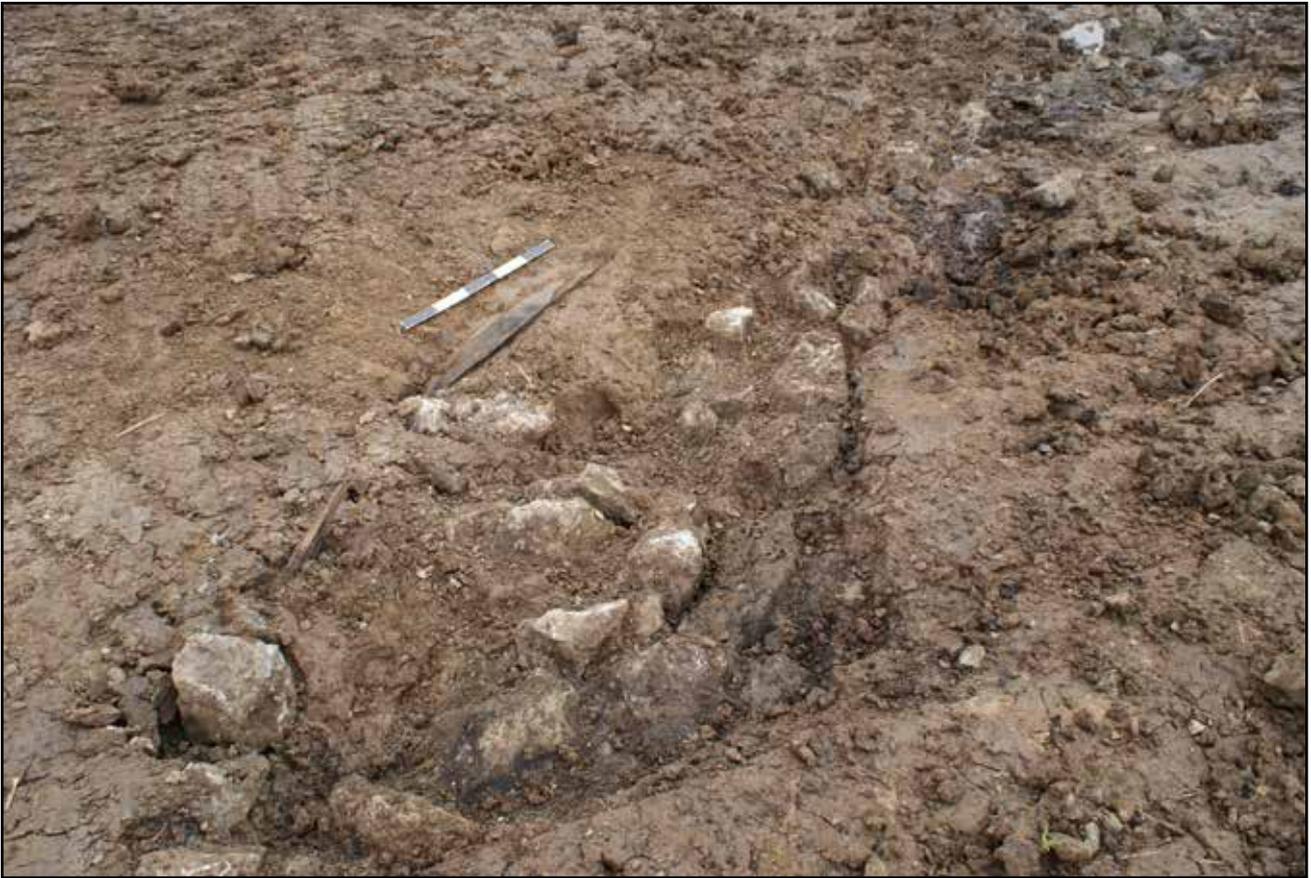
Plate 21: Breach 3. Detail of stone structure 103 showing wooden stake.

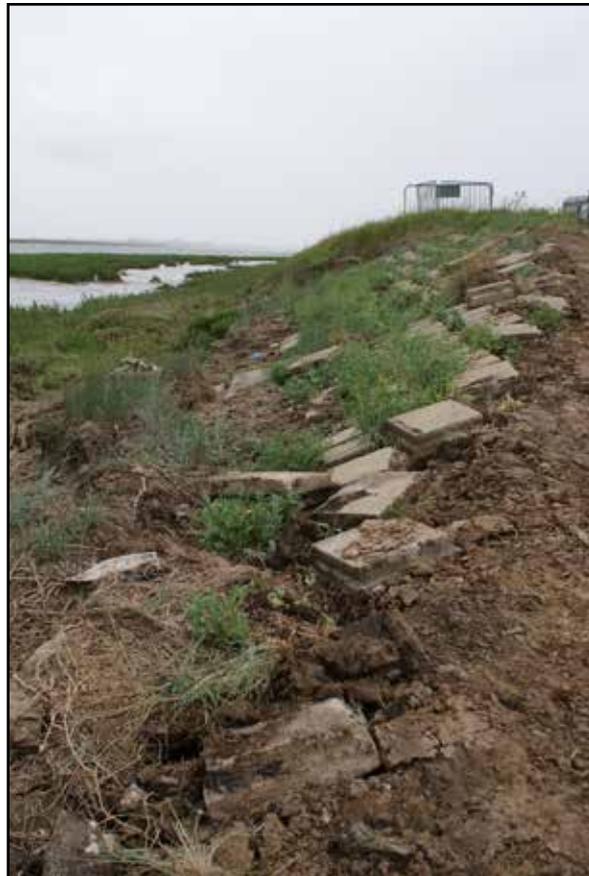
- 4.4.15 Finally it may be that the stones are simply some form of sub-base or foundation layer for the original sea wall, one of the subsequent repairs or from the extensive post 1953 flood rebuild.
- 4.4.16 The layer of concrete Essex Blocks set in hot poured mastic on the embankment's seaward appears to date from this programme of consolidation in the 1970-1980s. In an attempt to protect the toe of the bank from wave attack (Plate 21).

Plate 22: Breach 3. Seaward base of existing sea wall showing disturbed concrete Essex block facing and rough hewn stones along the toe of the clay bank
