**C263 LATE EAST**  
**Non-listed Built Heritage Recording Report**  
**Plumstead Portal, Worksites West and East**

**Document Number: C263-MLA-X-RGN-CRG07-50025**

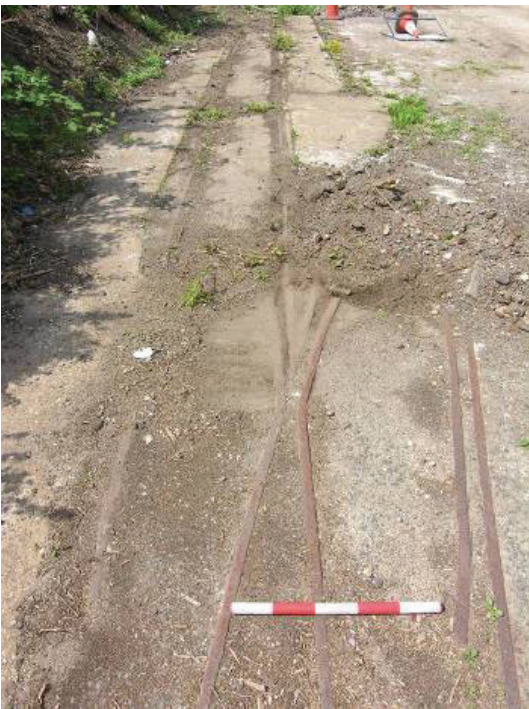
<p>Photo 1. The small gauge tracks and the set of points looking west.</p>	<p>This feature is due to be removed during the enabling works was photographed from multiple angles and in detail on the 11th of July. The gauge was 2 feet in width and it is likely to have been for the transport of coal or similar materials through the Depot yard. From their easternmost extent the tracks progressed westwards and included a set of points towards the eastern end, sending a branch off to the north west, which had been truncated after a short distance. The tracks were set within concrete which rose from east to west to form a platform approximately 50m in length, up to a height of approximately 0.45m above existing ground level, truncated at its western end. The track is located within the cartilage of the Grade II Listed White Hart Depot and is of local interest and of low significance as a heritage asset.</p>

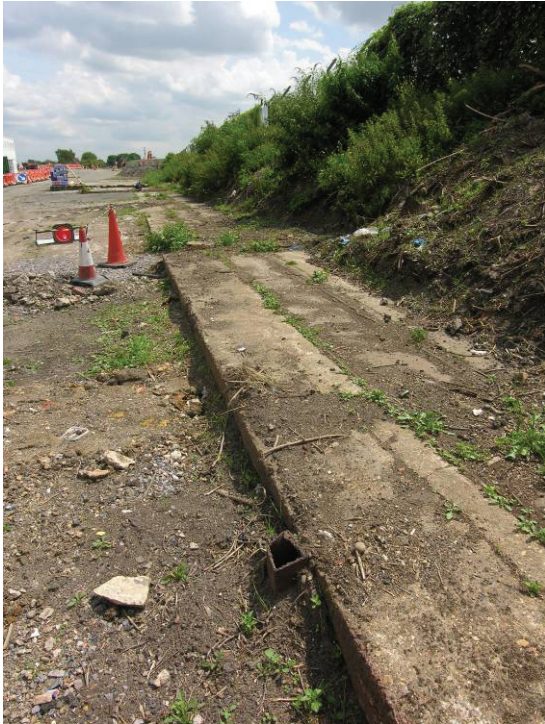
Photo 2. The concrete track bed looking south east.

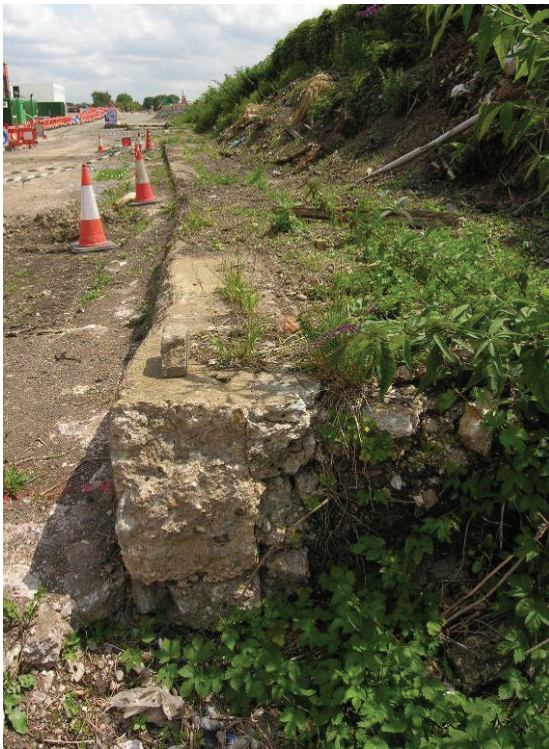
Photo 3. The truncated western end of the concrete track bed.

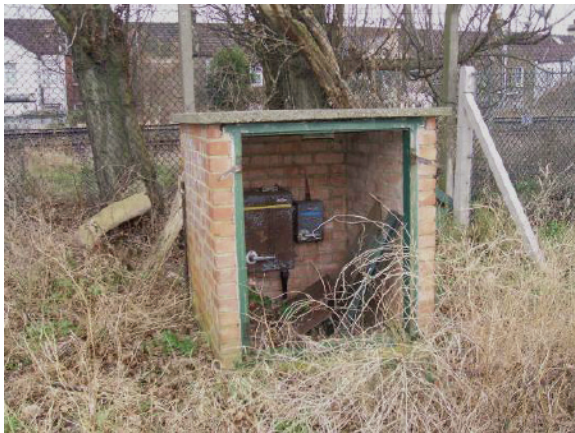
Photo 4. Image taken from Site Specific WSI. Doc no. CR-SD-PRW-X-IS-00004.

The small square structure of orange bricks in stretcher bond located on the southern edge of the White Hart Depot is likely to have been built within the last 35 years. It is of no architectural merit, and of negligible significance as a heritage asset, though it is within the cartilage of the Grade II Listed building. This structure was not visible during the visit by MOLA on July 11th and is likely to have already been demolished. The photograph taken by Crossrail prior to demolition shown opposite (taken from the Site Specific WSI, document number CR-SD-PRW-X-IS-00004), is sufficient to form a basic Level 1 record.

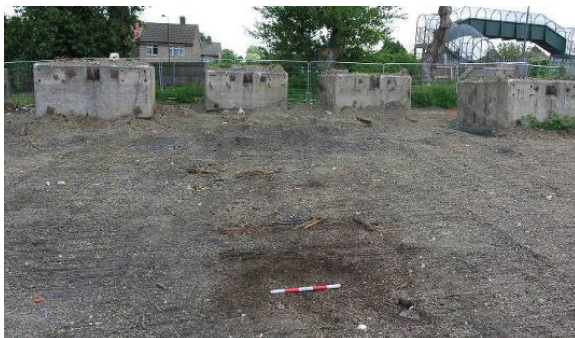
Photo 5. The group of concrete buffer blocks at the far eastern end of Worksite east, looking east.

At the far eastern end of worksite east were 5 large concrete blocks which originally formed buffers at the end of the Depot railway tracks. They were approximately 2.10m in height and formed from five concrete blocks 0.5m in width, secured together with steel ties. Beneath the blocks were visible the remnants of the former railway tracks. These features were considered to be of low heritage significance.

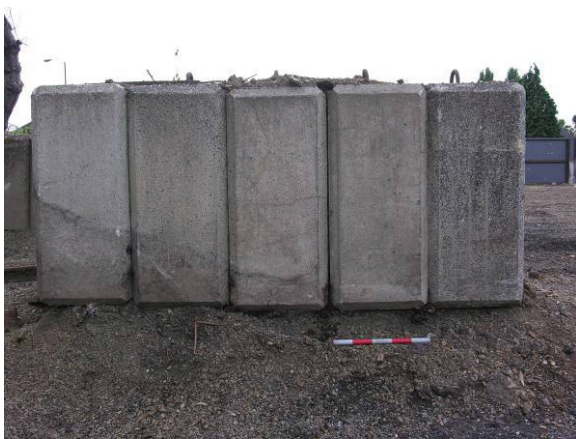
Photo 6. The side view of one of the blocks showing its composition from five separate blocks, looking south.

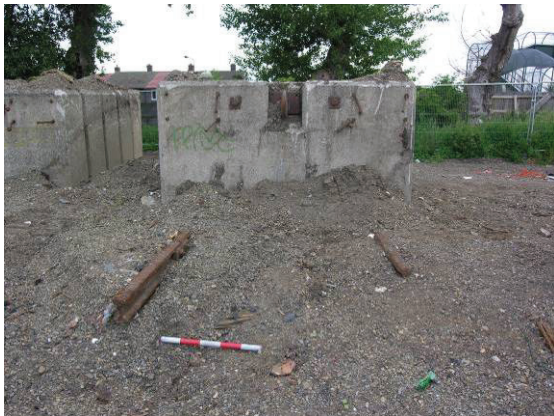
Photo 7. The former tracks visible running beneath the southernmost block, looking east.

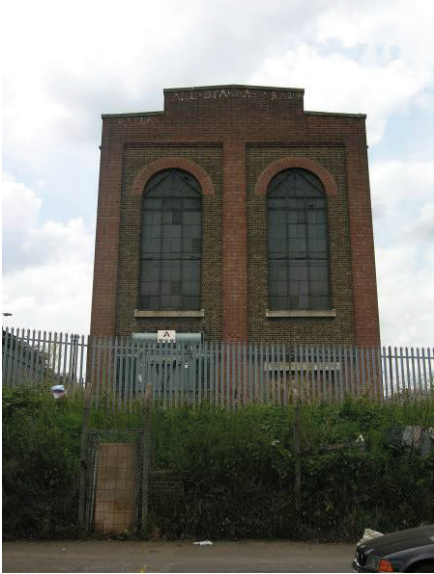
<p data-bbox="199 1104 906 1171">Photo 8. The view of the building from the entrance to Worksite east, looking west.</p>	<p data-bbox="943 315 1430 1021">This building is under the management of Network rail and therefore no access was possible up close to the structure or to the interior. The building was observed from the currently available areas within Worksite West and from White Hart Road. It is locally listed and a heritage asset of medium significance with the potential for this significance to increase with time. The impacts on the building are likely to be minimal and that the building will not be demolished or altered. There will therefore be no physical impact on the building itself. The impact of the proposed scheme on the building's setting is also likely to be minimal. If this is the case further detailed recording will not be required.</p>

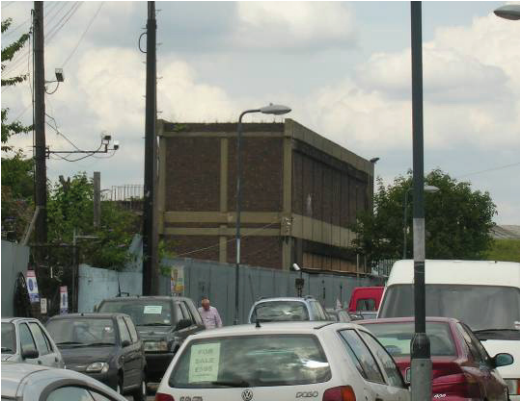
<p data-bbox="199 1765 916 1832">Photo 9. The view of Building Item 4 from the entrance to the Worksite east, looking north.</p>	<p data-bbox="943 1249 1430 1485">This building is currently in use as a motor vehicle breakers yard. It was visually assessed from White Hart Road and is of negligible heritage significance as a heritage asset. The impact of the proposed scheme upon its setting is also negligible.</p>

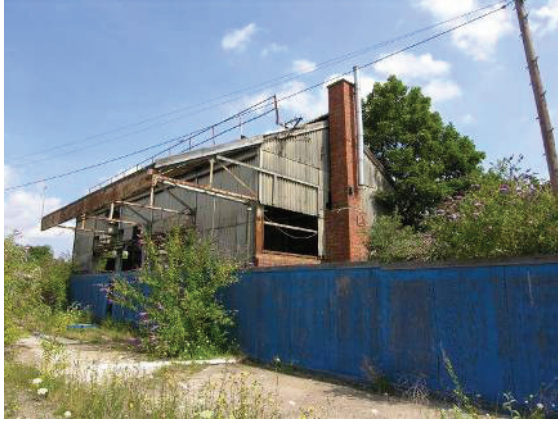
Photo 10. Building item 4, looking north east.

This building and its extension to the south was observed and photographed internally and externally. It is of very low significance as a heritage asset. It had been used until recently as a mechanic's workshop and there was a water-filled inspection pit along with an overhead hoist and chain, attached to an overhead RSJ. The annex to the south was a single storied structure constructed of cement blocks and was also briefly photographed internally.

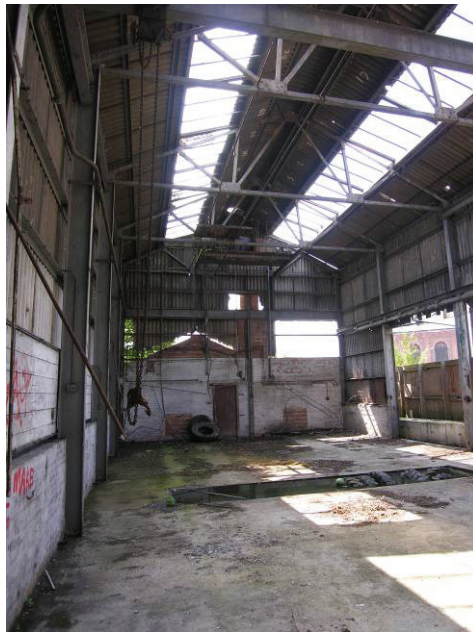
Photo 11. The interior of building item 4, looking south.

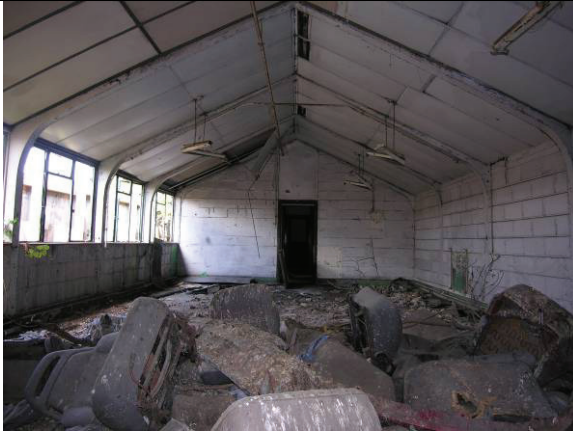
Photo 12. The interior of the southern annexe of building item 4, looking north.

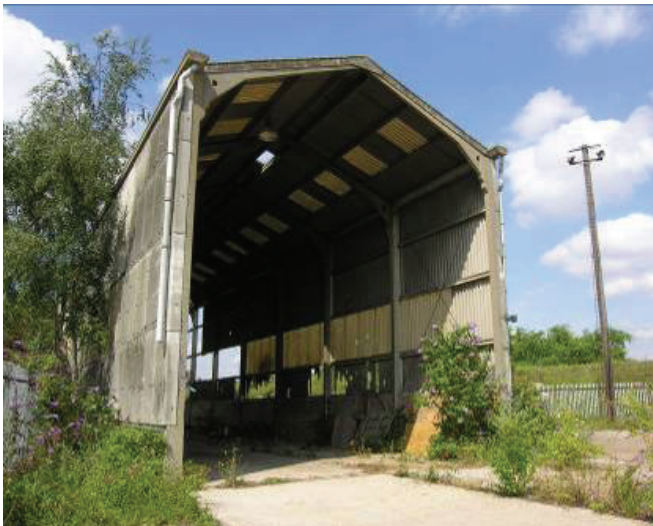
Photo 13. Building item 6, the train shed, looking north west.

This building which is likely to be cleared in advance of worksite establishment was observed and photographed internally and externally. The associated rail tracks to the west and north were also photographed (see below). The structure had been built as a train shed, though short in length, presumably for the maintenance and inspection of single engines or carriages.

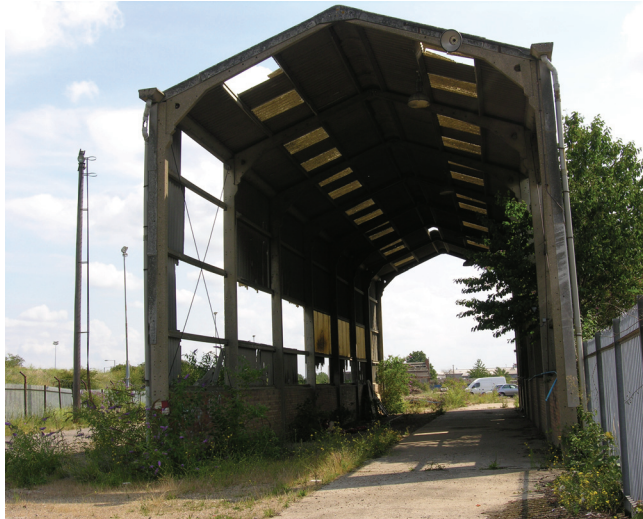
Photo 14. The western end of the building looking east.

The building lay orientated west to east and was constructed with a brick base, with tall concrete posts, which divided the structure in to seven bays. The concrete uprights supported concrete roof trusses, whilst the structure above the brick base was clad in corrugated asbestos and PVC material, or similar.

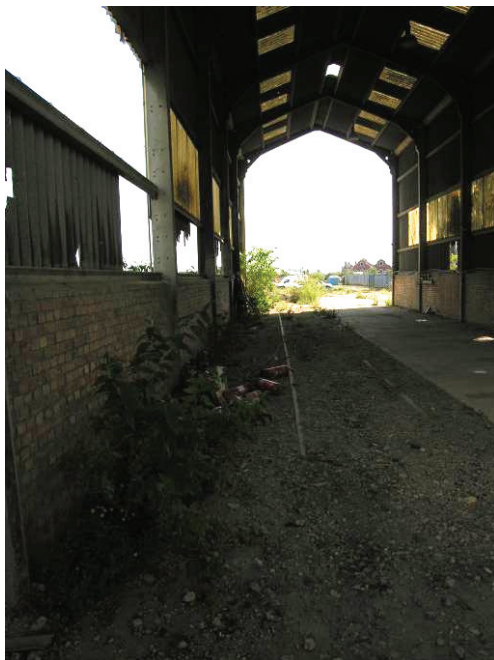
Photo 15. The interior of the structure looking east.

Internally the southern side of the structure had a concrete slab surface whilst railway tracks were visible on the northern half, running through the building.

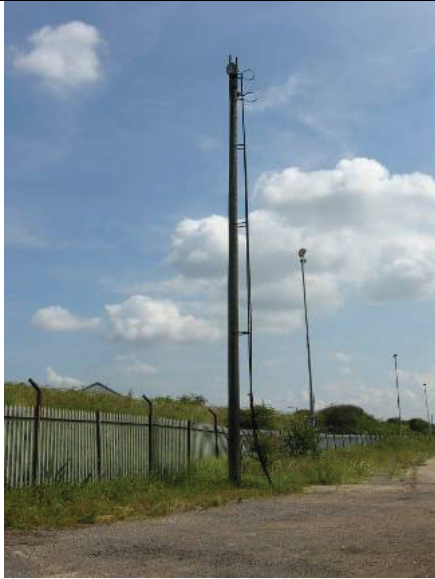
Photo 16. Item 7, The laddered telegraph pole, looking east.

from the photos in the WSI its form clearly conformed to the group of other identical laddered telegraph poles on the site which were photographed from multiple directions. The photographs taken constitute an appropriate, Level 1 record and no further mitigation is likely to be necessary.

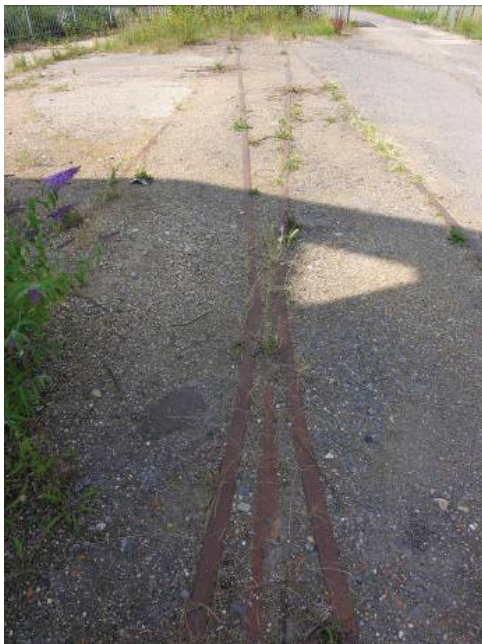
Photo 17. Item 8, disused railway tracks.

Item 8 were disused railway tracks at the western end of the old Goods yard. They were situated alongside and to the north of the rectangular corrugated and concrete framed building at the west end of worksite west.

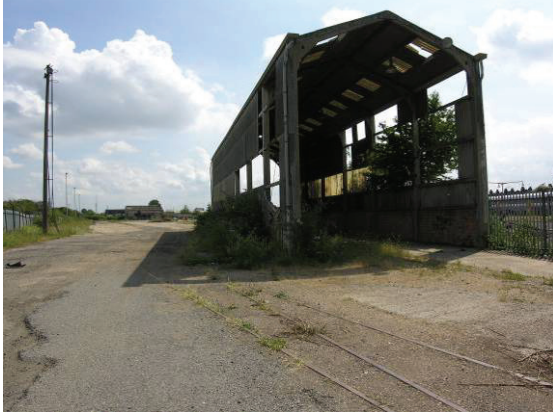
Photo 18. The railway tracks looking towards the south-east showing their position in relation to the engine shed (Item 6).

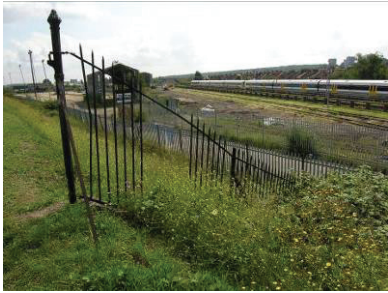
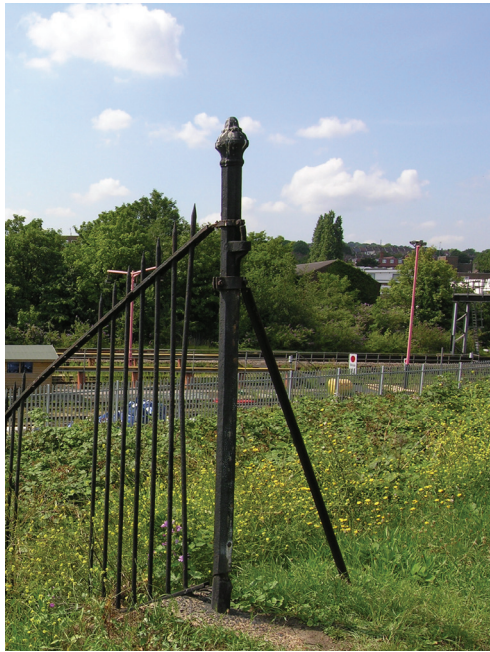
<p>Photo 19. The iron railings looking south-east</p>

<p>Photo 20. The iron post, looking south-west</p>	<p>The iron railings, considered to be of low heritage significance, were situated outside the site boundary to the north west, upon the Ridgeway Path, which runs south-west to north-east along the northern edge of Worksite west. A single iron post remained, with iron railings running down the slope to the south. The iron post was hexagonal in profile, with a decorated bauble at the top.</p>
<p><b>Item 10</b> Black and white painted rectangular corrugated iron shed</p>	<p>This is outside the worksite east area and of negligible significance as a heritage asset. The impact of the scheme does upon its setting would be negligible. No level 1 record was required.</p>

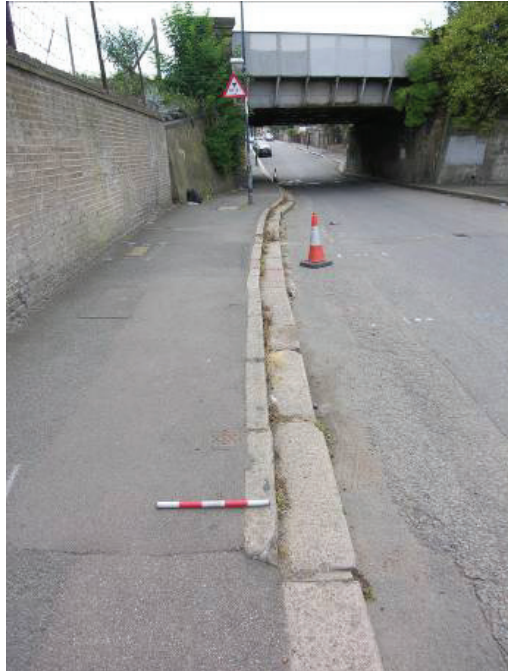
Photo 21. The kerbstones on White Hart Road, looking south

The stepped kerb was observed and photographed from multiple directions on the 11th of July. The asset is outside the worksite areas but may be subject to adverse impacts due to contact with site traffic.

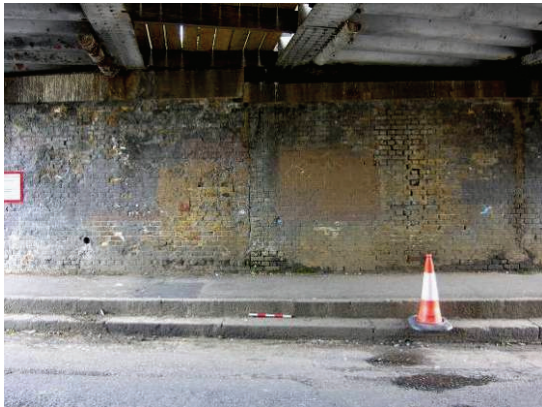
Photo 22. The kerbstones beneath the railway bridge on White Hart Road, looking east. Note the two separate builds visible in the fabric of the bridge

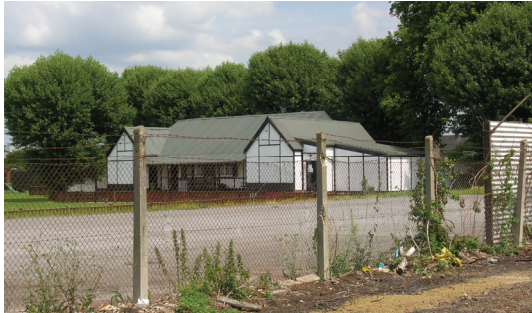
Photo 23. The pavilion outside the Worksite East boundary

Outside and to the north-east of the worksite East boundary was a pavilion serving the recreation ground to the north. The building may in fact be the same structure visible on the 1916 OS map. The proposed scheme would have a negligible impact of the setting of the asset in this case. In particular as railway infrastructure has existed to the south of the pavilion in the past.

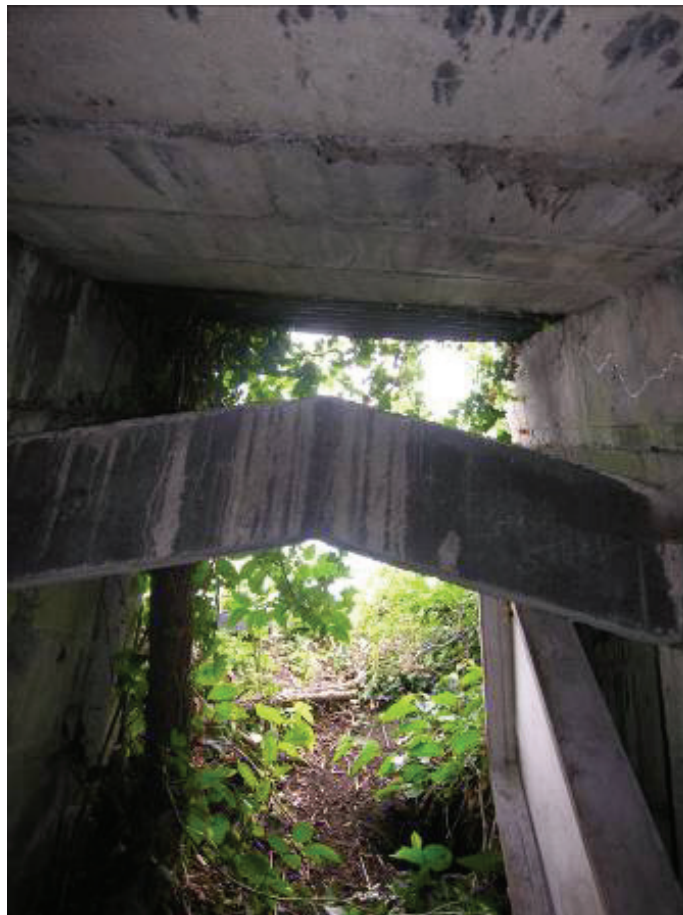
Photo 24. The entrance of Shelter 1 from within, looking south

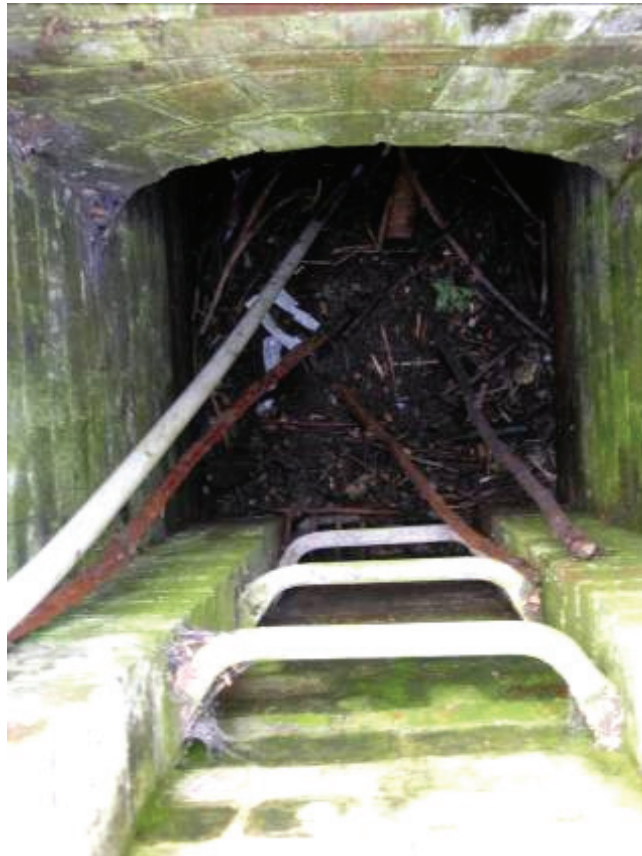
Photo 25. The escape shaft to the south of the shelter, with the brick tunnel running to the west

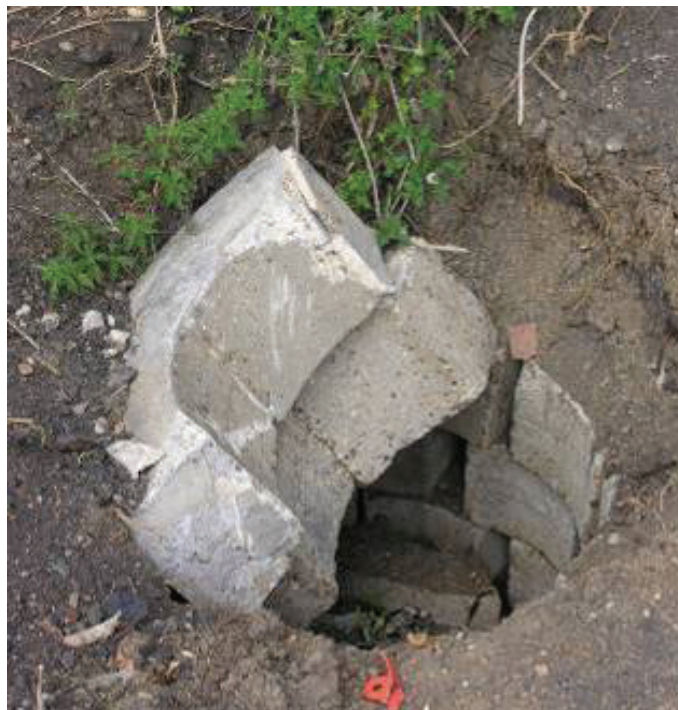
Photo 26. The remains of the air vent to the west of the shelter

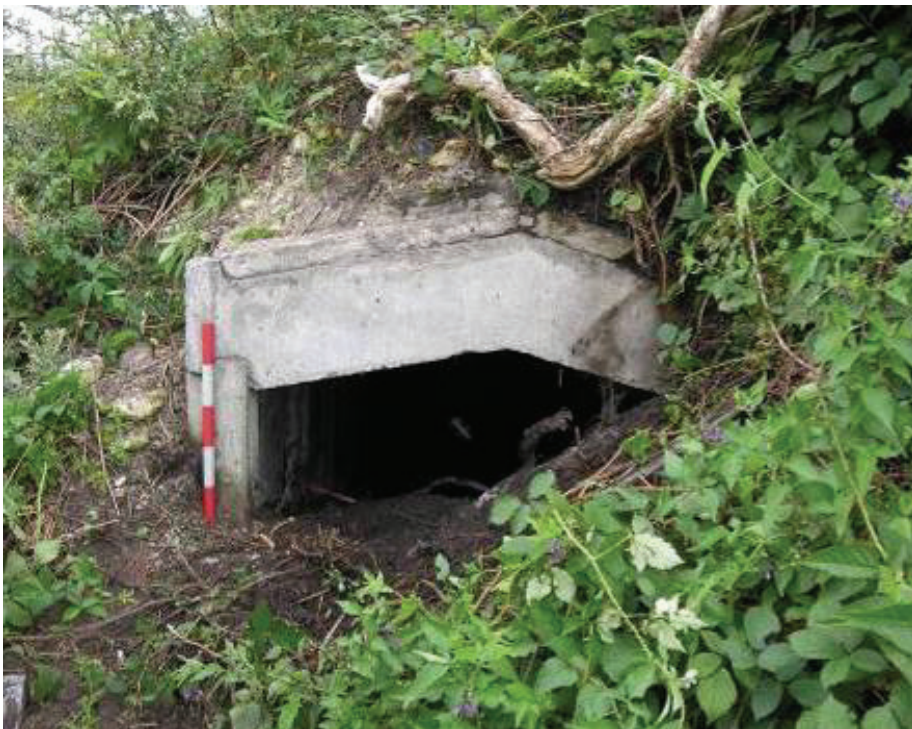
Photo 27. A view of the entrance to shelter 2 at its eastern end looking west

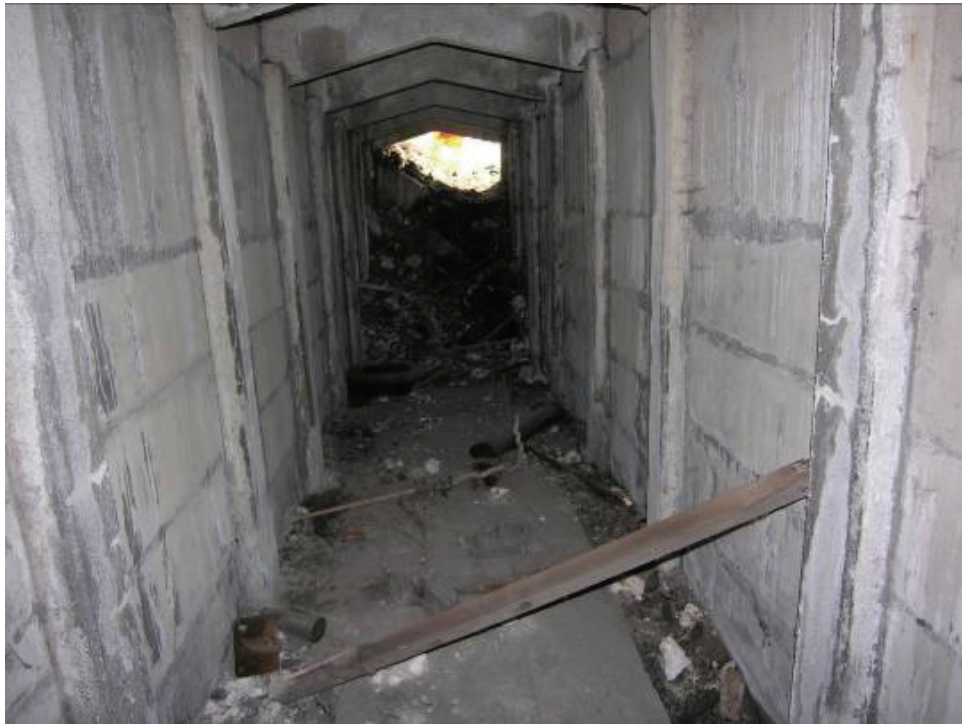
Photo 28 An internal view of shelter 2 looking east towards the present entrance

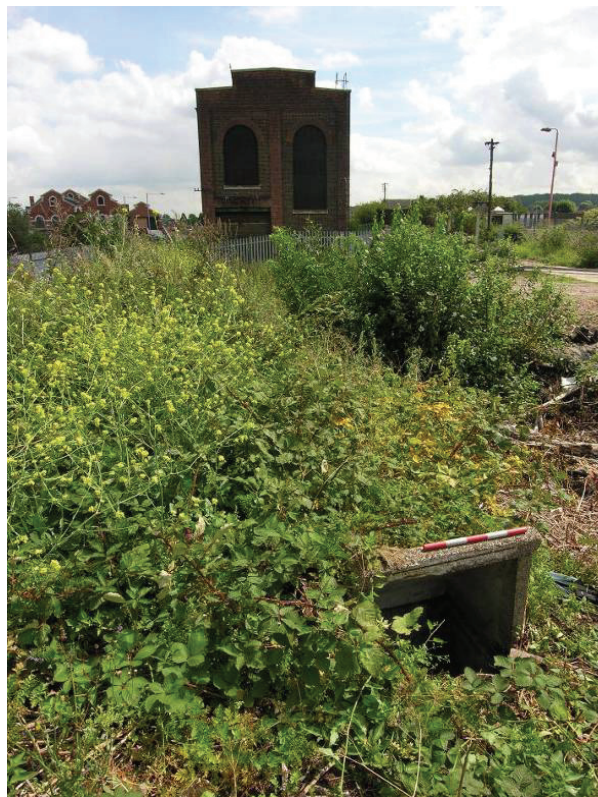
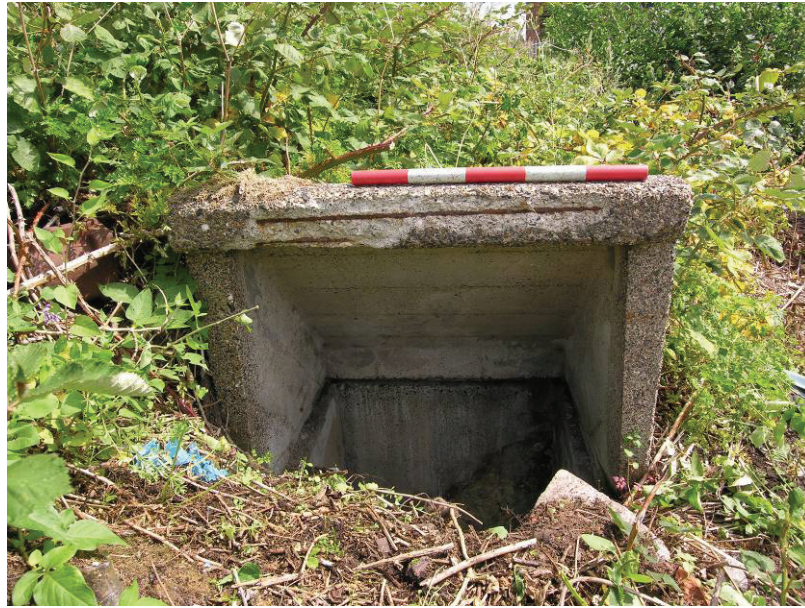
Photo 29 The entrance to the escape hatch in the foreground, the electricity substation, Item 3 is in the background.

Photo 30. The concrete escape hatch looking east.

Approximately 15m to the west and slightly south of the present entrance was the escape hatch (Photo 29 and Photo 30), which unlike that seen on Shelter 1 had a sloped concrete cover or embrasure. It led down to a tunnel the continued northwards, towards the main part of the shelter. Unlike Shelter 1, there was no 90° angle at the current entrance of Shelter 2. There was also no arched brick tunnel from the escape hatch and unusually, there was no metal step ladder for the escape hatch.

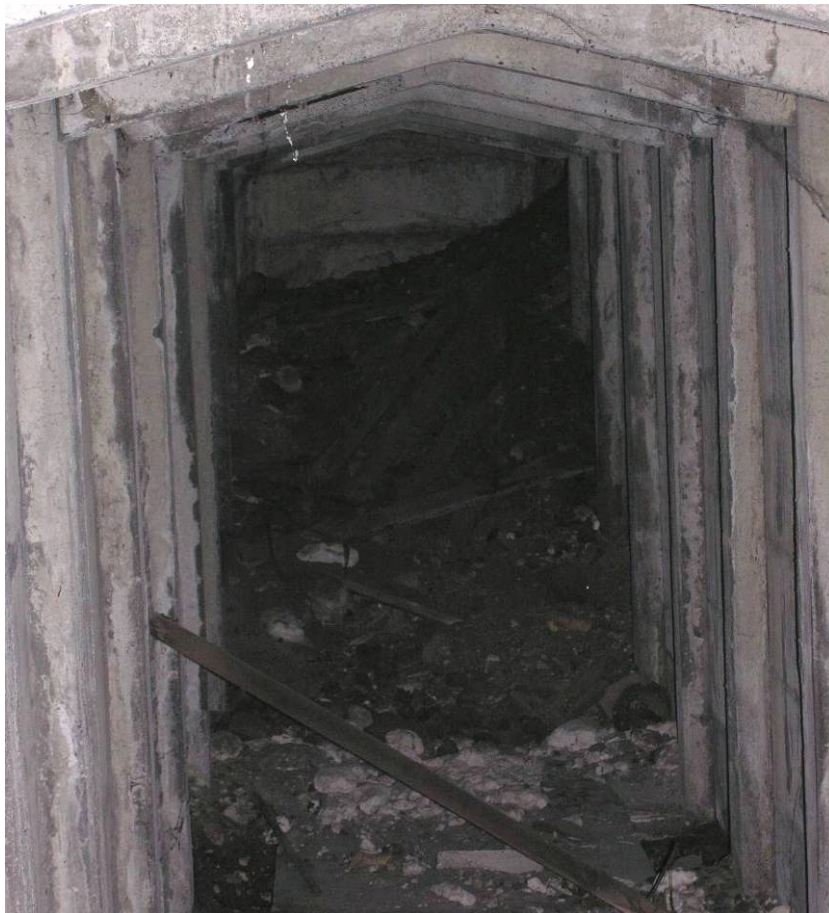
Photo 31. The internal view towards the western end of the shelter and the concrete wall behind the collapse of earth

It is very likely that the original entrance to shelter 2 was in fact at the western end (Photo 31) and that this original entrance, like shelter 1, was at a 90° angle. An angled entrance limits the effect of blast damage into the shelter and would have been a common feature used to protect the occupants of such structures. The present eastern entrance (Photo 27) is therefore probably a recent break in the structure and this explains why there was no sign of a sloped or stepped decent with a 90° turn as there was in the eastern entrance of Shelter 1. This may also explain the lack of a visible air vent shaft, which was probably removed from the eastern end of the structure.

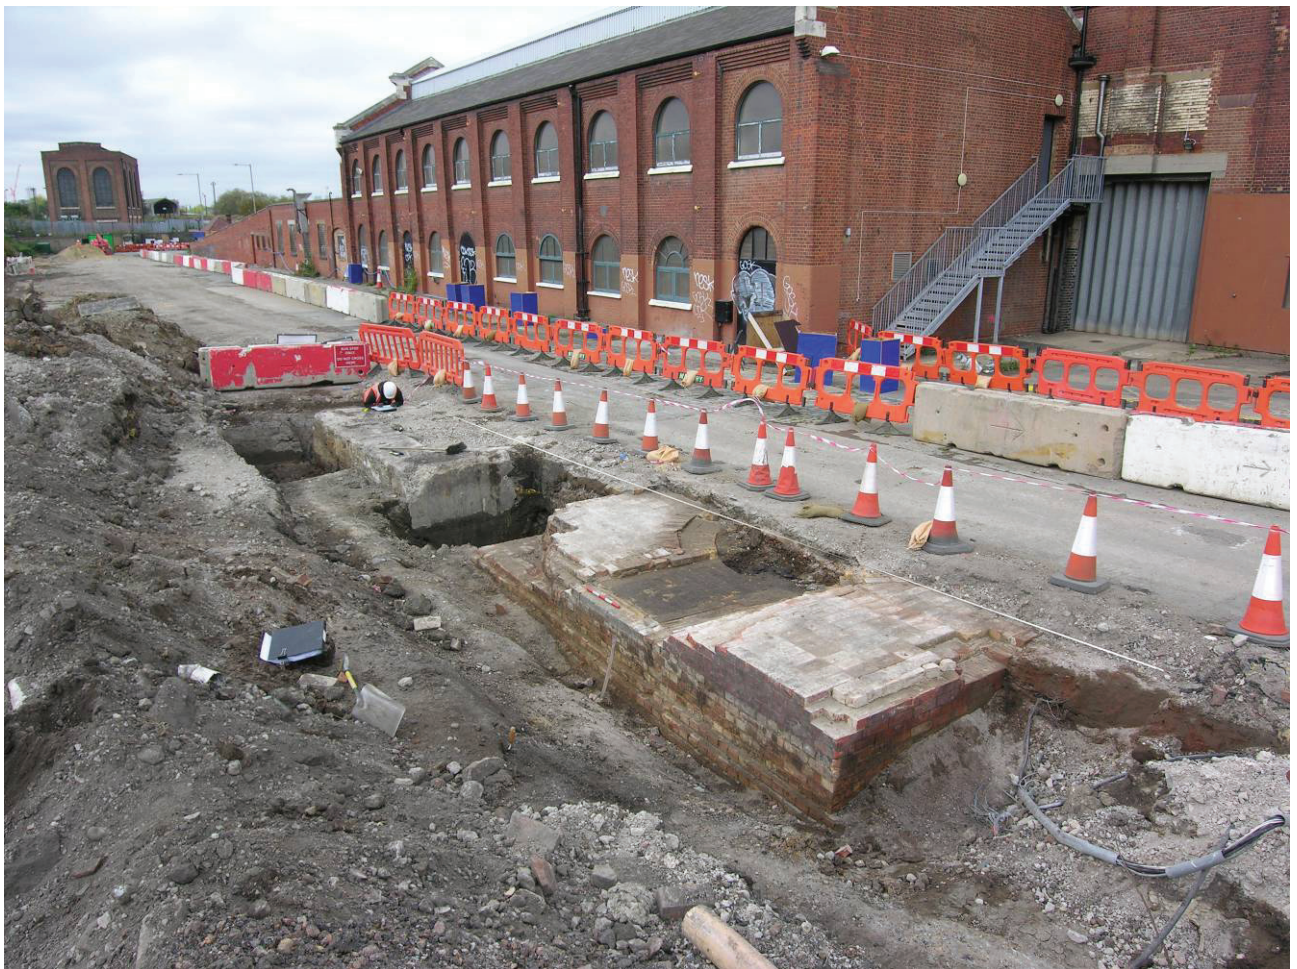
Photo 32. The excavations looking north east and the location of the recorded features in relation to the Listed Depot building

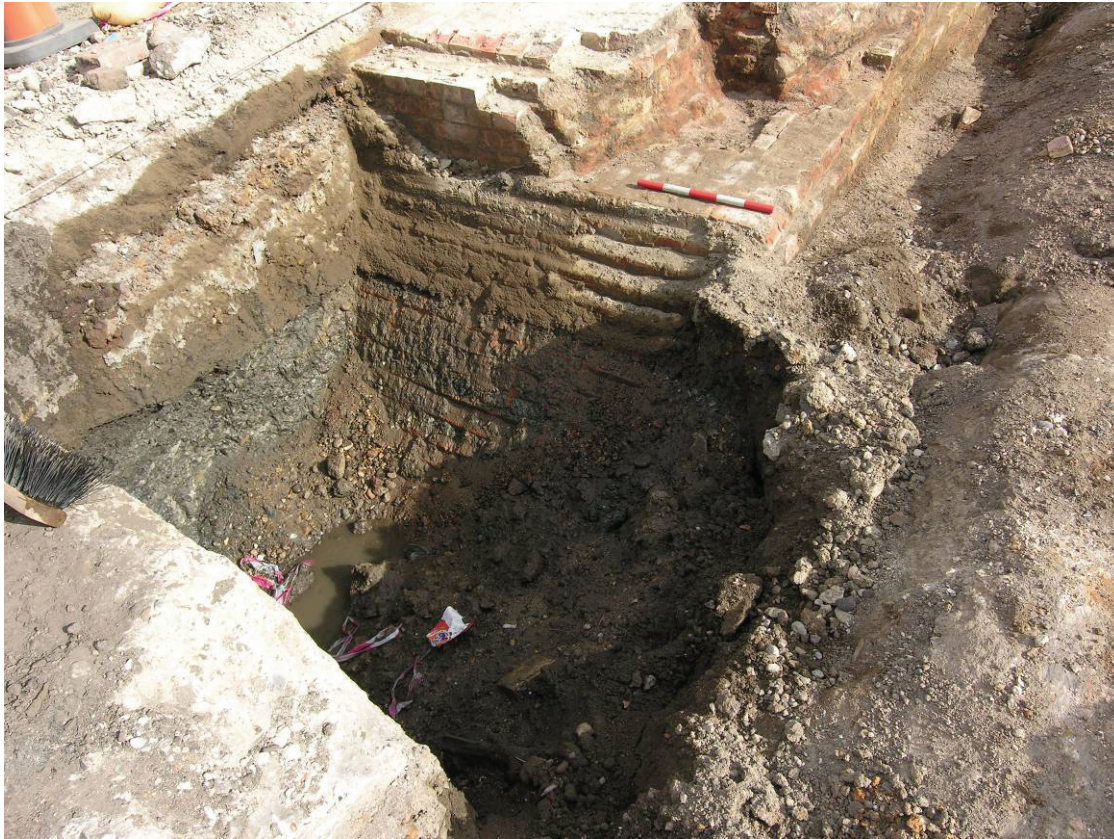
three of these were visible, but a deep sondage dug by machine on the western side of the structure showed that the extensive foundations continued deeper, as eleven brick foundation steps were recorded reaching a depth of 1.8m below the current surface level. These were noted continuing deeper and the base of the structure was not reached or observed (see Photo 33).

Photo 33. The stepped foundations of the brick chimney base which continued below the exposed levels, looking north east.

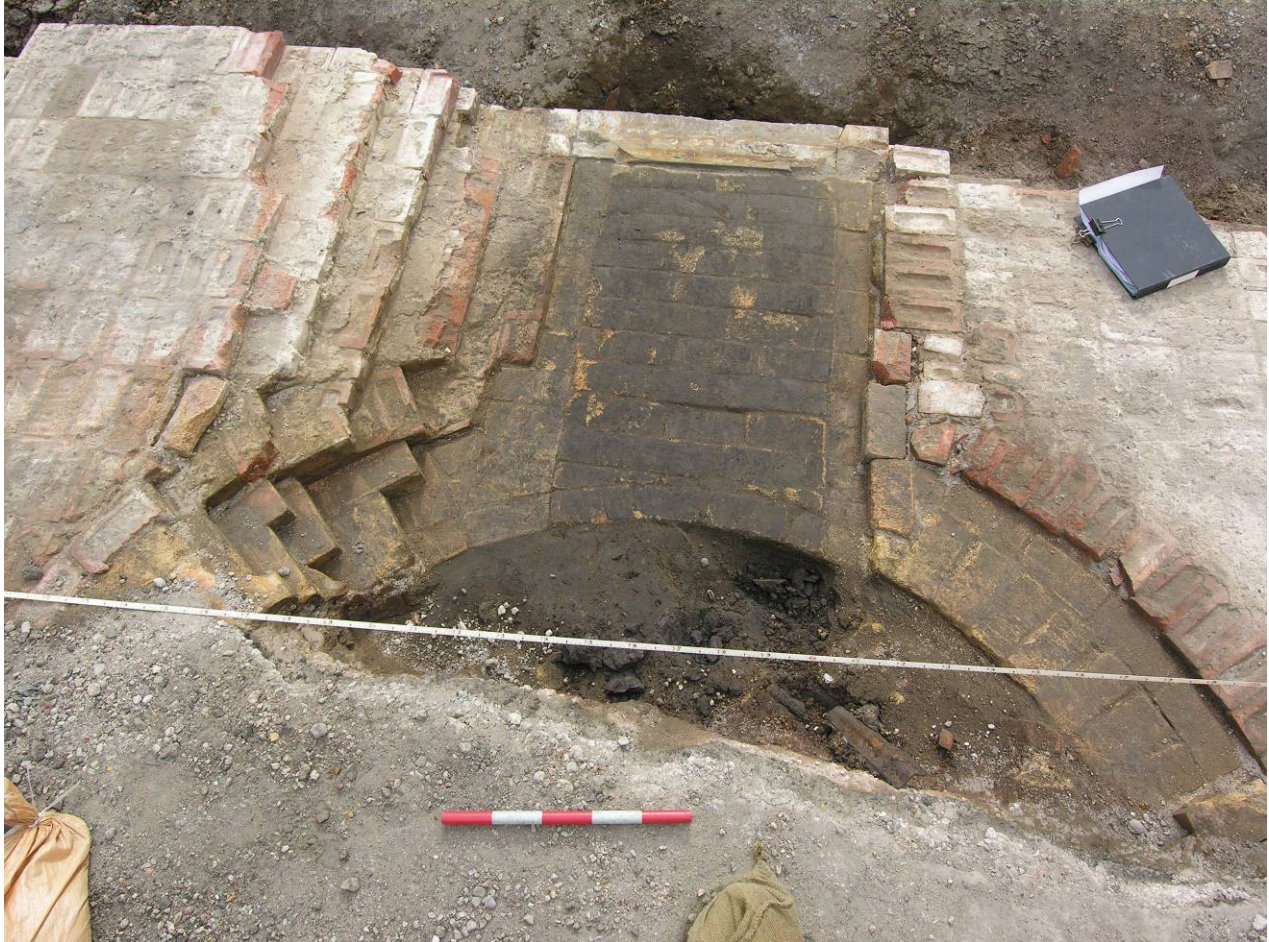
Photo 34. the central area of unfrogged bricks looking south, with the circular area or furnace of burnt soil and the stone sill on the southern edge

The central area is likely to be the remnants of an opening in the base of the chimney from which burnt debris was removed or possibly where fuel for burning was loaded. The stone sill and the unfrogged bricks formed an area with a smooth surface, from which material could be easily removed. The small gauge tracks recorded as Item 1 (Photo 1) are without doubt related to the chimney, specifically the removal or addition of material, as the branch that emanated from the set of points shown in Photo 1 headed directly towards the hatch in the chimney base. Also within this area was the lowest part of a copper lightning conductor protruding from the ground adjacent to the southern side of the structure, this along with the deep foundations of the structure suggest the chimney had been of considerable height prior to its demolition.

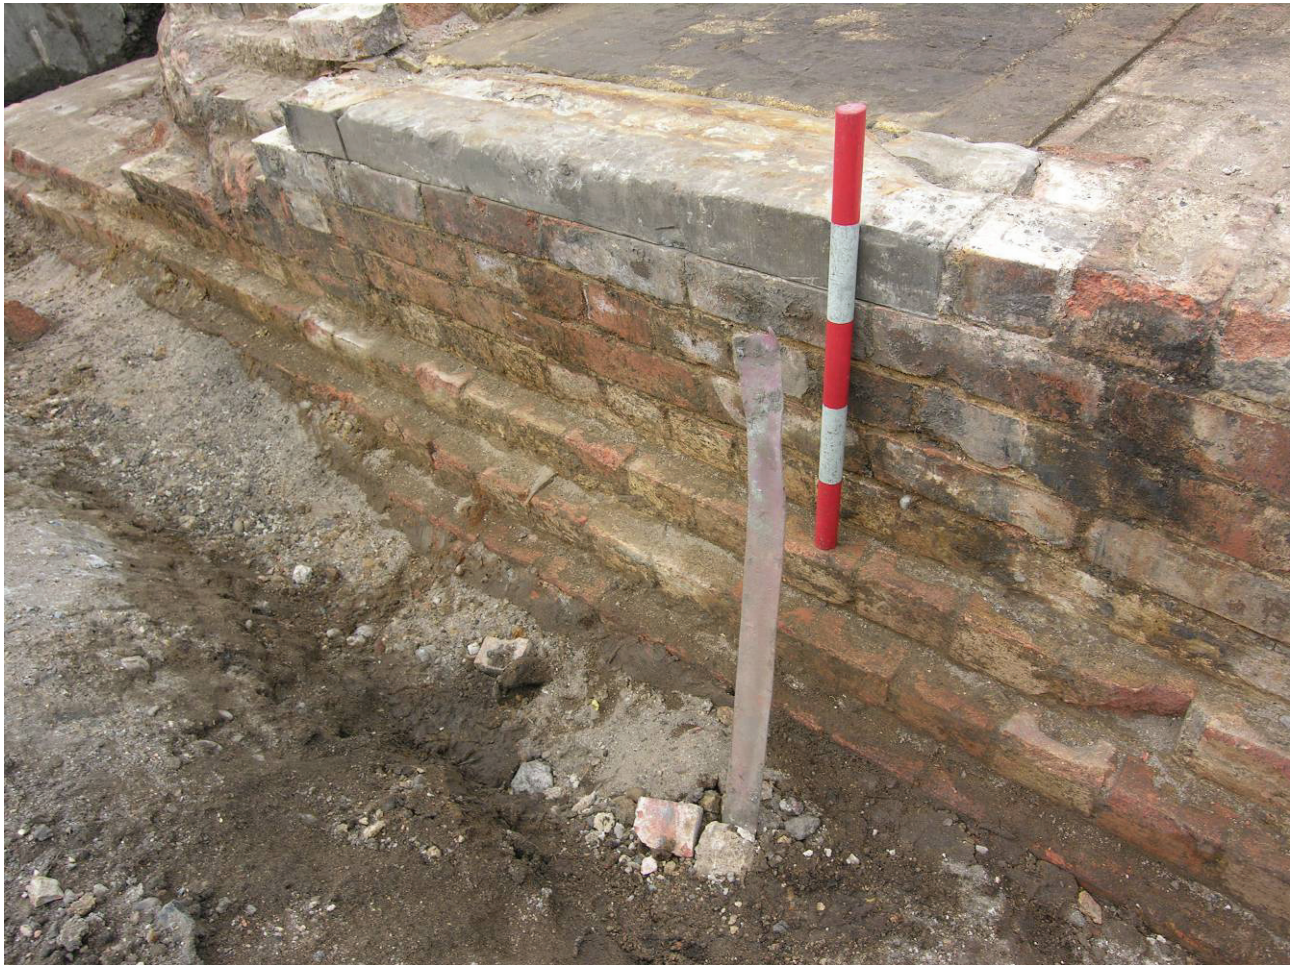
Photo 35. The copper lightning conductor and the stone sill on the southern side of the brick structure

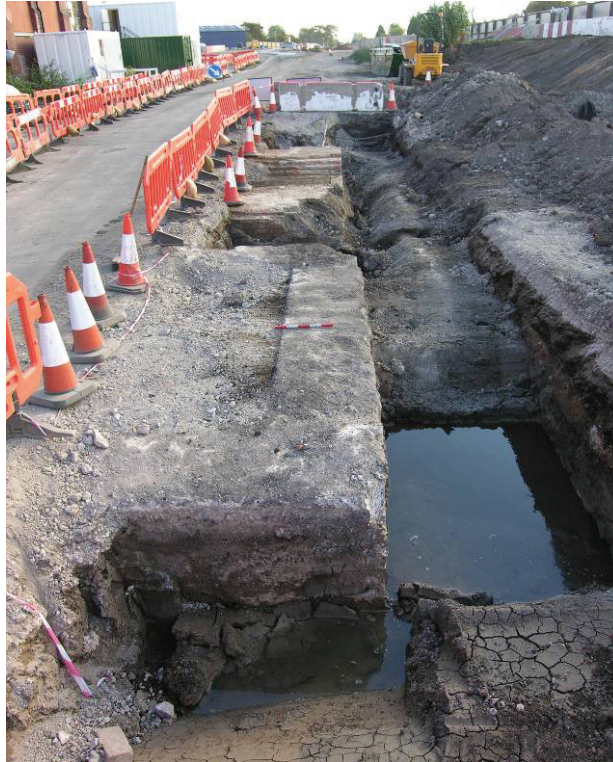
The concrete structure was situated approximately 2m to the west of the brick chimney base (above the stepped foundation level). It was rectilinear in plan and formed from a single wall of concrete 0.77m thick, forming three sides of the rectangle, the fourth being beyond the limit of excavation to the north (*Photo 36*). The central area of the concrete structure was probably originally hollow or void, but had been backfilled with concrete rubble, presumably during the structure's demolition. Emerging from the south eastern area of the tank was a wide pipe approximately 0.35m in diameter, of which the majority was buried being only visible as a linear stretch of raised ground. However a small section of the steel pipe had been exposed and could be seen to have been set within or surrounded by a thin layer of concrete.

Photo 36. The concrete structure, or cooling tower, looking east with the brick chimney base in the background

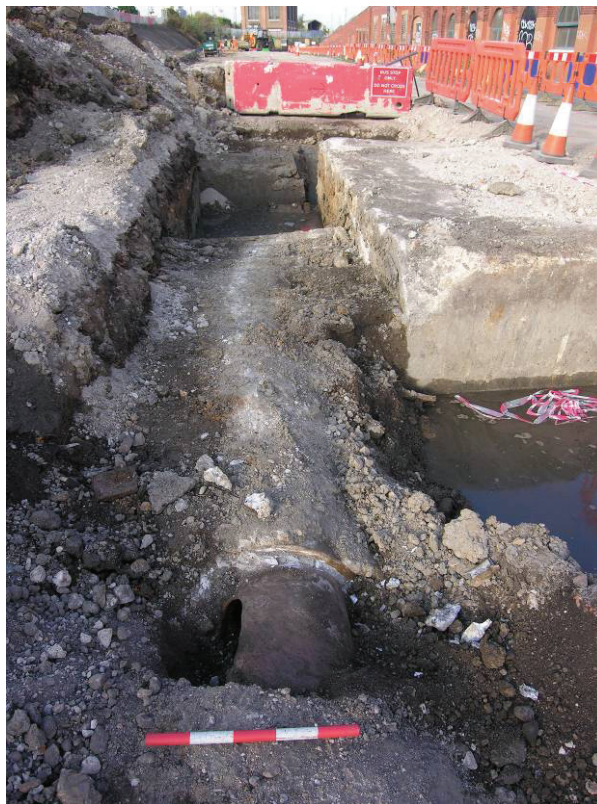
Photo 37. The exposed section of the pipe emanating from the former cooling tower
