HOCHTIEF MURPHY Joint Venture		C310 THAMES TUNNEL REPORT			
EMPLOYER	CROSSRAIL	eB NO	C310-HTM-C-RGN-CR148-50027	Rev	1.0
TITLE	Close-Out Report for DLR-Tunnels (DLR Asset DLR/12 Woolwich Tunnels)

1.0	Introduction
2.0	Reference Documents
3.0	Observation
4.0	Summary
5.0	Appendices

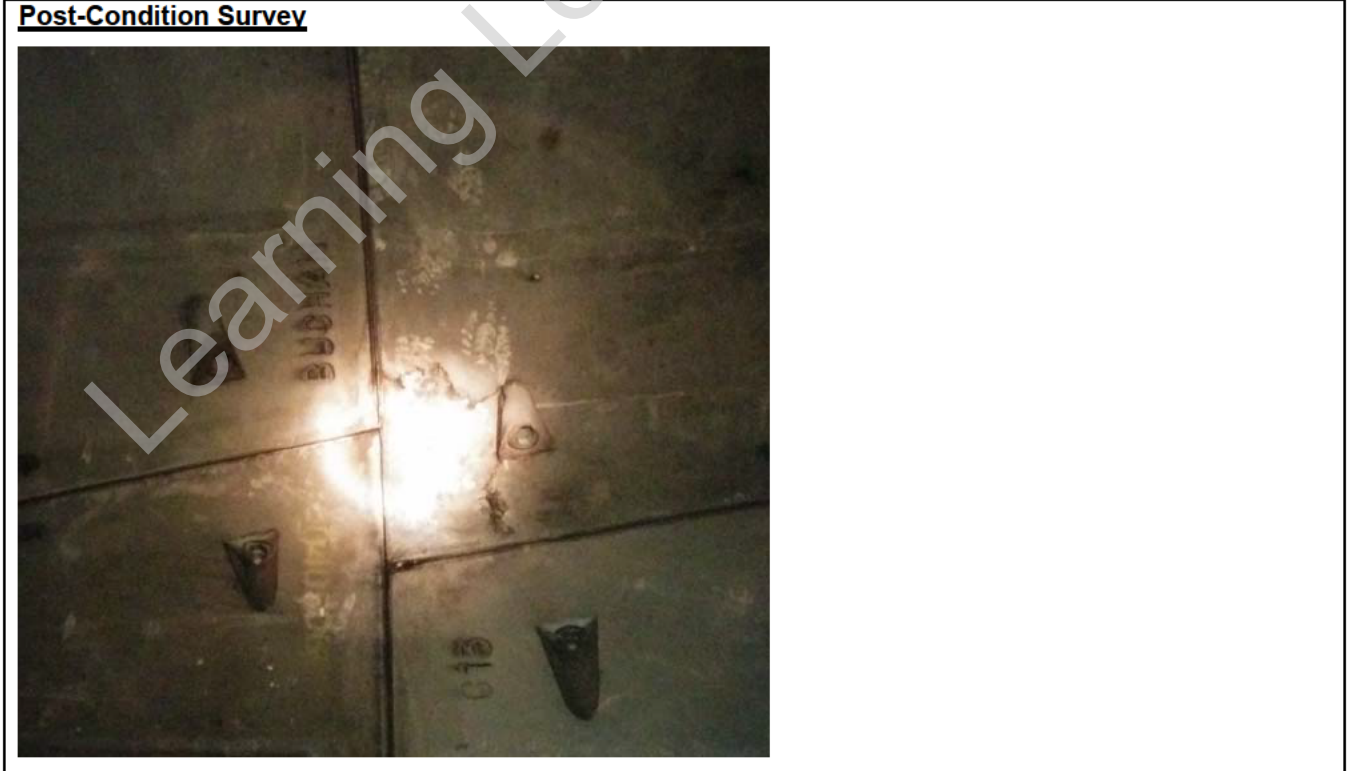
Ring No.	Appendix	Observation	Photo no.	Pre construction Survey Observations	
964	B	Spalling in tunnel crown	DLR Photo01	Same Observation made 21/10/2012	See Damage Inspection Report (A.1 & J)
	C	Spalling in tunnel shoulder - east	DLR Photo02	Same Observation made 21/10/2012	
971	D	Watermark and spalling in tunnel crown	DLR Photo03	Same Observation made 21/10/2012	See Damage Inspection Report (C.1 & A.1)
978	E	Watermark and spalling in tunnel crown	DLR Photo04	Same Observation made 21/10/2012	See Damage Inspection Report (B.2)
980	F	Spalling in tunnel shoulder - east	DLR Photo05	Same Observation made 21/10/2012	See Damage Inspection Report (B.1/2)
981	G	Spalling in tunnel shoulder - east	DLR Photo06	Same Observation made 21/10/2012	See Damage Inspection Report (B.1 & B.2)
983	H	Spalling in tunnel crown	DLR Photo07	Same Observation made 21/10/2012	See Damage Inspection Report (B.2)
985	I	Spalling in tunnel shoulder - west	DLR Photo08	Same Observation made 21/10/2012	See Damage Inspection Report (B.1 & B.2)

986	J	Spalling in tunnel shoulder - west	DLR Photo09	Same Observation made 21/10/2012	See Damage Inspection Report
987	K	Spalling in tunnel shoulder - west	DLR Photo10	Same Observation made 21/10/2012	See Damage Inspection Report (Cracks)
990	L	Wet / damp patch in tunnel crown	DLR Photo11	Same Observation made 21/10/2012	See Damage Inspection Report (D.1/2)

No.	Ring Number	TYPE	Description	Witness (Signature)			Photo Documentation	HMJV	CRL	DLR	1	987	A.1	Cracks				<input type="checkbox"/> <input type="checkbox"/> <input type="checkbox"/> <input type="checkbox"/> <input type="checkbox"/> <input type="checkbox"/> <input type="checkbox"/> Refer to: MG. 495 Refer to: MG. 496 Refer to: MG. 499 Refer to: MG. 497	2	987	E.1/2	Hollow sounding				3	987	D.1/2	Leakage				4	987	A.1	Minor spalling				5	987	J.	Tailskin grease coming out				6	987	B.1	Major spalling				7						
No.	Ring Number	TYPE	Description	Witness (Signature)						Photo Documentation																																																								
				HMJV	CRL	DLR																																																												
1	987	A.1	Cracks				<input type="checkbox"/> <input type="checkbox"/> <input type="checkbox"/> <input type="checkbox"/> <input type="checkbox"/> <input type="checkbox"/> <input type="checkbox"/> Refer to: MG. 495 Refer to: MG. 496 Refer to: MG. 499 Refer to: MG. 497																																																											
2	987	E.1/2	Hollow sounding																																																															
3	987	D.1/2	Leakage																																																															
4	987	A.1	Minor spalling																																																															
5	987	J.	Tailskin grease coming out																																																															
6	987	B.1	Major spalling																																																															
7

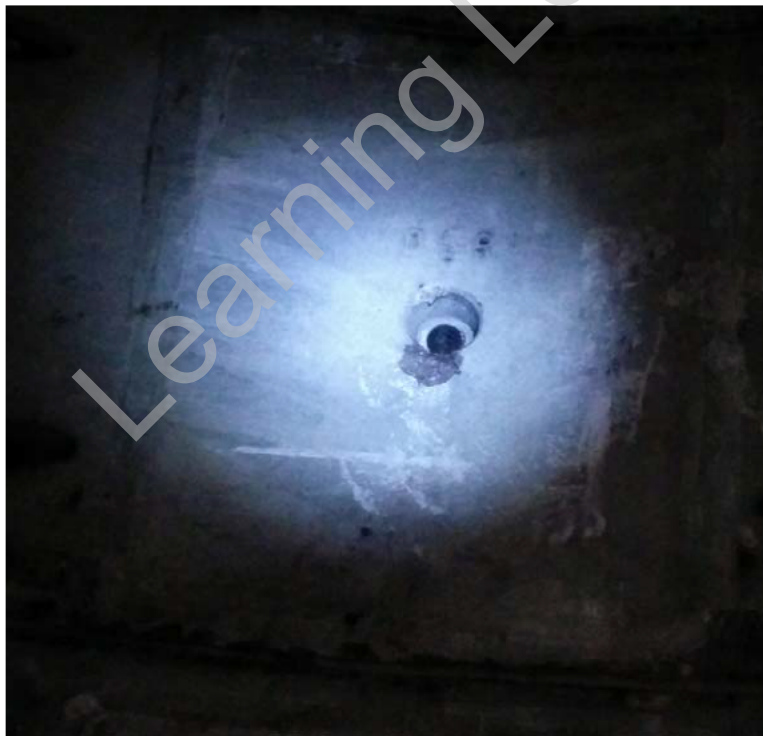
Ring No.	Appendix	Observation	Photo no.	Pre construction Survey Observations	
951	M	Spalling in tunnel crown	DLR Photo12	Same Observation made 21/10/2012	See Damage Inspection Report (B.1/2)
956 957	N	Wet / damp patch observed between ring joint in tunnel crown	DLR Photo13	Same Observation made 21/10/2012	See Damage Inspection Report (D.1)
964 965	O	Wet / damp patch observed between ring joint in tunnel crown	DLR Photo14	Same Observation made 21/10/2012	See Damage Inspection Report (D)
969	P	Spalling in tunnel shoulder - west	DLR Photo15	Same Observation made 21/10/2012	See Damage Inspection Report (B)

No.	Ring Number	TYPE	Description	Witness (Signature)			Photo Documentation																																																																					
				HMJV	CRL	DLR	Check																																																																					
1	951	J.	All joints sealed + corked				<input type="checkbox"/>																																																																					
2	951	E.1	Hollow sounding				<input type="checkbox"/>																																																																					
3	951	D.1	Leakage				<input type="checkbox"/>																																																																					
4	951	A.1	Minor spalling				<input type="checkbox"/>																																																																					
5	951	J.	Resin coming through bolt hole				<input type="checkbox"/>																																																																					
6	951	C.1	Cracks				<input type="checkbox"/>

7	951	B.1	Major spalling (Ring building)				<input type="checkbox"/>

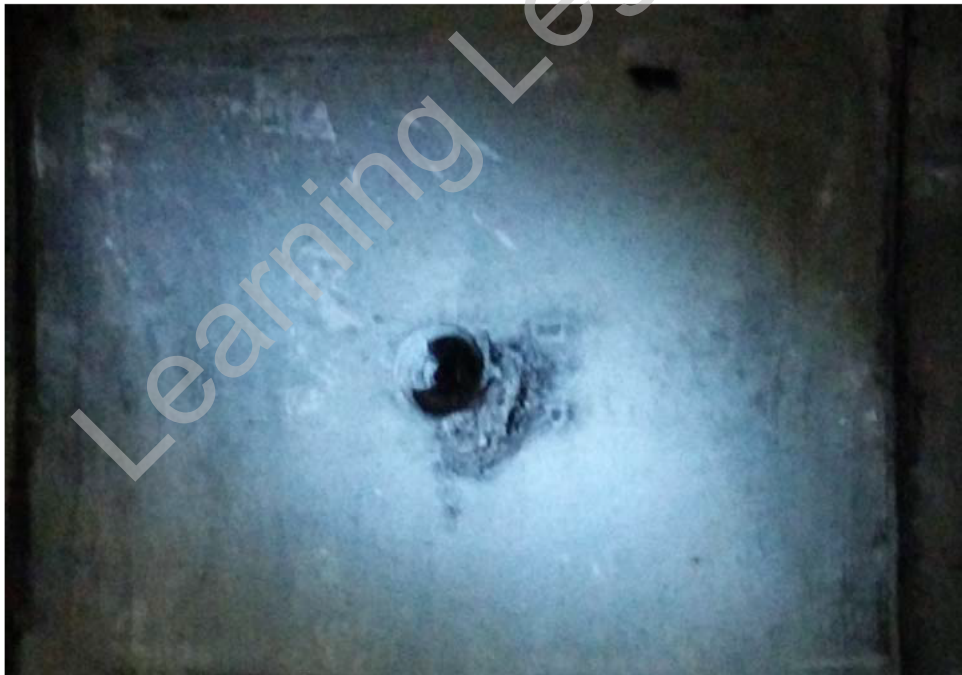
APPENDIX P

No.	Ring Number	TYPE	Description	Witness (Signature)			Photo Documentation																																																																						
				HMJV	CRL	DLR	Check																																																																						
1	999	D.1	Leakage				<input type="checkbox"/>																																																																						
2	999	J.	Calcification built up				<input type="checkbox"/>																																																																						
3	999	C.	Repaired crack				<input type="checkbox"/>																																																																						
4	999	B.	Major spalling at grout plug				<input type="checkbox"/>																																																																						
5	999	C.	Minor crack				<input type="checkbox"/>																																																																						
6	999	J.	Damp				<input type="checkbox"/>
