# C435 Farringdon Main Station

## Monitoring Close-Out Report:

### In-ground Monitoring Section B and Internal Monitoring installed on 66 Cowcross St.

**CRL Document Number: C435-BFK-C2-RGN-M123-51605**

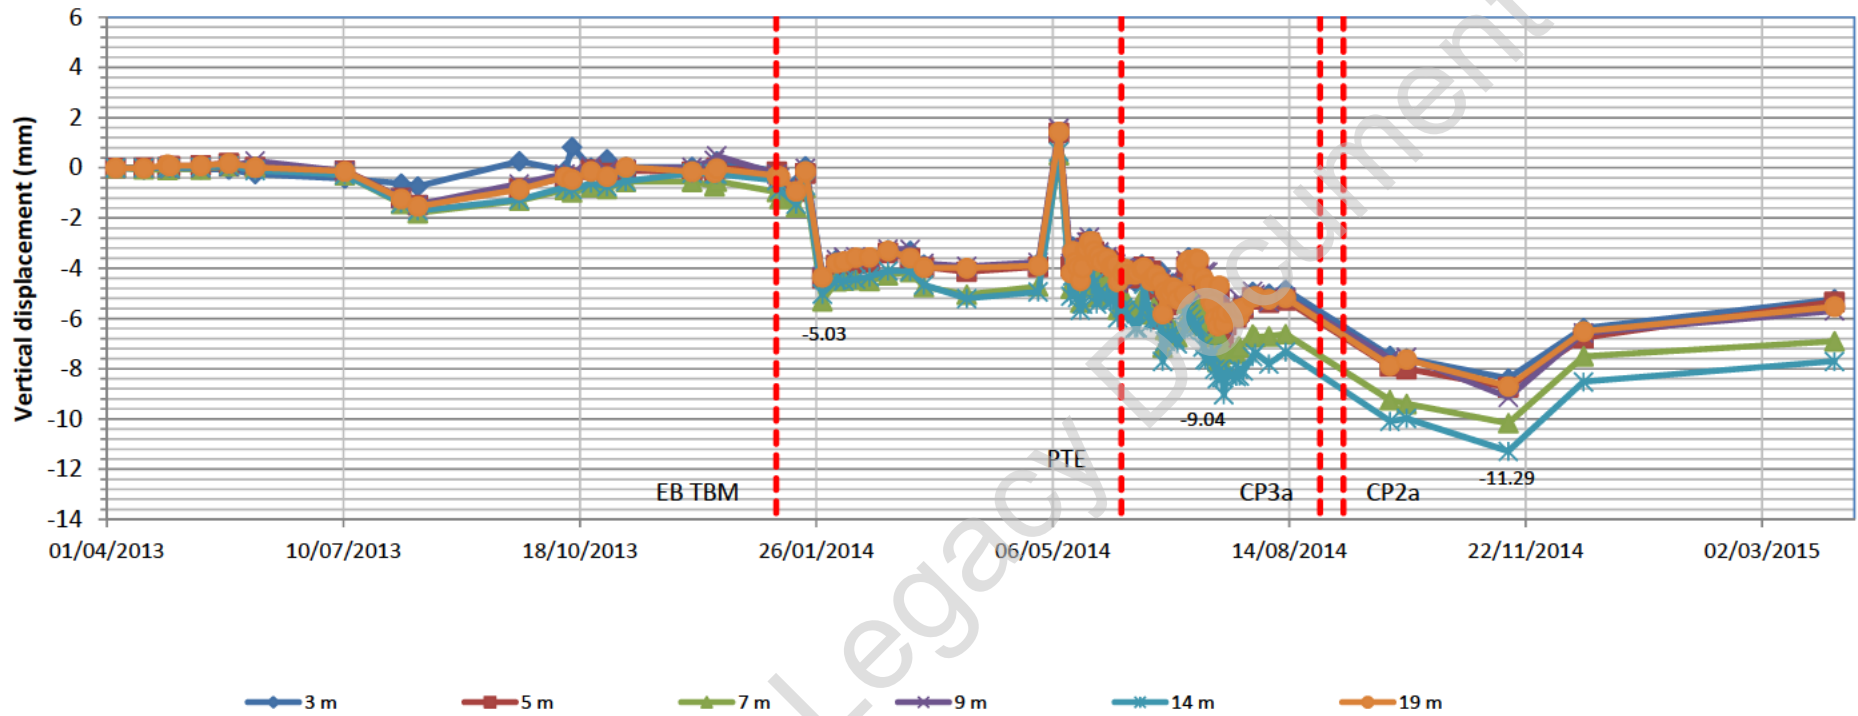
Extensometer C435-XR07000

The monitoring data for the extensometer at street level located at 27m from the axis of the EB TBM (C435-XR07000) is shown in Appendix B. The passage of the EB TBM is shown to have caused a maximum settlement of 5mm, recorded on the extensometer rod at 14m below street level. During the enlargement of PTE the extensometer show a maximum settlement of 9mm, recorded on the extensometer rod at 14m below street level. During CP3a and CP2a construction, no significant settlement was observed on the extensometer.

REMARKS: The first reading 14m and 9m are mistakes rebase line required. Three readings taken between 25-09-2014 and 14-11-2014 show bad readings. Some grouting episode was carried out on this period.

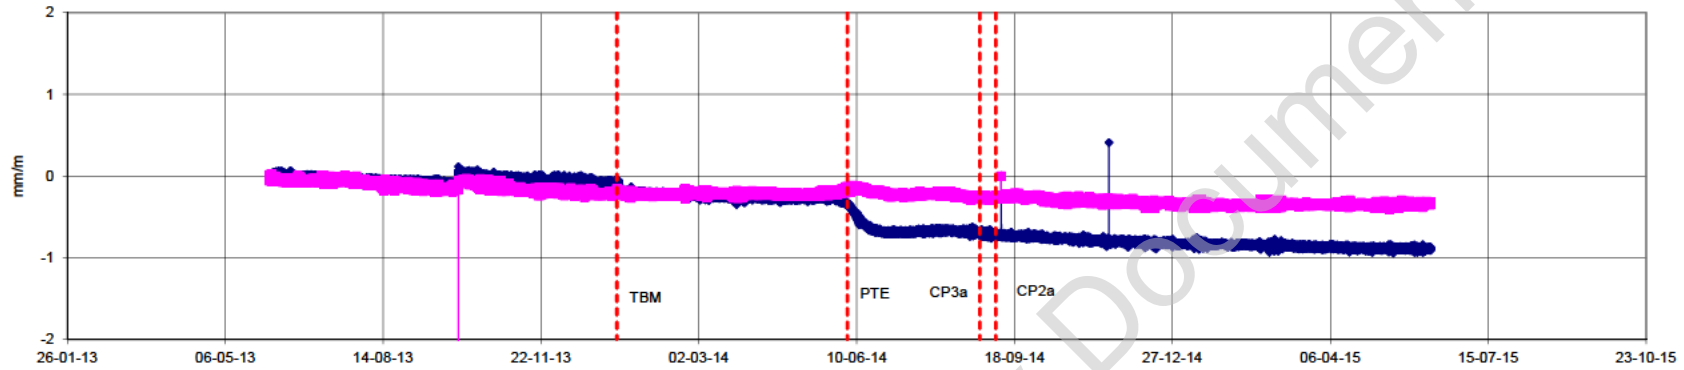
The monitoring data for the tiltmeters located on the basement for the building (C435-XR00701 and C435-XR00702) is presented in Appendix B. The results obtained from these instruments do not show any conclusive movements from construction.

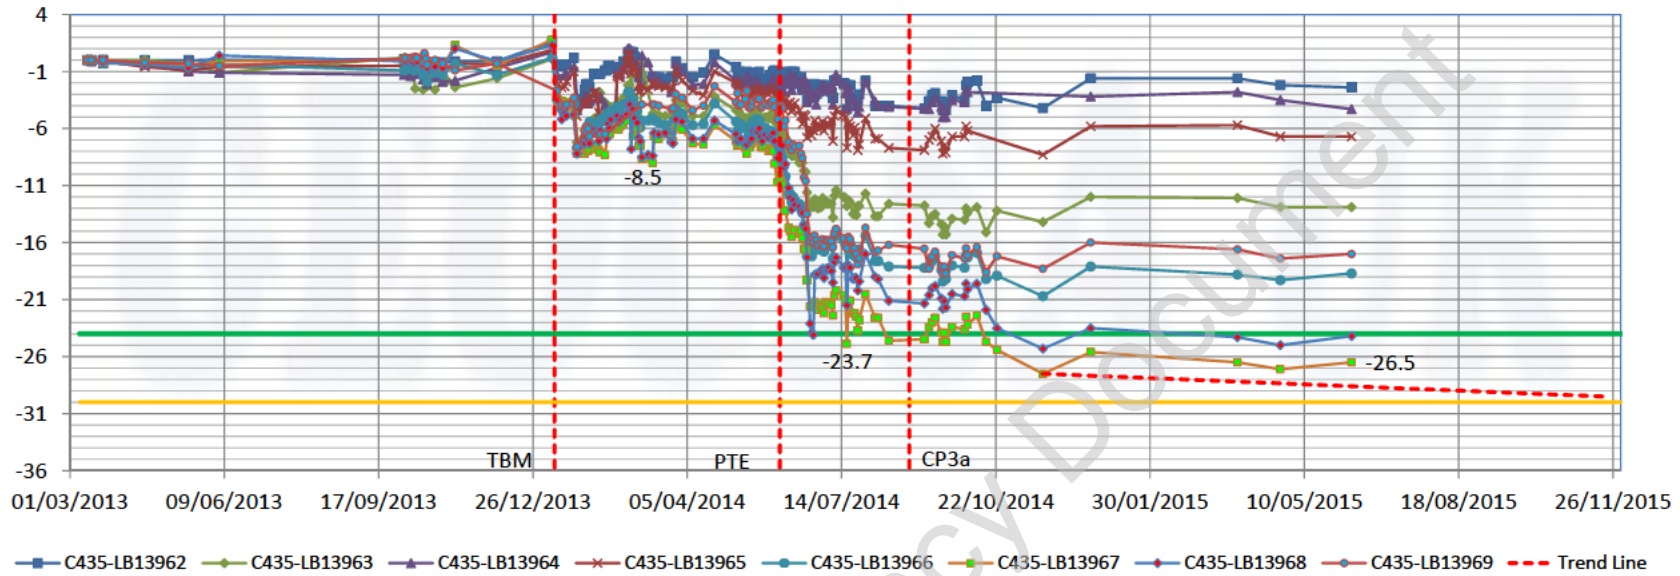
During the TBM, the sockets show 8.5mm maximum of settlement. The socket that shows the maximum settlement is located in the western wall, and is the first socket that was affected by TBM. After the TBM, some grouting episode was carried out. These episodes have produce maximum 4mm maximum after TBM.

During the PTE enlargement, the sockets show another 15mm settlement. The maximum movement during this construction phase was 23.7mm. When the sockets were outside for the influence area for PTE enlargement, these sockets show stable conditions, but with a residual settlement.

CP3a tunnel construction was made in two different stages. During the first stage, sockets didn't show significant movement. Second stage for CP3a construction produced another 4mm settlement. In this period, green trigger (-24mm) was breached by two sockets, the sockets closer to CP3a.

**REMARKS:**No access to the reference point between December 2014 and April 2015. This point was covered by boxes.
