C435 Farringdon Main Station

Monitoring Close-Out Report:

Internal Monitoring in buildings between Charterhouse Street, Cowcross Street and Greenhill's Rents

CRL Document Number: C435-BFK-C2-RGN-M123-51618

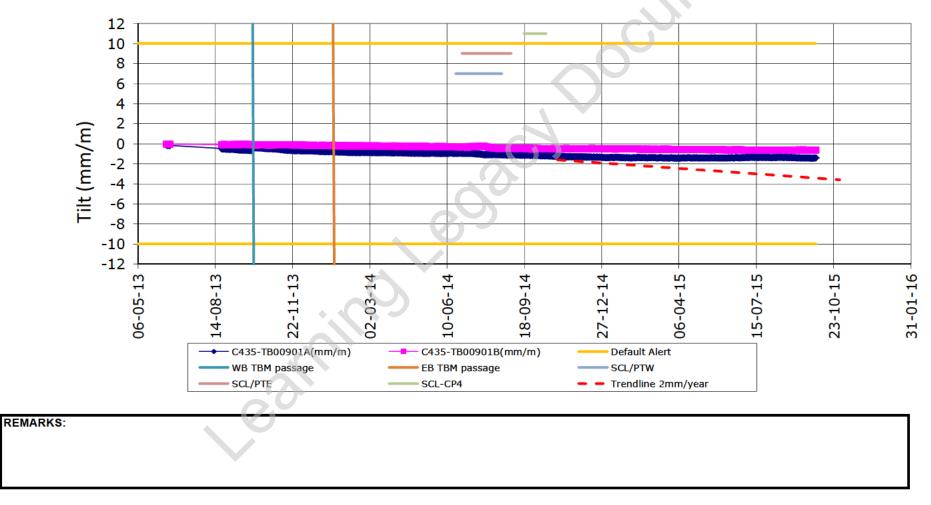
85 Cowcross Street

data for Tiltmeters and Electrolevel beams installed internally in this building is shown in Appendix B. No unusual movement recorded by Tiltmeters during WB-TBM and EB-TBM passages. Some fluctuation in readings recorded during PTE and PTW enlargement works, but being insignificant the movement caused by these activities and by CP4 cross passage excavation.

By Electrolevels, no significant movement recorded during WB and EB TBM passages, being the maximum movement recorded of 1.7mm during SCL-PTE Enlargement works

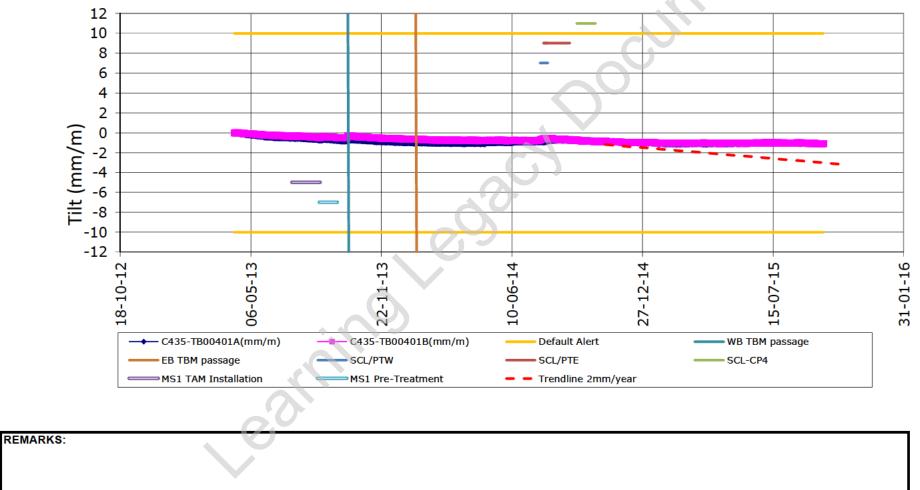
94 Cowcross Street

data for Tiltmeters installed internally in this building is shown in Appendix B. No unexpected movement recorded during WB-TBM and EB-TBM passages. Some fluctuation in readings recorded during PTE and PTW enlargement works, but being insignificant the movement caused by these activities and by CP4 cross passage excavation. Around 1mm/m of movement recorded during Pre-Treatment works carried out from Moorgate Spur No.1 shaft.
