C435 Farringdon Main Station

Monitoring Close-Out Report: Internal monitoring – Buildings between St John St and Charterhouse St

CRL Document Number: C435-BFK-C2-RGN-M123-51648

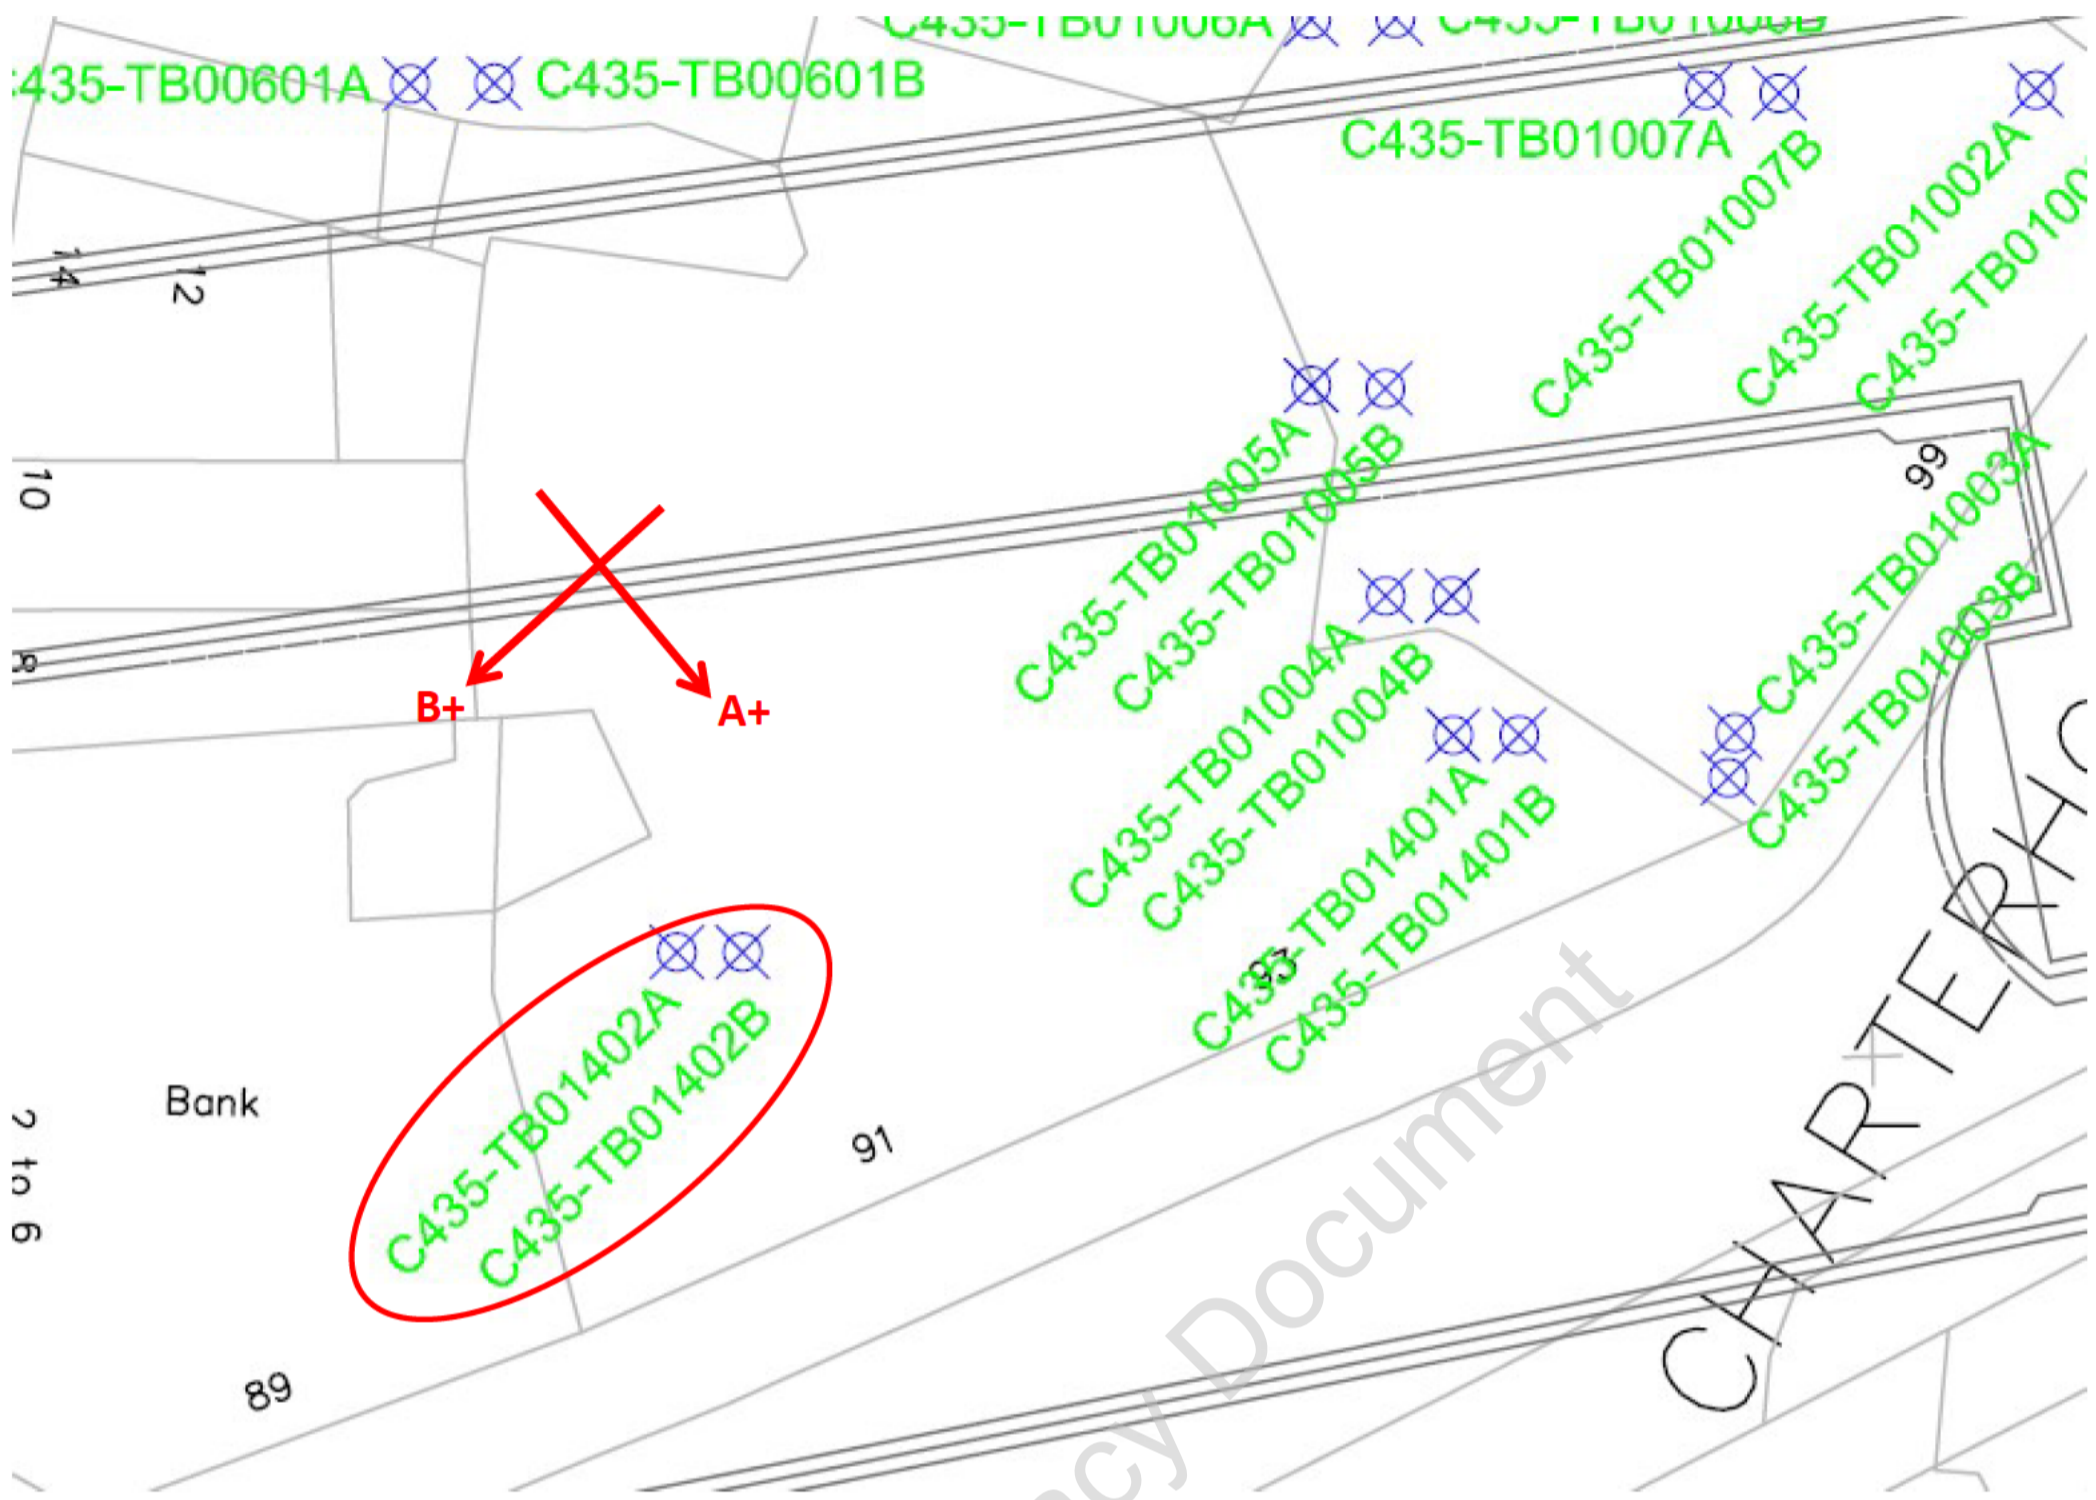
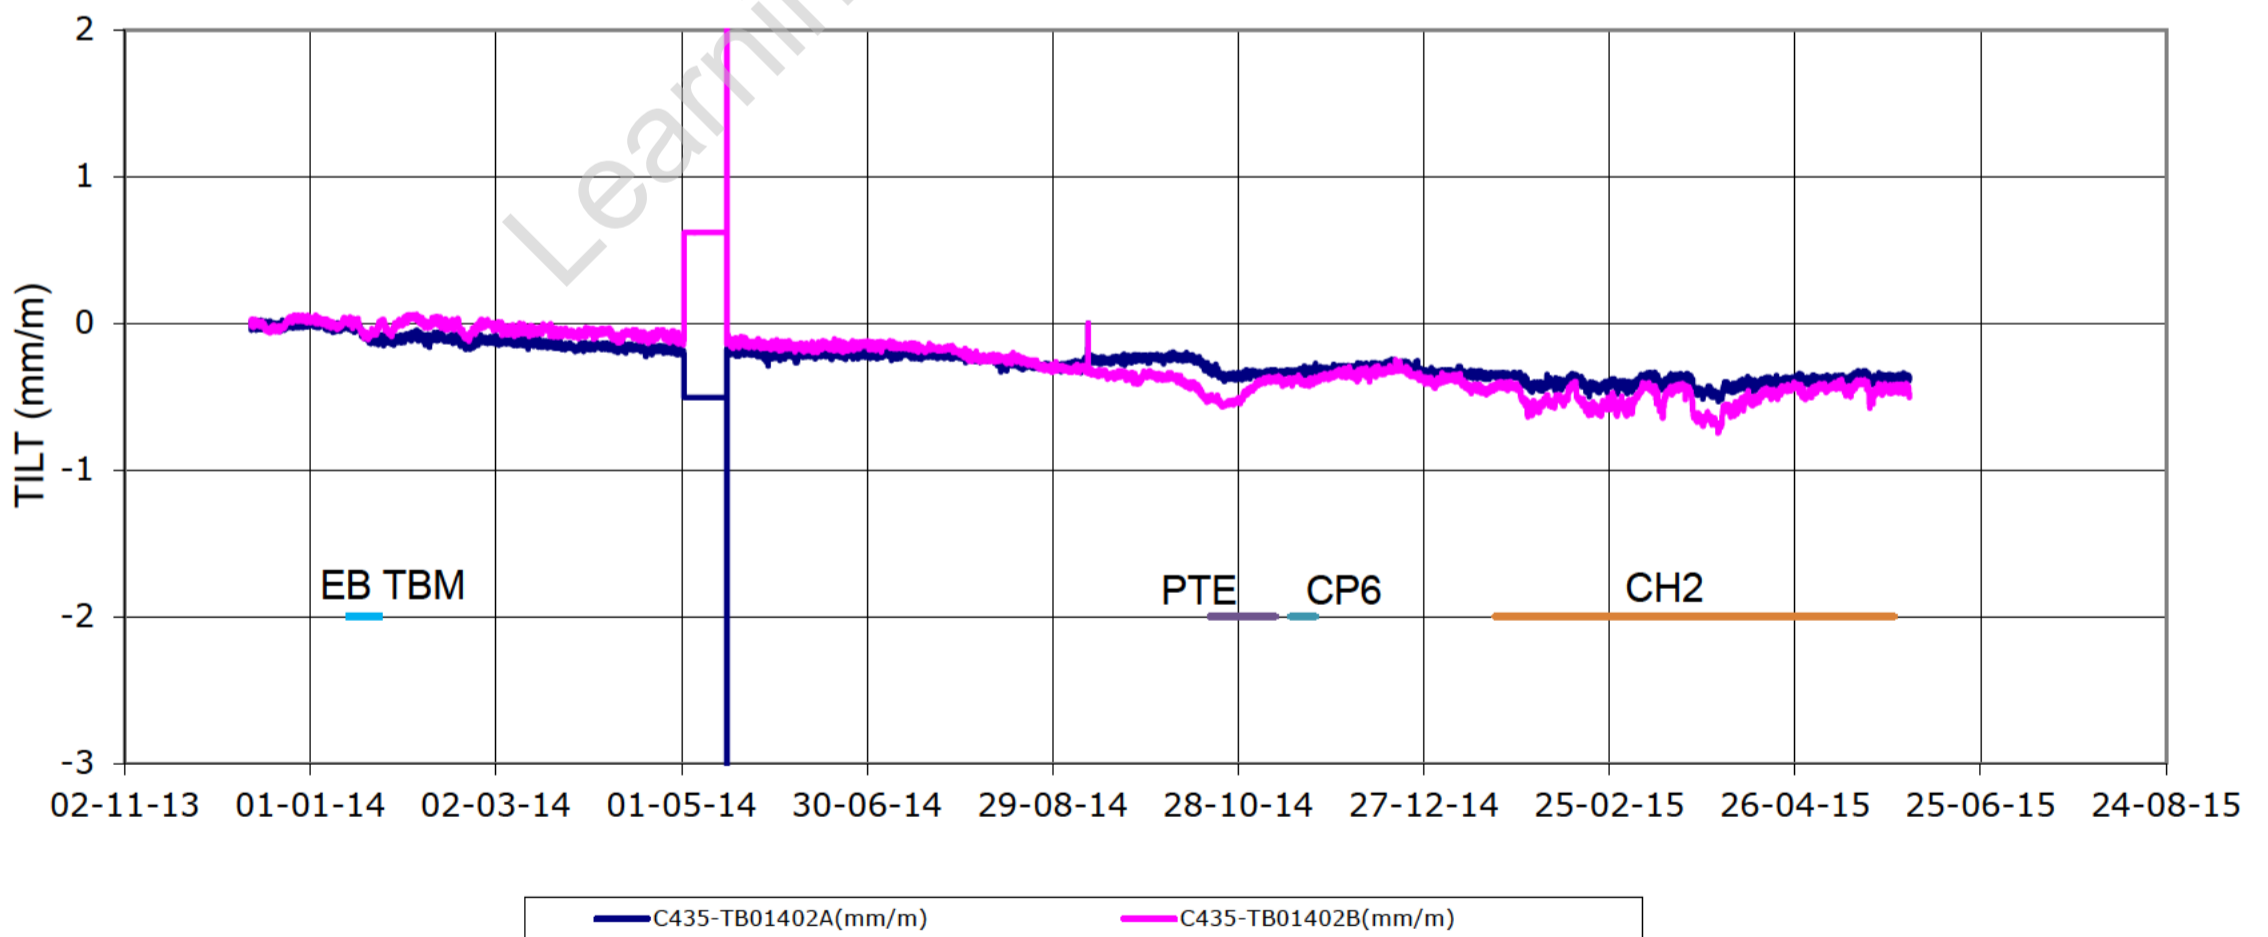
— C435-TB01402A(mm/m) — C435-TB01402B(mm/m)

- EB TBM caused maximum 0.2mm/m of horizontal displacement from 17-01-2014 to 20-01-2014
- PTE caused maximum 0.4mm/m of horizontal displacement from 19-10-2014 to 09-01-2014.
- No horizontal displacement caused by the CP6 works.
- No horizontal displacement caused by the CH2 works.
- Maximum horizontal displacement 0.7mm/m.
