C435 Farringdon Main Station

Monitoring Close-Out Report: Extensometers XR04000, XR05000, XR08000, XR09000 and XR25000.

CRL Document Number: C435-BFK-C2-RGN-M123-51671

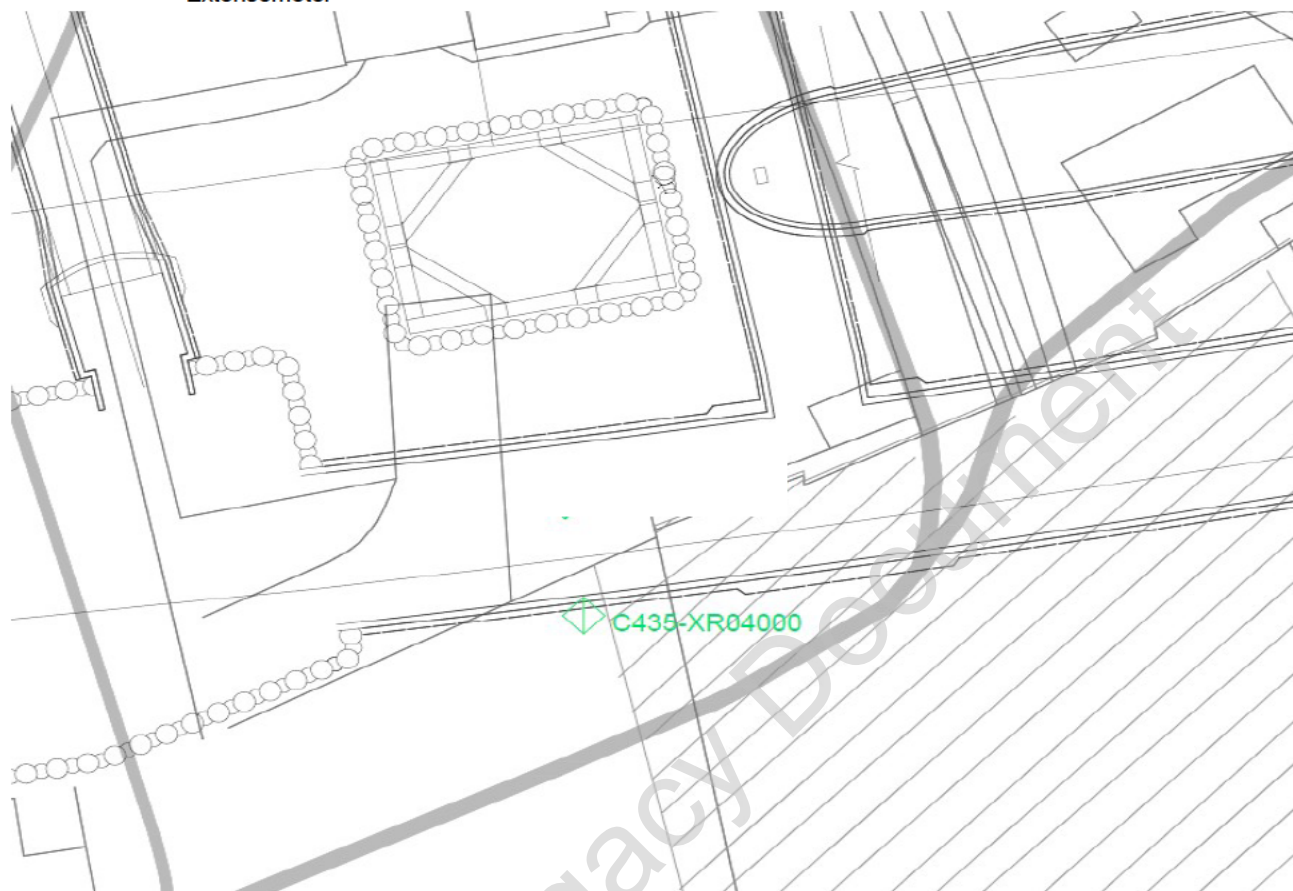
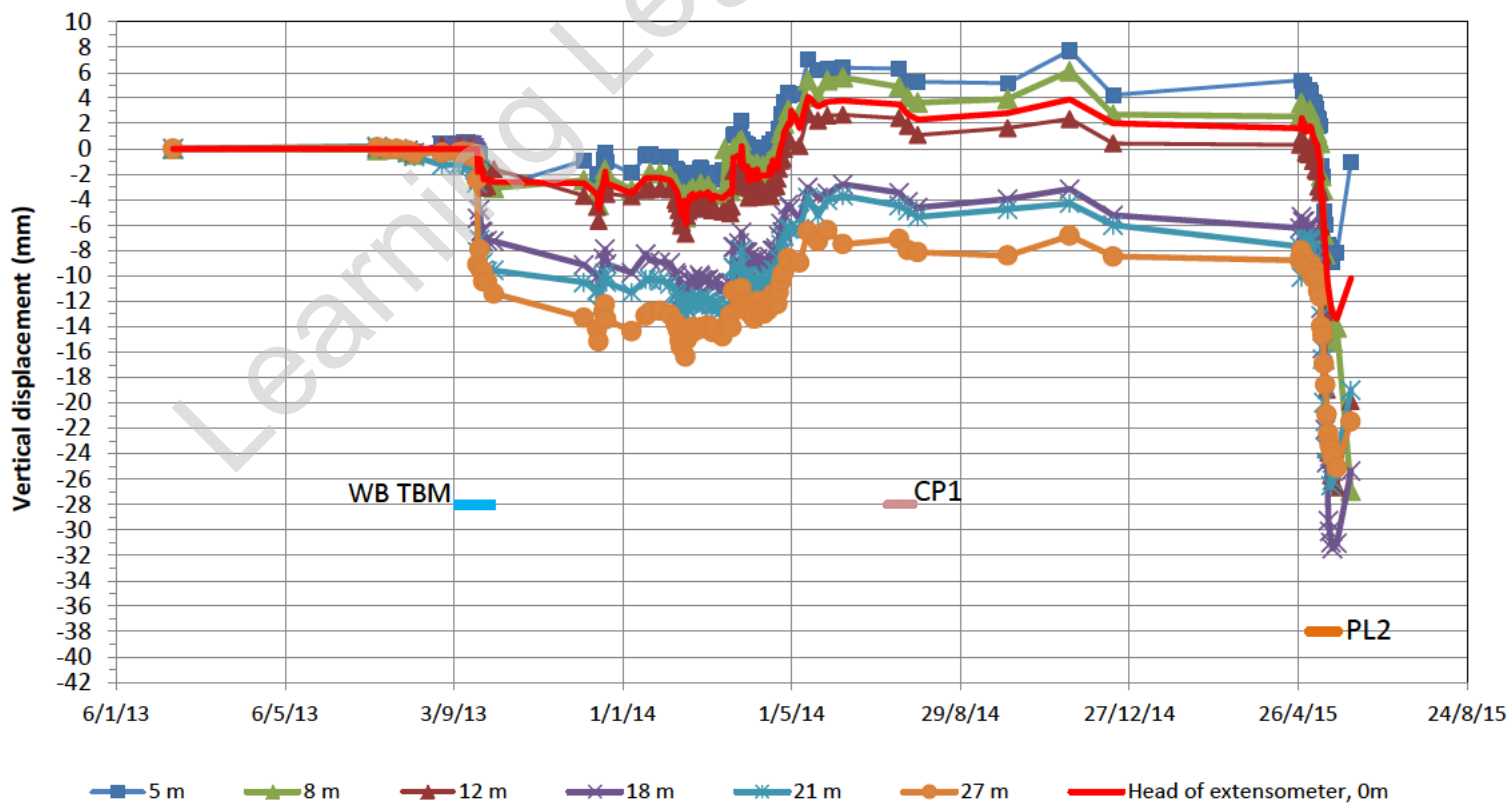
Extensometer C435-XR04000

- WB TBM caused maximum 12mm of settlement, captured on the deepest anchor from 17-09-2013 to 19-09-2013.
- Residual settlement caused 2mm maximum.
- Compensation grouting from Butcher's ramp Shaft caused maximum of 9mm of heave from 04-04-2014 to 12-05-2014.
- No movements caused by the CP1 works.
- PL2 caused maximum 16mm of settlement from 04-05-2015 to 24-05-2015.
- Maximum settlement captured by the extensometer at the end of the works -31mm.

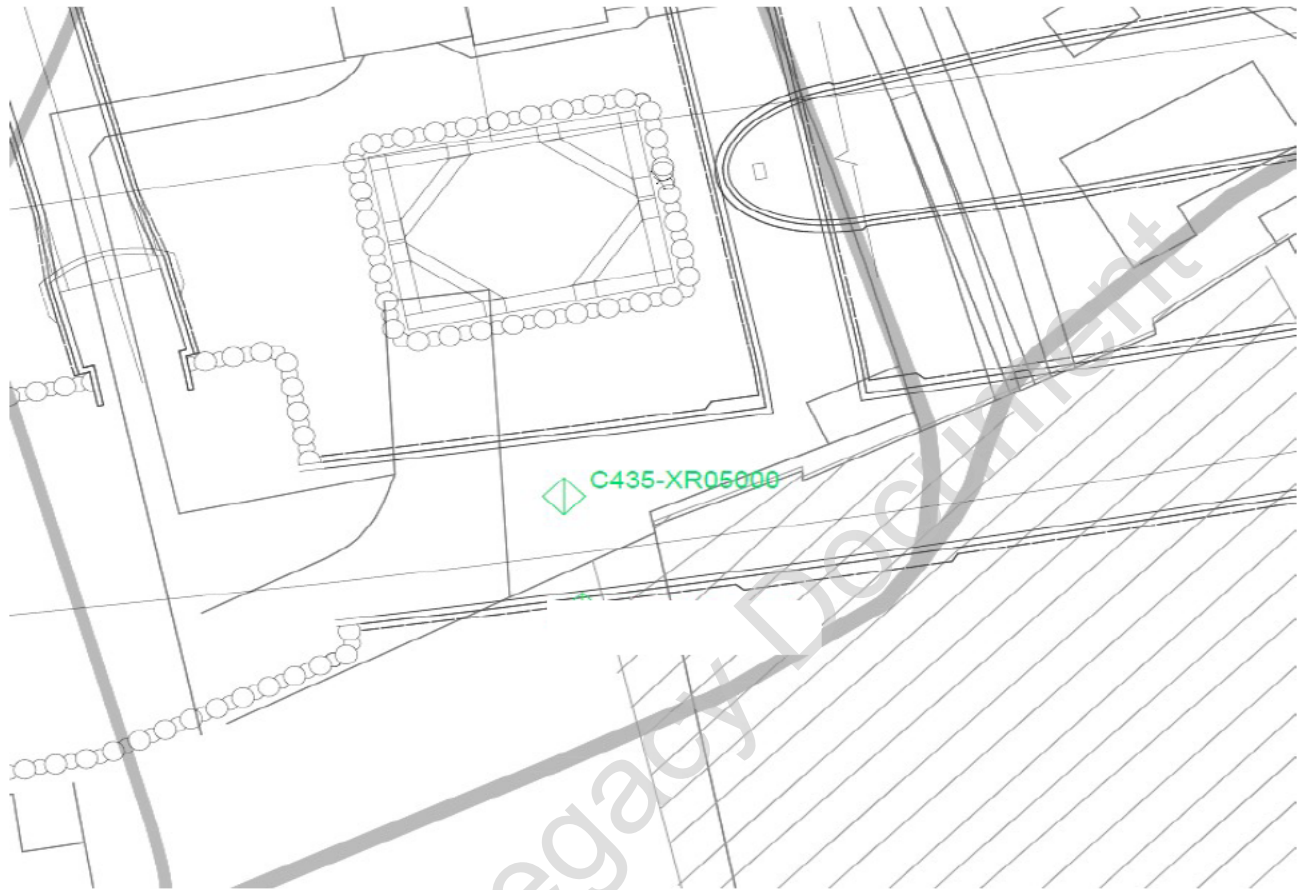
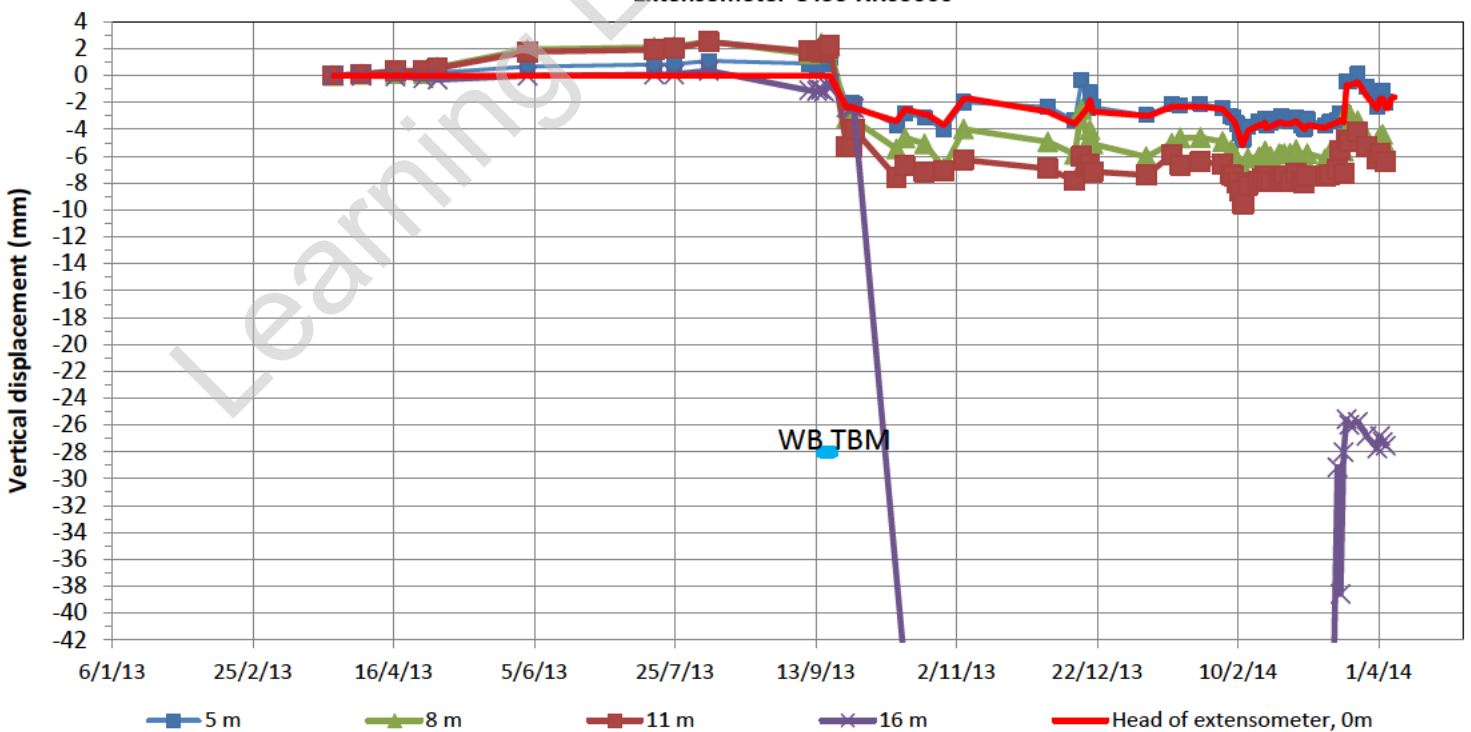
Extensometer C435-XR05000

- WB TBM caused maximum 8mm of settlement from 15-09-2013 to 19-09-2013.
- Residual settlement caused 2mm maximum.
- Compensation grouting from Butcher's Ramp Shaft caused maximum 3mm of heave from 14-03-2014 to 24-03-2014.
- Maximum settlement captured by the extensometer was 8mm.

Due the TBM passage, the deepest anchor of the extensometer (16m) was damaged after the WB TBM passage on 19-09-2013. The other anchors were not affected by the TBM.

The extensometer was installed on WTH site. During the excavation works and pile works for the Escalator Shaft, the extensometer was covered by concrete on 05-04-2014.

The deepest anchor was broke due the TBM passage from 15-09-2013 to 19-09-2013.
 The extensometer was covered by concrete on 05-04-2014 due the works carried out on Caxton Slab. No more reading

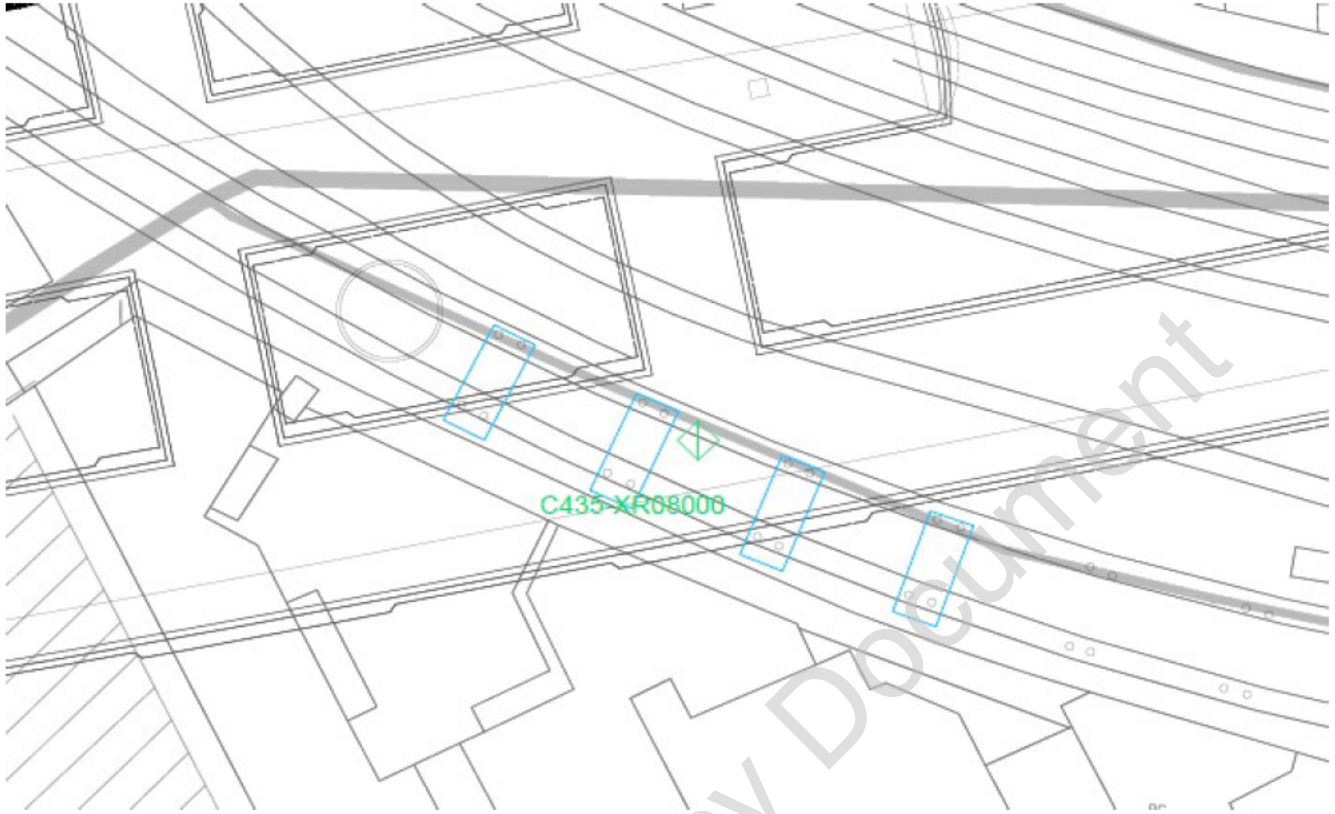
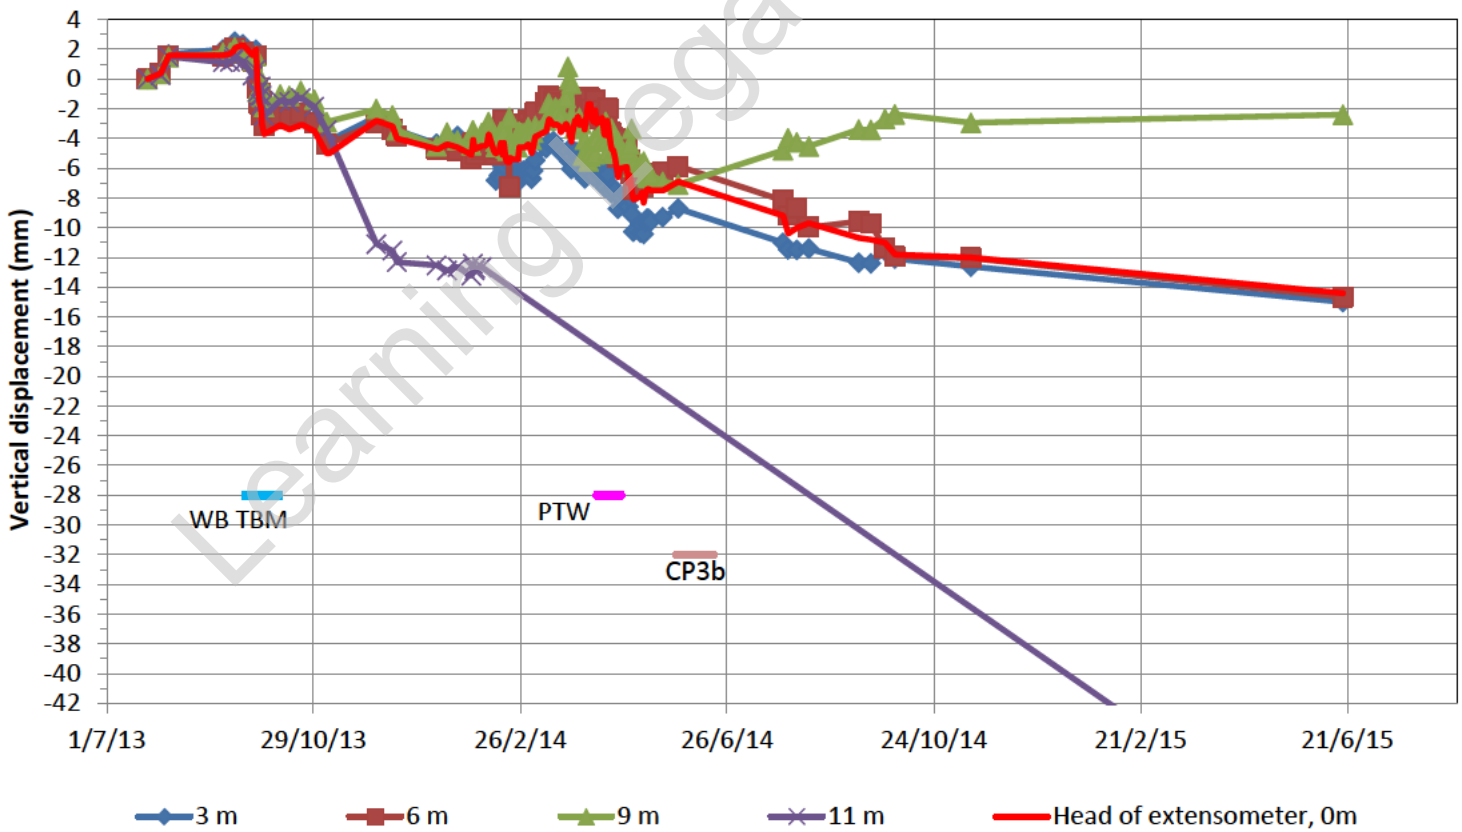
Extensometer C435-XR08000

- During the TaM's drilling from Butcher's Ramp Shaft, 2mm maximum of heave was captured by the extensometer from 01-08-2013 to 25-09-2013.
- WB TBM caused maximum 7mm of settlement from 28-09-2013 to 30-09-2013.
- Residual settlement caused 3mm maximum.
- Compensation grouting from Butcher's Ramp Shaft caused maximum 5mm of heave from 18-02-2014 to 06-04-2014.
- PTW enlargement works caused maximum 7mm of settlement from 12-04-2014 to 25-04-2014.
- CP3b caused maximum 3mm of settlement from 28-05-2014 to 18-06-2014.
- Maximum settlement captured by the extensometer was 15mm.

The deepest anchor was damaged after the WB TBM due the passage. The rest of the anchors work properly.

The deepest anchor was broke due the TBM passage. The rest of the anchors cotinued working properly.

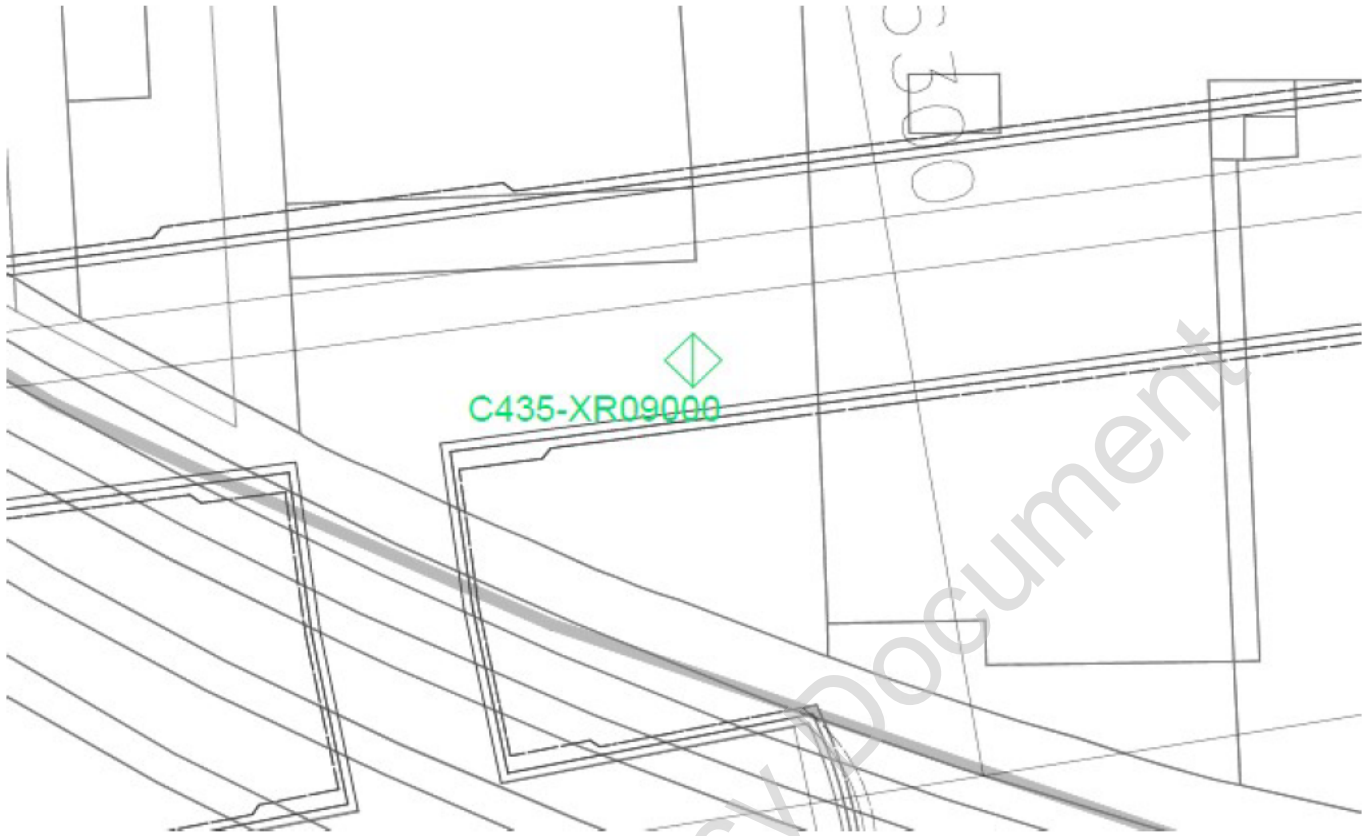
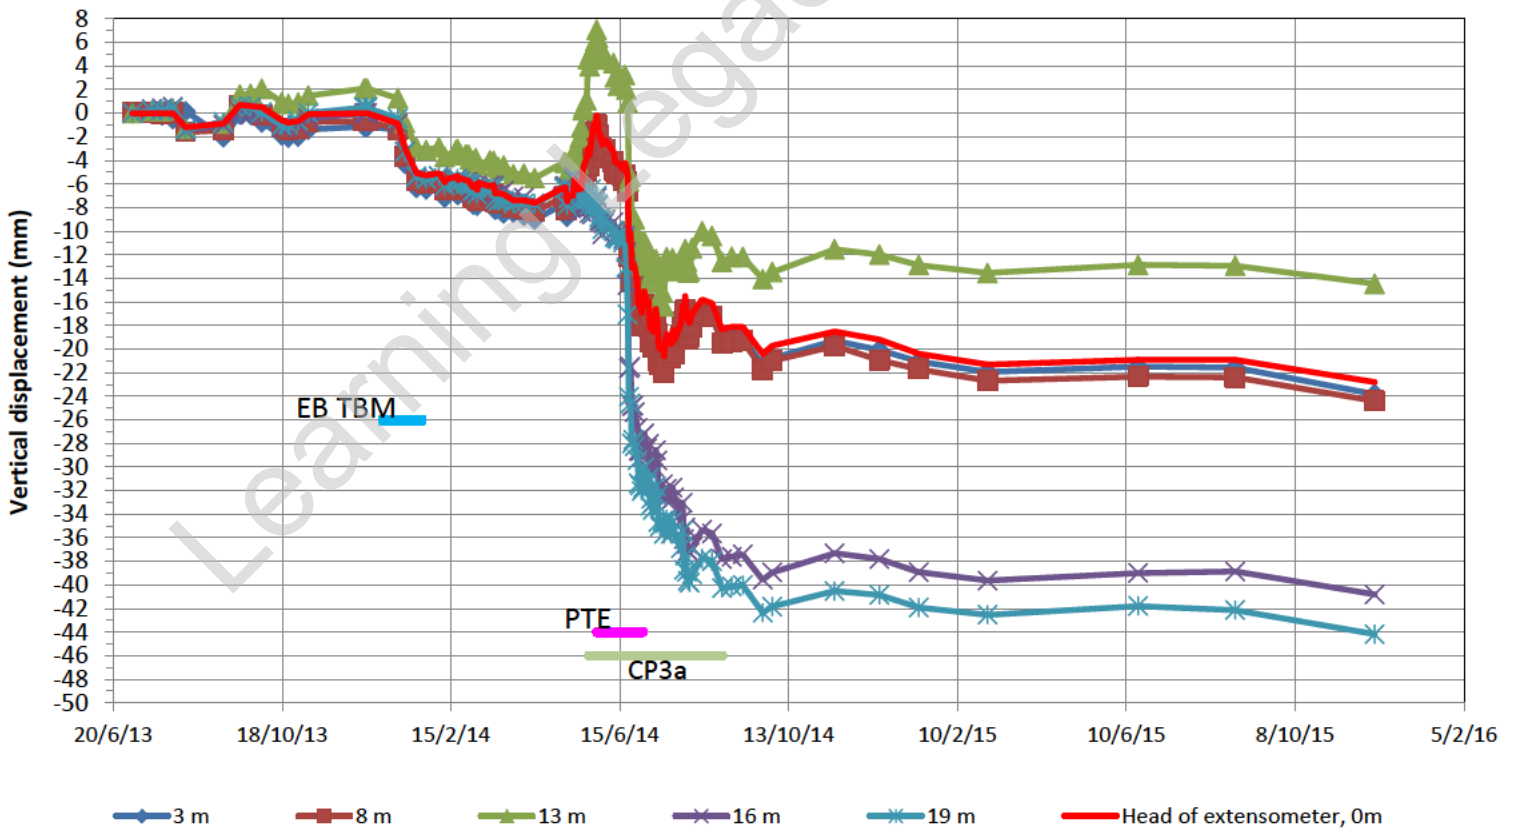
Extensometer C435-XR09000

- TaM's drilling caused maximum 2mm of heave from 06-09-2013 to 25-09-2013.
- EB TBM caused maximum 5mm of settlement from 09-01-2014 to 13-01-2014.
- Residual settlement caused maximum 3mm.
- Compensation grouting from Butcher's Ramp caused maximum 12 mm of heave from 08-04-2014 to 28-05-2014.
- PTE enlargement works caused maximum 37mm captured in the deepest anchor. The rest of the anchors showed 20mm of settlement.
- CP3a caused maximum 6mm of settlement from 24-05-2014 to 27-08-2014.
- Compensation grouting caused maximum 5mm of heave from 16-07-2014 to 05-08-2014.
- Maximum settlement captured by the extensometer at the end of the works -44mm.

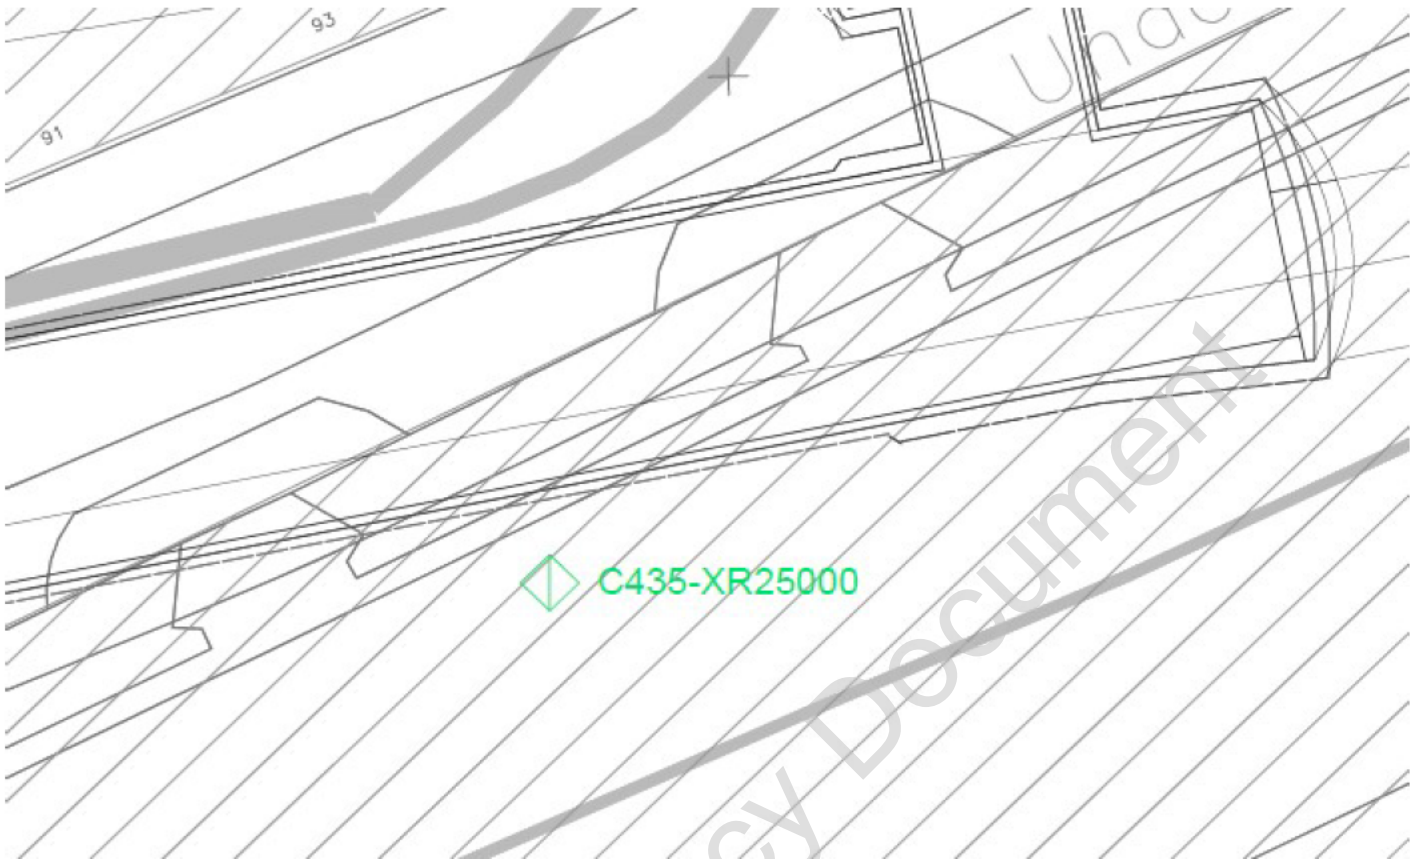
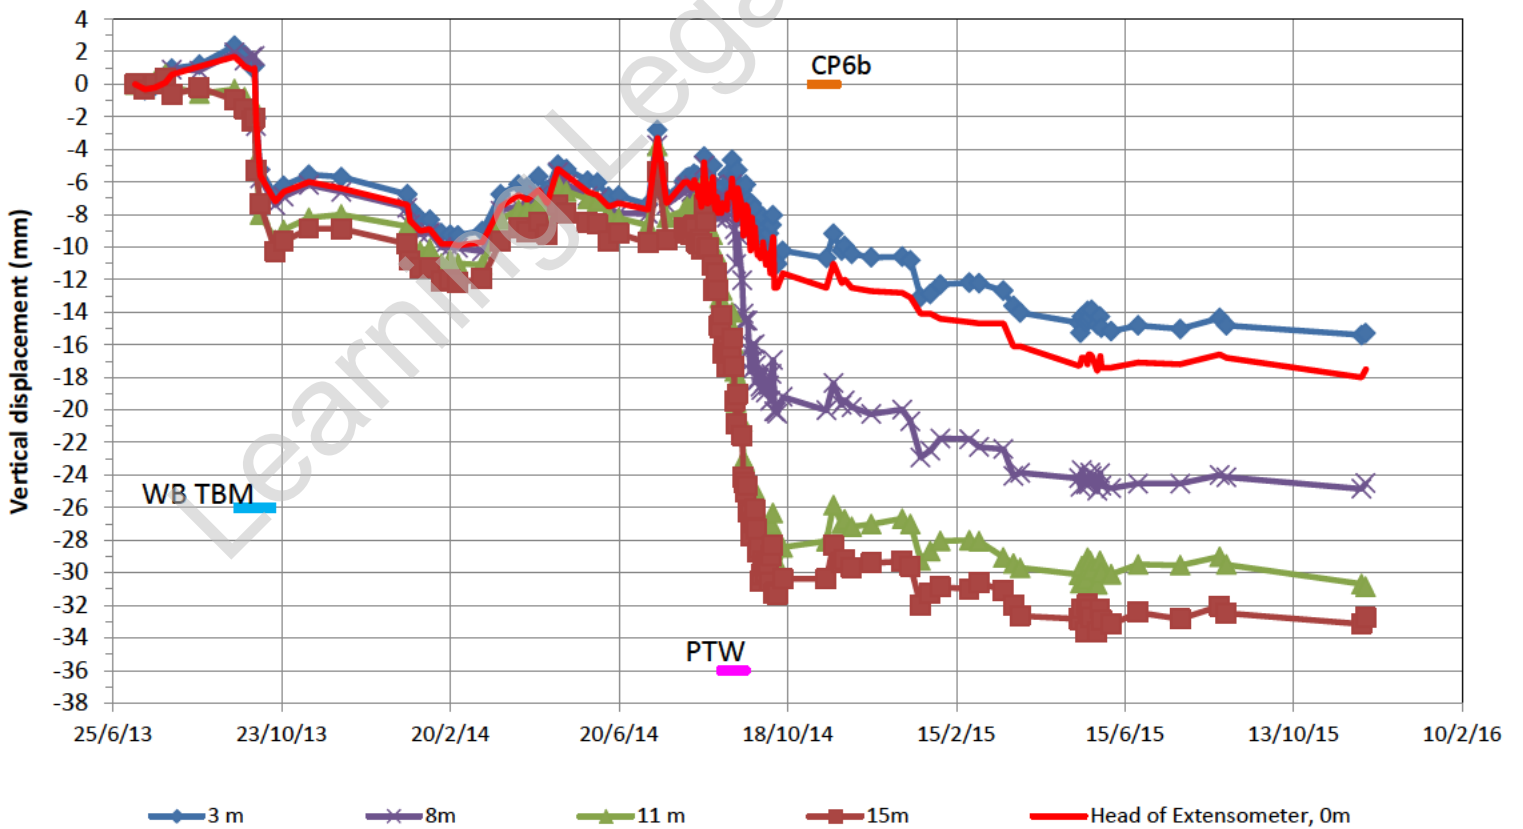
Extensometer C435-XR25000

- TaM's drilling from Moorgate Spur 2 caused maximum 3mm of heave from 01-08-2013 to 19-09-2013.
- WB TBM caused maximum 10mm of settlement from 03-10-2013 to 05-10-2013.
- Residual settlement caused 2-3mm.
- Compensation grouting from Moorgate Shaft 2 caused maximum 5mm of heave from 25-02-2014 to 13-05-2014.
- PTW enlargement caused maximum 24mm of settlement captured in the deepest anchor.
- No movements caused by the CP6b works.
- Maximum settlement captured at the end of the works -33mm.
