Work Area: SMM
Work Type: I&M
Originator Company: GEOCISA

# C435 Farringdon Main Station

## Monitoring Close-Out Report: Sockets & Studs Installed on Cowcross St. CRL Document Number: C435-BFK-C2-RGN-M123-51664

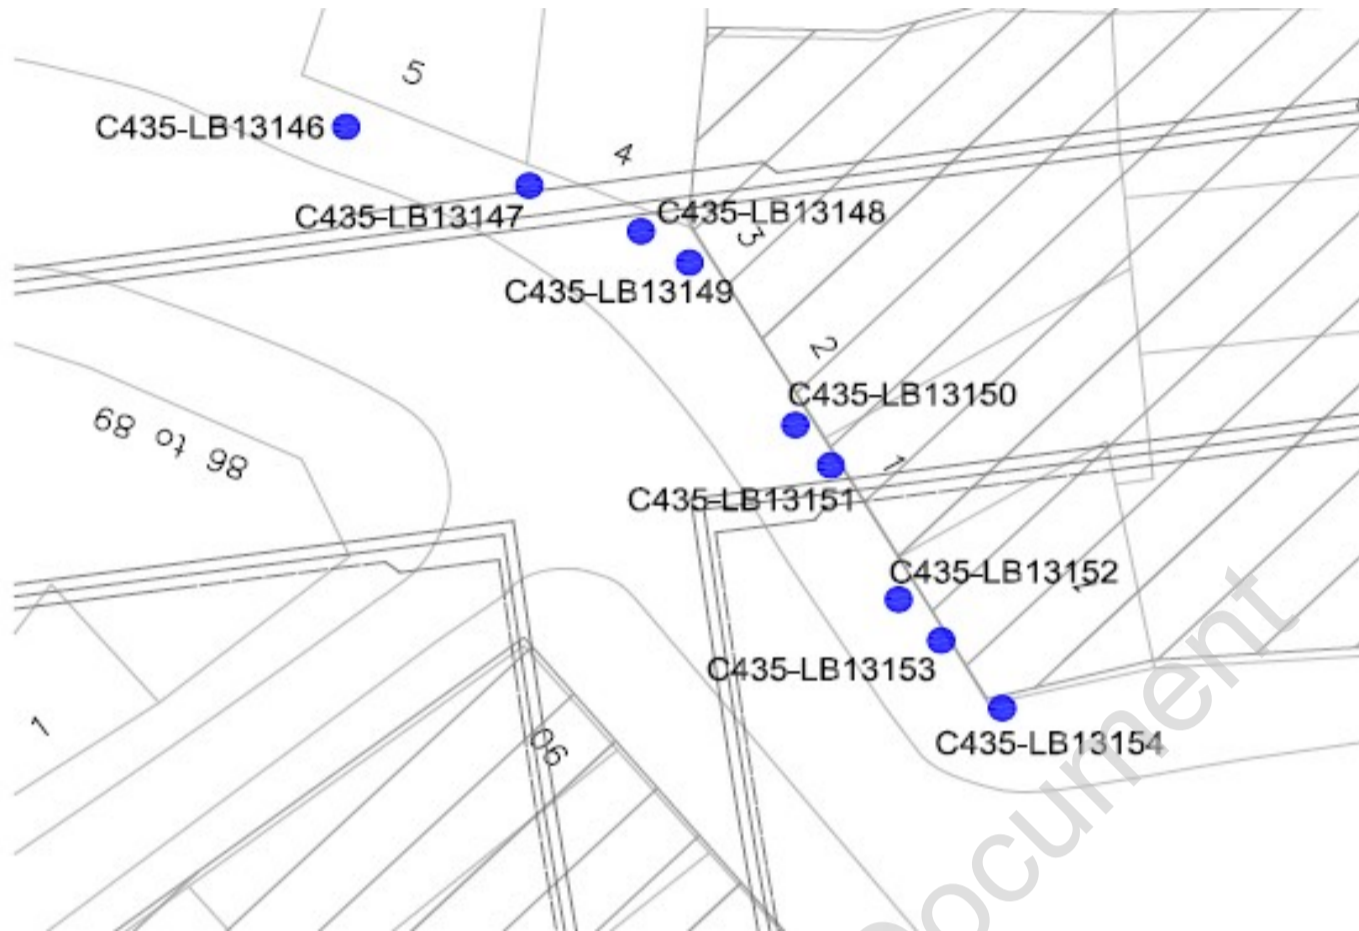
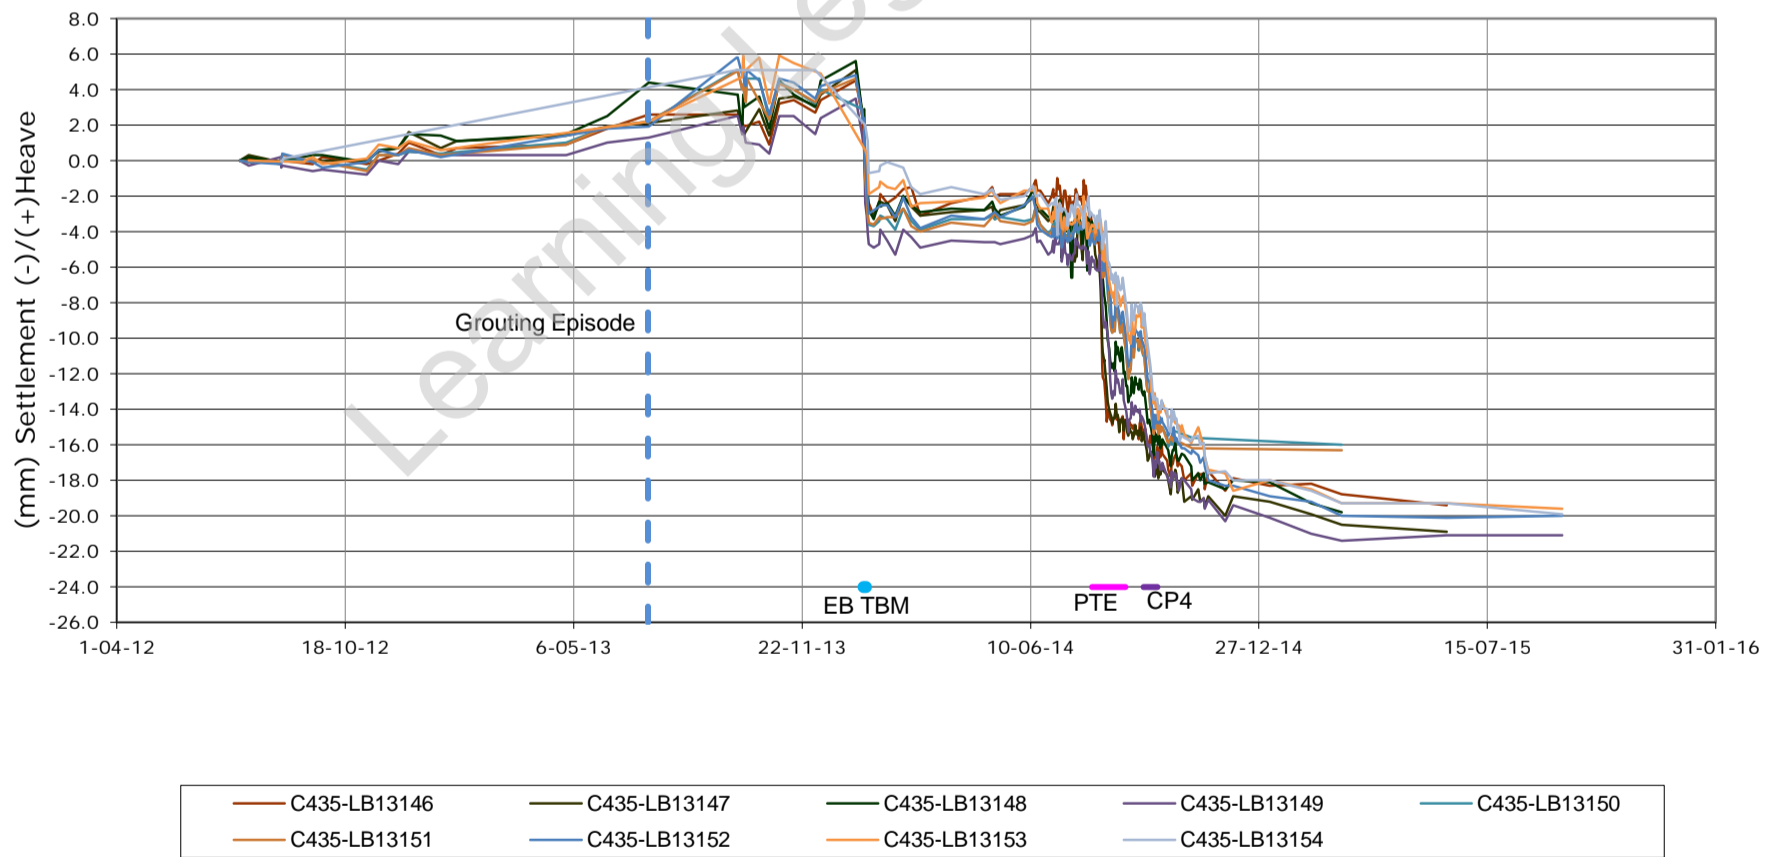
Building: 1-5 COWCROSS STREET

- Compensation grouting from Moorgate Shaft 1 caused 4mm maximum of heave on 10-07-2013.
- EB TBM caused 6mm maximum of settlement from 15-01-2014 to 17-01-2014.
- PTE enlargements works caused 10mm of settlement from 03-08-2014 to 01-09-2014.
- CP4 construction caused 3-4mm of settlement from 17-09-2014 to 29-09-2014.
- Maximum settlement at the end of the works was 22mm.

**REMARKS:**  
 Sockets inside the Compensation Grouting Area. No triggers breached.

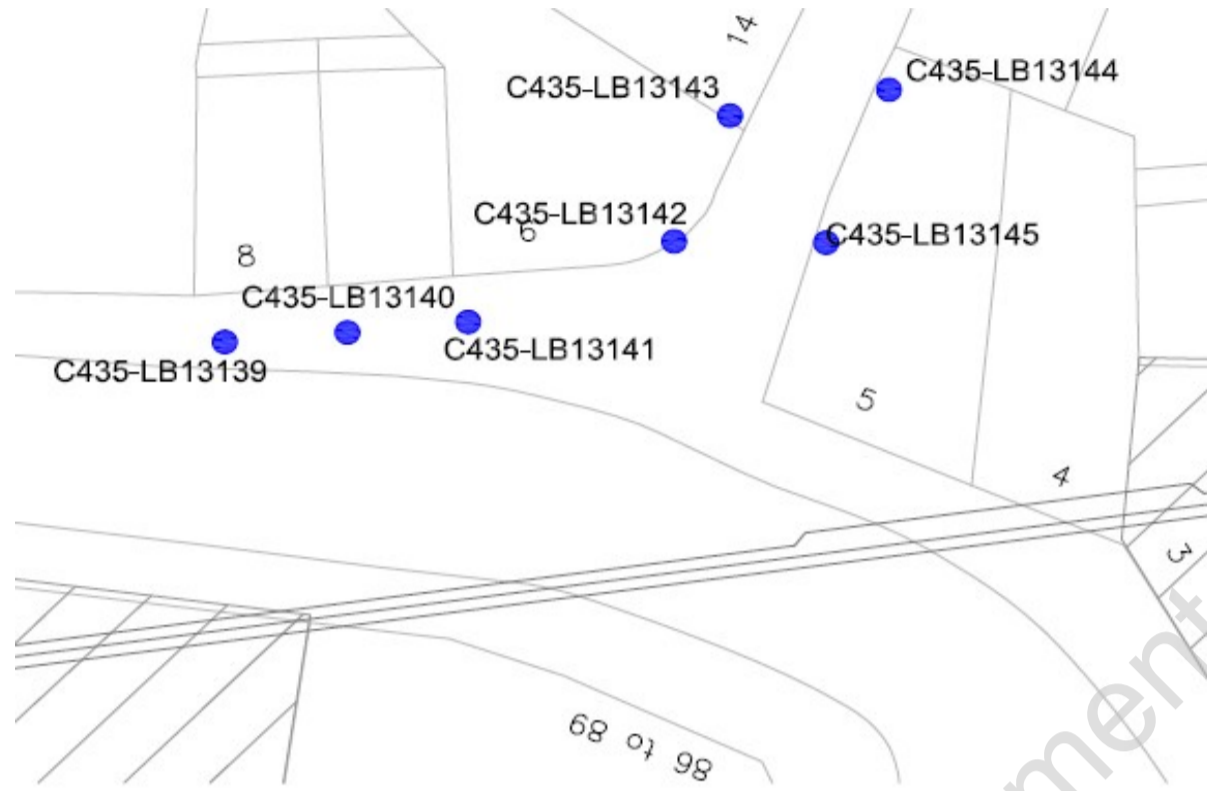
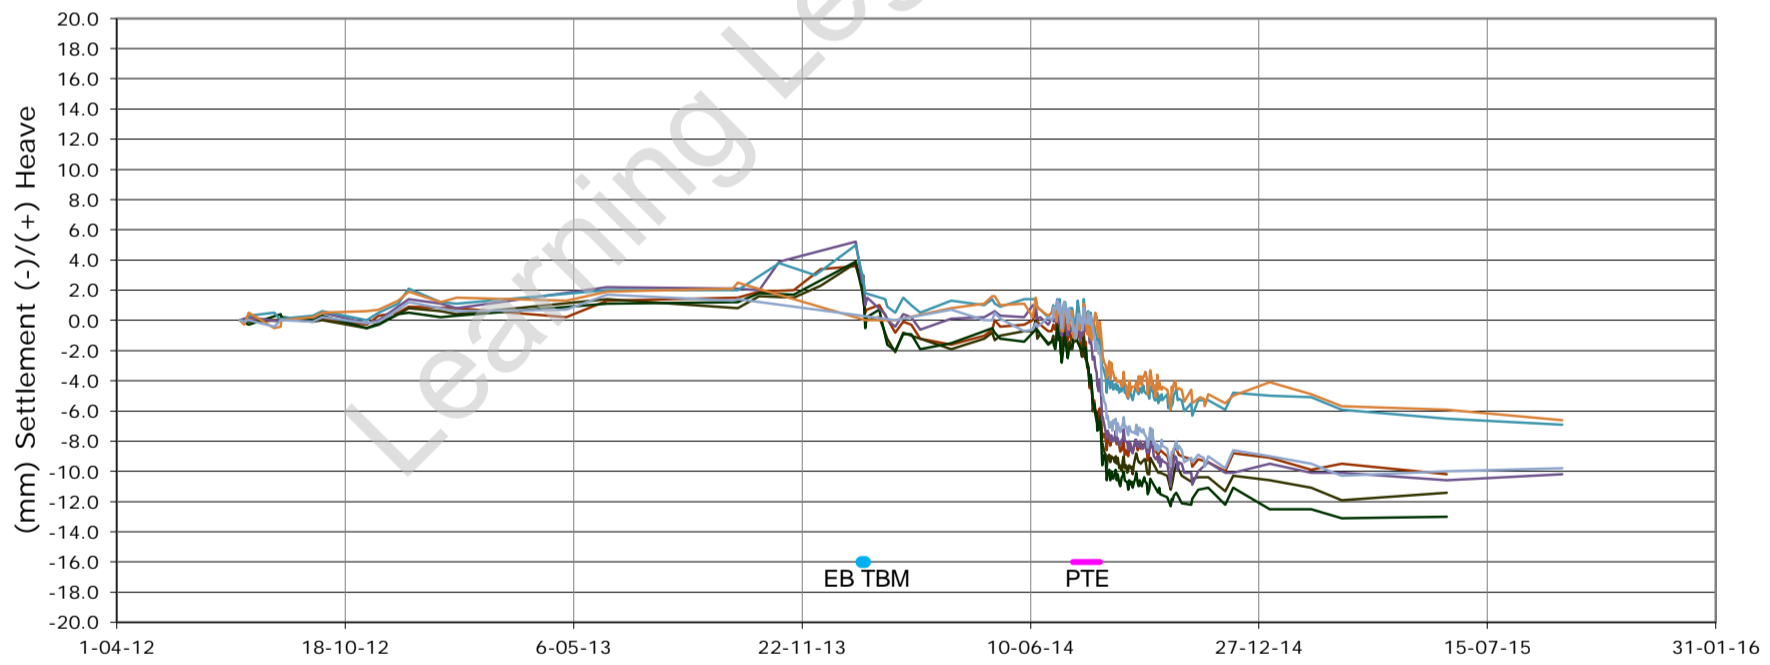
Building: 4-8 COWCROSS ST

- EB TBM caused maximum 3-4mm of settlement from 13-01-2014 to 16-01-2014.
- PTE enlargement caused 8-9mm of settlement maximum from 17-07-2014 to 10-08-2014.
- Maximum settlement at the end of the works was 11mm

**REMARKS:**  
Sockets outside Compensation Grouting Area. No triggers breached.

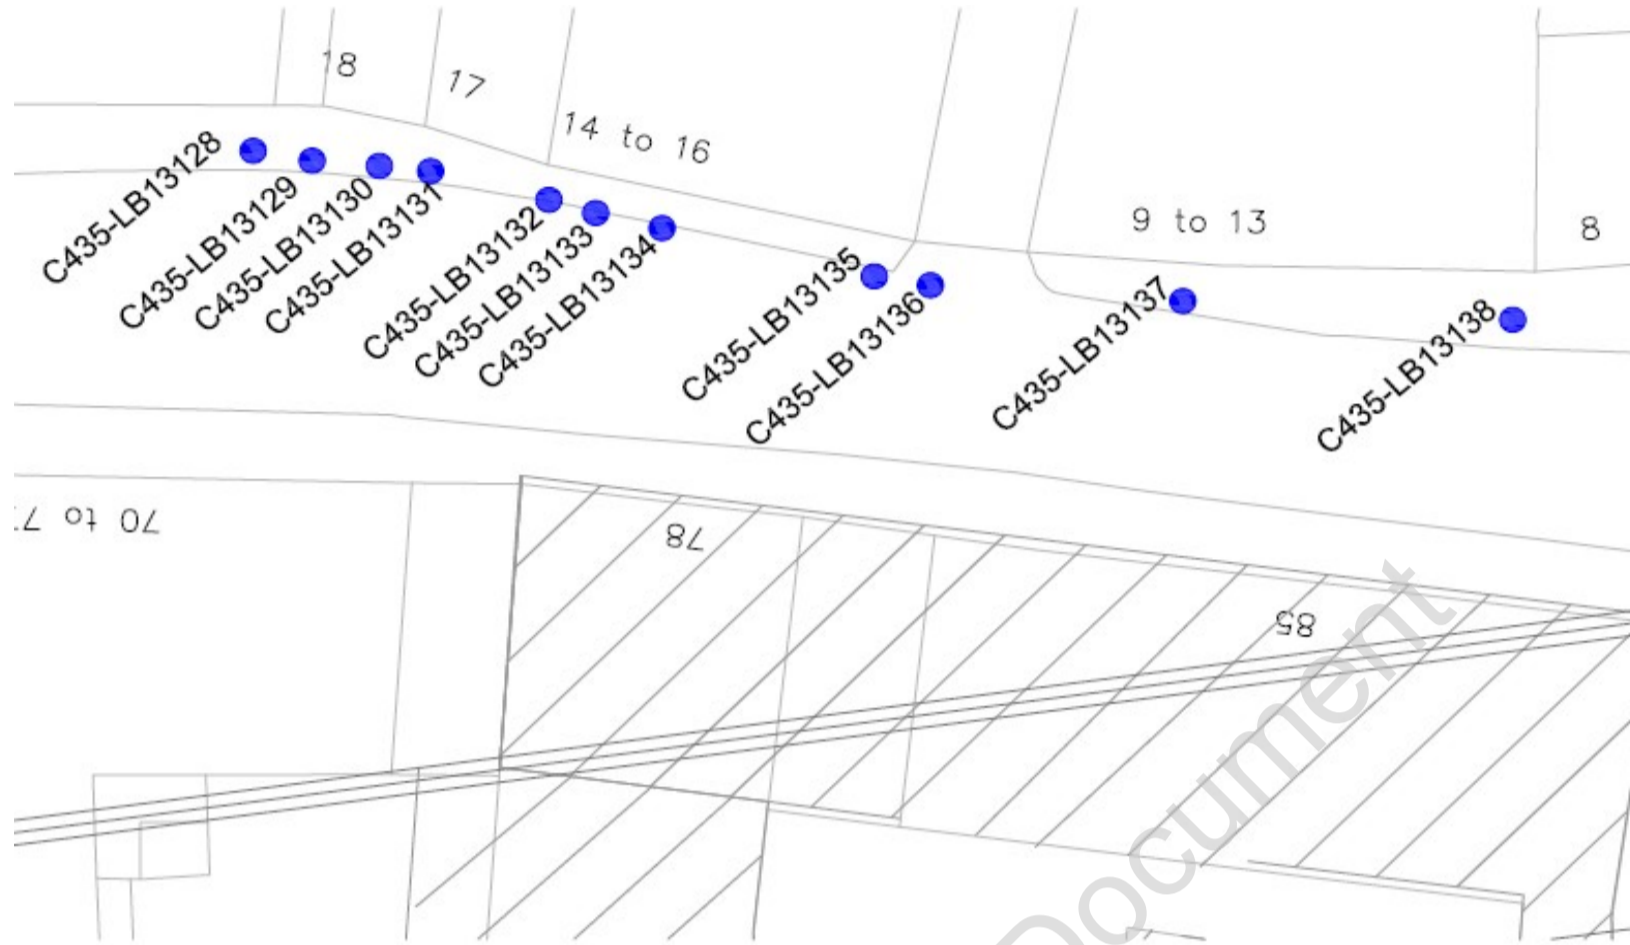
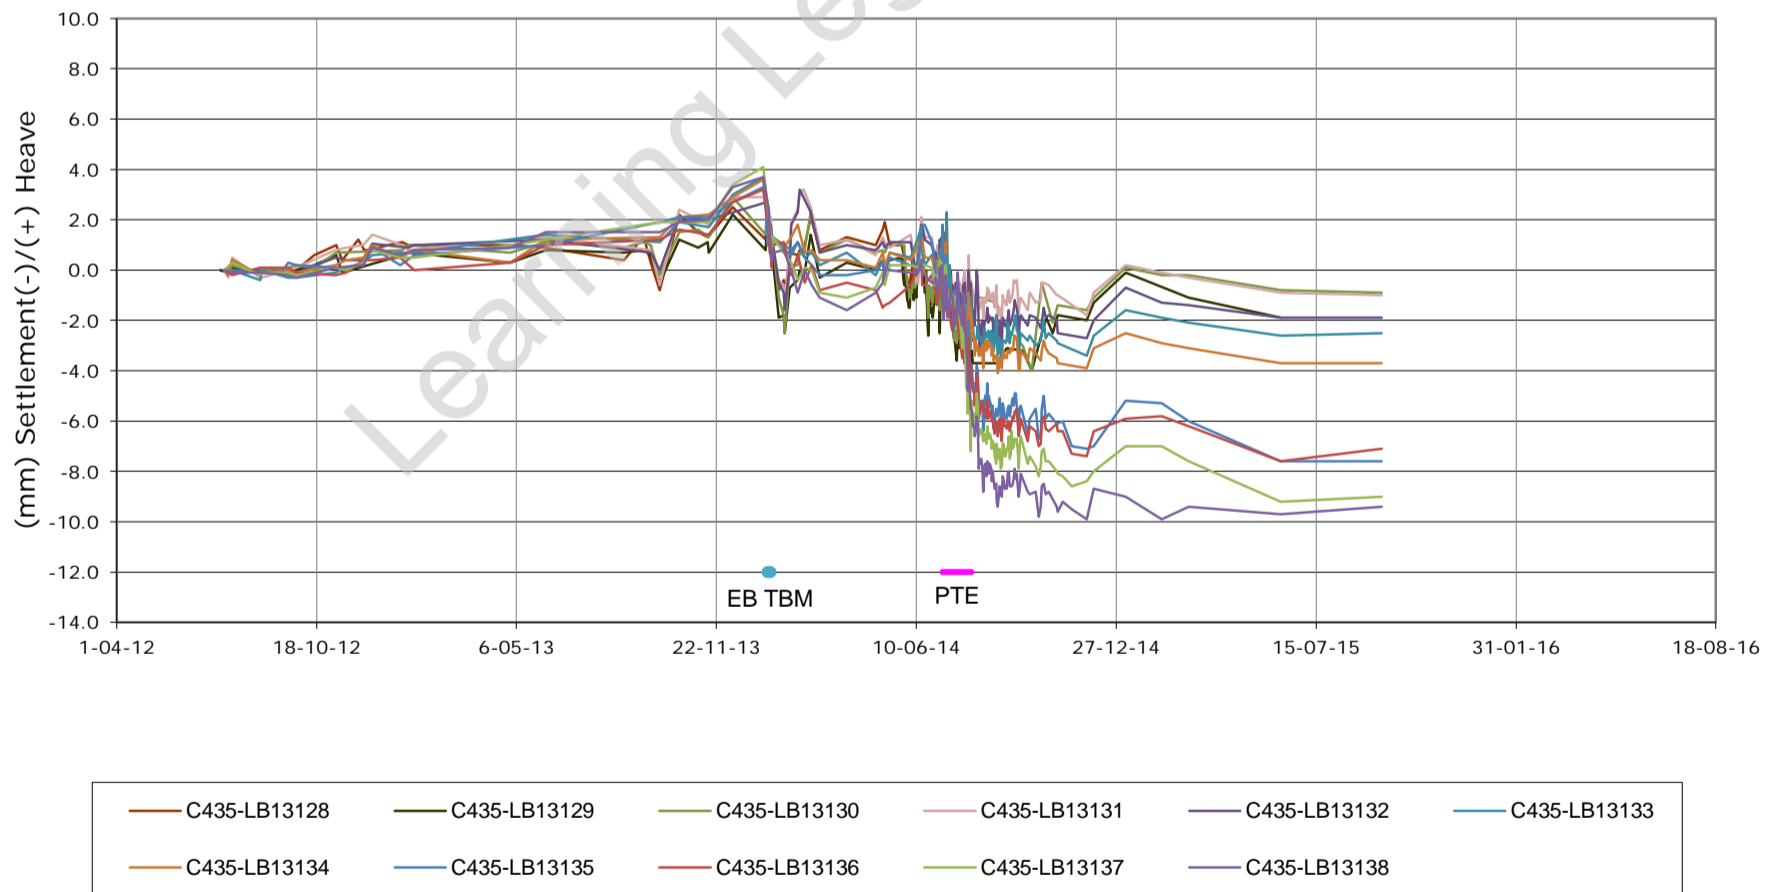
Building: 9-18 COWCROSS ST

- EB TBM caused maximum 2mm of settlement from 12-01-2014 to 15-01-2014.
- PTE works caused maximum 10mm of settlement from 06-07-2014 to 04-08-2014.
- Maximum settlement at the end of the works was 10mm

**REMARKS:**  
 Sockets outside Compensation Grouting Area. No triggers breached.

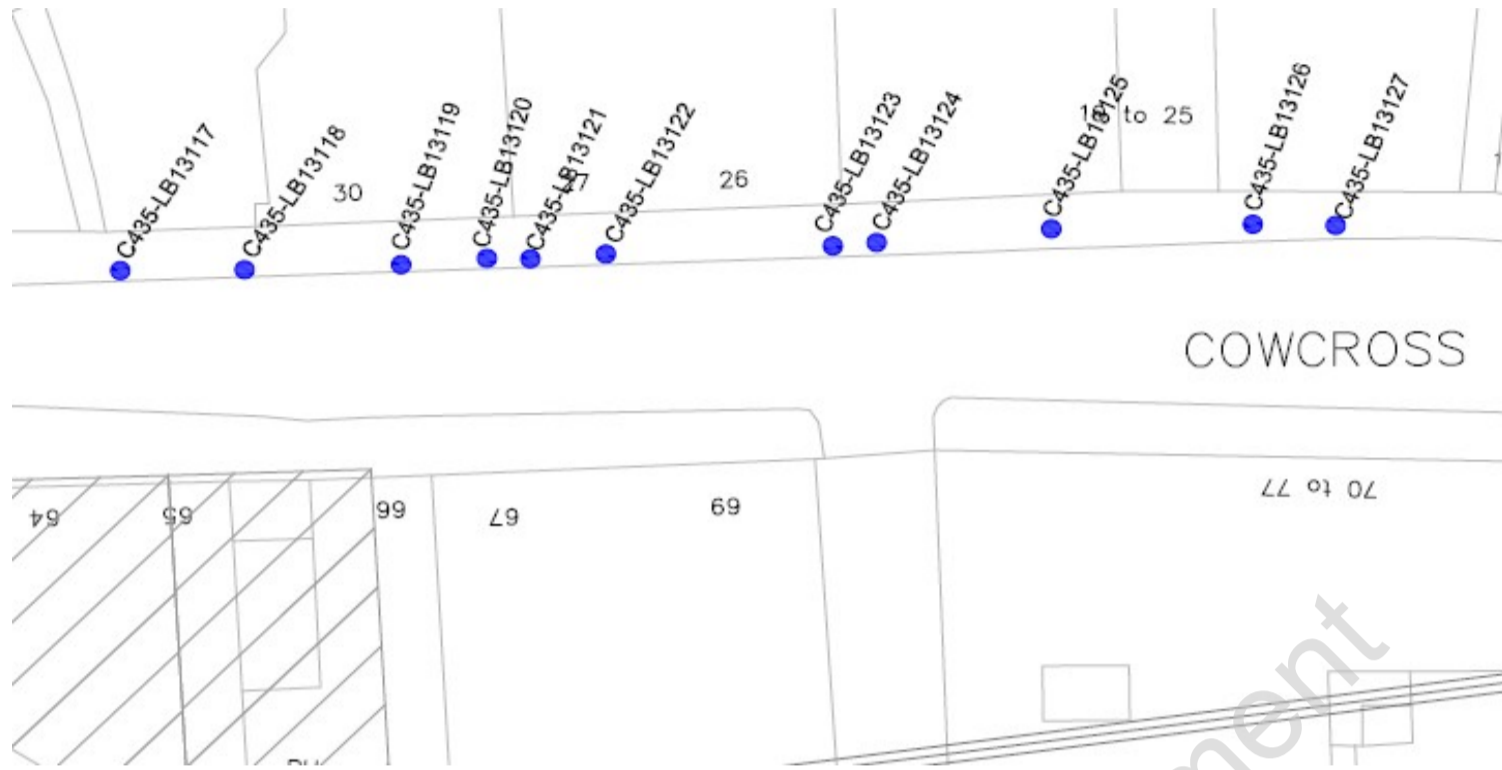
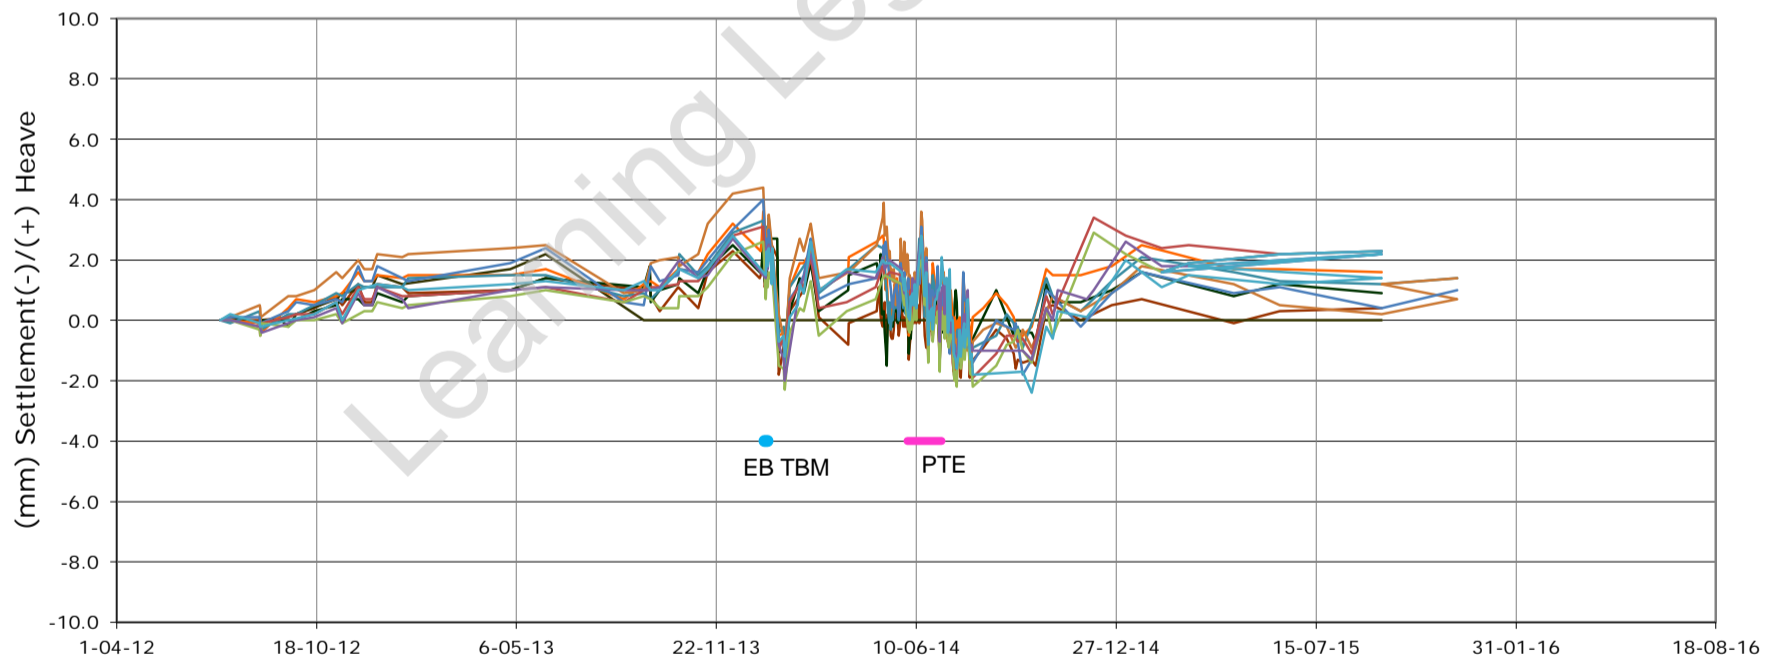
Building: 19-30 COWROSS ST

- EB TBM caused maximum 2-3mm of settlement from 09-01-2014 to 12-01-2014.
- PTE caused 2mm maximum of settlement from 01-06-2014 to 05-07-2014.
- Maximum settlement at the end of the works was 2mm

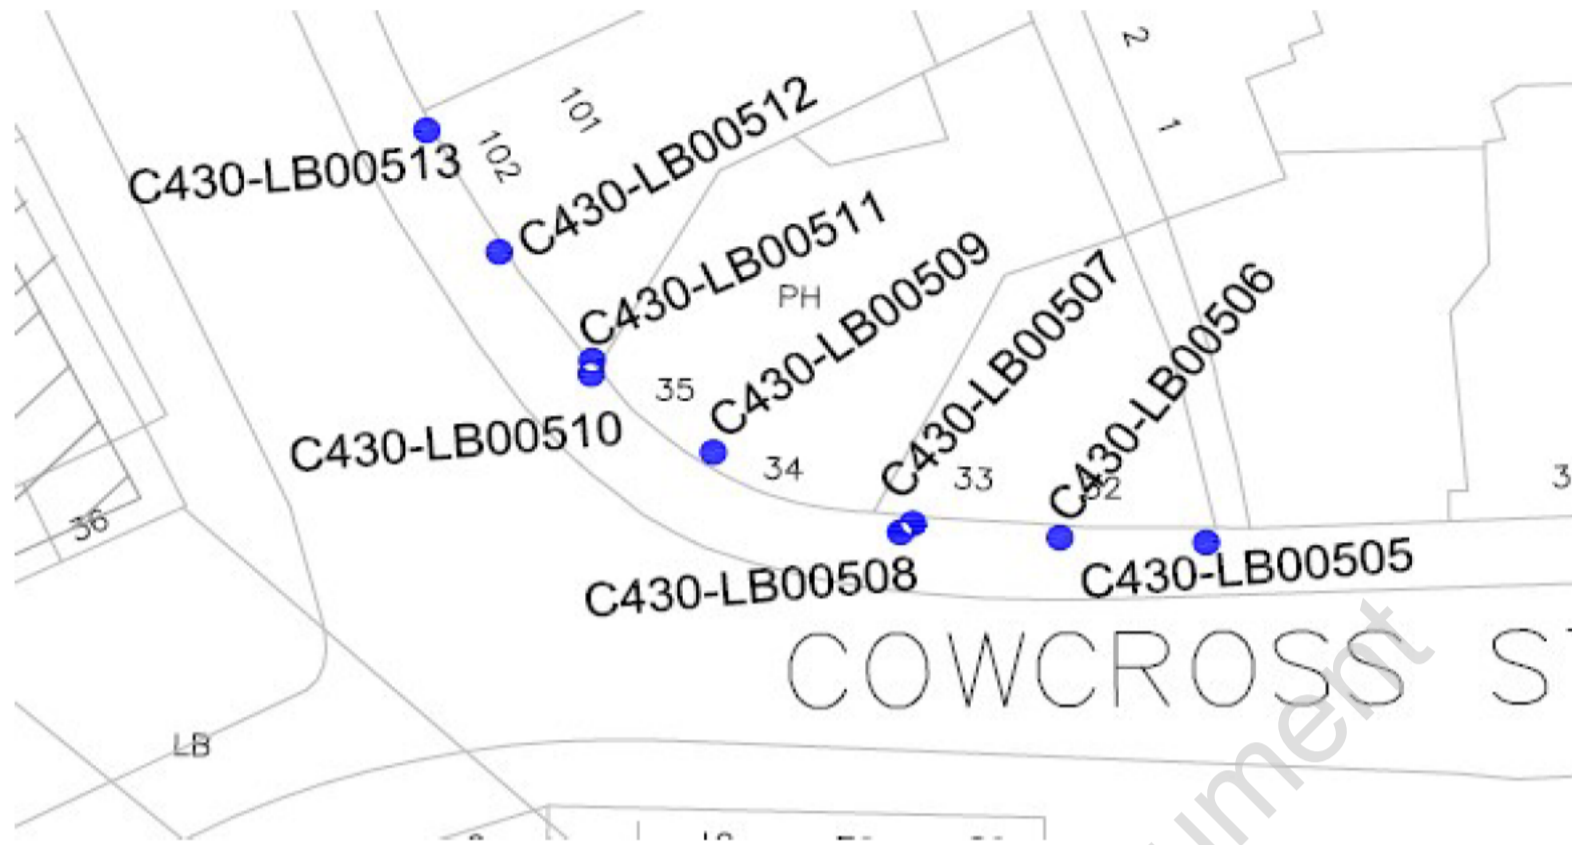
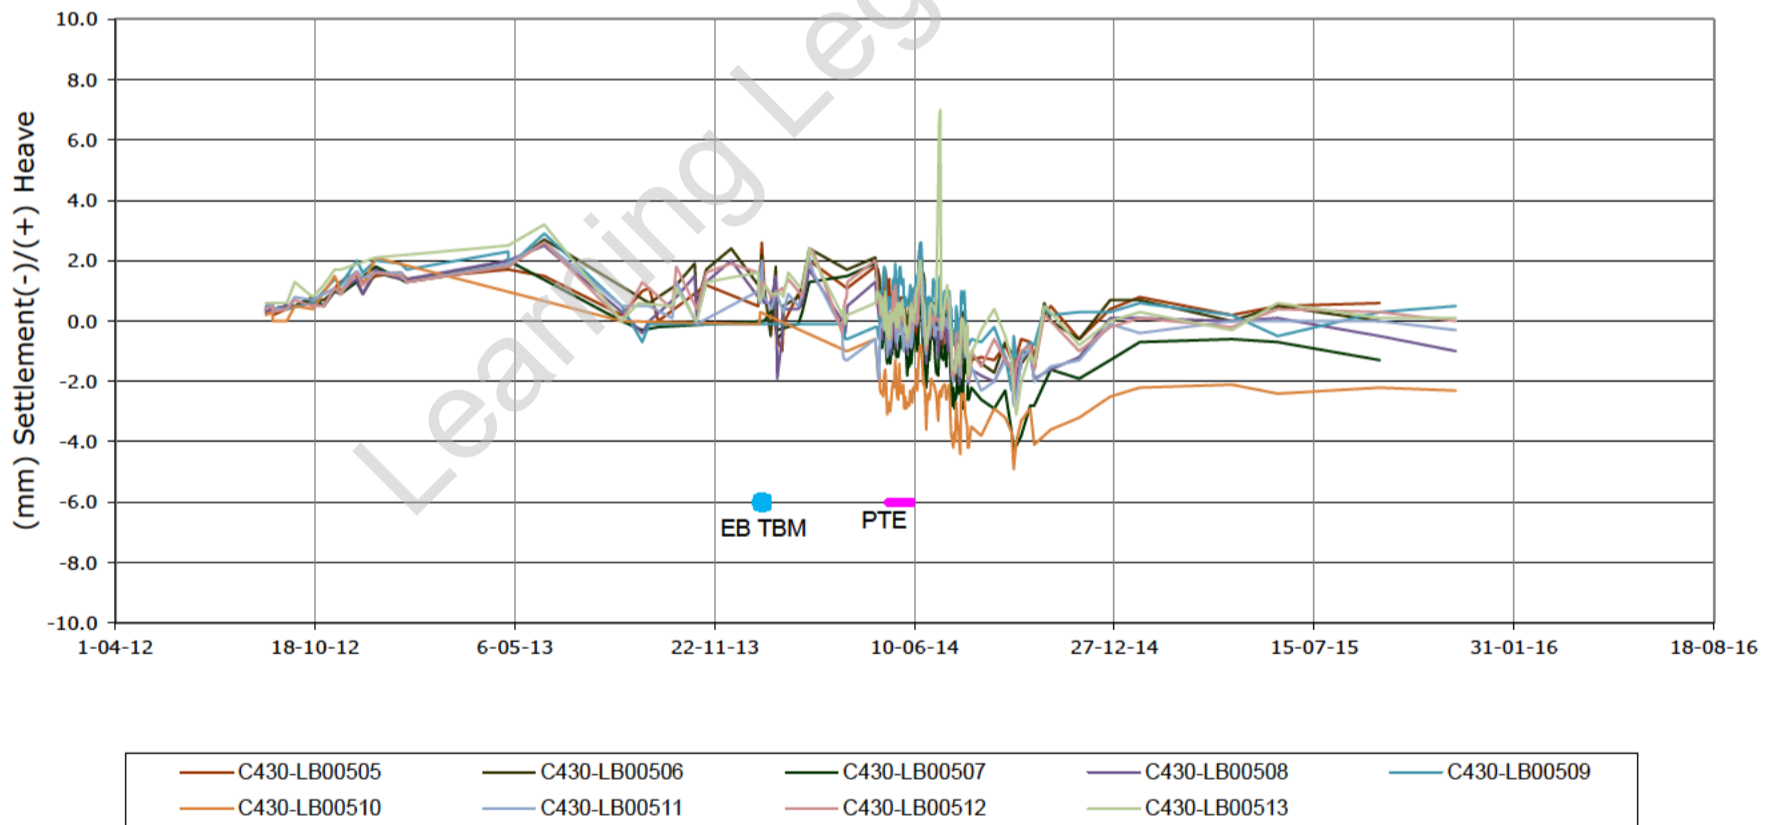
Building: 32-33 COWCROSS ST

- EB TBM caused maximum 1-1.5mm of settlement from 08-01-2014 to 09-01-2014.
- PTE enlargement works caused 3-4mm of settlement from 15-05-2014 to 07-06-2014.
- Maximum settlement at the end of the works was 4mm

**REMARKS:**  
Sockets outside Compensation Grouting Area. No triggers breached.

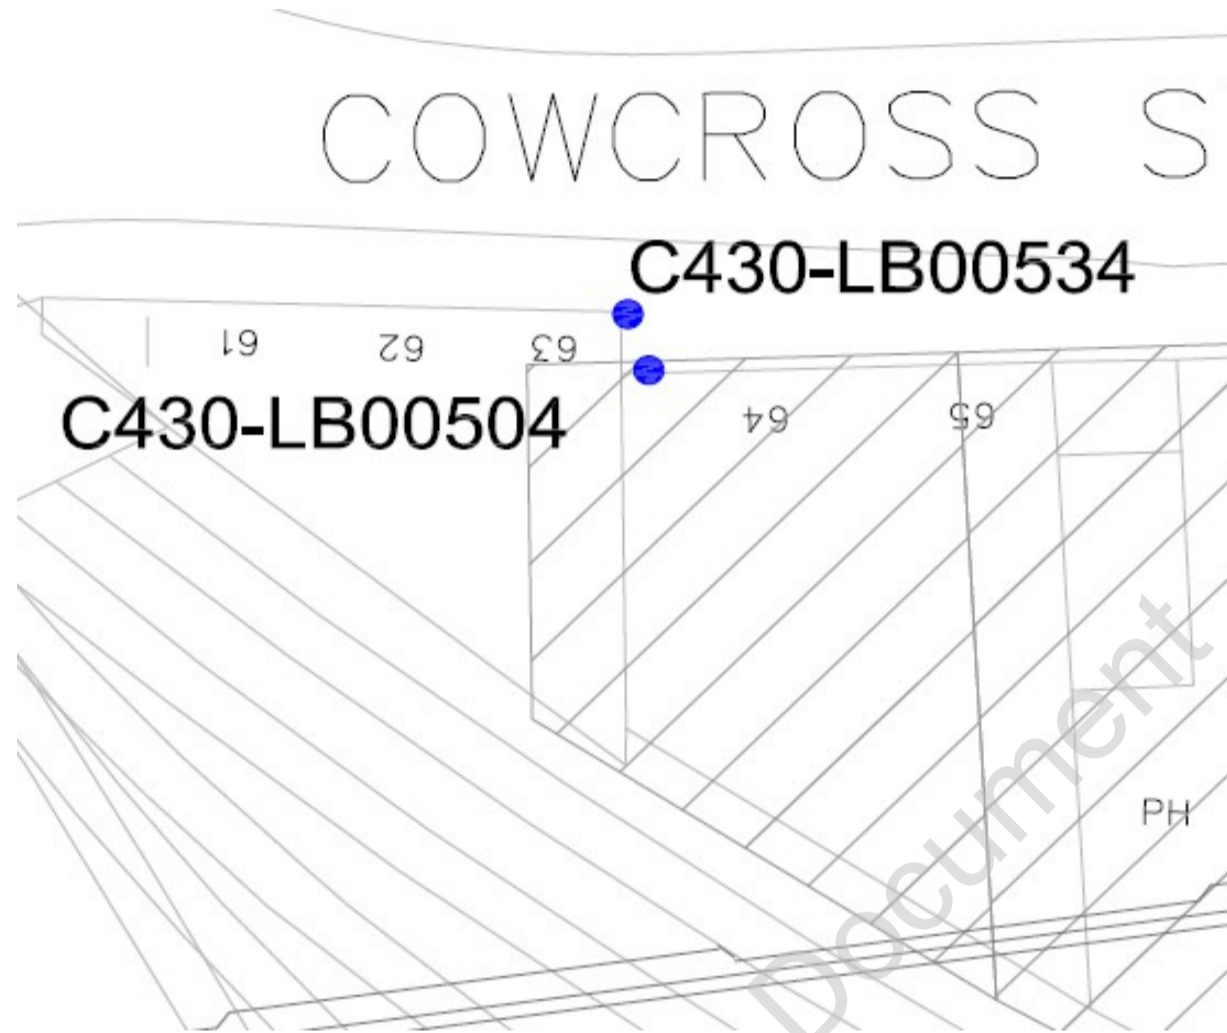
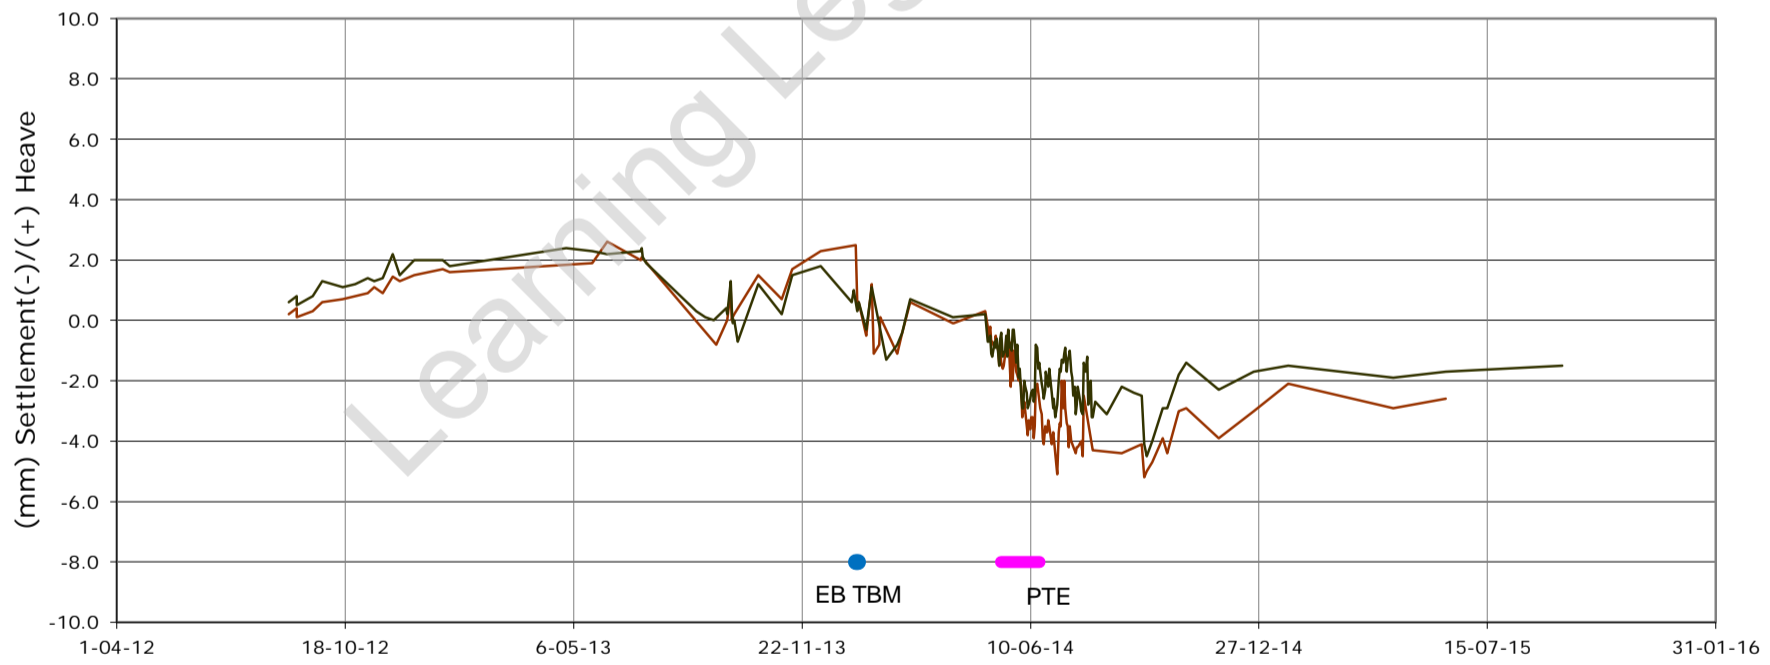
Building: 64-65 COWCROSS ST

- EB TBM caused maximum 1-1.5mm of settlement from 08-01-2014 to 10-01-2014.
- PTE enlargement works caused 2-3mm of settlement from 15-05-2014 to 18-06-2014.
- Maximum settlement at the end of the works was 5mm

**REMARKS:**  
Sockets outside Compensation Grouting Area. No triggers breached.

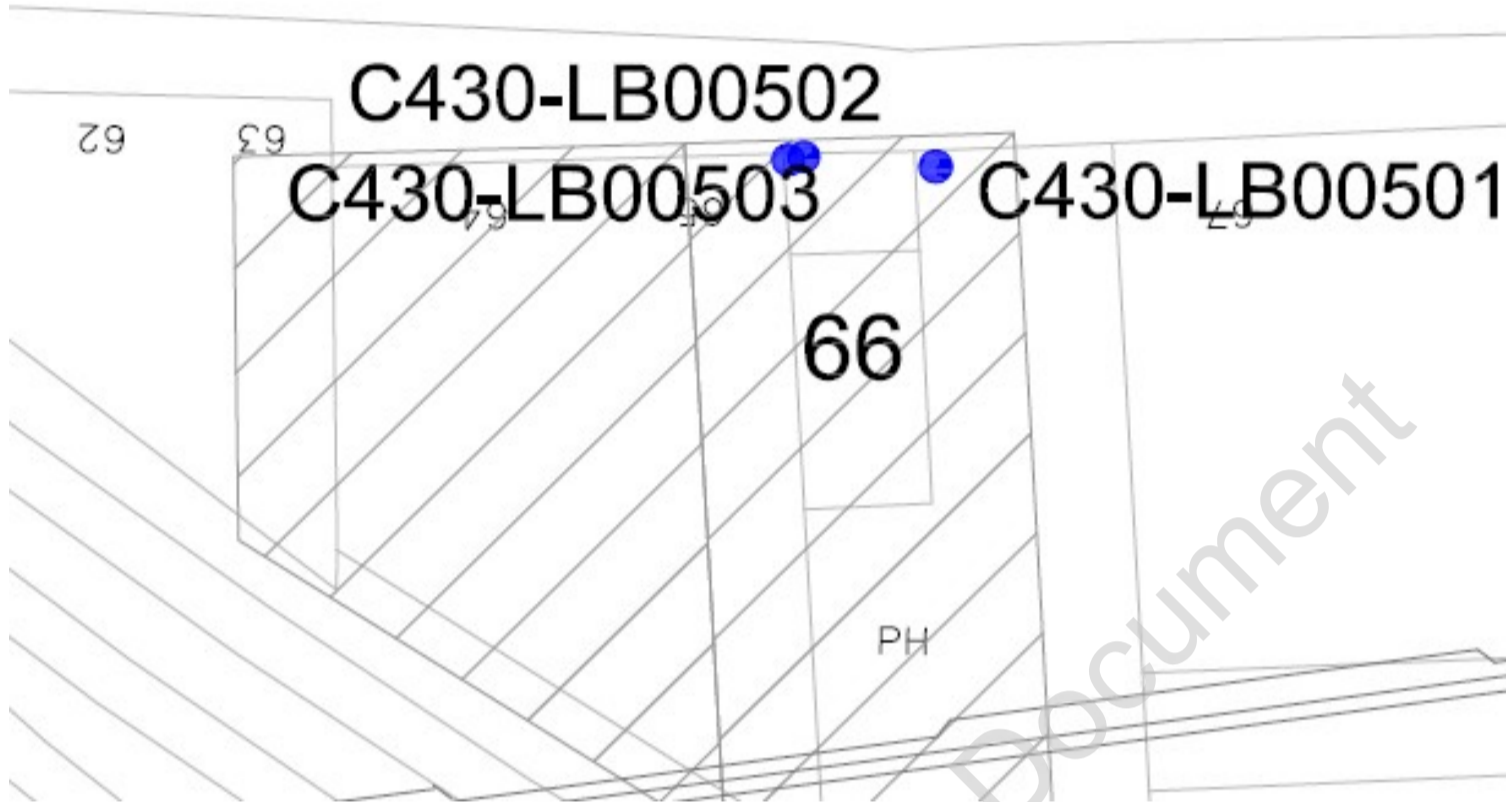
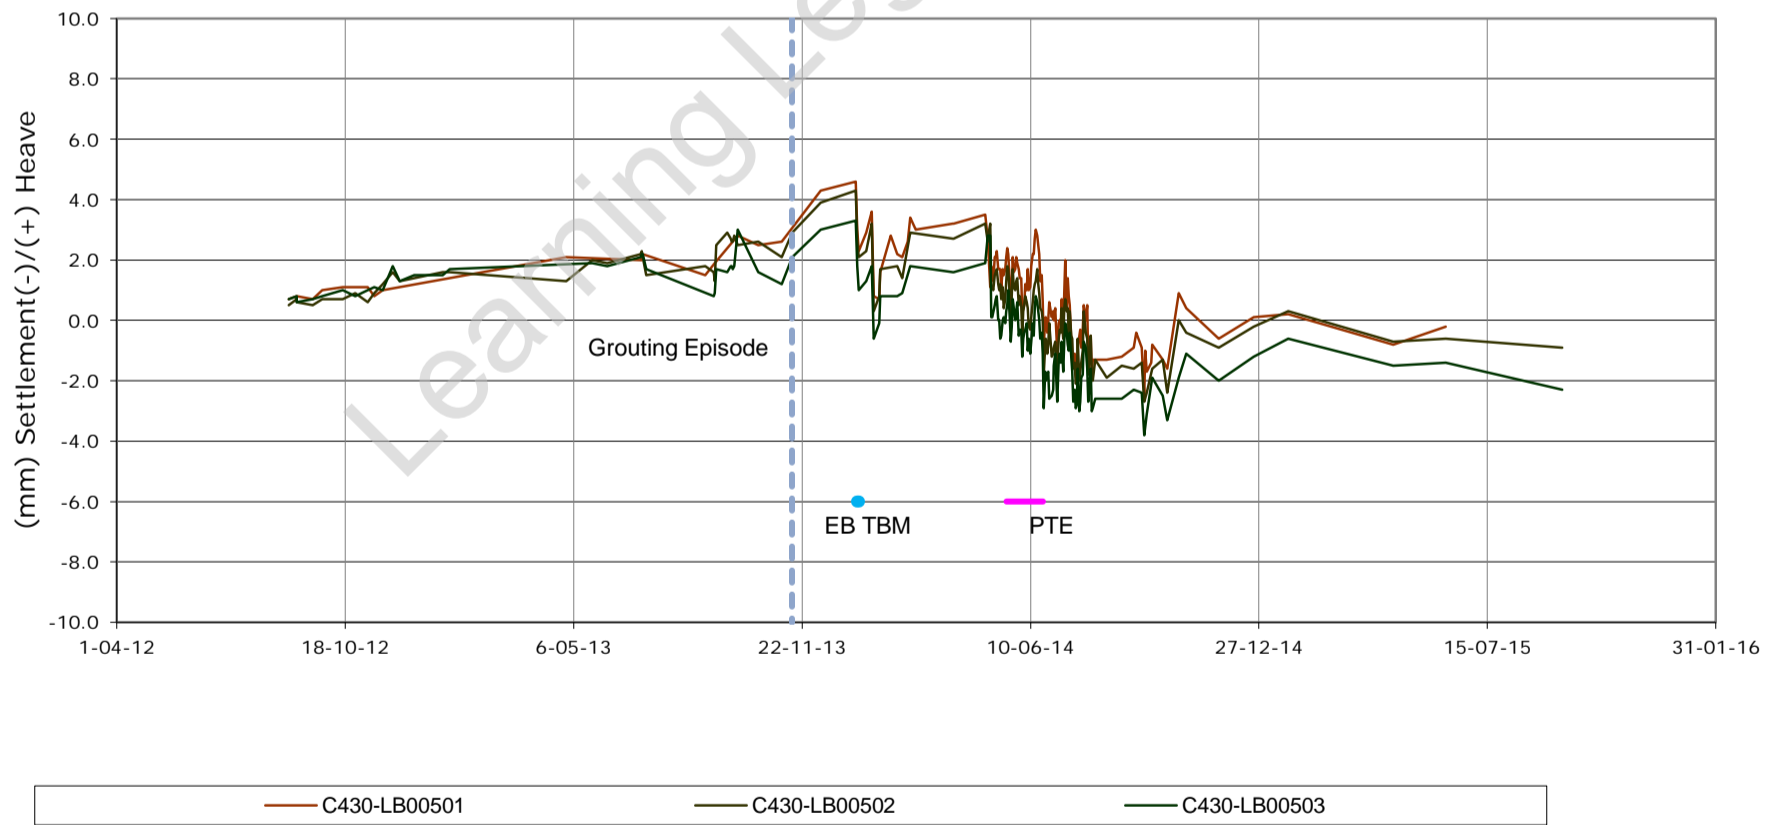
Building: 66 COWCROSS ST

- Compensation grouting from Butcher's Ramp Shaft caused 2mm of heave on 13-11-2013.
- EB TBM caused 3-4mm of settlement from 09-01-2014 to 11-01-2014.
- PTE enlargement works caused 5-6mm of settlement from 20-05-2014 to 21-06-2014.
- Maximum settlement at the end of the works was 4mm

**REMARKS:**  
Sockets outside Compensation Grouting Area. No triggers breached.

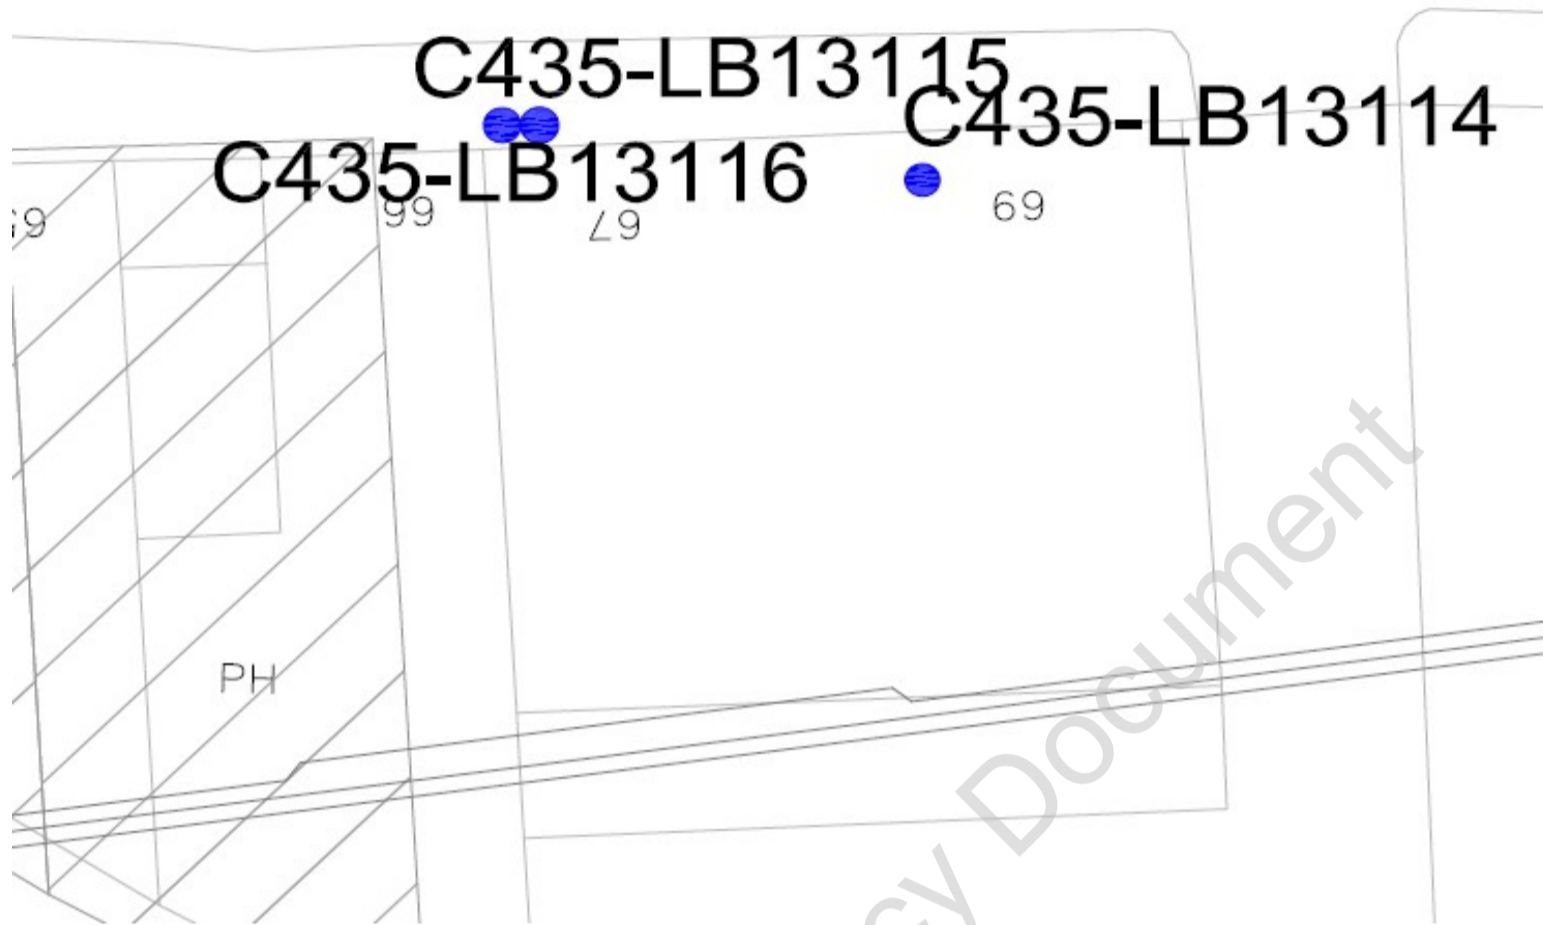
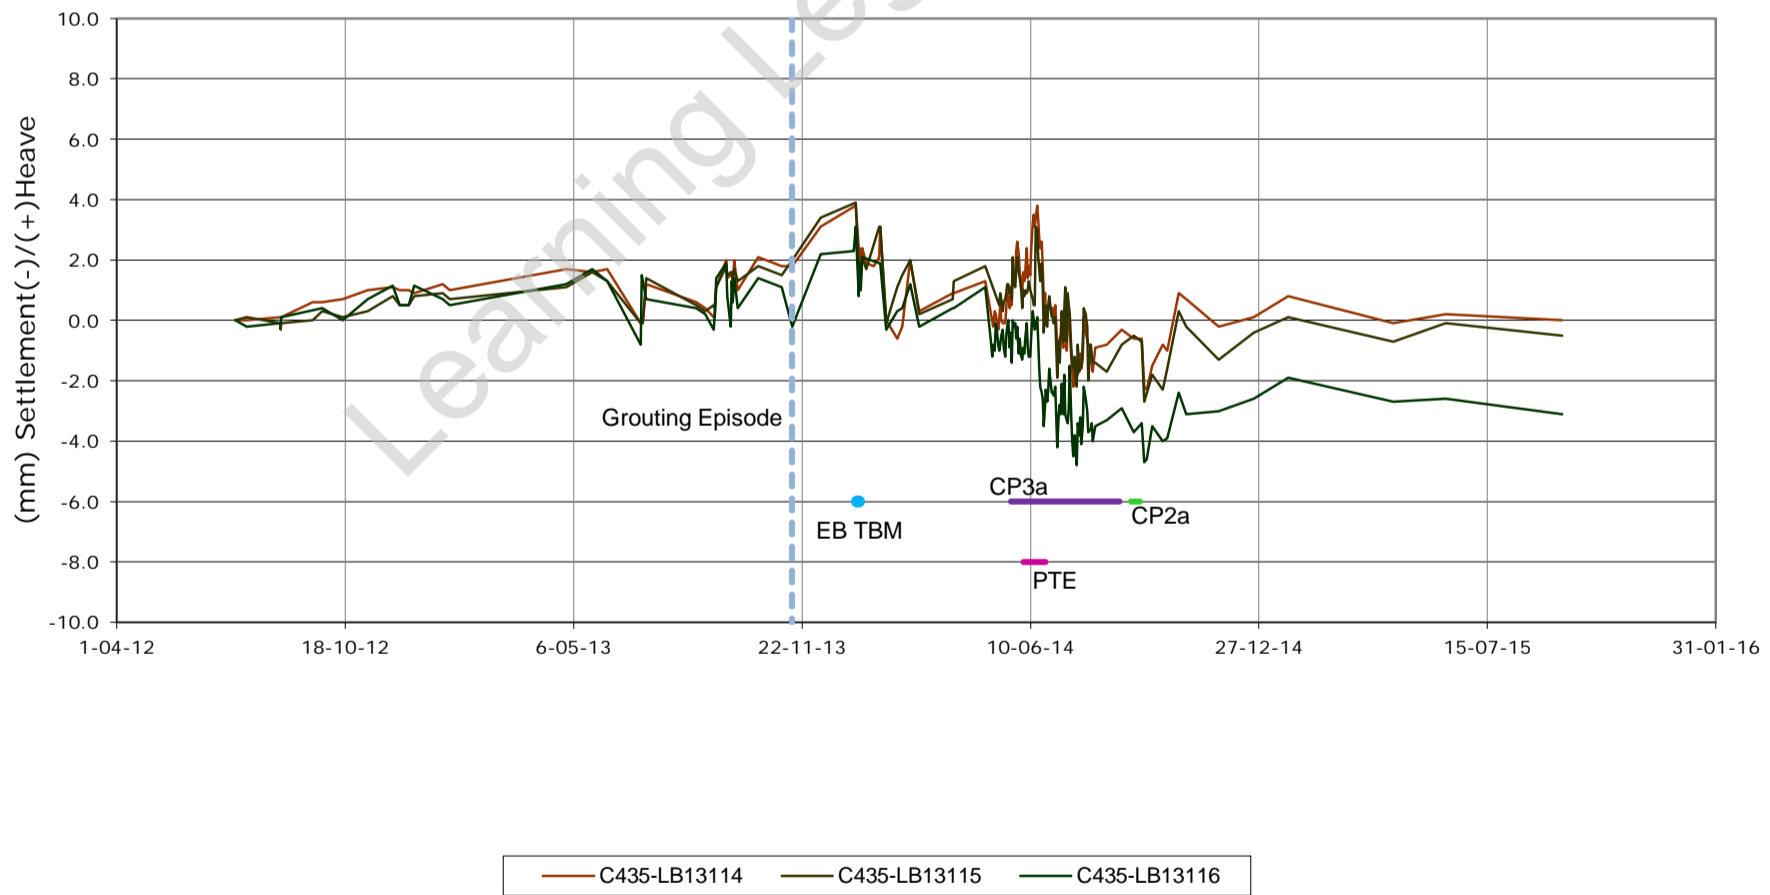
Building: 67-69 COWCROSS ST

- Compensation grouting caused 2mm of heave on 13-11-2013.
- EB TBM caused 2mm maximum of settlement from 09-01-2014 to 11-01-2014.
- Compensation grouting caused 2-3mm of heave on 10-06-2014.
- CP3a, CP2a and PTE combination caused maximum 3-4mm of settlement from 24-05-2014 to 14-09-2014.
- Maximum settlement at the end of the works was 5mm

REMARKS:  
Sockets outside Compensation Grouting Area. No triggers breached.
