Work Area: SMM
Work Type: I&M
Originator Company: GEOCISA

# C435 Farringdon Main Station

## Monitoring Close-Out Report: Sockets & Studs Installed on Cowcross St. CRL Document Number: C435-BFK-C2-RGN-M123-51664

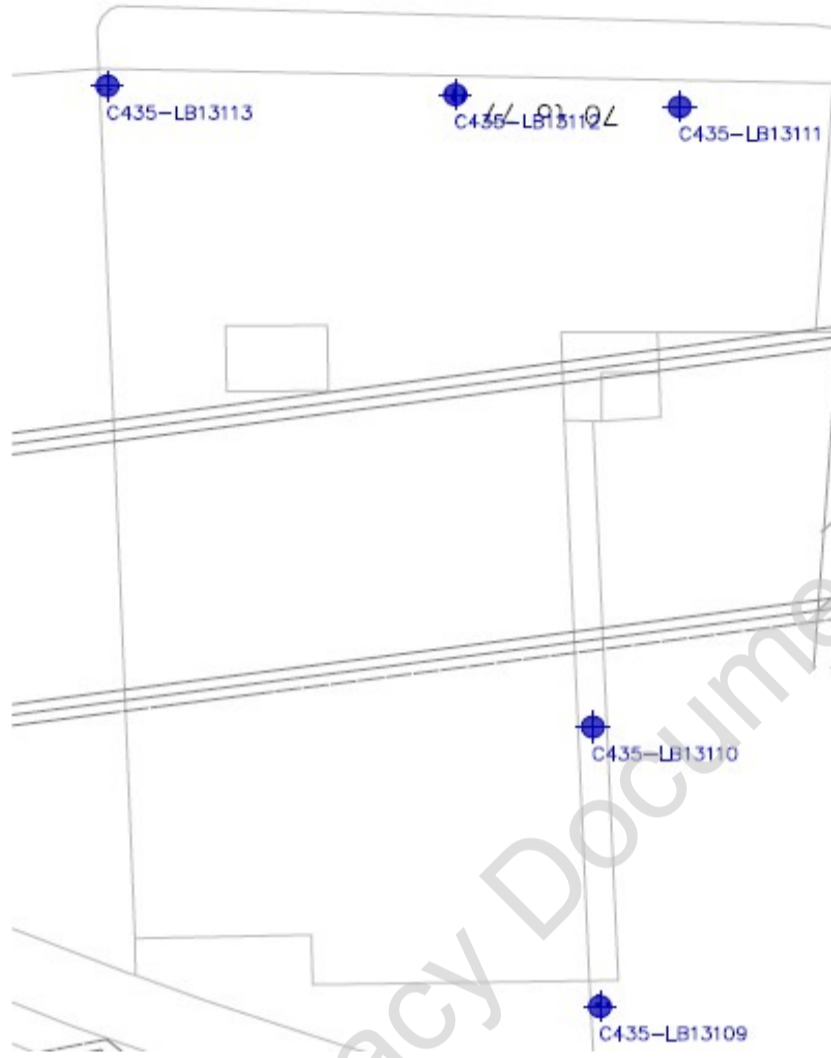
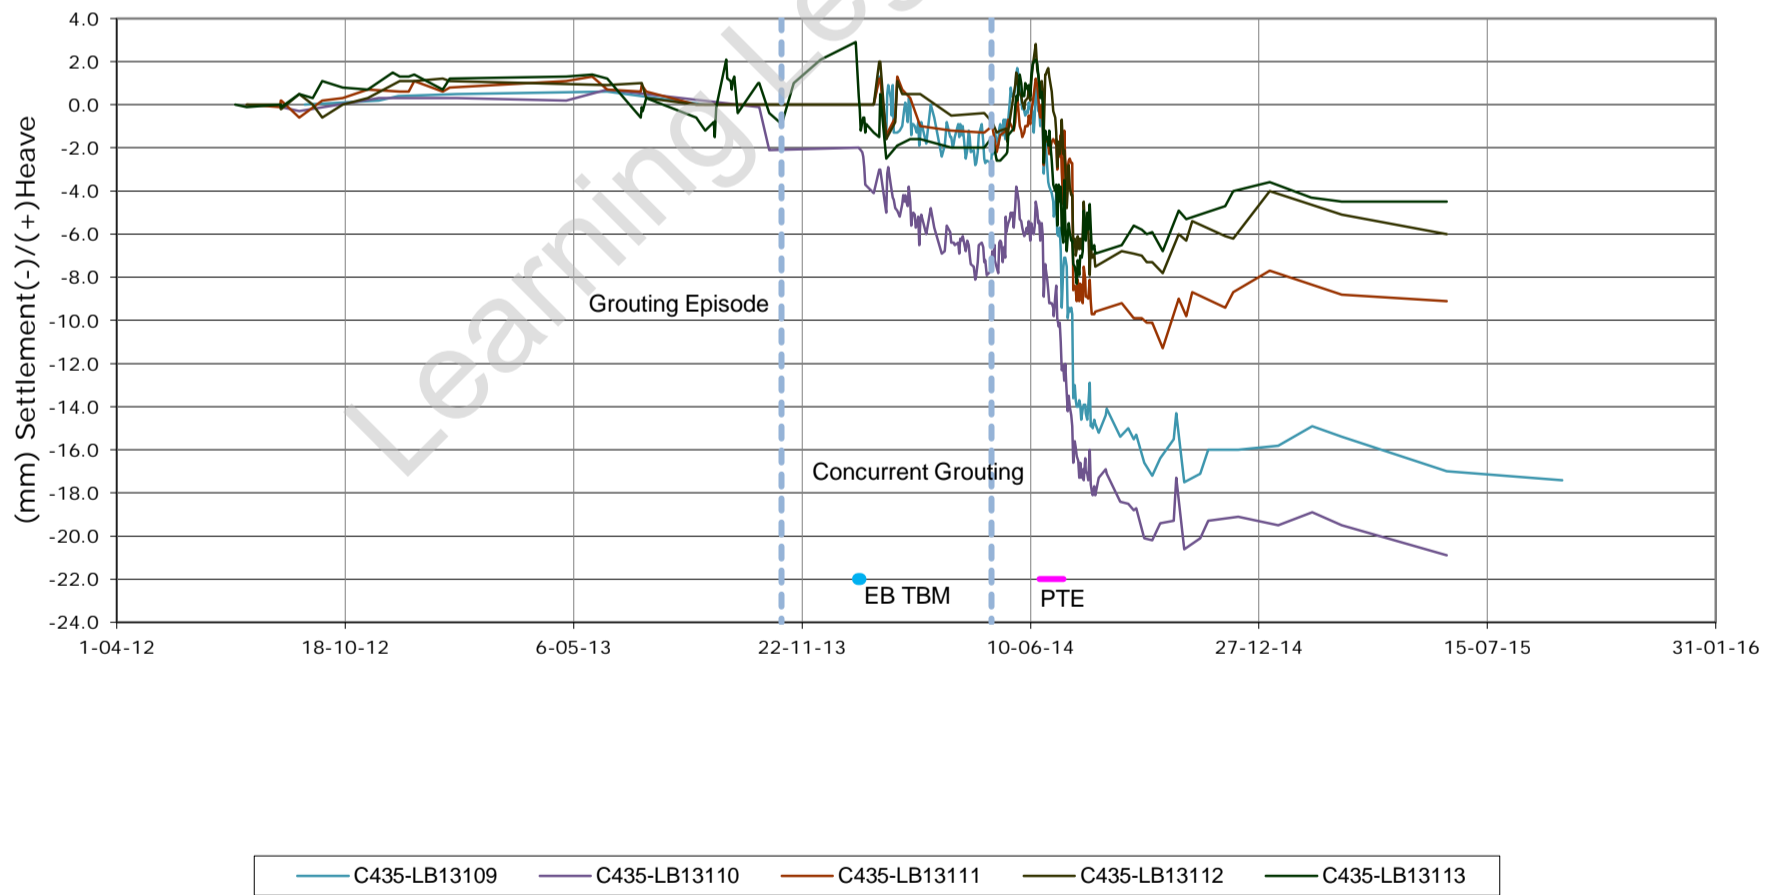
Building: 70-77 COWCROSS ST (Cowcross St facade)

- Compensation grouting caused 2-2.5mm of heave on 04-11-2013.
- EB TBM caused maximum 2-3mm of settlement from 10-01-2014 to 12-01-2014.
- Compensation grouting caused 2-3mm of heave on 07-05-2014.
- PTE enlargement works caused 18mm of settlement from 18-06-2014 to 09-07-2014.
- Maximum settlement at the end of the works was 21mm

REMARKS:  
 Sockets inside Compensation Grouting Area. No triggers breached.

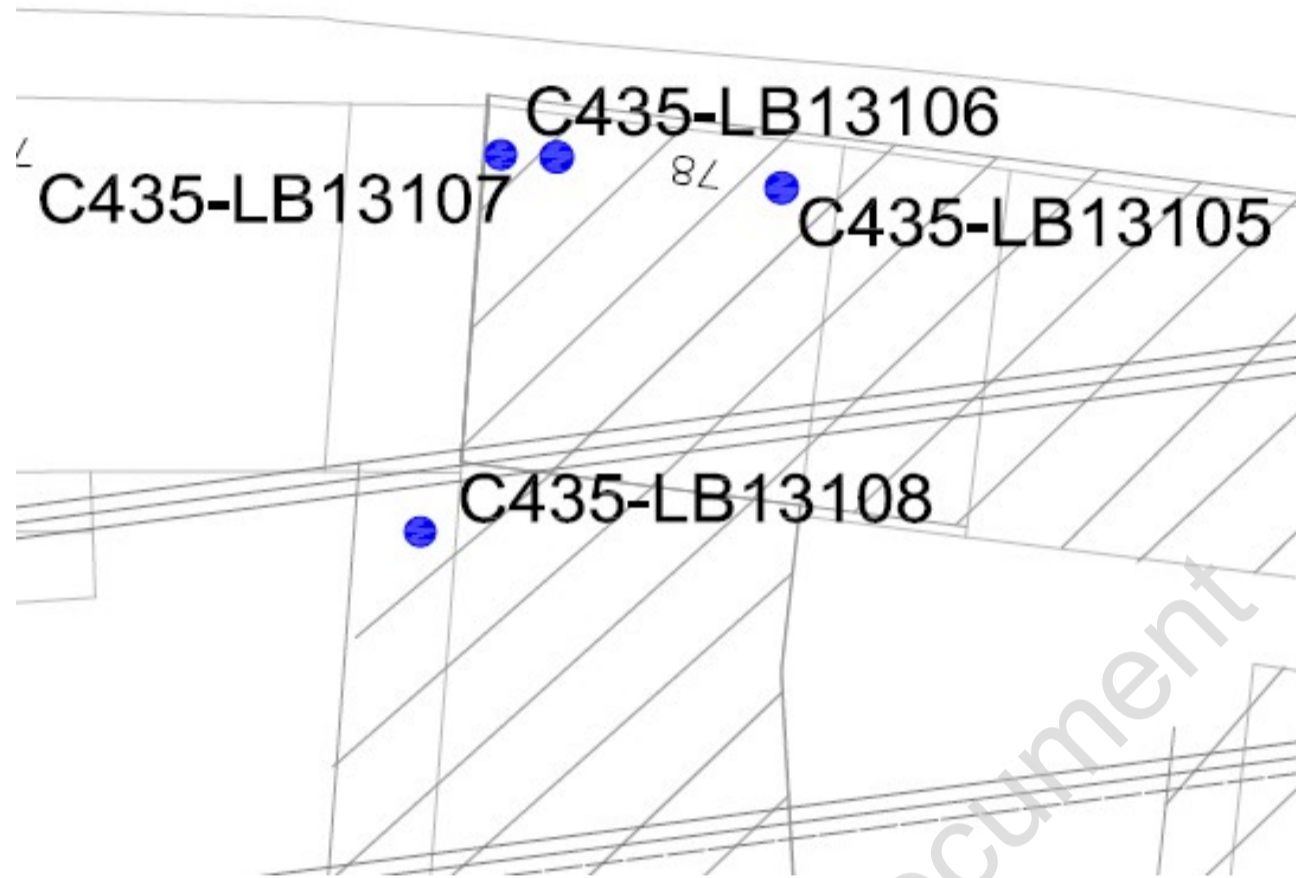
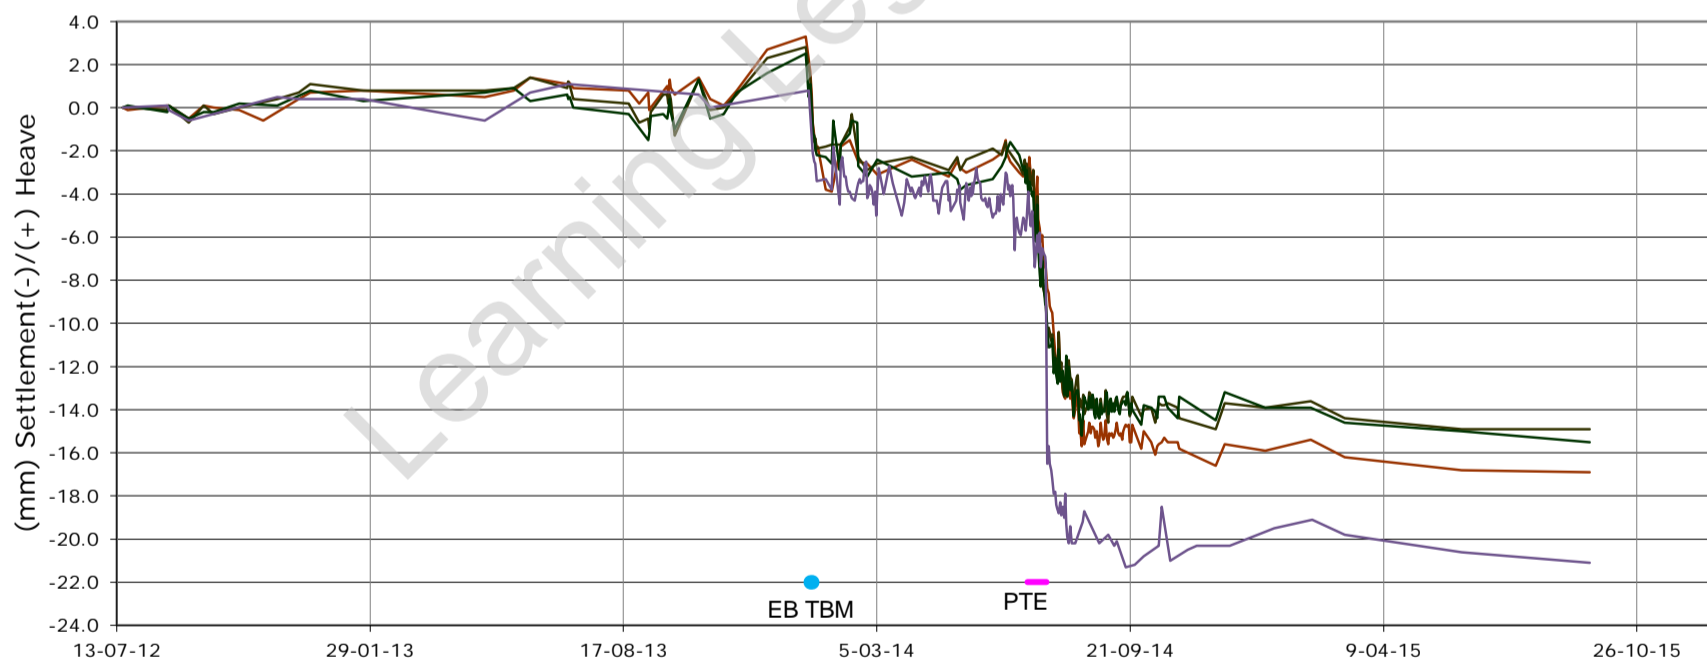
Building: 78 COWCROSS ST

- Compensation grouting caused 2-3mm of heave on 08-01-2014.
- EB TBM caused 4-5mm of settlement on 12-01-2014.
- Residual settlement caused 1-1.5mm of settlement.
- PTE enlargements works caused maximum 10mm of settlement from 02-07-2014 to 17-07-2014.
- Maximum settlement at the end of the works was 21mm

**REMARKS:**  
Sockets outside Compensation Grouting Area. No triggers breached.

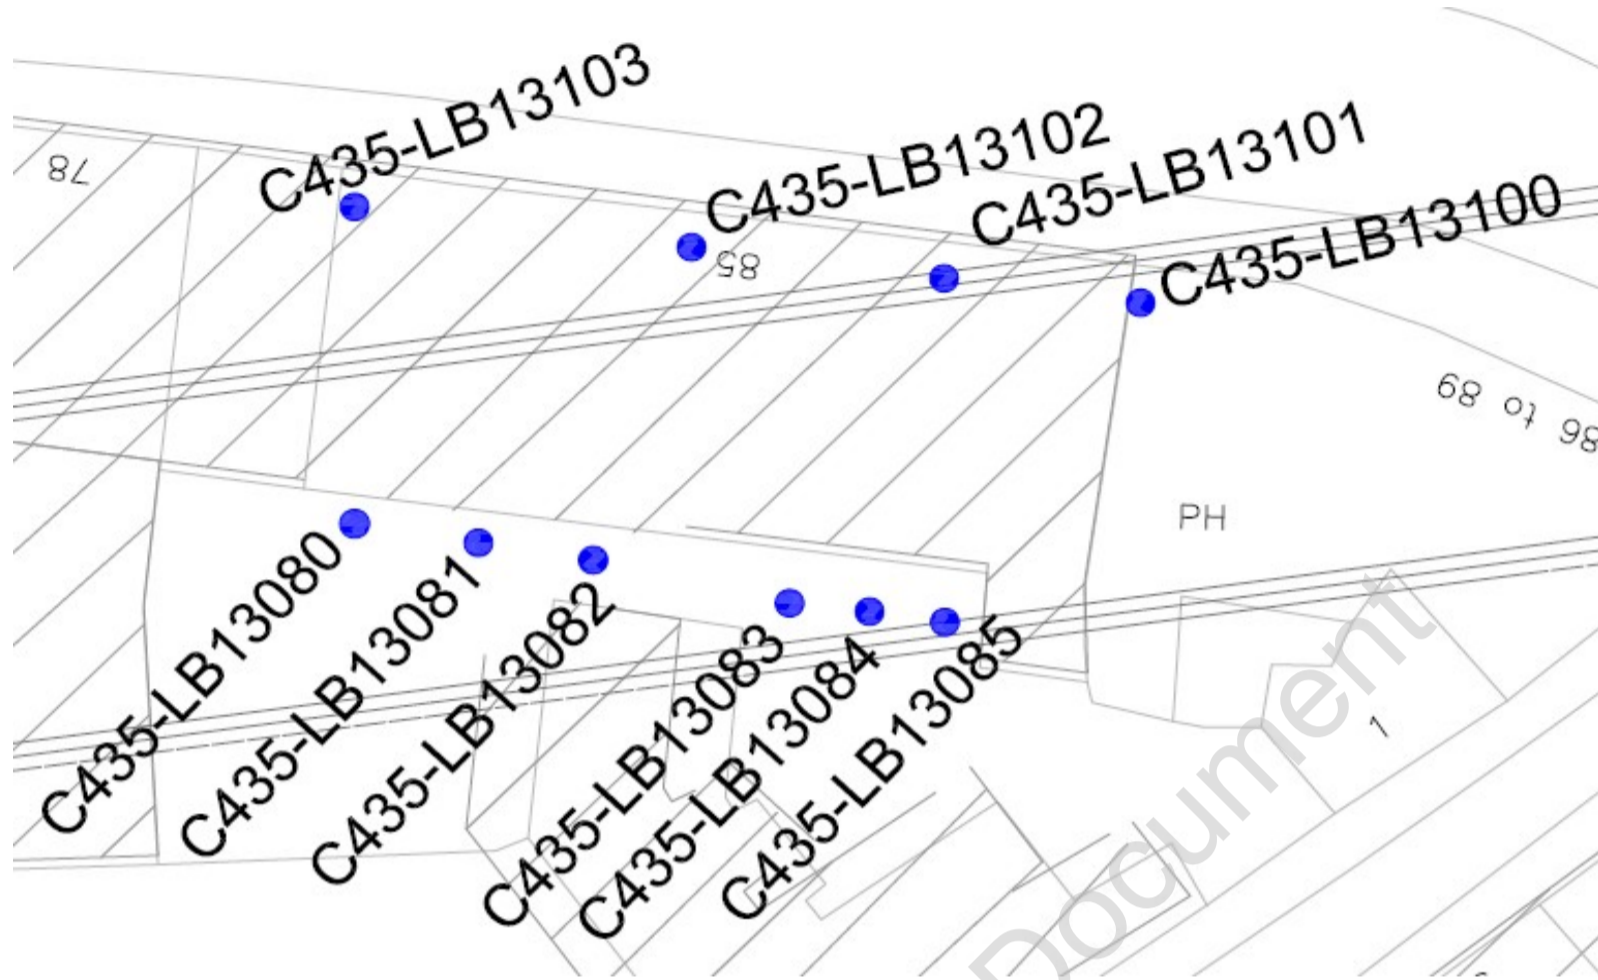
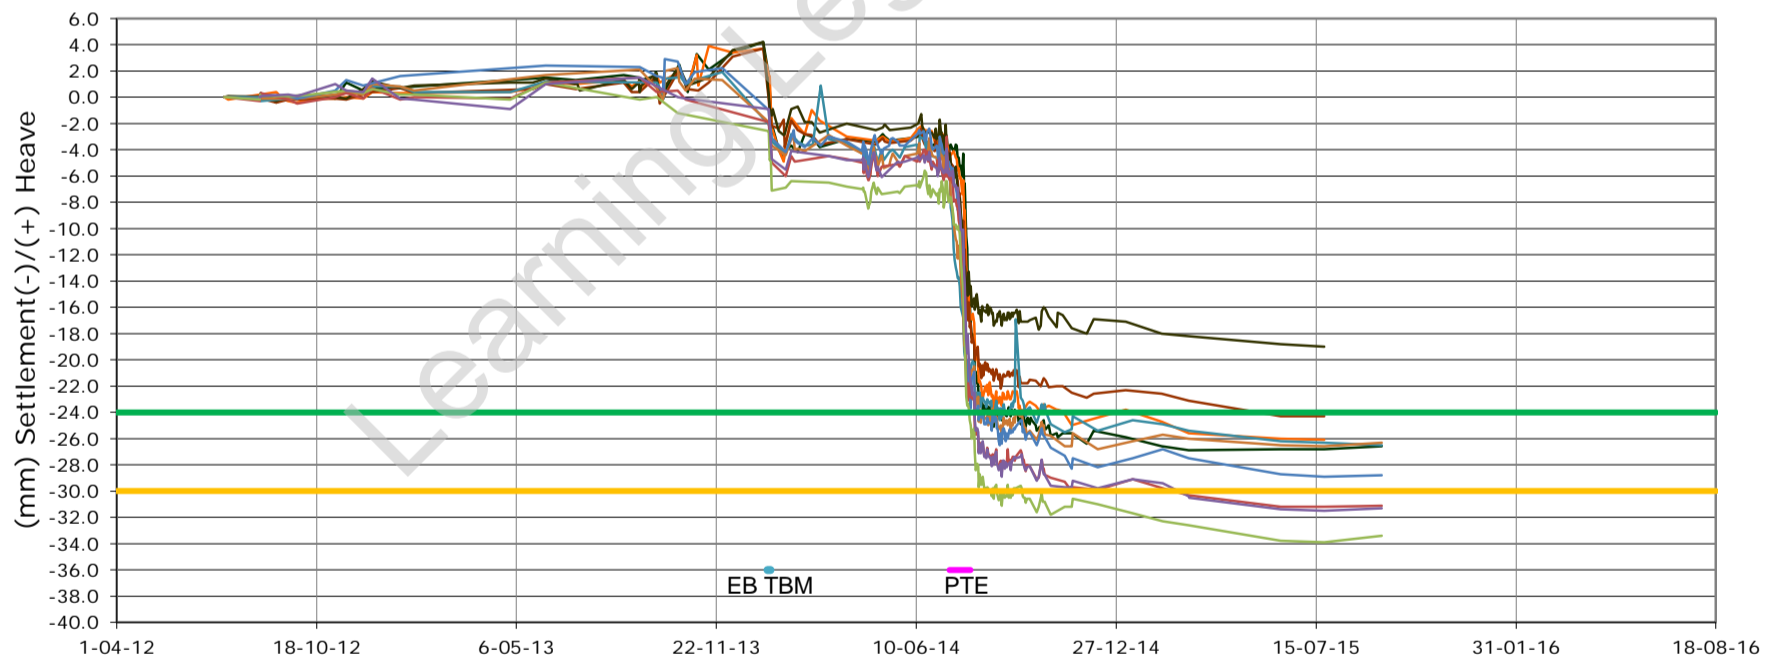
Building: 79-85 COWCROSS ST (Cowcross St façade)

- 3-4mm of heave captured caused by the EB TBM pressure on 08-01-2014.
- EB TBM caused 6mm of settlement from 12-01-2014 to 15-01-2014.

- PTE enlargement works caused 30mm maximum of settlement from 13-07-2014 to 03-08-2014.
- Maximum settlement at the end of the works was 34mm

REMARKS:  
 Sockets outside Compensation Grouting Area.  
 Green trigger breached by C435-LB13080 on 01-09-2014.  
 Green trigger breached by C435-LB13081 on 11-08-2014.  
 Green trigger breached by C435-LB13082 on 11-08-2014.  
 Green trigger breached by C435-LB13083 on 07-08-2014.  
 Green trigger breached by C435-LB13084 on 02-08-2014.  
 Green trigger breached by C435-LB13085 on 07-08-2014.  
 Green trigger breached by C435-LB13086 on 11-08-2014.  
 Green trigger breached by C435-LB13100 on 15-08-2014.  
 Green trigger breached by C435-LB13101 on 22-09-2014.  
 Green trigger breached by C435-LB13102 on 09-06-2015.  
 Amber trigger breached by C435-LB13083 on 09-03-2015.  
 Amber trigger breached by C435-LB13084 on 24-09-2014.  
 Amber trigger breached by C435-LB13085 on 09-03-2015.

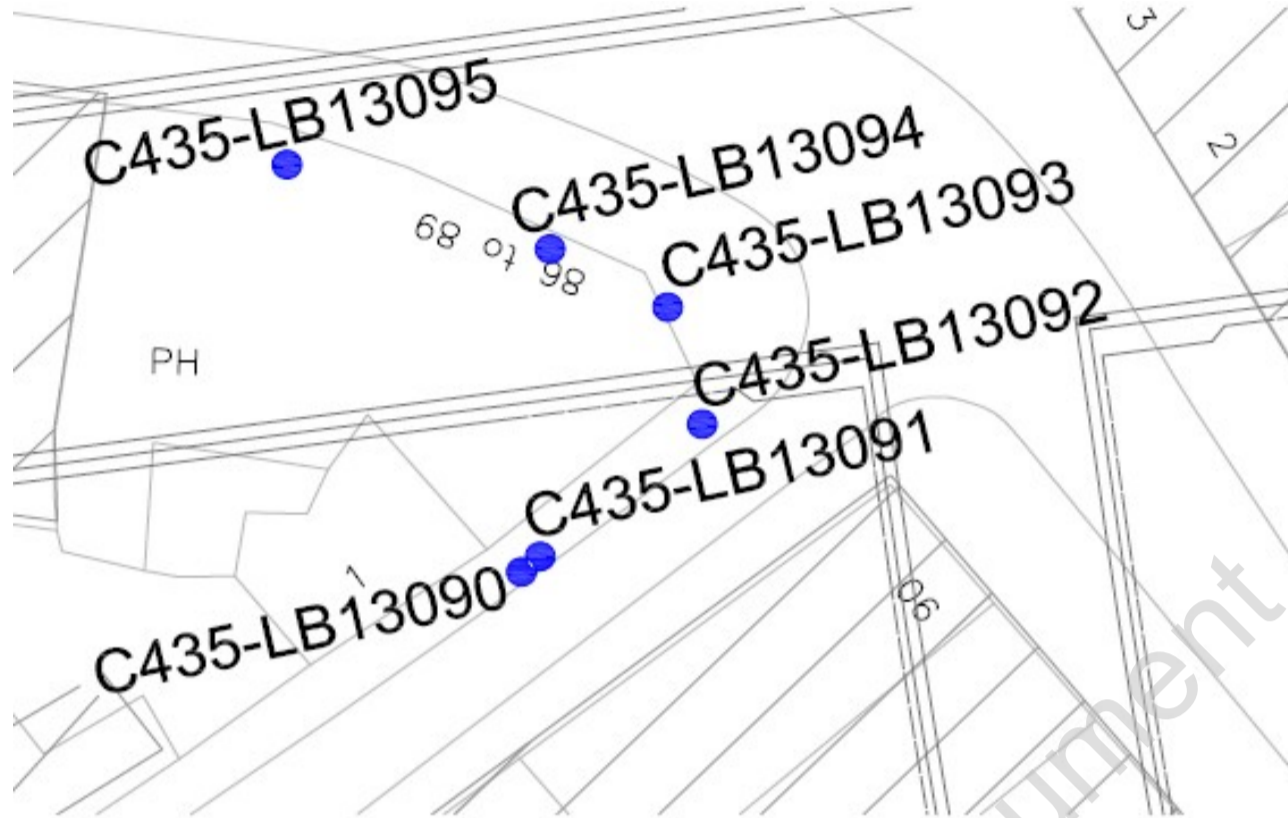
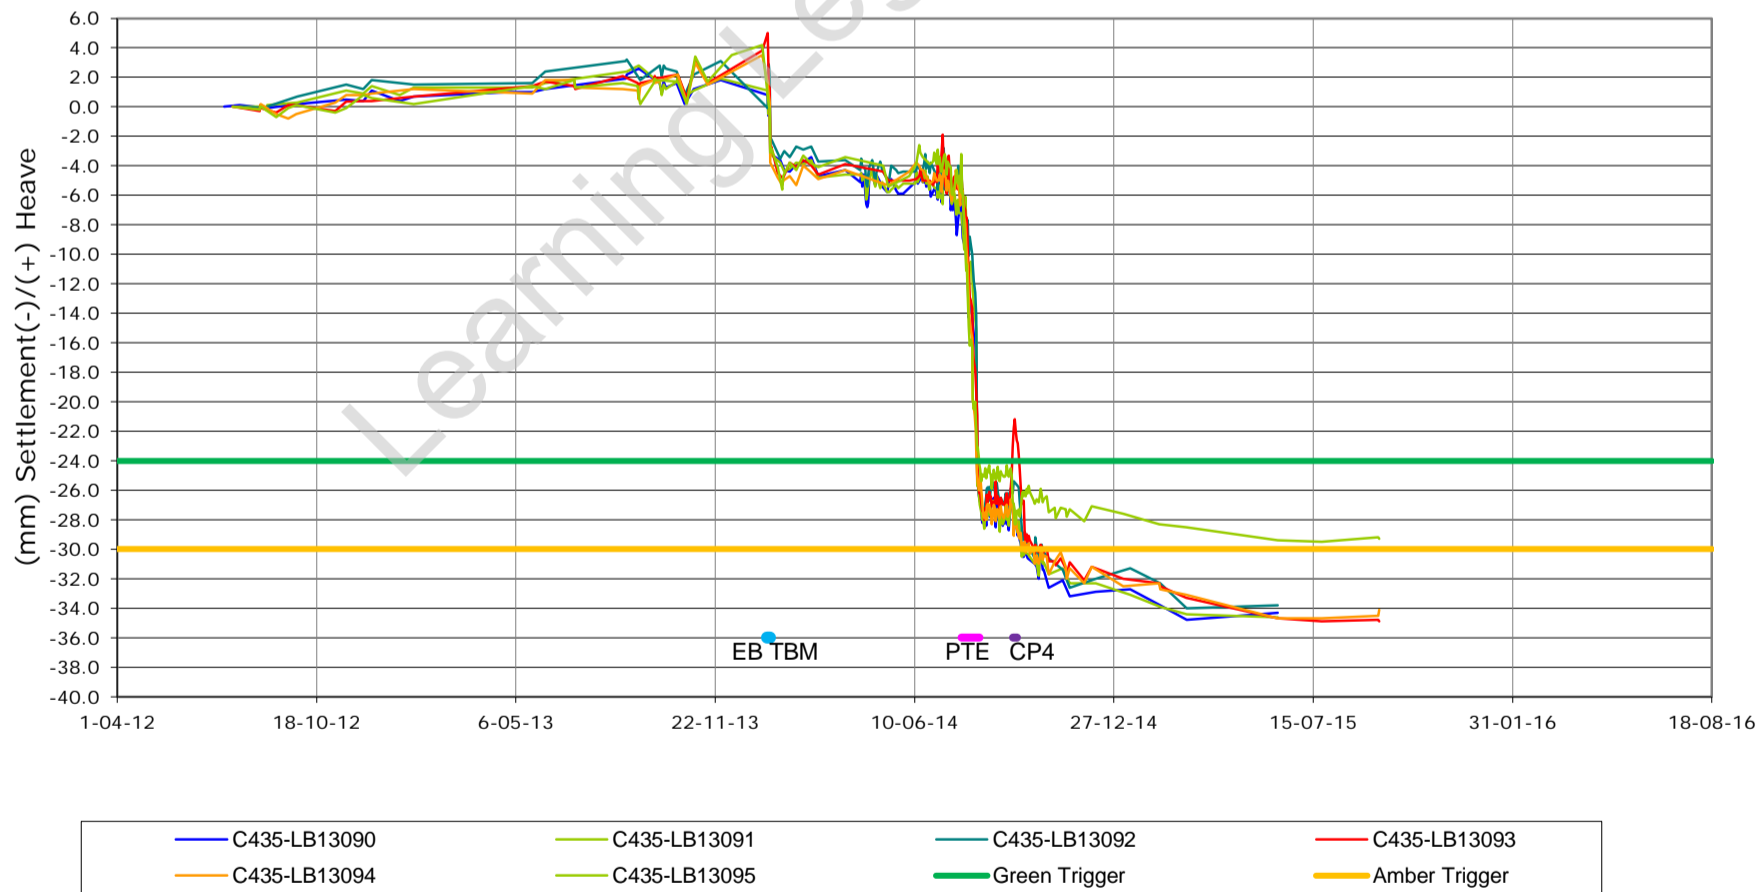
Building: 86-89 COWCROSS ST

- 3-4mm of heave captured caused by EB TBM pressure on 08-01-2014.
- EB TBM caused maximum 4-6mm of settlement from 13-01-2014 to 16-01-2014.
- PTE works caused 28mm of settlement from 27-07-2014 to 14-08-2014.
- CP4 caused 2-3mm of settlement from 17-09-2014 to 21-09-2014.
- Maximum settlement at the end of the works was 35mm

Sockets outside Compensation Grouting Area.

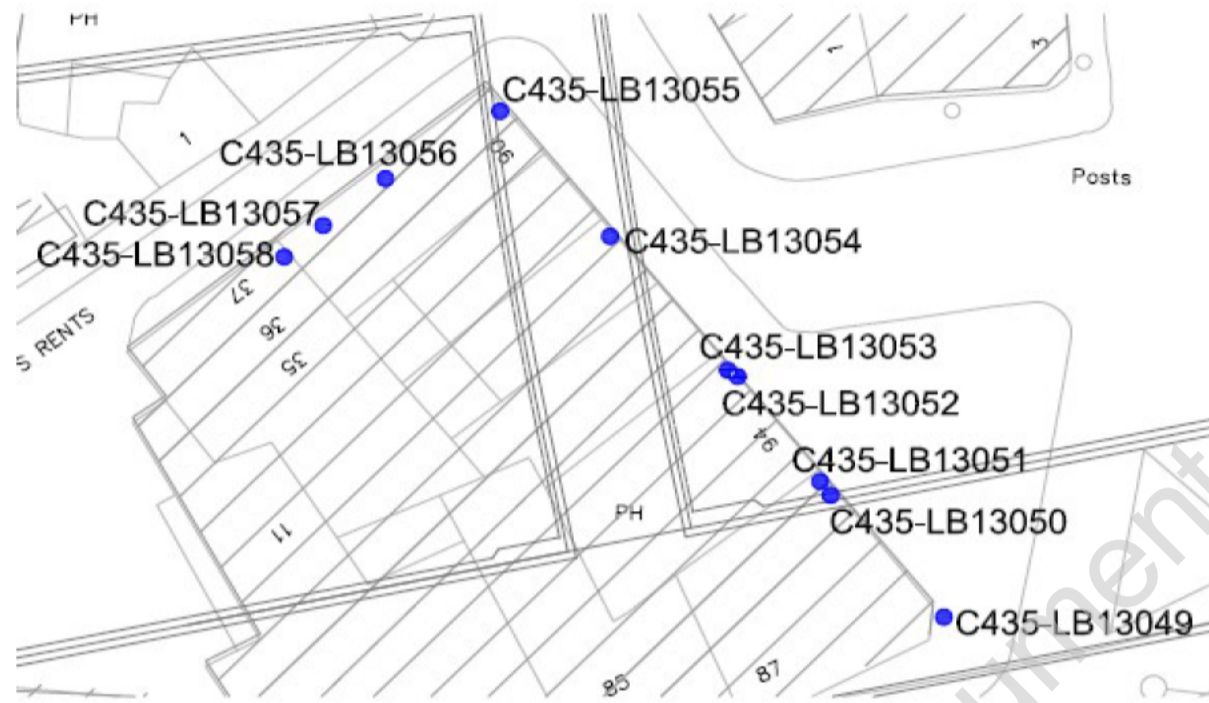
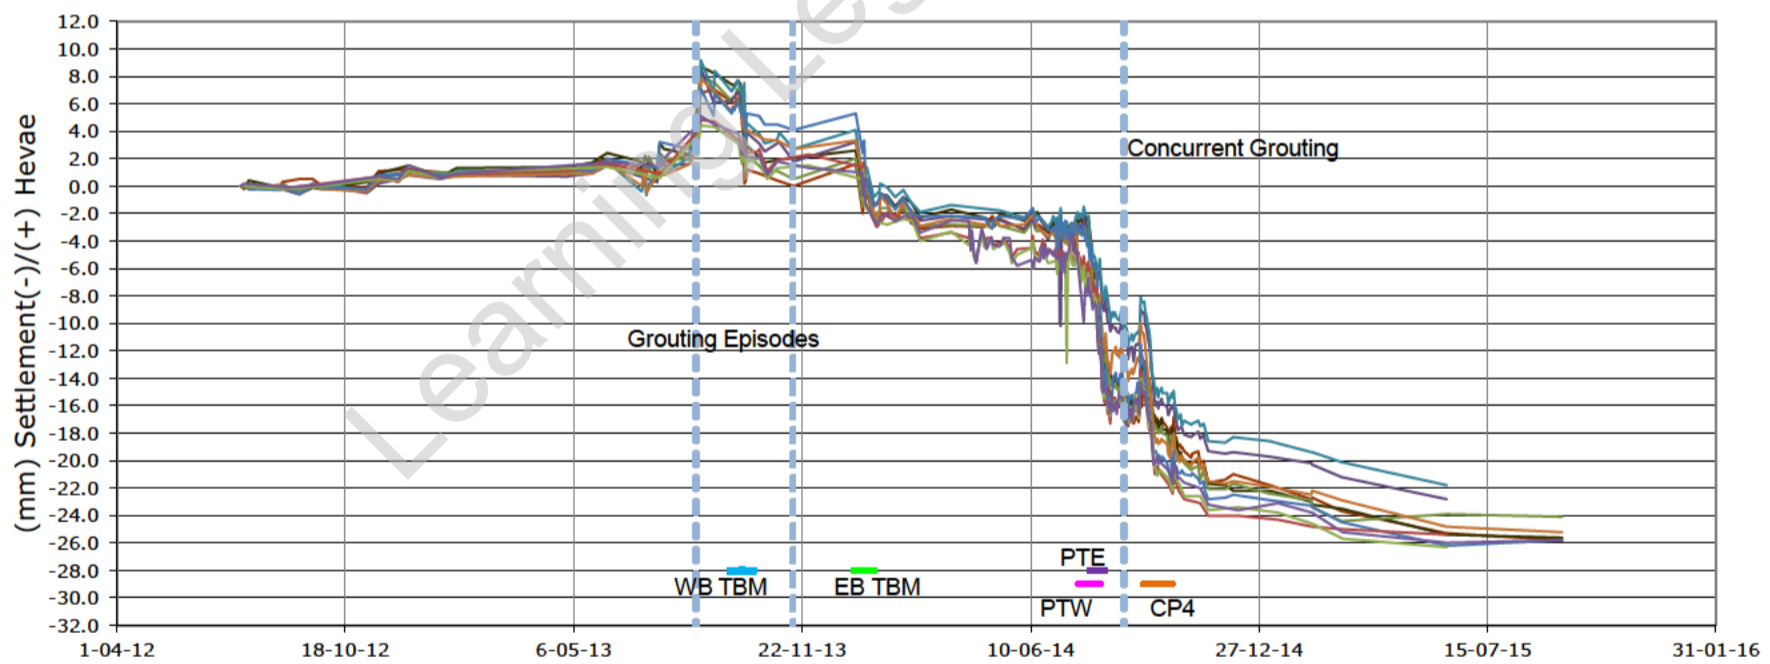
Building: 87 CHARTERHOUSE STREET

- Compensation grouting from Moorgate Shaft 1 caused 4-6mm of heave on 21-08-2013.
- WB TBM caused maximum 5-6mm of settlement from 30-09-2013 to 01-10-2013.
- Compensation grouting caused maximum 2-3mm of heave on 14-11-2013.
- EB TBM caused 6-7mm of settlement on 15-01-2014.
- PTW works caused 6mm of settlement from 22-07-2014 to 10-08-2014.
- PTE enlargement caused 8mm of settlement from 01-08-2014 to 14-08-2014.
- Compensation grouting caused 3-4mm of heave on 31-08-2014.
- CP4 construction caused 10mm of settlement from 17-09-2014 to 12-10-2014.
- Maximum settlement at the end of the works was 26mm

**REMARKS:**  
 Sockets inside Compensation Grouting Area. No triggers breached in slopes.

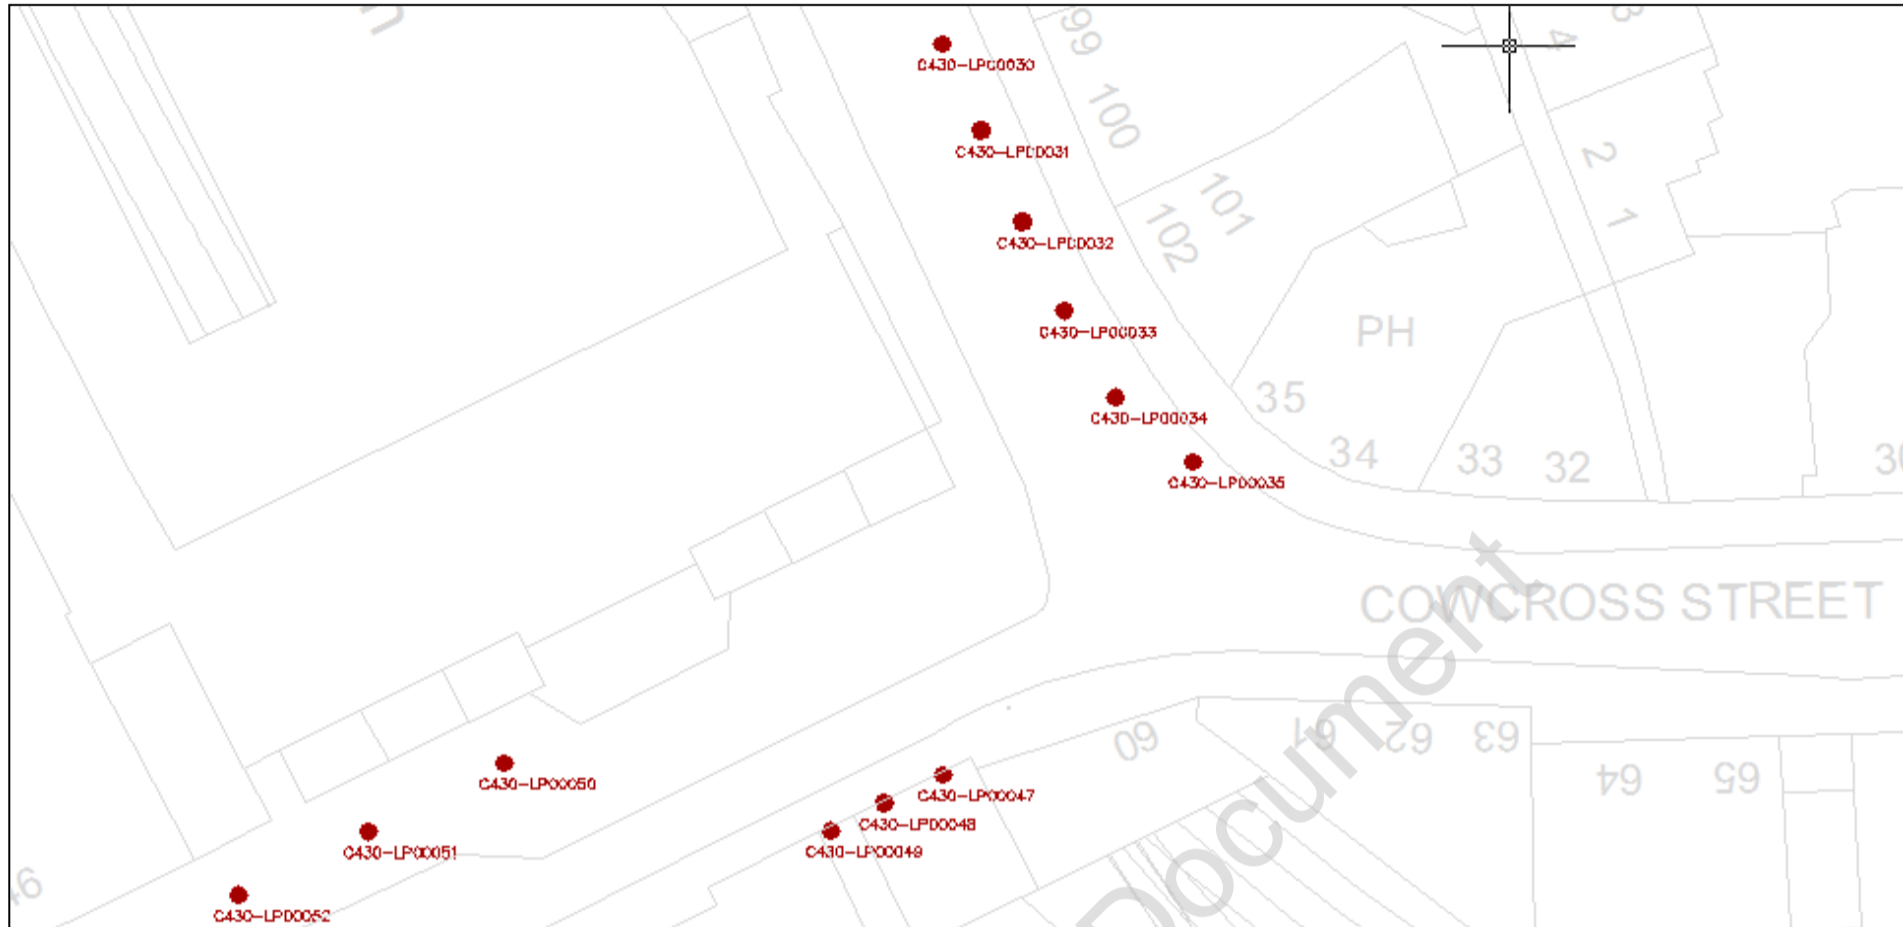
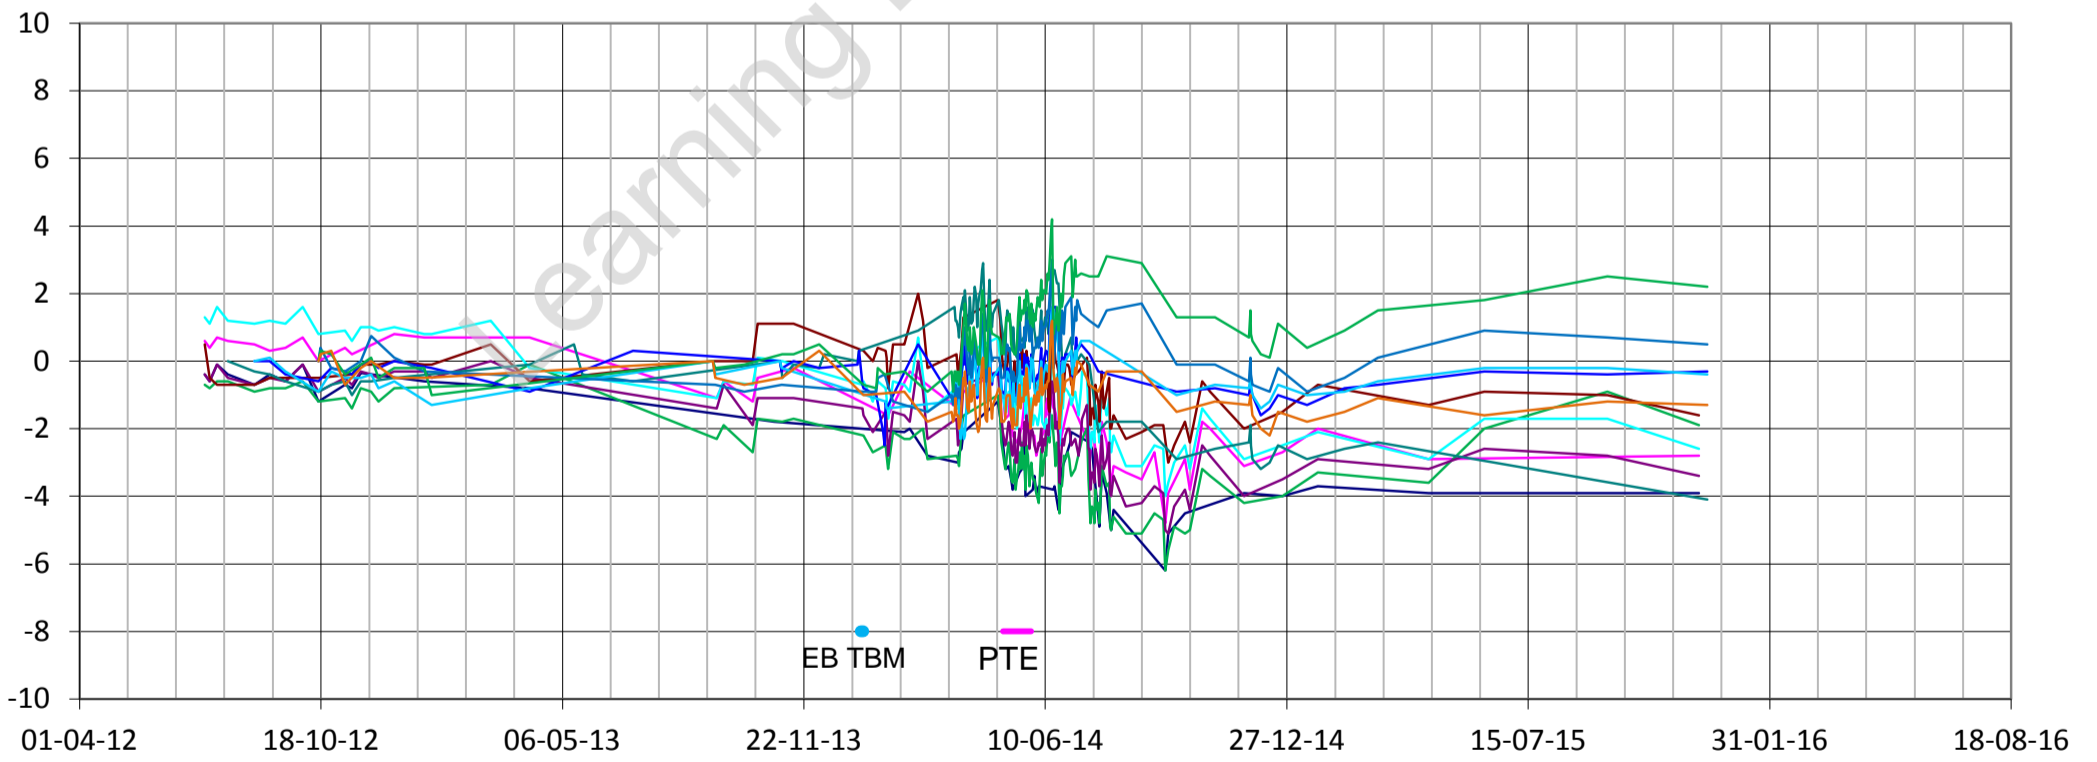
- EB TBM caused 1-2mm of settlement from 08-01-2014 to 10-01-2014.
- PTE enlargement works caused 2mm of settlement from 06-05-2014 to 29-05-2014.
- Maximum settlement at the end of the works was 6mm

Studs outside for the compensation grouting area. No triggers breached.

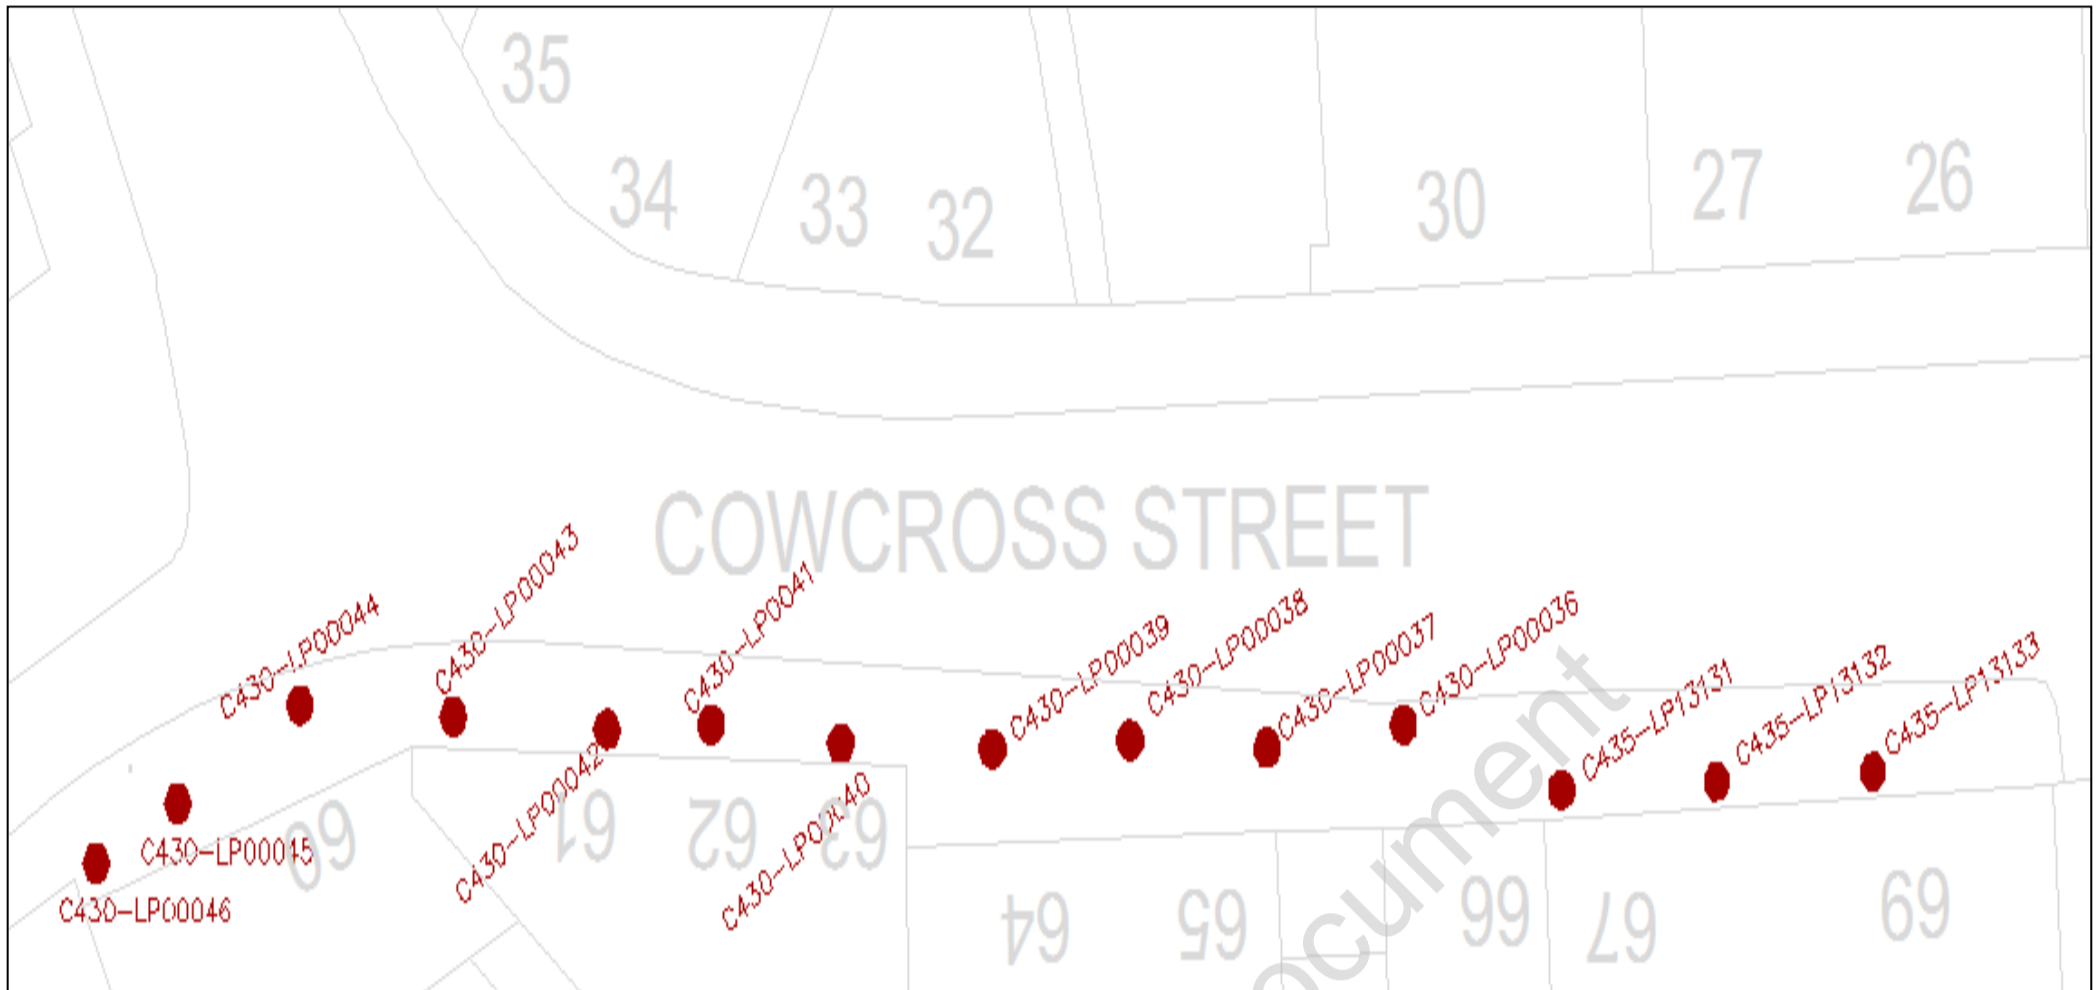
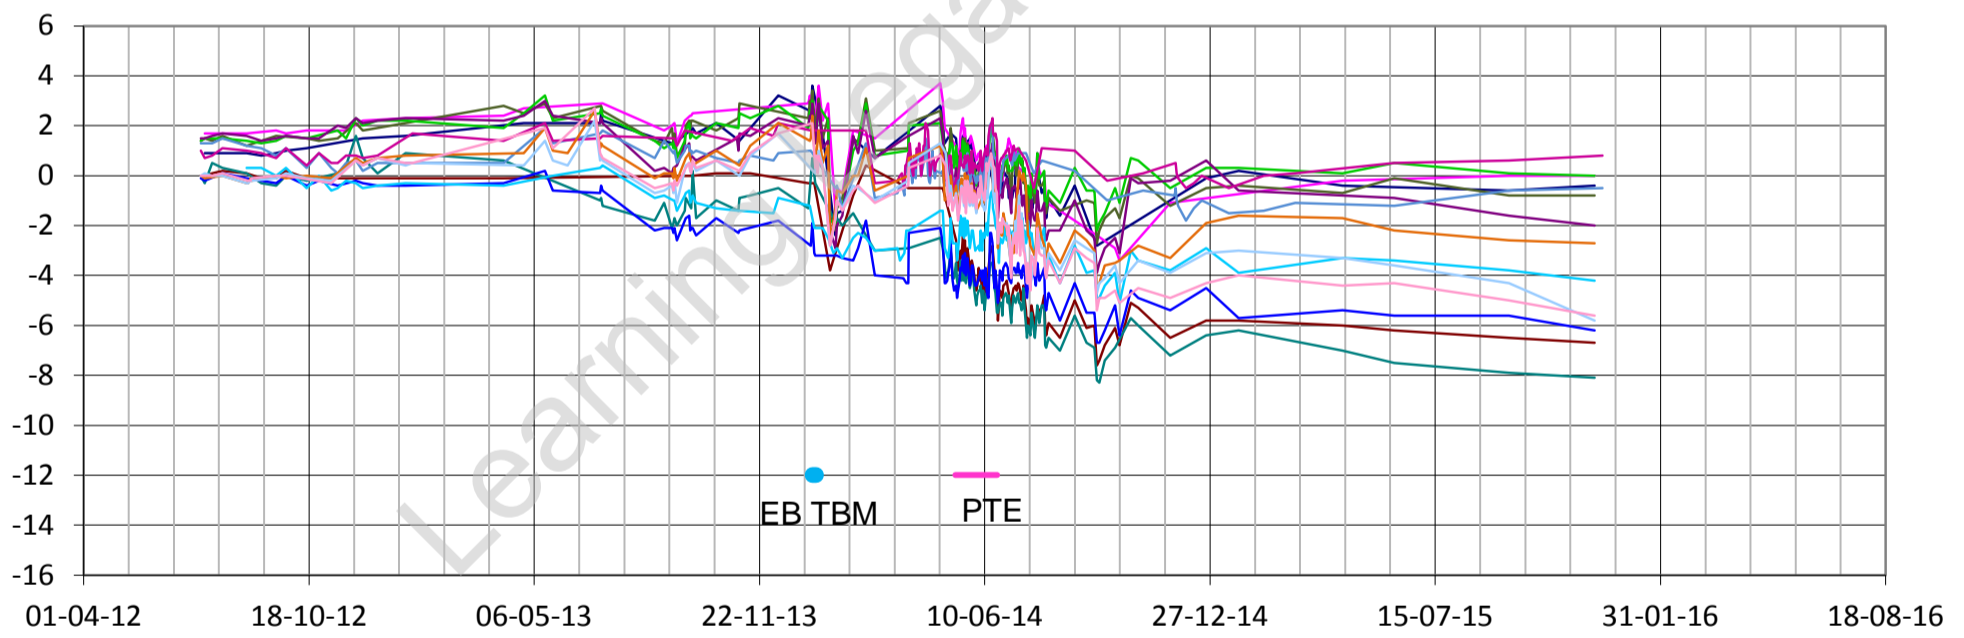
- EB TBM caused 2-3mm of settlement from 08-01-2014 to 11-01-2014.
- PTE enlargement caused 6-7mm of settlement from 15-05-2014 to 21-06-2014.
- Maximum settlement at the end of the works was 8mm

**REMARKS:**  
 Studs outside for the Compensation Grouting Area. No triggers breached.
