Work Area: SMM
Work Type: I&M
Originator Company: GEOCISA

# C435 Farringdon Main Station

## Monitoring Close-Out Report: Sockets & Studs Installed on Cowcross St. CRL Document Number: C435-BFK-C2-RGN-M123-51664

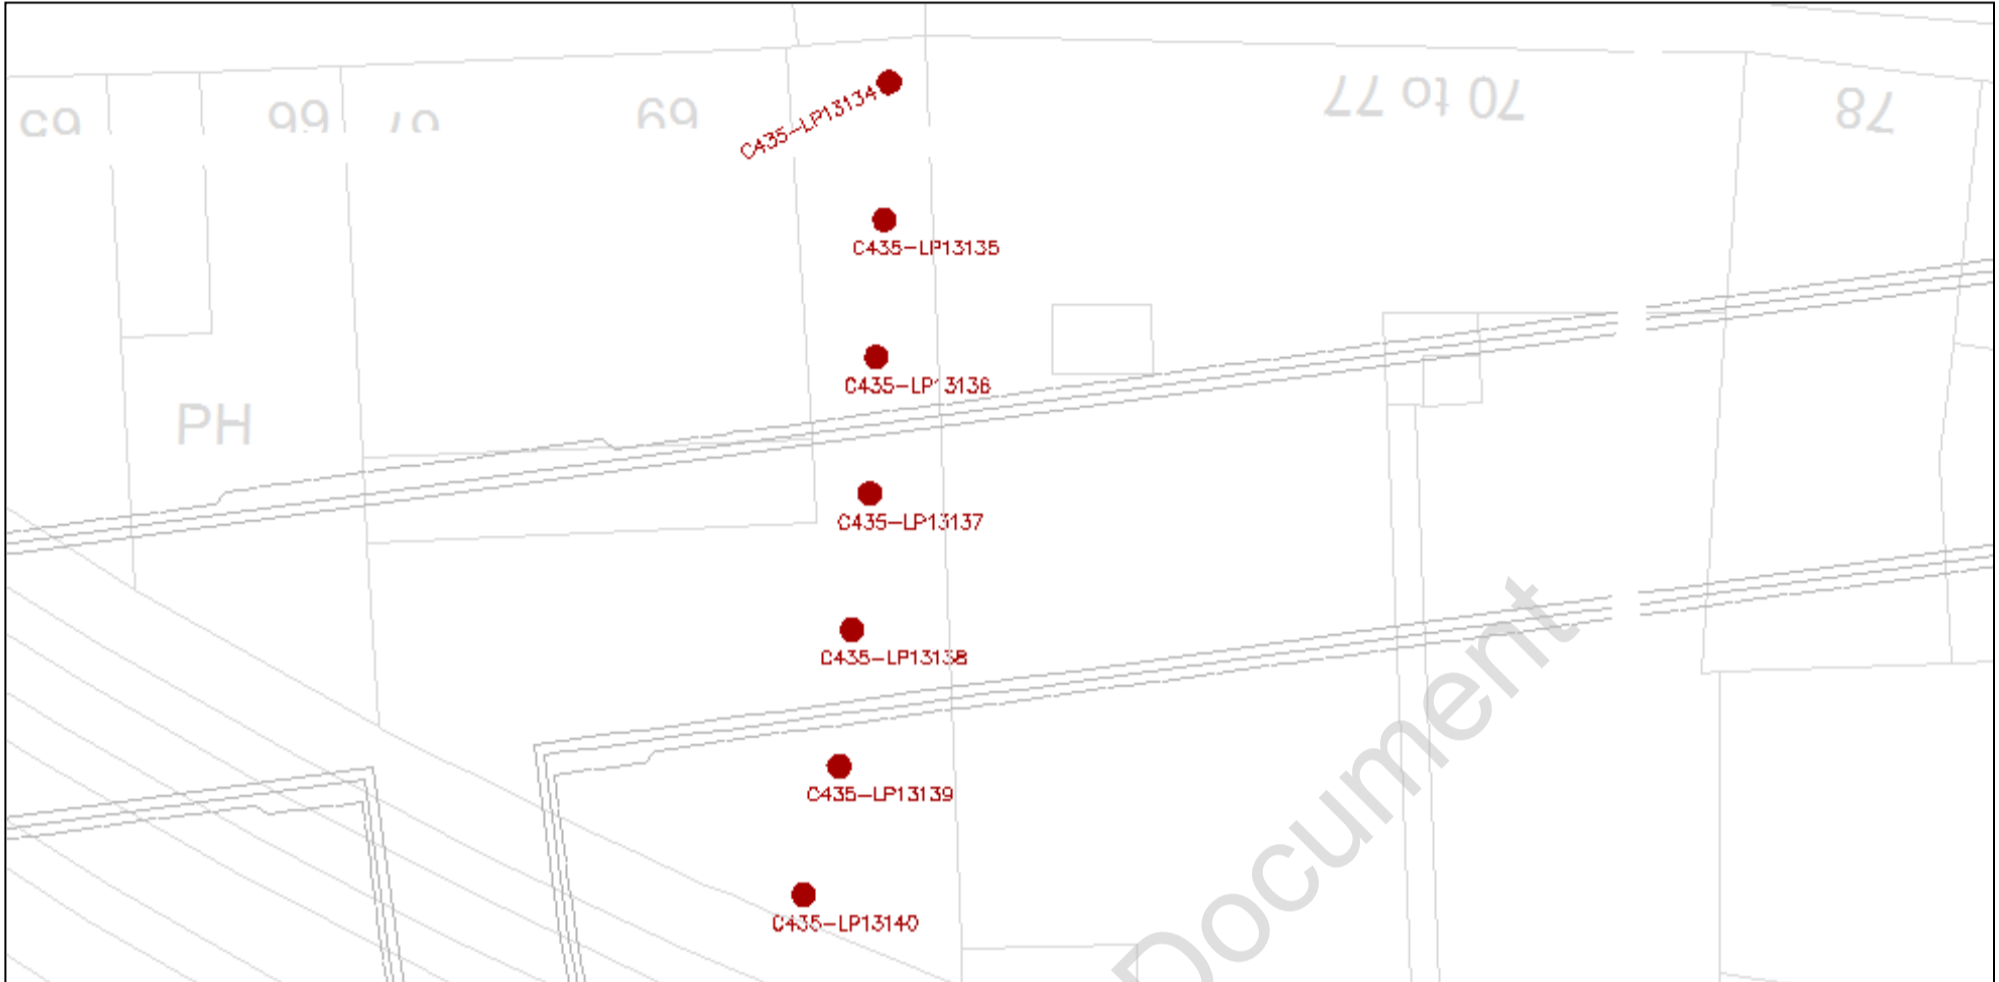
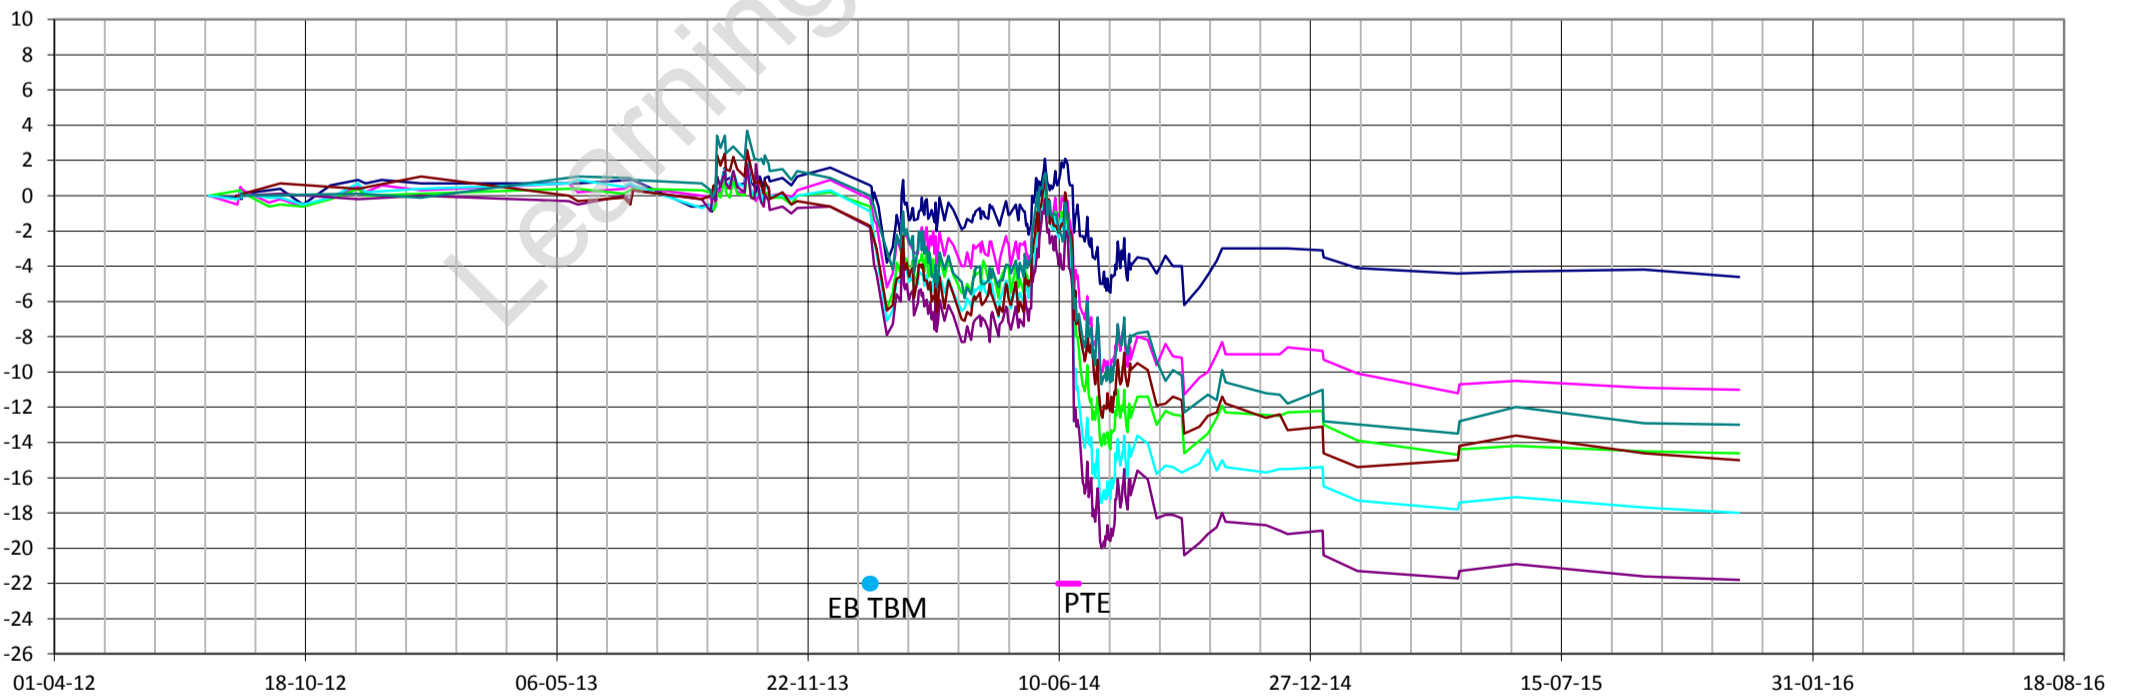
- Compensation grouting from Butcher's Ramp Shaft caused 2-3mm of heave from 06-09-2013 to 17-10-2013.

- EB TBM caused maximum 7-8mm of settlement on 10-01-2014.
- Compensation grouting caused 3-4mm of heave from 12-05-2014 to 10-06-2014.
- PTE works caused 18mm maximum of settlement from 09-06-2014 to 26-06-2014.
- Compensation grouting caused 3-4mm of heave on 26-07-2014.
- Maximum settlement at the end of the works was 22mm

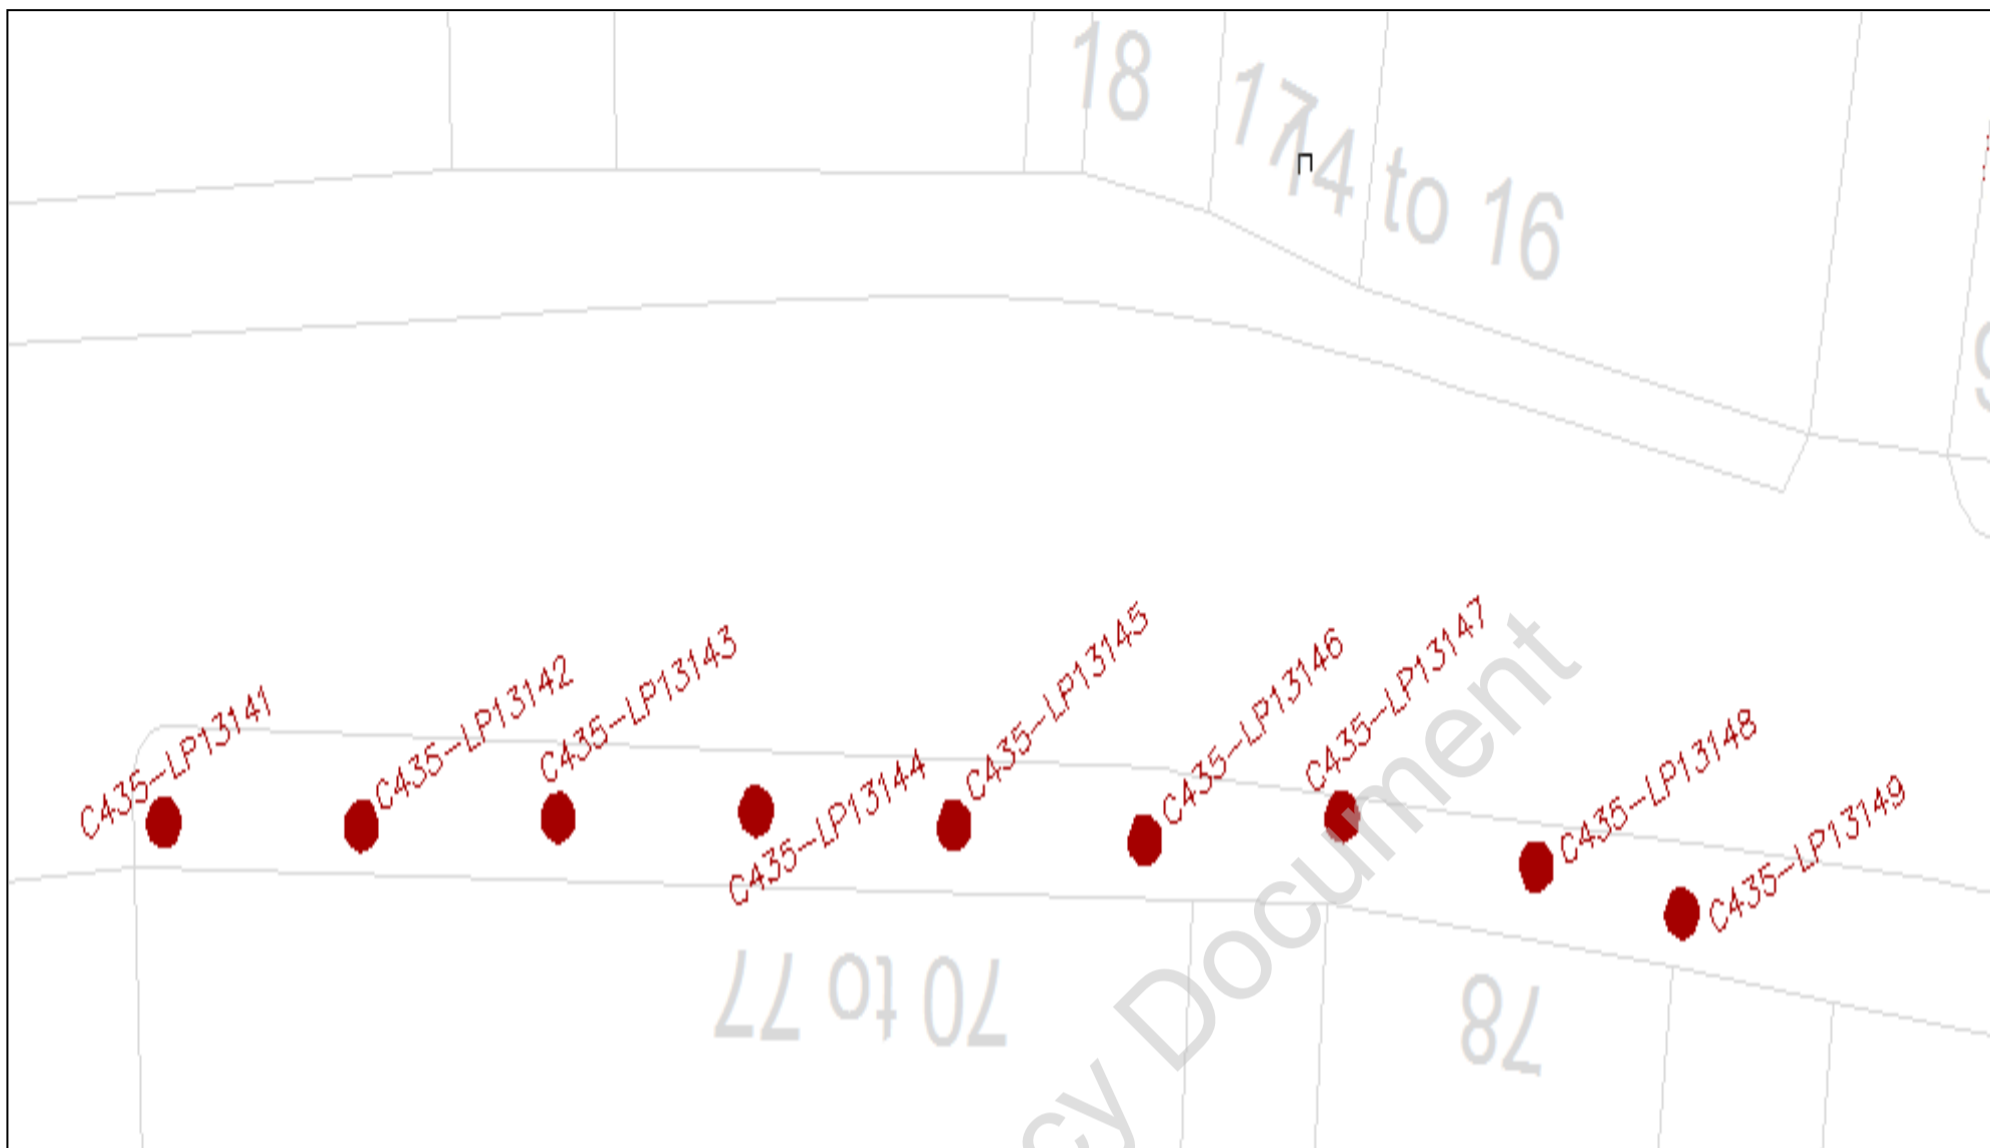
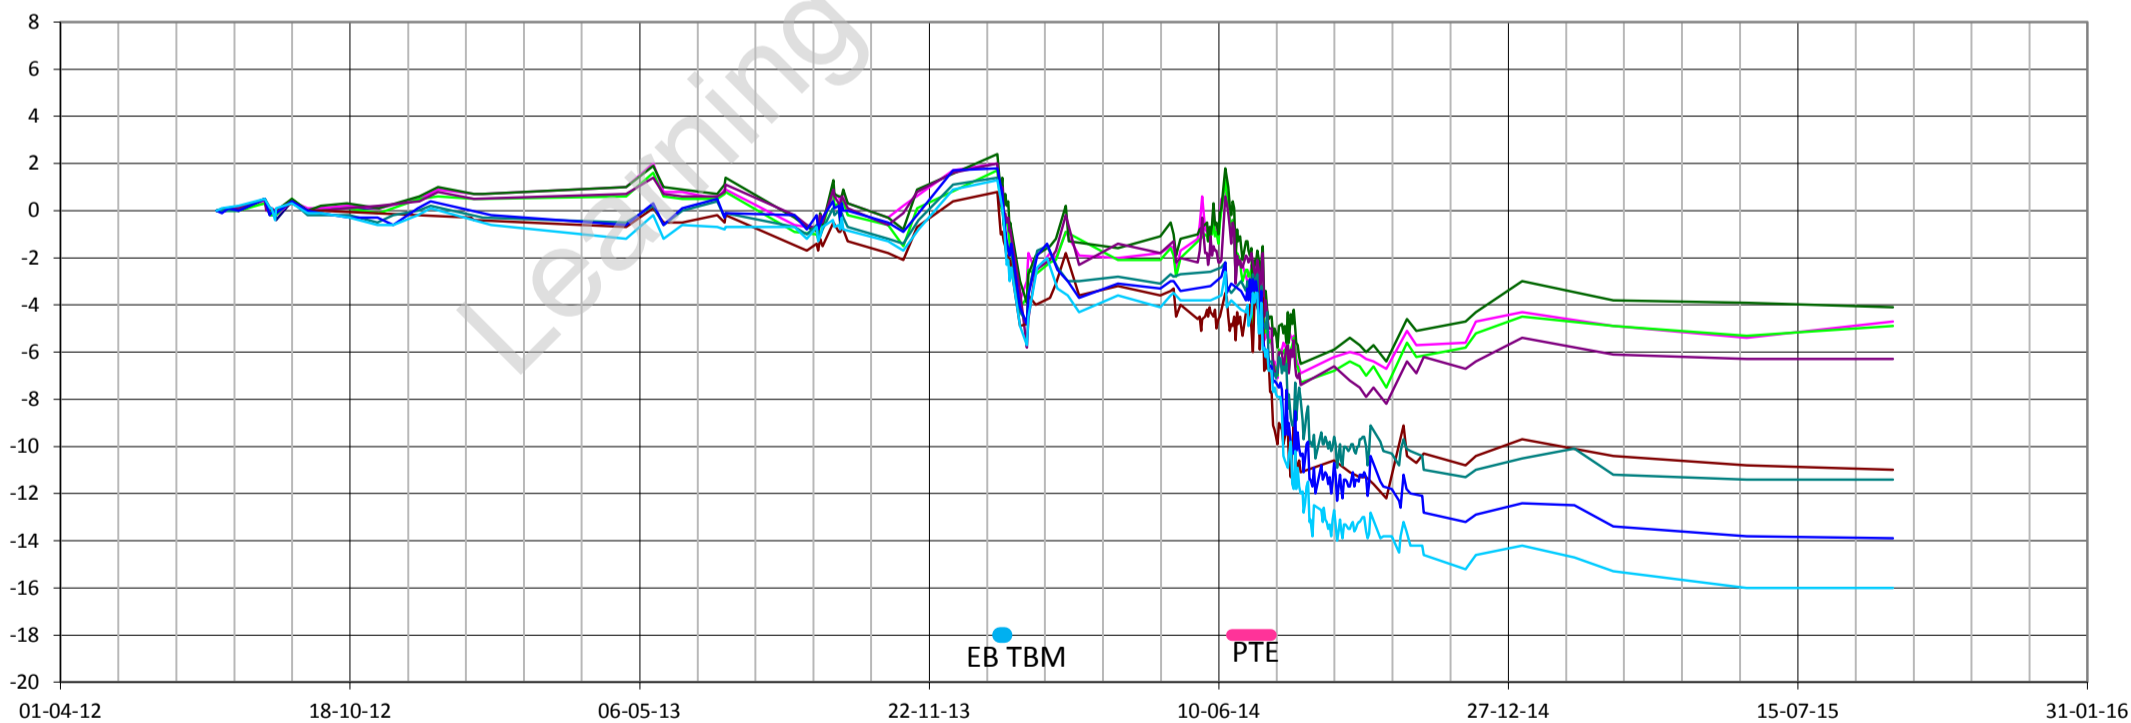
- EB TBM head pressure caused 2-3mm on 08-01-2014.
- EB TBM caused 7-8mm of settlement maximum from 10-01-2014 to 13-01-2014.
- PTE works caused 12mm of settlement from 19-06-2014 to 16-07-2014.
- Maximum settlement at the end of the works was 16mm

**REMARKS:**  
Studs inside the Compensation Grouting Area. No triggers breached.

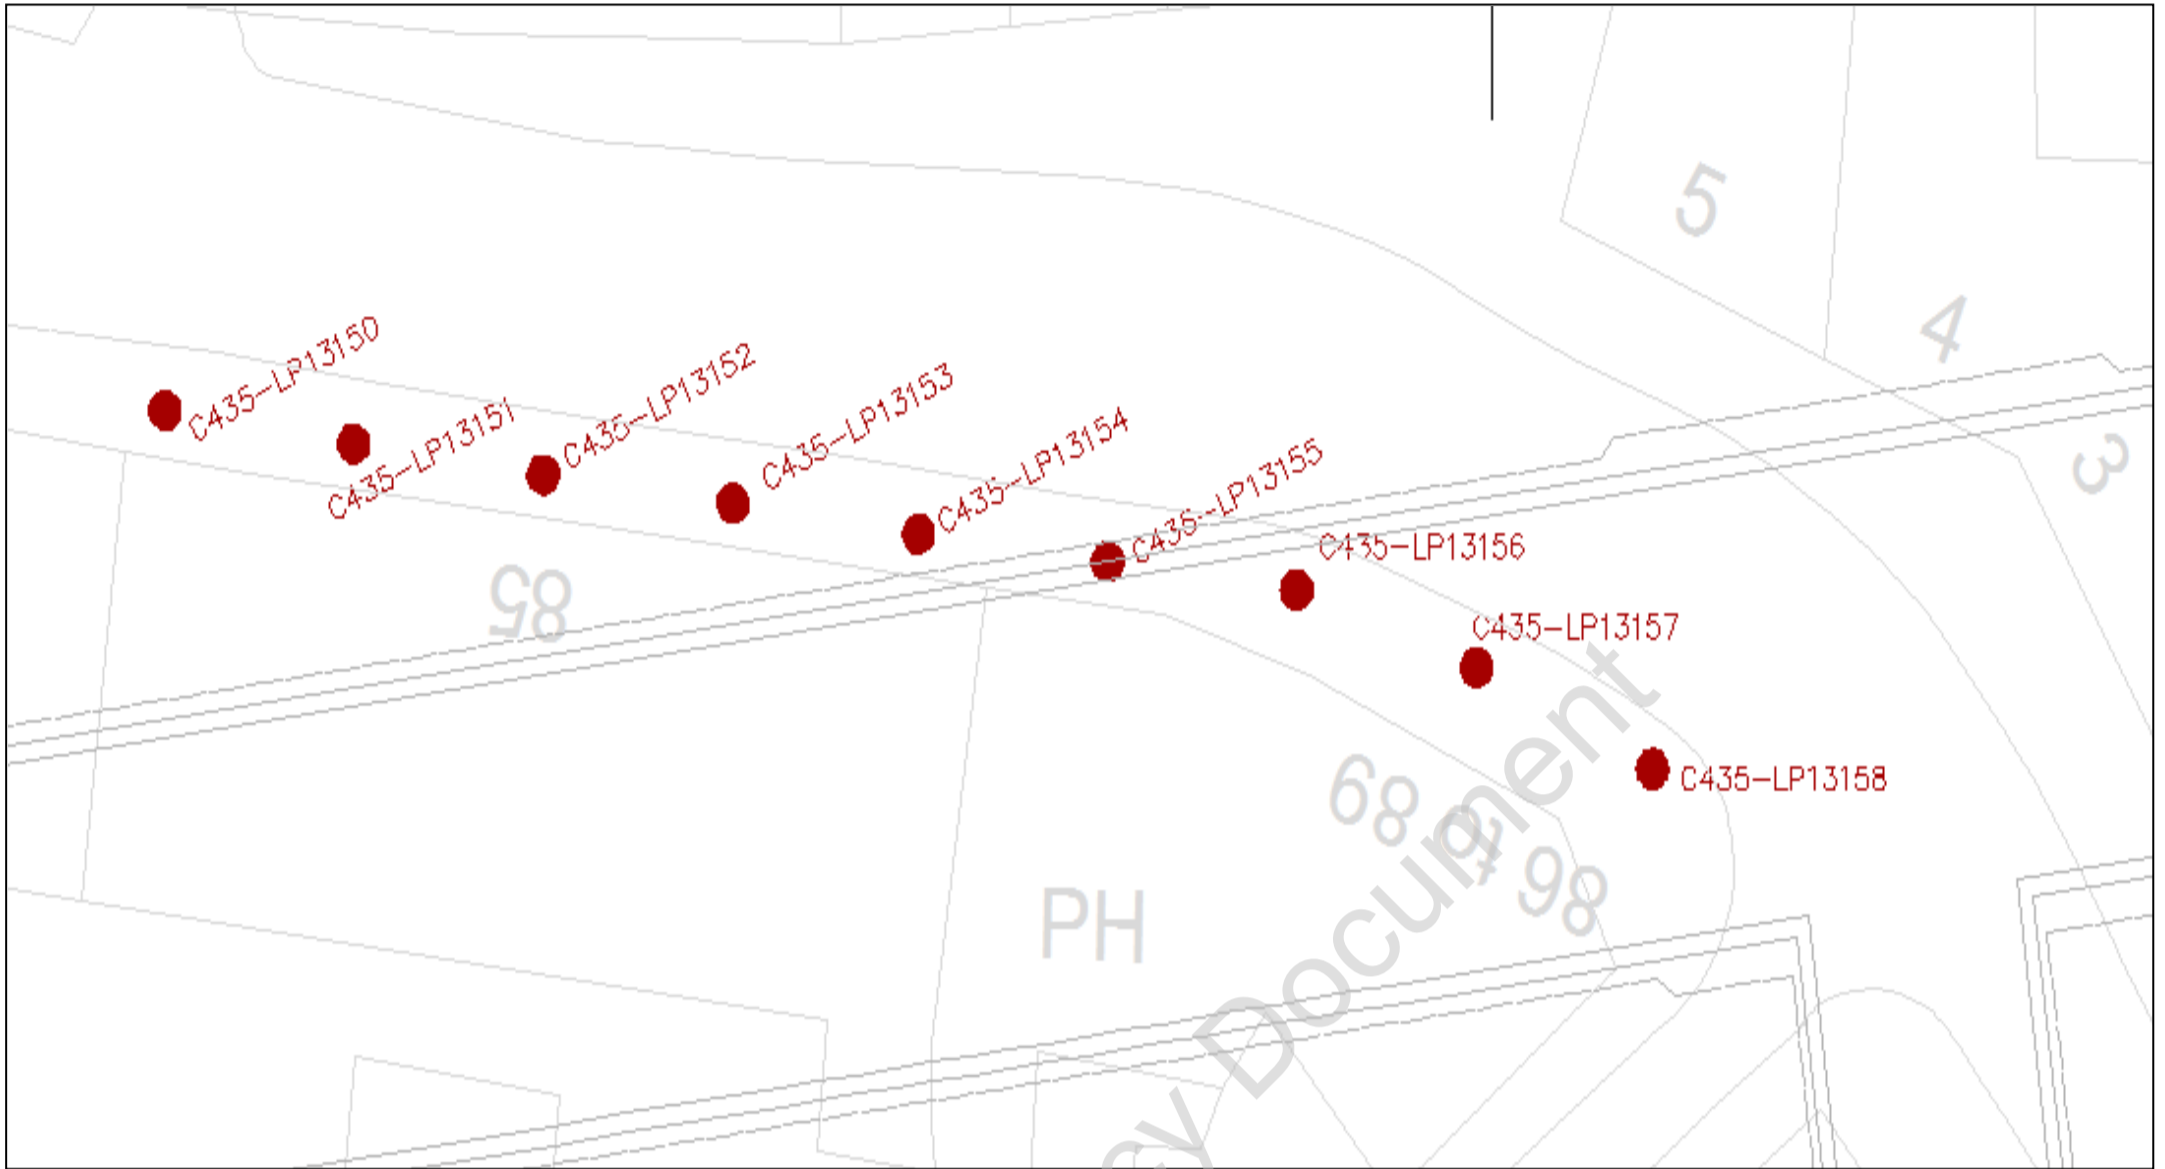
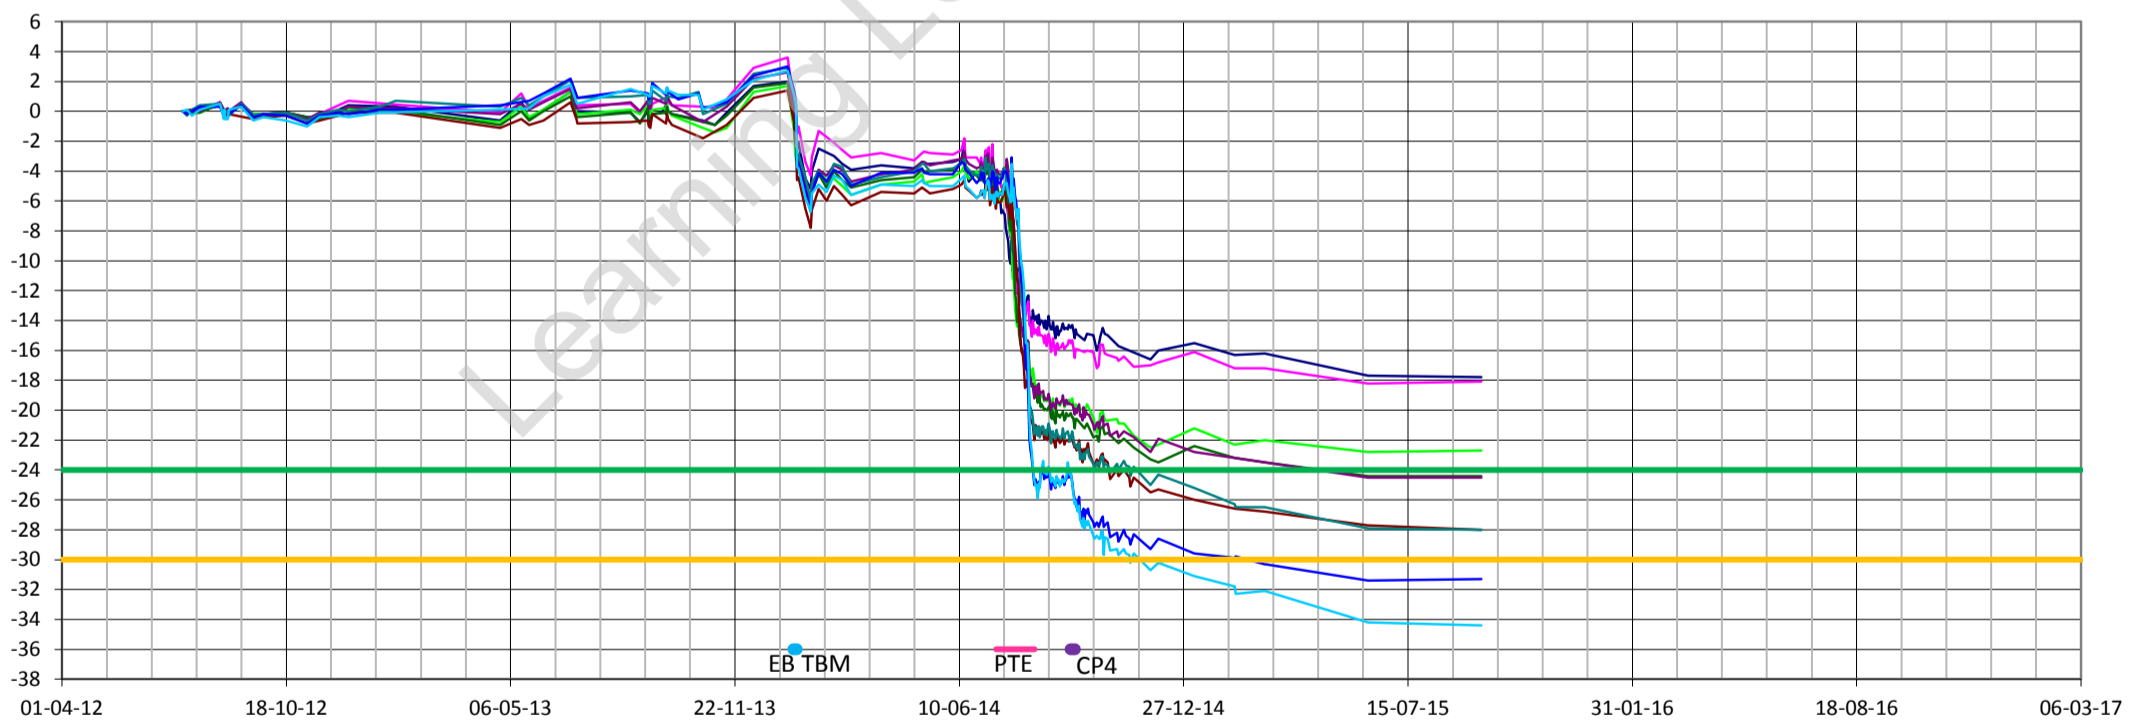
- 2-3mm of heave captured caused by the head pressure on 08-01-2014.
- EB TBM caused 9-10mm of settlement maximum from 13-01-2014 to 16-01-2014
- PTE enlargement caused maximum 25mm of settlement from 13-07-2014 to 16-08-2014.
- CP4 construction caused 5-6mm of settlement from 17-09-2014 to 21-09-2014.
- Maximum settlement at the end of the works was 35mm

Studs outside influence Compensation Grouting Area. Green trigger was breached by C435-LP13157 on 14-08-2014, C435-LP13158 on 15-08-2014, C435-LP13155 on 22-10-2014 and C435-LP13156 on 22-10-2014.  
Amber trigger was breached by C435-LP13158 on 27-11-2014 and C435-LP13157 on 09-03-2015.

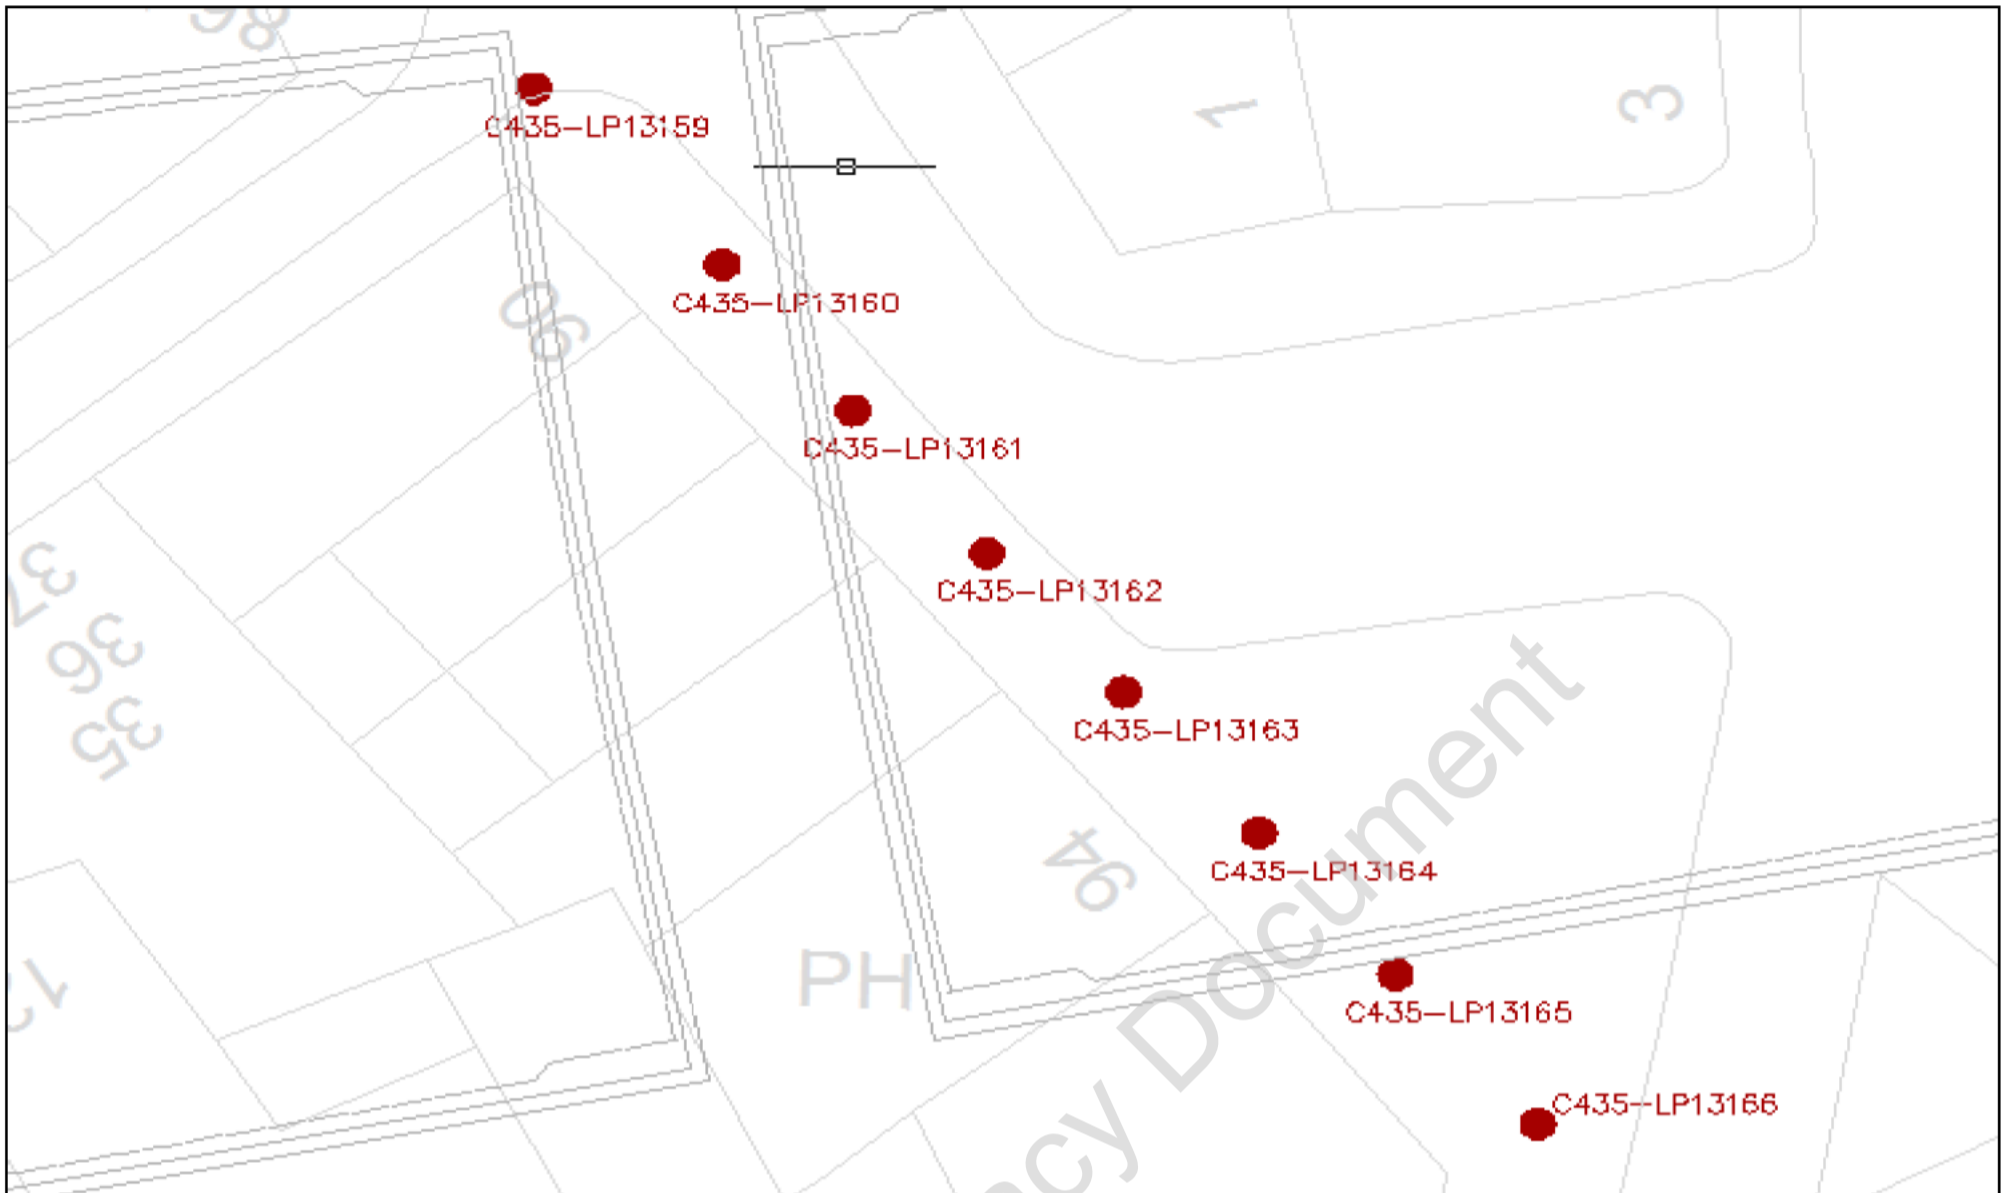
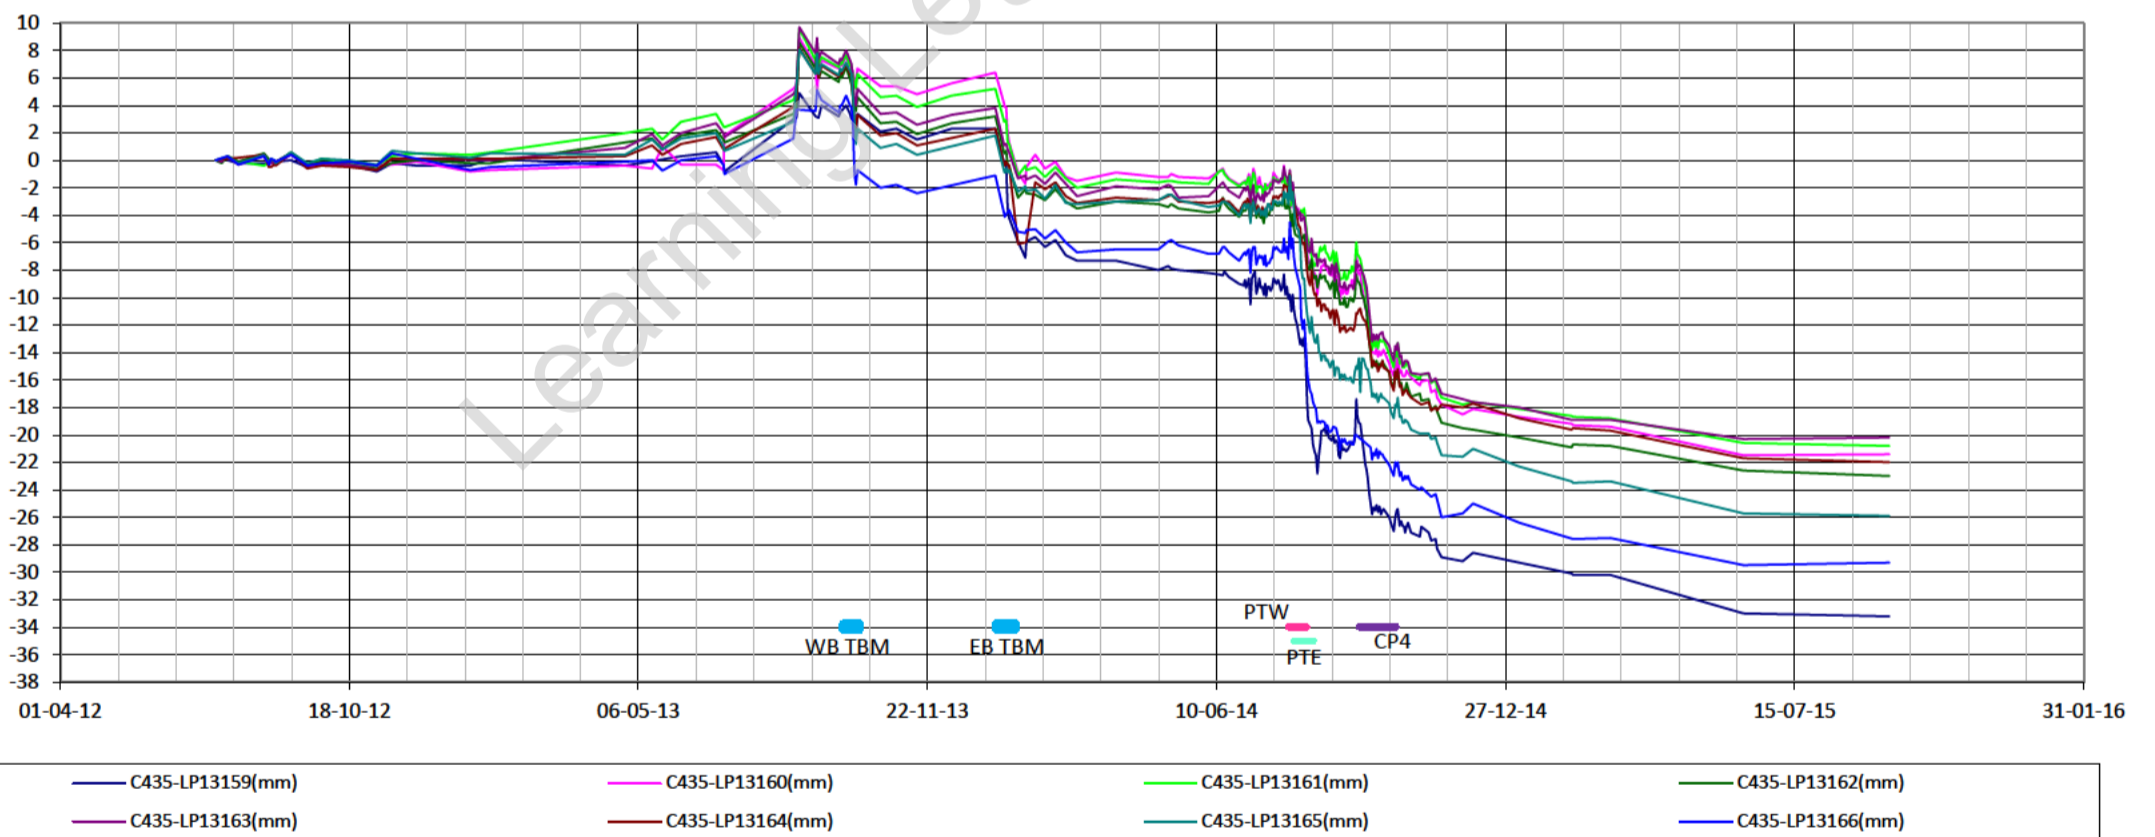
- Compensation grouting from Moorgate Shaft 1 caused 9mm of heave from 04-07-2013 to 23-08-2013.
- WB TBM caused maximum 2mm of settlement on 30-09-2013.
- EB TBM caused maximum 3-4mm of settlement on 15-01-2015.
- PTE and PTW combination caused maximum 14mm of settlement between 30-07-2014 to 16-08-2014.
- Compensation grouting caused 2-3mm of heave on 18-09-2014.
- CP4 construction caused 3-4mm of settlement from 17-09-2014 to 12-10-2014.
- Maximum settlement at the end of the works was 33mm

Studs inside Compensation Grouting Area. Green trigger was breached on slope between C435-LP13164 and C435-LP13166 on 15-05-2014.

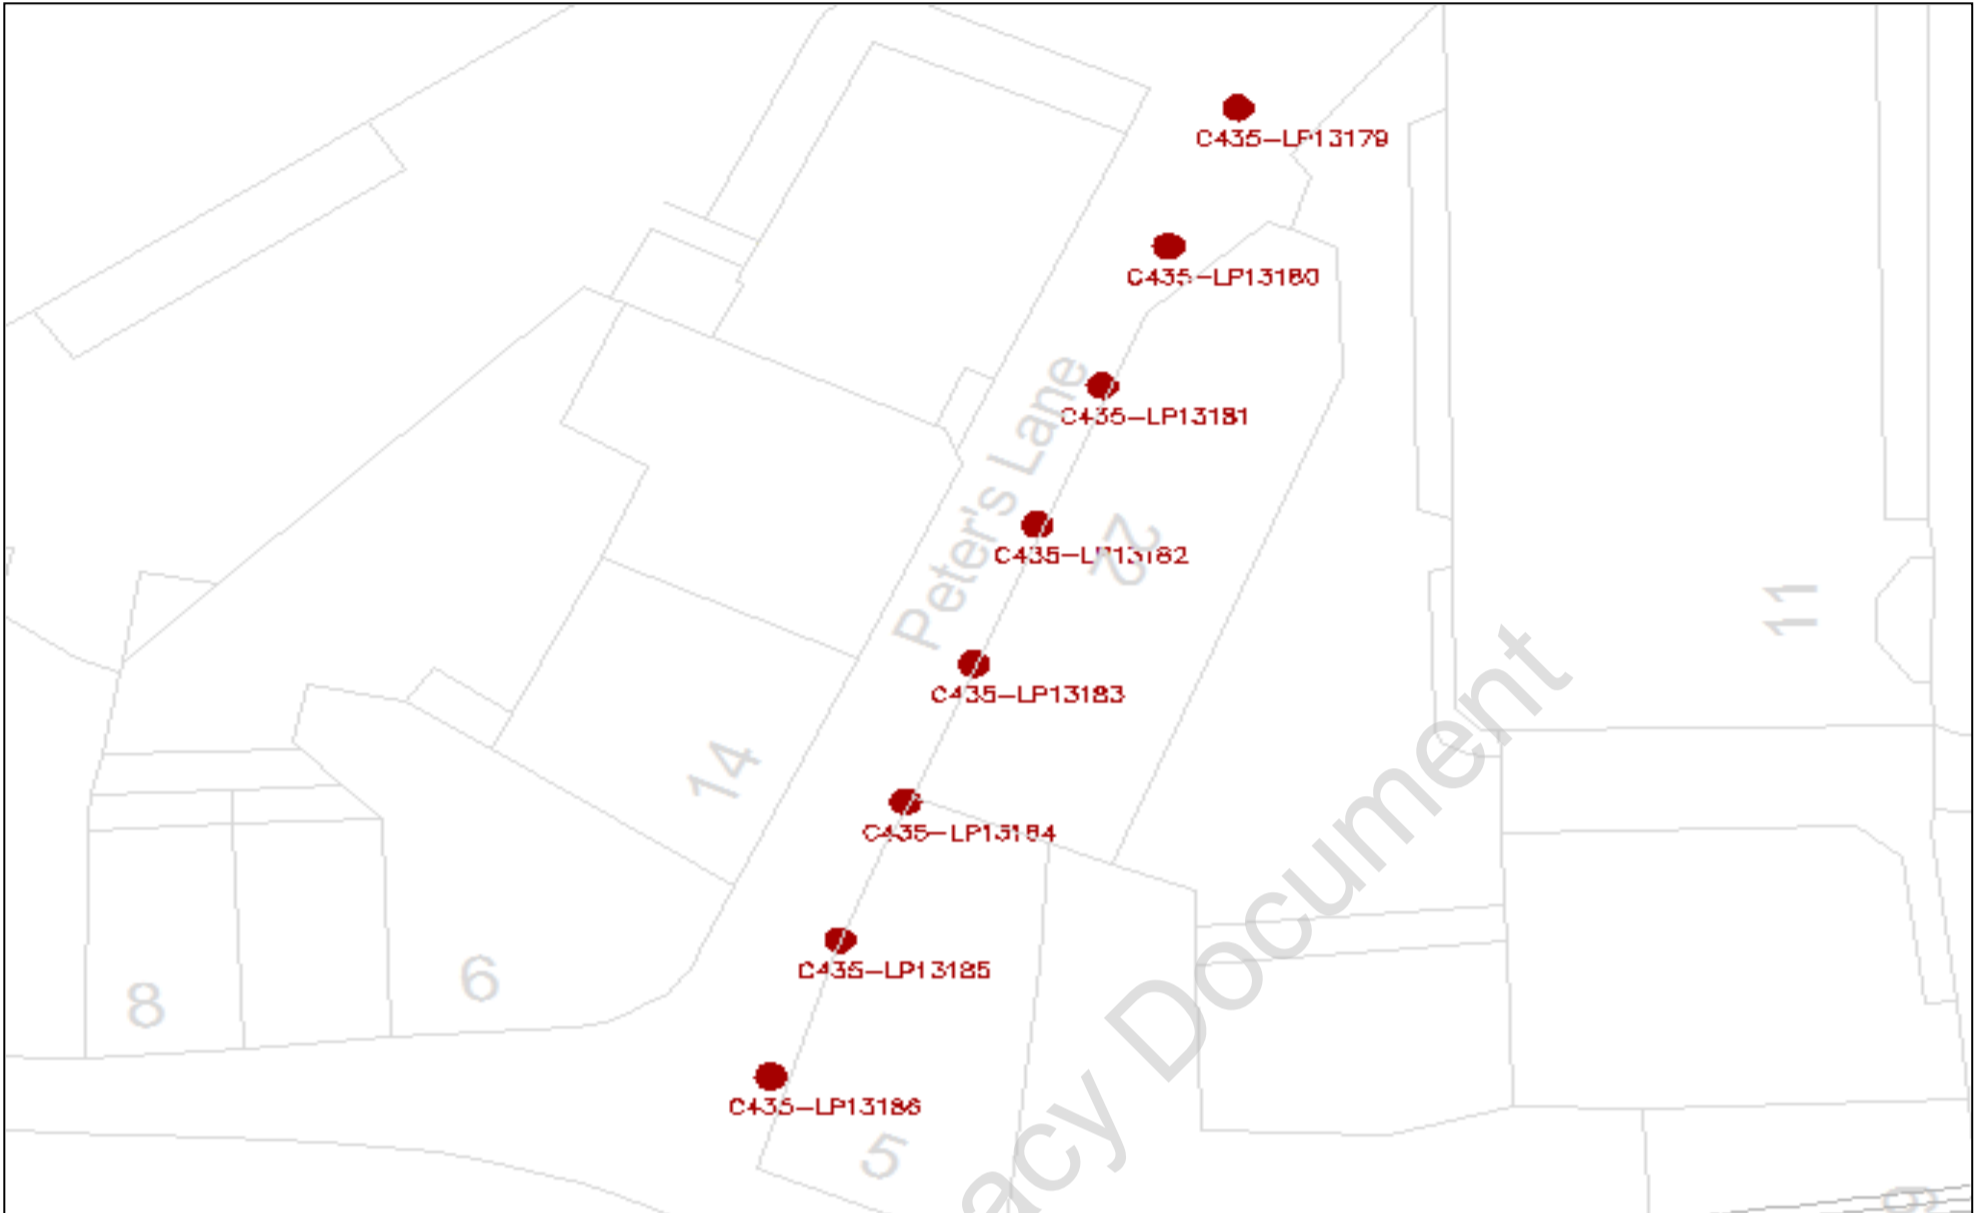
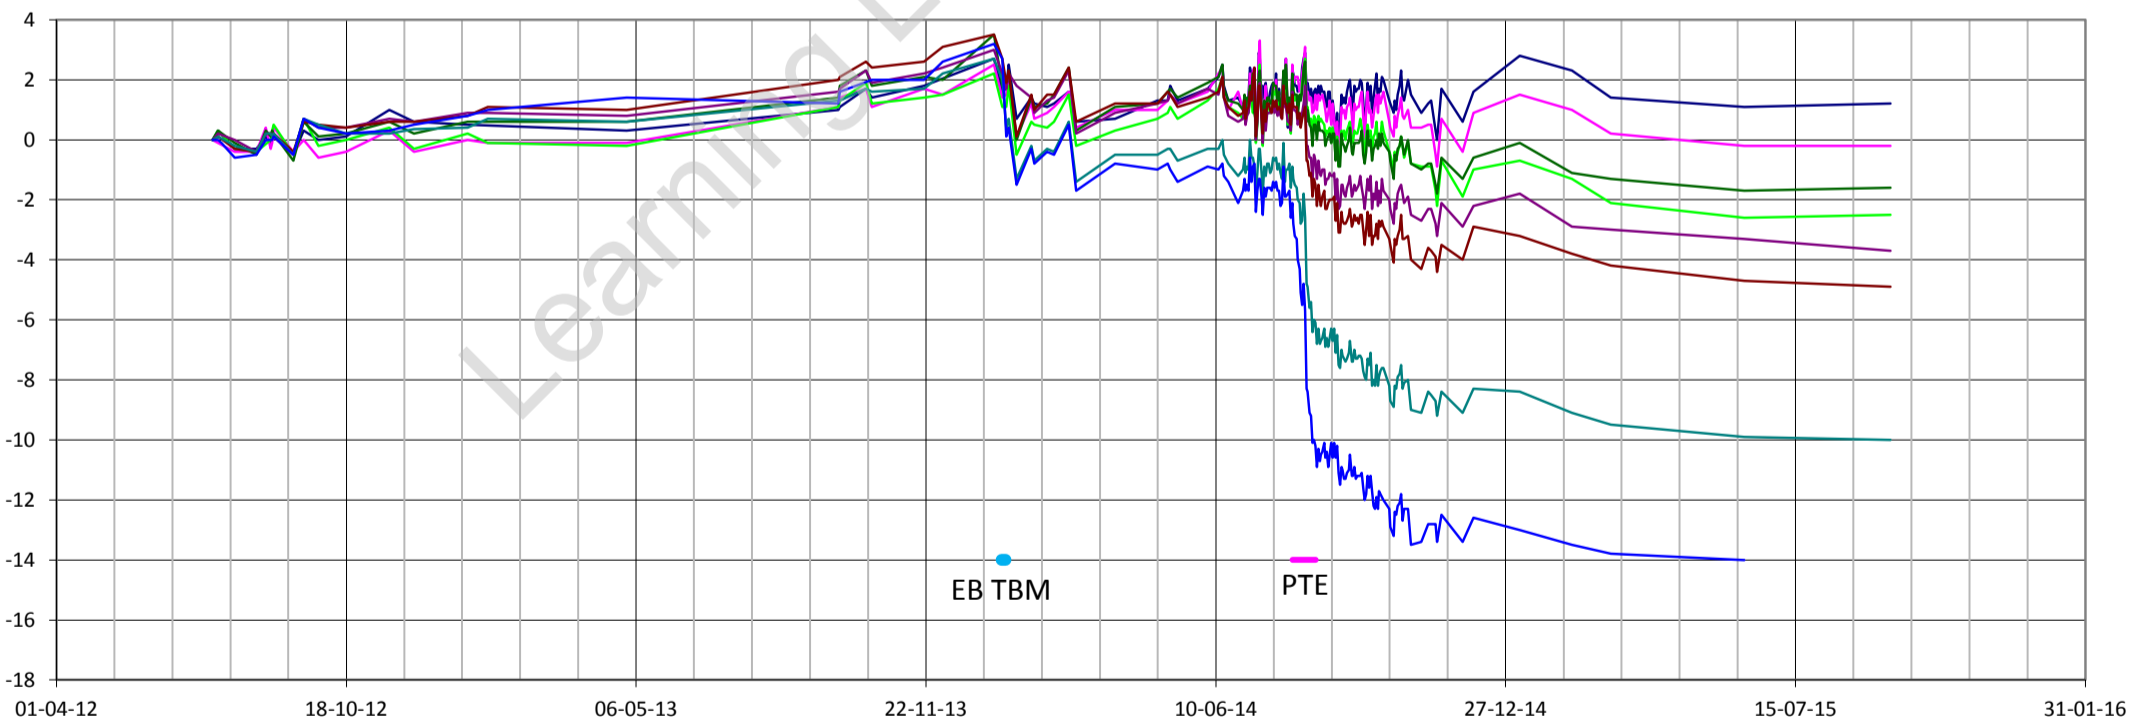
- 3-4mm of heave caused by EB TBM head pressure captured on 08-01-2014.
- EB TBM caused maximum 4mm of settlement from 13-01-2014 to 16-01-2014.
- PTE enlargement construction caused 10mm of settlement from 02-08-2014 to 18-08-2014.
- Maximum settlement at the end of the works was 14mm

**REMARKS:**  
 Studs outside Compensation Grouting Area. No triggers breached.
