Work Area: SMM
Work Type: I&M
Originator Company: GEOCISA

# C435 Farringdon Main Station

## Monitoring Close-Out Report: Sockets & Studs Installed on Cowcross St. CRL Document Number: C435-BFK-C2-RGN-M123-51664

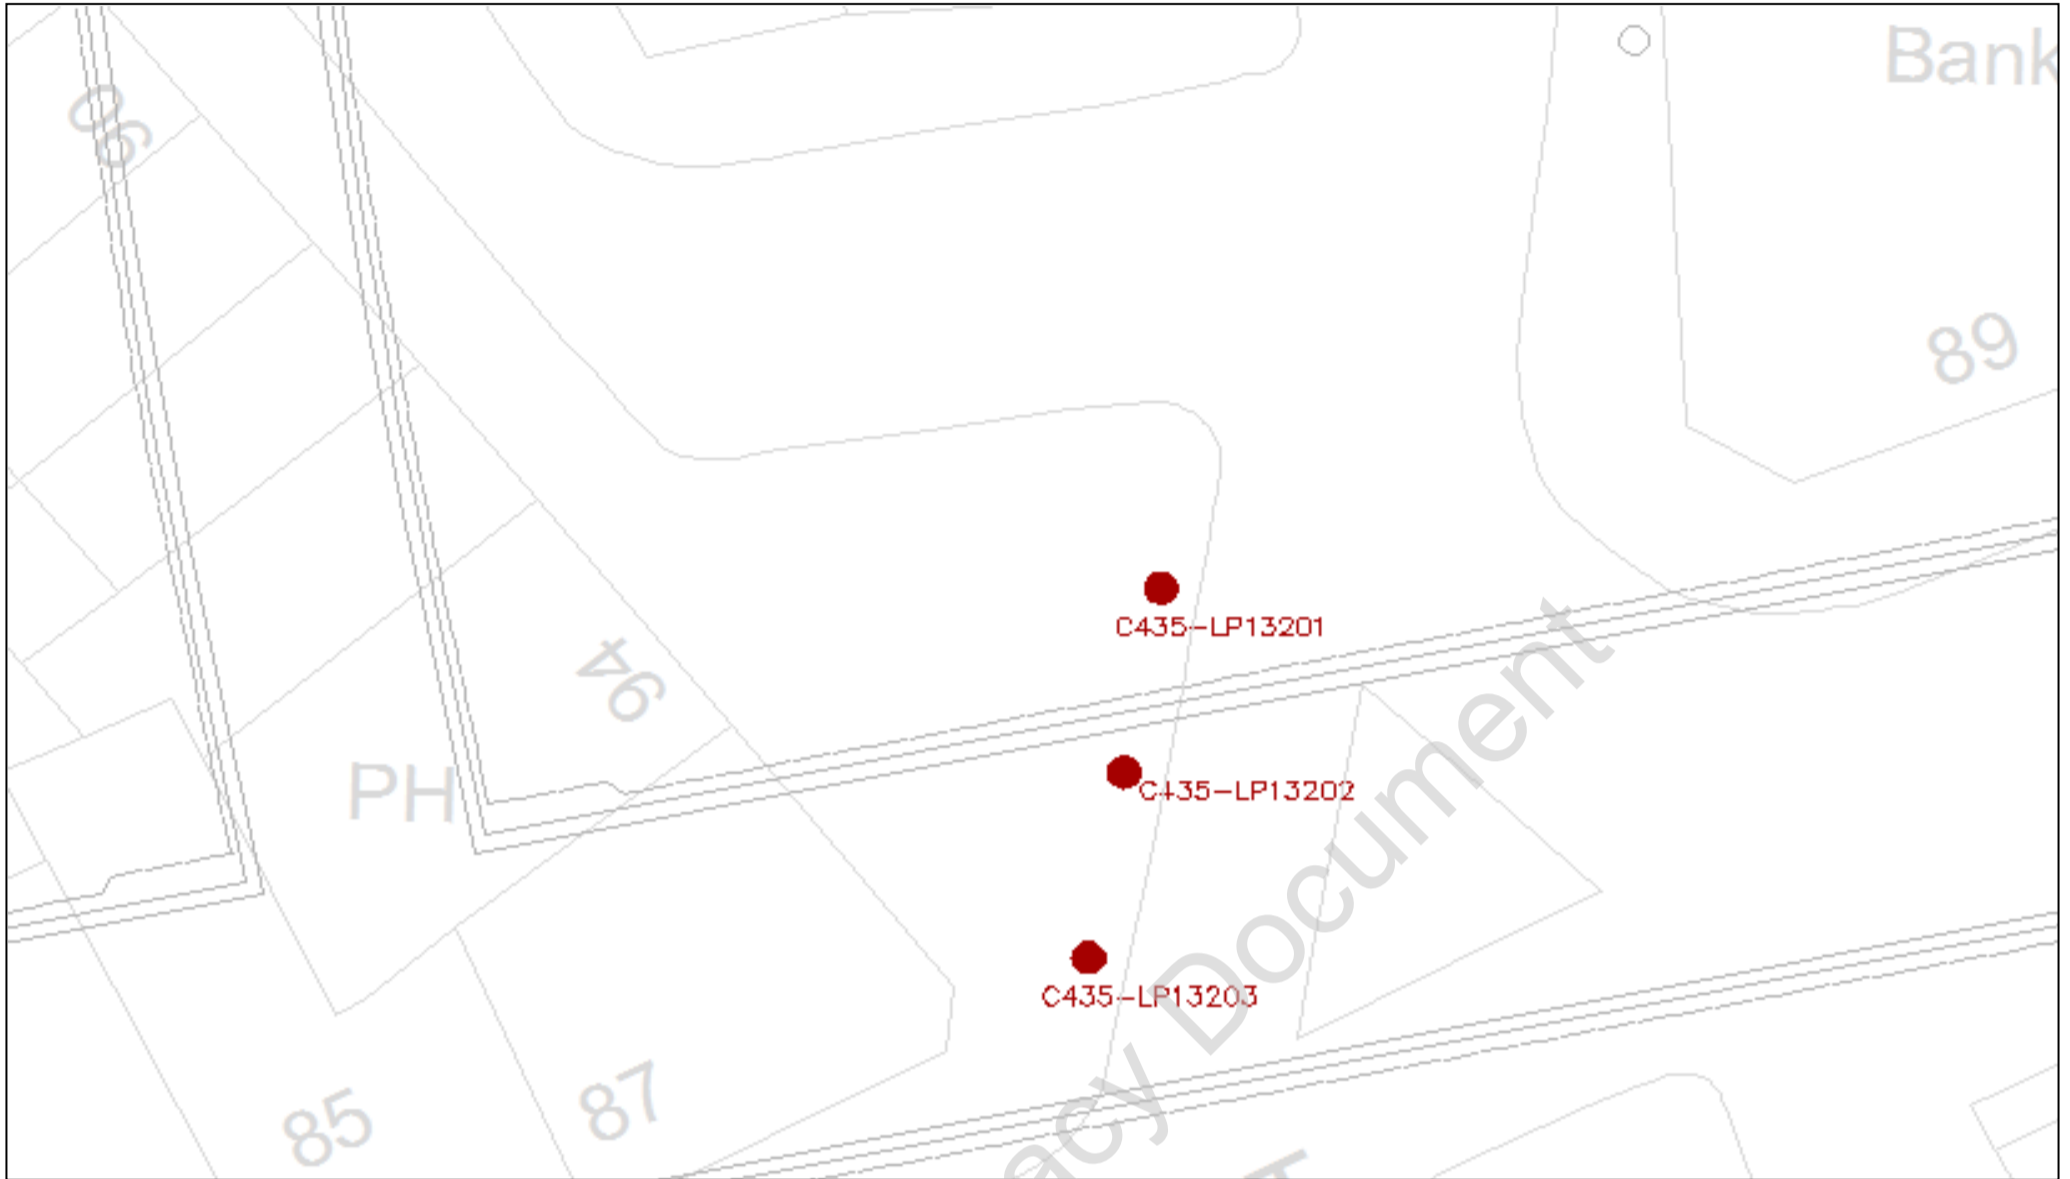
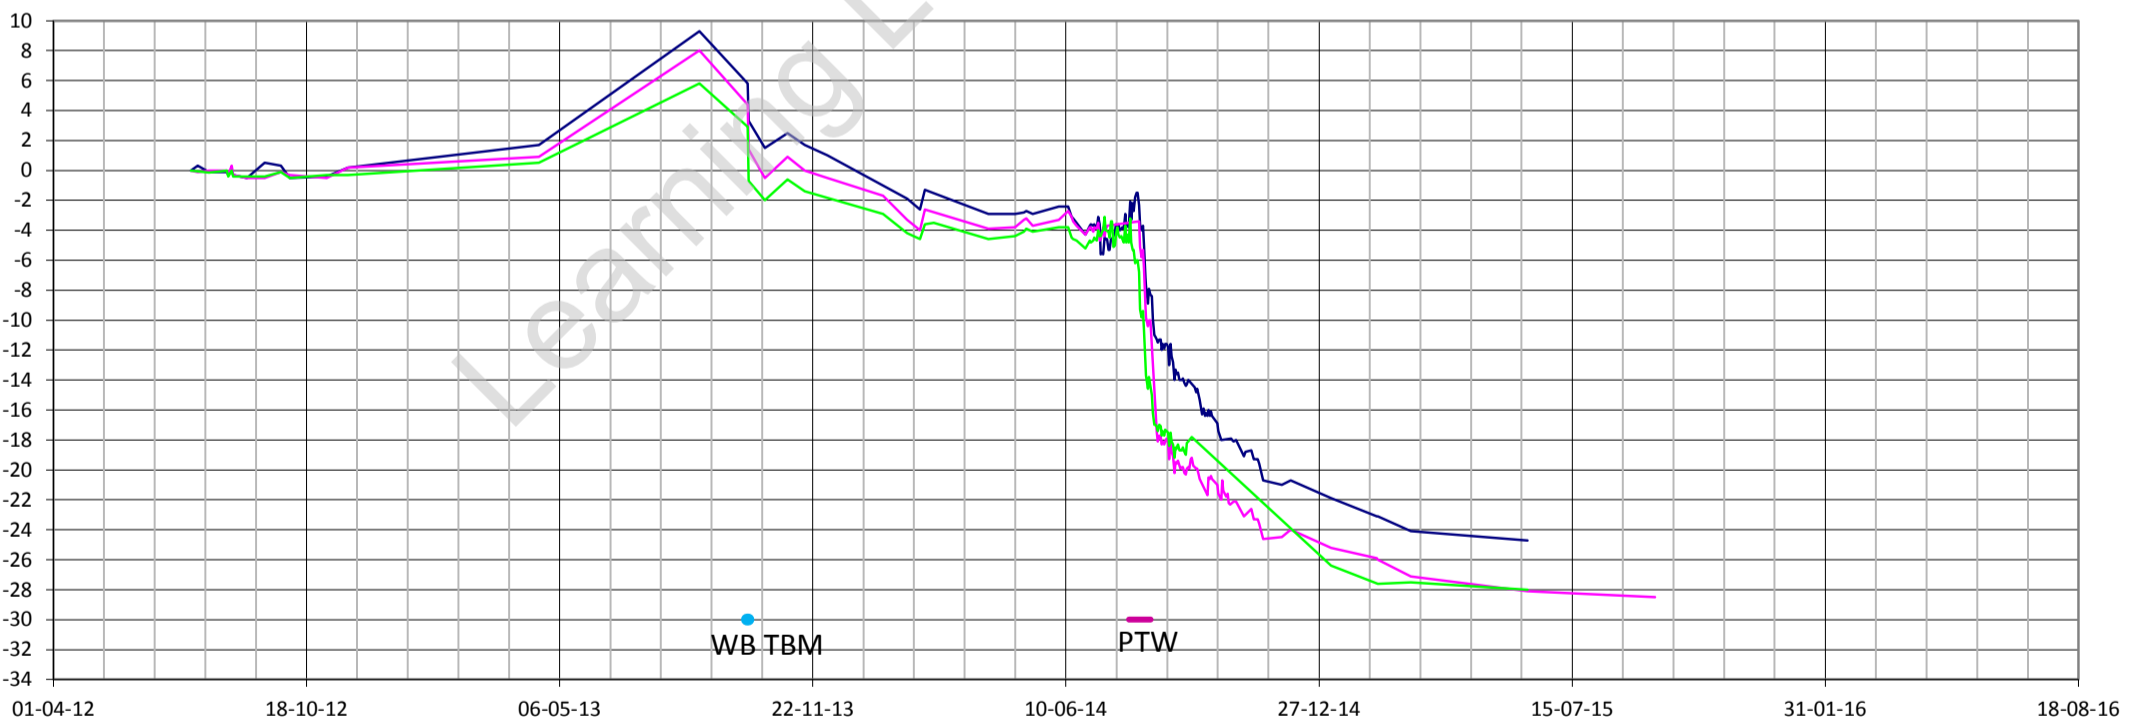
- Compensation grouting caused 9-10mm of heave from 19-04-2013 to 24-08-2013.
- WB TBM caused 4-5mm maximum of settlement on 01-10-2014.
- Compensation grouting caused 2mm of heave from 20-07-2014 to 05-08-2014.
- PTW construction caused 14-15mm of settlement maximum from 30-07-2014 to 16-08-2014.
- Maximum settlement at the end of the works was 28mm

Studs inside Compensation Grouting Area. No triggers breached.
