This safety alert was provided by our colleagues at National Grid following an over 7 Day RIDDOR incident where a crane operator sustained a chest and knee injury attempting to access a crane.

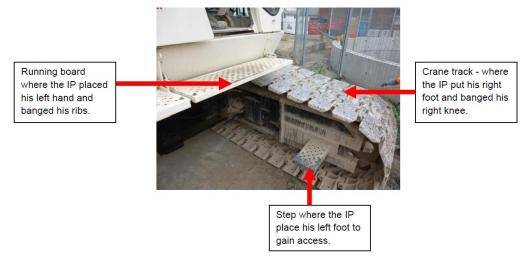
The Injured Person (IP) tried to gain access to the cab by putting his left foot on the step inside the crane track and his left hand on the running board. As the IP went to put his right foot on the crane track, his left hand slipped and he hit the left side of his body on the running board and his right knee on the crane track.

- The IP was holding a bag in his right hand during the process, restricting his access.
- The crane had also been left in the incorrect position on the previous shift, preventing the IP
 from being able to access the crane in the manner intended i.e. using the step and the handrail
 on the front of the crane.

- Cranes to be left in a safe position for safe egress and access to the cab.
- Consider re-briefing operators on the correct means of access / egress (from supplier information)
- Ensure there is suitable access into all work areas.
- 3 points of contact must be maintained when accessing any type of plant.
