# Rigorous assessment of existing overhead line gantries for the Elizabeth line

## Synopsis

The Elizabeth line will use above-ground sections of existing Great Eastern and Great Western tracks between Stratford and Maidenhead where new overhead line equipment (OLE) and traction power supply will be installed.

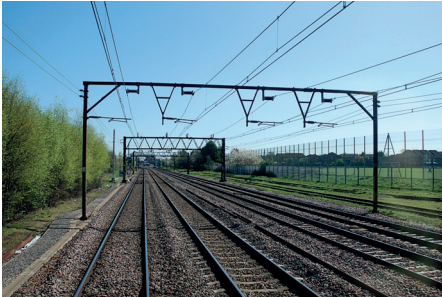
**a) Single-span knee-braced portal (Great Eastern)**

The gantries may be categorised into families of similar structural types. Common families are single masts, cantilevers, head span and portal structures, some varieties of which are illustrated in Figure 1. Most of the members making up the gantries are relatively slender rolled steel sections, either single or compound. The masts of the gantries are generally either embedded in, or bolted to, mass concrete foundations.

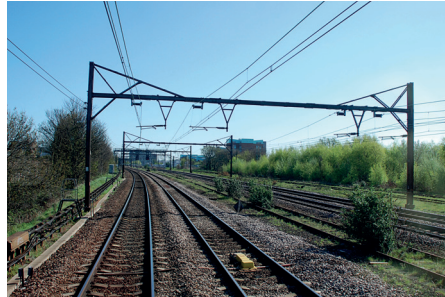
**b) Single-span top-tie portal (Great Eastern)**

Of the remaining structures, a number failed assessment due to condition. A common defect was corrosion where water tends to collect at the base of the mast. Single-span top-tie portals on the Great Eastern and two-track cantilevers on the Great Western were found to have a problem with connection capacity, which is why they failed even when assessed using non-linear analysis.

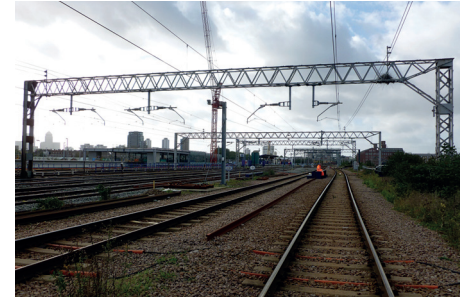
**c) Single-span lattice portal (Great Eastern)**

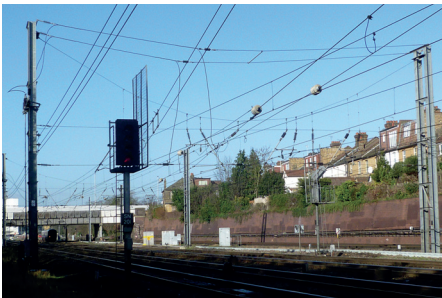
**d) Head span (Great Western)**

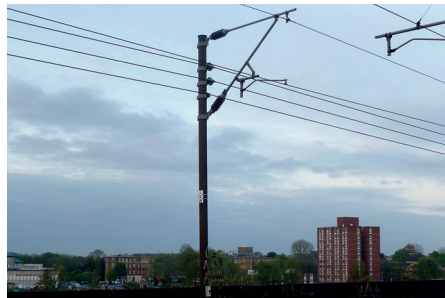
**e) Single-track cantilever (Great Western)**

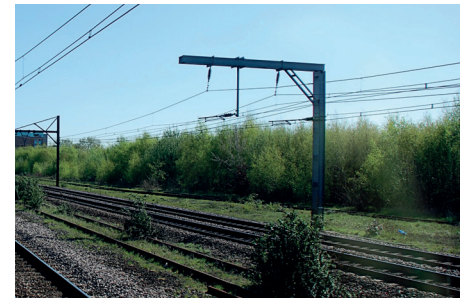
**f) Two-track cantilever (Great Western)**

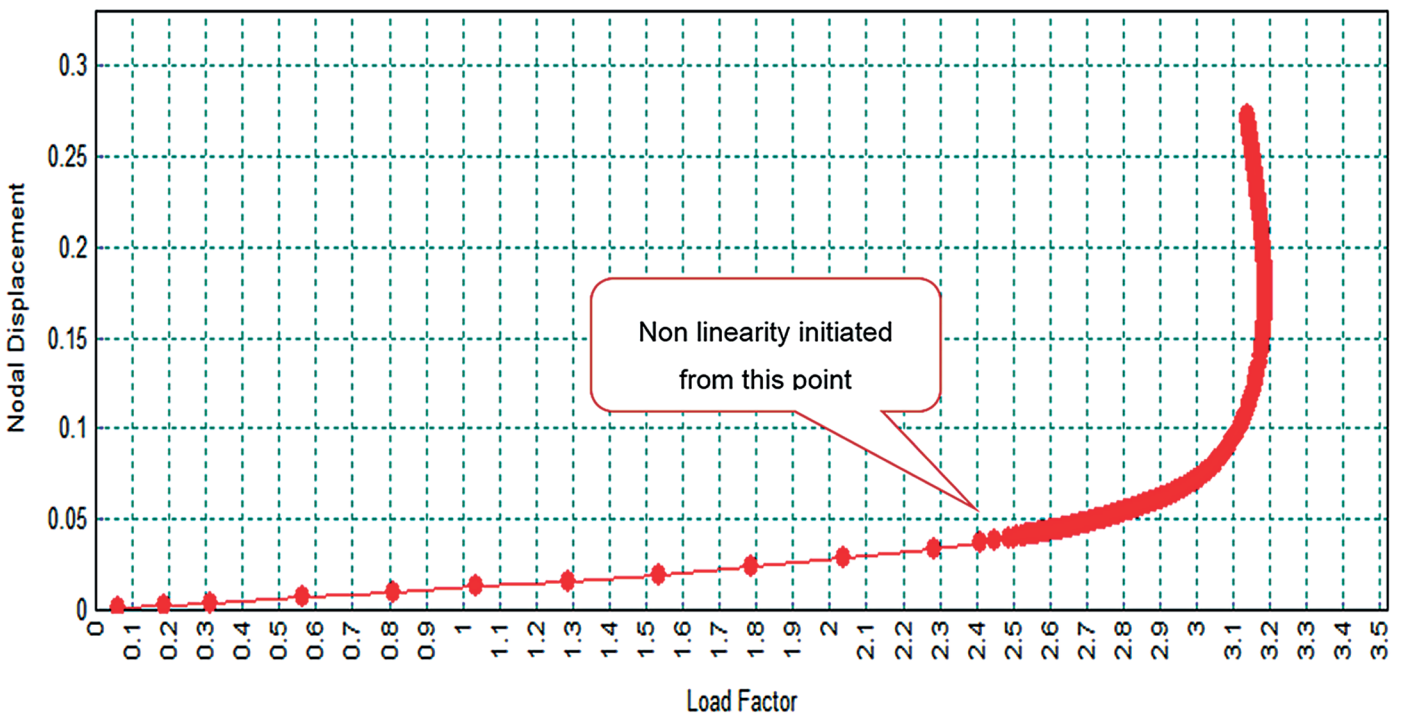
**Figure 3**  
Typical result from non-linear analysis indicating onset of non-linearity at load factor of approx. 2.4, based on displacement (m)

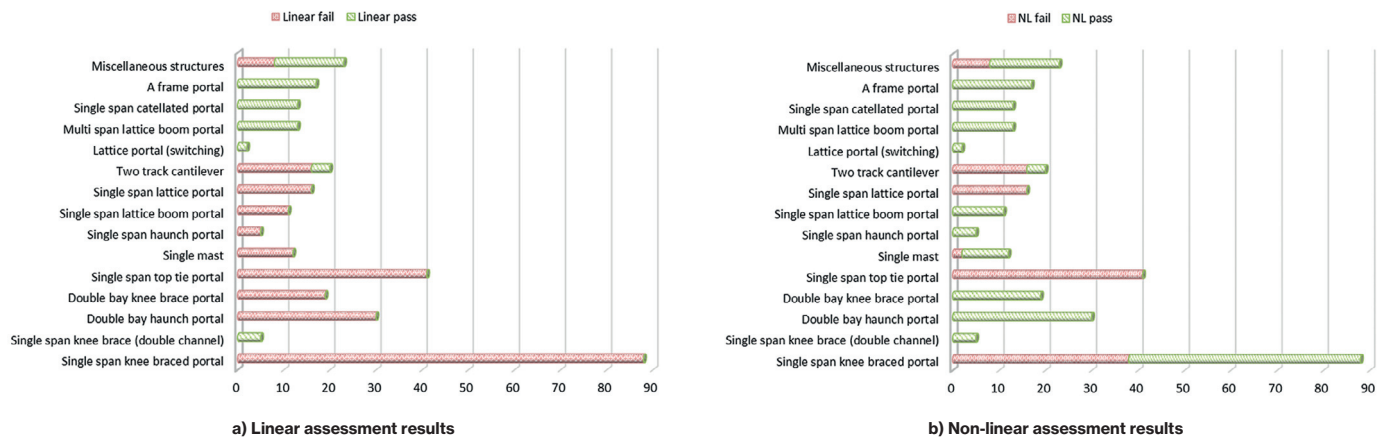
**Figure 4**  
Summary of assessment results for main types of structure (Great Eastern)

The assessment results are summarised graphically for the Great Eastern and Great Western structures in Figures 4 and 5 respectively. It can be seen that the rigorous non-linear assessments showed a significant improvement in terms of the number of gantries shown to be able to sustain the new TPS/OLE loading compared to the linear analysis. Overall, this number increased from 40% of the gantries considered to 75%.

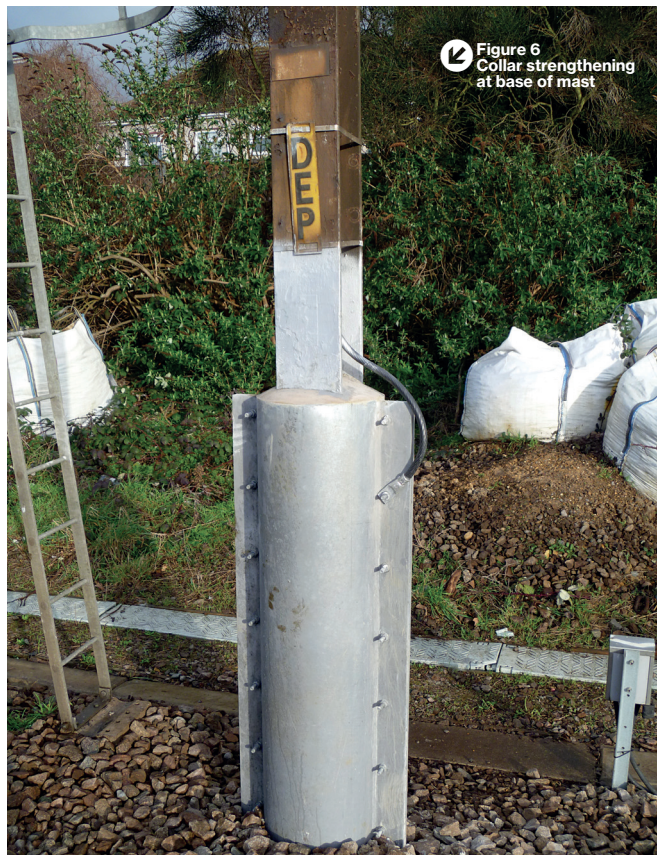
**Figure 6**  
Collar strengthening at base of mast

Where this had occurred, or mast base capacity was found to be inadequate, remedial measures were investigated. The solution proposed was a steel strengthening collar to be fixed around the base of the mast and bolted into the foundation. The space between the collar and the mast member was then infilled with concrete (Figure 6).
