Crossrail Archaeology Framework

C254 – Archaeology West

Non-listed Built Heritage Recording at Old Oak Common, Acton

CRL Document Number: C254-OXF-T1-RGN-CRG05-50001rev2

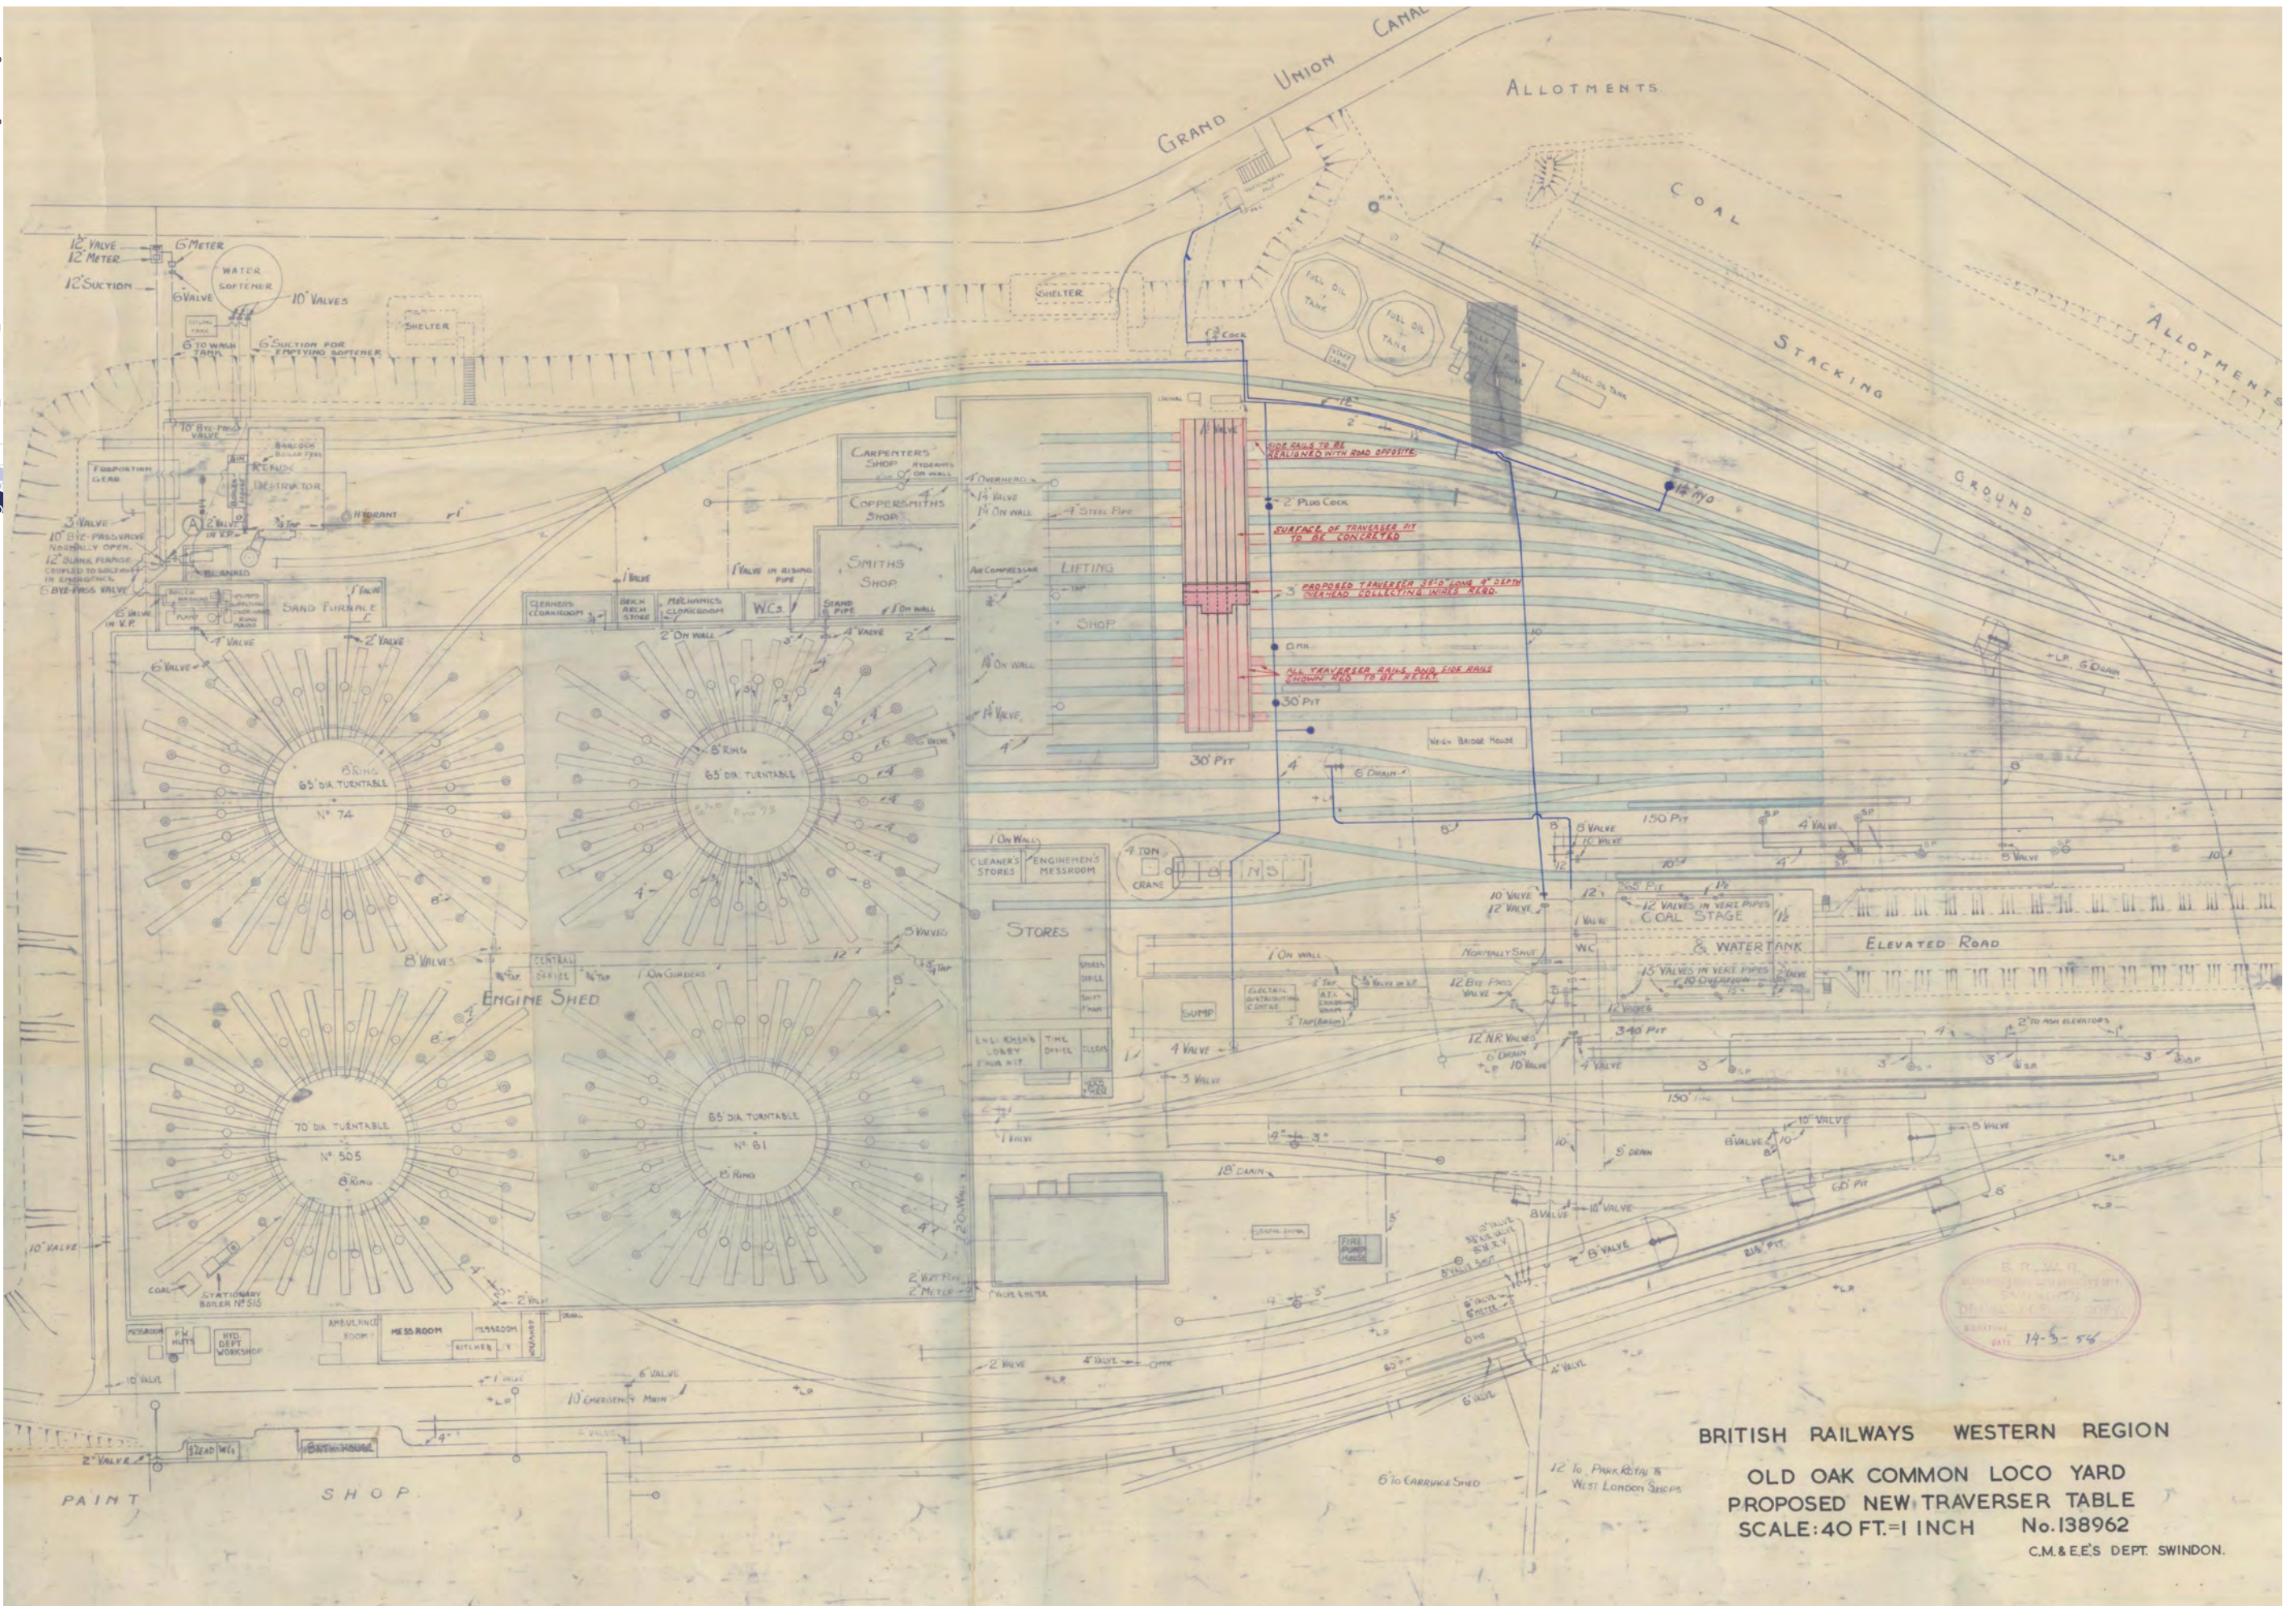
Figure 12: 1958 plan (ref: 2515-403-2195)

BRITISH RAILWAYS WESTERN REGION
 OLD OAK COMMON LOCO YARD
 PROPOSED NEW TRAVESER TABLE
 SCALE: 40 FT. = 1 INCH No. 138962
 C.M. & E.E.'S DEPT. SWINDON.

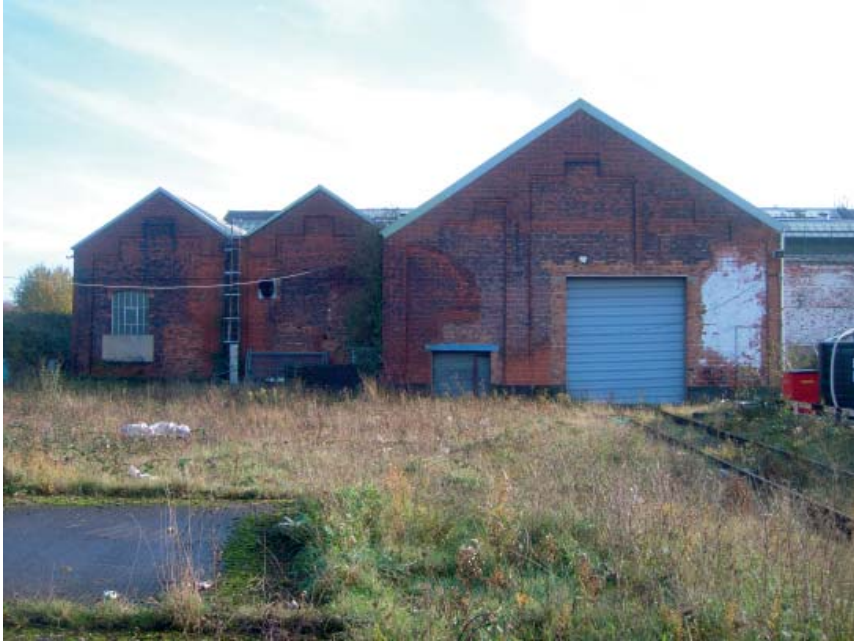
Plate 1

- Plate 15b.1: West elevation of Structures 15b and 15c
- Plate 15b.2: West elevation of 15b
- Plate 15b.3: South elevation of 15b
- Plate 15b.4: Interior of 15b looking east
- Plate 15b.5: Interior looking towards west wall
- Plate 15b.6: Roof inside 15b looking east
- Plate 15b.7: Door from 15b to 15c
- Plate 15b.8: North wall of 15b shared with 15c
- Plate 15b.9: View west in 15b
- Plate 15b.10: Jacks in 15b
- Plate 15b.11: Jacks in 15b.

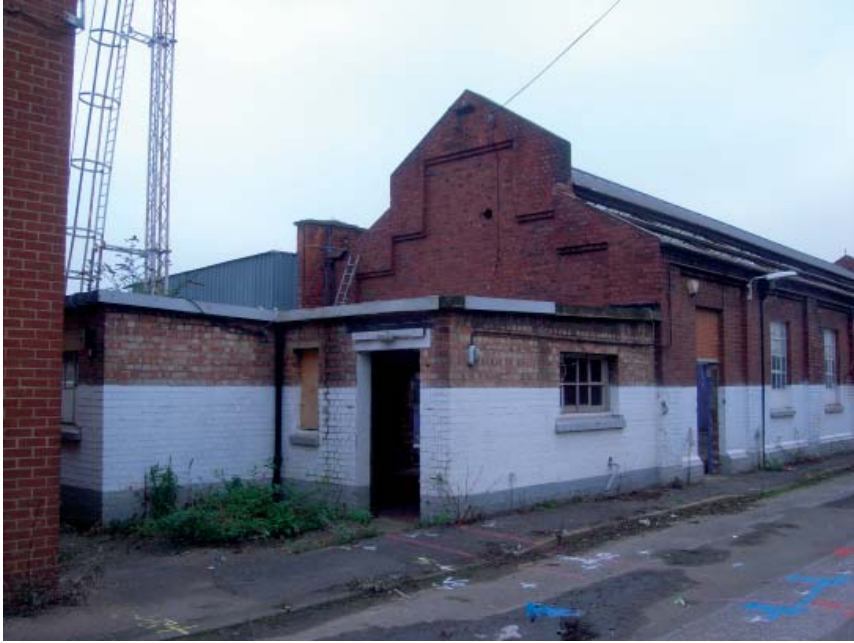
Figure 20.4: Building 20, North elevation

10.3.6 The **northern elevation** (*Plate 20.6; Fig 20.4*) was among the most interesting parts of the building because this represented one of the small surviving parts of the great engine shed which would have dominated the original Old Oak Common depot but which was demolished in 1964. Therefore the external (north) elevation of Structure 20 was originally an internal wall within the engine shed and it appears that the internal (south) face of this same wall was originally (briefly) the external face of the engine shed. The internal face of this wall is described further below in the internal

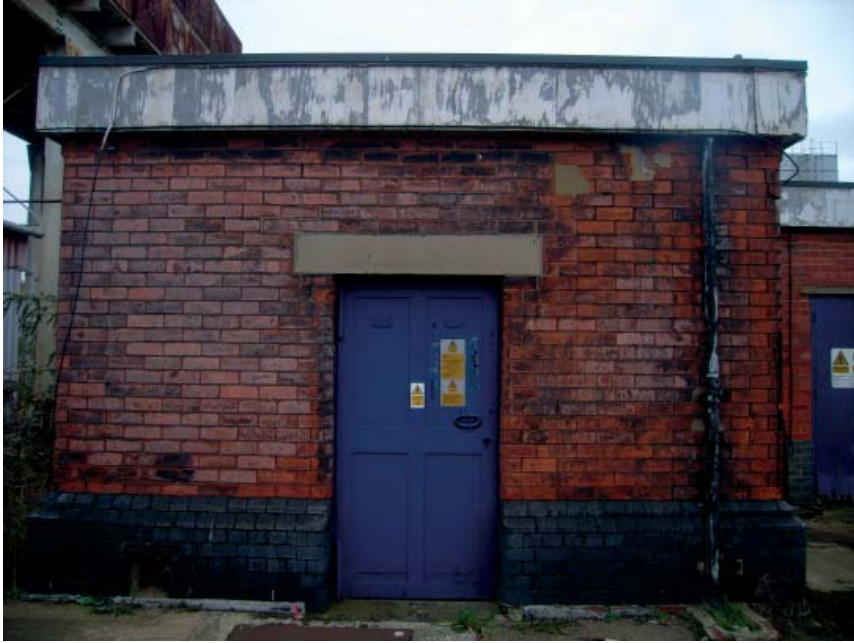
Plate 1

11.3.3 The doorway (*Plate 26.1*) into the original part of the building was set into the western elevation and had a deep concrete lintel. There was a large, steel four-panelled door with iron hinges, set into a steel frame. The heavy oval door handle (*Plate 26.12*) was stamped internally with 'Ratner Safe Co Ltd'. Identical maker's plates were attached to the upper exterior panels and read 'Ratner London'. There were recent soffits and fascias, through which a cast-iron downpipe passed. A cast iron warning sign attached to the southern elevation at chest-height read 'B.R.-W.R. Caution. Buried Electric Cables'. An attractive steel sign reading 'Danger High Voltage' was also attached to the northern elevation.

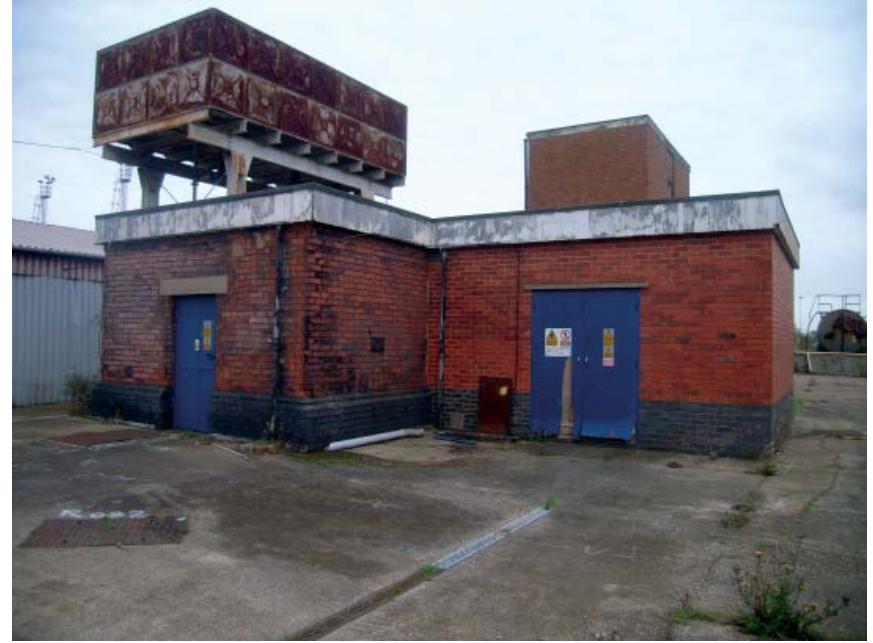
Plate 2

- 11.3.4 The c.1960s extension tried to match the original (at least superficially), with red stretcher-bond brick above a blue brick band although the newer building was simpler and did not have the chamfered plinth detail or rounded corners (*Plate 26.2, 26.4*). The same fascias and soffits were carried round the extension, but the cast iron downpipe in the angle between the two builds was clearly an original fitting re-used from the earlier building (*Plate 26.3*). Simple square grilles were set into the top-left and bottom-left of the western elevation and the top-right of the eastern elevation. A double door was set into western elevation and had been panelled over with plyboard, now delaminating. A second door was set into the eastern elevation. Both doorsets had thin concrete lintels. On the east elevation the two phases of brickwork were crudely keyed together.

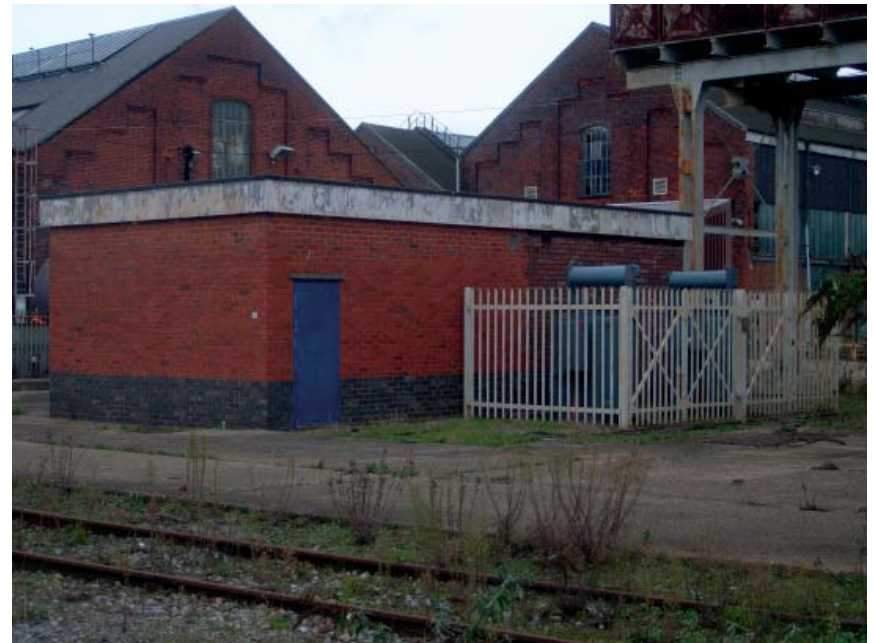
Plate 4

11.3.2 The original building was of red brick laid with a stretcher bond, sat on a deep plinth of blue bricks and a stepped shoulder of two chamfered brick courses. The four corners of the building were all formed from bullnose bricks with attractive stop bricks just below a flat roof – the chamfered shoulder also had bullnosed bricks on the corner. The brickwork was of the same character and same detailing as other primary buildings in the complex (eg Structure 15). The flat roof had a simple boarded fascia (1980s?) which also continued around the secondary extension.

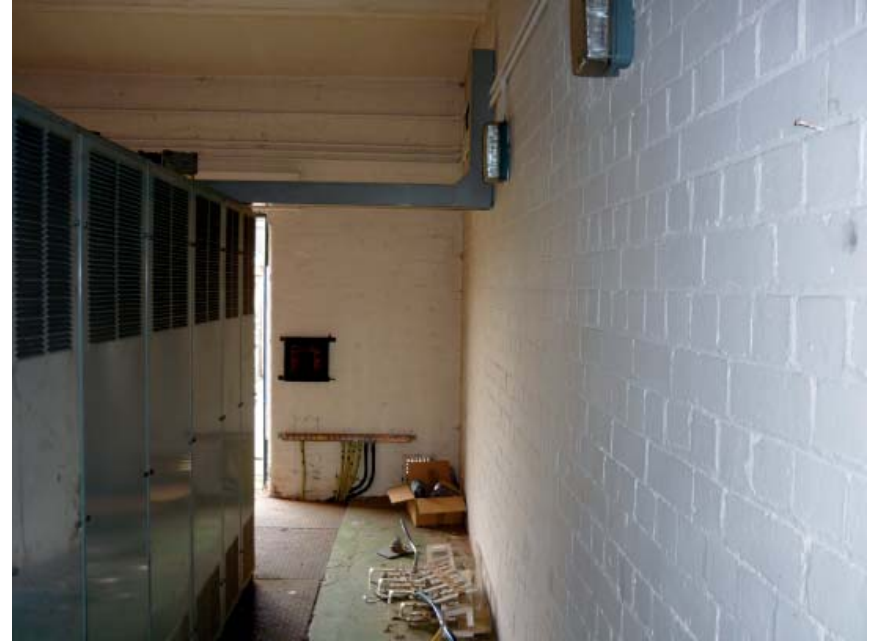
Plate 6

- 11.3.5 Internally, the primary building was a single open space housing a large bank of electrical plant towards the centre (*Plate 26.6, 26.7*). The walls of the original structure were of painted brick (unplastered English bond) and the roof structure was seen to be of cast concrete, the underside attractively shuttered into shallow barrel vaults (*Plate 26.9*). A shallow internal brick arch relieved the primary single door and both the internal and external jambs of this doorway were bullnosed. The steel frame of this doorway was fixed to the brick jambs with large steel screws. Light switches (*Plate 26.11*) were of old brass toggle-type in steel boxes although the lights themselves were relatively modern fluorescent tubes. The floor was a concrete slab although it incorporated steel sheets which presumably covered sunken cable ducts.

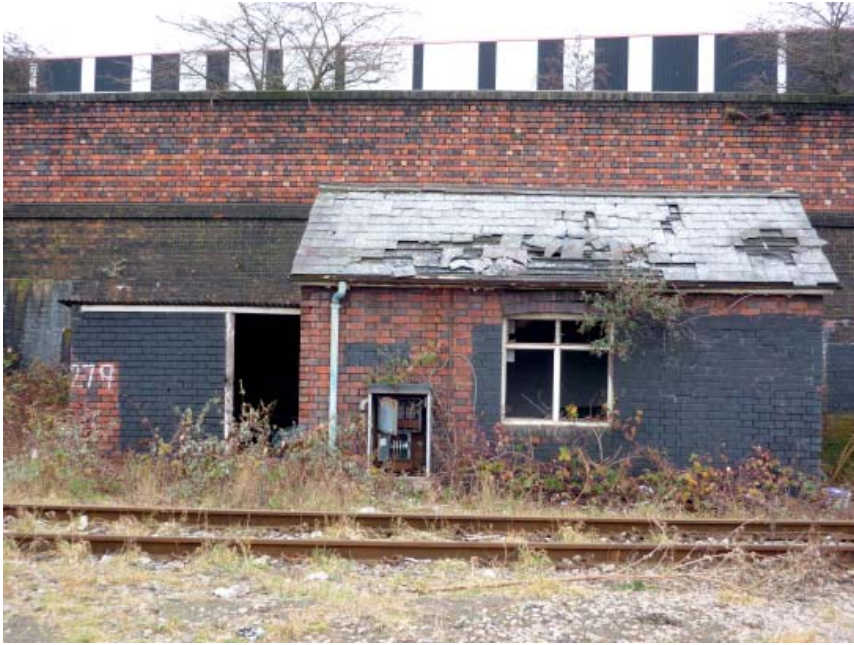
Plate 1

- 12.3.1 **Exterior:** This small single-storey building was constructed from red brick and had a rectangular plan with a double-pitched roof. The roof was clad in slate (although many had fallen off when the recording was undertaken) and there were white timber barge boards to each end (*Plate 39.1 - 39.3*). Building 39 comprised two distinct structures: the main primary building and a small outbuilding at the west end.

- 12.3.3 A small brick outbuilding with a single-pitched corrugated iron roof was attached to the western elevation (*Plate 39.1*). This had the initial appearance of being a rough extension but it is also shown on the 1916 map and it was constructed from the same bricks as the original structure and with the same bond. The two buildings are also roughly keyed in so they may be contemporary with each other. The roof of this structure was later and was supported by three east-to-west timbers, two of which also provided the wall plates to the northern and southern elevations. There was a simple, single door opening in the southern elevation and a brick-paved floor. Fitted timber shelves showed it had been used as a storeroom.

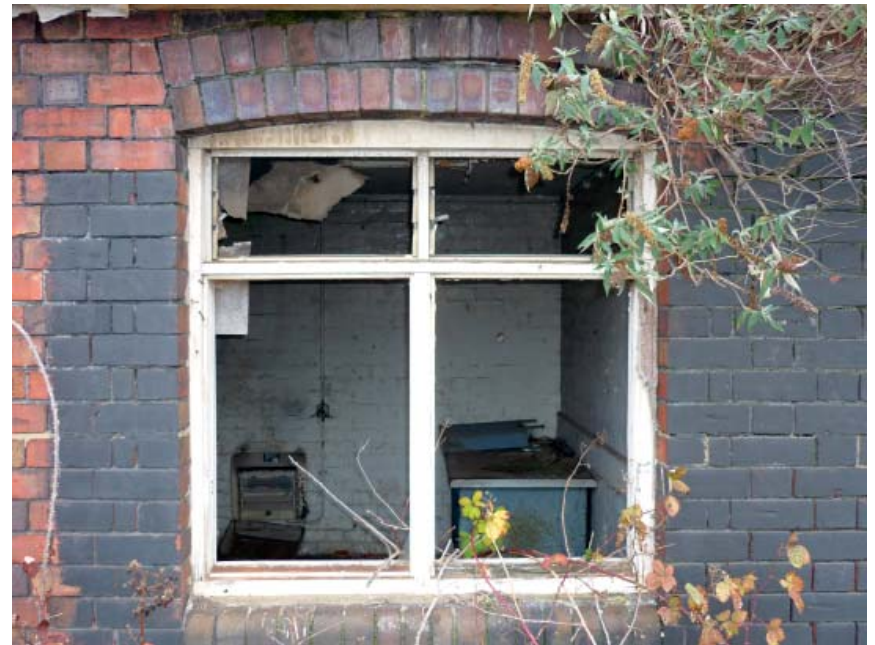
Plate 4

- Plate 39.1: South elevation of Building 39
- Plate 39.2: Building 39 from south-east
- Plate 39.3: Building 39 from south-west
- Plate 39.4: Window in south wall of Building 39
- Plate 39.5: Door at east end of Building 39
- Plate 39.6: Detail within Building 39
- Plate 39.7: Old boarding within Building 39
- Plate 39.8: Blocked fireplace in Building 39

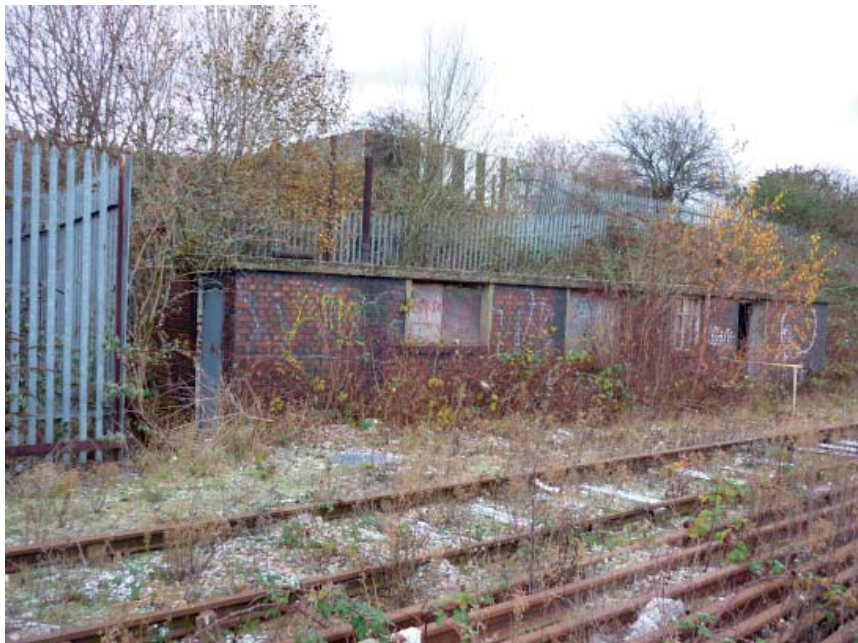
Plate 1

- Plate 1.1: Shunters Cabin from south-west
- Plate 1.2: South side of Shunters Cabin
- Plate 1.3: South side of Shunters Cabin
- Plate 1.4: Shunters Cabin from south-east
- Plate 1.5: Interior of Shunters Cabin
- Plate 1.6: Interior
- Plate 1.7: General view in Shunters Cabin
- Plate 1.8: General view inside building

14.3.3 The south elevation (*Plate 1.1 - 1.3*) contained three windows with concrete jambs, Crittal-type steel window frames and sills of brick set on edge at a slight gradient to shed water. All three windows were of different size. The easternmost was of six-pane, double casement design, with one casement opening. The central window was deeper and wider, and the westernmost window shallower and wider. The 1959 image referred to above shows that the westernmost window had a three-casement window with single panes. All the extant openings post-dated the use of the building as an air raid shelter, and dated from its conversion into a worker's cabin, probably shortly after the end of the war.

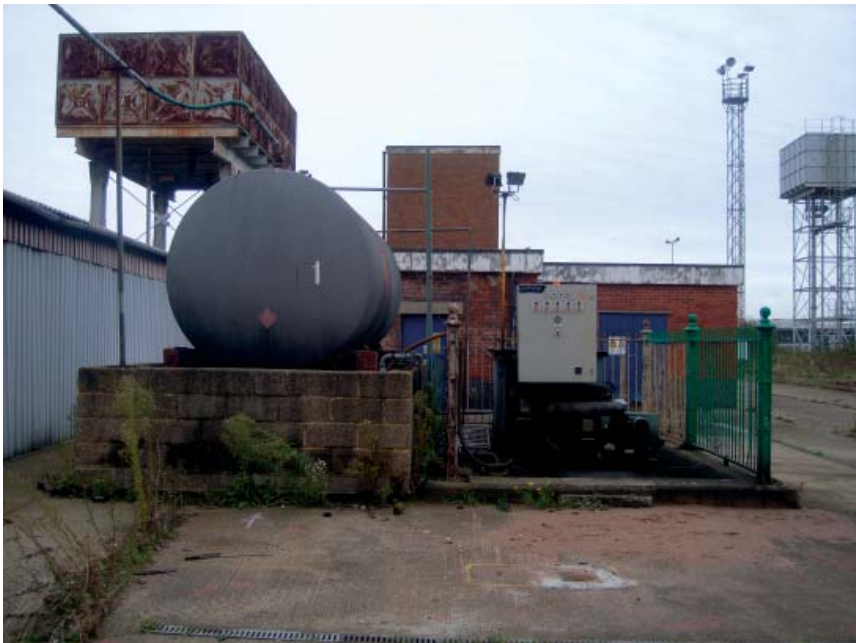
Plate 3

17.1.5 Structure 24 comprised a sunken, shuttered concrete-lined sump-pit (c.3.5 m x 7 m in plan) above which was set a metal grille and pump plant set on an RSJ across the pit. The RSJ supported a large oblong steel tank or container sat centrally within the footprint of the grille, and twin sets of pumps to which flexible hoses were attached mounted to the south of the tank; another was located to the east. A grey control box was mounted to the western side of the tank (*Plates 24.3-23.4*).

Plate 24.3: General view looking east

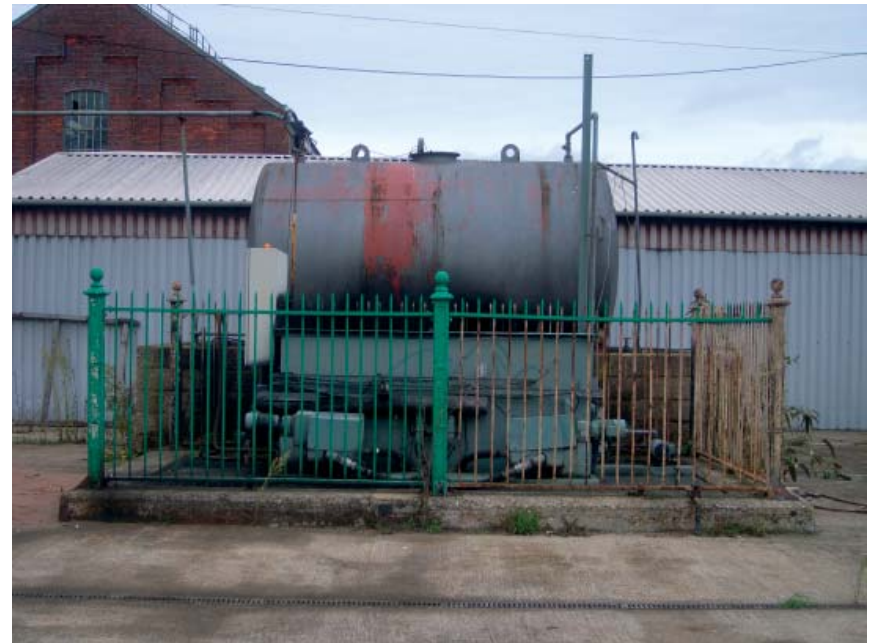
Plate 4

Plate 24.4: General view looking north.

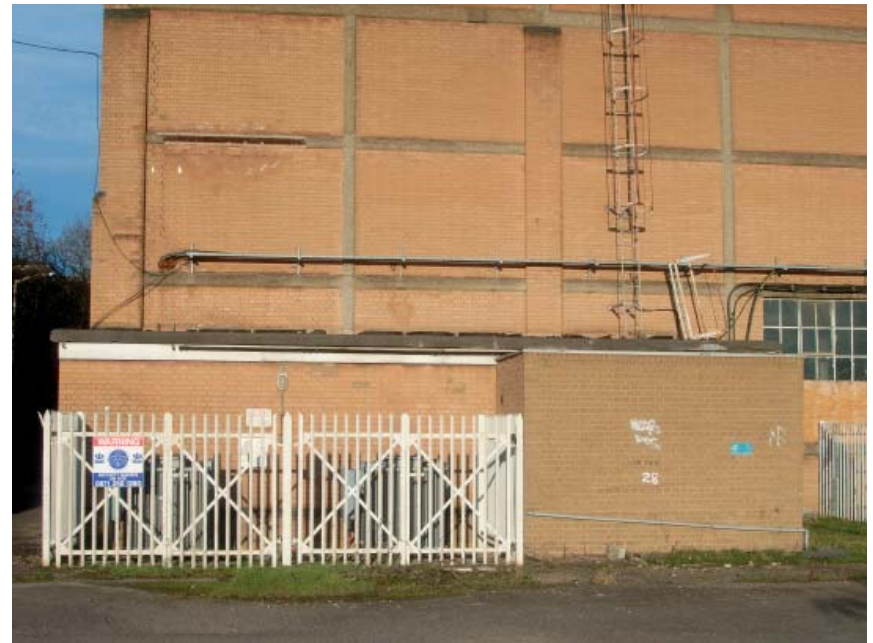
Plate 4

18.1.7 At the eastern end of the southern wall (*Plate 36.4*) a small secondary extension had been added in a beige brick which was similar to the brick used in the reconstruction of the east end of Structure 22 (in c.1940). The west elevation of Building 36 had been largely rebuilt with the same beige coloured brick used in the extension (but without the low shoulder) and it may be that it was dismantled to allow the removal/replacement of a large transformer (or other plant) inside (*Plate 36.3*). To the north end of the west elevation was a simple set of double doors.

Plate 36.4: View looking north

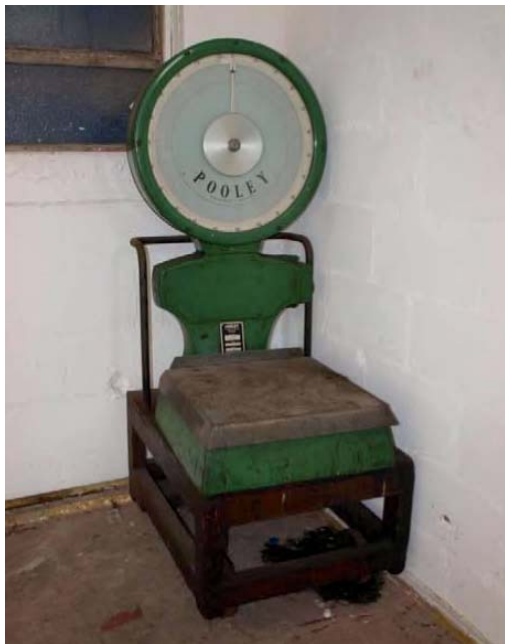
Plate 3

21.1.6 A set of metal scales (rated to 220lbs) on a timber trolley with a metal handrail were situated inside the building (*Plate 5.3*). The maker's mark on the backplate read: 'H Pooley & Son LTD contractors BR (W) 11347'. The face of the scales indicated that they had been built in Birmingham. The serial number was S-584164. The firm was founded during the 18th century in Liverpool, where it remained until it moved to Birmingham in the 1890s. In 1913 the firm became part of the Avery organisation, although it continued to manufacture goods under its own name ('English Weights and Measures', online at: <http://home.clara.net/brianp/nameskp.html>). The firm was responsible for supplying and maintaining the weights and scales of many railway companies and continued to do so until after nationalisation, as this example attests.

Plate 5.3: Scales inside building

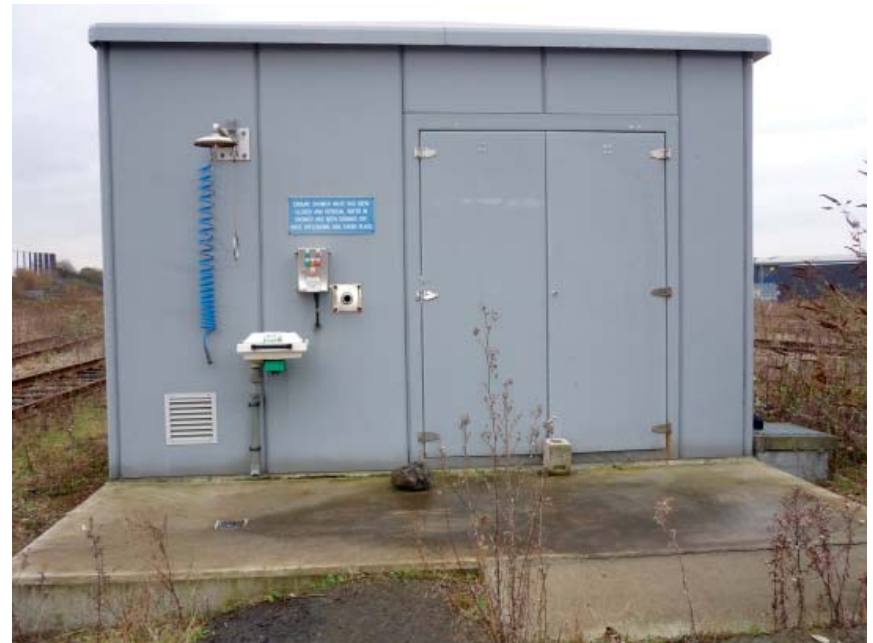
Plate 4

22.1.6 The most interesting feature of this structure was an external emergency shower and eyewash station (*see Plate 7.4*) which drained into a central drain set in the external concrete apron in front of the western gable.

Plate 7.4: West end of Building 7

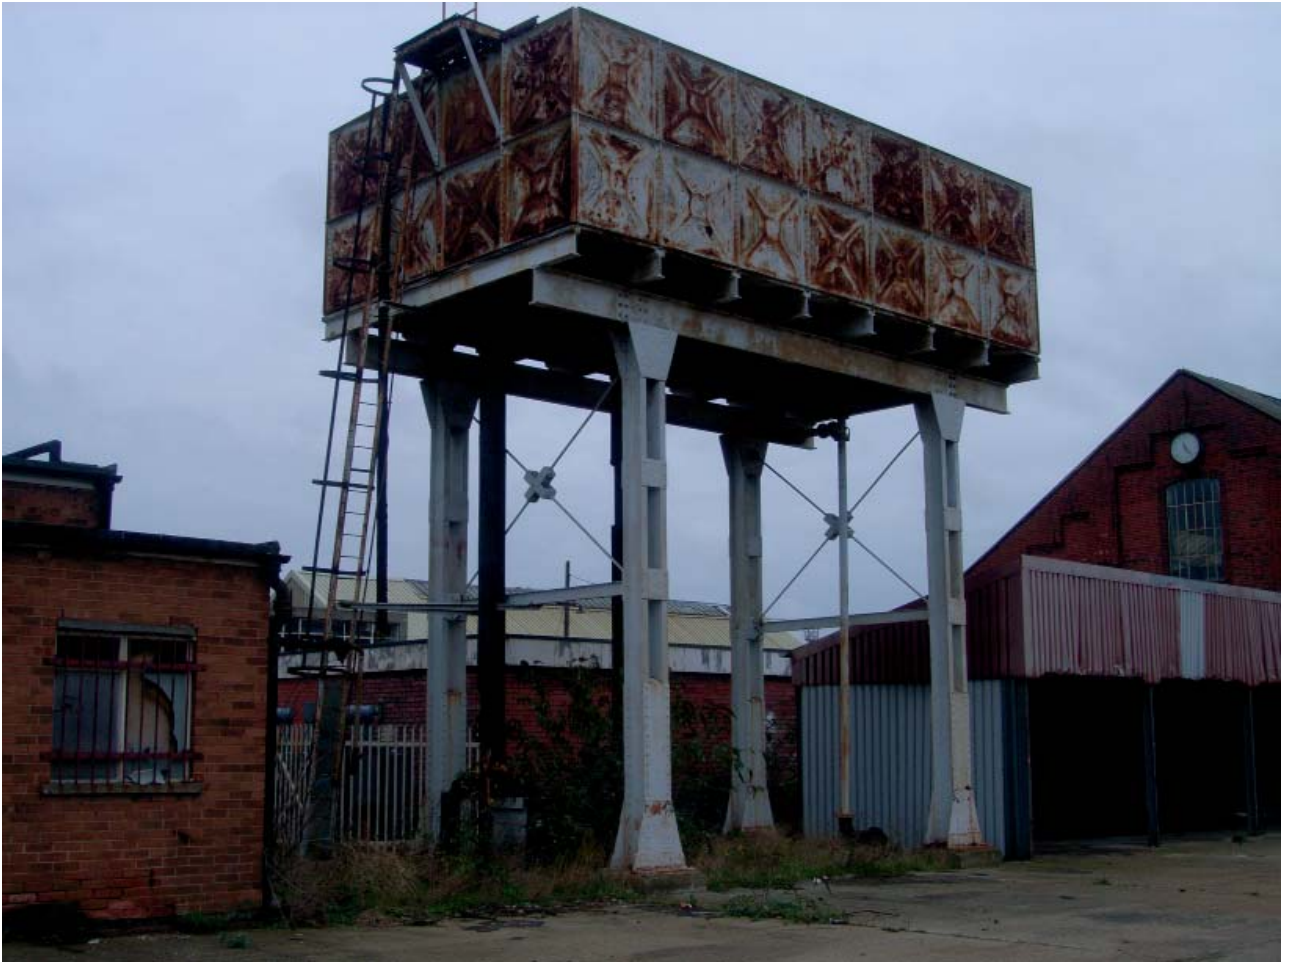
Plate 1

26.1.5 A large tank was supported at each corner by four heavy-duty stanchions set on concrete plinths (*Plate 13.1*). The stanchions were formed from two C-section RSJs braced by various plates and connectors rivetted to the RSJs. The stanchions, which were stamped 'Earl of Dudley Steel' supported two large horizontal RSJs which bore eight shorter transverse RSJ rails which carried the tank. The stanchions were joined mid-way to their height at each end, above which crossed tie bars further bracing the stanchions (*Plate 13.2*). The tank itself on top of the support structure was formed of modular square plates, impressed to add strength, and bolted together. The base of the tank was formed from four rows of seven plates, the long sides being of two rows of seven, and the sides of two rows of four. The top of the tank was open to the skies.

Plate 13.1: General view of water tower looking south-west

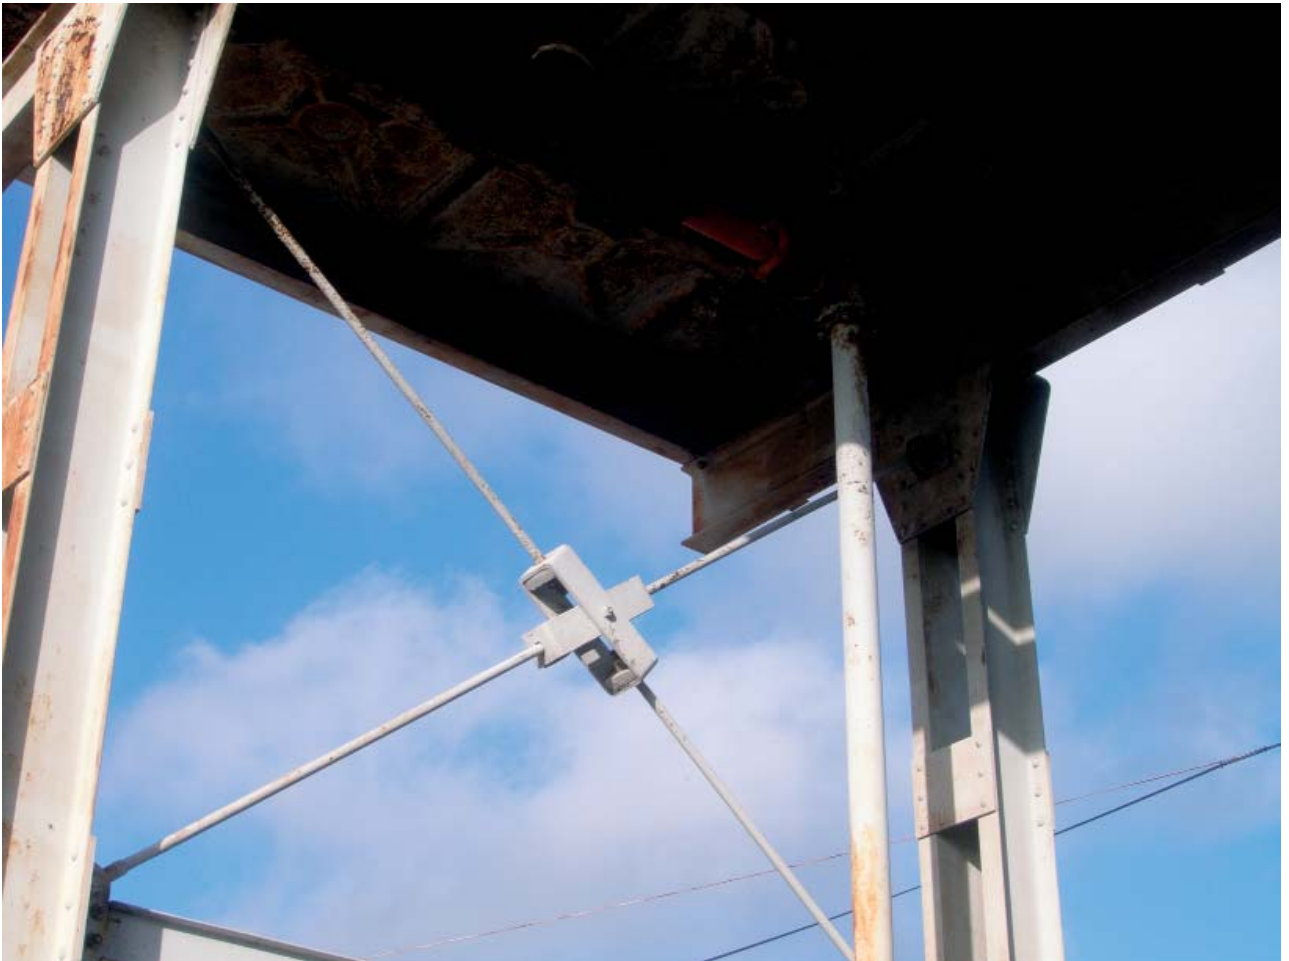
Plate 2

Plate 13.2: Detail of water tower structure
