CENTRAL SECTION PROJECT
INTERIM STATEMENT
Archaeological Evaluation & Boreholes
91 to 109 Moorgate – XSP10

Document Number: C257-MLA-X-RGN-CRG02-50051

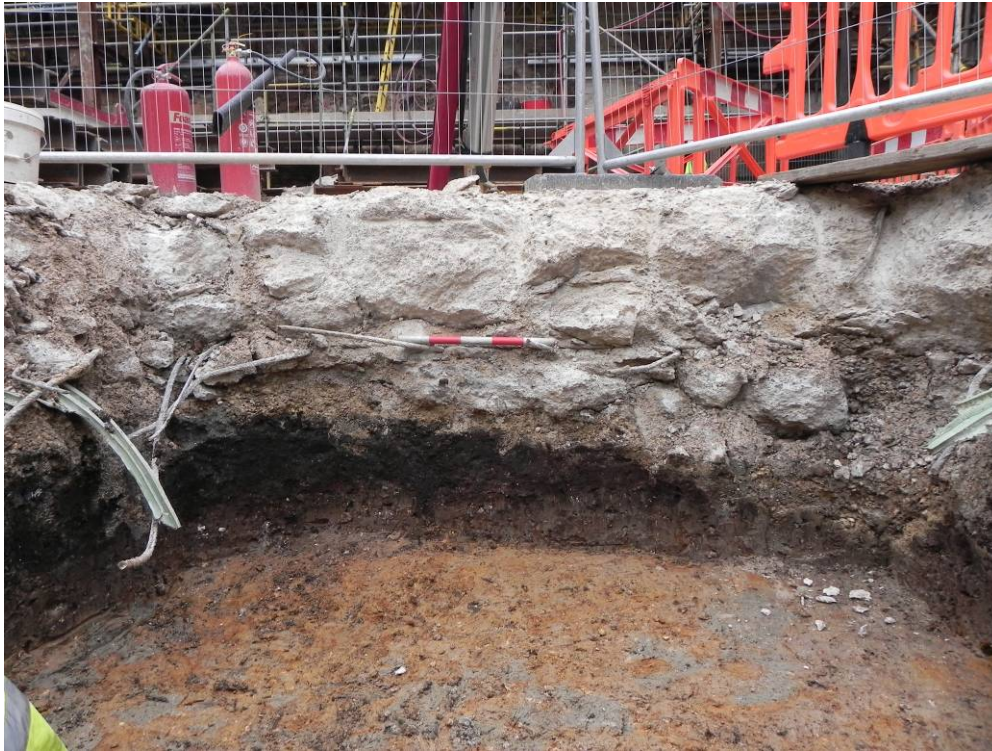
Photo 1 Trench 4 looking north. Section showing gravelly brickearth natural overlain by marsh deposits.

Trench 4 (see Fig 1)	
Location	91 to 109 Moorgate (in the west of the basement)
Dimensions	3.50m north-west to south-east and 2.40m north-east to south-west x 1.20 to 1.60m deep
Centre of test trench: London Survey grid co-ordinates:	83057/ 36320
OS grid co-ordinates:	
Modern Ground Level/top of the slab	110.00m ATD (10.00m OD)
Modern subsurface deposits	None
Level of base of archaeological deposits observed and/or base of trench	Base of archaeological deposits: 108.83m ATD (8.83m OD, 1.17m bGL) Base of trench: 108.60m ATD (8.60m

OD, 1.40m bGL)
Natural observed	Gravelly brickearth [15] at 108.83m ATD (8.83m OD, 1.17m bGL), overlaying natural brickearth layer [16] at 108.60m ATD (8.60m OD, 1.40m bGL) Natural gravel not seen.
Extent of modern truncation	110.00m to 109.25m ATD
Archaeological remains	Dating Evidence, Finds, and Samples
Organic wetland clay layer [14] with very occasional anthropogenic material, including animal bone fragments and Mortar fragments. Highest surviving point at 109.05m ATD (9.05m OD, 0.95m bGL). Overlies natural brickearth and overlain by [13].	Undated. Assumed to be Roman in period from observation in other evaluation trenches (Trench 5 and 6). CBM fragments (Roman?) Monolith and bulk samples (20 litres) (Bulk sample No. {9} and Monolith {7}) from context [14] in the south-east section.
Dark brown organic silty clay layer [13]. Highest surviving point at 109.27m ATD (9.27m OD, 0.73m bGL).	Undated – no dating evidence, assumed to be late Roman or early medieval Monolith and bulk samples (20 litres) (Bulk sample No. {6} and Monolith {7}) from context [13] in the south-east section.

Cut of small trench [18] truncating layers [13] and [14] and natural layer [15]. Highest surviving point 109.25m ATD (9.25m OD, 0.75m bGL).	
Clay fill [17] of small trench [18]. Sealed by modern overburden.	Undated – no dating evidence, assumed to be medieval or post-medieval.
Interpretation and summary	
<p>The gravelly brickearth layer [15] could potentially be re-deposited given its position immediately below layer [14]. The absence of any man-made material does not support or disprove this. The cleaner brickearth layer [16] can confidently be identified as natural.</p> <p>Layer [14] is likely to be Roman in date, and is comparable with layer [10] from Trench 5 and layer [3] from Trench 6 (see C257 ARCHAEOLOGY CENTRAL Interim Statement Archaeological Evaluation (C136 Moorgate Shaft) 91 to 109 Moorgate - XSP10, Document No. C257-MLA-X-RGN-CRG02-50028) both of which produced Roman pottery. This layer can be interpreted as either a dumping or levelling layer, or as a proto-marsh deposit within which Roman finds accumulated. The geo-archaeological samples should help to refine this interpretation.</p> <p>Layer [13] is almost certainly representative of the formation of the marsh in this area and is, therefore, likely to be late Roman or medieval in date.</p> <p>The small pit [18] in the south-western corner is currently undated. It could be modern as it is immediately below the concrete in the sequence and cuts layers [13] and [14]. However no modern remains were found in the fill and as such it may also be of medieval or post-medieval date.</p>

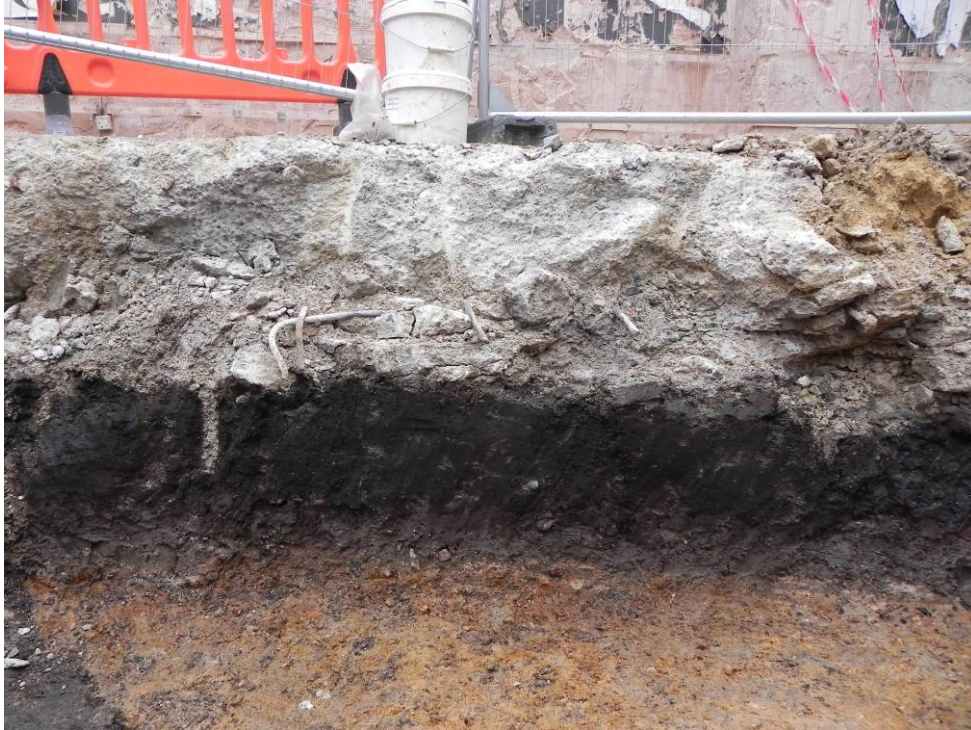
Photo 2 Trench 5 looking west. Section showing natural gravelly brickearth overlain by clay and marsh deposits

Trench 5 (see Fig 1)	
Location	91 to 109 Moorgate (in the west of the basement)
Dimensions	2.80m north-west to south-east and 3.10m north-east to south-west x 1.20 to 1.60m deep
Centre of test trench: London Survey grid co-ordinates	83064/36317
OS grid co-ordinates:	
Modern Ground Level/top of the slab	110.00m ATD (10.00m OD)
Modern subsurface deposits	None
Level of base of archaeological deposits observed and/or base of trench	Base of archaeology: 108.83m ATD (8.83m OD, 1.17m bGL) Base of trench: 108.45m ATD (8.45m OD)
Natural observed	Gravelly brickearth [11] at 108.81m ATD (8.81m OD, 1.19m bGL), overlaying natural brickearth layer [12] at 108.45m ATD (8.45m OD, 1.55m bGL) Natural gravel not seen.
Extent of modern truncation	110.00m to 109.25m ATD
Archaeological remains	Dating Evidence, Finds, and Samples
Organic wetland clay layer [10] with very occasional anthropogenic material, including animal bone fragments and mortar fragments. Highest surviving point at 108.99m ATD (8.99m OD, 1.01m bGL). Overlaying natural [11] and overlain by [9].	3 sherds of pot – Provisionally dated to Roman CBM fragments (Roman?) Monolith and bulk samples (20 litres) (Bulk sample No. {10} and Monolith {8}) from context [10] in the eastern section.

Dark brown organic silty clay layer [9]. Highest surviving point at 109.35m ATD (9.35m OD, 0.65m bGL). Overlaying [10] and sealed by modern overburden.	Undated – no dating evidence, assumed to be late Roman or early medieval Monolith and bulk samples (20 litres) (Bulk sample No. {5} and Monolith {8}) from context [9] in the eastern section.
Interpretation and summary

The gravelly brickearth layer [11] could potentially be re-deposited given its position immediately below layer [10]. However the absence of any man made material does not support or disprove this. The cleaner Brickearth layer [12] can confidently be identified as natural.

Layer [10] is likely to be Roman in date as it contained Roman pottery and other evidence of Roman activity such as CBM. This layer can be interpreted as either a dumping or levelling layer, or as a proto-marsh deposit within which Roman finds accumulated. The geo-archaeological samples may be able to refine this interpretation.

Layer [9] is almost certainly representative of the formation of the marsh in this area and is likely to be late Roman or Medieval in date.

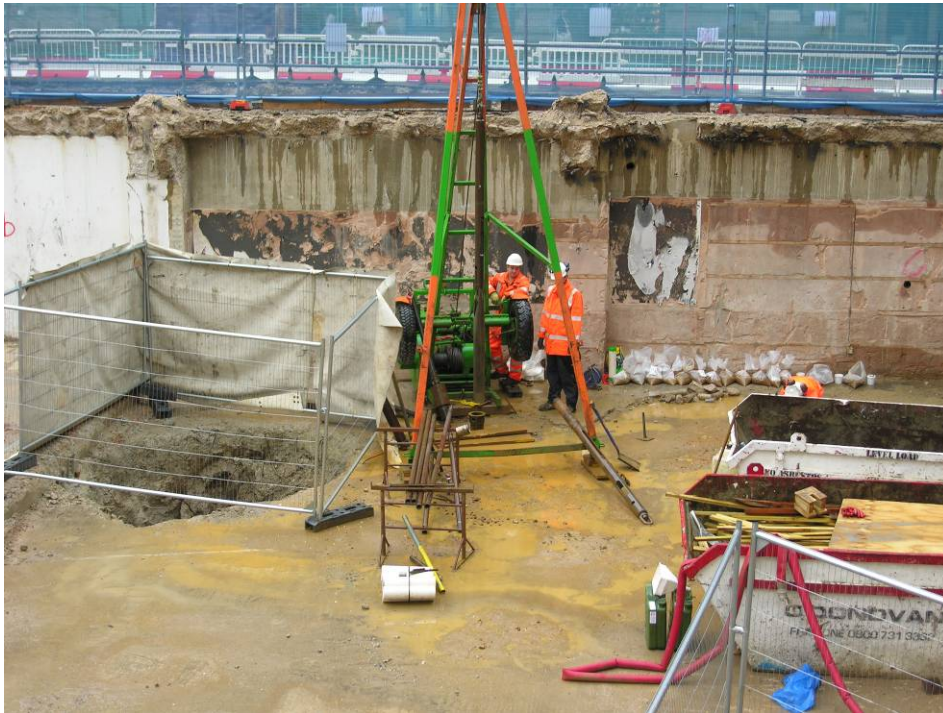
Borehole 01					
Location		Basement of 91-109 Moorgate			
Dimensions		Excavation monitored to 2.95m bGL			
OS National grid coordinates		532716/181622			
LSG grid coordinates		83065/ 36314			
Modern Ground Level/top of the slab		110.00m ATD (10.00m OD)			
Modern subsurface deposits		Excavated to 2.95m bGL			
Level of base of archaeological deposits observed		108.50m ATD (8.50m OD)			
Natural observed		Sandy gravel			
Truncated/not truncated?		Not truncated at 1.50m bGL (108.50m ATD (8.50m OD))			
Extent of modern truncation		Concrete slab 600mm thick (9.40m OD)			
Top (m bGL)	Base (m bGL)	Top (m OD)	Base (m OD)	Description	Interpretation

0.00	0.60	10.00	9.40	Reinforced concrete slab	Basement slab
0.60	1.05	9.40	8.95	Soft mid purplish grey silty clay	Marsh deposit clay
1.05	1.50	8.95	8.50	Dirty clay silt, occasional small CBM & charcoal fragments.	Redeposited brickearth

1.50	1.95	8.50	8.05	Mixed clayey gravel, small-mid sub-rounded pebbles. No anthropogenic signs or inclusions.	Natural brick earth
1.95	2.45	8.05	7.55	Sandy gravel	Natural terrace gravel

2.45	2.95	7.55	7.05	Coarse sandy gravel	Natural terrace gravel

Photo 3 Borehole 1. Looking east. During drilling

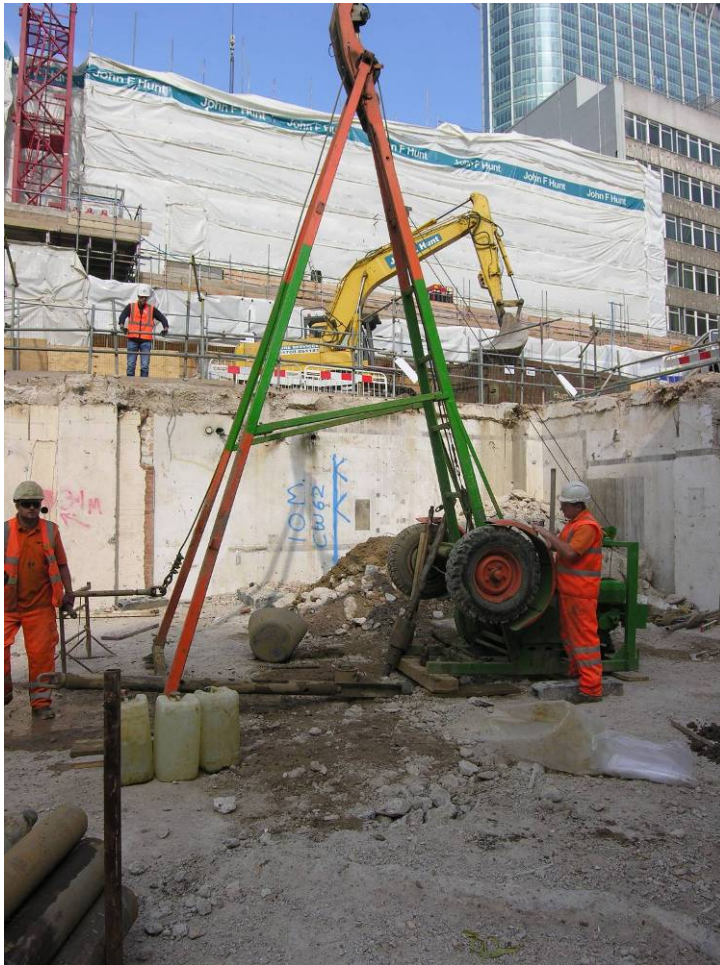
Borehole 03					
Location		91-109 Moorgate			
Dimensions		Borehole excavation monitored to 2.4m bGL			
OS National grid coordinates		532710/181639			
LSG grid coordinates		83060/36331			
Modern Ground Level/top of the slab		110.30m ATD (10.30m OD)			
Modern subsurface deposits		Concrete slab over modern made ground			
Level of base of archaeological deposits observed		108.50m ATD (8.50m OD)			
Natural observed		Natural brickearth at 108.30m ATD (8.30m OD) and Sandy gravel at 107.90m ATD (7.90m OD)			
Truncated/not truncated?		Not truncated at 2m bGL (108.30m ATD (8.30m OD))			
Extent of modern truncation		Concrete slab 600mm thick (9.40m OD)			
Top (m)	Base (m)	Top (m OD)	Base (m OD)	Description	Interpretation

0.00	1.40	10.30	8.90	Reinforced concrete slab.	Basement slab
1.4	2.00	8.90	8.30	Firm light brown very slightly sandy clay. Rare lenses of slightly greyer clay. Occasional small bi-valve, sub rounded pebbles, charcoal and CBM flecks.	Re-deposited brickearth

2.00	2.4	8.30	7.90	Slightly laminated firm greyish brown sandy clay. Sterile with moderate-frequent sub angular pebbles.	Natural brickearth
2.4	LOE	7.90	7.90	Sandy gravel. Occasional sub rounded pebbles.	Natural terrace gravel

Photo 4 Looking north-west. Borehole 3 during drilling

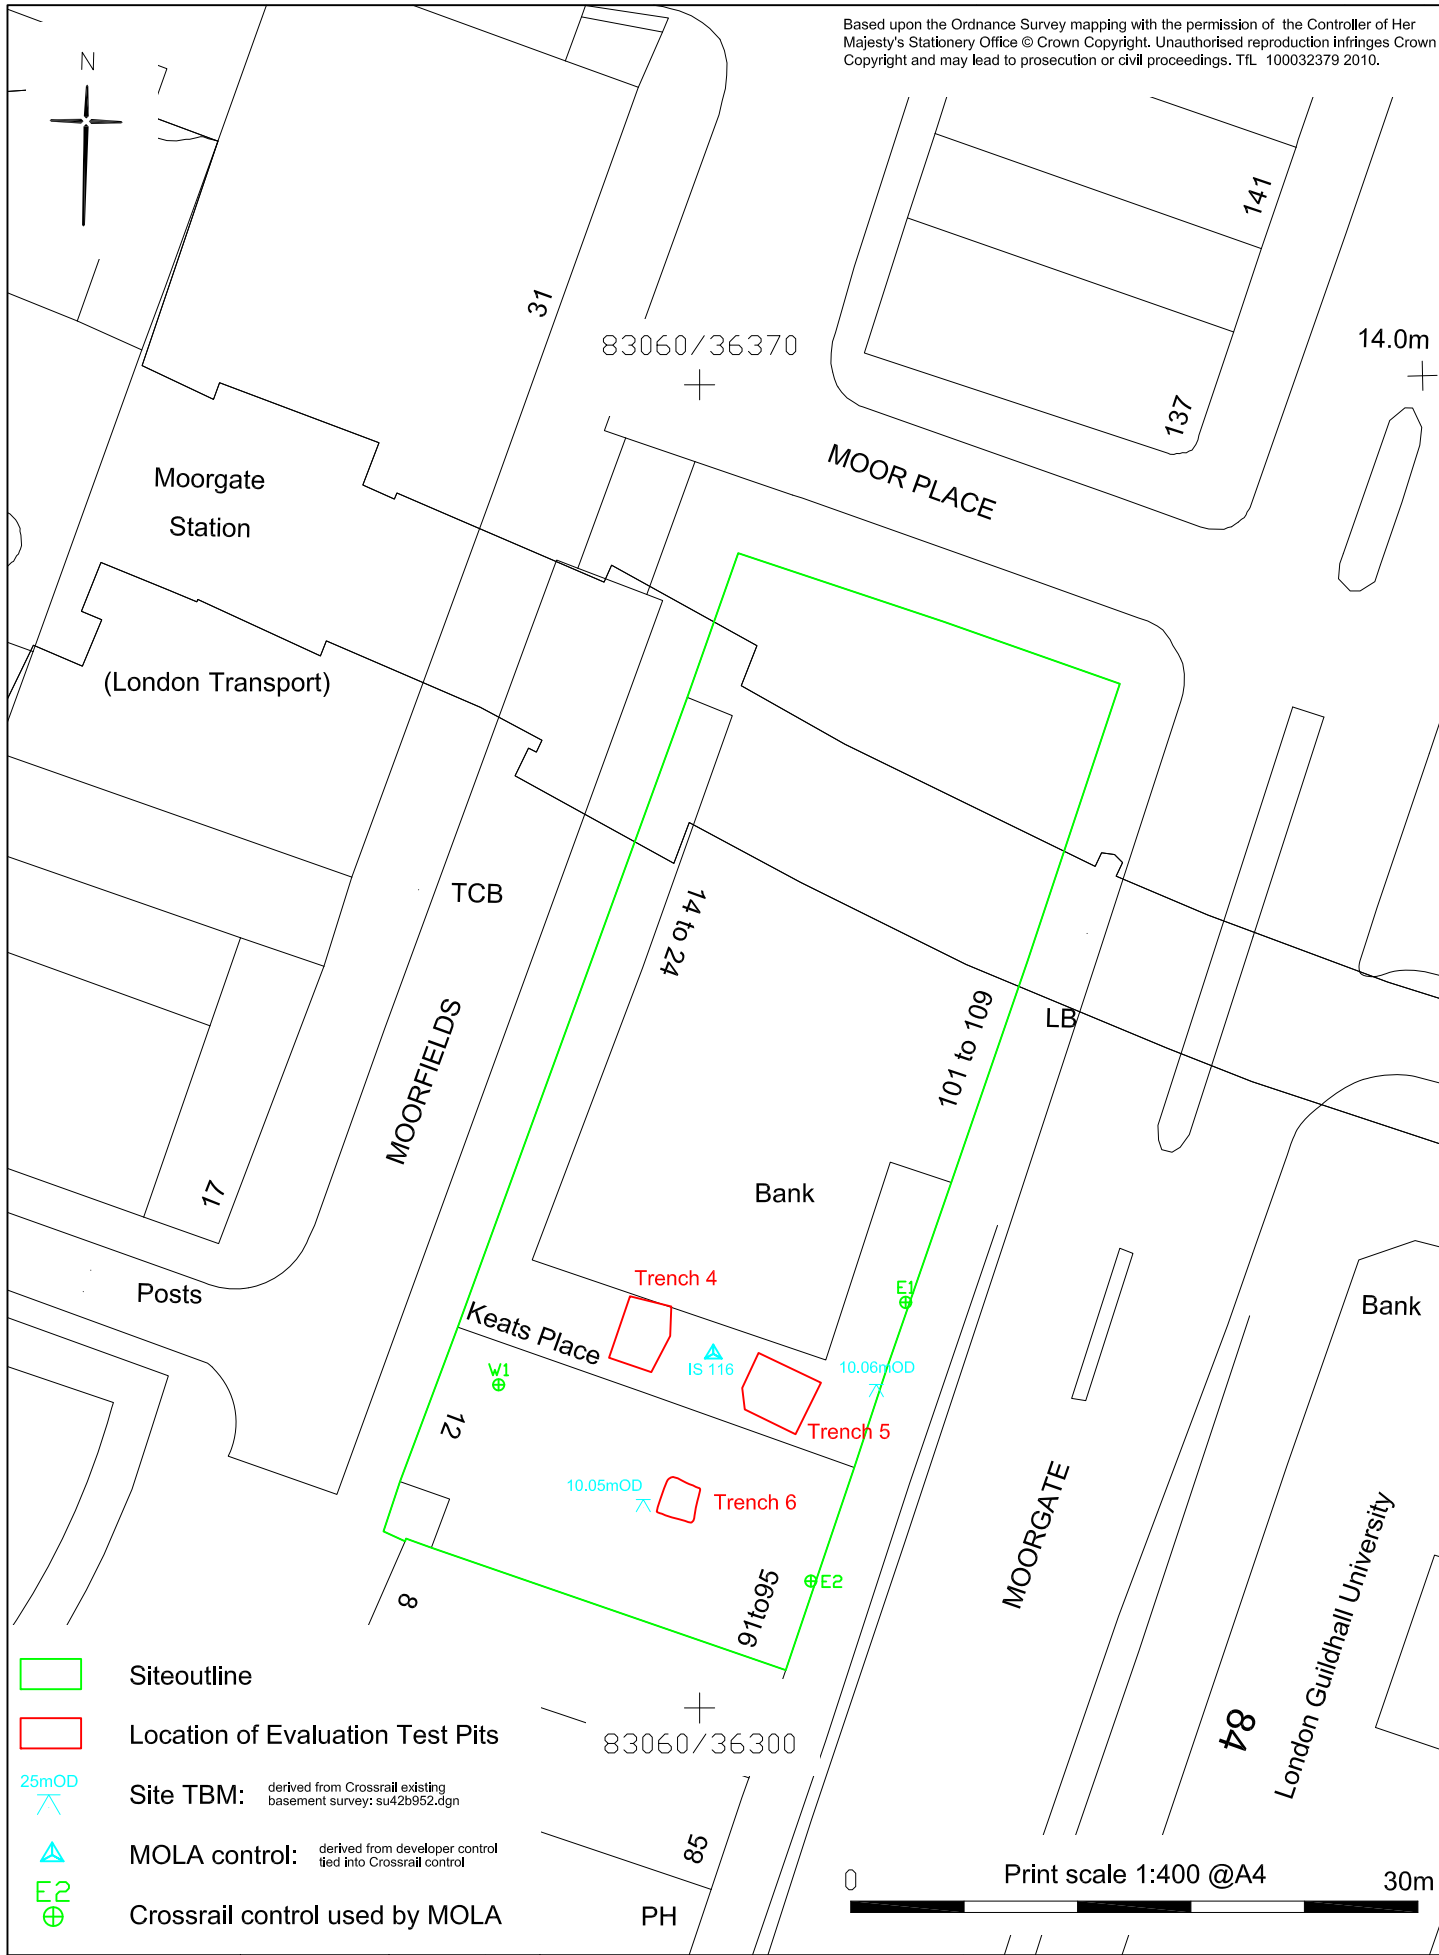
Event code / Site code:
XSP10: FIG 1

Fig 1 Location of Evaluation Test Trenches and Boreholes
