C261 ARCHAEOLOGY EARLY EAST

Interim Statement

Archaeological Excavation

Stepney Green Shafts

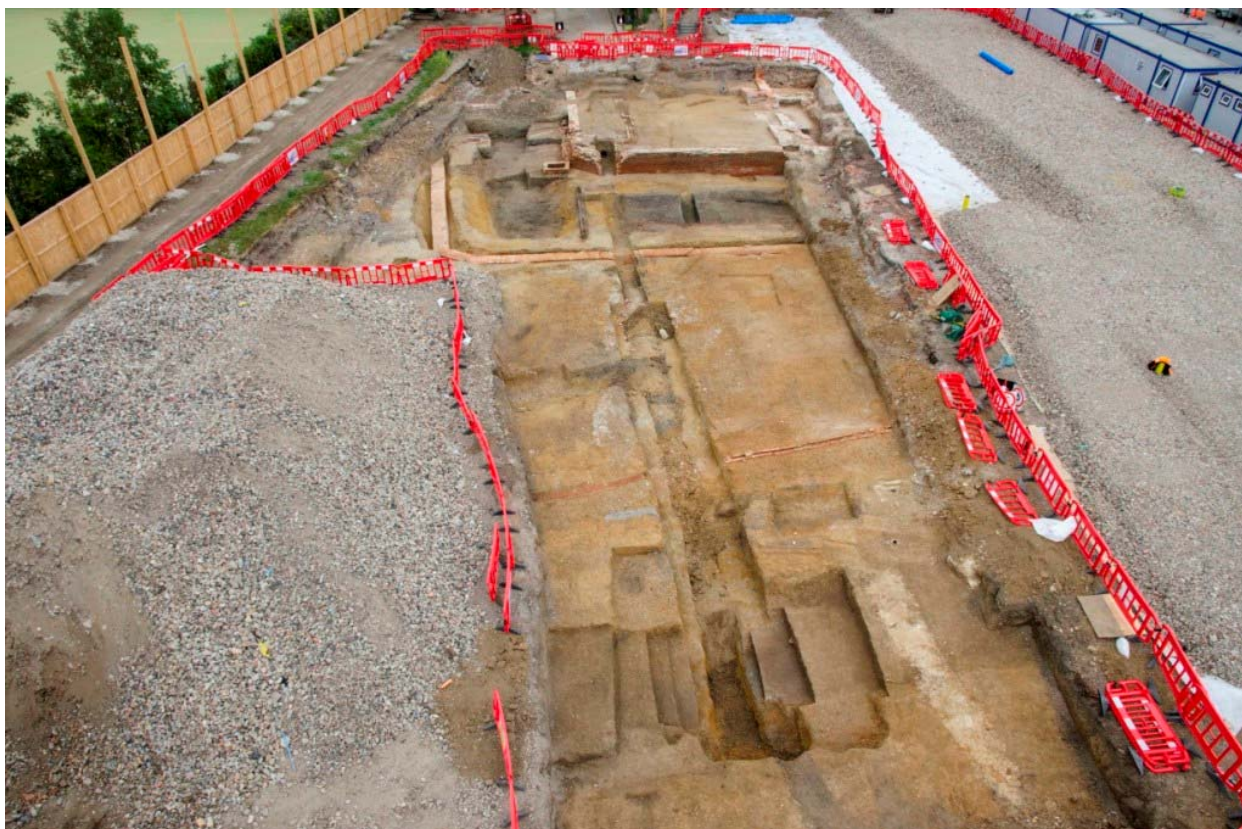
Photo 1 Excavation trench looking north, 16th August 2011. Late-medieval or early-Tudor ditch to the bottom of the picture, King John's Court (Palace) / Worcester House to the top. Earlier, remains were excavated in the area below the crushed concrete, to the left.

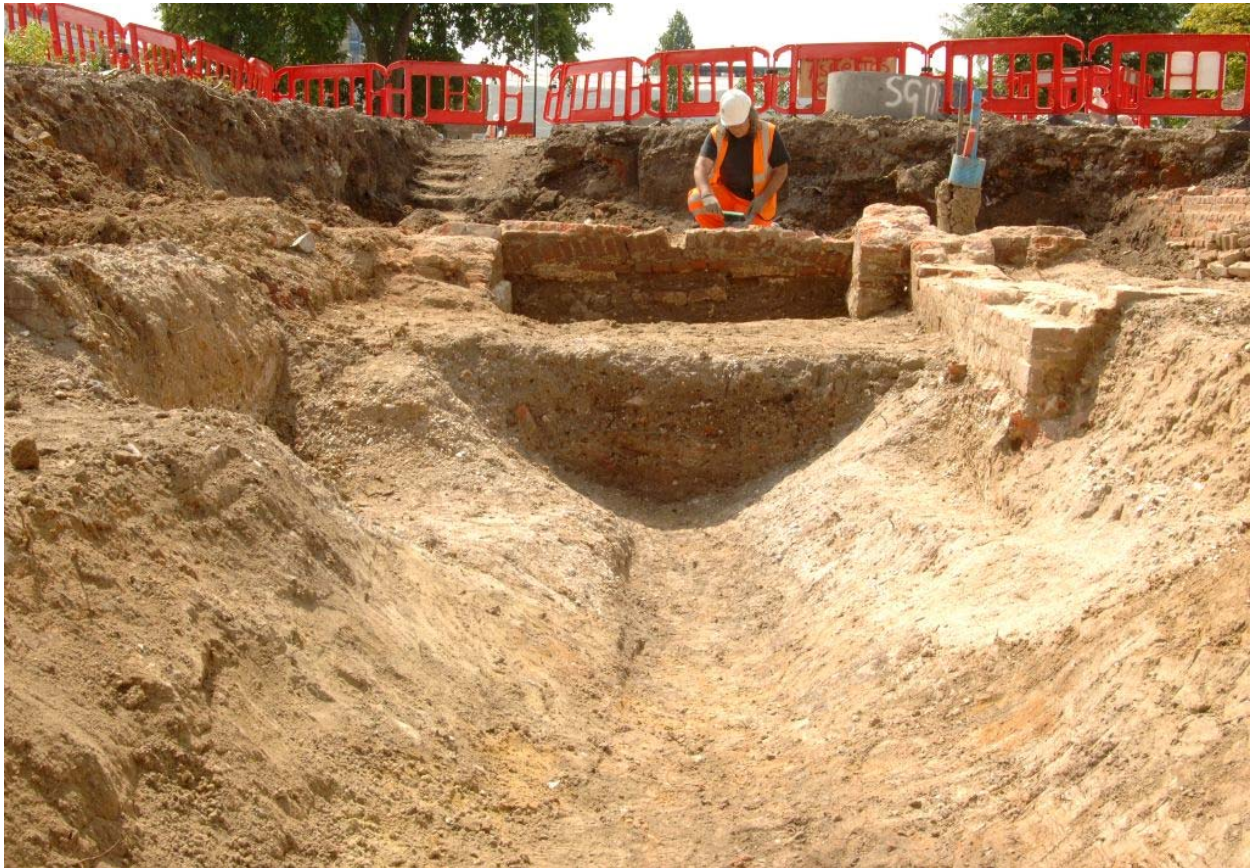
Photo 2 Possible latrine structure [210] (after north side removed), and wall [212] dug into late-medieval or early-Tudor ditch fills [229][219][218][217] and [216].

A brick structure over the backfilled south end of the ditch is possibly a latrine, although this interpretation is tentative, and a further wall built onto it overlies a drain dug into the later fills north of the possible latrine. Preliminarily dated by bricks on site, it was constructed in the 16th- or early 17th-century.

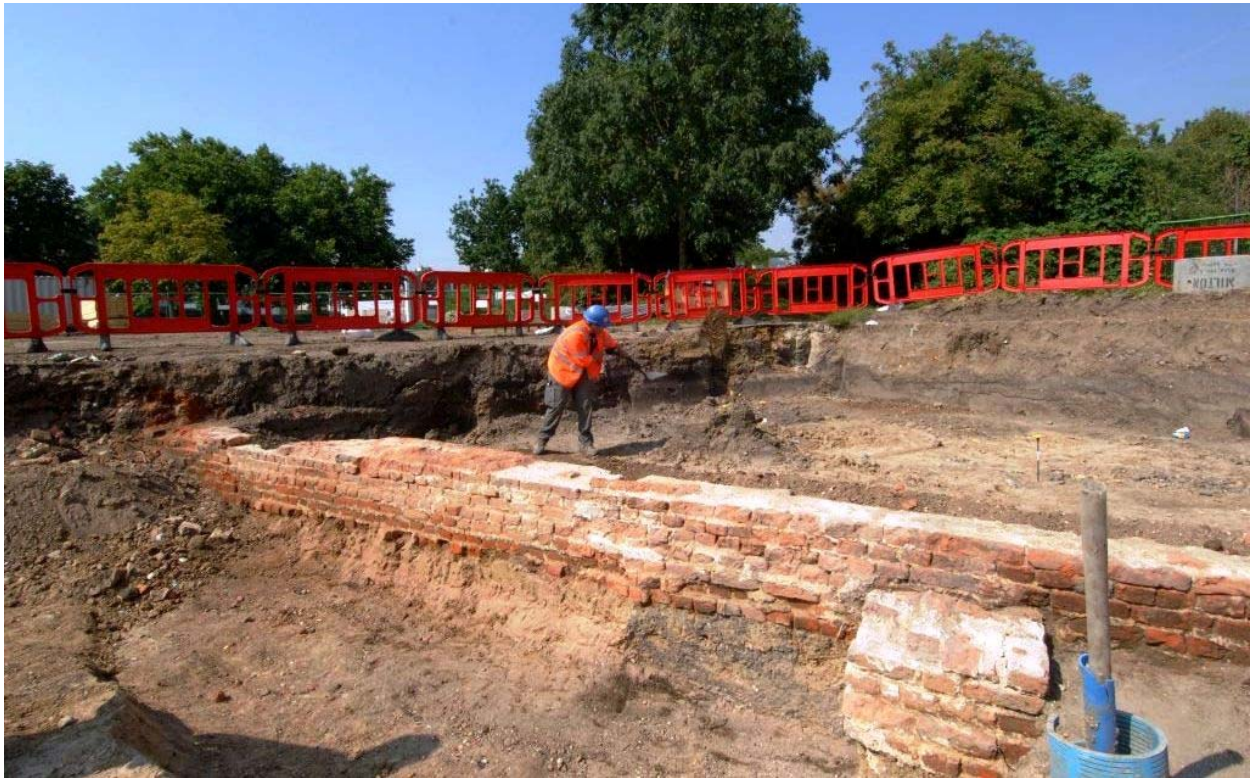
<p>Interpretation and summary</p>	
<p>Brick wall [196] might have been the “estate” wall of the property that became known variously as King John’s Palace, King John’s Court and Worcester House, or that of a neighbouring property. It is possible that L-shaped ditch [220] / [284] was part of an earlier moat which enclosed a larger “island” and that it was retained as a decorative garden feature.</p> <p>It is possible that structure [210] is a form of latrine – or else it is some garden feature over part of the ditch that was retained when the southern part was backfilled. Whatever its function, it seems probable that the structure was retained when ditch [220] was filled as drain [206] was dug through the ditch fills and a brick wall [212] both covered [206] and joined onto [210]</p> <p>The most significant remains are those of the main phase of King John’s Court (Palace) / Worcester House. Unfortunately the floor levels of this building have been truncated by later activity, but some details of the superstructure may be gleaned from bricks and tile reused in later drains and moulded-stone fragments found elsewhere.</p> <p>Outer wall [233] was substantial and probably implies that the moat [279][249] not only lapped at its edge (and thereby it functioned as a retaining wall) but also that it stood to a considerable height and would have been a significant “security” feature (cf Lullingstone and Herstmonceaux castle). The timber baseplate [287] is thought to have originally been paired with another the east side of the natural gravel “causeway”. It is likely that they lay just below the water level of the moat and that mortices held tennoned uprights of a bridge crossing the moat. There is no door opposite the end of the baseplate, lending support to the idea that it supported a bridge at a higher level. If this interpretation is correct, the location of such a bridge</p>

Photo 3 Late 15th- or 16th-century wall [196]

The earliest remains of King John's Palace are thought to have been a major wall and ditch found on the south-west area of the excavation trench. The wall has been provisionally dated to the late 15th-century or 16th-century and these remains may be from the end of the medieval or the transition to the post-medieval period.

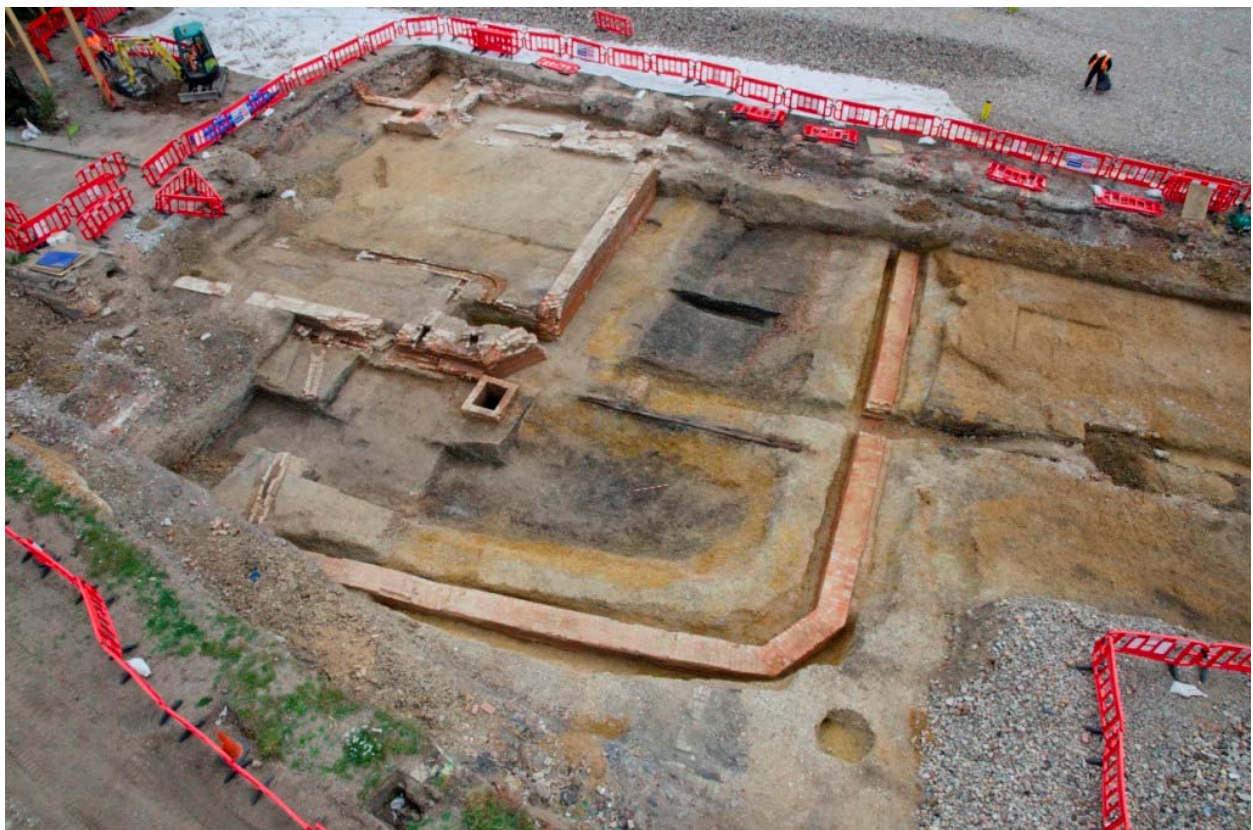
Photo 4 Remains of King John's Court (Palace) / Worcester House

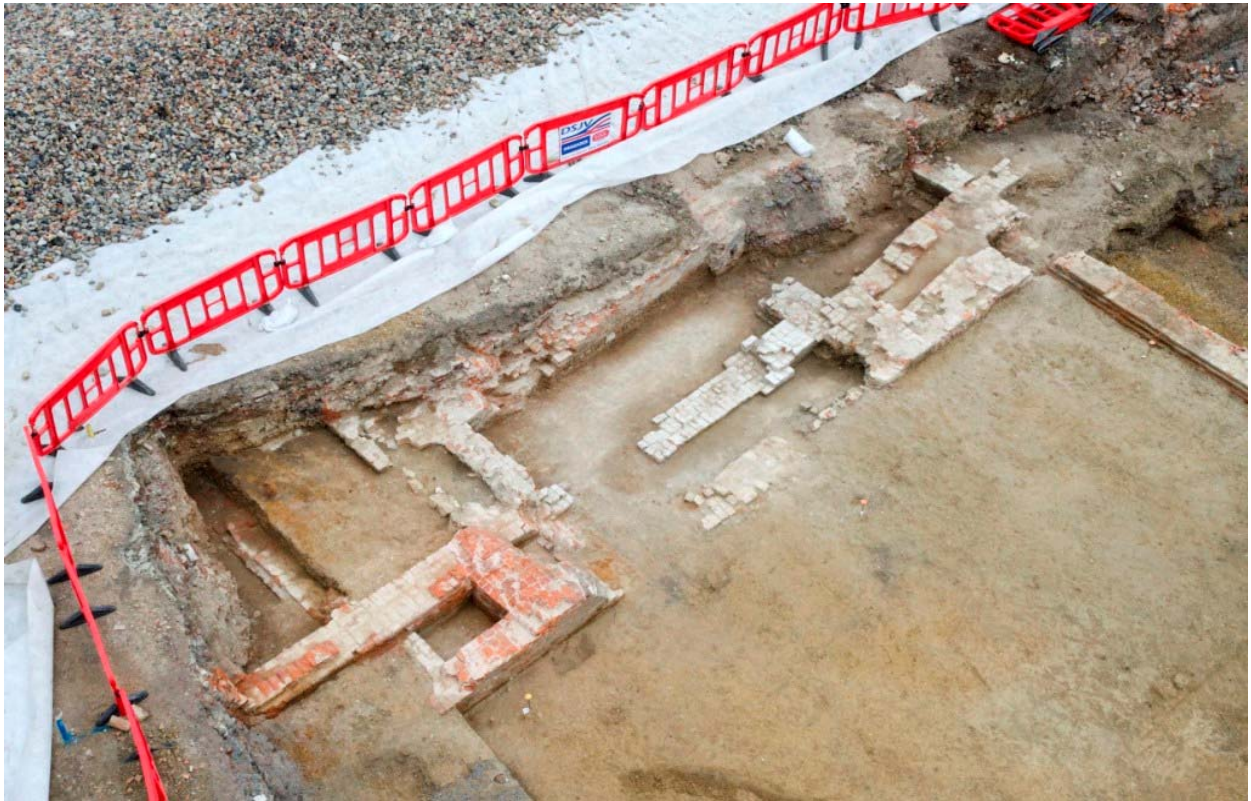
Little can be gleaned by examining the few rooms exposed in the main excavation, outlined by walls [235][237][238][269]. However, a comparison with remains found in the evaluation may be more fruitful, as would specific historical research.

The north end of Garden Street was beginning to be constructed in the early 19th-century and is represented in the 1819 Horwood map. This included building a road over the drains and a chapel, part of which is still standing. The rooms of the college south of the chapel included the brick walls [241] that cut into the 17th-century rooms in the north-east corner of the excavation trench.

Photo 5 Internal walls of King John's Court (Palace) / Worcester House [235][237][238][269], and inserted early 19th-century (lighter) walls [241]

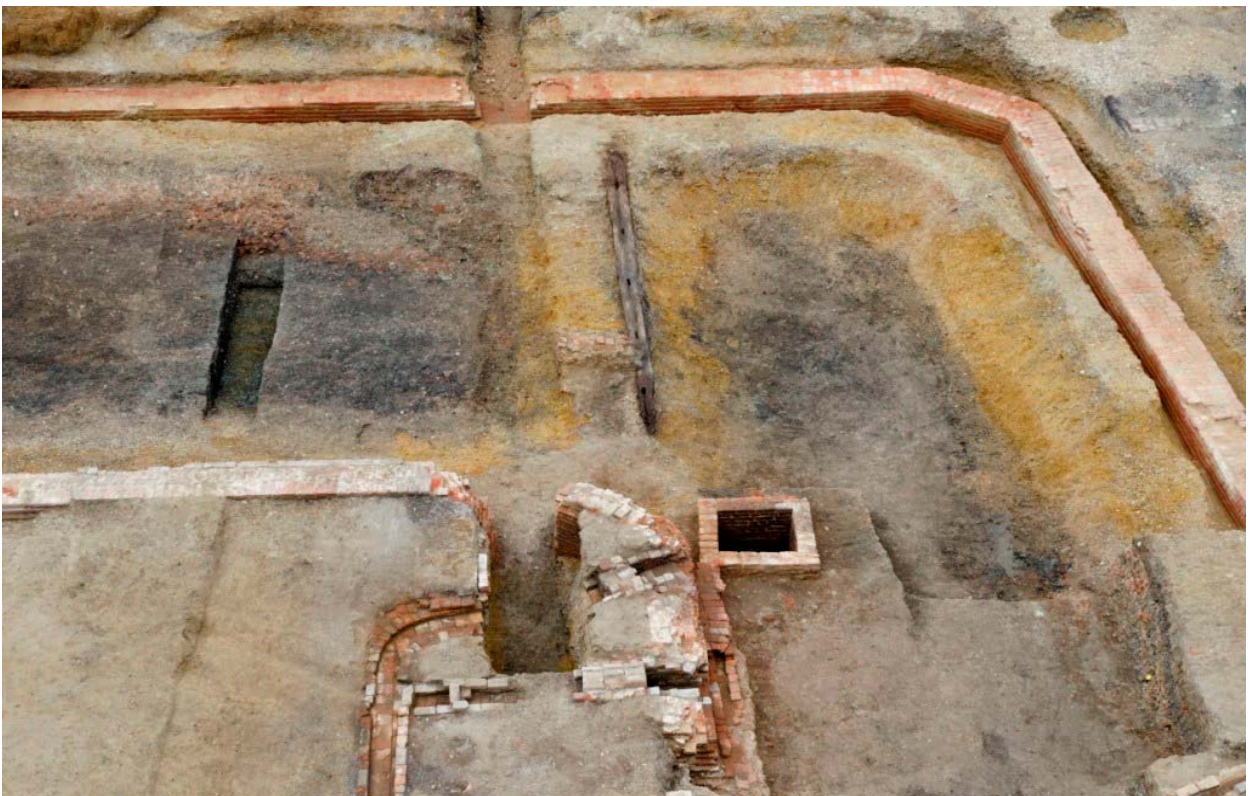
is still curious. It would have exited or arrived at the south-west corner of the “island” and/or possible building. Samples were taken from the baseplate and radio carbon dating may give a construction date for the complex.

Photo 6 Detail of causeway across the moat with timber baseplate [287], cess pit or trap [254] and drains [265][267][271]

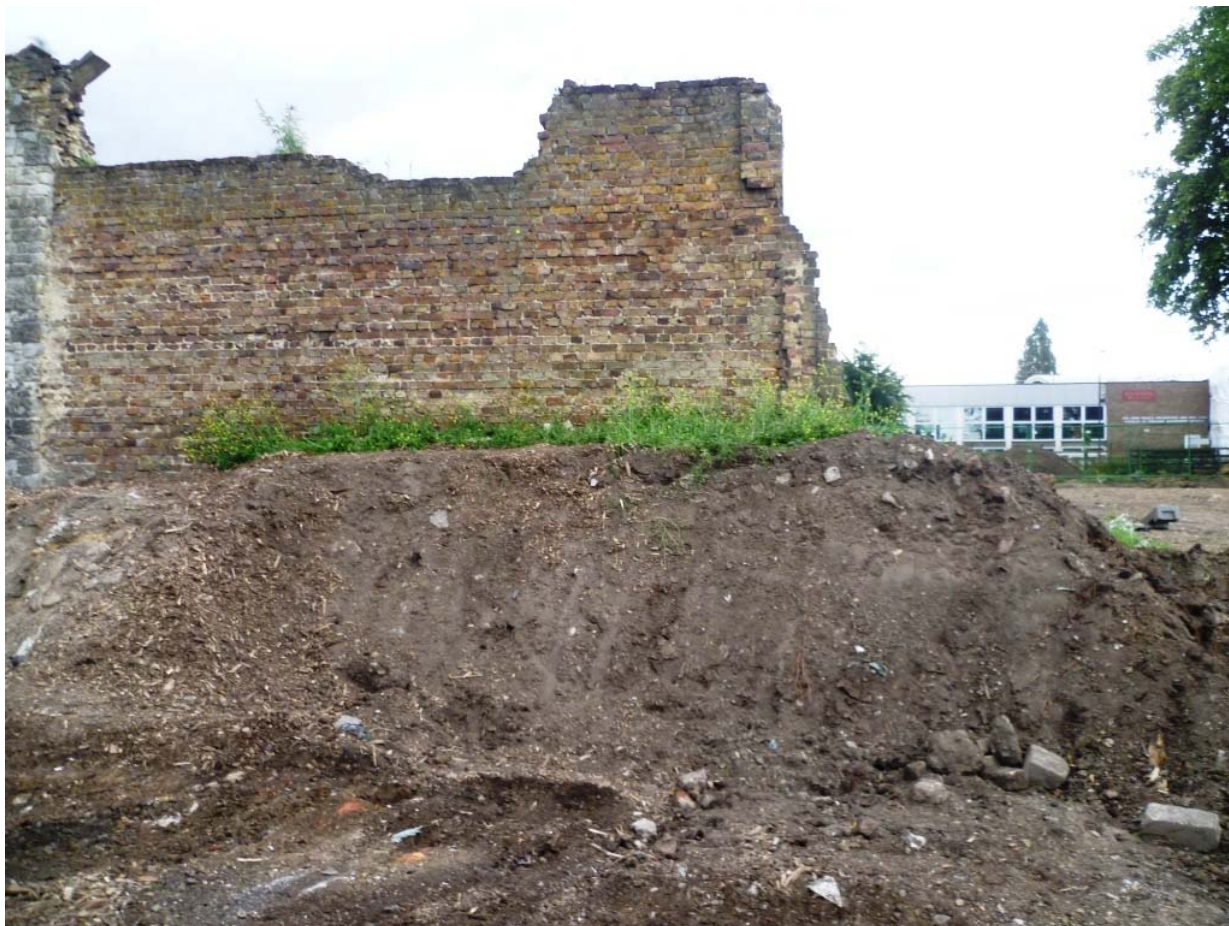
Photo 7 Removal of first metre of modern fill

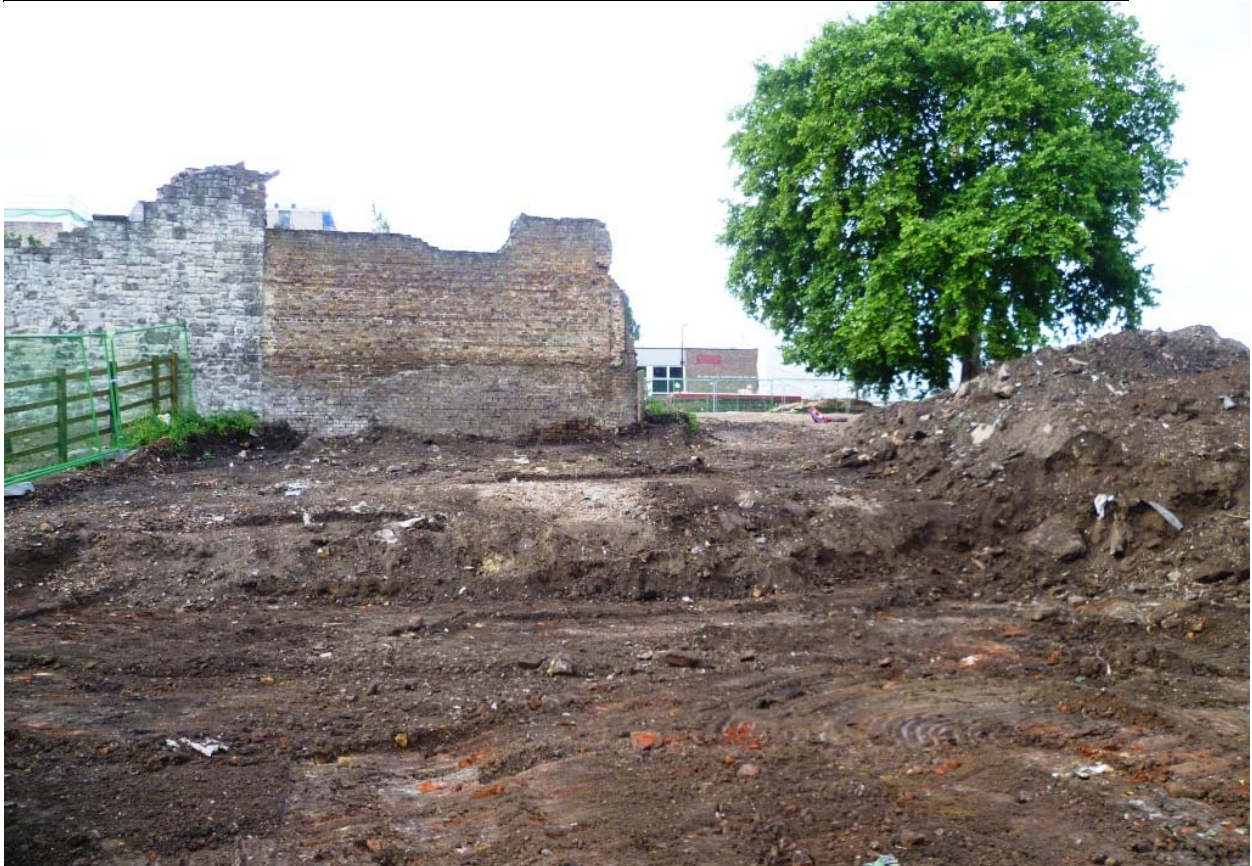
Photo 8 Removal of second metre of modern fill

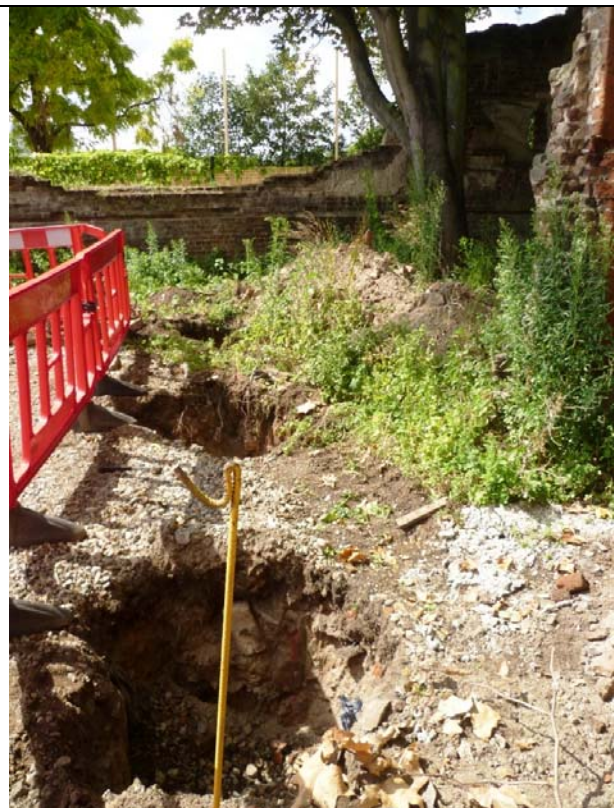
Photo 9 Baptist College Chapel, looking west

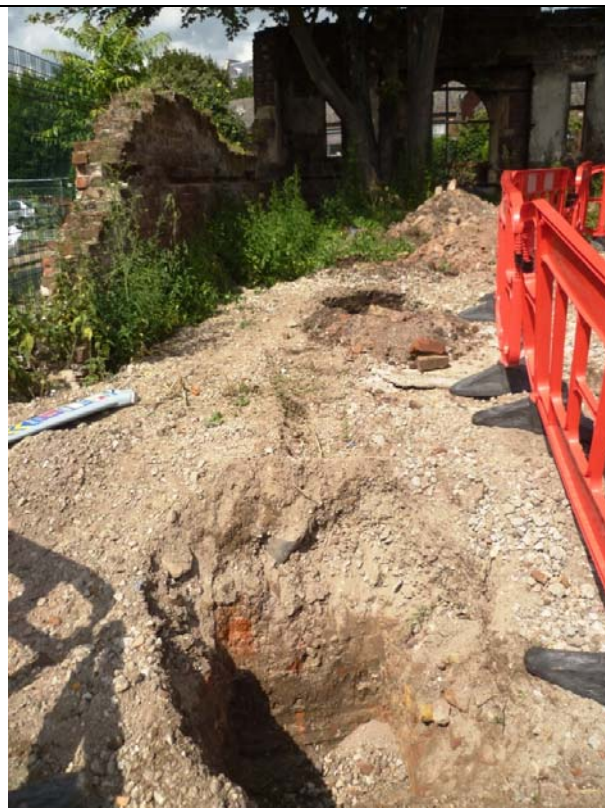
Baptist College Chapel, looking north
