C263 Archaeology Late East
Interim Statement
Non-Listed Built Heritage Recording
Plumstead Portal, Worksites West and
East

Document Number: C263-MLA-X-RGN-CRG07-50014

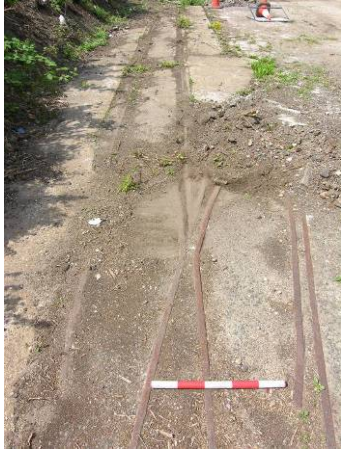
<p><i>Fig 1 Disused railway lines by the southern boundary of White Hart Depot Worksite</i></p>	<p>This feature, due to be removed during the enabling works was photographed from multiple angles and in detail on the 11th of July. The gauge was measured (2') and it is likely to have been for the transport of coal through the goods yard. It located within the cartilage of the Grade II Listed White Hart Depot and is of local interest and of low significance as a heritage asset. The photographs taken, the location of the feature on plan and a description of the feature would constitute a Level 1 record of the structure. No further mitigation is likely to be necessary.</p>

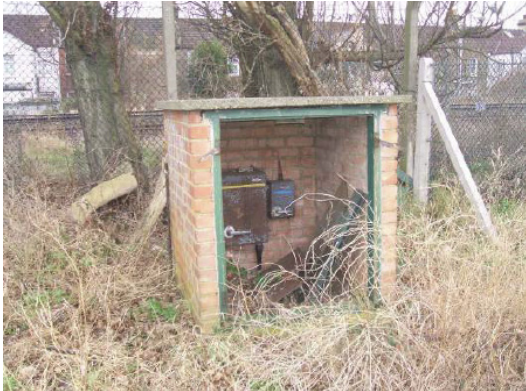
<p><i>Fig 2 Small square brick structure within cartilage of listed building on southern edge of White Hart Depot</i></p> <p>(Image taken from Site Specific WSI. Doc no. CR-SD-PRW-X-IS-00004)</p>	<p>The small square structure of orange bricks in stretcher bond located on the southern edge of the White Hart Depot is likely to have been built within the last 35 years. It is of no architectural merit, and of negligible significance as a heritage asset, though it is within the cartilage of the Grade II Listed building. This structure was not visible during the visit by MOLA on July 11th and is likely to have already been demolished. The photographs taken by Crossrail prior to demolition (See Site Specific WSI, document number CR-SD-PRW-X-IS-00004), will be sufficient to form a basic Level 1 record of the structure and no further mitigation is likely to be necessary.</p>

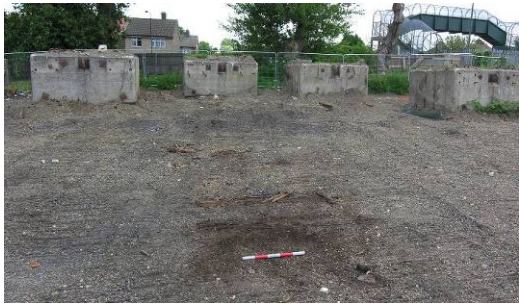
<p><i>Fig 3 Concrete blocks at far eastern end of White Hart Depot within former railway sidings</i></p>	<p>These features, considered to be of low heritage significance, were photographed from multiple directions on 11th July 2011. The photographs taken, when combined with a short description will constitute an appropriate, Level 1 record and no further mitigation is necessary.</p>
<p>Worksite West</p>	
<p>NLBH item</p>	<p>Results/comments</p>

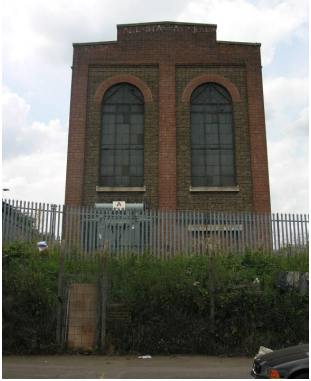
<p><i>Fig 4 Network Rail electricity sub-station on west side of White Hart Road</i></p>	<p>This building and its associated brick structure (see below) are under the management of Network rail and therefore no access was possible up close to the buildings or to their interiors. The building was observed from the currently available areas within Worksite West and from White Hart Road. It is locally listed and considered to be a heritage asset of medium significance with the potential for this significance to increase with time. Though the impacts on the building are likely to be minimal and that the building will not be demolished or altered there will therefore be no physical impact on the building itself. The impact of the proposed scheme on the building's setting is also likely to be minimal. If this is the case further detailed recording is not thought to be required.</p>

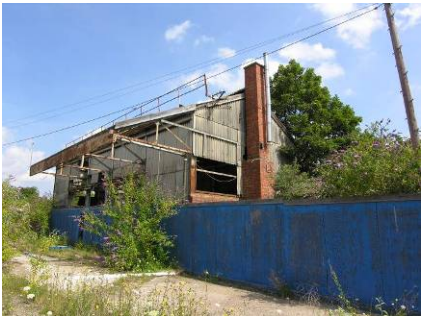
<p><i>Fig 5 Corrugated iron and steel frame structure, with brick base walls within Old Goods Yard.</i></p>	<p>This building and its extension to the south was observed and photographed internally and externally. It is of very low significance as a heritage asset and the photographs taken on 11th July will constitute the photographic element of a level 1 record of the building, to be combined with a written description. No higher level of record or further mitigation is necessary.</p>

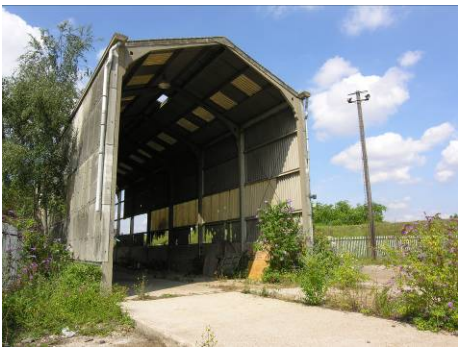
<p><i>Fig 6 Rectangular corrugated iron sheeting and concrete framed building at west end of proposed worksite west of White Hart Road</i></p>	<p>This building which is likely to be cleared in advance of worksite establishment was observed and photographed internally and externally. The associated rail tracks to the west and north were also photographed (see below). It is of very low significance as a heritage asset and the photographs taken on 11th July will constitute the photographic element of a level 1 record of the building, to be combined with a written description. No higher level of record or further mitigation is likely to be required.</p>

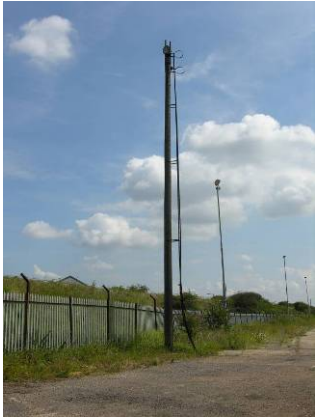
<p>Timber telegraph pole outside of Old Goods Yard, presumed redundant, west end of Old Goods yard</p>	<p>Not present at time of site visit, see below (<i>Fig 7</i>)</p>

<p><i>Fig 7 Timber telegraph pole, presumed redundant, within heavily vegetated portion of Old Goods Yard.</i></p>	<p>The previous telegraph pole mentioned above (also specified in the WSI doc no. CR-SD-PRW-X-IS-00004) was no longer present in-situ at the time of the site visit. However from the photos in the WSI its form clearly conformed to the group of other identical laddered telegraph poles on the site which were photographed from multiple directions. The photographs taken constitute an appropriate, Level 1 record and no further mitigation is likely to be necessary.</p>

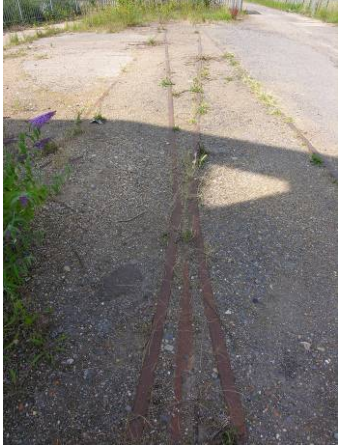
<p><i>Fig 8 Series of disused railway lines at west end of old Goods yard.</i></p>	<p>Disused railway tracks lines at west end of old Goods yard were photographed and measured. They were associated with the rectangular corrugated iron sheeting and concrete framed building at the west end of worksite west</p>

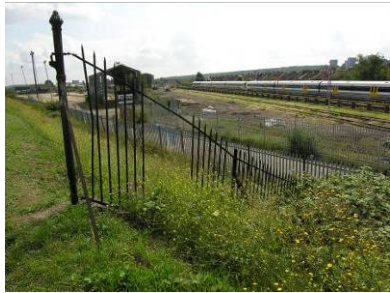
<p><i>Fig 9 Iron railings outside old goods yard on southern side of southern outfall sewer</i></p>	<p>This feature, considered to be of low heritage significance, was photographed from multiple directions on 11th July 2011. The photographs taken, when combined with a short description of the features location will constitute an appropriate, Level 1 record and no further mitigation is necessary.</p>
<p>Black and white painted rectangular corrugated iron shed underneath NKL railway bridge.</p>	<p>This is outside the worksite east area and of negligible significance as a heritage asset. The impact of the scheme does upon its setting would be negligible.</p>

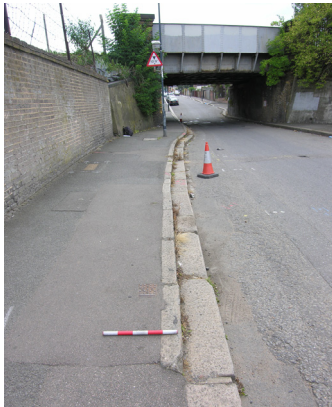
Fig 10 Kerbstones underneath NKL railway bridge on White Hart Road.

The stepped kerb was observed and photographed from multiple directions on the 11th of July. The asset is outside the worksite areas but may be subject to adverse impacts due to contact with site traffic. The photographs taken, combined with a brief description would constitute a level 1 record of the feature.

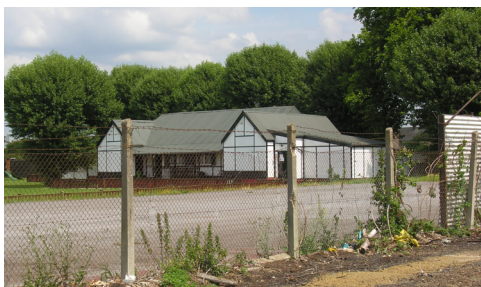
Fig 11 Pavilion on sports ground adjacent to White Hart Depot (assessment of setting only as no physical impact anticipated)

The proposed scheme would have a negligible impact of the setting of the asset in this case. In particular as railway infrastructure has existed to the south of the pavilion in the past.

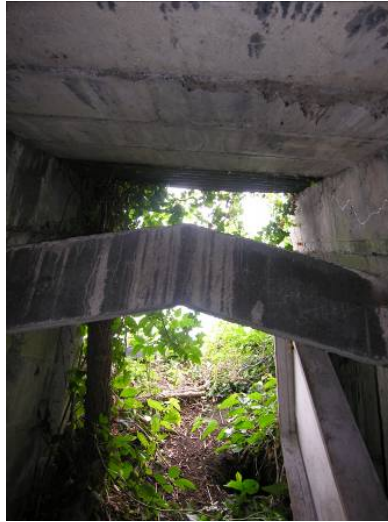
A World War II air-raid shelter was recorded within the Worksite East area in sufficient detail to constitute an appropriate level 2 record. Photographs were taken and the feature was drawn to scale in plan and section, whilst its relationship to other possible elements of the subterranean complex, the air vent and escape shaft were also photographed and located in plan (Fig 13 and Fig 14).

Fig 12 The entrance of the shelter from within, looking south

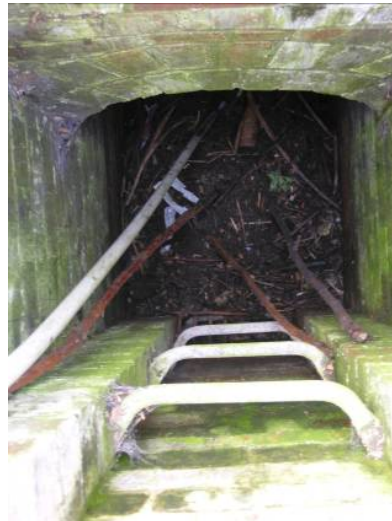
Fig 13 The escape shaft to the south of the shelter

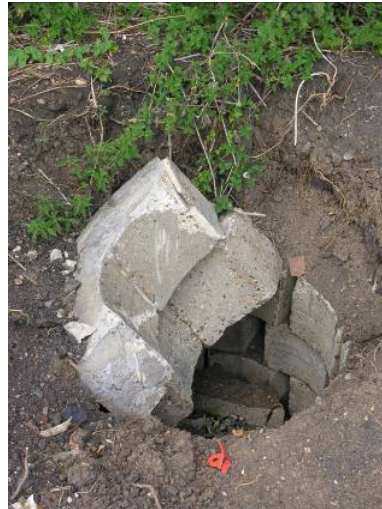
Fig 14 The remains of the air vent to the west of the shelter

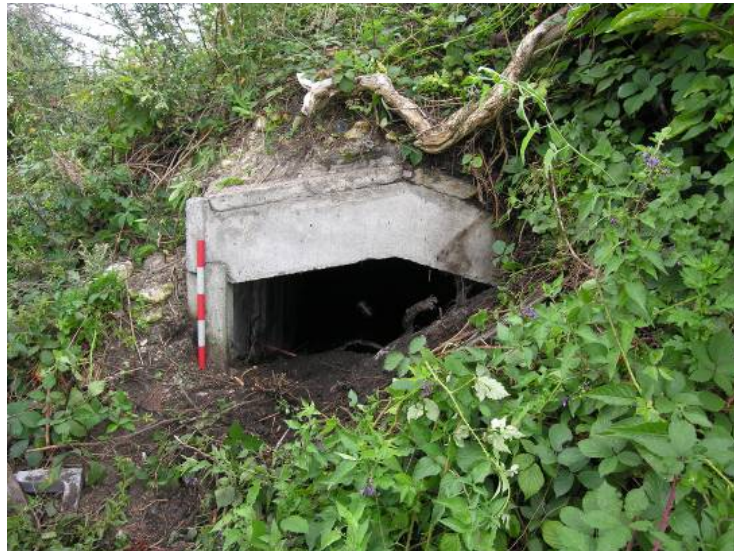
A second WWII air-raid shelter within the Worksite West area was recorded to the west of the former electricity power station adjacent to the railway tracks. Foliage was cut back from around the east facing entrance to the feature (Fig 15) and annotated and measured sketches were made of the structure both internally and externally. A second opening was also discovered approximately 20m to the west of the entrance (Fig 17) which is likely to have formed an emergency exit or escape hatch to the shelter. However a definitive link was not established between the escape hatch and the observed underground shelter area. It may be that the link between the two has collapsed or has been obscured by dumped soil or that the underground network originally extended westwards, beyond the accessible and observed area.

Fig 15 A view of the entrance to shelter 2 looking west

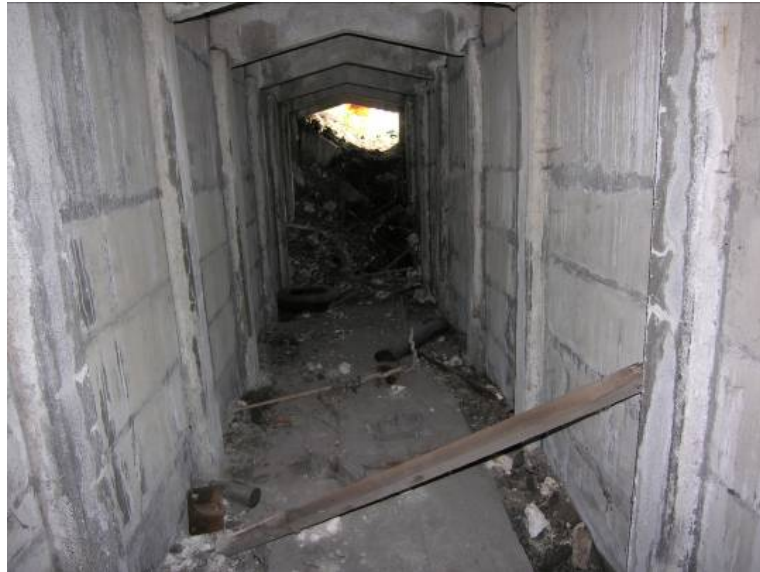
Fig 16 An internal view of shelter 2 looking east

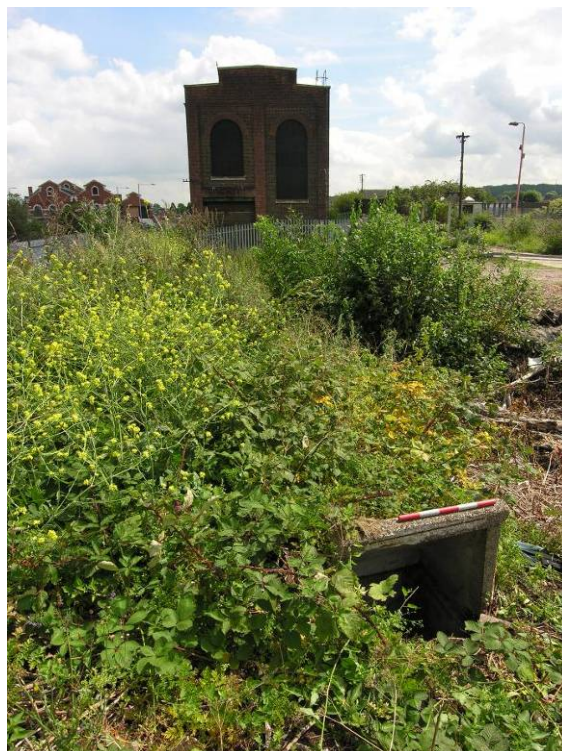
Fig 17 The escape hatch in the foreground, looking east
