C263 ARCHAEOLOGY LATE EAST
Fieldwork Report
Non-Listed Built Heritage
The Barge Public House

Document Number: C263-MLA-X-RGN-CRG03-50044

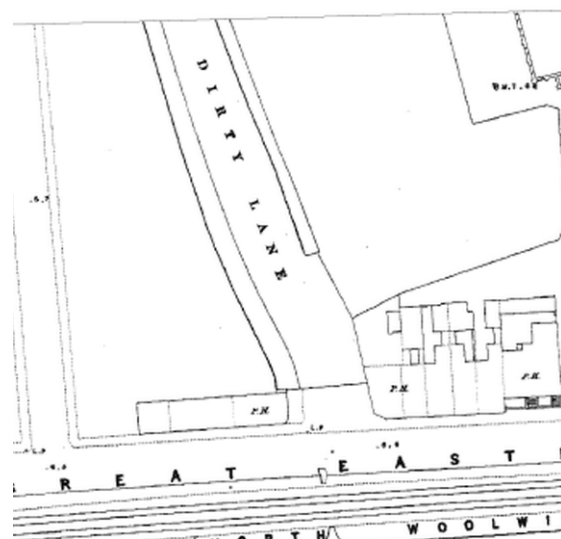
Fig 3 OS 1:2500 map of 1869

- Phase 1: The earliest represented by the rectangular structure in the southern part of the site, running alongside Victoria Dock Road as shown on the OS 1:2500 map of 1869 (Fig 3).
- Phase 2: This structure was then extended to the north after 1899 and prior to the 1912 photograph (Fig 5) a fact emphasised by a fine Art Nouveau style entrance lobby complete with a wrought-iron gate surround.
- Phase 3: The second floor of the original public house was rebuilt during the second half of the twentieth century, possibly as a result of bomb damage during World War 2.
- Phase 4: During the 1990s the building was converted into a 'halfway' hostel for teenagers.

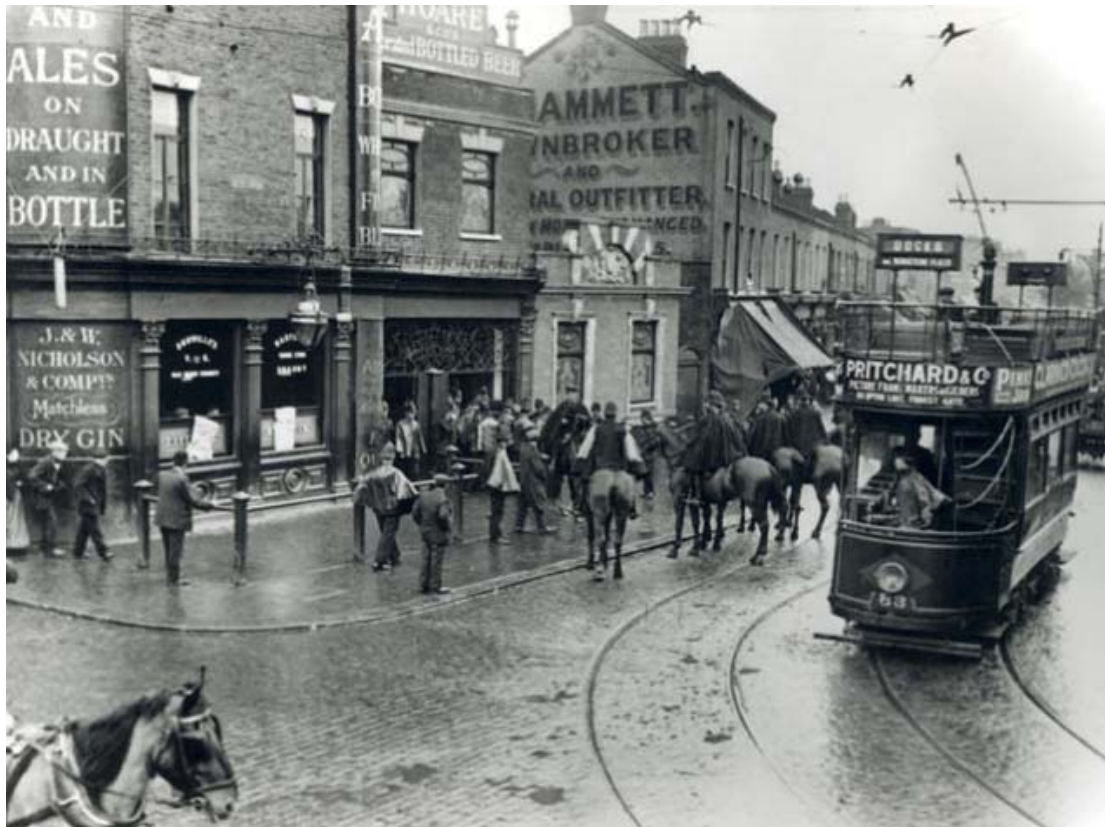
Fig 5 The Freemasons Tavern photographed in 1912 during a dock workers strike (Source: London Borough of Newham)

protest immediately outside of the east elevation of the pub being monitored by mounted police as a tram passes by (London Borough of Newham, date unknown). This photograph demonstrates that somewhere between the OS 1:10560 map of 1899 (not reproduced) and 1912 the Freemasons Tavern had been extended to the north by two bays, one of two storeys and the northernmost of a single storey.

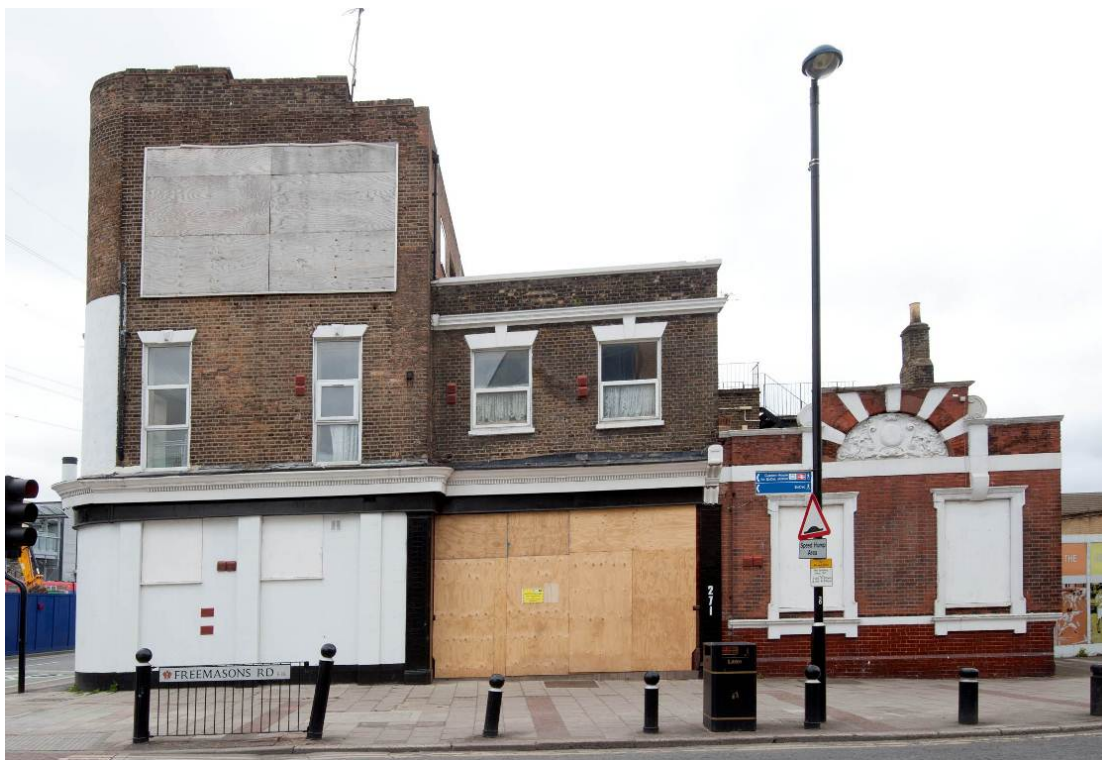
Fig 7 the east façade of the Barge, looking west

The south and east elevation of the ground floor level of this wing of the Phase 1 building is rendered and painted white. The high level but smaller windows (boarded over at the time of the survey) replaced the original larger windows, which can be seen in the archive photograph of c 1912 and were almost the full length of each bay (Fig 5). The pilasters which divide up the bays of the south and east elevations at ground level are plain and rectangular in profile and constructed from concrete. However they were originally decorative pilasters with Classical-style capitals (the exact type is not discernible on Fig 5). There are three blocked doorways to the public house on the south elevation, with step stones from the Victoria Dock Road and a blocked cellar drop in the pavement of the east elevation.

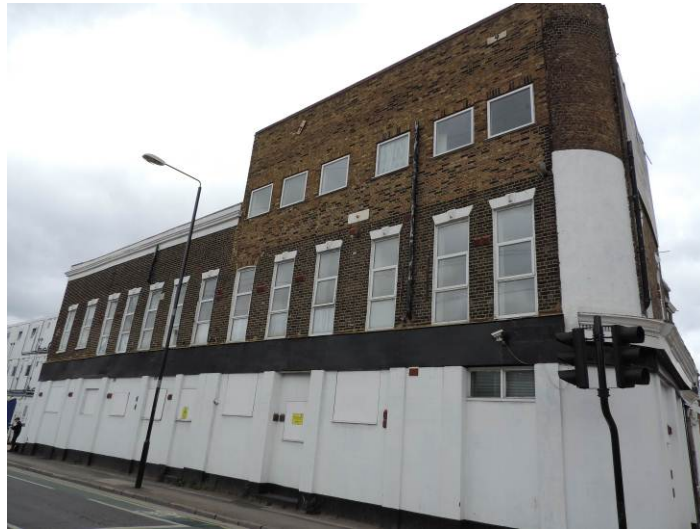
Fig 8 The southern façade of the Barge, looking north-west

The western two storey part of the south elevation has a moulded cornice and low rise parapet, both rendered and painted white. The windows of the first floor have modern uPVC glazing and are identical apart from the last two to the west, which have a higher sill. The windows have rendered heads with lozenge-shaped key stones in the centre, which are painted white. Behind the painted heads the windows have flat cambered arches. A dentilled cornice divides the ground floor and first floor on the east elevation of the Phase 1 building only, although this cornice has also been continued above the ground floor of the Phase 2 northern extension.

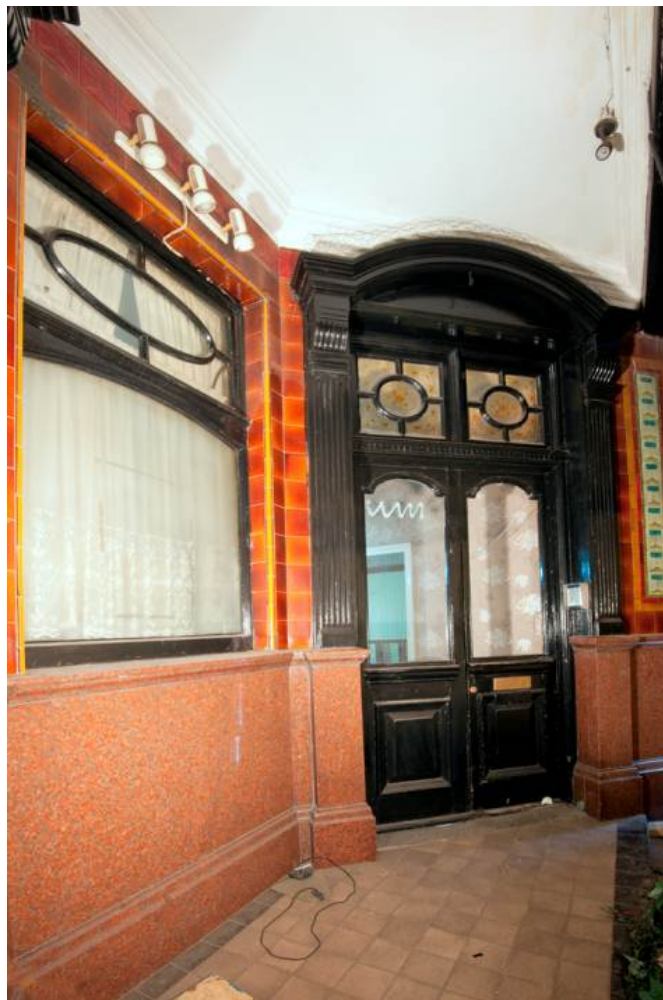
Fig 9 The latest entrance to the public house, looking north-east

The current entrance to the public house (Fig 9) in the centre of the east elevation dates to c 1900 and was added during Phase 2. The early 20th century lobby is typical of public houses constructed during the period where Art Nouveau design was ascendant. A single central window with an upper panel with a decorative oval glazing design is flanked by two identical double-swing doorways with yellow floral stained glass window lights above. Either side of the doors are elaborately moulded fluted pilasters supporting a segmental pediment. The dressed red granite façade plinth is surmounted with ox-blood red and yellow tiles. There are two identical panels of dust pressed Art Nouveau tiles adjacent to the doorways (Fig 10) with a floral motif relief design similar in style to those produced by Pilkington's Tile and Pottery Company during the first decade of the 20th century (Lemmen 2008). The façade has an open work wrought iron gate in scroll design (Fig 11).

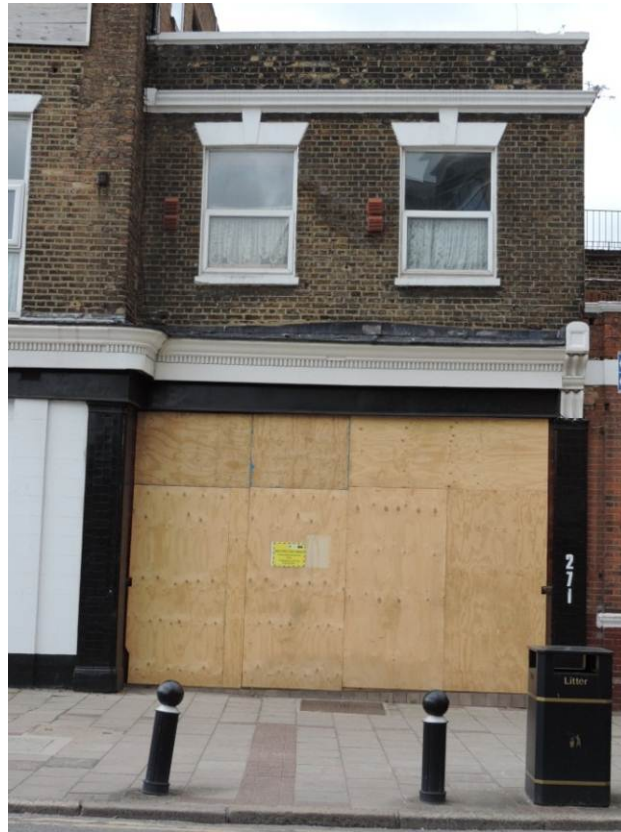
Fig 12 East elevation of the Phase 2 extension, looking west

At first floor level above the main entrance, are two identical windows with modern uPVC glazing shorter than those of the south wing. These windows also have similar rendered heads with a key stone dropping from the crown moulded cornice similar to those of the south elevation. A moulded cornice sits below a plain parapet which hides a flat roof behind (Fig 12).

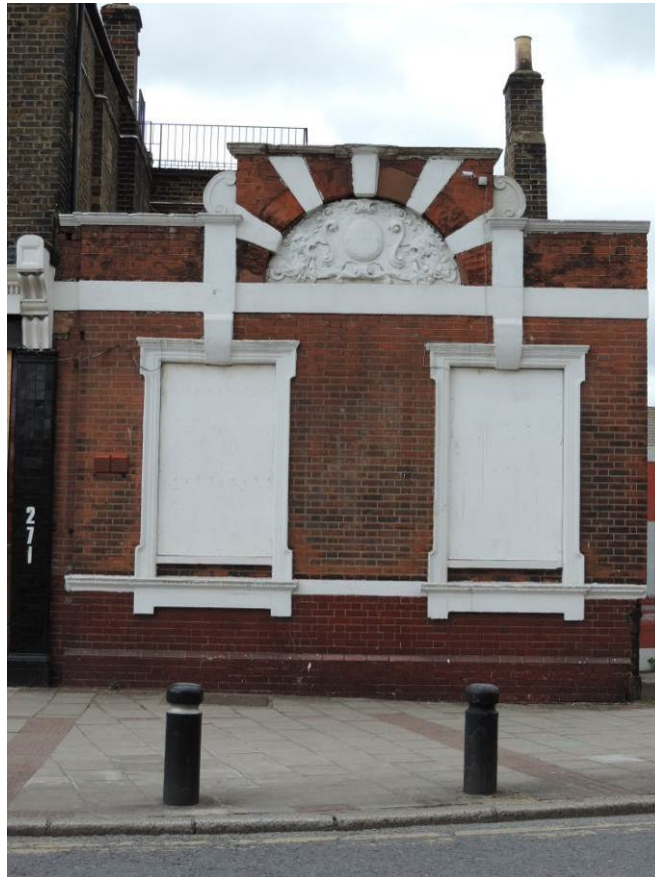
Fig 13 East elevation of the north end block of the building, looking west

The northernmost part of the Phase 2 extension appears to be a separate build to the block immediately to the south however is part of the same Phase 2 build despite its radically different appearance resulted from the use of red bricks on the façade contrasting the rest of the structure constructed of yellow stock bricks. This part of the building is single storied and has a flat roof. It has a symmetrical east elevation with two identical windows dressed with moulded stone architrave and key stones dropping from the stone plat band (or string course) and a parapet decorated with moulded tympanum that has a semi-circular brick arch with keystone and voussoirs (Fig 13). The stone dressed surrounds and architraves of the windows are identical to the moulded timber frame and architraves of the windows inside. East face of this part of the building also has a plinth of up to five courses of red glazed bricks topped with a course of plinth-brick. Bricks between the plinth and the stone plat band are also glazed.

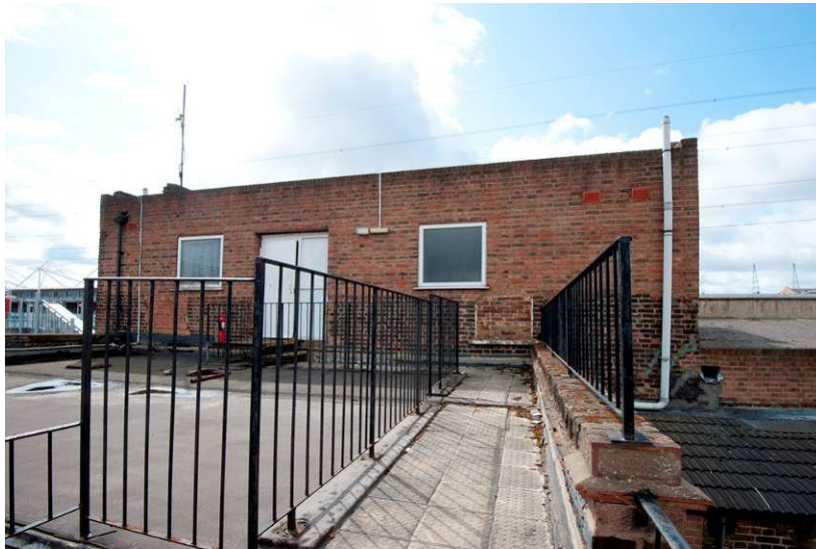
Fig 14 North facing elevation and access to the second floor level, looking south

The north facing elevation of the three storey part of the building has the access door to the second floor level and two modern windows. Most of this elevation is rebuilt with modern bricks in English bond. The lower half of two original windows are visible along with their sills in the lower level of the original wall constructed with a mix of yellow and darker bricks in Flemish bond. These windows, such as they survive, were blocked at the time that the second floor was rebuilt subsequent to Second World War bomb damage (Fig 14).

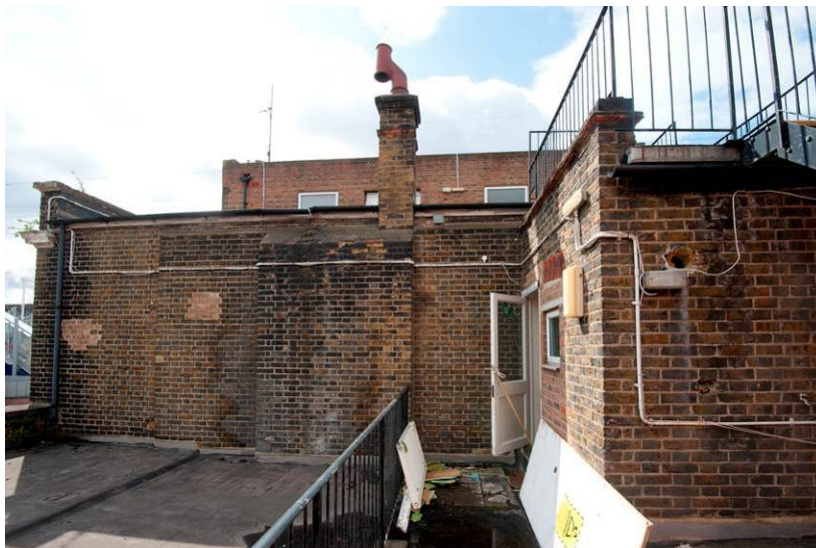
Fig 15 North facing elevation and alternative entrance to the 1st floor of the middle block, looking south

North facing elevation of the 1st floor level of the middle block, constructed with a mix of yellow and darker bricks in Flemish bond has not been altered much. It has a projected chimney breast and a small chimney stack with only one pot. The 1st floor level is also accessible from the roof of the single storey north block. This door and a small window next to it are modern additions in the place of an original window with a segmental brick arch in the east facing elevation of the 1st floor wing to the north. Part of the segmental brick arch is still visible (Fig 15).

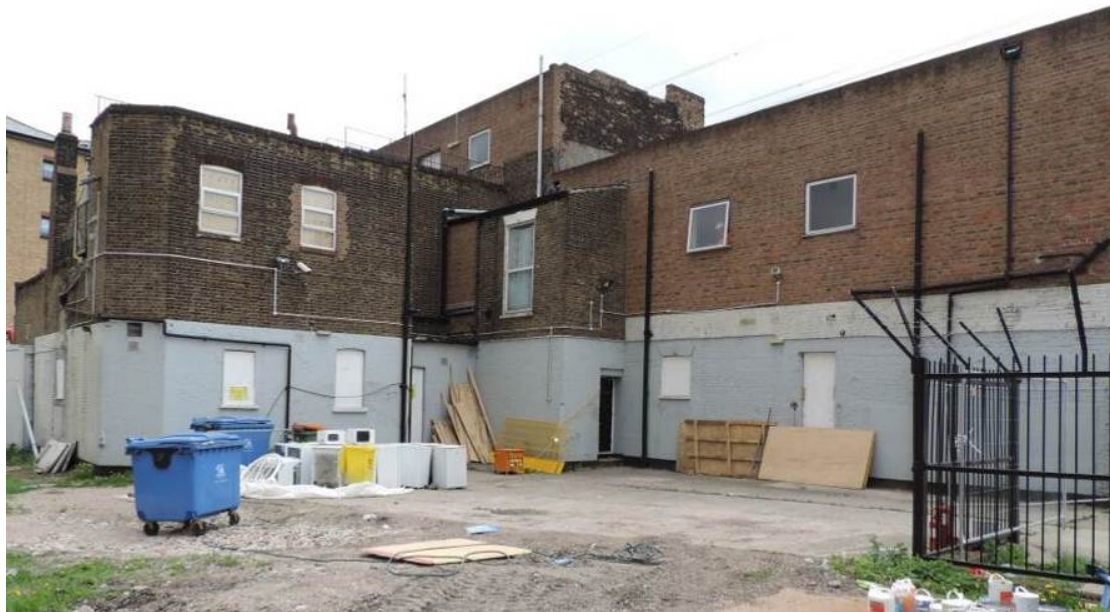
Fig 16 North and west elevation of the building, looking south-east

The basement of the property is also accessible from the stairwell and an external cellar drop, at the rear of the middle block of the building. The west elevation of the middle and north block of the building has a plain chamfered corner to the north end, two identical windows with segmental arches on each floor and a door with a step from the ground level. It has a flat roof with plain parapet and cornice (Fig 16).

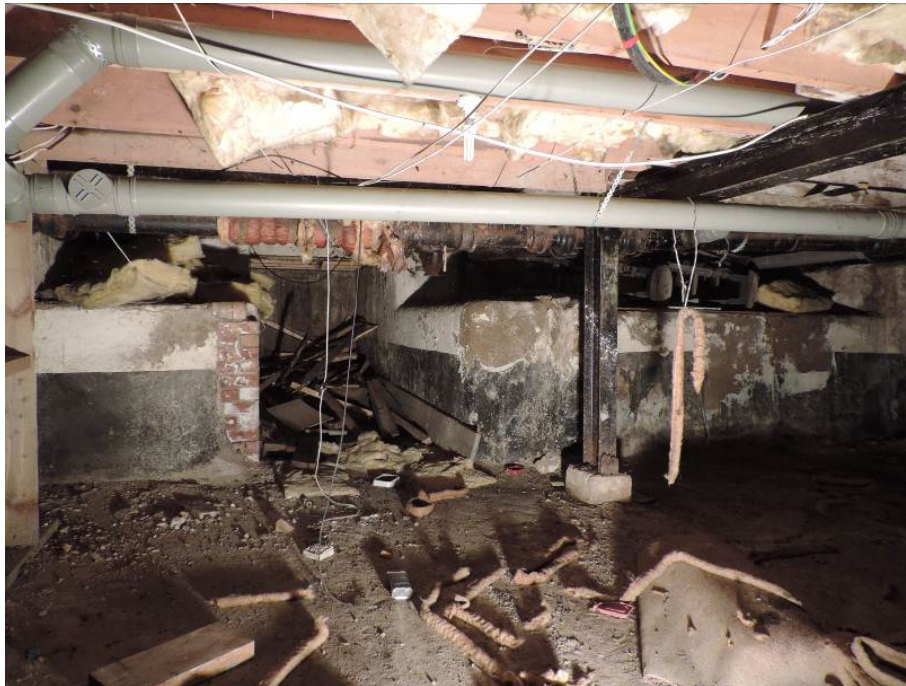
The basement was originally accessed via a cellar drop from Freemasons Road which existed on the pavement in front of the east elevation of the Phase 1 building. This is now blocked but survives as a scar in the pavement. The storage cellar exists directly beneath the rectangular superstructure above and has a concrete floor surface with brick walls and a low composite ceiling constructed from both timber and rolled steel joists supported by stanchions. Stillages for barrel storage are found immediately to the north and south of the cellar drop, but they do not survive anywhere else within the cellars. The Phase 1 cellar has been subdivided into five smaller rooms by brick and concrete block walls. The four western rooms all have modern plasterboard ceilings.

There is an alcove in the second room to the west of the cellar drop in the south wall which is flanked on both sides by blocked pavement lights. Another blocked pavement light is also partially visible within the fourth chamber to the west of the cellar drop, however this is obscured by a modern concrete block wall.

Fig 18 The Phase 1 cellar, looking east. Note the stillages and blocked cellar drop between them.

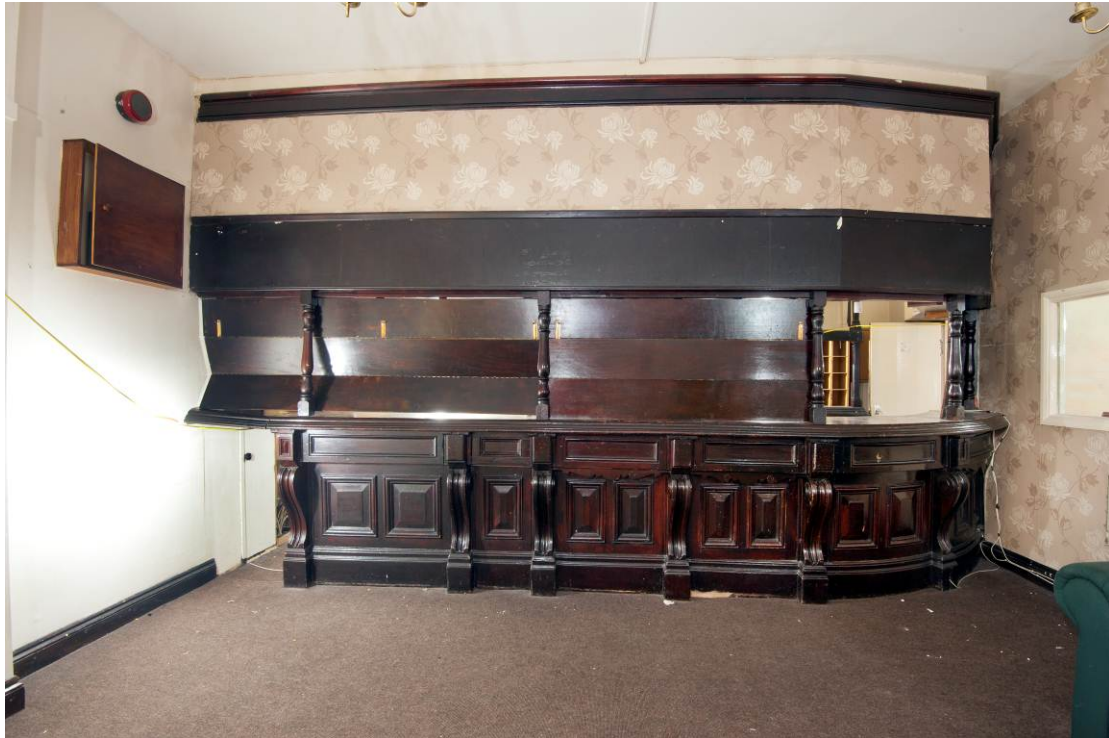
Fig 19 The timber bar in the Phase 2 northern extension, looking west

The bar remains the central hub of the Barge (Fig 19), as much in its life as a hostel as it was during its time as a public house. Lit by a tall window to the east with an impressive timber architrave which mirrors the elaborate moulding on the exterior elevation, the bar is a square room with an access to the Phase 1 part of the building to the south. To the north is an inserted modern timber and plaster wall with a wired glass window allowing inter-visibility to the saloon bar. This modern dividing wall is a

The west of the bar room is taken up with the timber bar itself (Fig 19). This is a carved, curving timber bar which is divided into six unequal bays by scrollwork pilasters which support the moulded surface above and has a moulded plinth and recessed timber panelling. The bar curves round in the north-western corner and has a vertical pivot hatch at its south end to allow access to and from the server behind. The bar appears to be contemporary with the build of the Phase 2 extension to the public house. There are modern folding timber flaps which can be unlocked to close off the bar at last orders to indicate that serving has ceased. The shelving unit above is supported on five turned timber balusters which are also contemporary with the Phase 2 build.

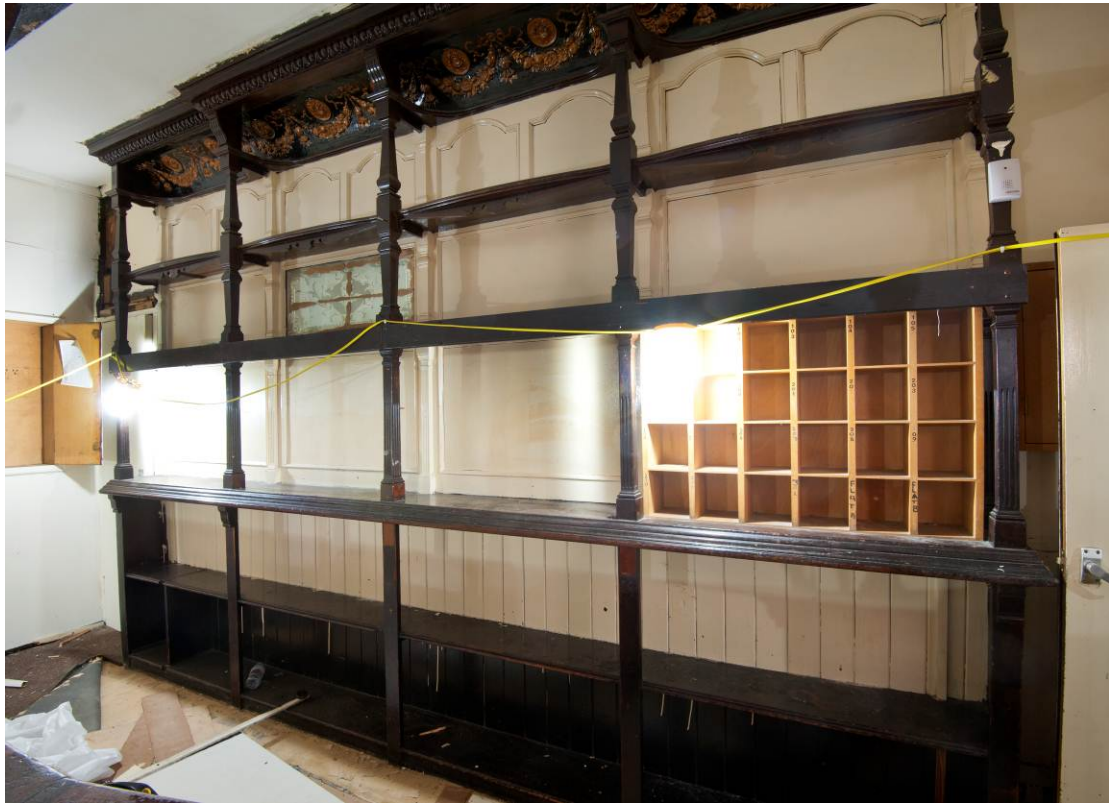
Fig 20 The spirits shelves behind the timber bar, looking south-west.

Behind the bar is an ornate four bay wide set of timber spirit shelves (Fig 20) with a moulded counter, fluted columns, scrollwork shelves, eight double tiered rectangular mirrors with a row of eight arched mirrors above. Three of the rectangular mirror and three of the arched mirrors still feature original early 20th century Art Nouveau floral motif frosted etched designs. Above the shelving is a dark green structurally integral plaster coving complete with original gold painted escutcheons and festoon swags with a timber egg and dart moulding above.

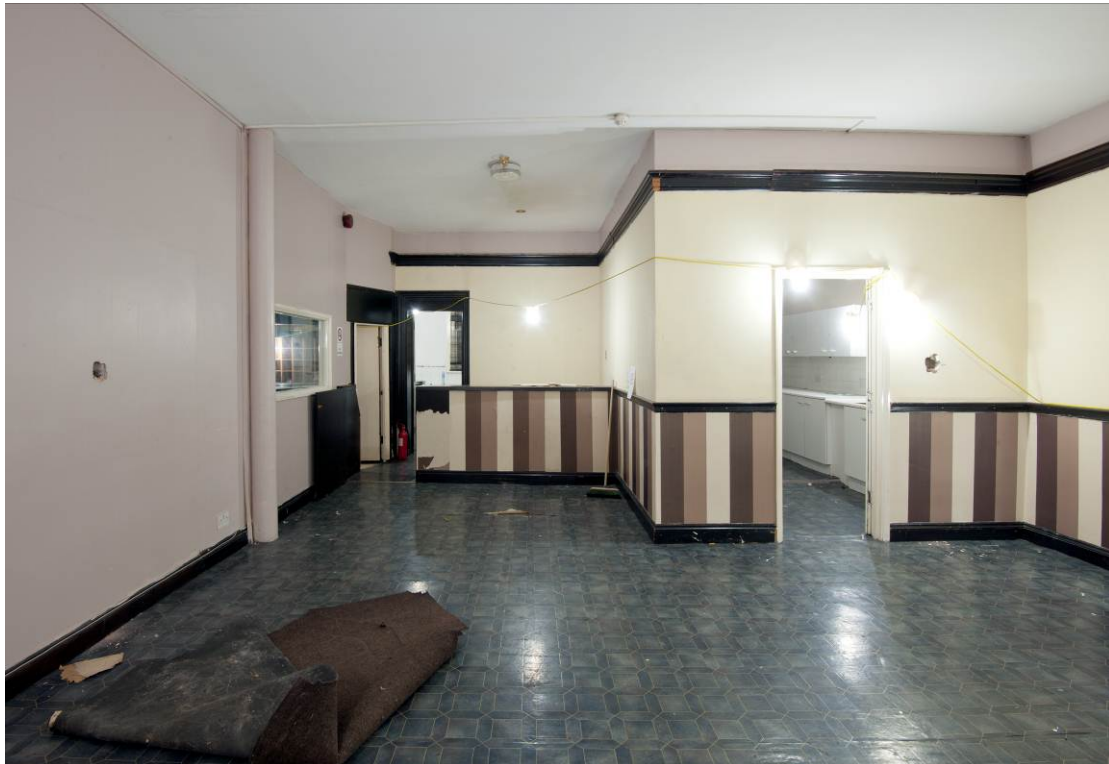
There is access to a small WC behind the bar directly opposite the serving hatch, and from the north side a door allows entry into a second server in the old saloon bar (Fig 21). This bar unit is a plain, modern, rectangular timber structure with a serving hatch on the south side. To the rear is a moulded doorway contemporary with the c 1900 Phase 2 extension which leads into what is now a kitchen and storage area. Also contemporary are the moulded timber dado and picture rails. The saloon bar was used as recreational space during the time that the building was a youth hostel and a second much larger kitchen unit was inserted in the north-west corner of the room. The dado and picture rail have been relocated to run around the exterior of this inserted kitchen and were removed from their original locations against the north and west walls. Originally the saloon bar was heated by a fireplace located centrally in the north elevation.

Fig 21 The saloon bar, looking west. Note the supporting column, the dado and picture rails and the moulded door architrave

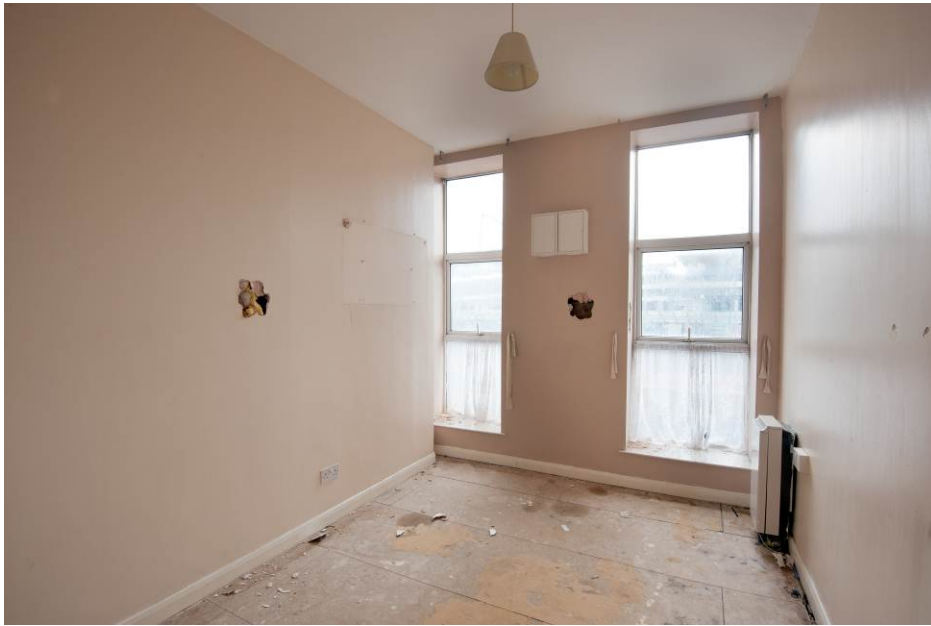
Fig 22 Representative first floor single occupancy hostel bedroom

The entire Phase 1 part of the building to the south was converted into eight single occupancy ensuite bedrooms (Fig 22) with a toilet, wash basin and shower (Fig 23). The rooms were all lit with high level windows in order to maintain the security of the vulnerable occupants. There are also two small kitchens and an office serving this part of the building. The rooms are all divided by modern plasterboard over a softwood framing. A corridor runs the length of the north side of this wing which is accessed from the main bar. There is a change in floor level adjacent to the kitchen which is negotiated by two steps down to the east. The original and subsequent layouts of this part of the building when it was a public house is no longer discernible as the interior was stripped and redesigned when it was converted into a hostel.

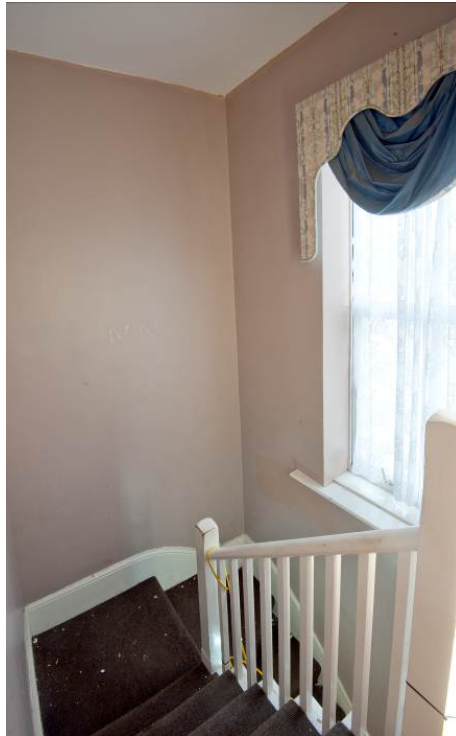
Fig 24 The staircase between the ground floor and the first floor, looking north-east

The stairwell is accessed from the east-west corridor and provides a route to both the first floor and the basement cellars. The banisters, newel posts and balusters are modern timbers of rectangular section (Fig 24).

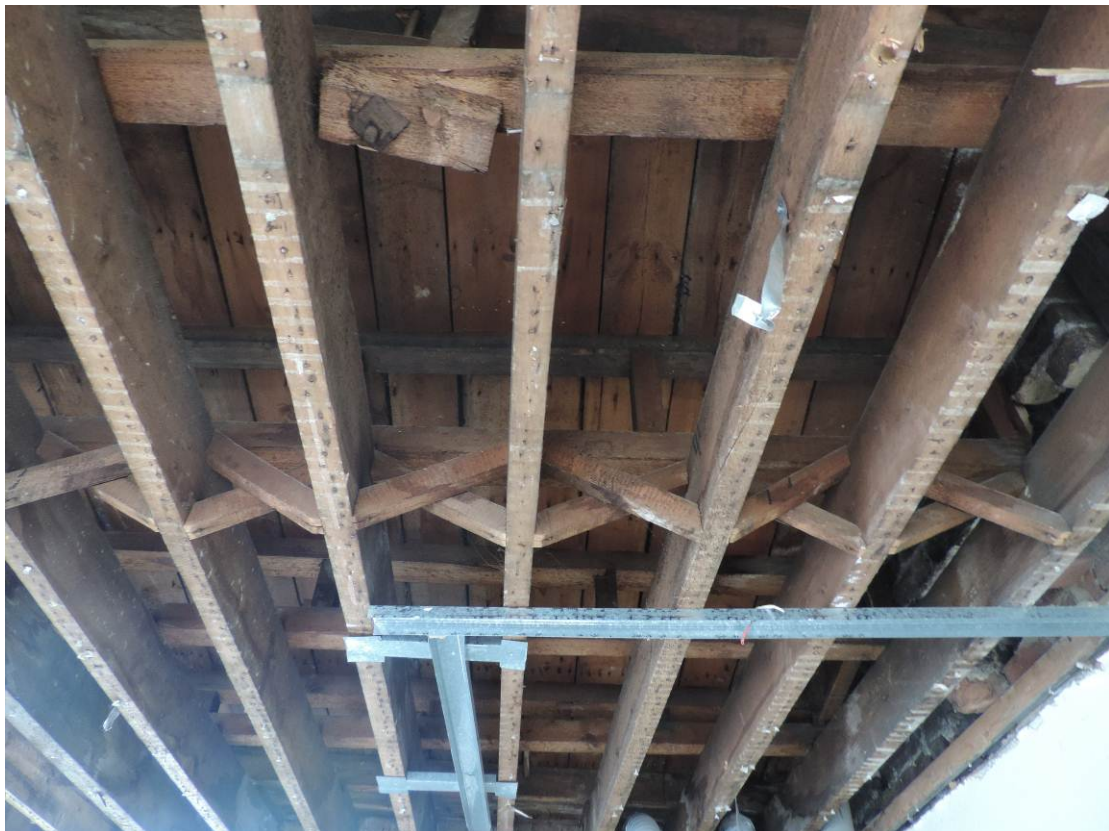
Fig 25 First floor ceiling structure, looking west

The ceiling structure of the first floor was examined during the course of a soft-strip on site and it was revealed that machine cut timber joists held up a superstructure reinforced with herringbone struts. This is not an un-common feature of late 19th century buildings, often found in public buildings and used extensively in warehouses (Fig 25).
