C263 ARCHAEOLOGY LATE EAST
Interim Statement
Non-listed Built Heritage Recording
The Barge Public House

Document Number: C263-MLA-X-RGN-CRG03-50031

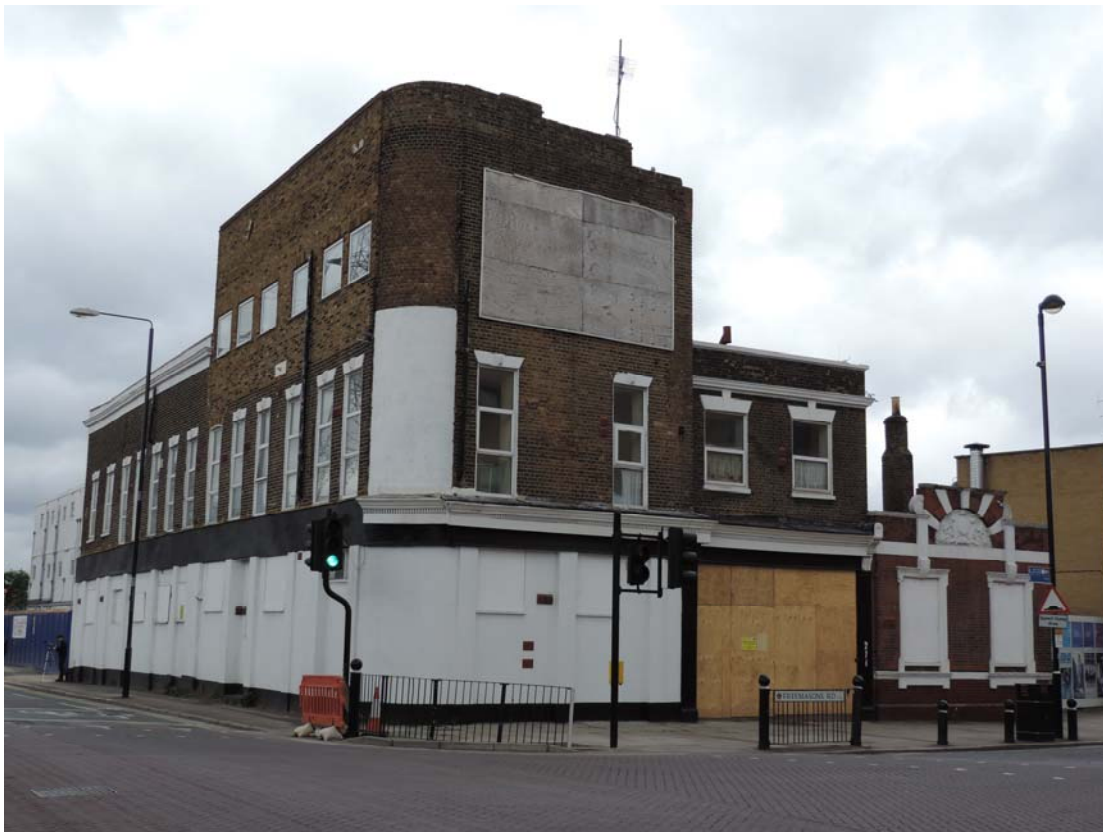
Fig 1 A general view of the late 19th century public house looking north-west

The building is an L-shaped yellow London stock brick structure (Fig 1) with high level, blocked ground floor windows replacing much larger openings. There are at least three blocked doorways pertaining to the original public house opening onto Victoria Dock Road, and a blocked cellar drop on the east elevation. The early 20th

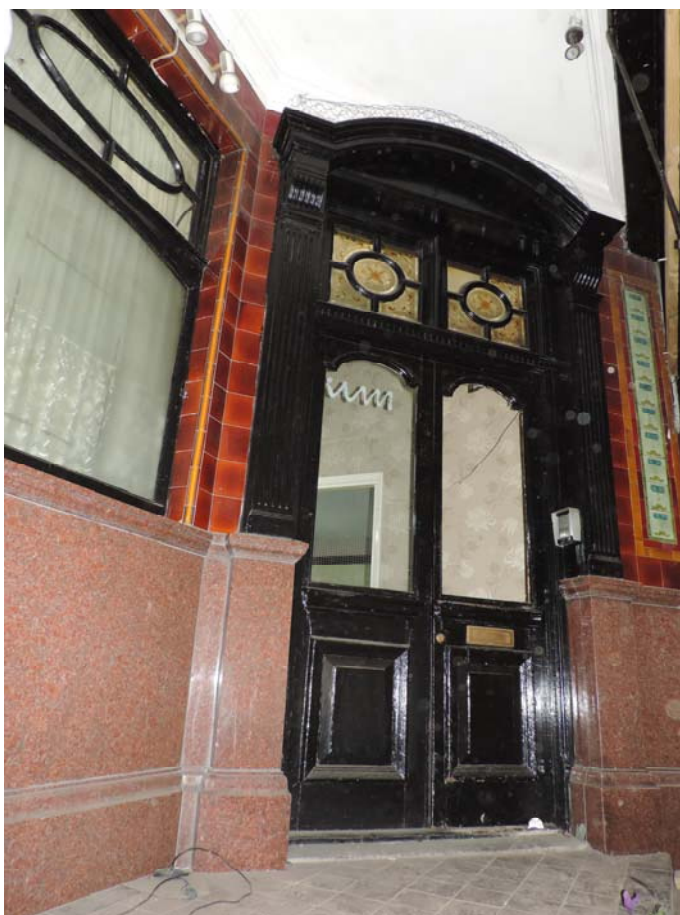
century Art Nouveau entrance lobby has a red granite façade with inset tiles and decorative moulded timber architraves around the two recessed canted bays which allowed access internally (Fig 2). The north end of the east elevation is a single storey flat roofed structure with stone window surrounds identical to the timbers ones of the lobby and a decorative parapet complete with moulded tympanum. The basement is accessed from the rear of the property via both an external cellar drop and an internal staircase.

Fig 2 A view of the entrance lobby on the east elevation, looking north-west

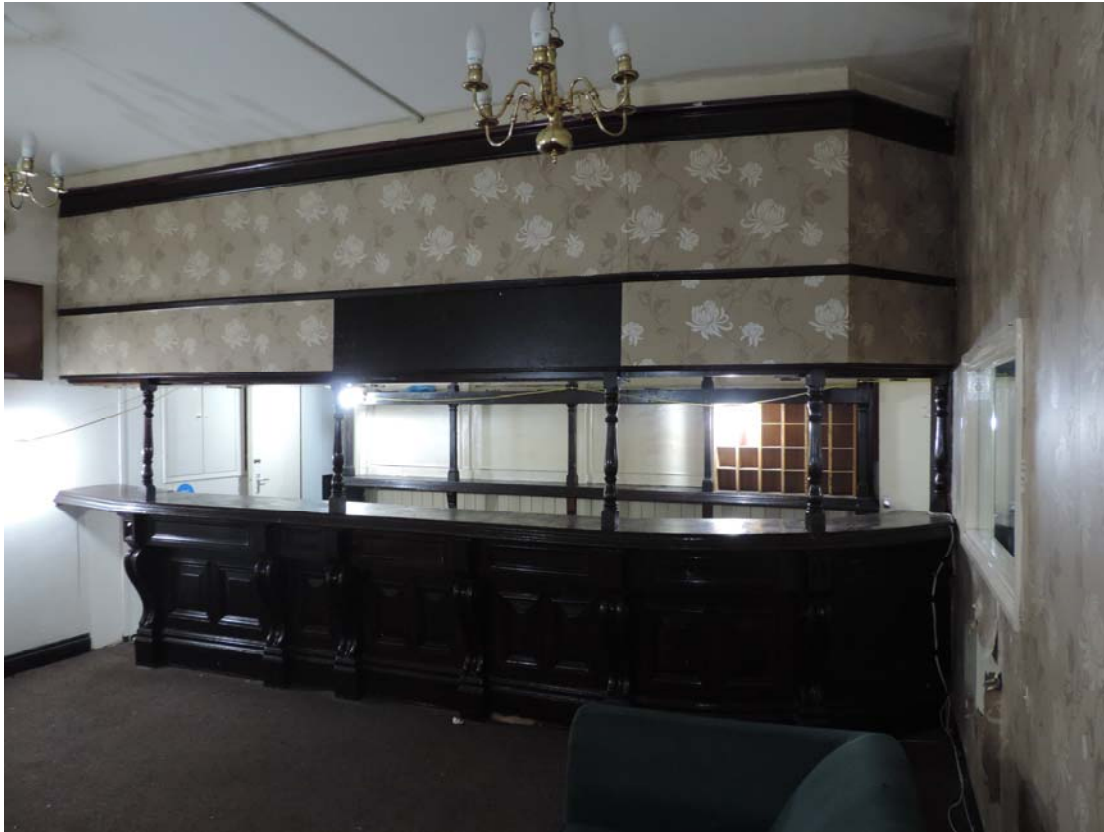
Fig 3 Timber bar, looking west

A list of salvageable items which could be reclaimed from the building prior to demolition was also produced. These items included decorated tiles, etched and stained glass windows, spirit shelves with decorated mirrors and the bar.

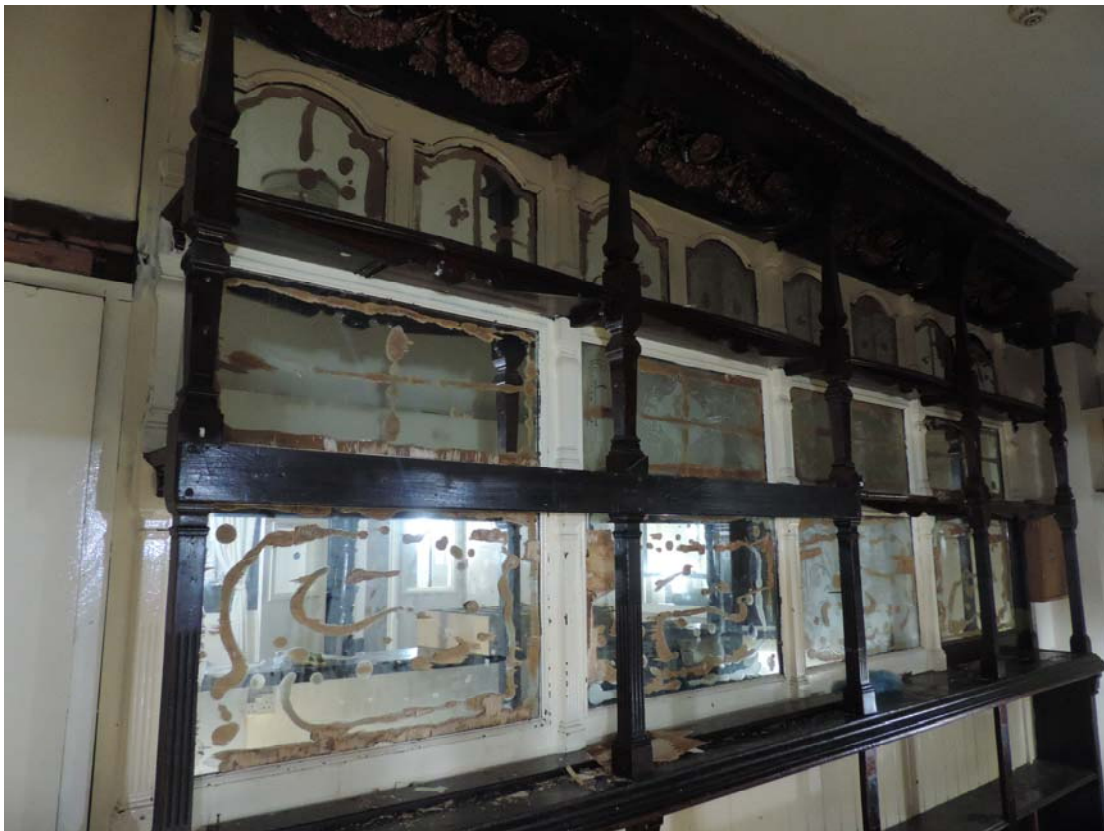
Fig 4 Spirit shelves with frosted and etched mirrors behind the timber bar, looking north-west

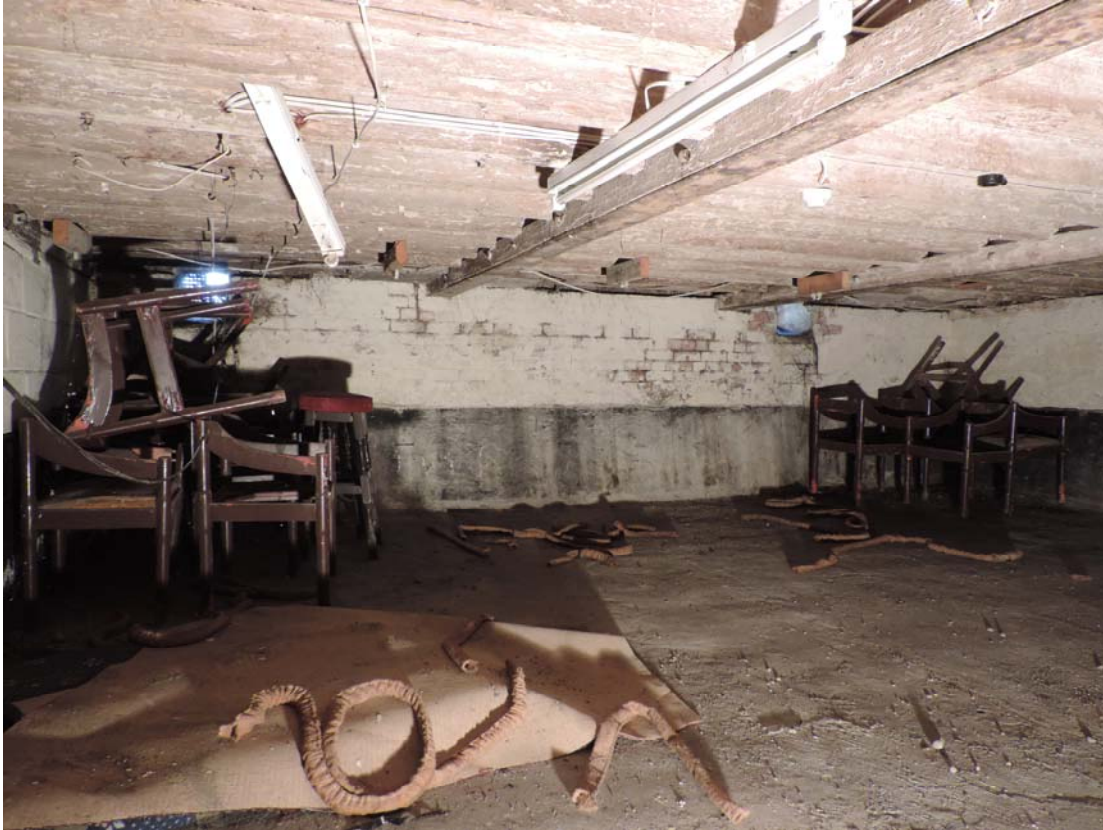
Soft stripping of the first and second floors revealed that the floor and roof structures were held by timber herringbone supports, whereas the cellar was supported by rolled steel beams with timber joists (Fig 5) occasionally held in place by stanchions.

Fig 5 View of part of the cellar beneath the early 20th century extension, looking north
