**C263 LATE EAST**  
**The Connaught Tunnel, Pumphouse**  
**and Air Vents:**  
**Non-Listed Built Heritage Recording**  
**Document Number: C263-MLA-X-RGN-CRG07-50039**

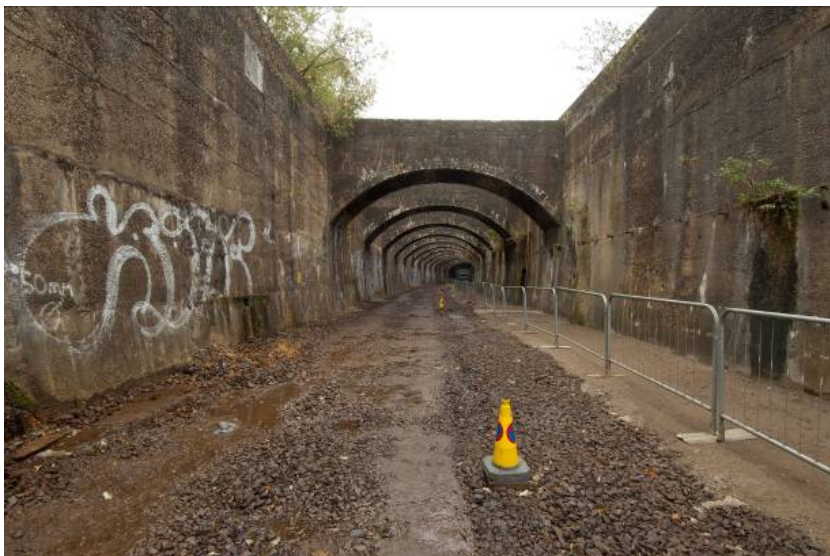
*Photo 1. The cutting and buttresses of the northern approach to the Connaught Tunnel, looking east*

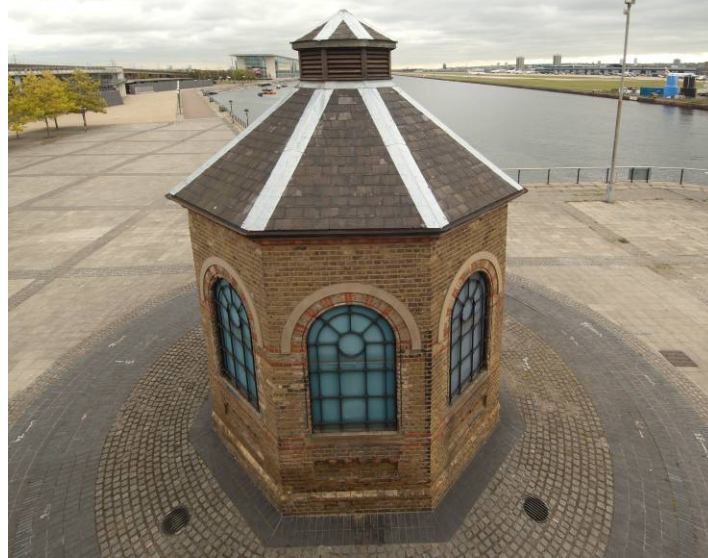
*Photo 2. The pumphouse looking east from the Connaught Bridge*

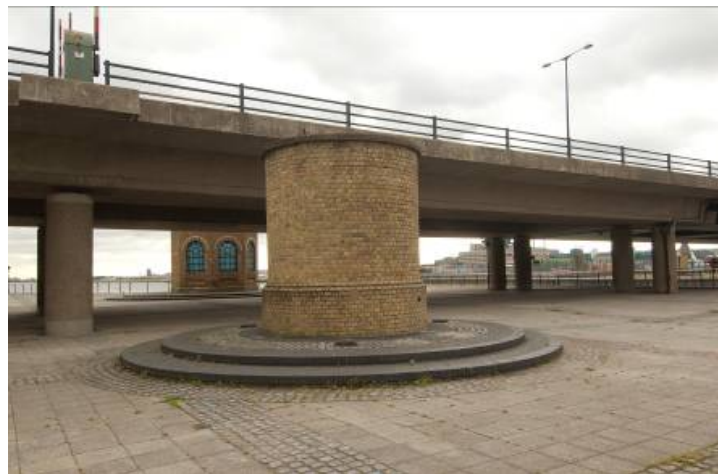
*Photo 3. The air vent on the north side of the Connaught Passage looking east, with the pumphouse in the background.*

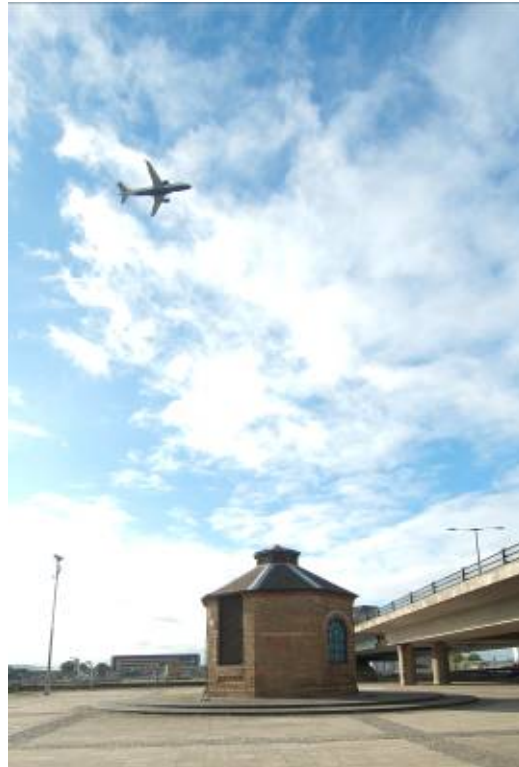
*Photo 4 The pumphouse looking south.*

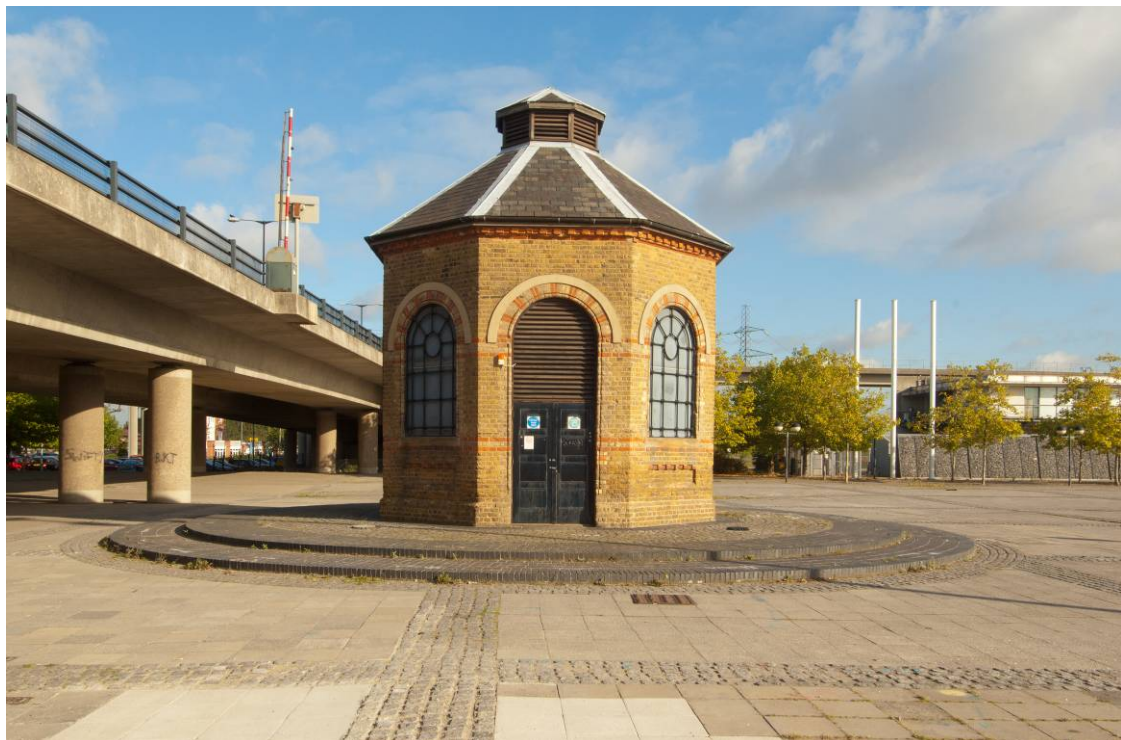
The building on the surface is a small, brick built, single storey, plinth built structure using yellow Gault bricks in English bond (Photo 5). Finer red stock bricks are used for decorative effect externally and form two pairs of string courses, one pair being at the level of the spring of the arched windows (of which there are five), the second pair being level with the window sills.

*Photo 5. The entrance and southern façade of the pumphouse looking north*

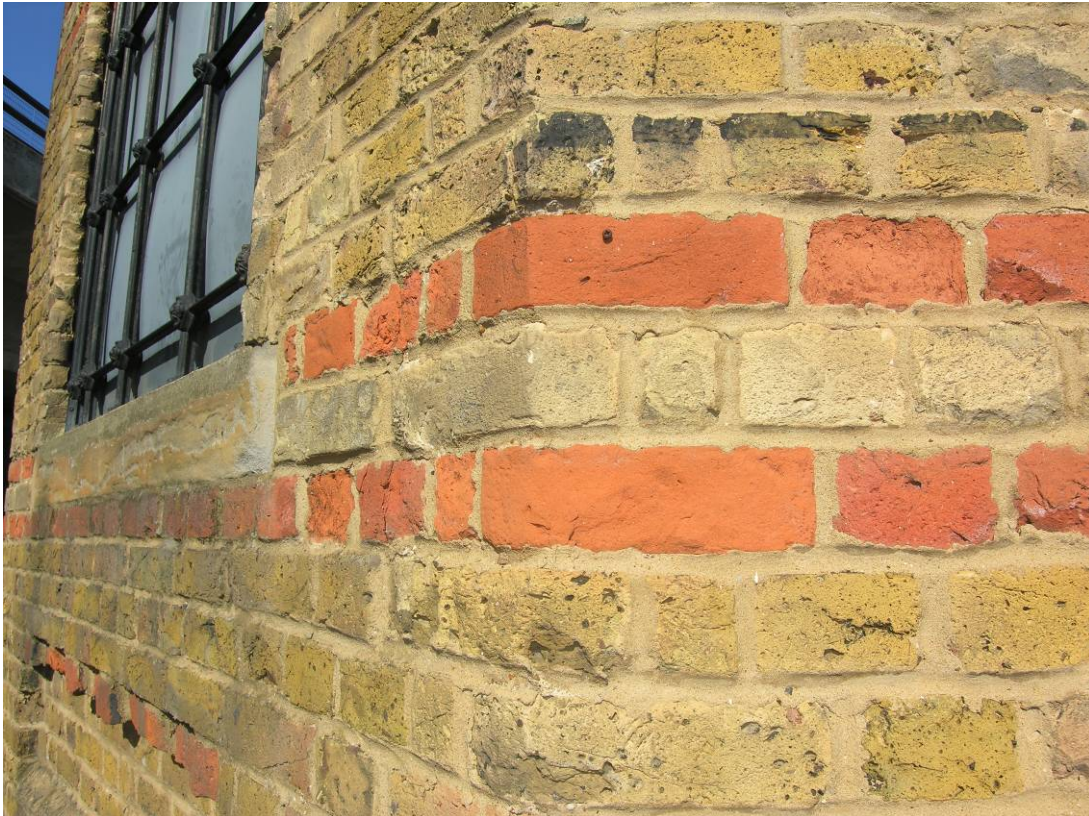
Further red bricks are used to form dentils at the tops of the recessed panels which are situated below each window (Photo 8). Red bricks also appear, again forming a line of dentils below the eaves at the top of the building. Throughout the building the standard dimensions of all of the bricks used are breadth: 105mm, length: 220mm and thickness: 60mm. The angled corners of the building are formed using King closer bricks in all three main brick types (Photo 6).

*Photo 6. The south west corner of the building looking north showing the three main brick types used in the building's construction, note the King closer bricks on the corner.*

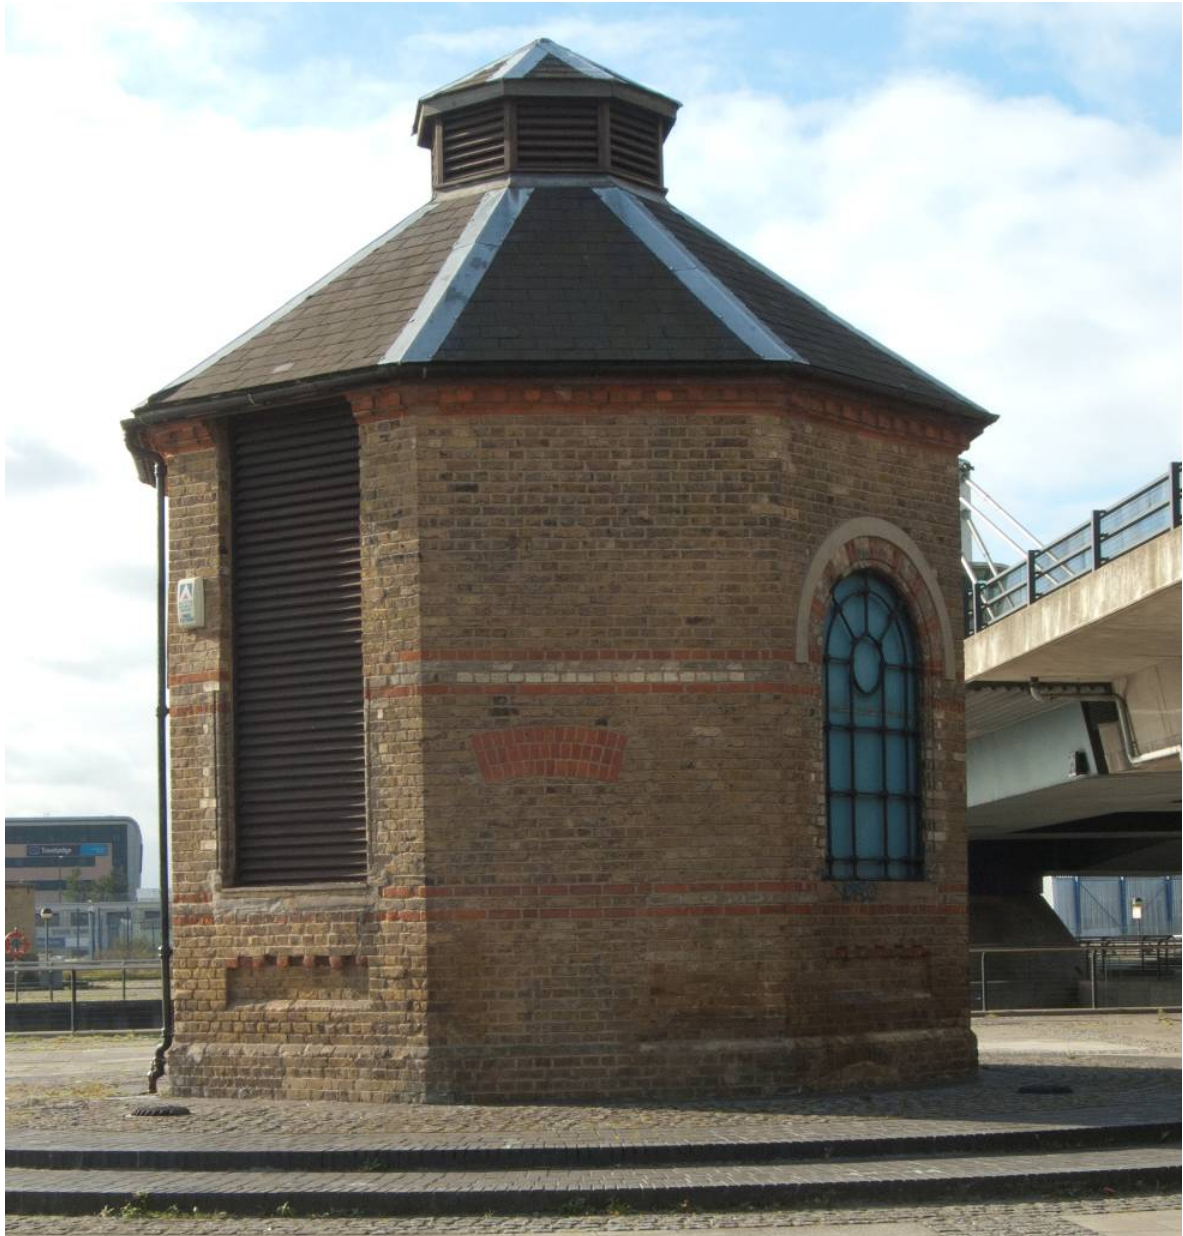
*Photo 7. The north east façade with the timber louvers and the north façade with the segmental arch visible from a blocked former doorway*

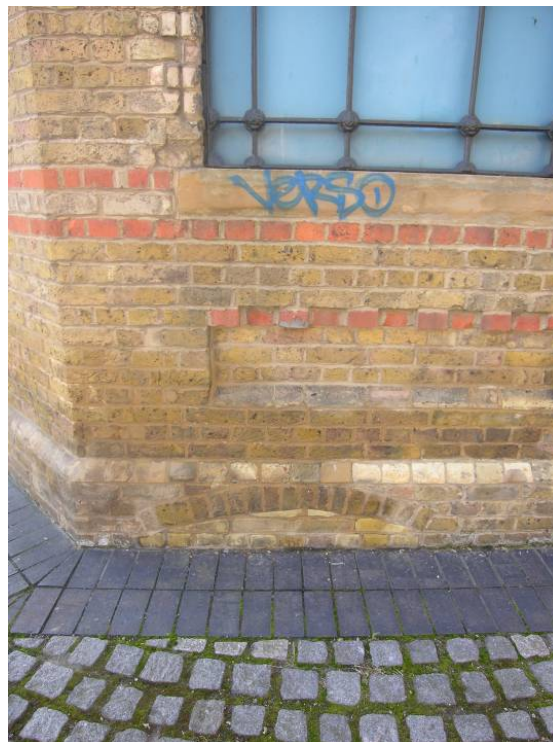
In the north western façade at plinth level is a single course segmental brick arch situated to the left of centre (Photo 9). It would seem likely that this was originally a low level window allowing some natural light to illuminate the upper levels of the pump shaft.

Photo 9. The single course segmental brick arch in the north western façade.

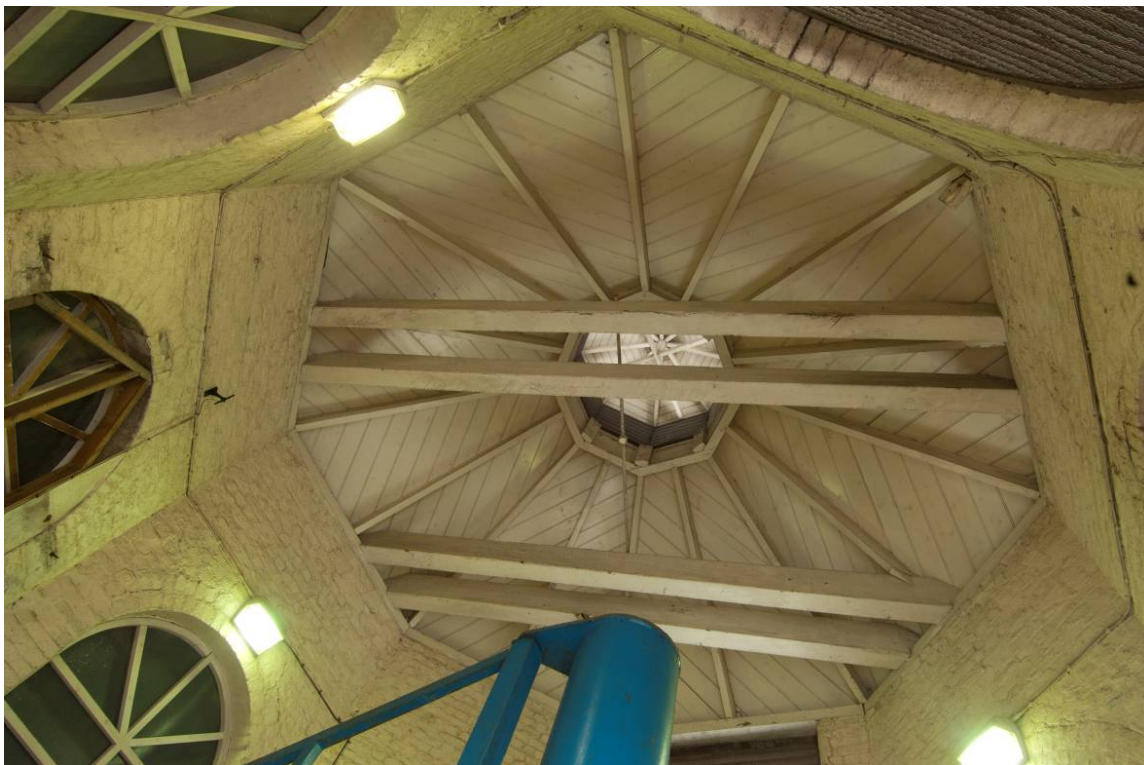
The pumphouse interior is accessed through the double doors in the southern façade of the building. The interior is open to the roof which is covered with boarding, set at an alternate angle within each of the eight sections of the roof, which as a whole, forms a herring bone pattern (Photo 10). Two pairs of substantial timbers run west to east across the roof space, resting on the wall plate. These do not appear to give structural support to the roof and are likely to have enabled machinery and parts to be hoisted up and down the pump shaft below. Two wheel-pullies are evident, one mounted on the northernmost of the four west to east timbers (Photo 12) and a second mounted at the south east corner (Photo 13). These both appear to be too small to have enabled the lifting of all but the lightest pieces of machinery. In the central louver smaller horizontal boards are used whilst a king post resting upon two cross beams supports the structure (Photo 11).

*Photo 10. The interior of the roof of the pumphouse, looking up and to the north.*

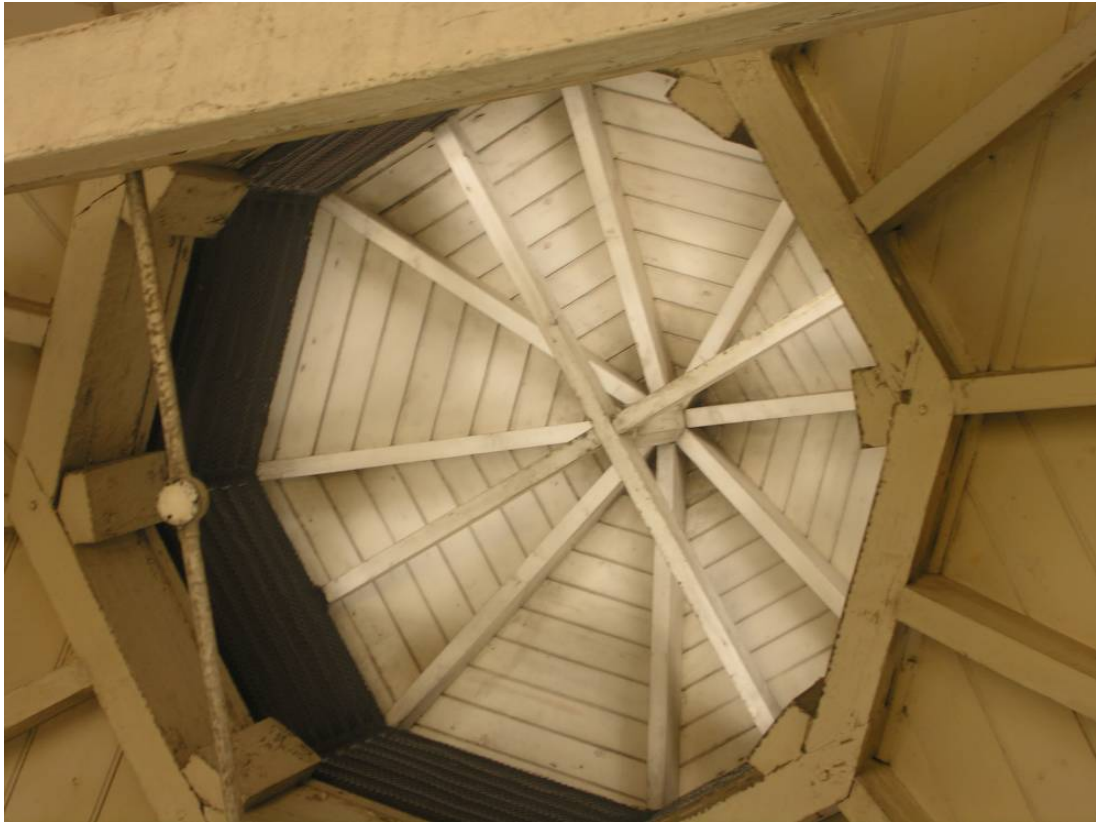
*Photo 11. Detail of the interior of the louver in the pumphouse roof, with the king post resting on the two small cross beams.*

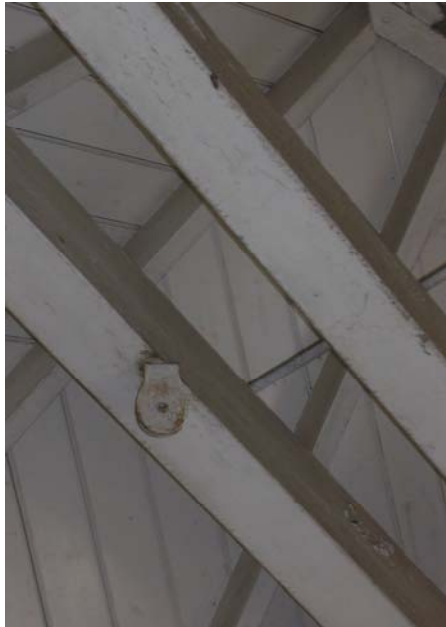
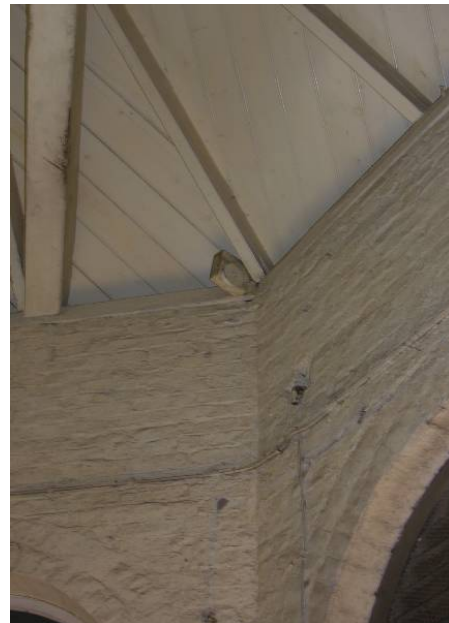
*Photo 12 left and Photo 13 right. The two pulleys within the pumphouse. The left pulley was mounted on the northernmost cross timber, the right in the south east corner.*

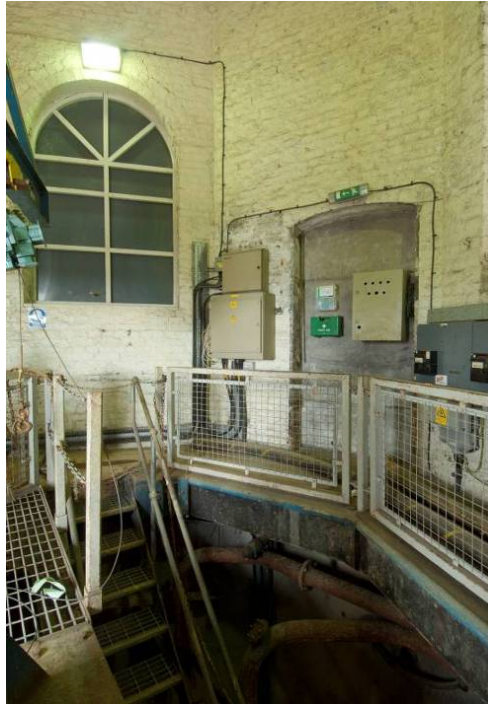
The interior of the building was undecorated and a simple frame had been inserted into each of the arched window spaces to support the opaque plastic glazing (Photo 14). The timber floor, supported by large timber joists ran around the opening of the shaft with a width of approximately 0.88m. A modern staircase ran down into the shaft from the north west (Photo 14). The south-western part of the shaft opening had been covered over in order to enable the instillation of a modern hoist (Photo 15). This was supported from below the floor by a joist, probably of wrought iron, which had tapered vertical flanges along its length suggesting a 19th century date (Photo 16).

*Photo 14. The interior of the pumphouse looking north west, with the steps into the shaft and the blocked doorway in the north elevation.*

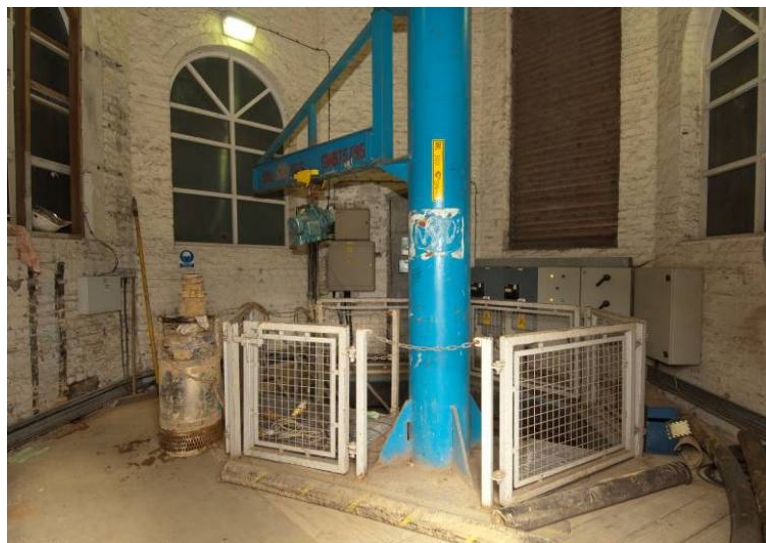
*Photo 15. The interior of the pumphouse looking north showing the modern hoist.*

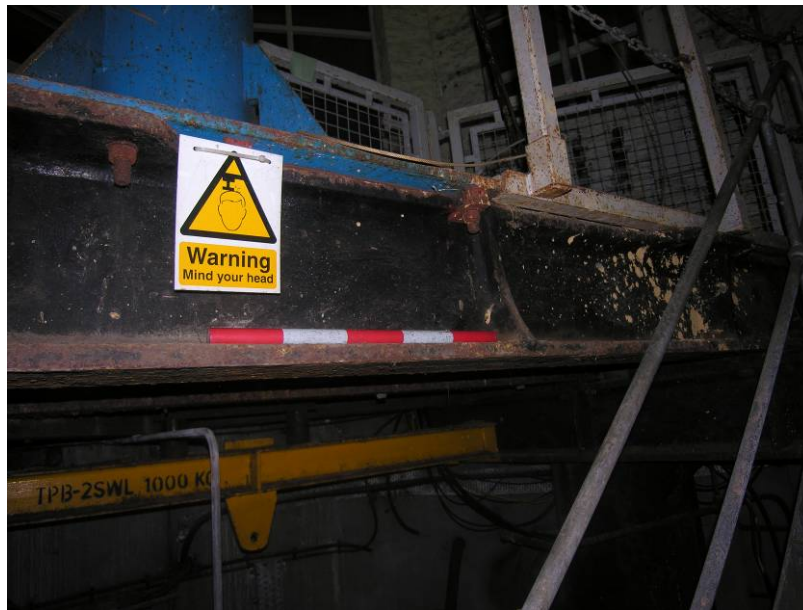
*Photo 16. The possible 19th century wrought iron joist across the centre of the shaft opening, used to support the modern hoist.*

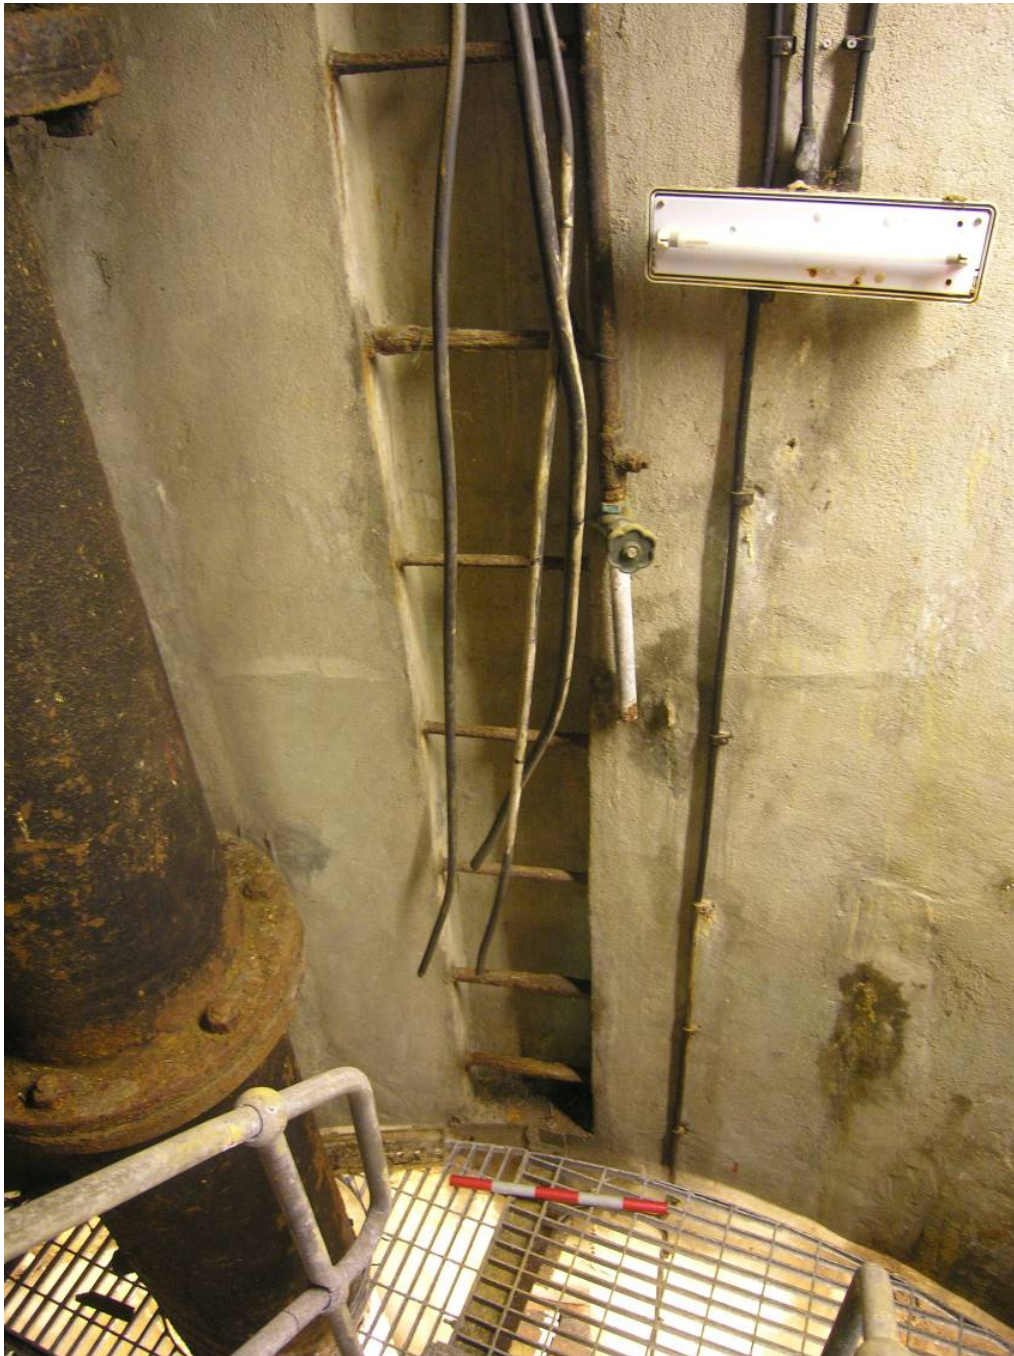
*Photo 17. The original step ladder access into the shaft, set within a recess in the western side of the shaft wall, looking west.*

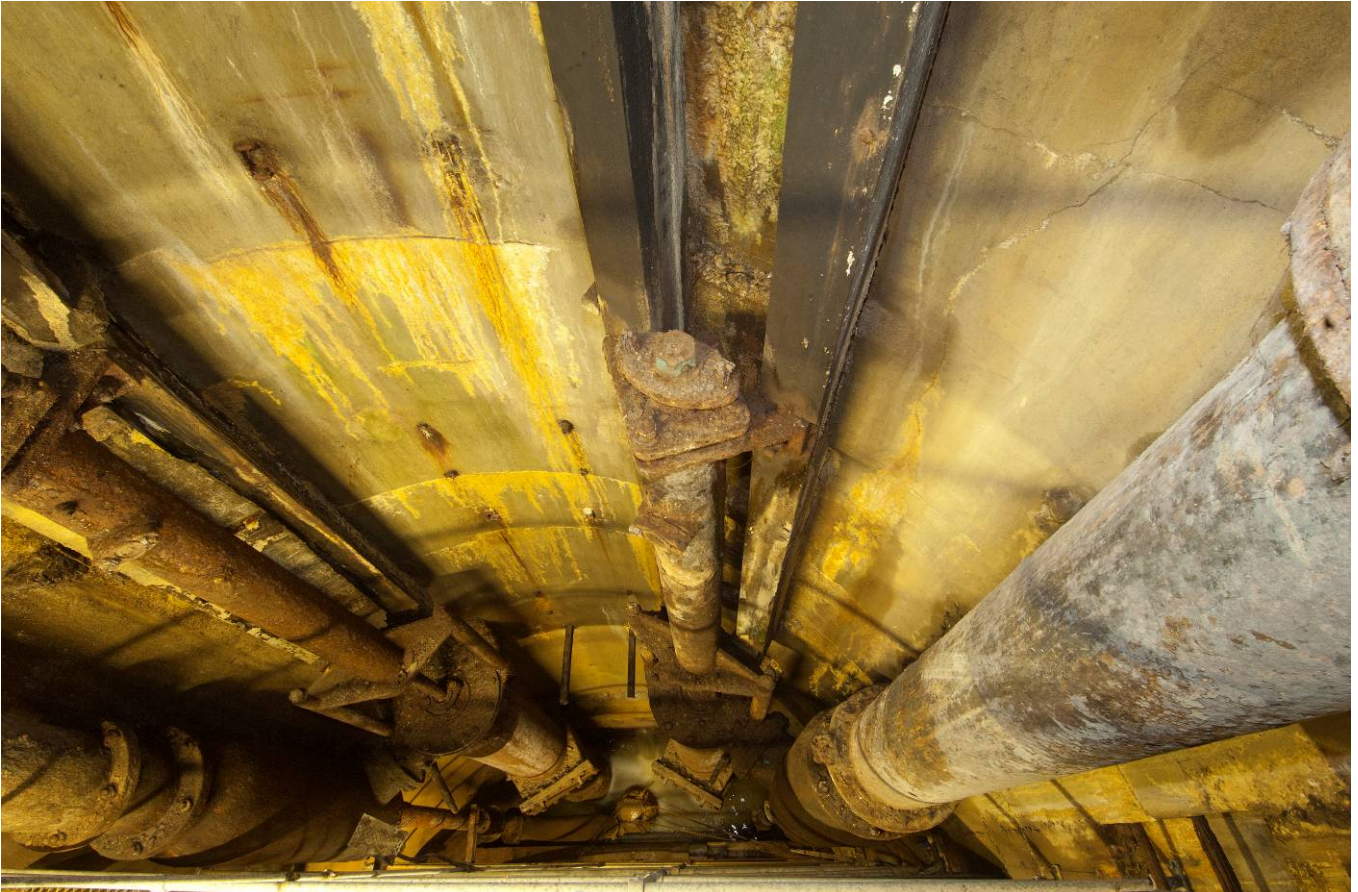
*Photo 18. The original pumping mechanism of 1878 on the southern side of the shaft, looking down and to the south. The westernmost of the two hydraulic pistons is in the centre of the photo, the other is on the left.*

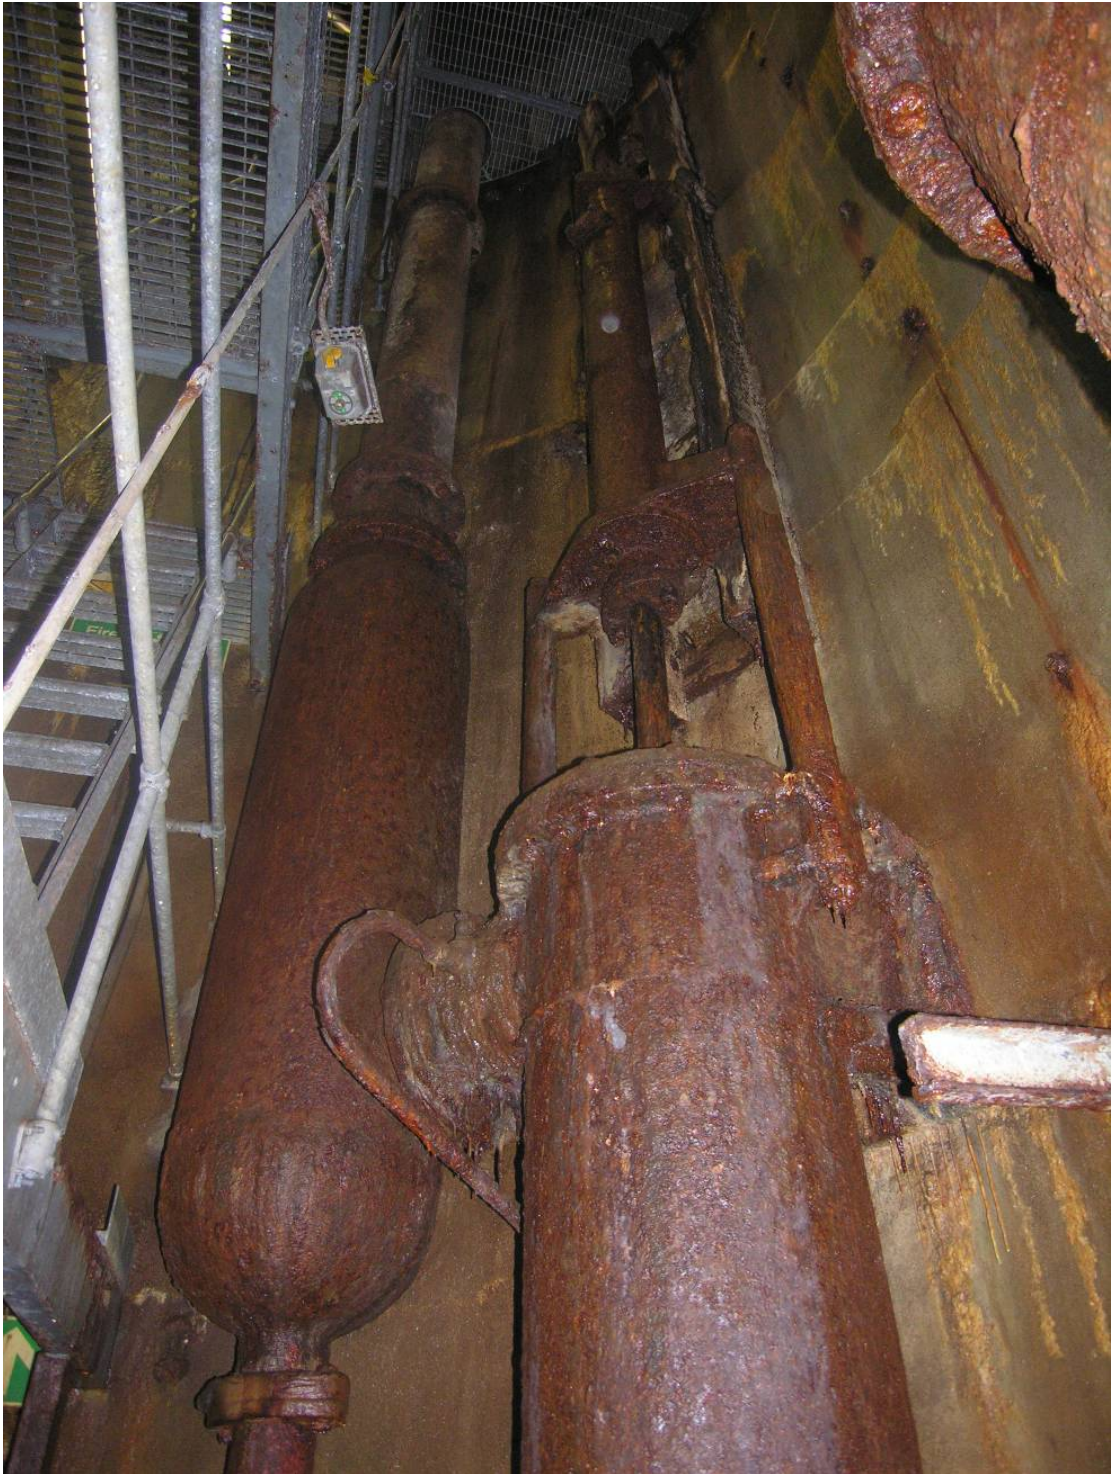
*Photo 19. The view looking up and to the south east at one of the two hydraulic pistons and its connection to the extractor pipe which continues up to the top of the shaft and out to the south.*

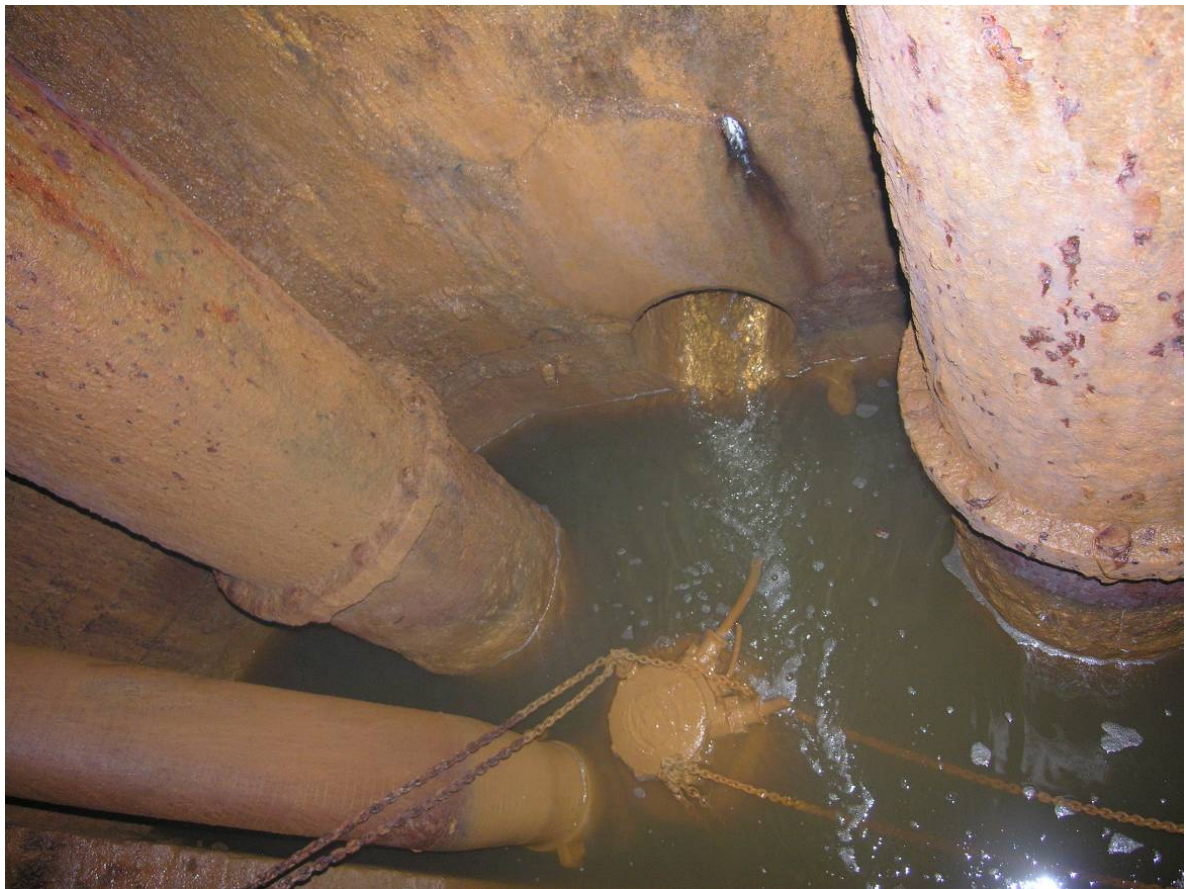
Interestingly there is a large spherical electric pump, now abandoned with its power cables cut, lying at the bottom of the shaft. This appears to have been an initial replacement for the hydraulic mechanism and it reused the easternmost of the two earlier extractor pipe, pumping water up and out to the south. However this in turn has been replaced by the new current mechanism, which is again electric. Two

*Photo 20. The base of the shaft showing the inlet with water flowing in from the Connaught Tunnel. The earlier abandoned electrical pump is partially submerged in the centre of the photograph.*

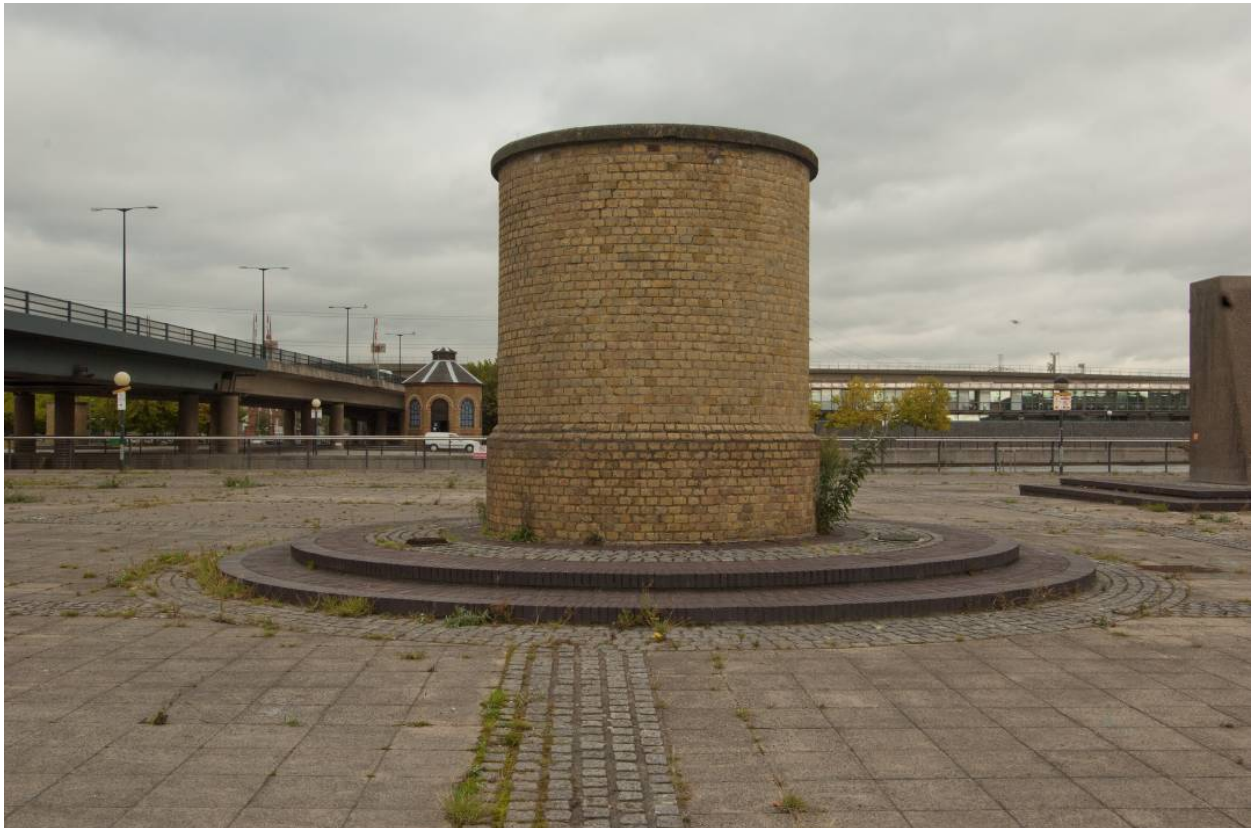
*Photo 21. The southern air vent structure with the pumphouse in the background, the northern air vent is just visible behind the Connaught Bridge in the far left of the photo.*

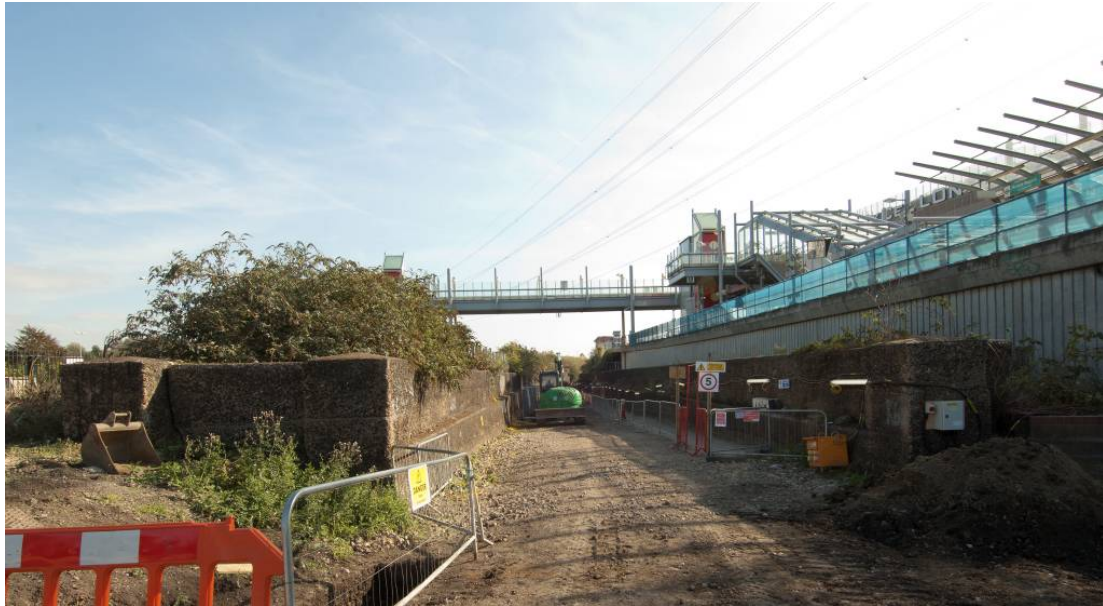
Photo 22. The northern entrance to the cutting of the Connaught Tunnel looking east.

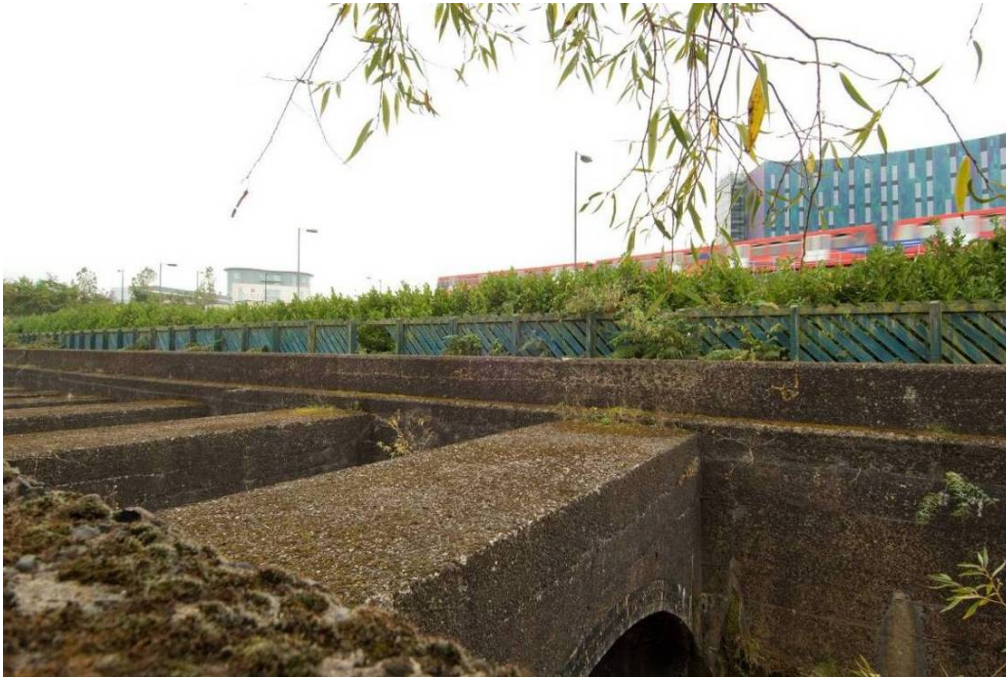
The arched buttresses are equally spaced, just under 5m apart. They are formed from a three course brick segmental arch which spans the cutting wall, with mass concrete above. The horizontal joints between the different concrete pouring episodes are continued into the arch, indicating that the arches were part of the original construction and built at the same time, using the same technique as the cutting walls.

*Photo 23. The first or westernmost of the arched buttresses in the approach to the north portal looking south east. Note the gradual increase in depth of the buttresses to the left.*

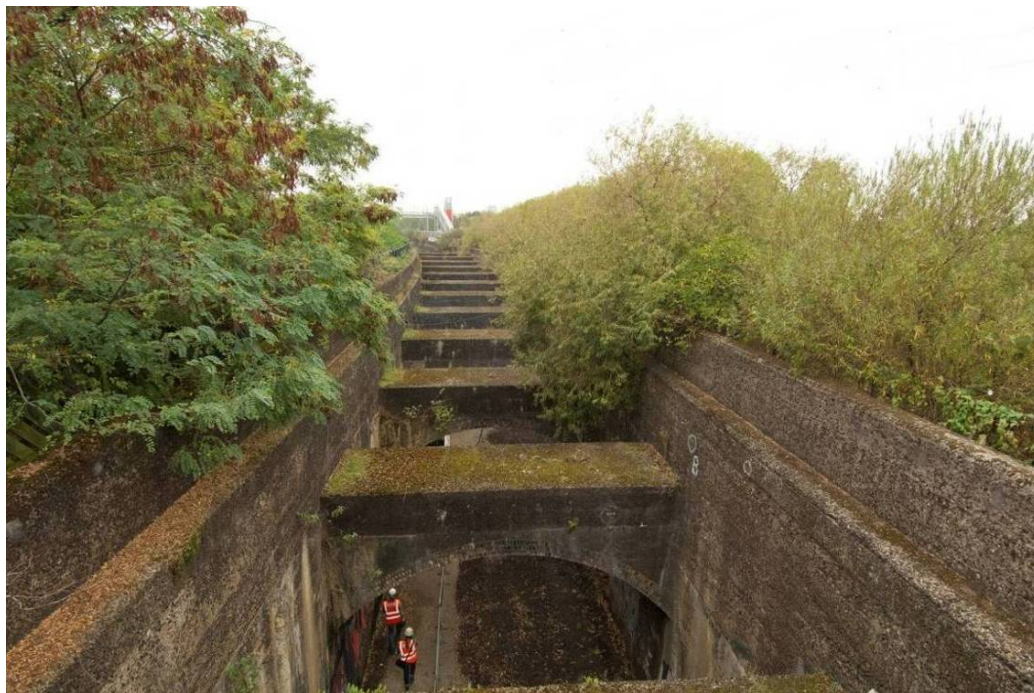
*Photo 24. The buttresses of the north cutting looking west.*

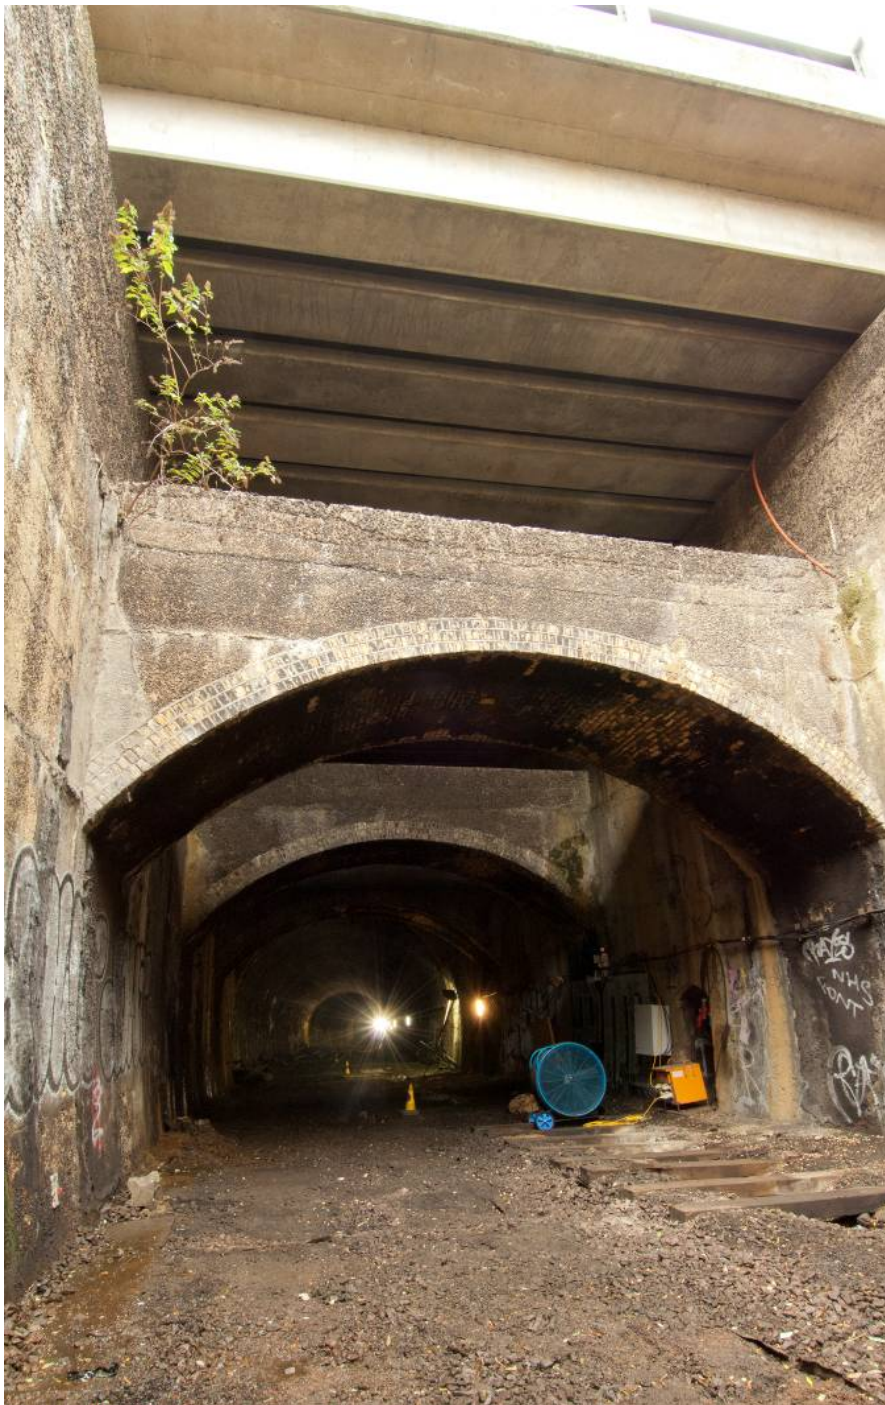
The last two buttresses of the cutting in the approach to the north tunnel portal are covered over by the modern concrete structure that supports the road which leads from Royal Albert Way to the Festoon Way Roundabout (see *Photo 26*).

*Photo 26 The view east towards the approach to the north portal of the tunnel covered by the concrete structure of the modern road.*

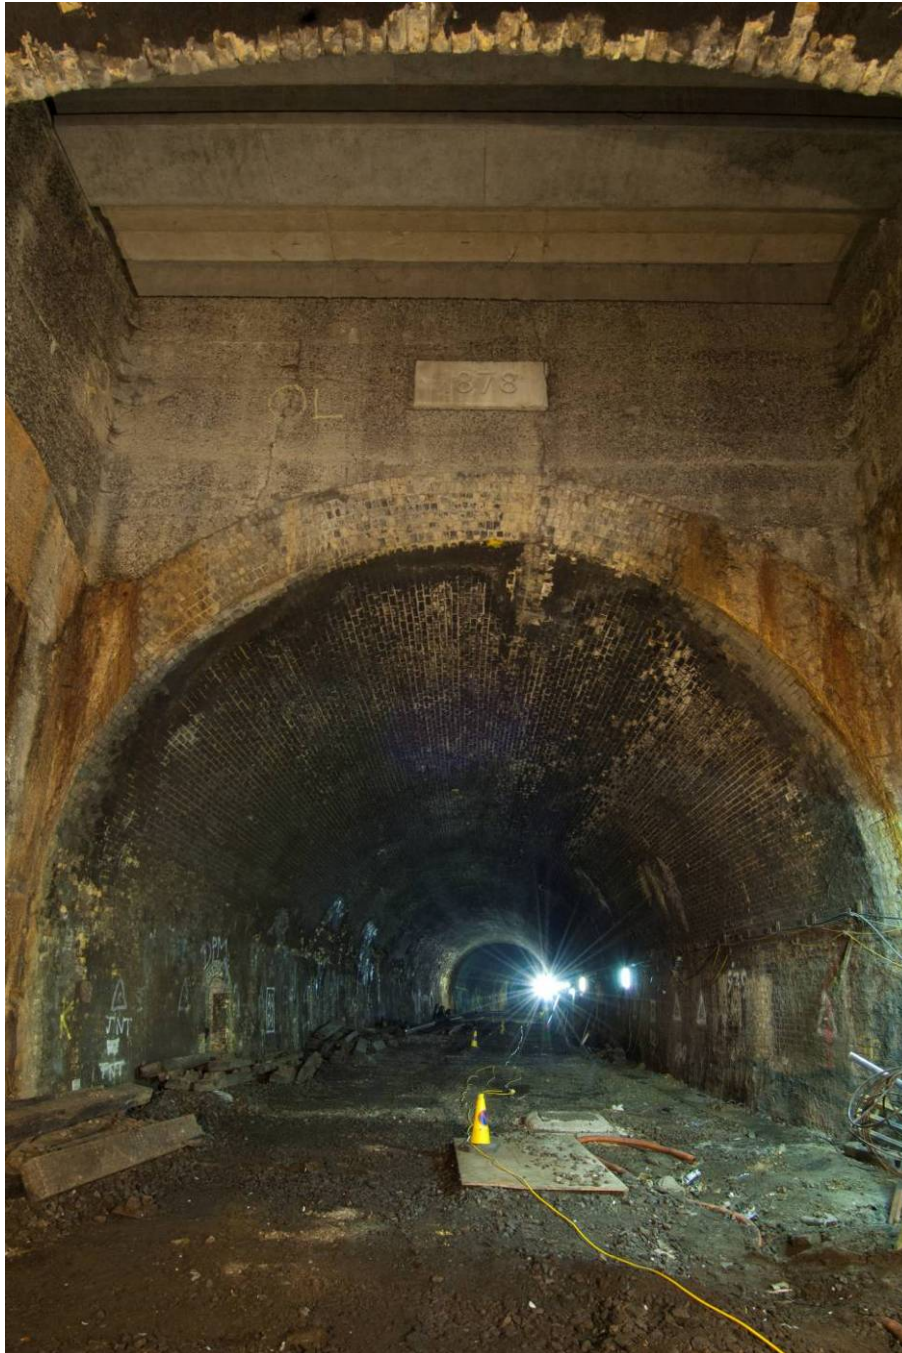
*Photo 27 The north portal of the tunnel, looking east.*

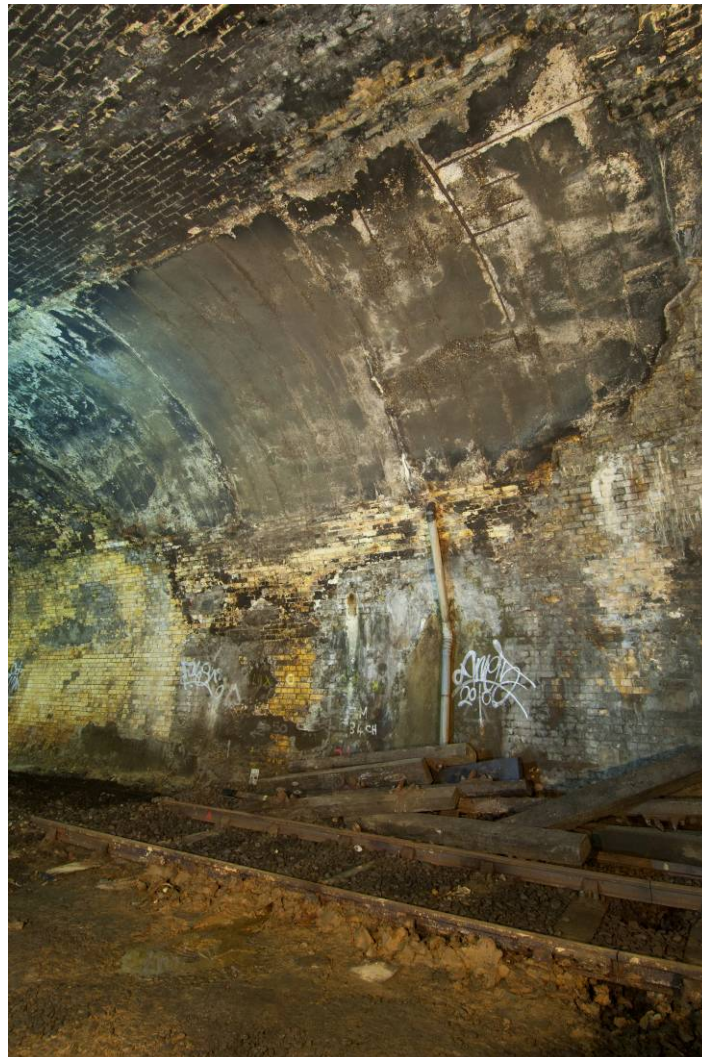
Within the north single tunnel section is an area of repaired Second World War bomb damage (Photo 28). The repair was done by shuttering the interior of the tunnel with concrete poured over reinforcing bars, some of which are visible at the eastern end of the repaired area. During this repair the opportunity seems to have been taken to address drainage problems and a drain pipe was inserted. At present a plastic replacement for the original, carries water down into a central drainage culvert that runs below the track bed. This brick built culvert can be seen in the original GER section drawings (Fig 2).

*Photo 28. The area of bomb damage repair in the northern single tunnel section, looking north west. Note the reinforcing bars on the right within the concrete and the inserted drain pipe.*

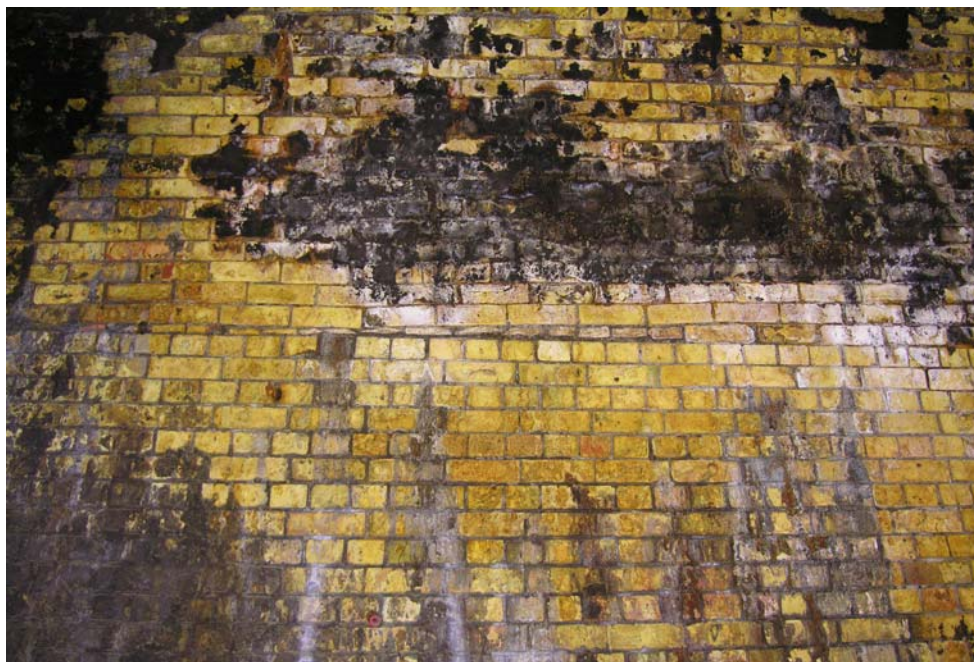
*Photo 29. The change in brick bonding from English to stretcher in the northern single tunnel section and the gradual insertion of an extra course of stretcher bricks from left to right.*
