**C263 LATE EAST**  
**The Connaught Tunnel, Pumphouse**  
**and Air Vents:**  
**Non-Listed Built Heritage Recording**  
**Document Number: C263-MLA-X-RGN-CRG07-50039**

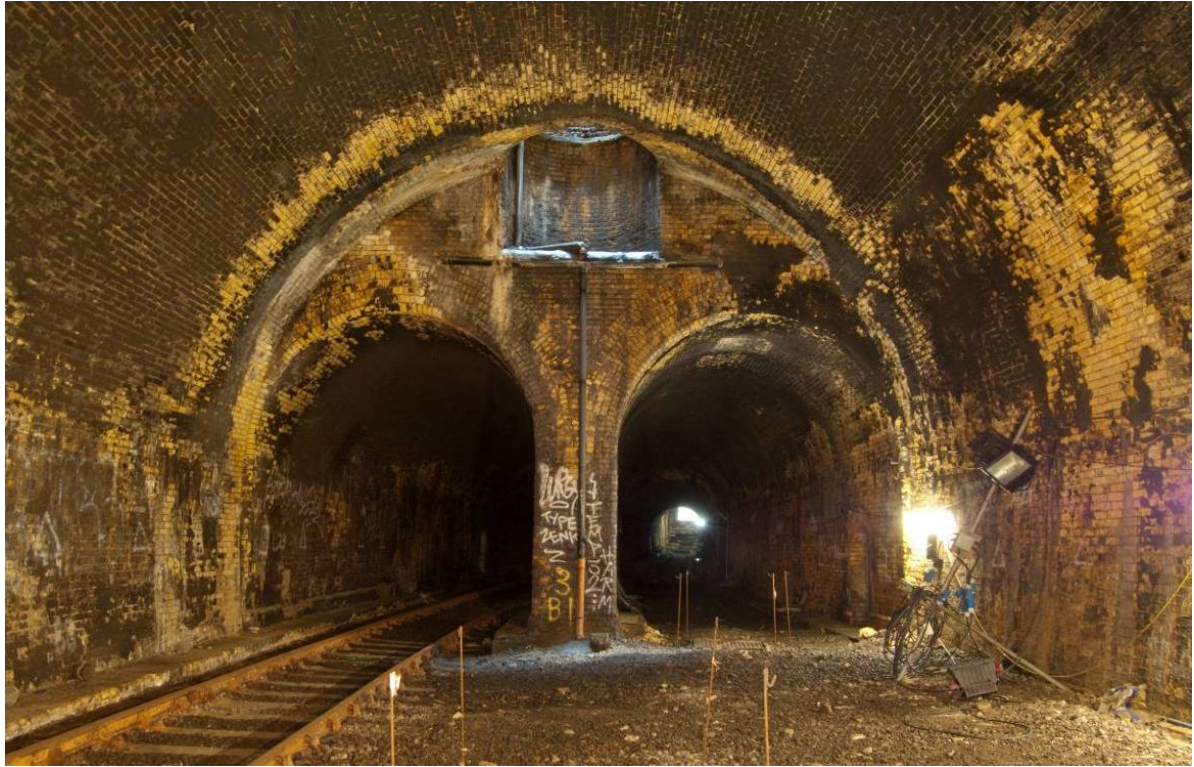
*Photo 30. The junction between the north single tunnel and the north twin tunnel sections, with the base of air shaft, looking south east.*

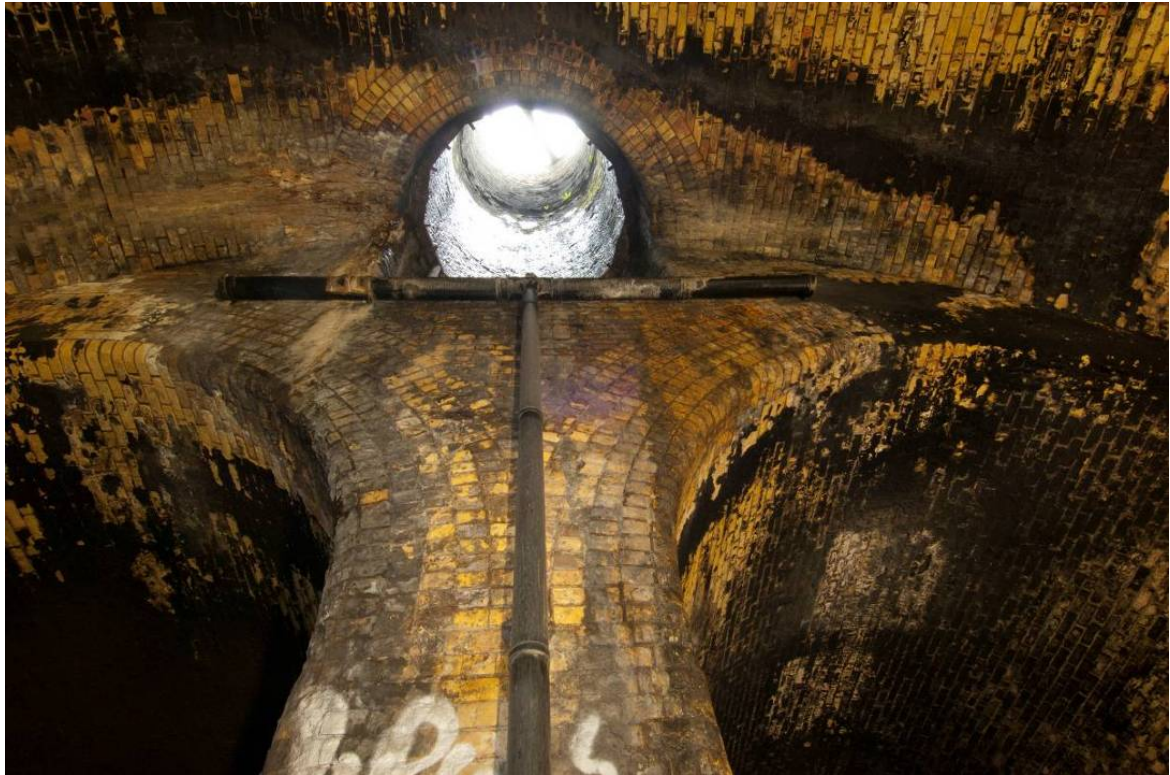
*Photo 31. The view up and to the south east at the north [portals of the twin tunnels showing the base of the northern air shaft.*

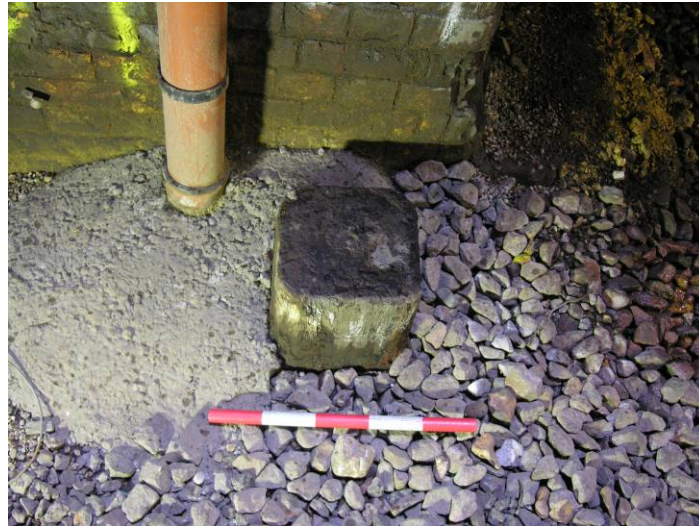
*Photo 33. The timber in the track bed between the north portals of the twin tunnel.*

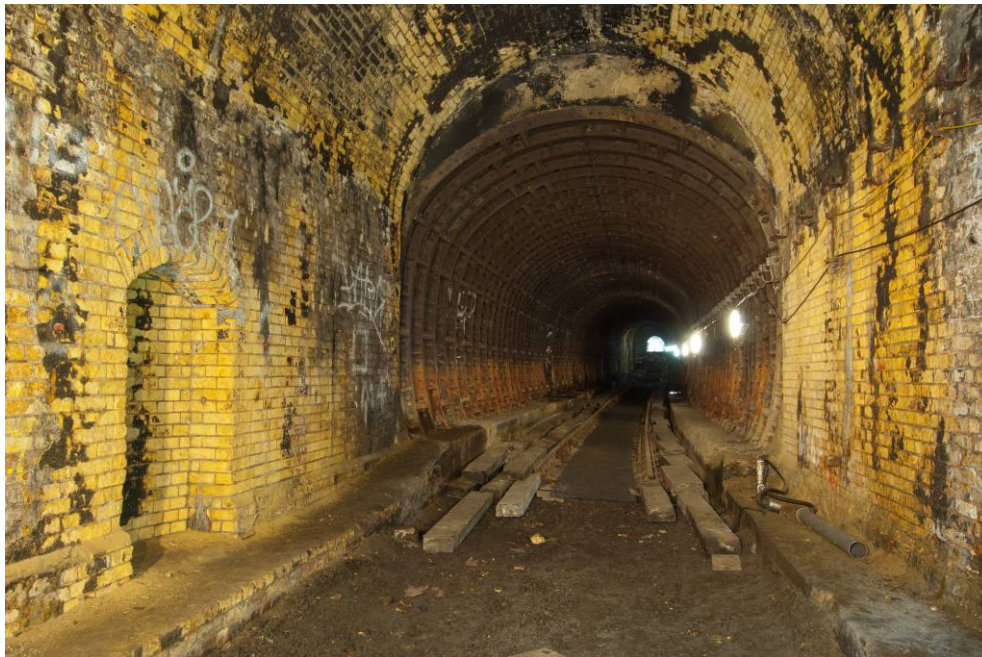
*Photo 34. The southern end of the western brick twin tunnel, looking south east towards the steel twin section with a refuge on the left.*

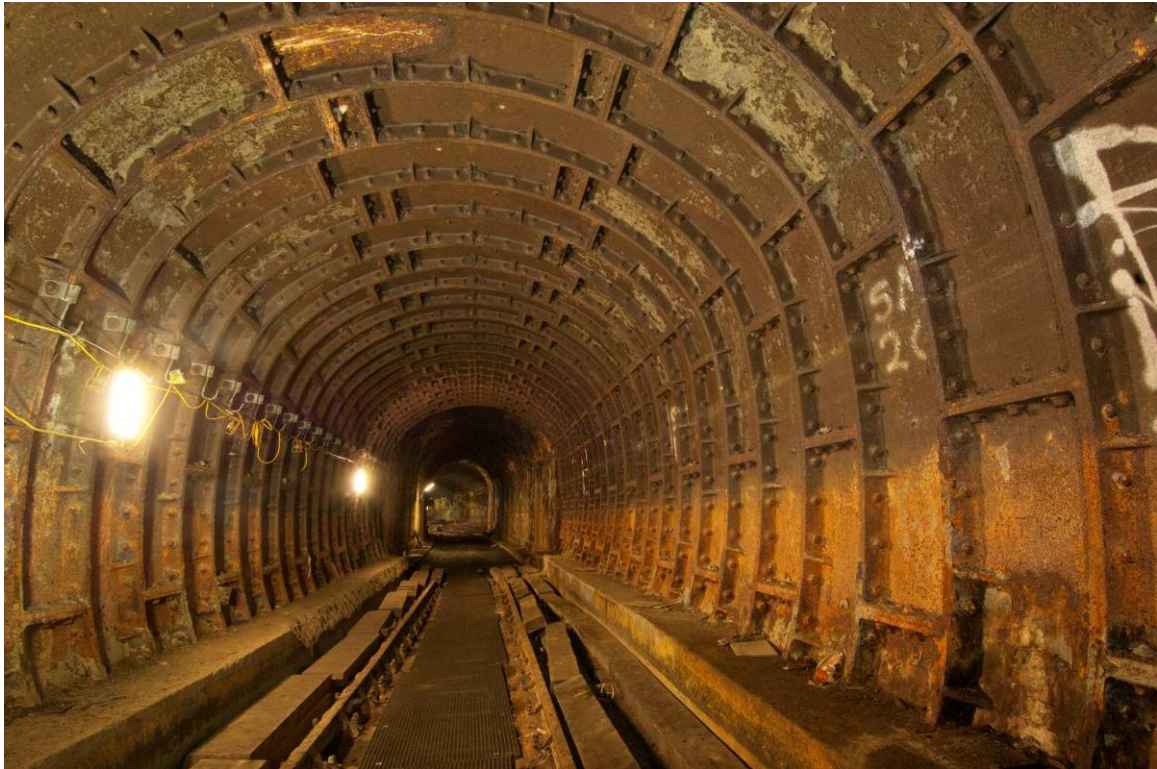
*Photo 35 the view north west along the western section of steel lined twin tunnel.*

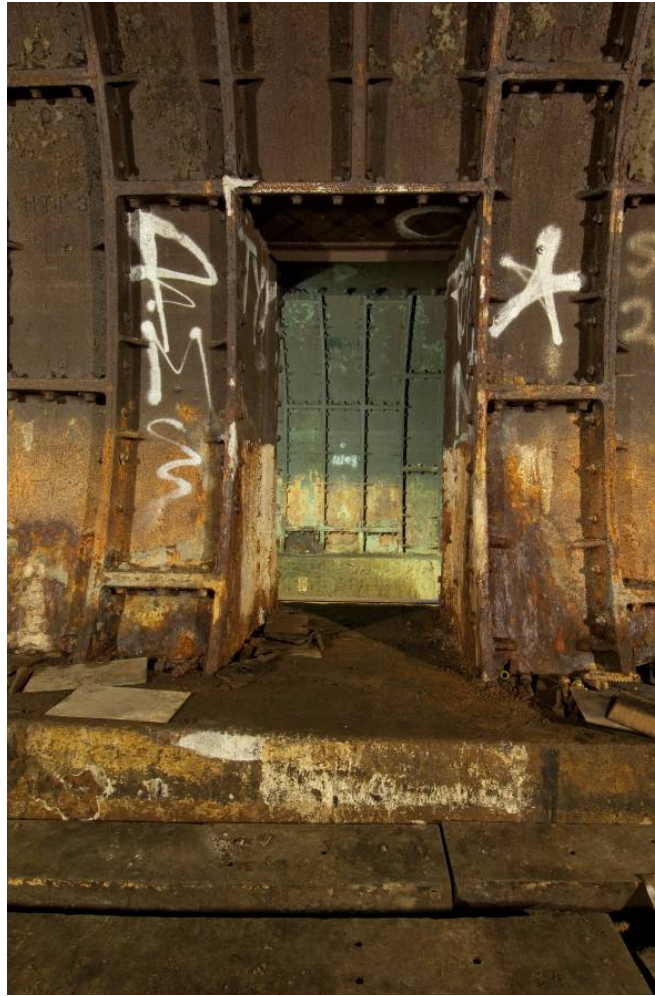
*Photo 36 the northernmost of the two cross passages in the steel lined section of the tunnel, looking north east.*

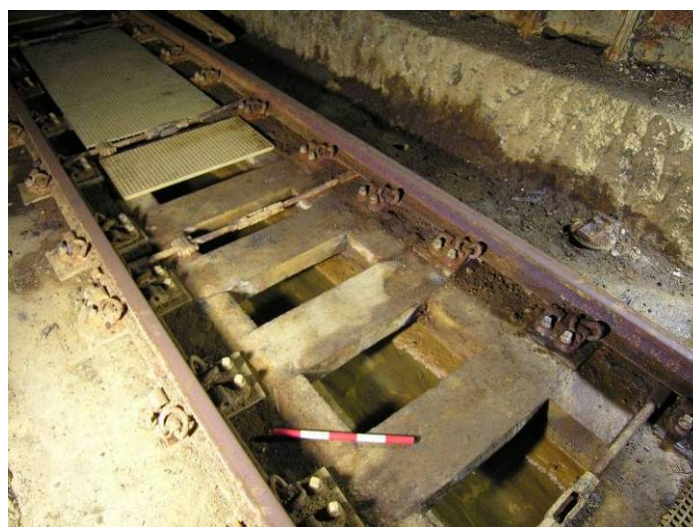
*Photo 37. The open culvert running beneath the sleepers in the steel lined section of the tunnel.*

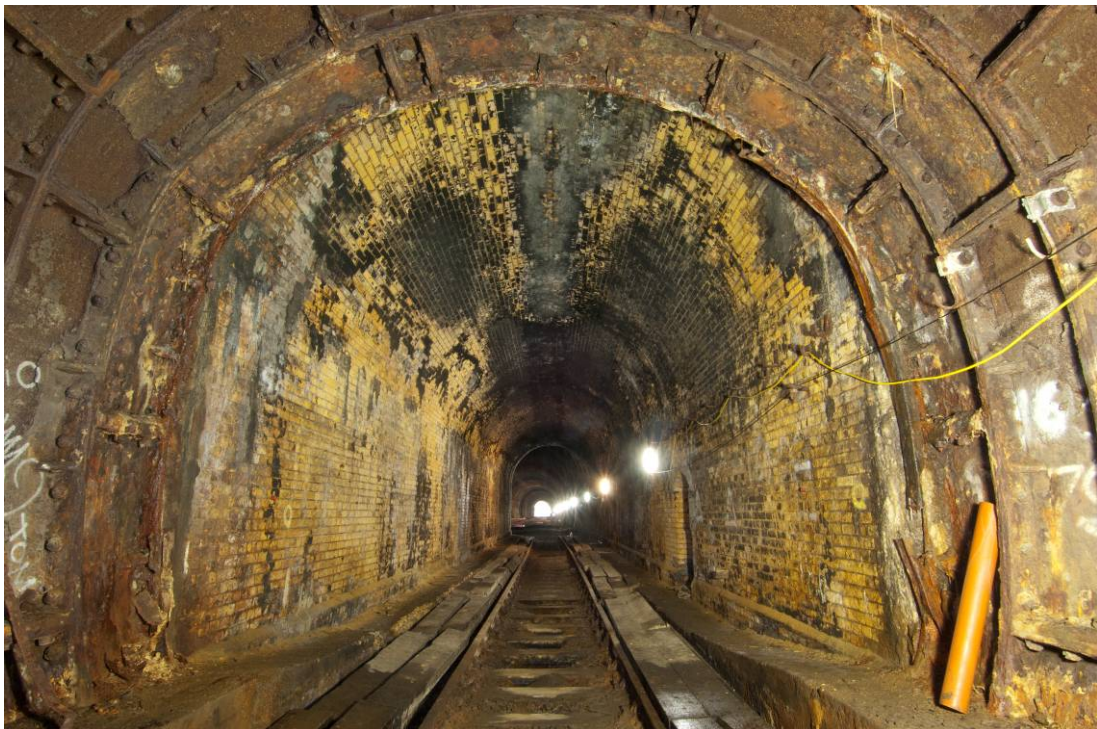
*Photo 38 The junction between the steel lined twin tunnel and the southern brick twin section, looking south.*

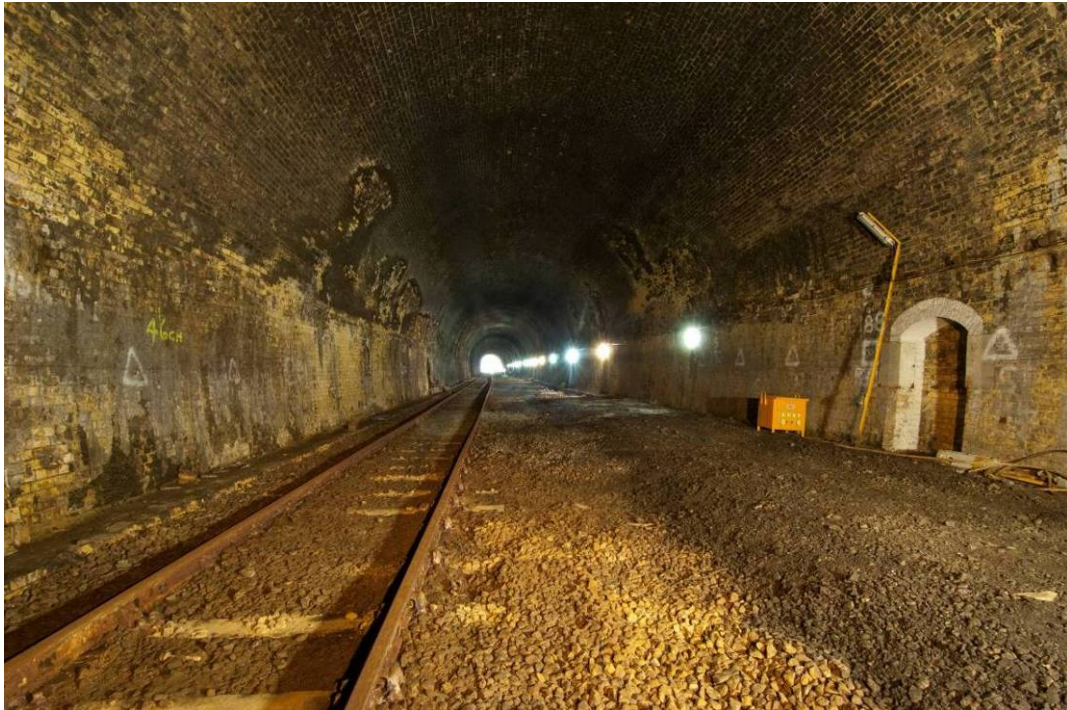
*Photo 40 The view south down the southern brick single section of tunnel.*

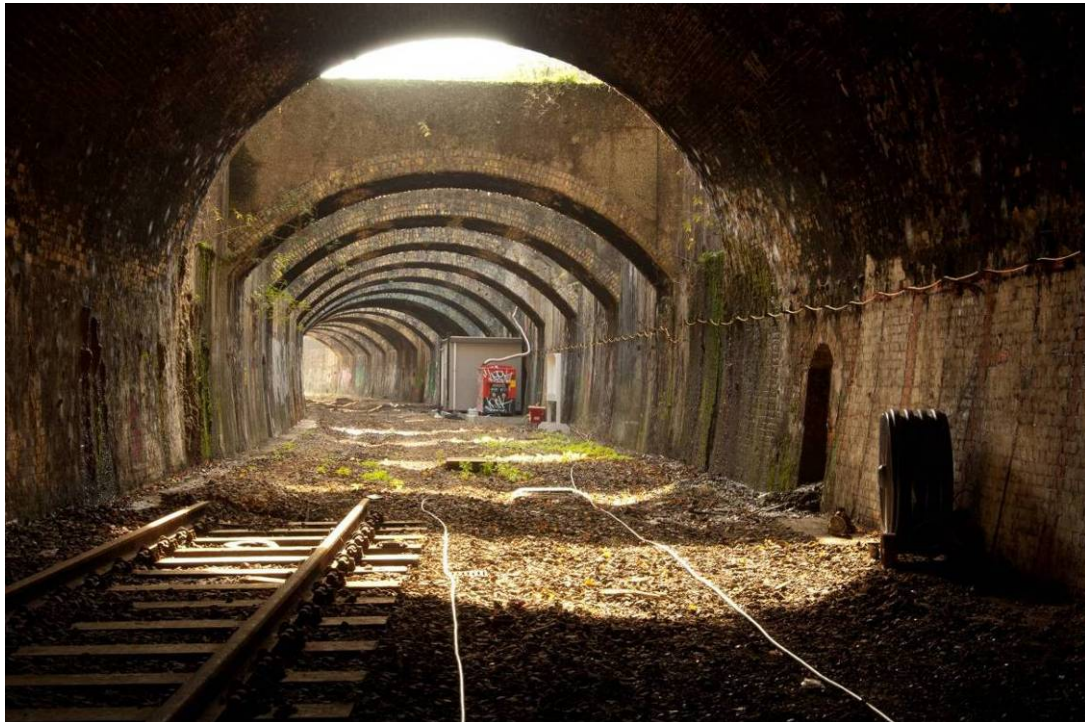
*Photo 41 The view south through the southern portal towards the buttresses of the southern cutting.*

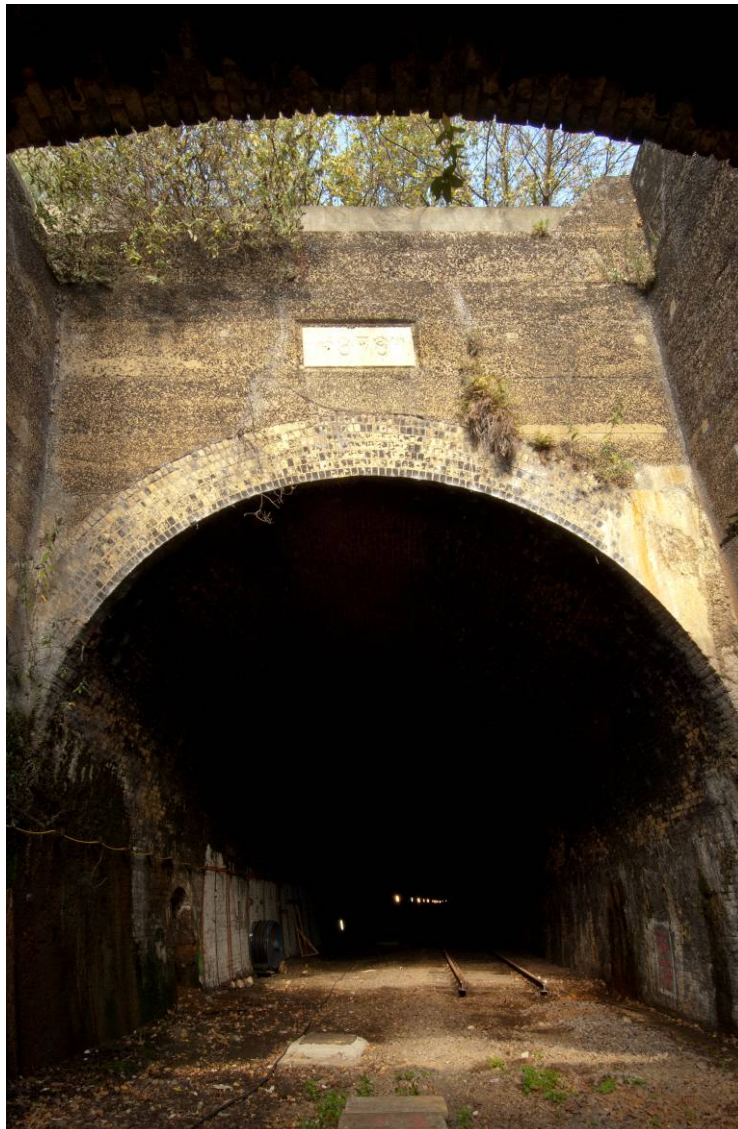
*Photo 42 The south portal looking north.*

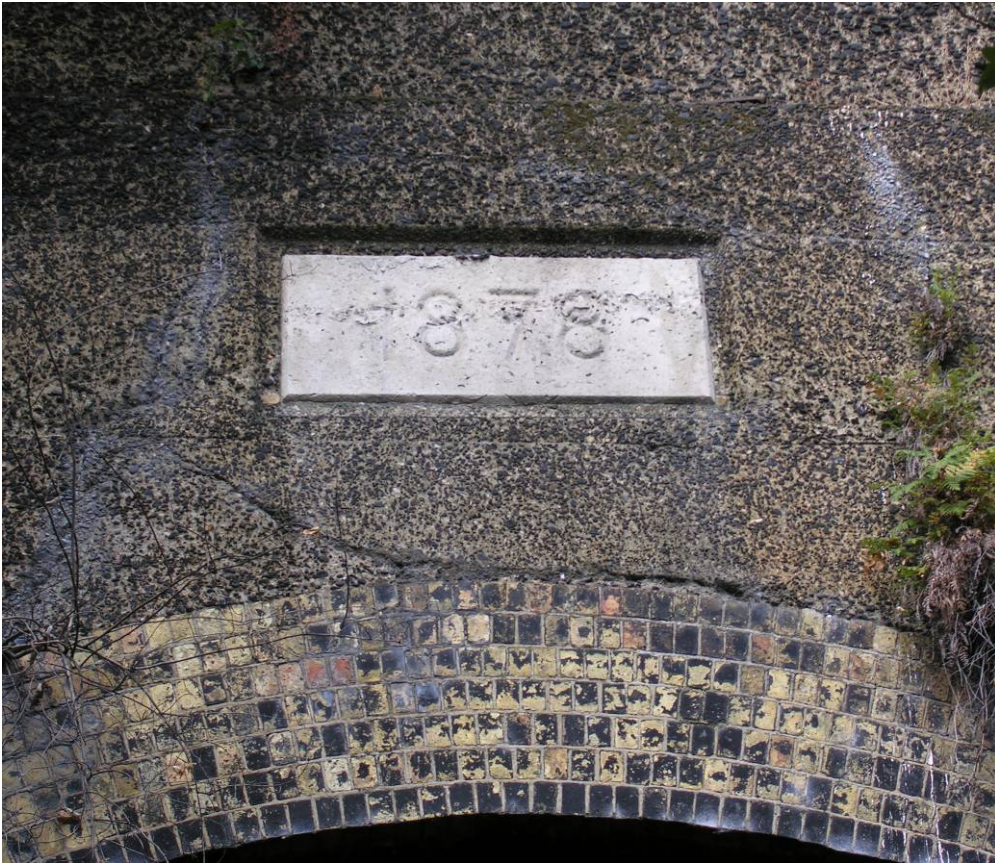
appear to be shell like inclusions in the stone, particularly visible on the plaque above the south portal (Photo 43), which are a common trait of Portland stone. The bricks used in the tunnel's construction are yellow Gault bricks, which were supplied by Aylesford Pottery Company (Halcrow, 1989) with a Portland cement mortar.

Unlike the north portal, the southern portal is not covered by a modern structure but open to the sky. The portal itself however is identical to that at the northern end of the tunnel, with a date plaque (Photo 43), chamfered along its edges, above the seven course brick arch. The concrete above the brick is again identical in appearance, with horizontal lifts or bands indicating the height of the shuttering and the various stages by which the concrete was poured. The horizontal banding continues along the cutting walls and the arched buttresses. Two pairs of buttresses (from the north buttresses 7/8 and 10/11) have been covered over with concrete slabs. This is likely to have been a necessary precautionary measure to prevent objects falling into the cutting as the DLR passes over head above buttress 9.

*Photo 43 The plaque above the southern portal, probably of Portland stone.*

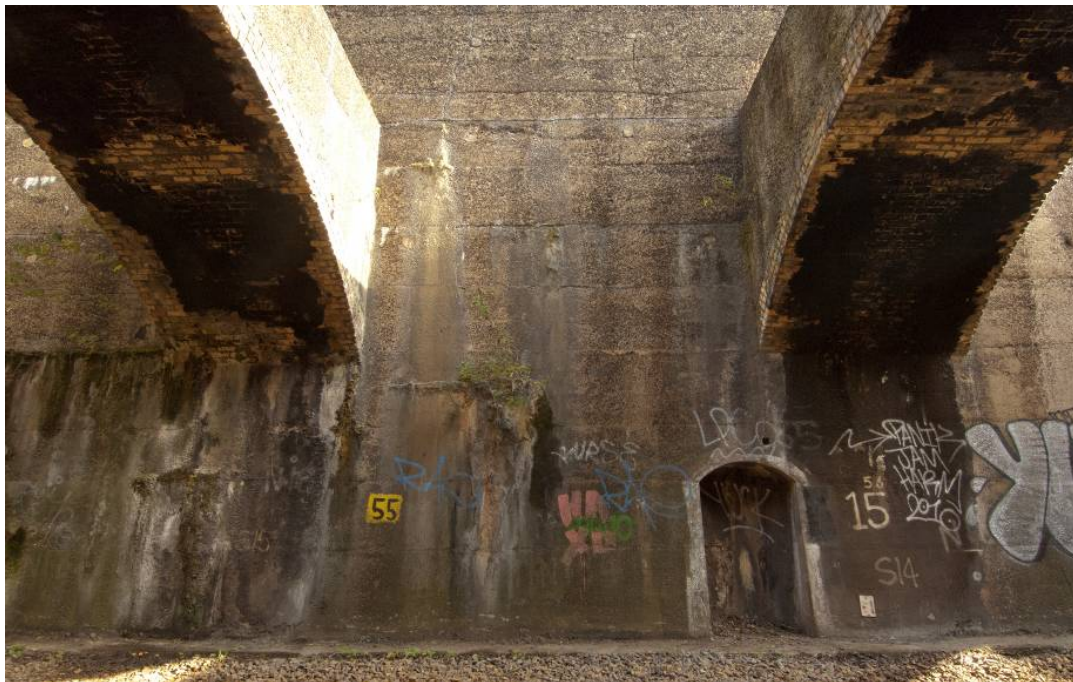
*Photo 44 Arched buttresses in the southern cutting, looking east.*

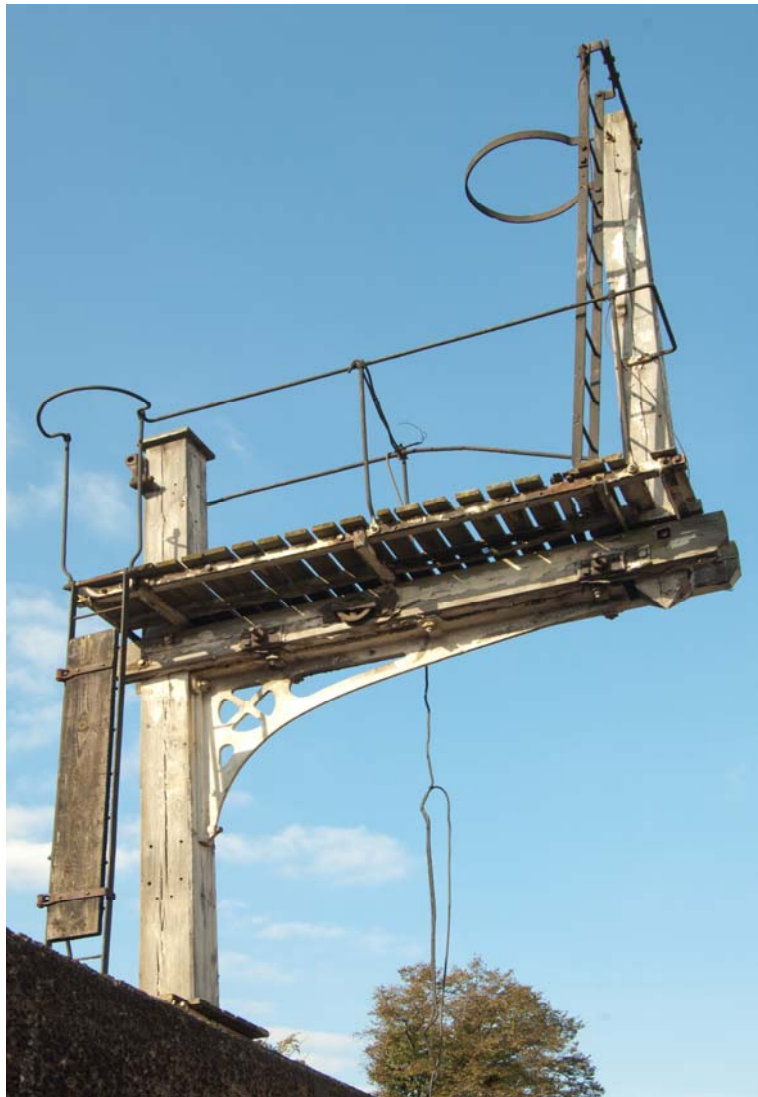
*Photo 45 The gallows signal at the southern end of the south cutting looking north west.*

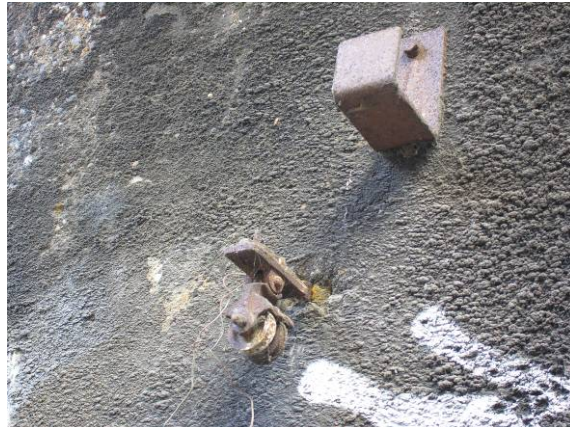
*Photo 46 A pulley wheel and cable bracket on the south-western site of the southern cutting*

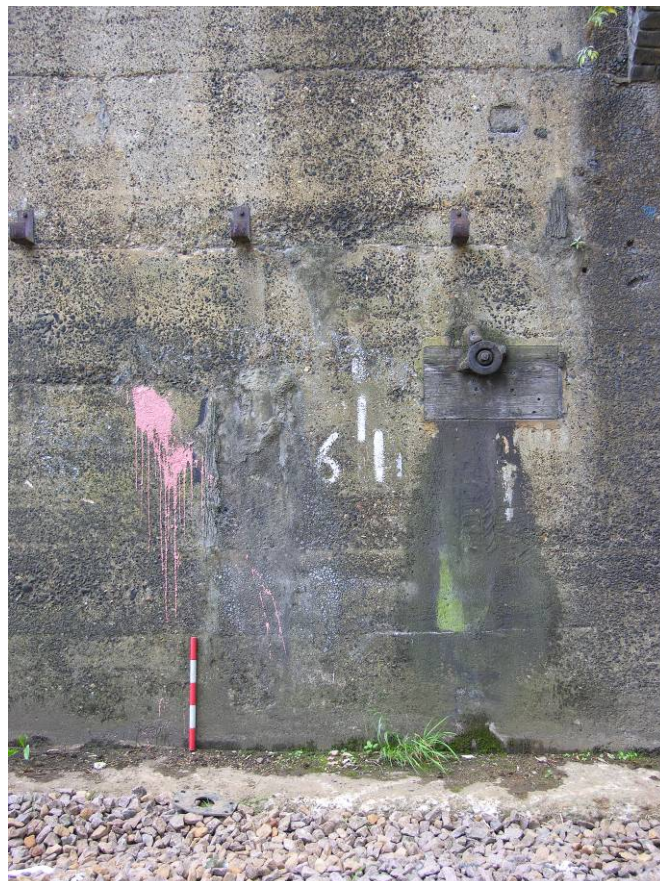
*Photo 47 The larger pulley wheel mounted on timber, set into the cutting wall, looking south.*

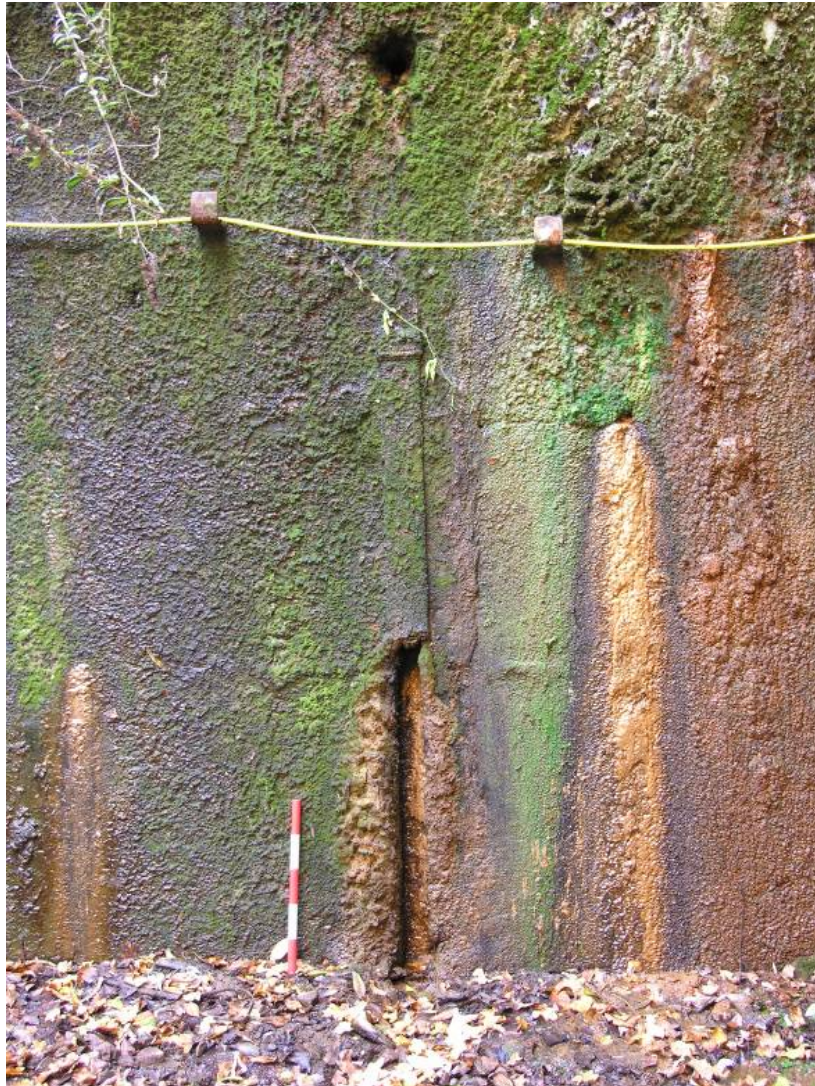
On the south wall of the south cutting, 0.66m outside the south portal are the remnants of a recessed drain pipe (Photo 48), now broken and much covered by moss. No other recessed pipes were noted either within the tunnel or in the cuttings. Due to the fact that the pipe is recessed within the concrete this may be an original feature intended to resolve a localised drainage issue.

*Photo 48 The recessed drain pipe outside the south portal looking south.*

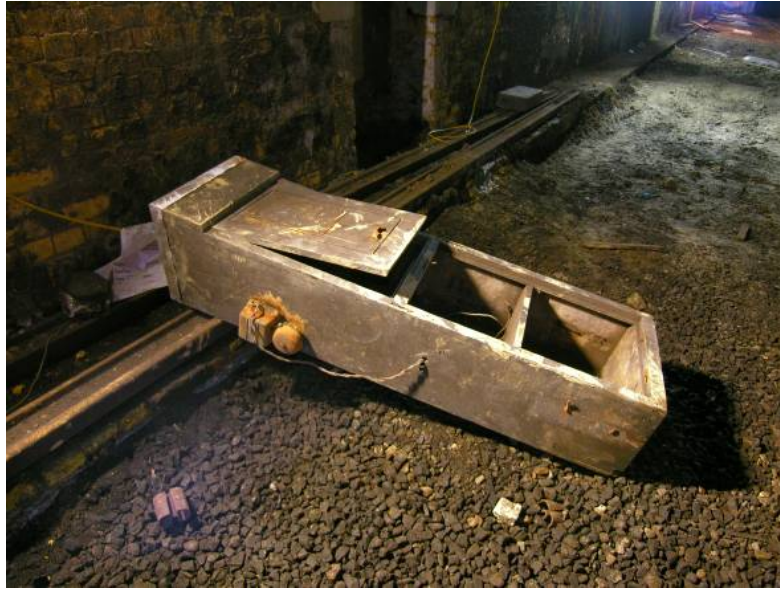
*Photo 49. the timber box with the electric bell found in the southern single tunnel, looking north west.*

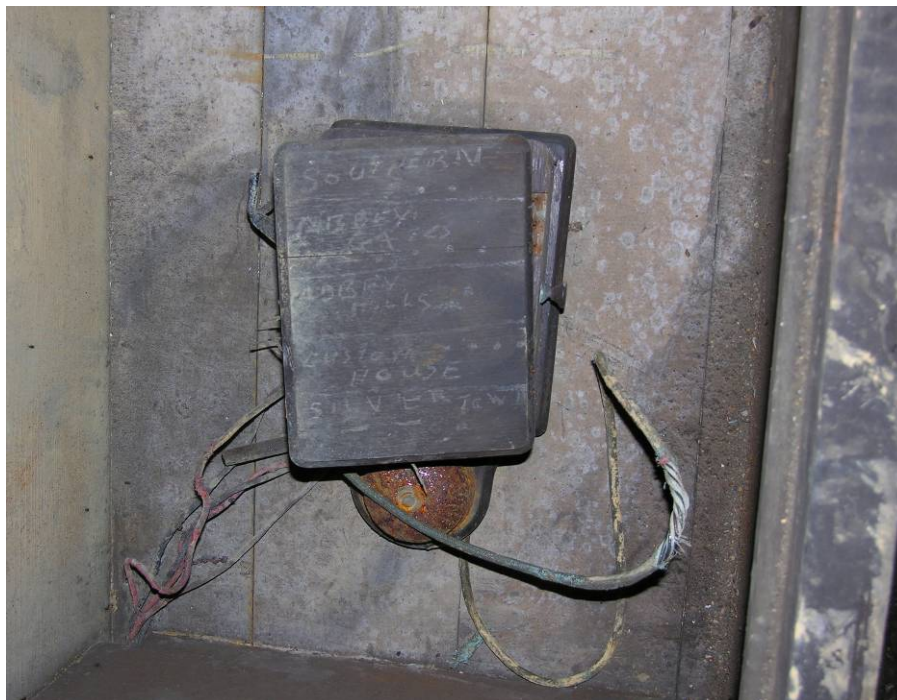
Within the southern single tunnel was a timber box with a hinged door and an electric bell mounted on the outside (Photo 49) with a further bell and box on the inside. The hinged cover to the box in the interior had the names Southern, Abbey Gates (?), Abbey Mills, Custom House and Silverton scratched into its surface (Photo 50).

*Photo 50 The names scratched into the surface of the box mounted in the interior of the timber box.*

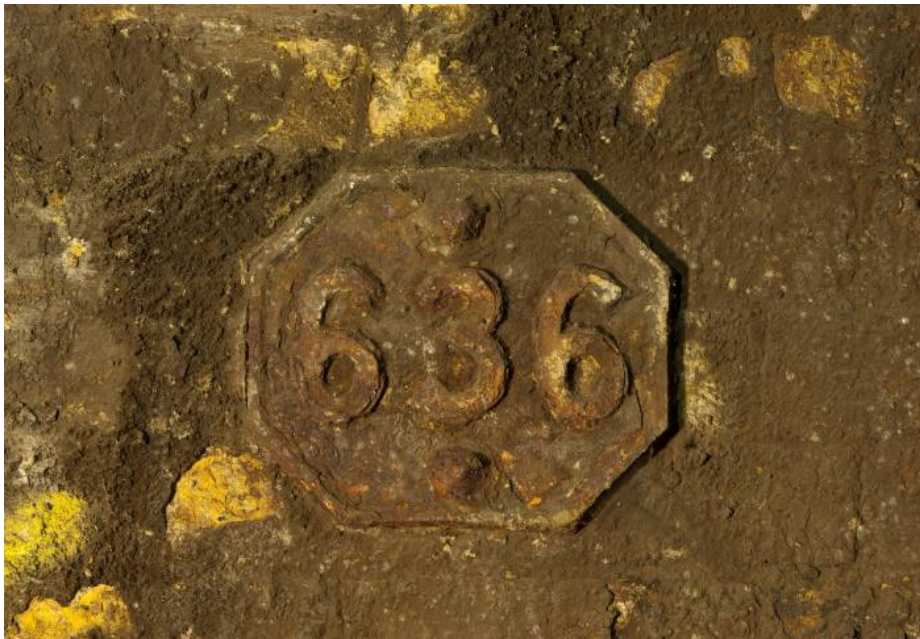
*Photo 51 the iron marker plate inside the north portal.*

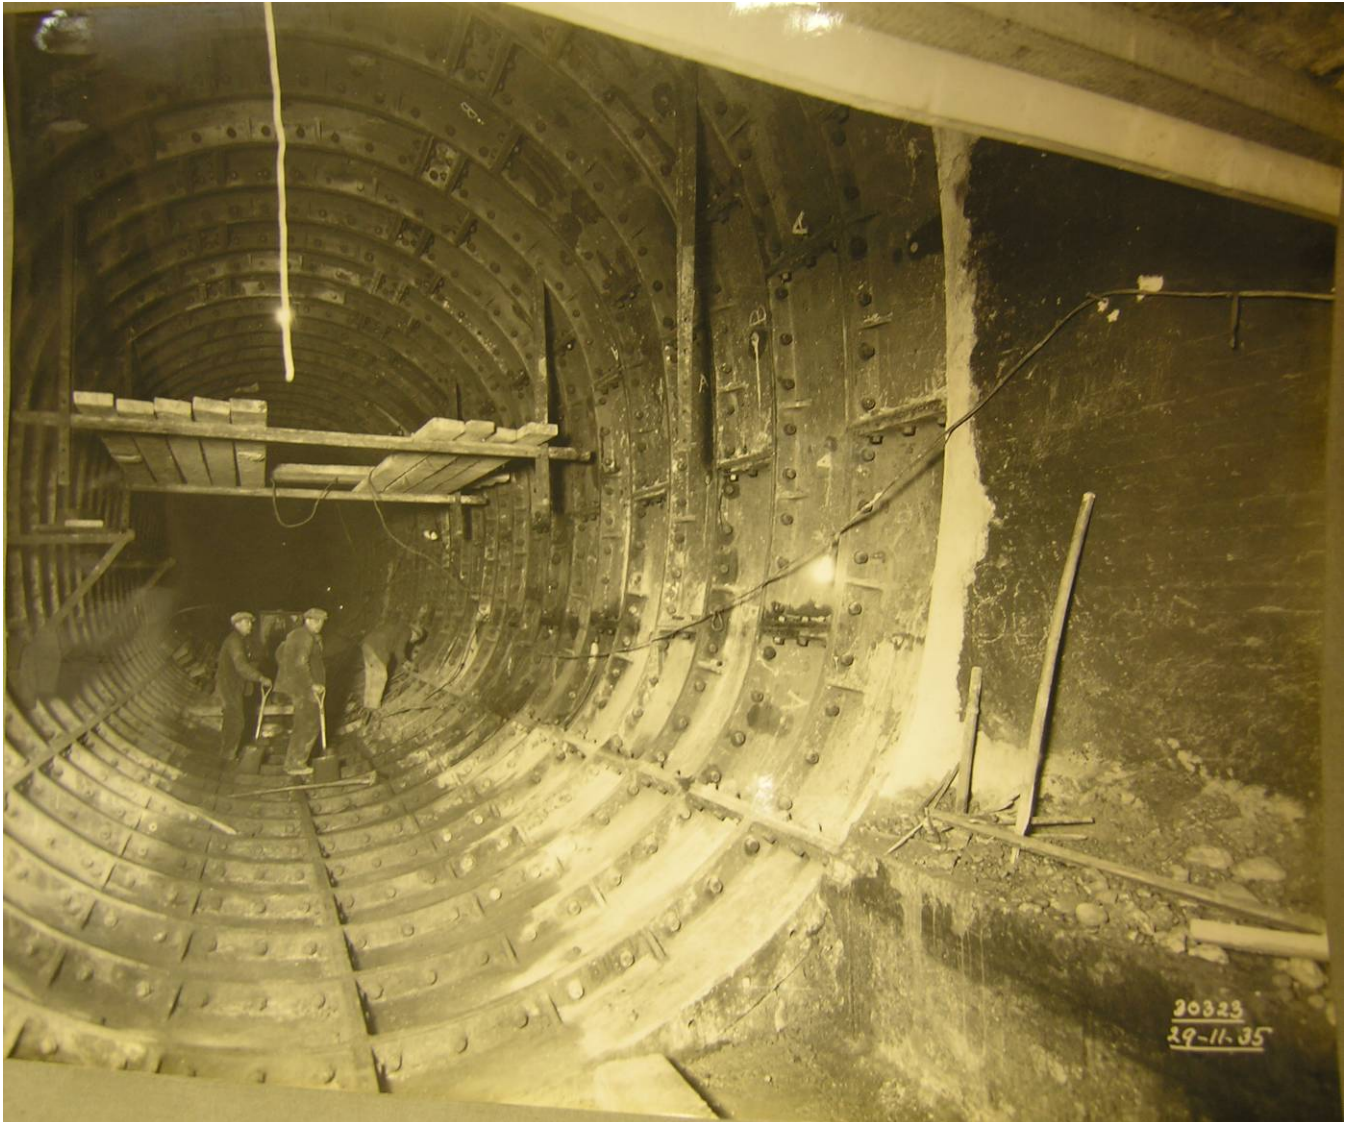
*Fig 6. A photograph taken in 1935 during the lowering of the tunnel height and construction of the cast steel central section of the tunnel. (MLDSSC 23896 – Album B)*

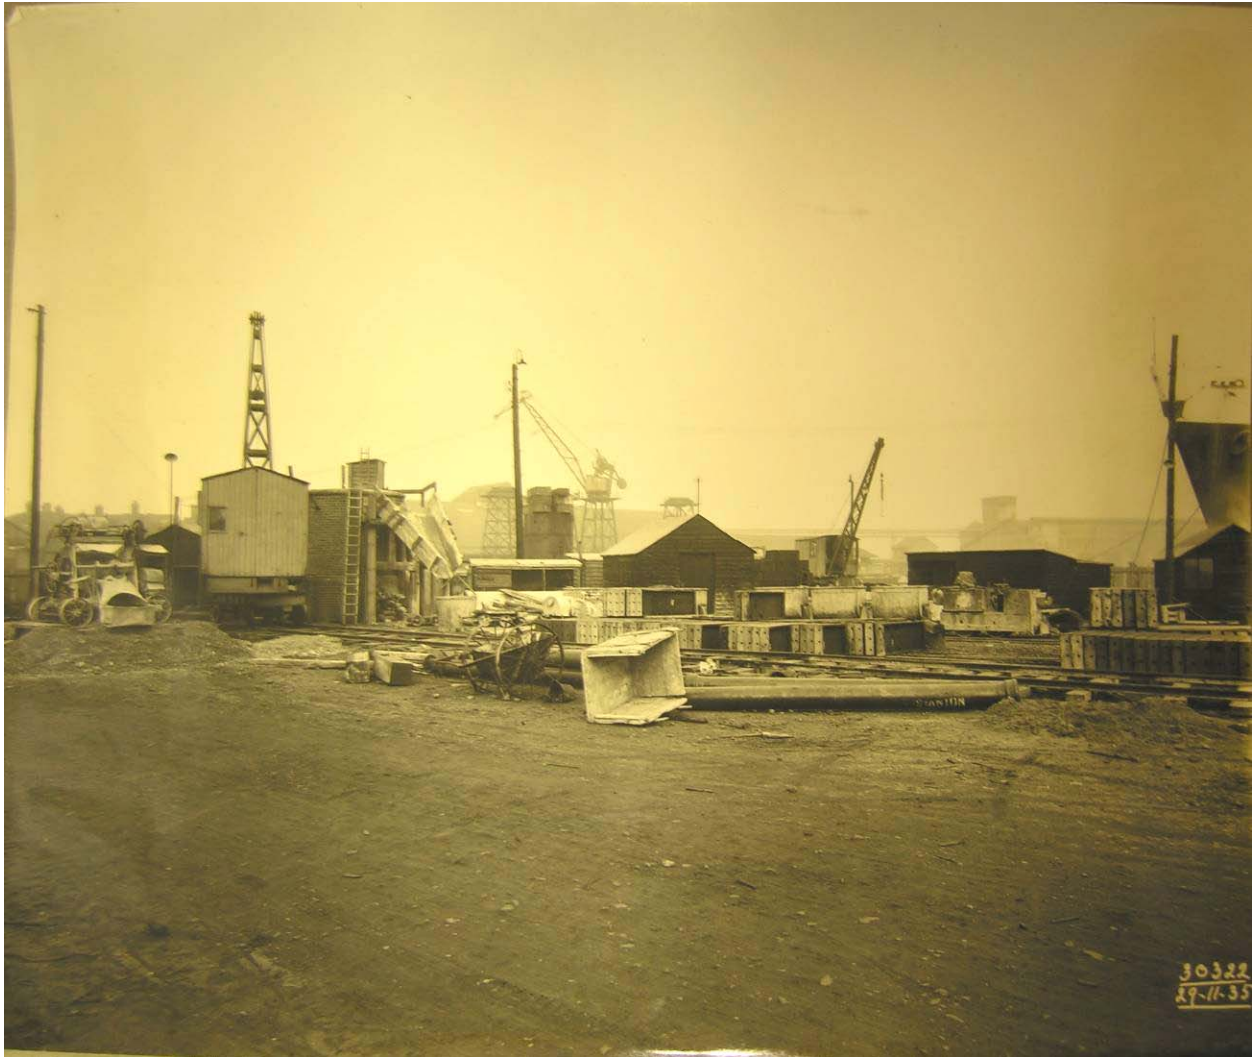
*Fig 7 DSCN6814 A 1935 photograph from Museum of London Docklands showing access to the tunnel works via the via southern ventilation shaft in the left of the photo next to the crane. (MLDSSC 23896 – Album B)*

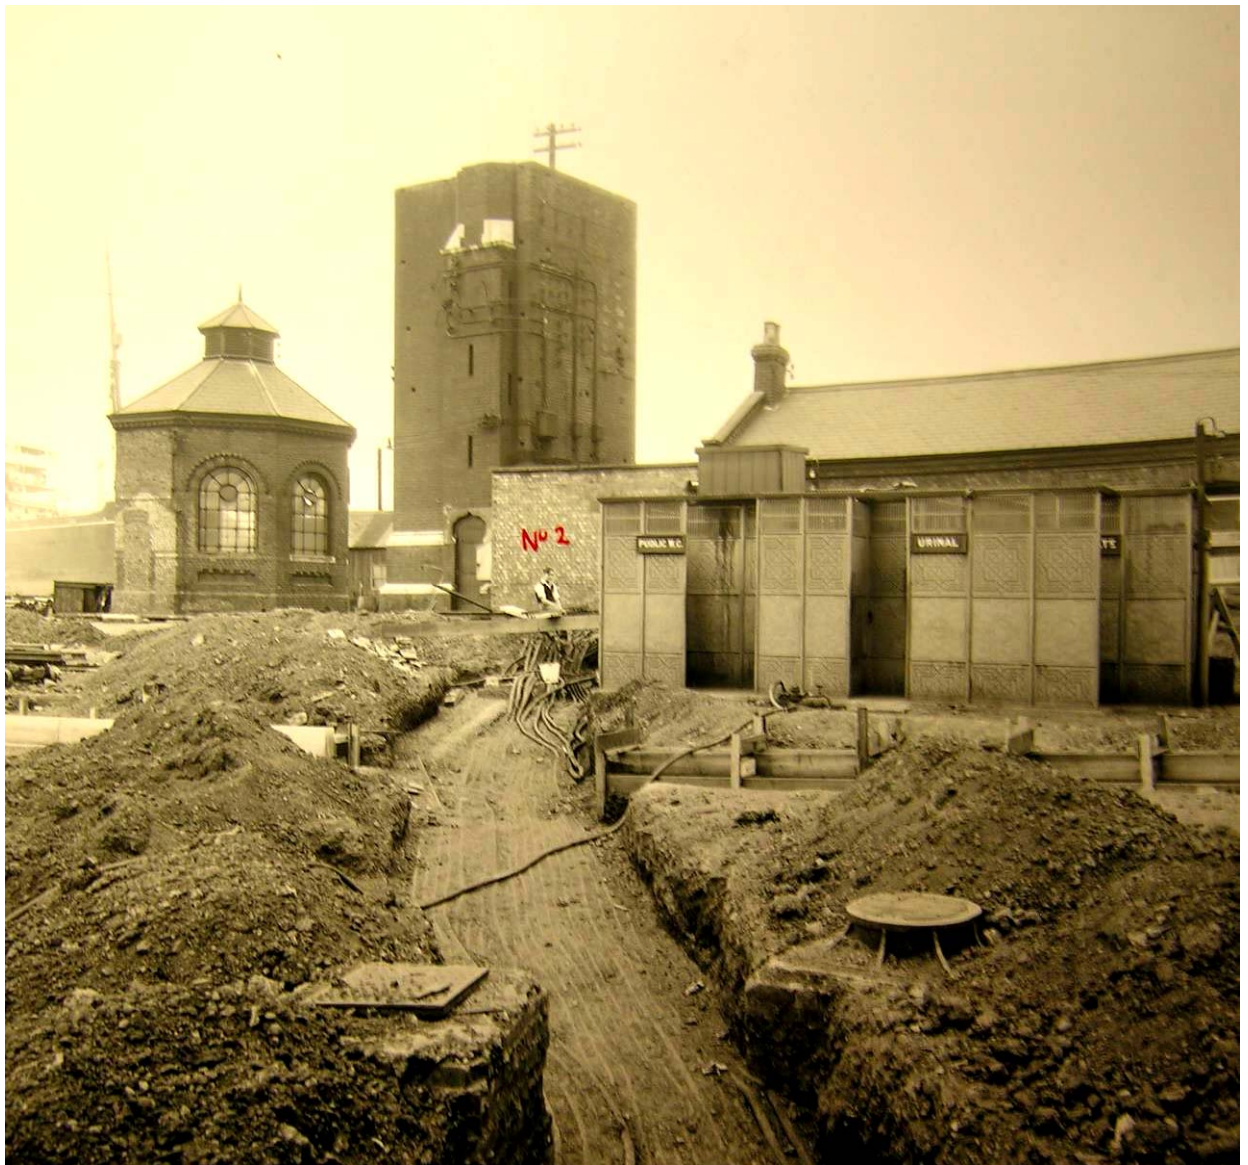
*Fig 8. The pumphouse from the north west taken in 1937(MLDSSC 23896 – Album B)*

double entrance door (visible in Fig 9) and its replacement with the present timber louvered fanlight visible in Photo 5. The 1992 drawings show the earlier (but probably not original) entrance door was also replaced with the four panelled double doors visible in Photo 5. Timbers adjoining the window on the west elevation were removed as were unspecified redundant external fittings. The brickwork repaired and the surfaces were made good in which may explain why the scar of a former pitched roof of an adjoining single storey structure on the north elevation that is visible in the 1935 photograph (Fig 8), is no longer clearly visible today (Photo 7) .

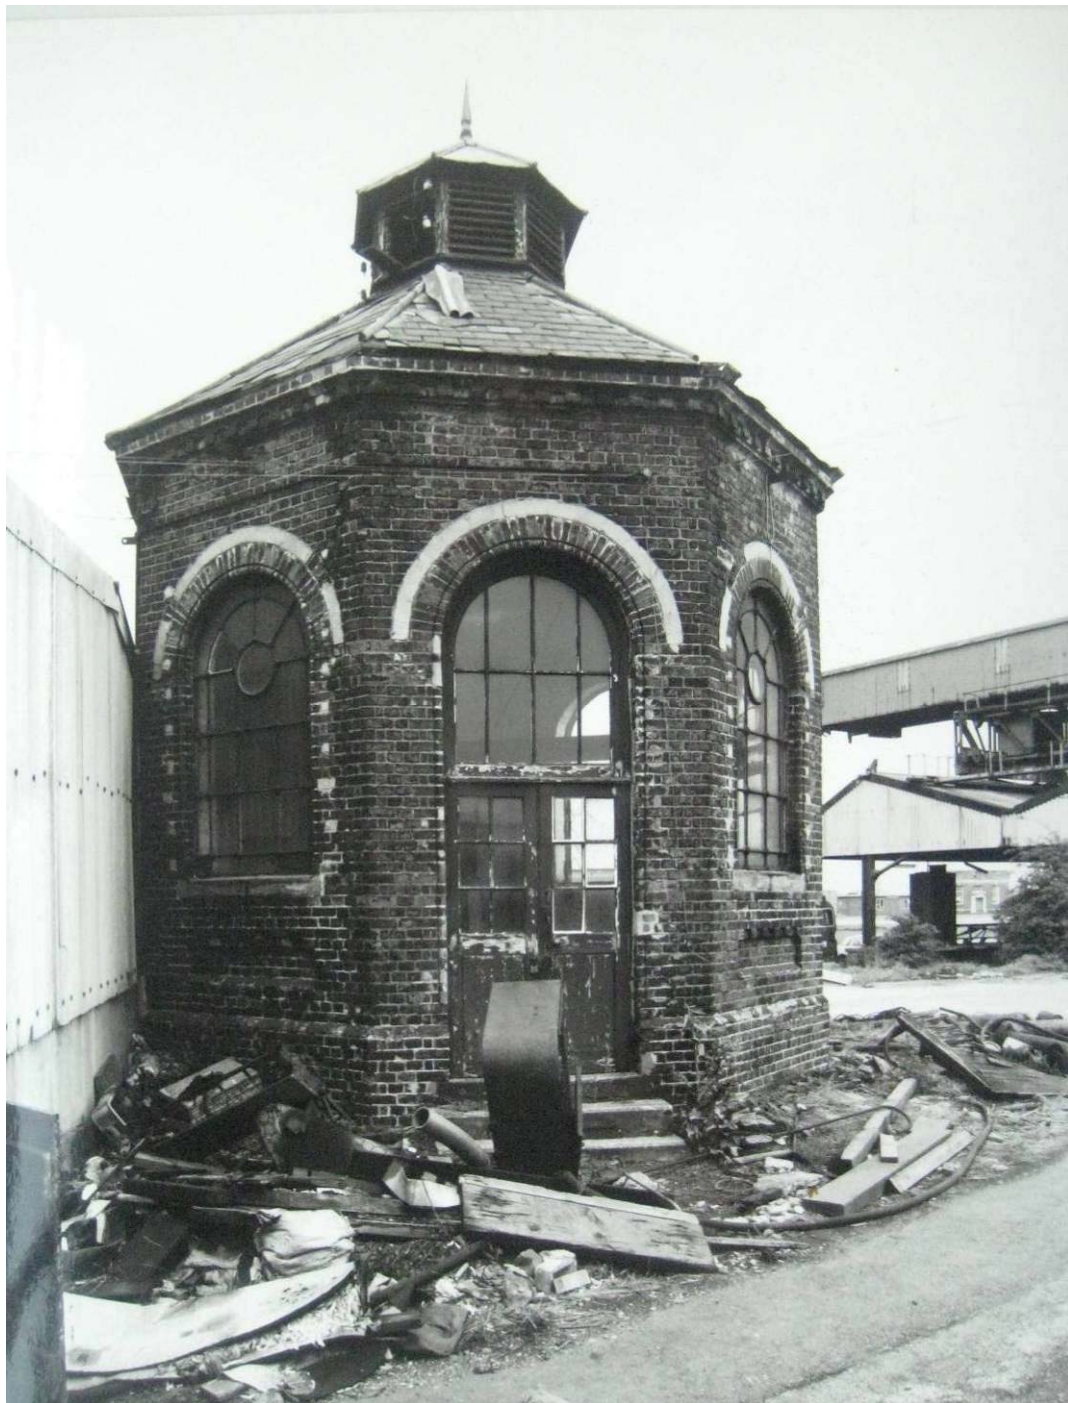
*Fig 9 The pumphouse entrance from the south, taken 1977. (LMA SC/PHL/02-SSo4 0921-30)*

A series of photographs taken in 1977 and held at the London Metropolitan Archive, show the pumphouse from various angles (Fig 9, Fig 10 and Fig 11) and illustrate the poor state of repair of the building at this time. The Crossrail document, *Connaught Tunnel Scope of Works: Pump Shaft Condition Survey* reproduces a series of drawings of the pumphouse made for the London Docklands Development Corporation by Halcrow in 1992, when various repairs and refurbishments were made to the building, possibly the first repairs since the photographs were taken in 1977. The changes include the removal and replacement of the render above the window arches (though the render removed in 1992 was probably that shown in the photos of 1977 which was not original, as the photograph from 1935 (Fig 8) shows that the dentil pattern was originally repeated over the arch), the replacement of the north east window with the louvers, the removal of an original fanlight above the

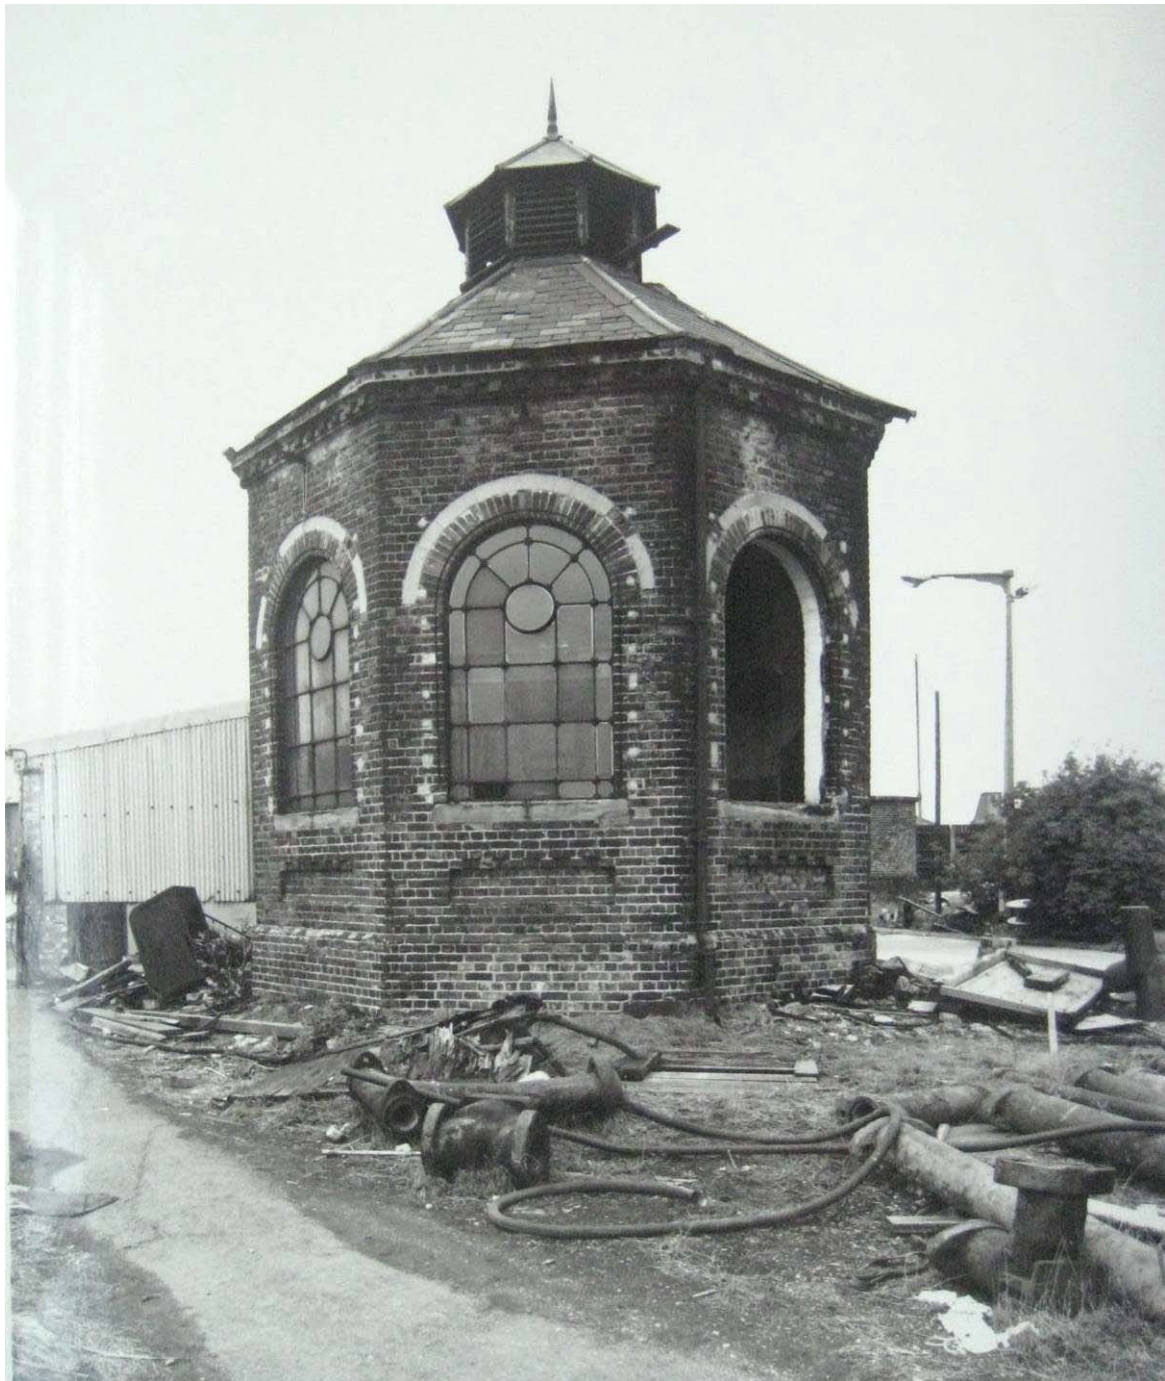
*Fig 10 The eastern elevation looking west, taken 1977. (LMA SC/PHL/02-SSo4 0921-30)*
