**C263 LATE EAST**  
**The Connaught Tunnel, Pumphouse**  
**and Air Vents:**  
**Non-Listed Built Heritage Recording**  
**Document Number: C263-MLA-X-RGN-CRG07-50039**

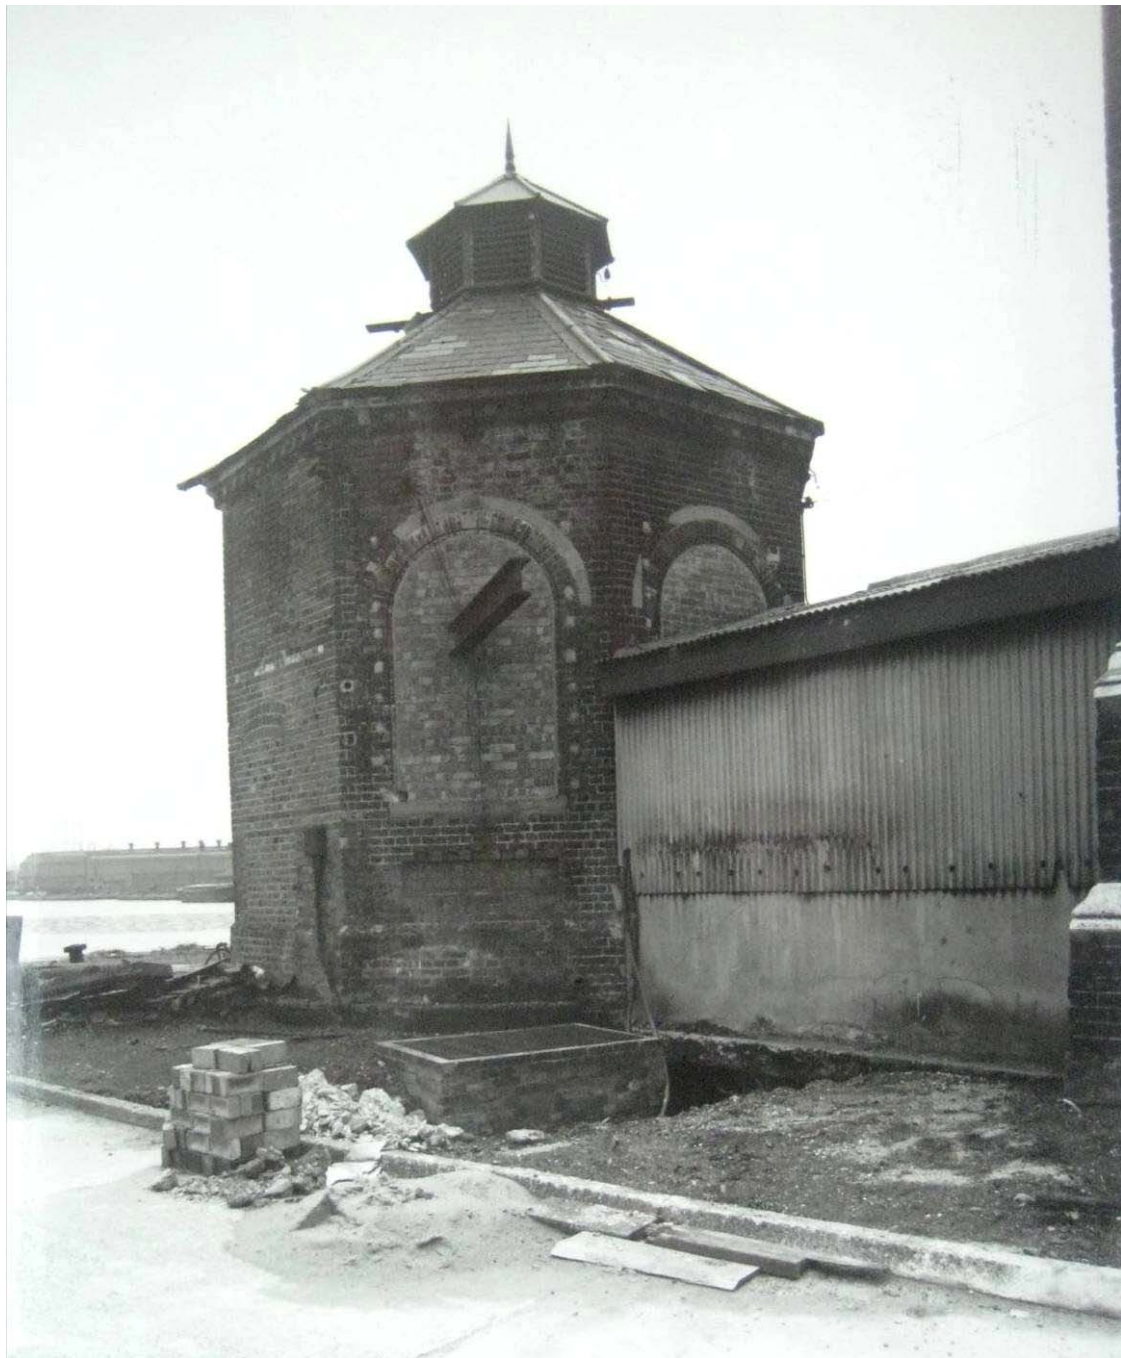
*Fig 11. The north-western elevation looking south east, taken 1977. (LMA SC/PHL/02-SSo4 0921-31)*

A series of photographs taken in 1977 and held at the London Metropolitan Archive, show the pumphouse from various angles (Fig 9, Fig 10 and Fig 11) and illustrate the poor state of repair of the building at this time. The Crossrail document, *Connaught Tunnel Scope of Works: Pump Shaft Condition Survey* reproduces a series of drawings of the pumphouse made for the London Docklands Development Corporation by Halcrow in 1992, when various repairs and refurbishments were made to the building, possibly the first repairs since the photographs were taken in 1977. The changes include the removal and replacement of the render above the window arches (though the render removed in 1992 was probably that shown in the photos of 1977 which was not original, as the photograph from 1935 (Fig 8) shows that the dentil pattern was originally repeated over the arch), the replacement of the north east window with the louvers, the removal of an original fanlight above the

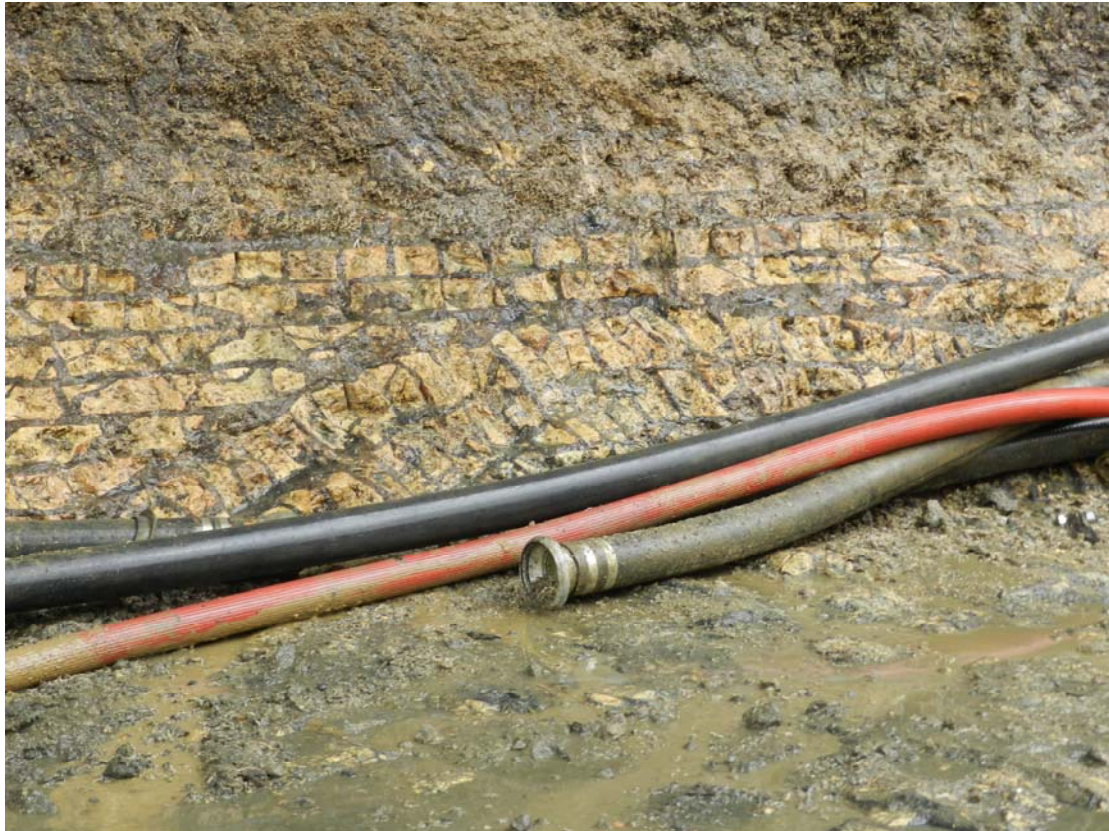
The yellow London stock brick of the top of the Connaught Tunnel was initially observed in the lower part of the northern dock wall. It was noted that the masonry was laid with a very high cementitious mortar (Photo 52). The brickwork had been cut back during the 1935-6 construction works when the dock passage was lowered and this has left visible scarring on the masonry.

*Photo 52 Brickwork at the bottom of the Connaught Passage*

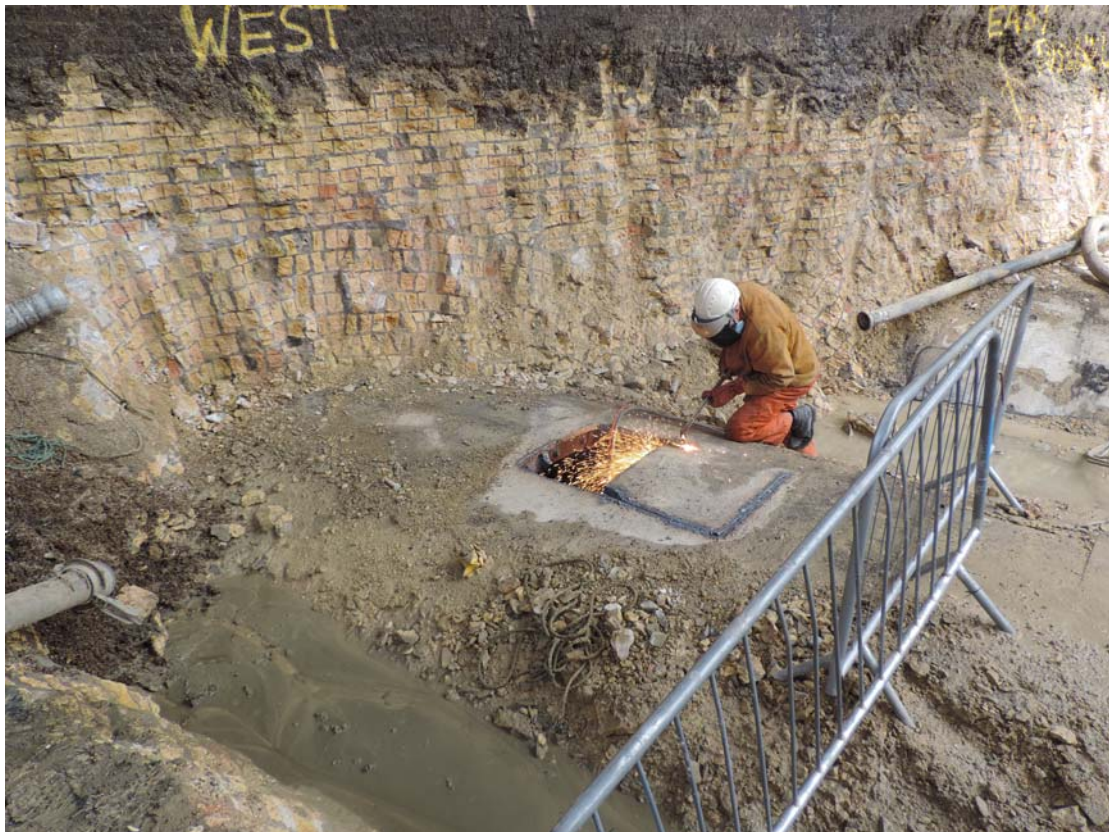
*Photo 53 Removal of the upper section of the steel rings*

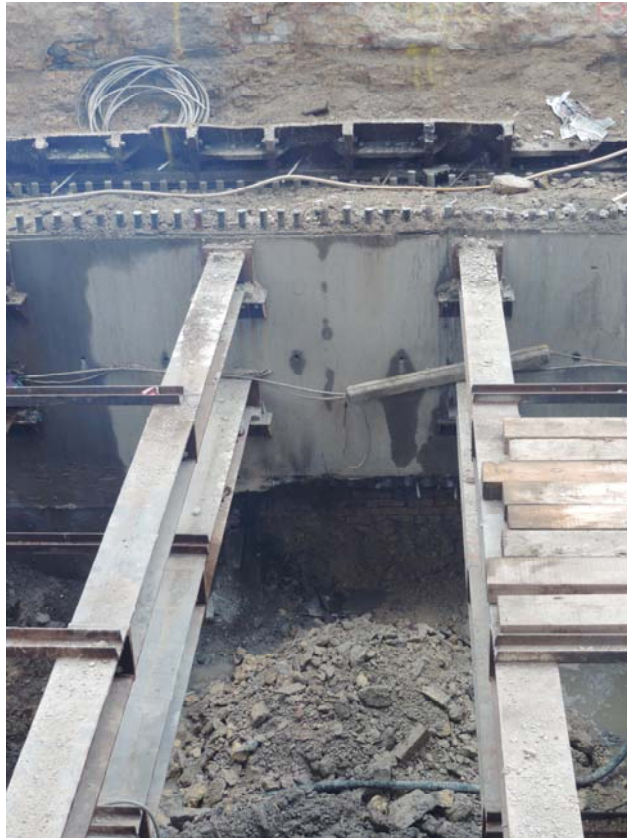
*Photo 54 Concrete wall of the new tunnel masking brickwork and steel rings of the former structure*

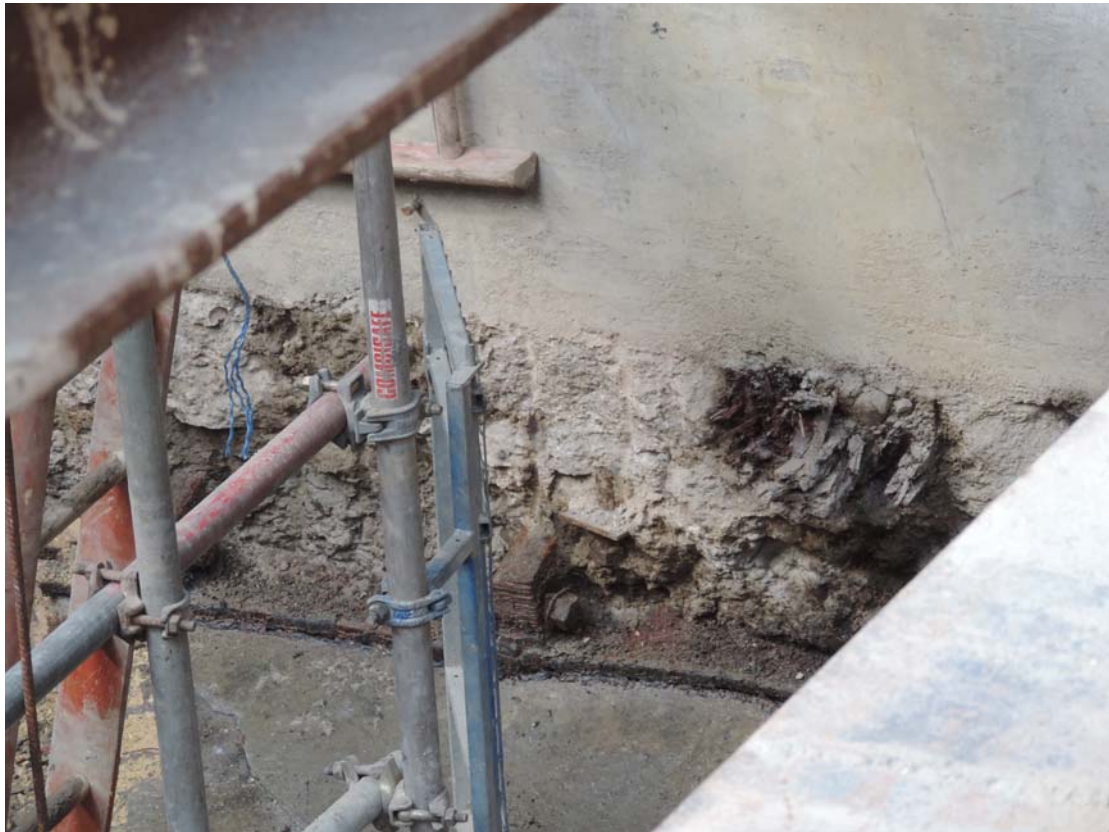
Originally the trackbed and ballast of the twin tunnels was laid upon a layer of concrete which in turn was laid on the inverted arch of the bottom of the steel rings. Horizontal timbers were noted, perpendicular to the alignment of the tunnel, embedded in concrete and may have been part of the original track bed (Photo 55).

*Photo 55 Timbers encased in concrete possibly relating to the former trackbed*

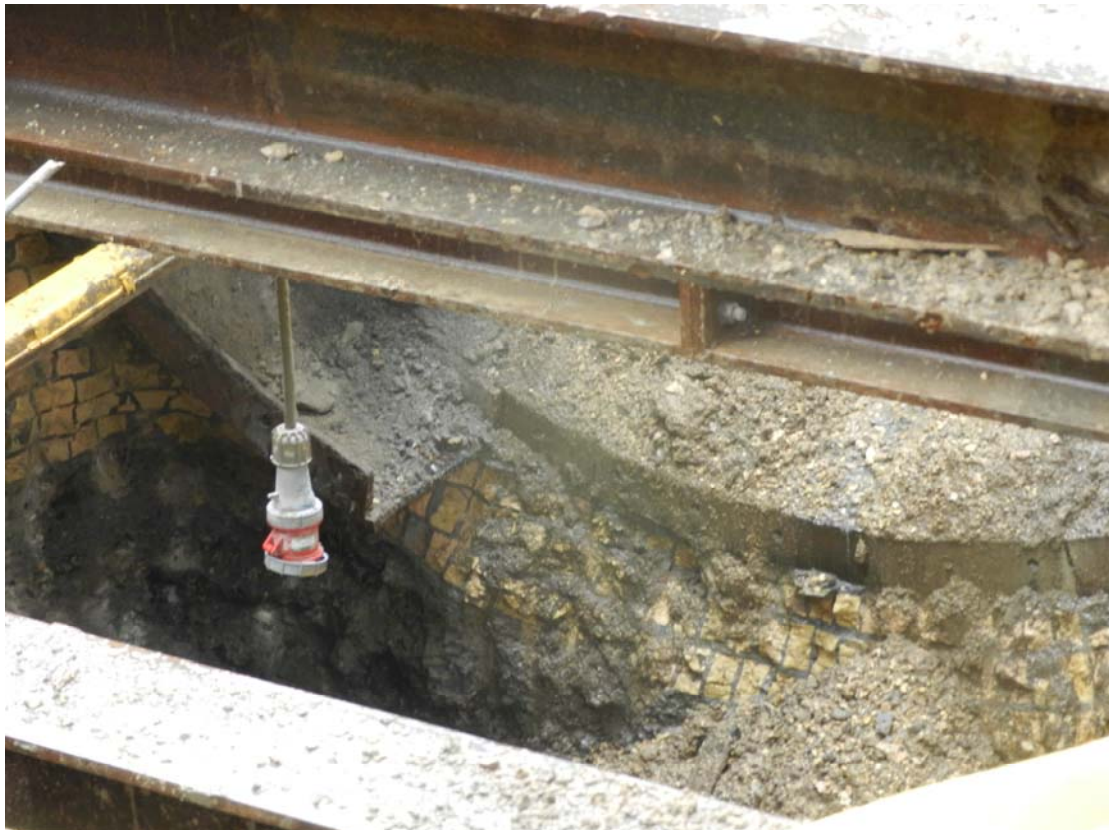
*Photo 56 Masonry below the steel rings*

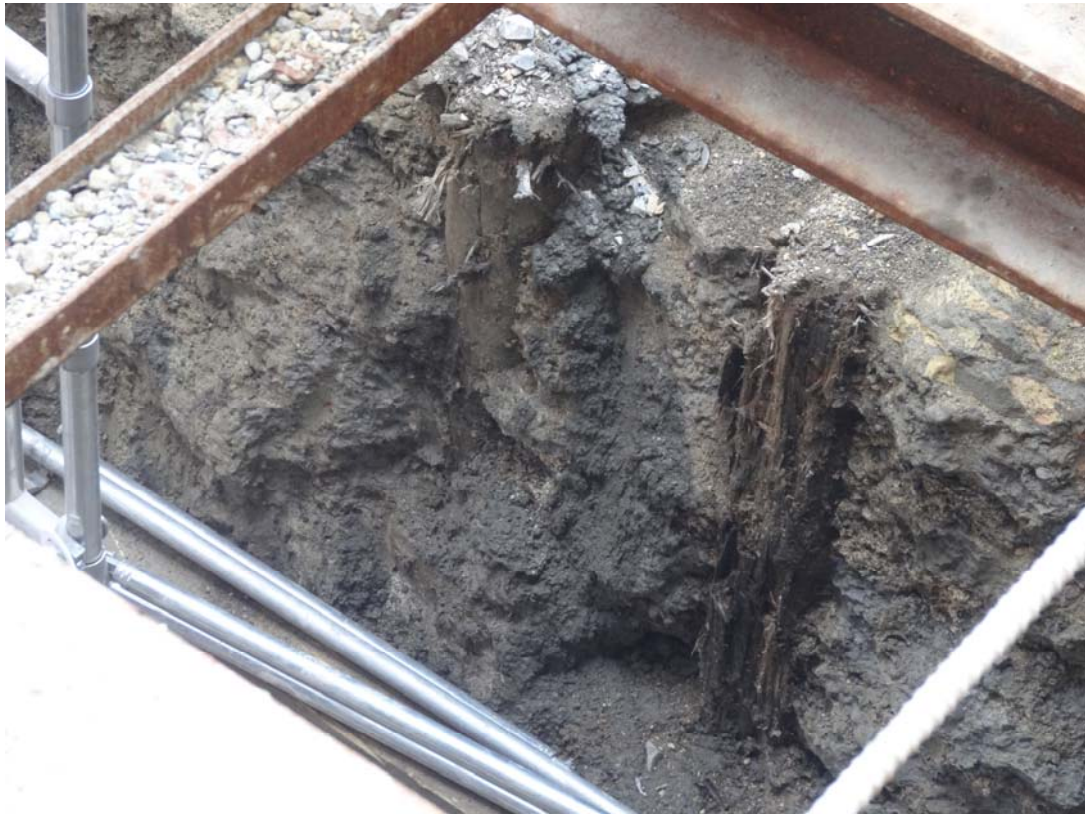
Two upright timber posts were exposed below 1870s brick masonry beneath the steel rings inserted during the lowering of the tunnel during 1935-6 (Photo 57). A further group of three timbers was recorded approximately 3 metres to the south of the two posts referred to above and were below the alignment of the shared wall of the twin tunnel. These again consisted of two upright timbers, smaller to those mentioned above, and an additional smaller upright post. No measurements were taken due to the inaccessibility of the site. The location and observed size of the timbers suggests that they may have been part of a system of timber piling intended to support and distribute the weight of the 1870s masonry build of the Connaught Tunnel through what was a very waterlogged and marshy area (see Chapter 3).

*Photo 57 Timber posts supporting masonry of the 1870s construction*
