CENTRAL SECTION PROJECT

Old Oak Common Worksites Non-Listed Built Heritage Recording of 70' Turntable.

Document Number: C150-CSY-T1-RGN-CR076_PT001-00019

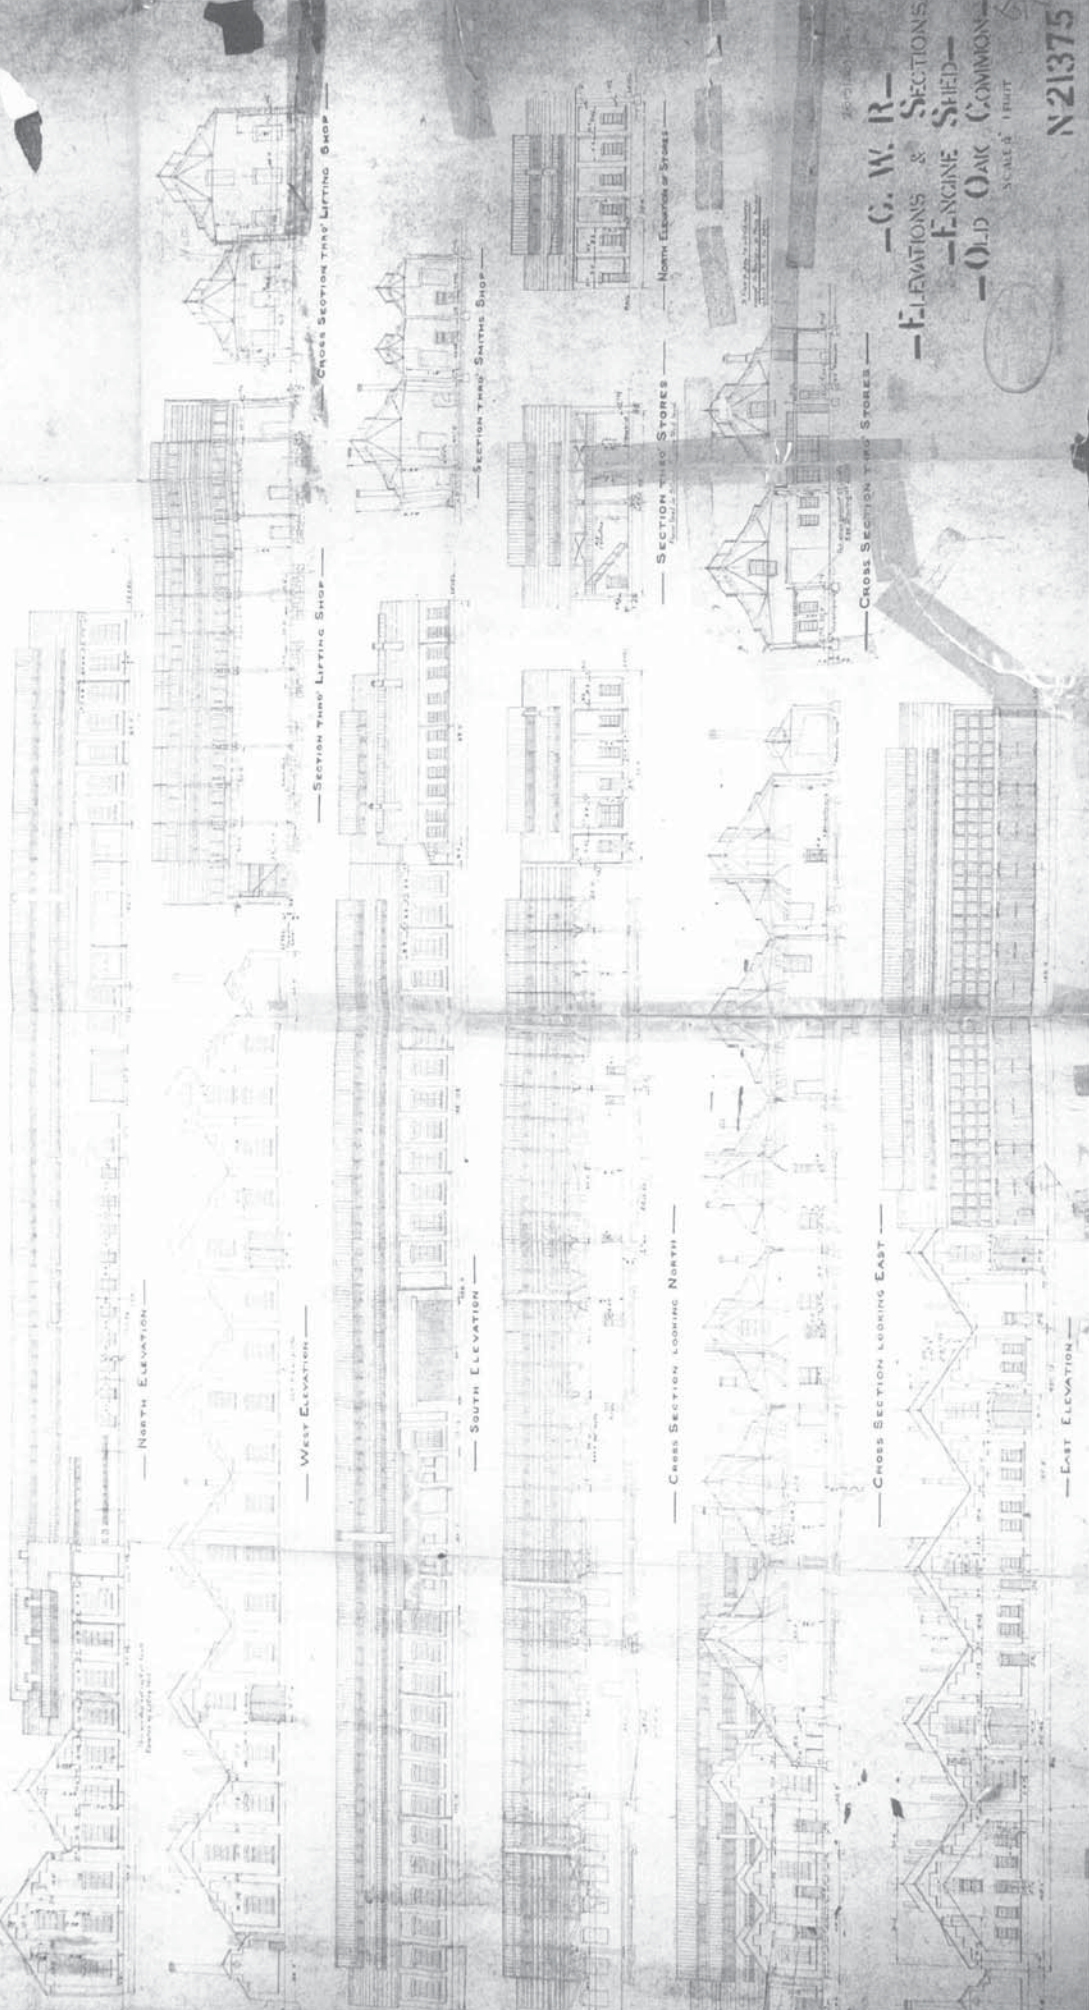
Figure 3
2515/409/0519 Sections and elevations of the Engine Shed, c.1903
not to scale

- 5.2.2 Walkerdine undertook to build the Factory, the engine shed, WCs, messrooms, internal and external inspection pits and turntable foundations (TNA RAIL 252/1340, Bill No. 2: 5; Bill No. 3: 48-55; see Figure 3). The foundation walls of the latter were to be built of brindled brickwork in cement (*ibid*: 9-10). The Great Western agreed to supply and fix the structural iron- and steelwork, and arrange the fitting of the majority of the plant and machinery including the turntables, traversers and traverser foundations within and without the engine shed.

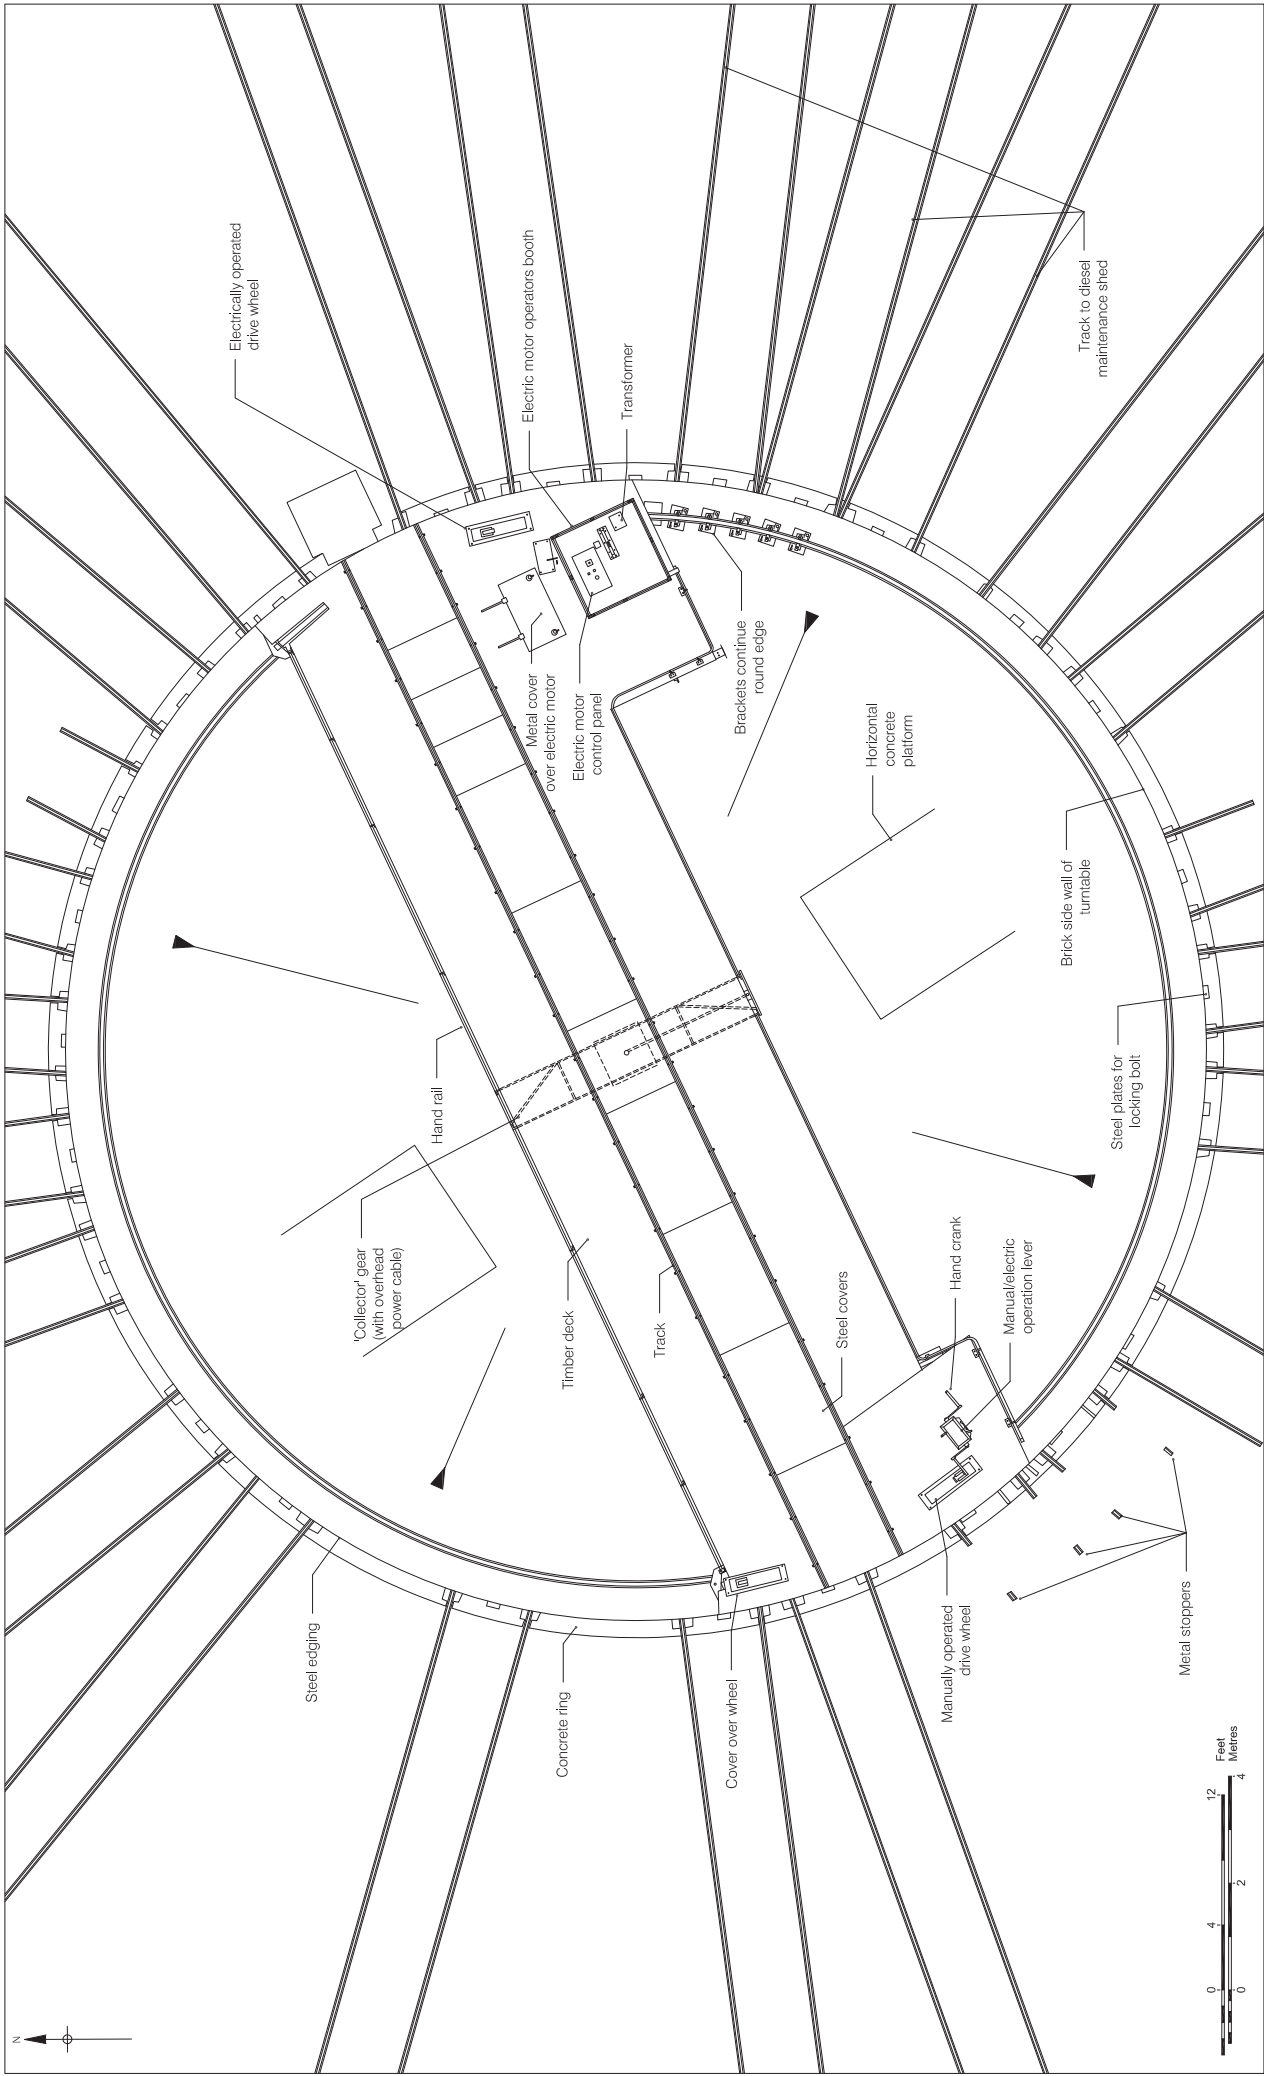
Figure 12
 Plan of Turntable
 (Surveyed 10-11/6/2010)
 Old Oak Common
 1:100 at A3

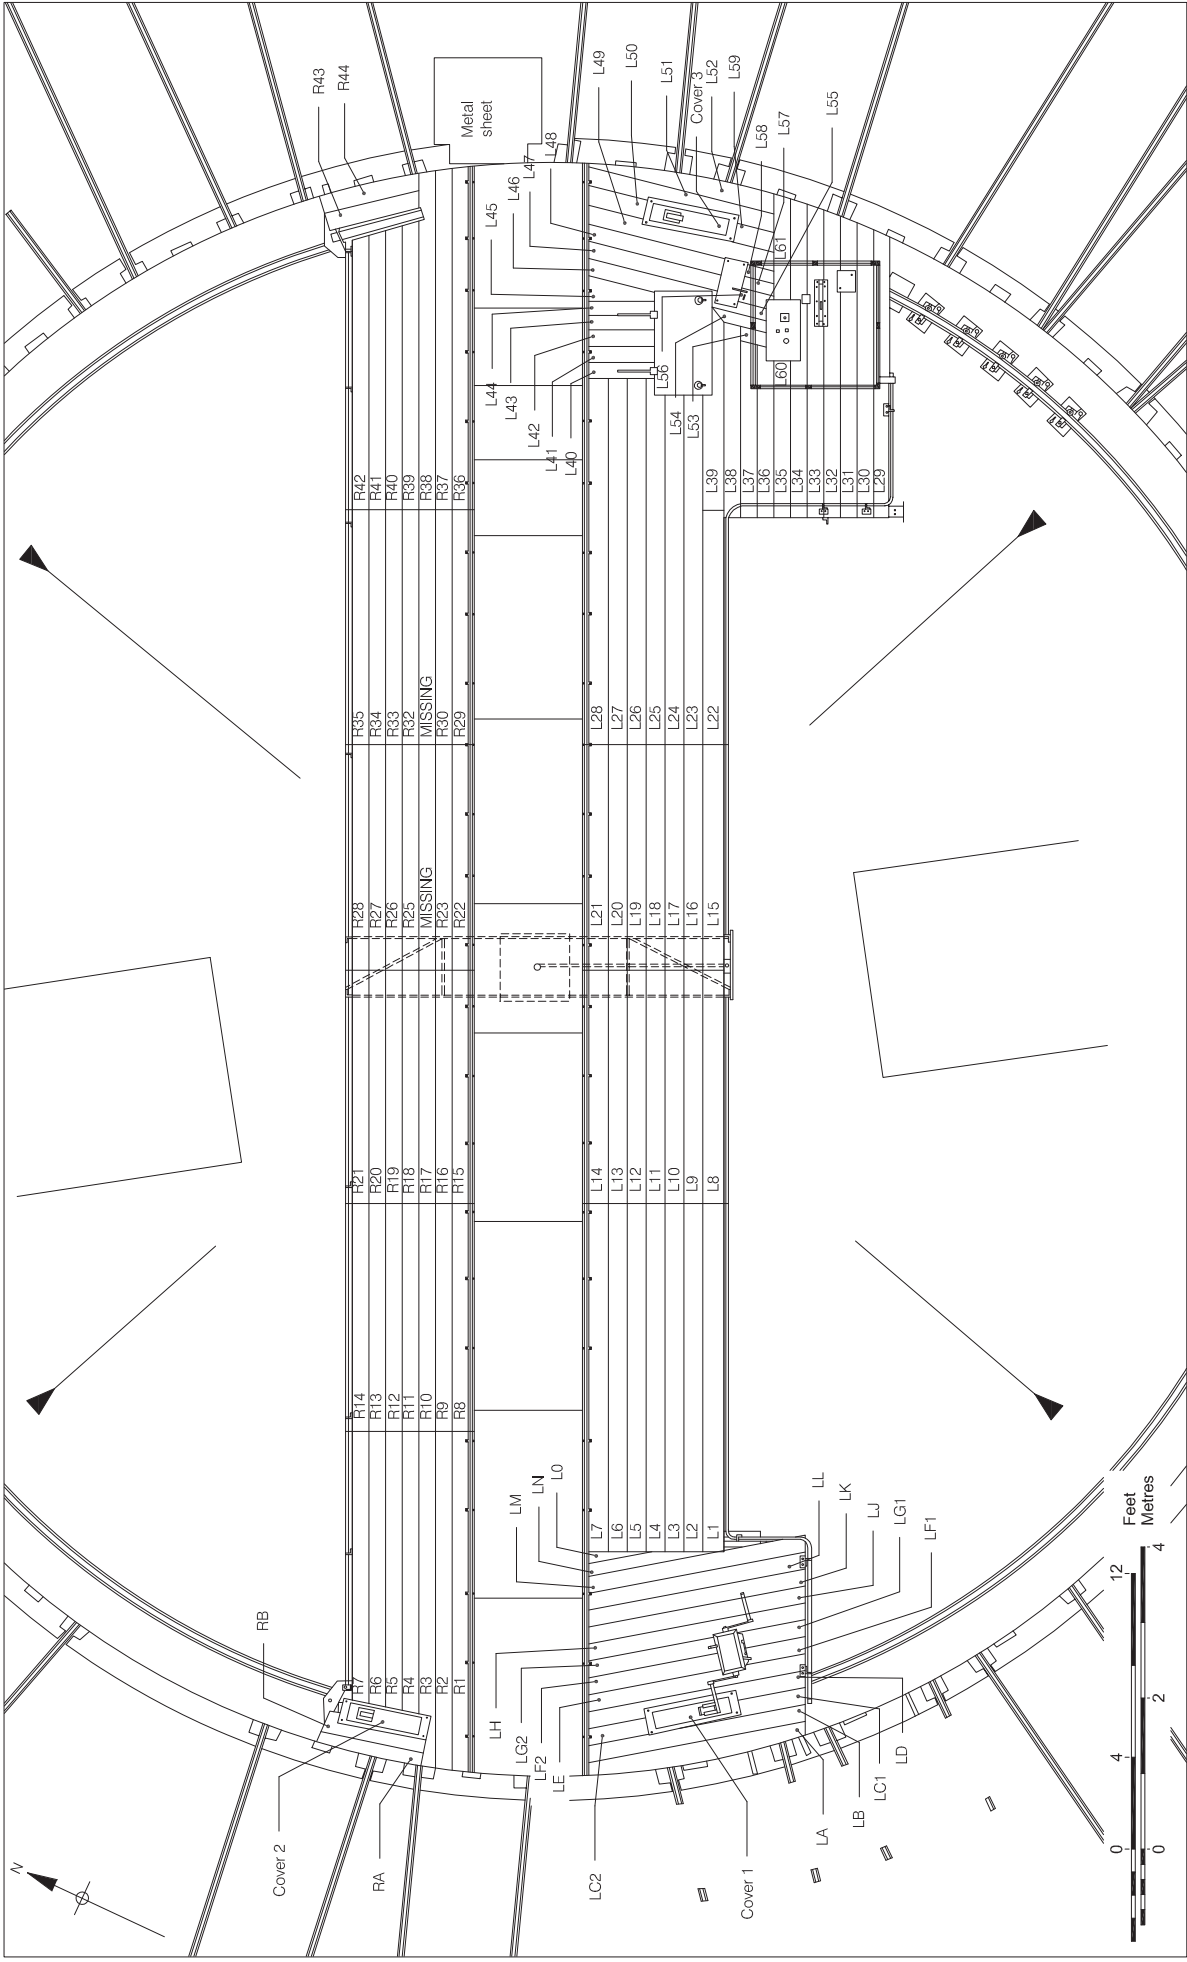
Figure 13
 Annotated Plan of Timber Deck
 Prior to Removal
 Old Oak Common
 1:100 at A4

- 10.3.9 Once numbered the softwood timber planks were removed. Two were found to be broken beyond repair and their position was numbered, but marked as 'missing' on the record deck plan drawing (Figure 13). The timber superstructure of the electric motor operator's booth was also removed in one piece at this time with the control panel and disused transformer box (Plates 22 and 23).

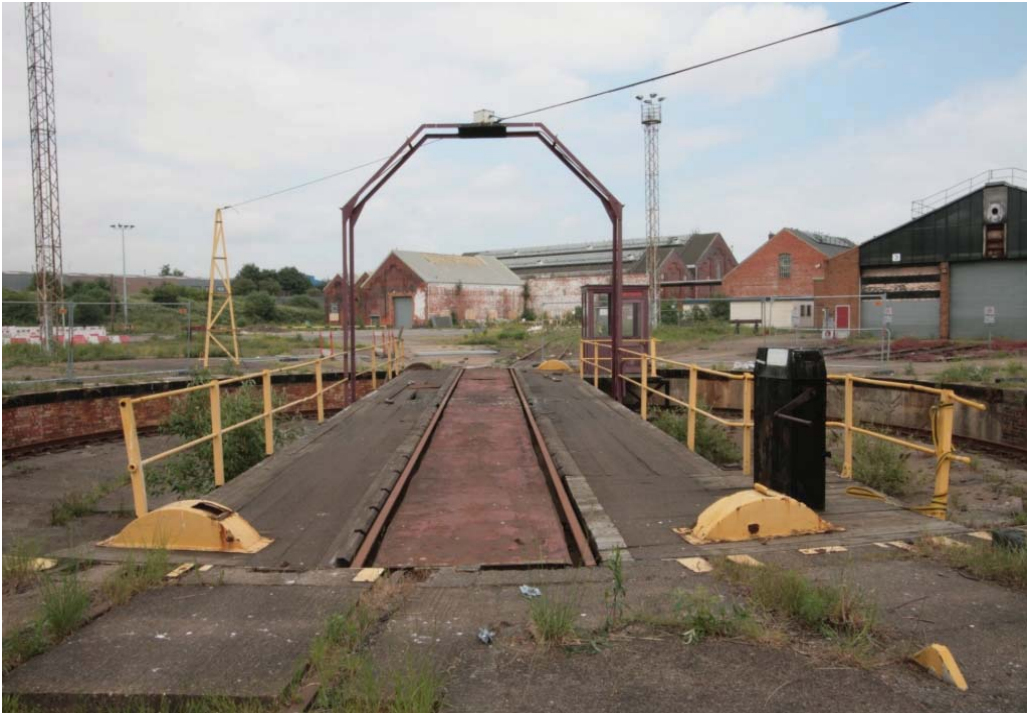
Plate 5. Turntable platform with hand crank mechanism on right and operator's booth at far end. Turntable wheels are beneath the arched metal covers in the foreground.

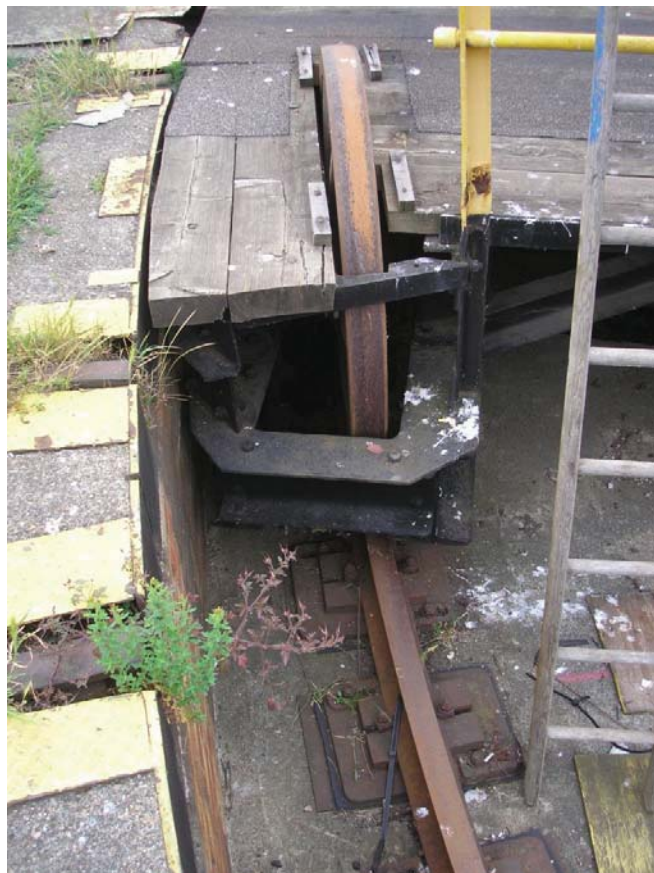
Plate 6. Exposed turntable race wheel, platform edge and track.

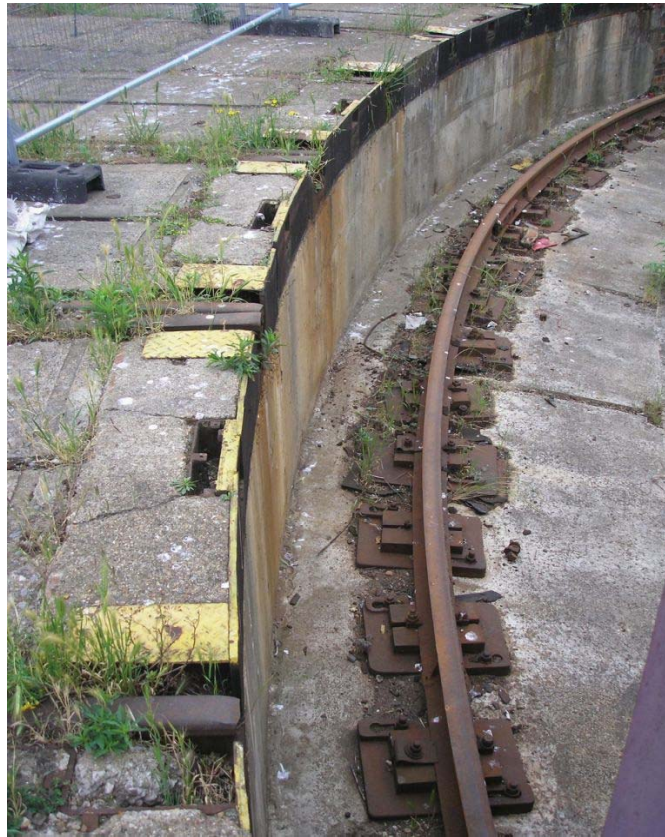
Plate 7. Metal edged turntable pit with locking pin fittings and track.

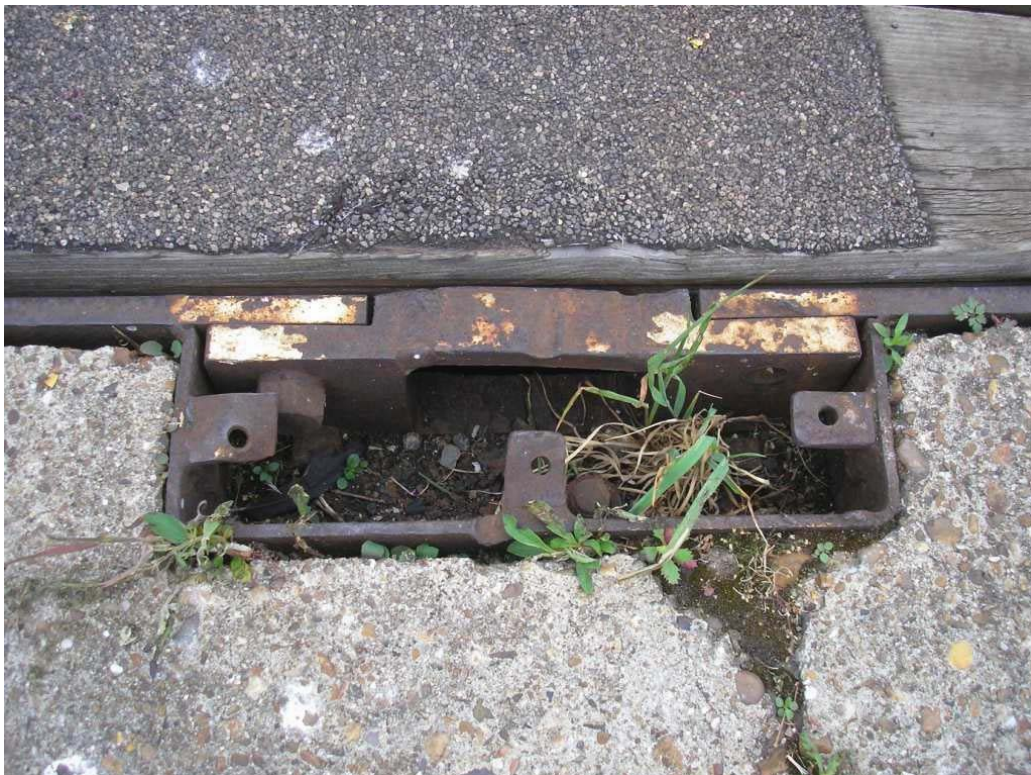
Plate 8. Locking plate for turntable with hole for locking bar from turntable found in between all tracks, here shown with cover plate missing.

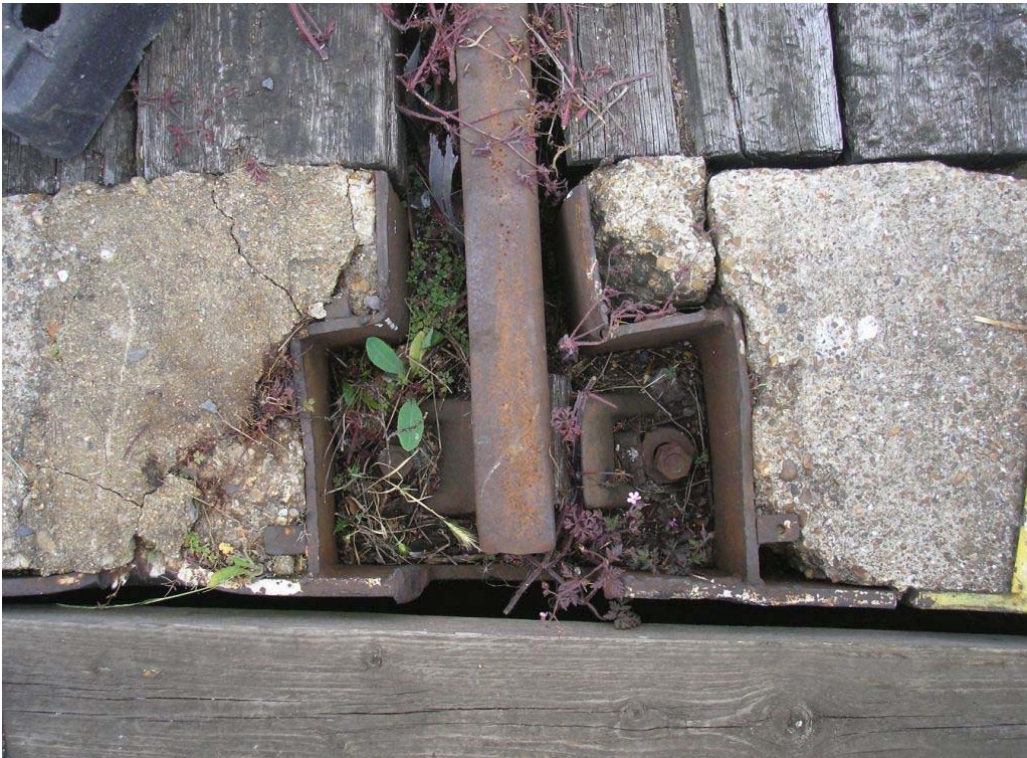
Plate 9. Junction of Engine Shed track and turntable deck at the bottom of the picture with covering metal plates removed, revealing metal side plates around rail retaining bracket.

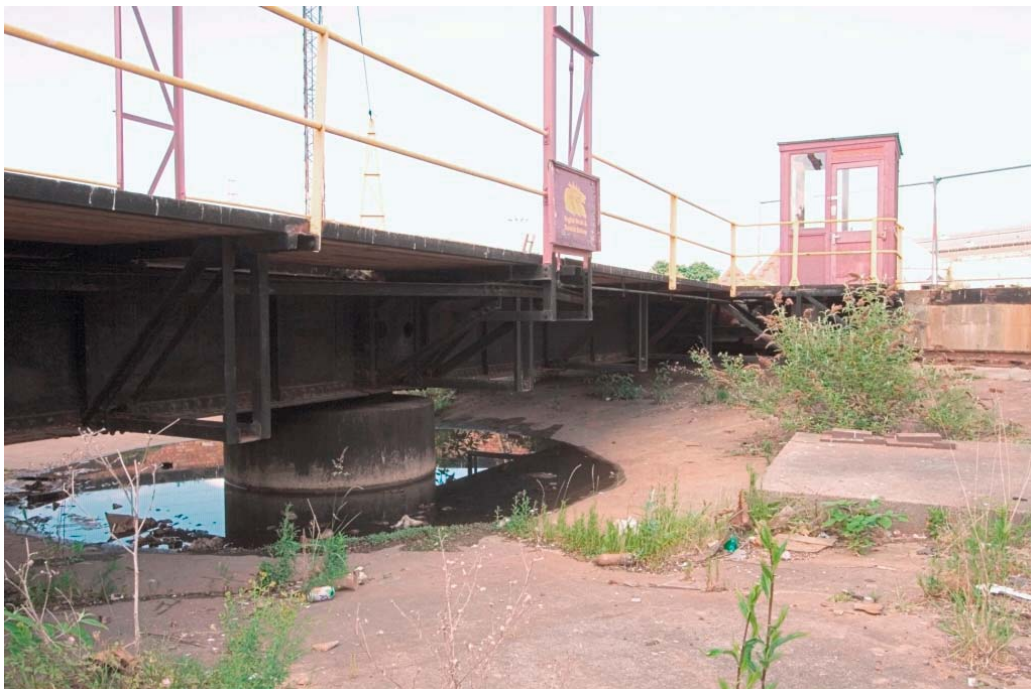
Plate 10. Side of turntable showing circular concrete pad for central pivot and horizontal section of concrete on right above sloping base of turntable pit.

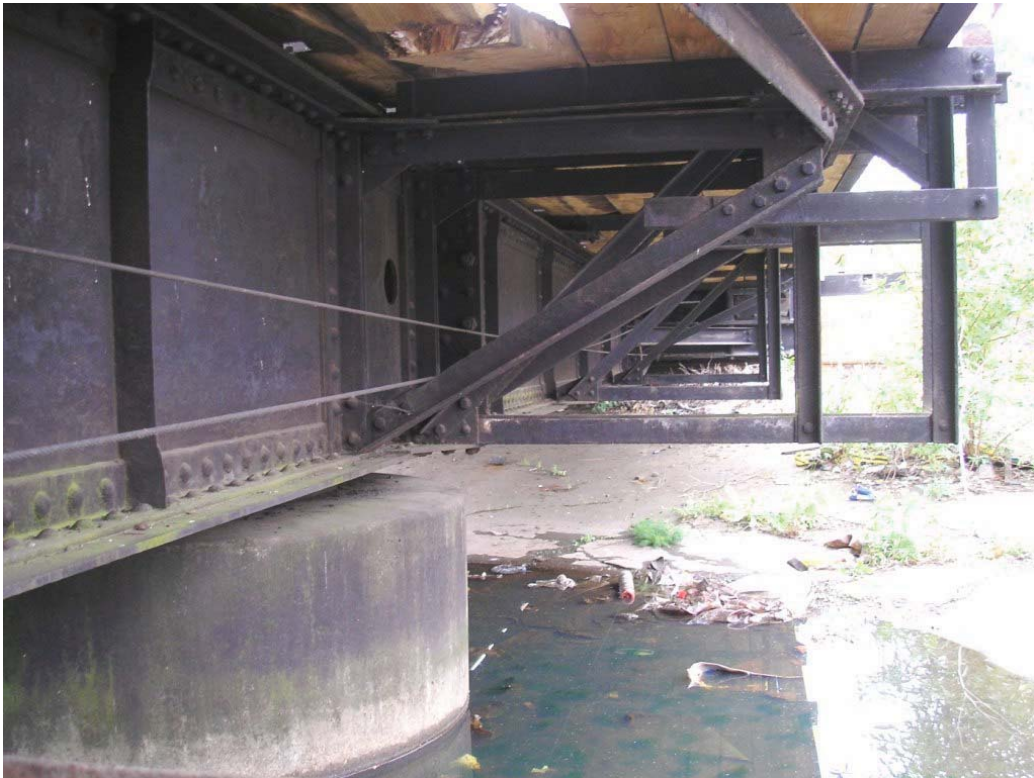
Plate 11. Underside of turntable showing supports for timber platform.

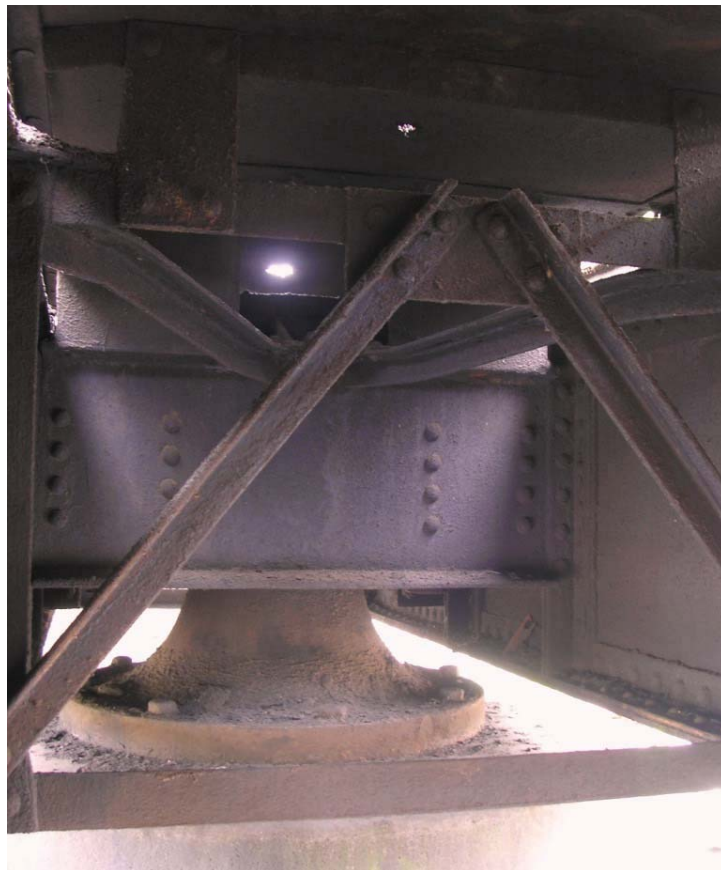
Plate 12. Underside of turntable between main beams showing central pivot.

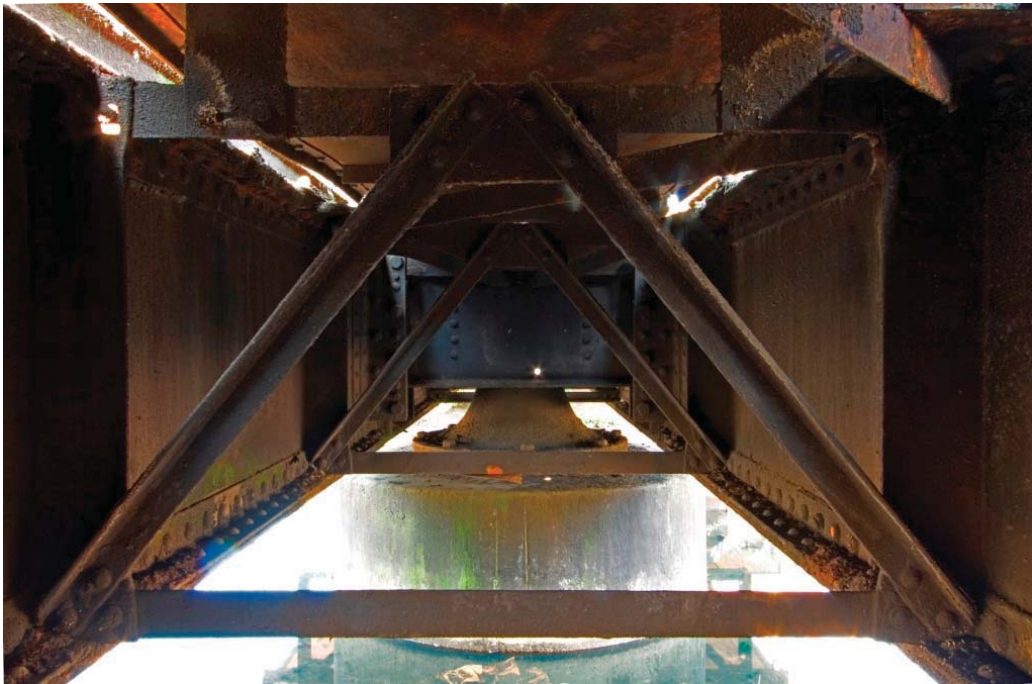
Plate 13. Underside of turntable between main beams showing horizontal and diagonal bracing and central pivot.

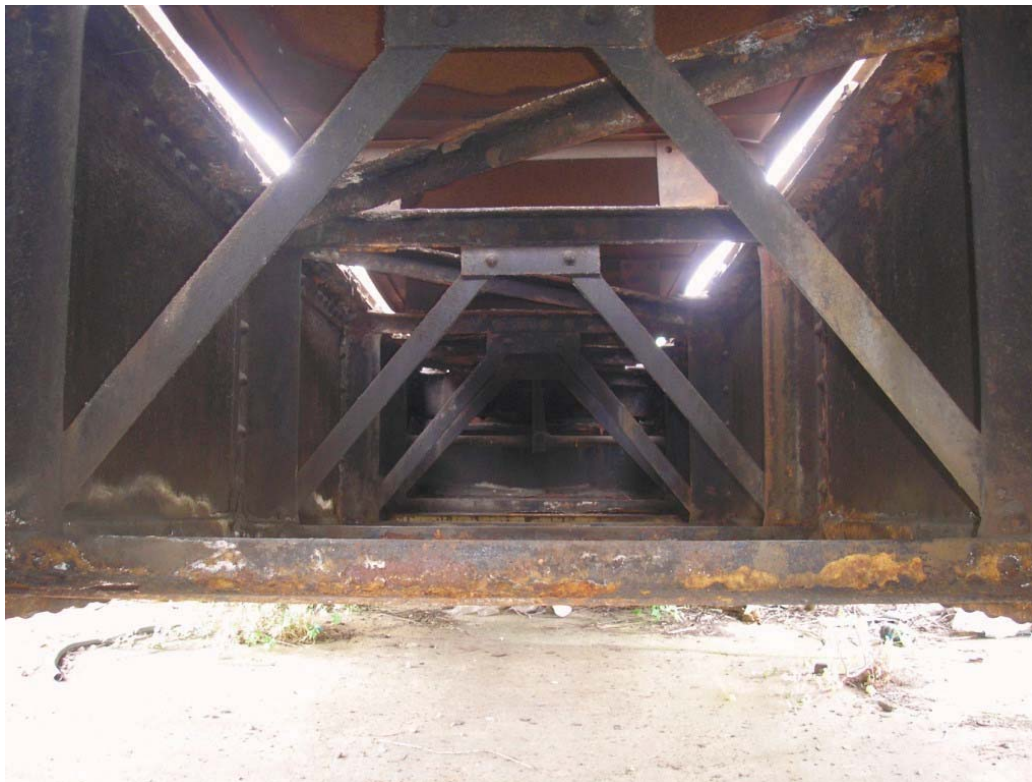
Plate 14. Underside of turntable between main beams looking toward outer edge, showing internal bracing covered by metal plates above fitted between the rails laid along the top of each main beam.

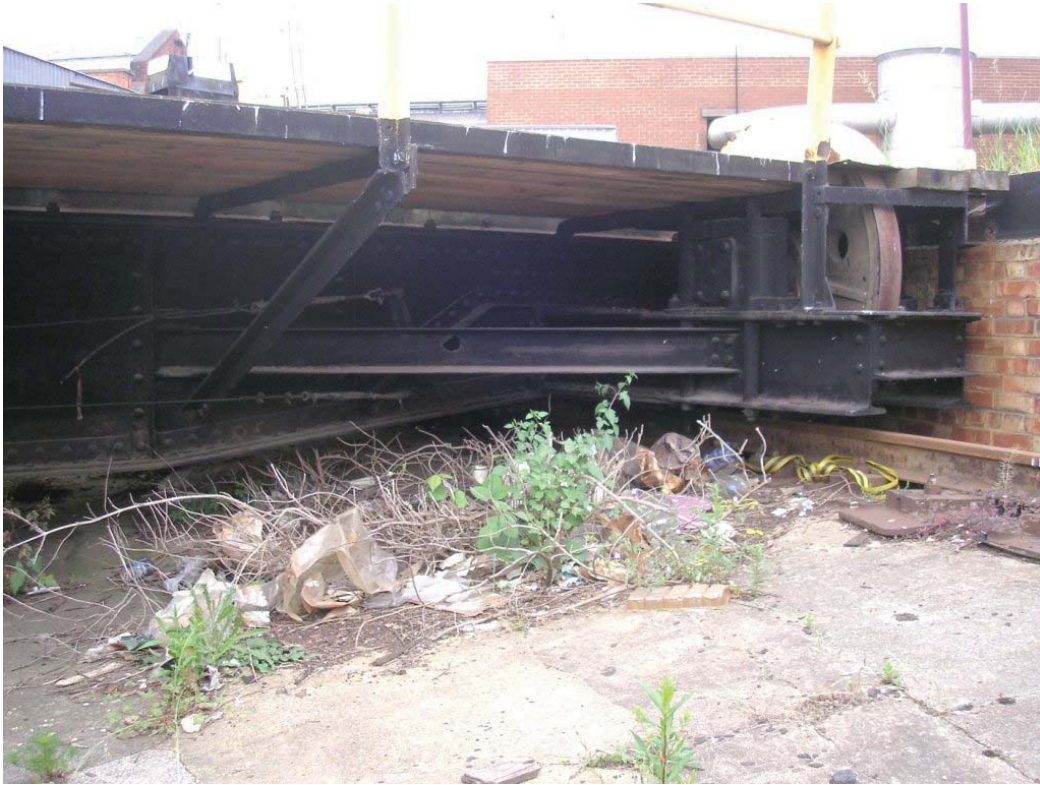
Plate 15. Turntable wheel, supporting structural elements and cables of locking bolt mechanism.

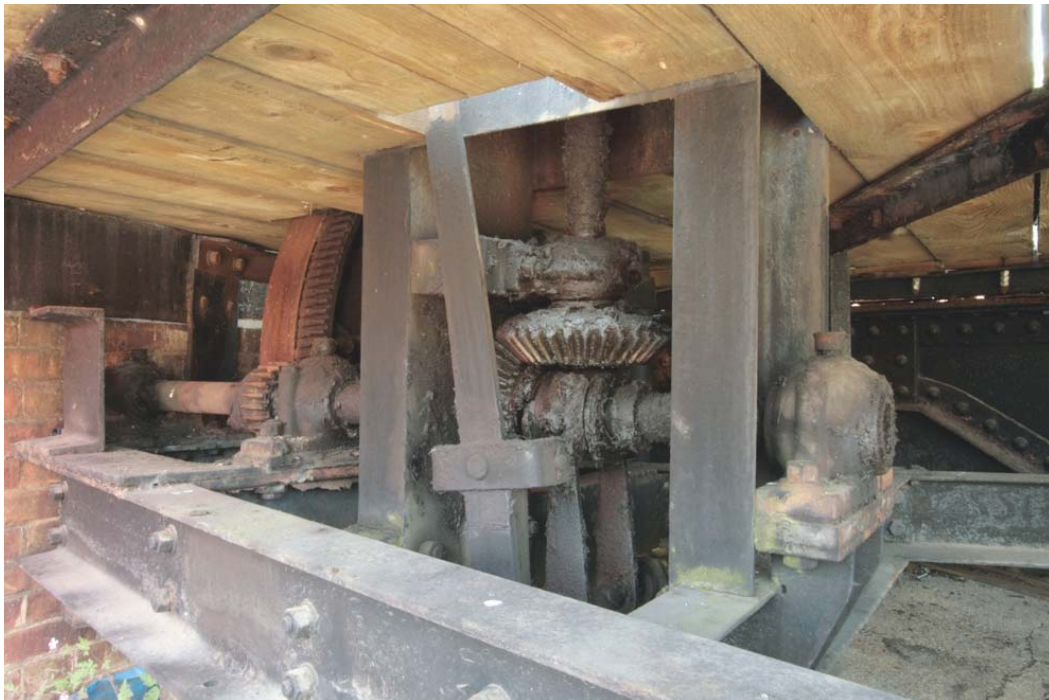
Plate 18. Turntable underside, showing gears with vertical shaft from the hand crank mechanism linked to a horizontal shaft and a turntable drive wheel. In front of the gears and extending upward through the deck is the electric/manual operation handle.

- 6.2.7 The horizontal 'hand gear reverse handle' was found below the location of this plate in both examples. Below this handle was a larger vertical lever rising through the floor of the deck and attached to the side of the hand cranked drive housing. The operation of this lever changed the use of the turntable from manual to electrically powered operation. The hand cranks turned a vertical steel drive shaft

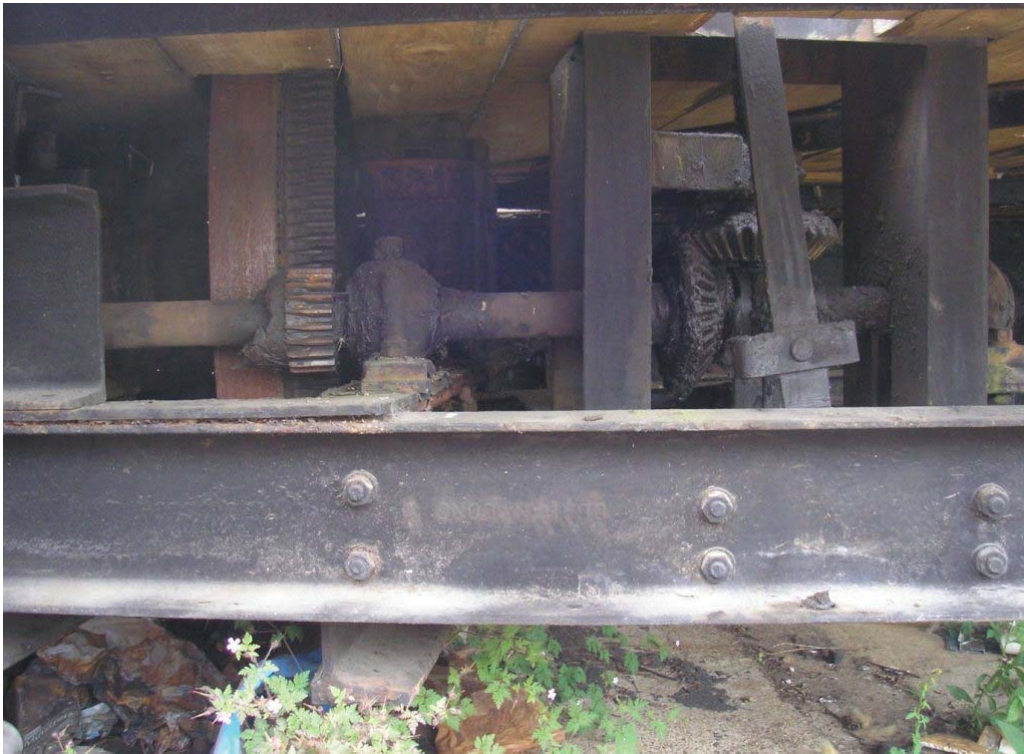
Plate 19. Turntable drive wheel linked to the hand crank mechanism. The horizontal girder in the foreground is marked with the maker's stamp 'Dorman Long Middlesbrough'.

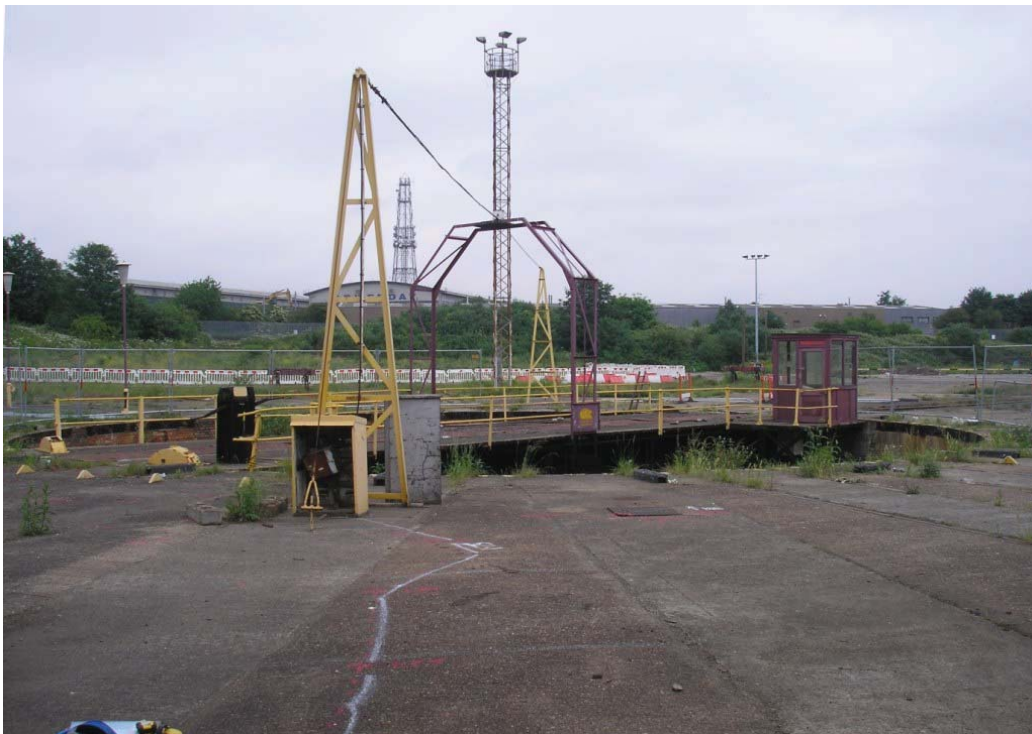
Plate 20. Turntable viewed from the south. The arched 'collector' frame over the turntable was embossed with the makers name 'Cargo Fleet England' and carried a power cable for the electric drive motor.

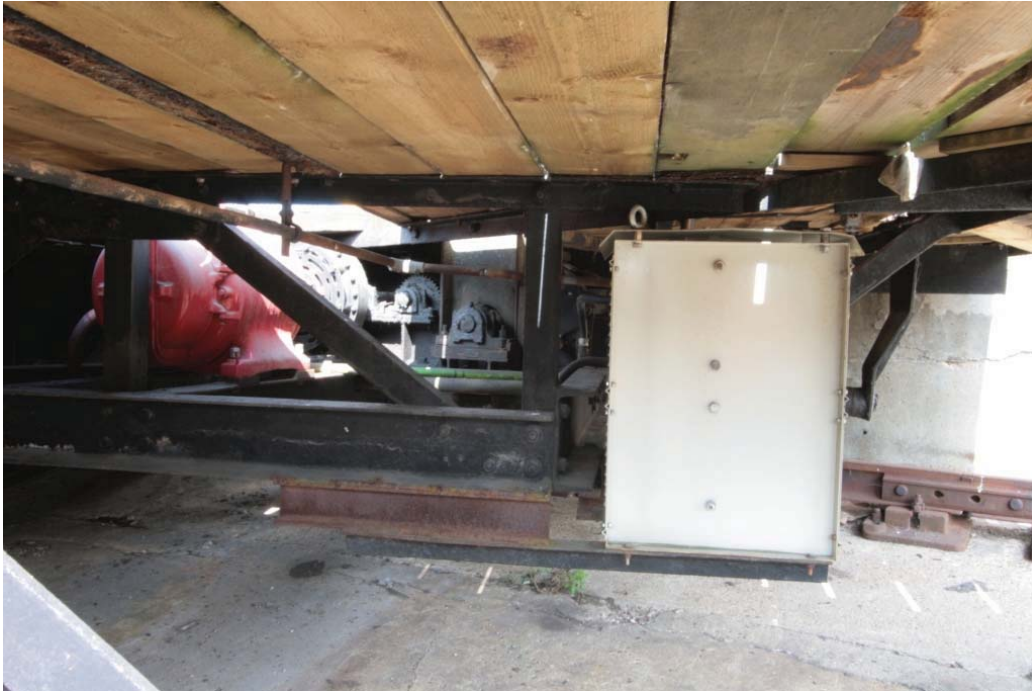
Plate 25. Electric drive motor on underside of turntable below operator's booth.

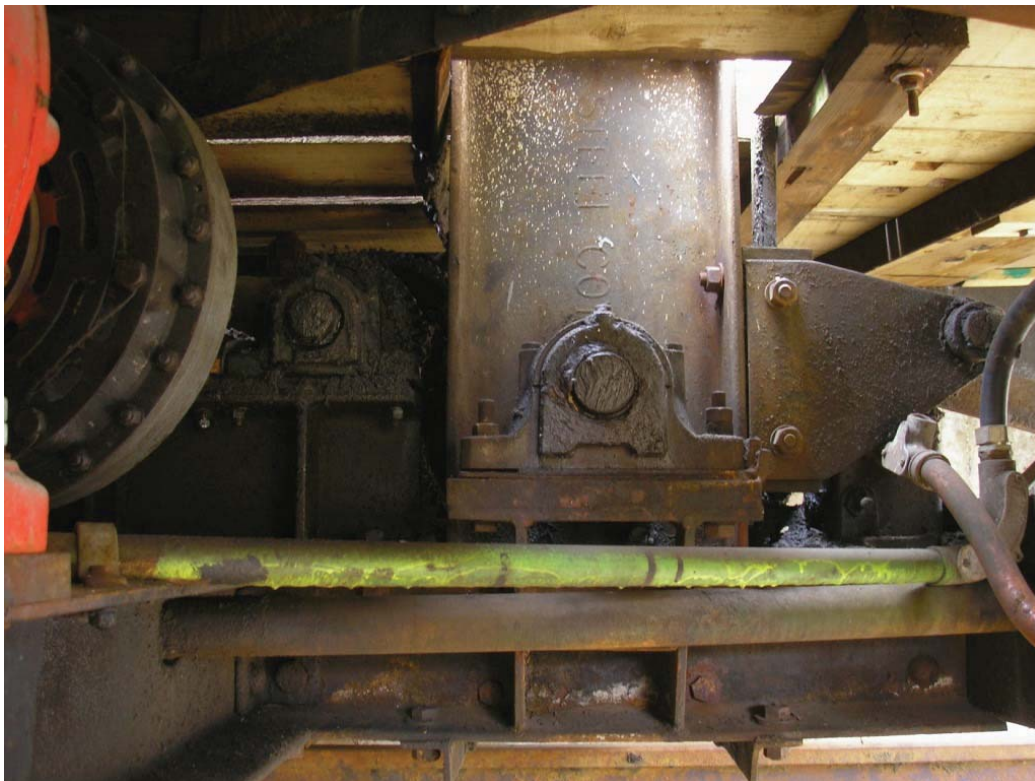
Plate 26. Detail of structural elements supporting electric drive mechanism.

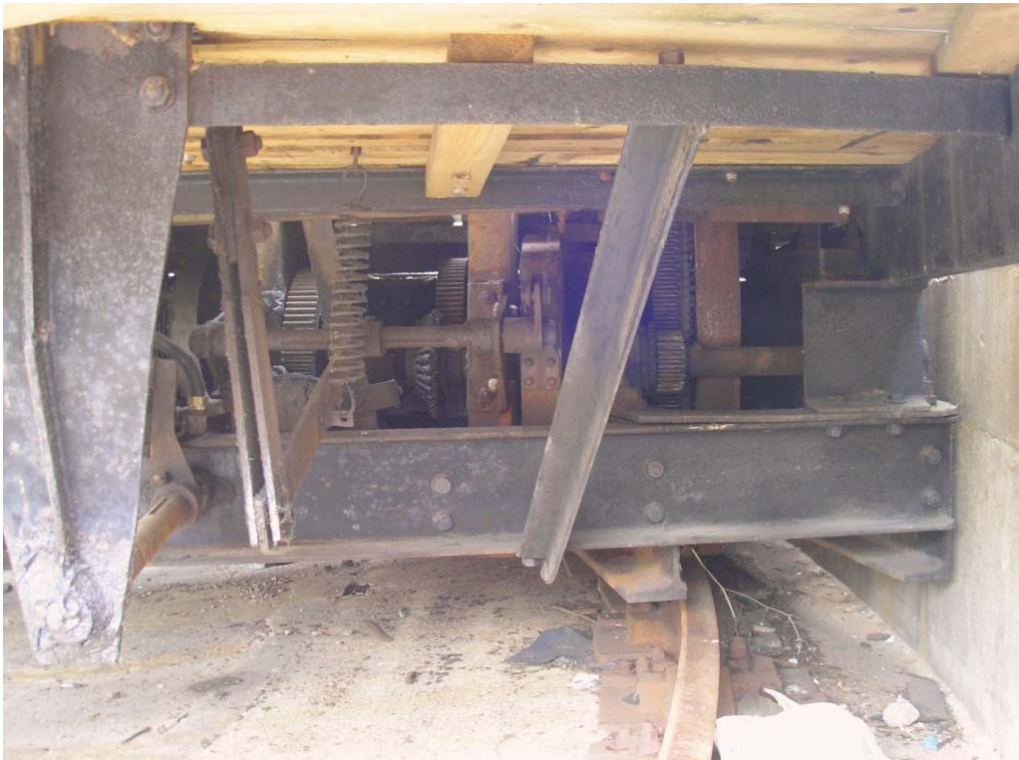
Plate 27. Side-on view of electrically powered drive mechanism and turntable wheel.

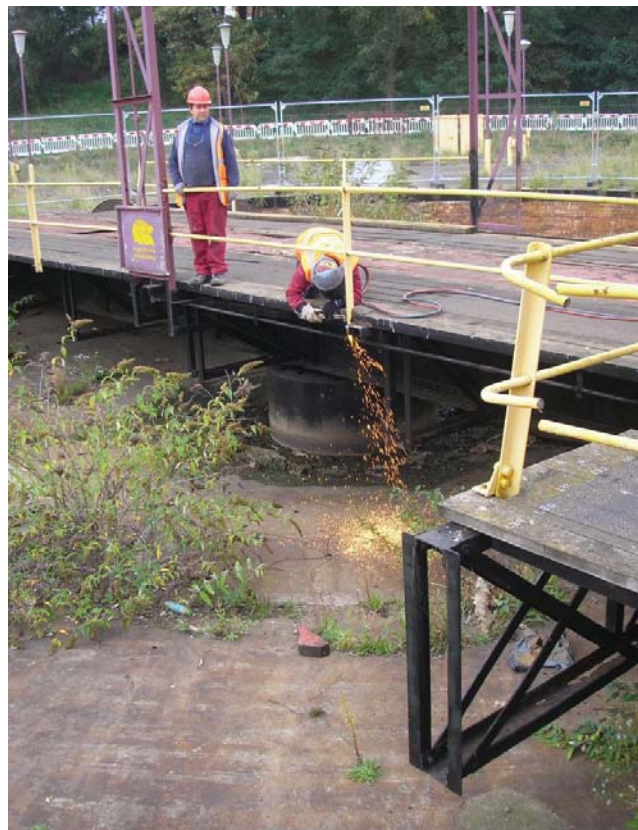
Plate 28. Handrail being removed. In foreground is truncated deck framework beneath electric operator's booth that once extended to support a deck enclosing the entire turntable pit.

- 6.2.4 Manufacturer's engineering drawings indicate that the deck was intended to extend across the entire turntable pit with three small supporting wheels on either side (Figure 8). The date of the reduction of the deck to its present size is unclear, but surviving elements of the supporting deck structure correspond to those shown on original drawings of a fully enclosed deck, suggesting that such a reduction did indeed take place and it was not installed in its present condition. On the same side of the platform at either end the platform was slightly wider to provide space for the turntable controls. At one end the controls comprised a manually operated (hand cranked) drive system and at the other were the controls for an electrically operated system.

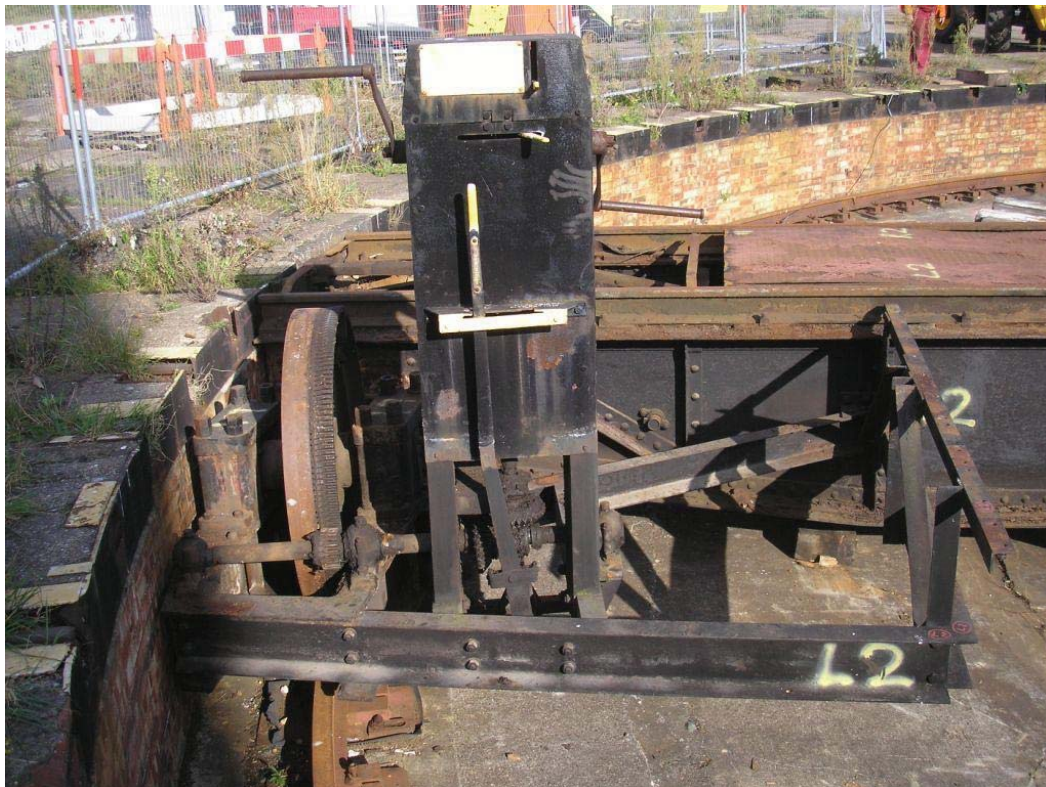
Plate 34. Manual drive mechanism and supporting framework revealed after deck removed.

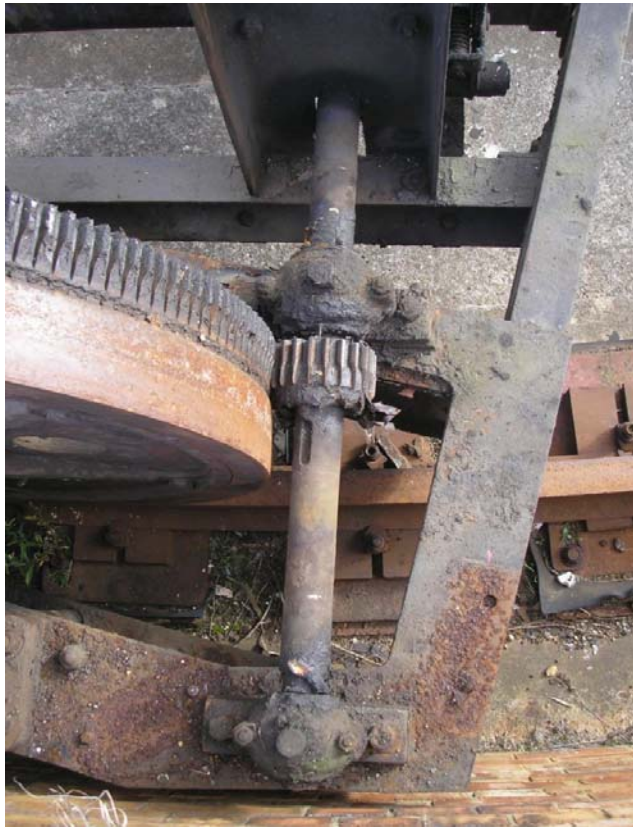
Plate 35. Detail of manual drive gearing, showing drive shaft, pinion and spur wheel.
