CENTRAL SECTION PROJECT

Old Oak Common Worksites Non-Listed Built Heritage Recording of 70' Turntable.

Document Number: C150-CSY-T1-RGN-CR076_PT001-00019

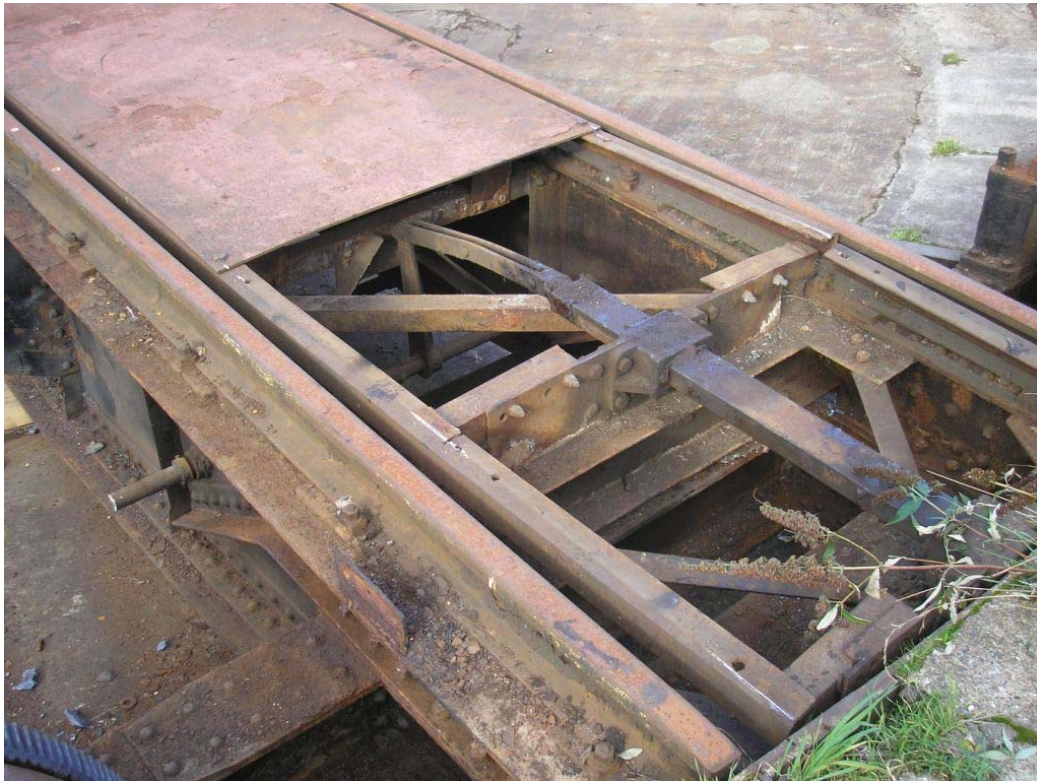
Plate 37. Locking bolt mechanism. The severed shaft on the left connected to the locking bolt lever which was left attached to the electric drive unit and removed.

- 10.3.14 In removing the electric drive unit to which the locking bolt lever was attached, the horizontal shaft from the lever had to be cut (Plate 37). As this shaft took only a quarter turn to operate the bolts and was therefore under little stress, it was considered unfortunate but necessary to sever this shaft instead of other parts that might prove more difficult to repair and involve a greater loss of original fabric. The loss in shaft length caused by the cut could be compensated by the minor inward movement of the shaft from its lever end without any misalignment of other operating elements

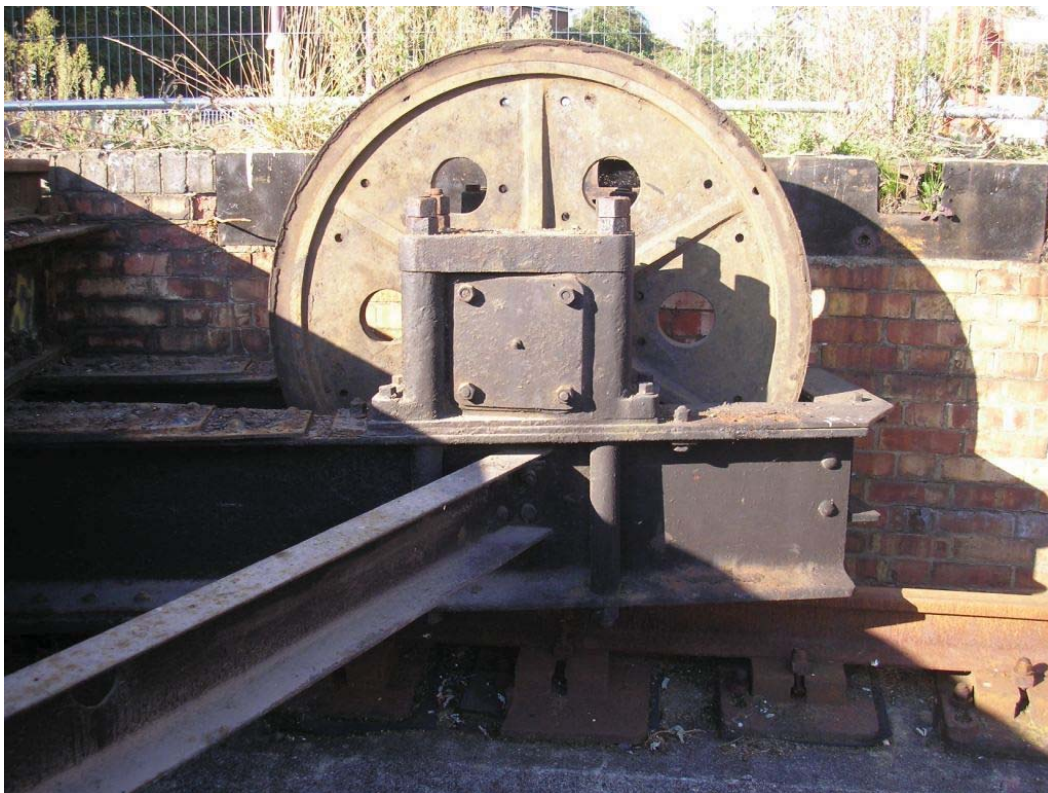
Plate 38. Free wheel at hand crank end with diagonal bracing beam to bogie and steel rim to iron wheel. the

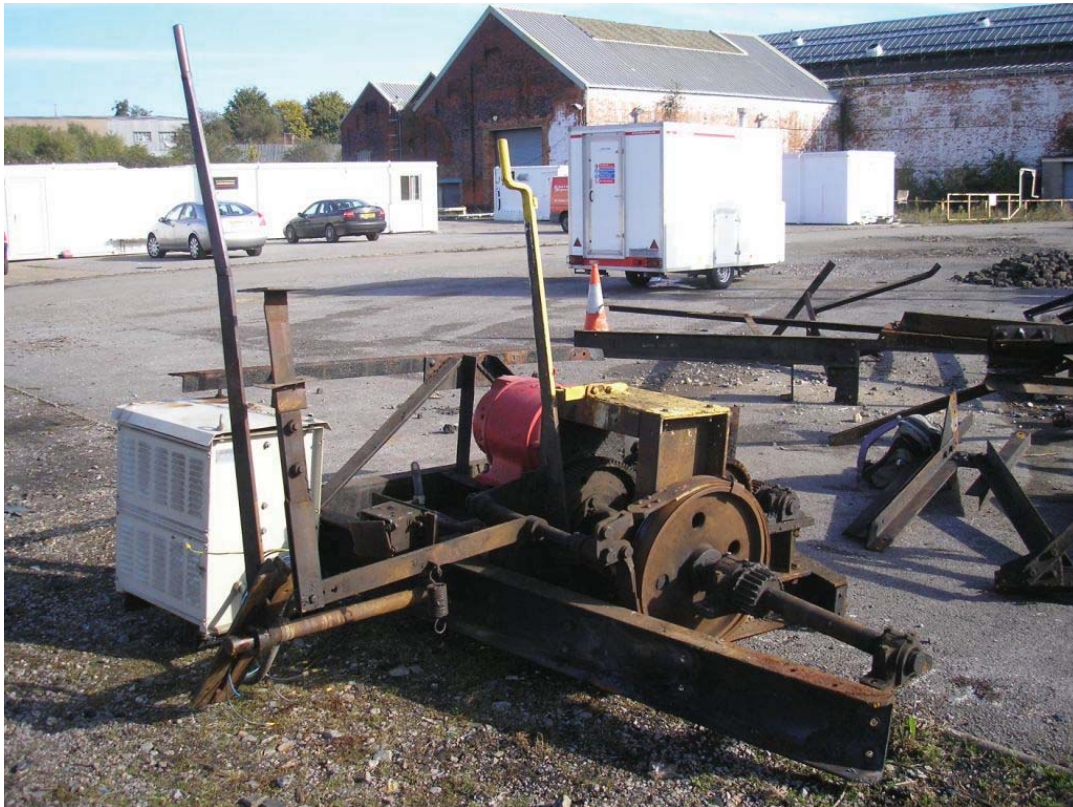
Plate 43. Electric drive unit and transformer in white casing. On the left is the locking bolt lever, brake pedal and the centrally located manual/electric operation lever.

- 10.3.17 The disconnected transformer box that had been removed from the floor of the electric motor operator's booth was replaced by a larger vented white transformer box fitted below the deck (Plate 43). Removing the electric drive unit in one piece showed that this new part had been bolted to two steel members that were crudely welded to the original supporting frame. The drive mechanism itself was also much easier to examine once removed. The arrangement of the brake system and with its pedal operation and large disc with constricting collar was clear (Plate 44). The manual/electric operation clutch lever was painted yellow and retained its original enamelled 'CLUTCH LEVER' plate. It was seen to have been disconnected as the disengaging collar seen on the manual drive unit was absent. This modification most likely occurred at the same time as the removal of the hand crank system at this end of the turntable. The four vertical L-shaped members that supported the crank mechanism had been truncated at deck level and a plate fixed between them (Plate 45). The angled cog to receive the vertical shaft from the crank remained *in situ* and was now redundant. The locking bolt handle had a small arm attached to it that when rotated to lock the turntable would move and push an electric pressure switch to presumably act as a failsafe and cut the electric motor.

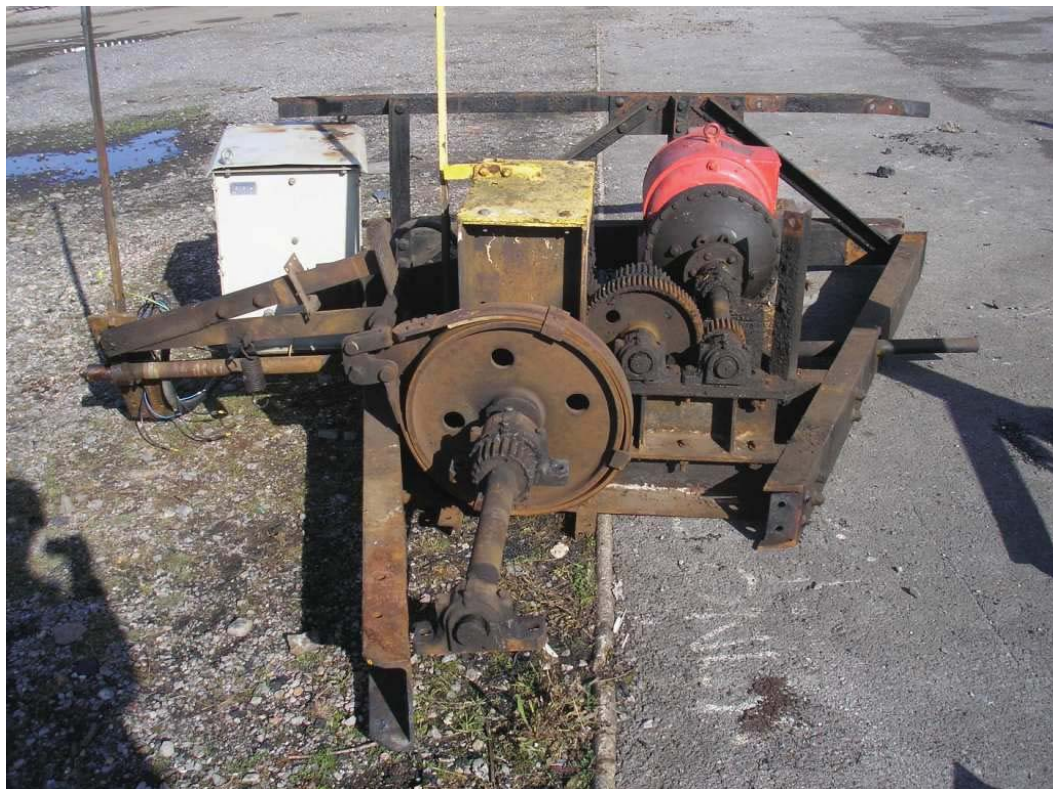
Plate 44. Electric drive unit with circular brake disc on drive shaft in foreground.

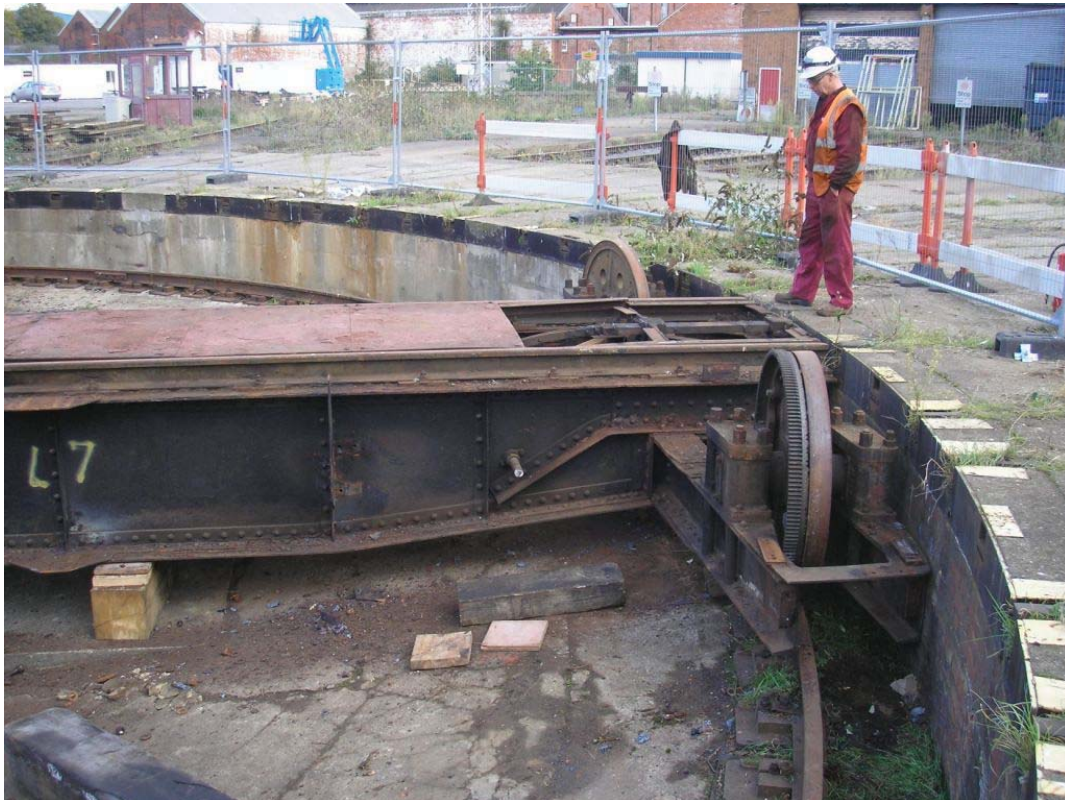
Plate 46. Turntable with electric drive unit removed. The only component that required cutting for the separation was the locking bolt shaft which can be seen in the centre of the turntable side panel.

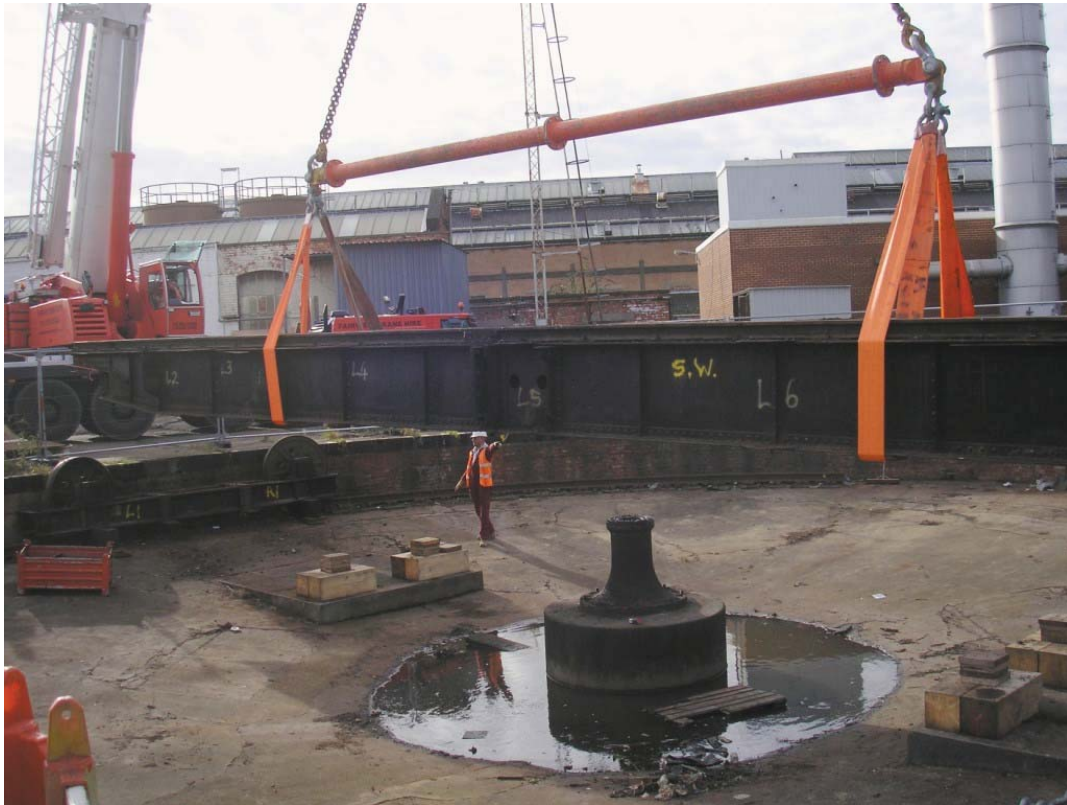
Plate 51. Turntable being lifted clear of central pivot and bogies and registering a weight of 22-tonnes on crane.

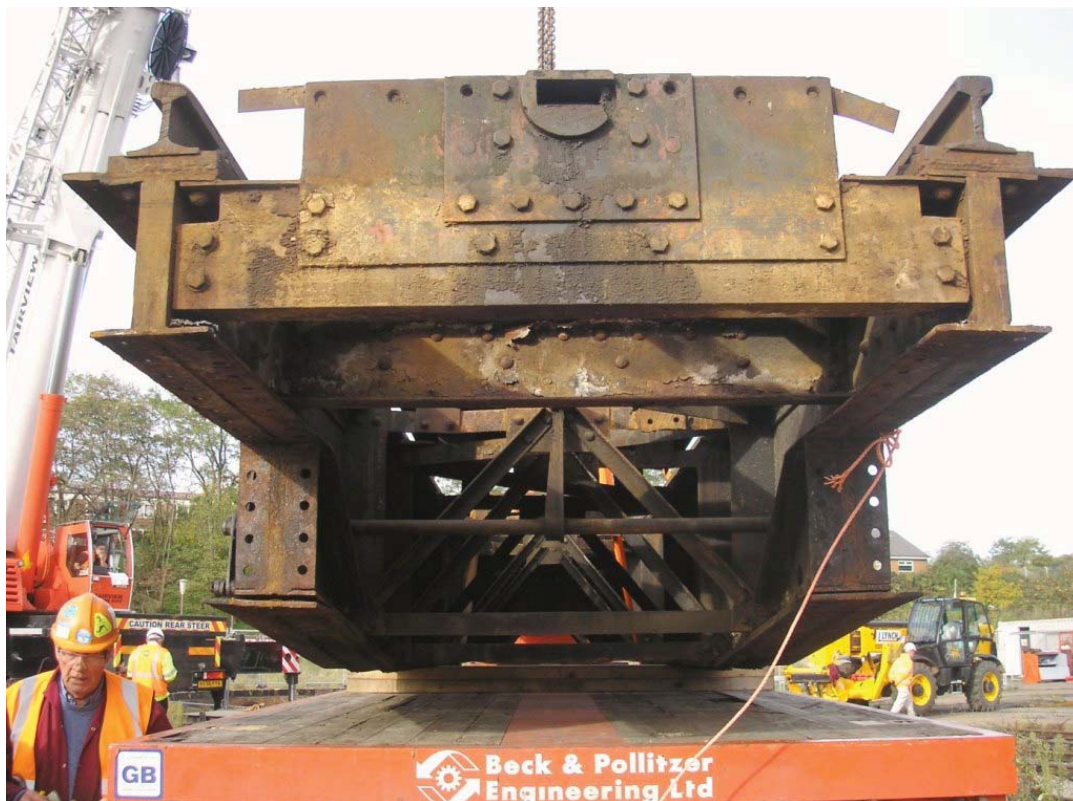
Plate 54. Previously unseen end of turntable showing rectangular slot for locking bolt at top, diagonal internal bracing, horizontal locking bolt shaft and connecting vertical arm and bolt holes for bogies.

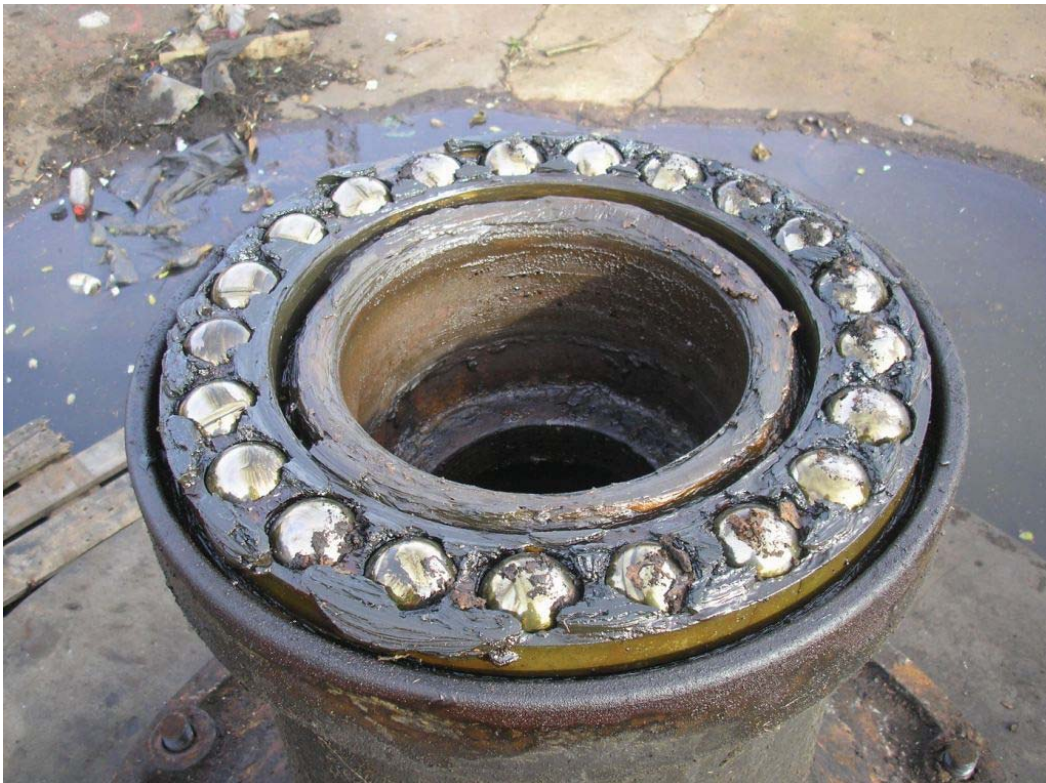
Plate 56. Greased ball bearings on top of central pivot.

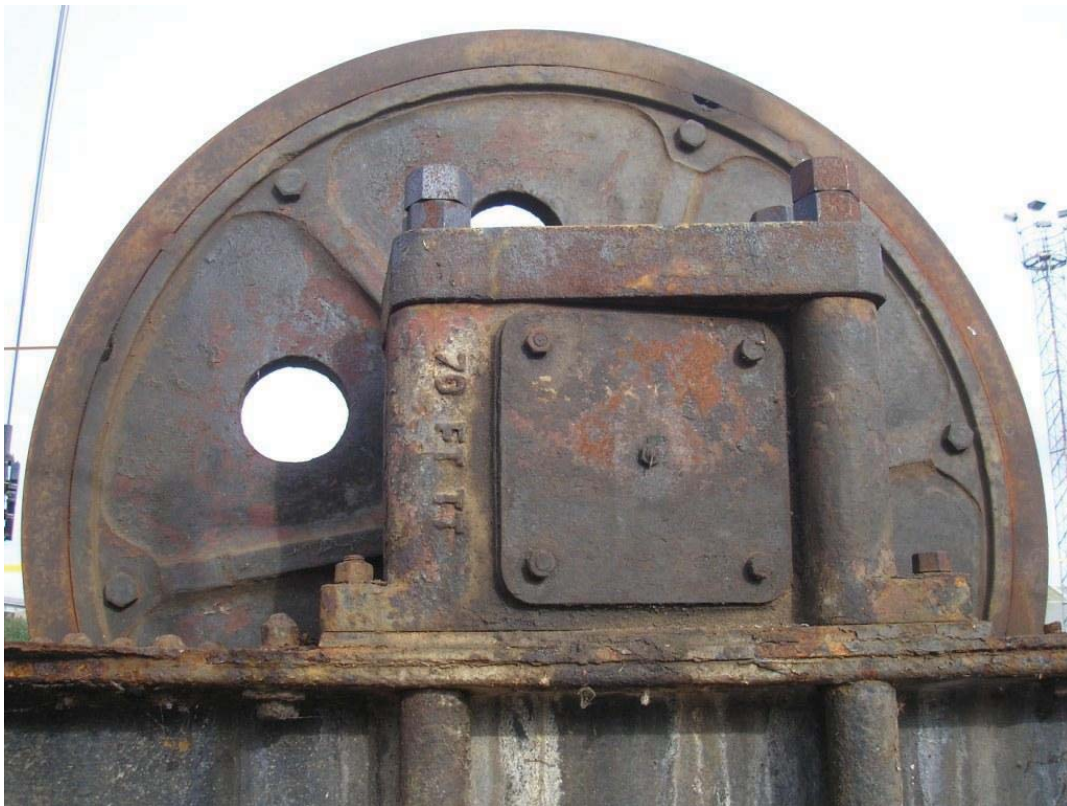
Plate 60. Outer face of manual drive wheel with '70FT TT' cast into axle bearing housing identifying the specific use of this component on this size of turntable.

- 10.3.19 The rectangular housing for each wheel axle was cast with '70FT TT', referring to the size of the turntable and implying that these parts and wheels were specifically designed for this model and not reused or cannibalised from previous designs. These markings were not previously observed as they were on the outer side of housing, either directly facing the wheel and therefore covered in grease and oil or facing the turntable pit wall. Once removed from the pit, the markings on the cleaner side that had faced the wall were clear (Plate 60).
