C254 – Archaeology West

Archaeological Watching Brief at Lord Hill's Bridge Interim Report

CRL Document Number: C254-OXF-T1-RGN-CRG03-50116

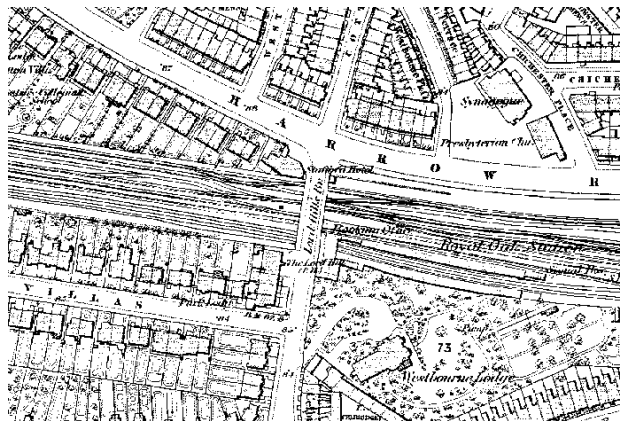
Figure 2: 1872 Ordnance Survey map

- 1.4.5 The Ordnance Survey map of 1872 shows further development of the railway in the area with additional lines having been installed and the construction of the Royal Oak Station. This is the first map upon which Lord Hill's Bridge is reference; a much wider bridge is shown compared to that of the 1862 map.

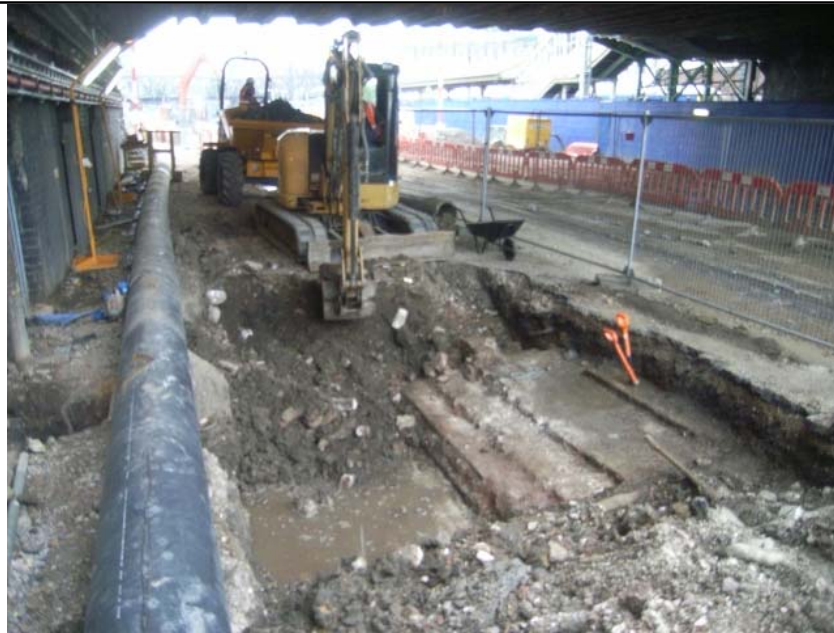
Plate 1: Exposure of northern abutments

- 1.6.1 The initial phase of works was the excavation of new service trench, running approximately 30m to the west and continuing under the present bridge. Excavation was carried out by mechanical excavator and hand, this methodology being dictated by the Principal Contractors method statement. During the excavation of this trench the northern abutments associated with an earlier phase of the bridge were exposed. This element of work did not require constant archaeological supervision. Subsequent to the initial identification of the abutments a greater archaeological presence was maintained.

- 1.6.2 A constant archaeological presence was maintained during the exposure of the abutments. Every effort was made to ensure any archaeological work was done in a timely manner which caused minimal distribution to the Principal Contractors program of works. The removal of the foundations was carried out using a 12 ton excavator using both bucket and breaker. This work was carried out under intermittent archaeological supervision. In addition to the exposure of the foundations the surrounding area was reduce to allow for the construction of a piling mat, this work was also carried out under archaeological supervision.

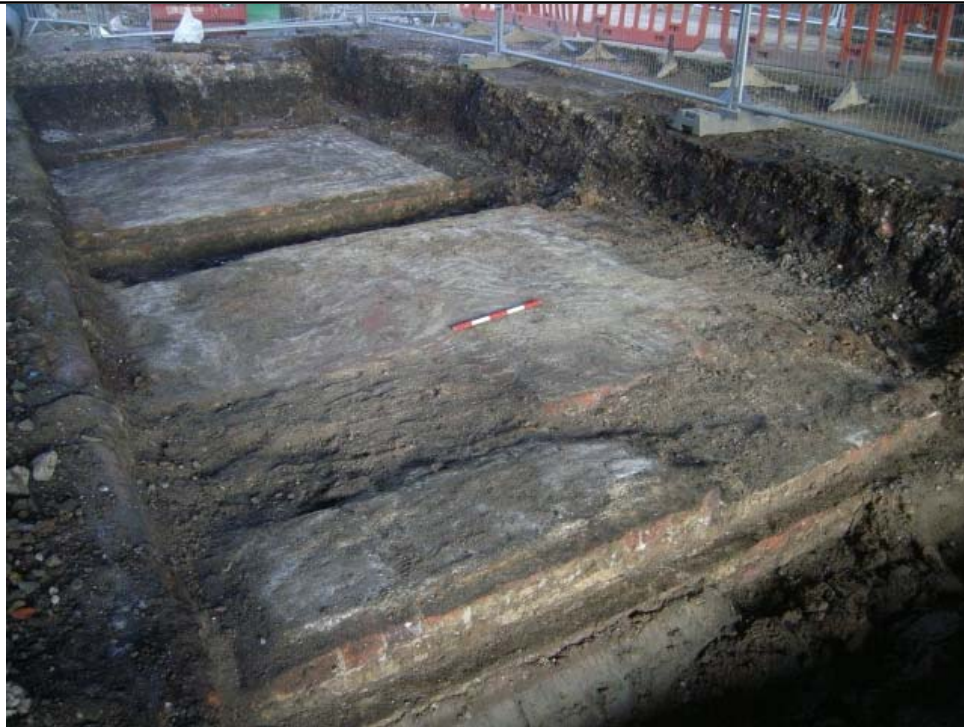
Plate 2: Southern brick abutments

- 2.1.3 The southern set of abutments comprised four independent rectangular structures running east - west along the southern edge of site and measuring 3.1 x 2.7x 0.6 m. These were formed of eight courses of shallow frogged red bricks with a white lime mortar. Each course was offset from the course above with an additional course, creating a series of steps toward the base. A single light grey sandy concrete foundation block was observed running underneath all four abutments and was approximately 16 x 4.5 x 1.1m in size. On the surface of each abutment a band of white mortar ran along the outside edge. A partially surviving wall on one abutment suggests the mortar indicates that further upstanding elements of the abutments have been truncated.

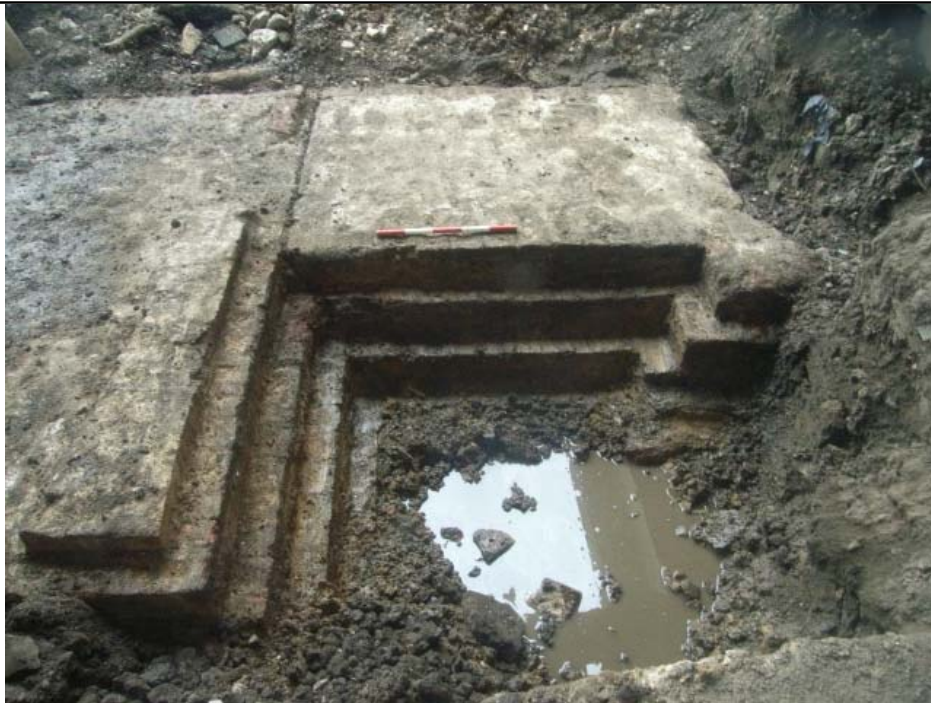
Plate 3: Additional brick abutment

- 2.1.5 Four attached structures had been built at right angles to each abutment. These were built from the same red shallow frogged bricks. The additional structures had not been keyed in with the east-west foundations and there was a gap of 10-30mm between the two structural phases.

- 2.1.6 Both the additional attached structures and the connecting walls had been constructed on a concrete base that could not be distinguished from that underlying the east-west foundations. No evidence of the bricks being keyed in and the small 10-30mm gap suggest these are later additions rather than contemporary structures. The use of similar bricks and mortar along with no identifiable change in the concrete base suggest that these additional abutments were constructed within a short period of the original structures. These additional structures are likely to be reinforcements to the initial foundations. The smaller nature of the northern foundations compared to the southern may be the reason why only the northern set was amended.

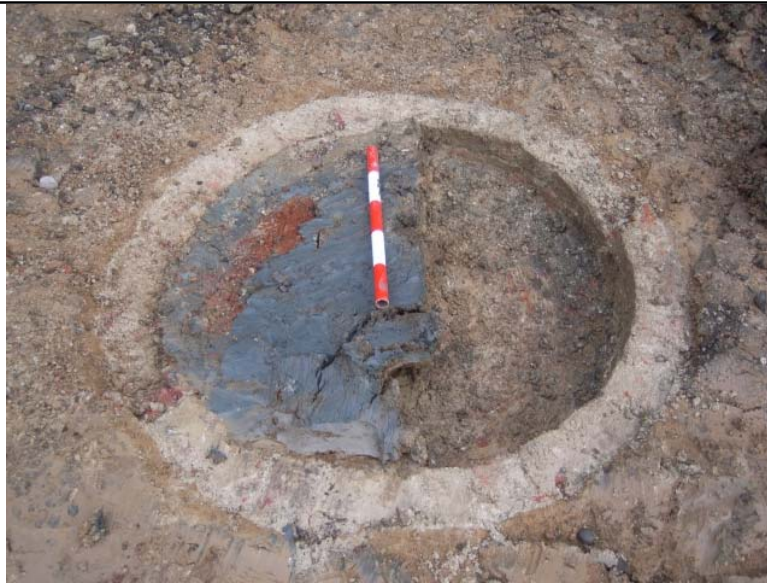
Plate 4: Circular drain/soakaway

- 2.1.9 While reducing the area to the west of the present bridge a circular brick structure (see Plate 4 below) was recorded. This comprised three courses of bricks (9 x 11 x 11mm) and measured 1.24 m diameter x 0.28 m depth. The structure was cut into redeposited clay and sealed by a further clay layer. This structure appeared have been heavily truncated. It is likely to be the remains of circular brick drain/soakaway dating to an earlier phase of activity associated with the railway.

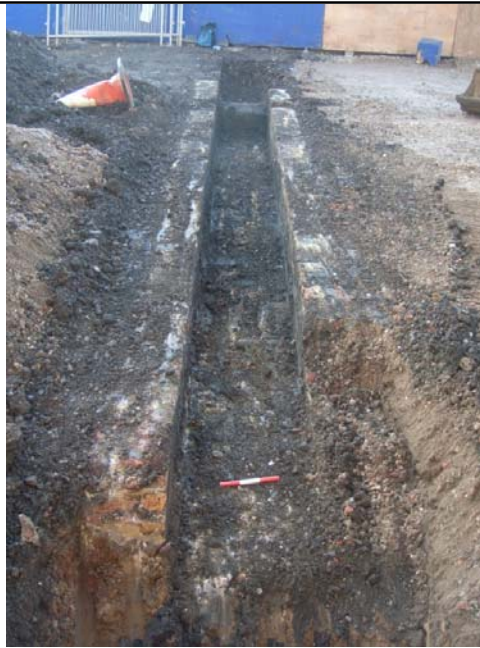
Plate 5 - Utilities trench

- 2.1.12 An additional structure was located 13m to the east of the Royal Oak Portal tunnel face (see Plate 5). This was uncovered during ground reduction. It comprised of two parallel walls, running north-south and constructed upon a base of concrete. The walls were bonded with a pale grey-yellow sand mortar. Steel bolts c.0.5m long were built into the wall, spaced 1.6m apart. The bolts ran the length of both walls. This structure had been heavily truncated at both its northern and southern end, thus its full original extent is unknown. As recorded the structure measured 12m north - south with two walls c 0.3m wide and 0.7m apart and standing 0.54m high. Two cast iron service pipes ran through the structure at its southern limit, the nature of construction suggest a contemporary date. Running perpendicular to the course of the former tracks this structure is likely to have functioned as utilities trench running under the rails, with the steel bolts being used to hold railway sleepers in place.

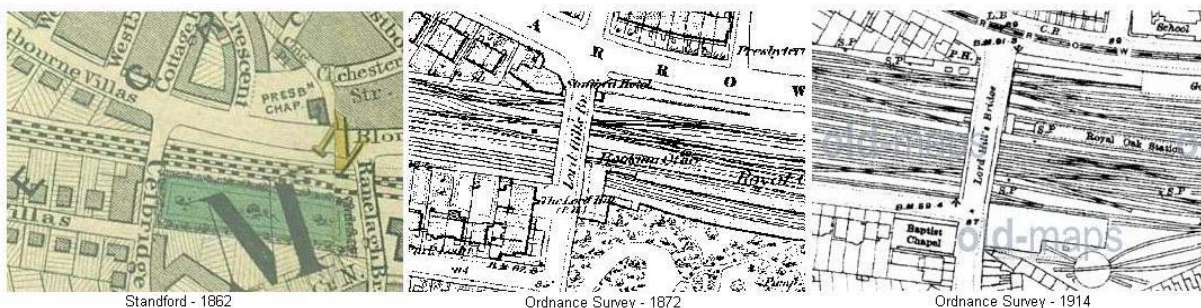
Figure 3: The evolution of Lord Hill's Bridge

2.2.1 The watching brief works have provided evidence of bridge footings pre-dating the existing structure. The concrete base observed under both sets of the recorded brick bridge foundations would be unusual for the primary Lord Hill's Bridge (1835-37) although the stepped brick foundation is characteristic of Brunel's early GWR structures. It is therefore likely that the foundations date to the (northward) widening of the tracks in the late 19th century and the need to increase the span of the bridge.
