# C254 Archaeology West

## Site Code - XSI 10

Paddington New Yard, Westbourne Park, London W9

### Archaeological Fieldwork Report

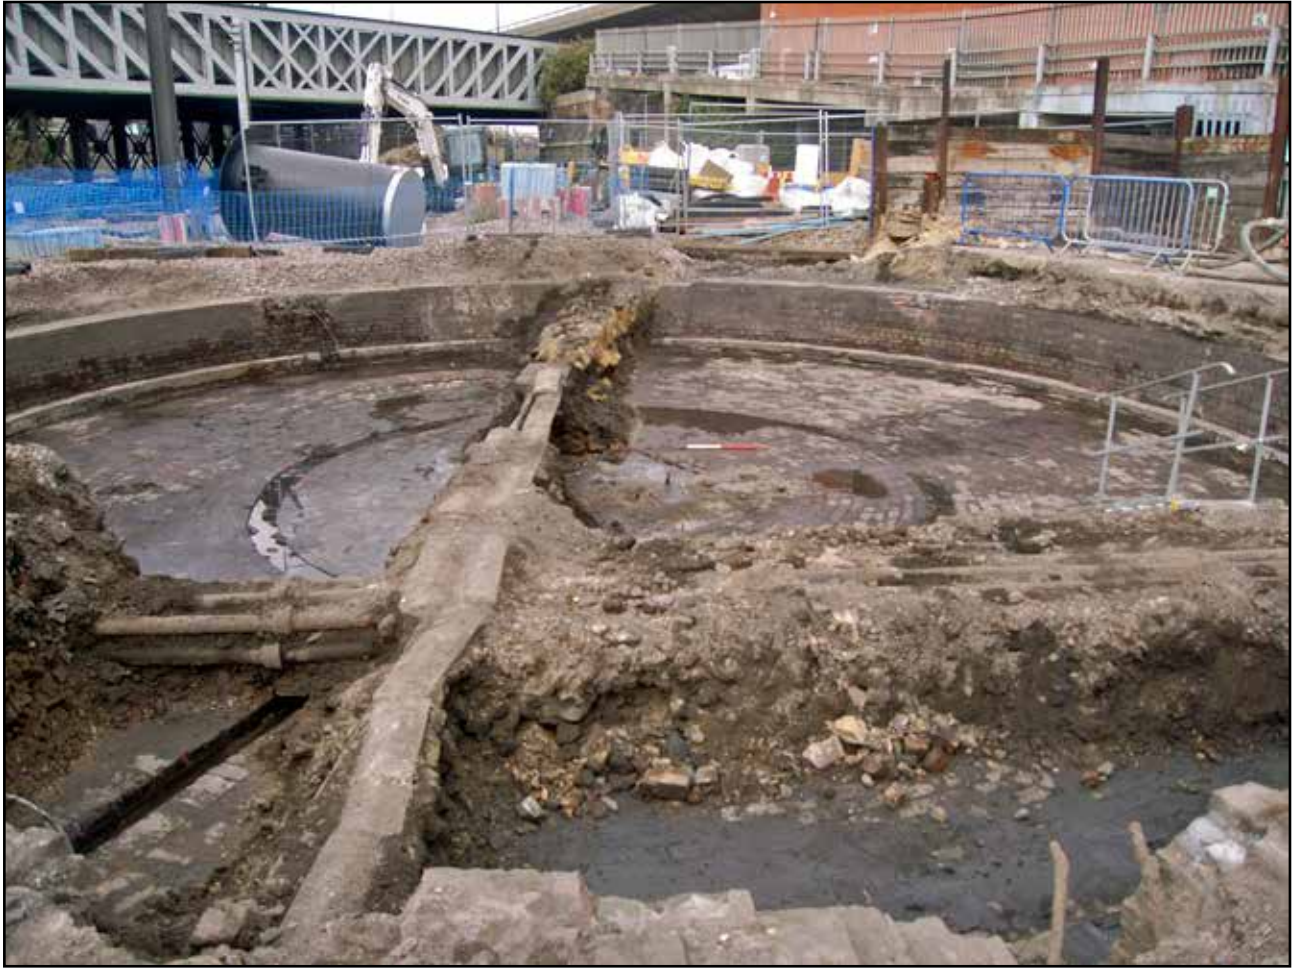
Plate 1: Overall view of western Turntable from southeast

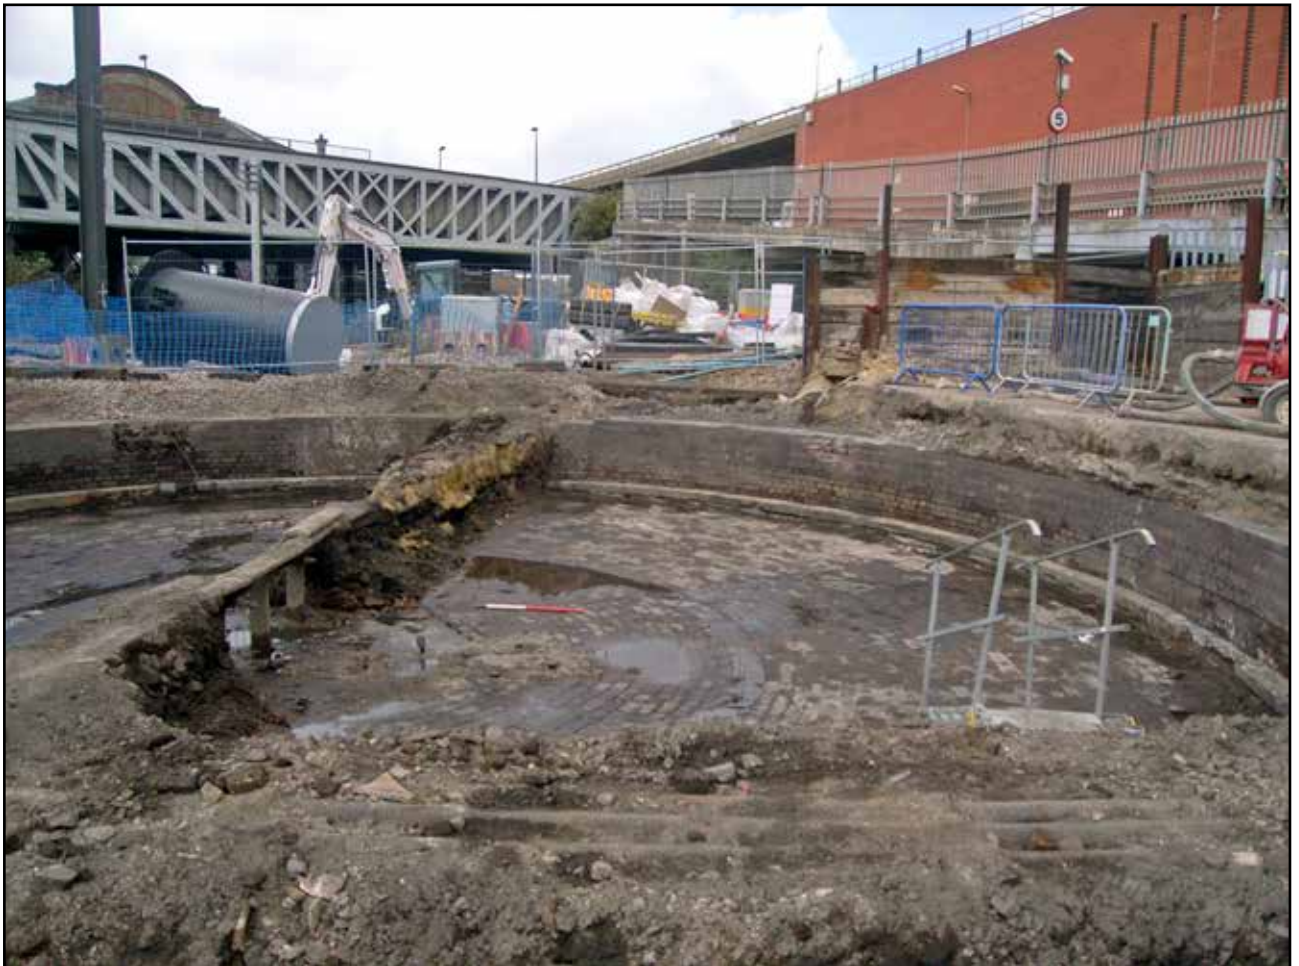
Plate 4: Overall from east showing floors [8524] and [8526]

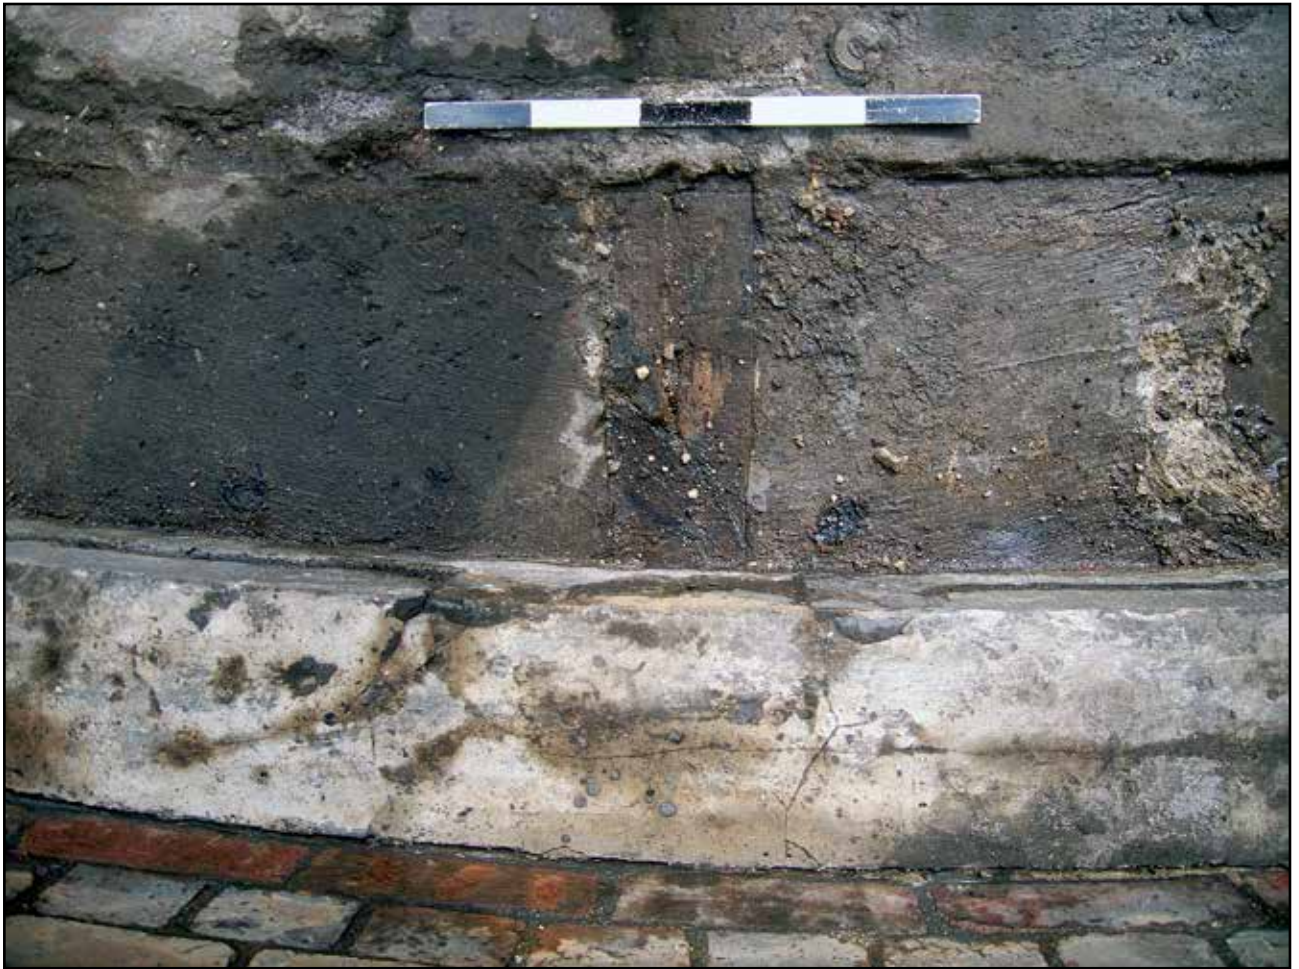
Plate 5: Guide rail gully [8523] showing timber sleepers and shorn off bolts

- 6.3.7 Interior to this was a 0.36m (10") wide gully (8525) Set into the brick floor this ran around edge of the entire turntable pit. Only 10mm deep, this gully contained a series of short, 0.35m long and 0.15m wide, wooden sleepers (8599) which were set at regular intervals into its base. A number of metal bolts 150mm (6") high and 25mm (1") in diameter were also set vertically at regular intervals into the base of this feature. The base of this gully was covered in a light brown render similar to that found on ledge 8522 (Plates: 3 and 5).

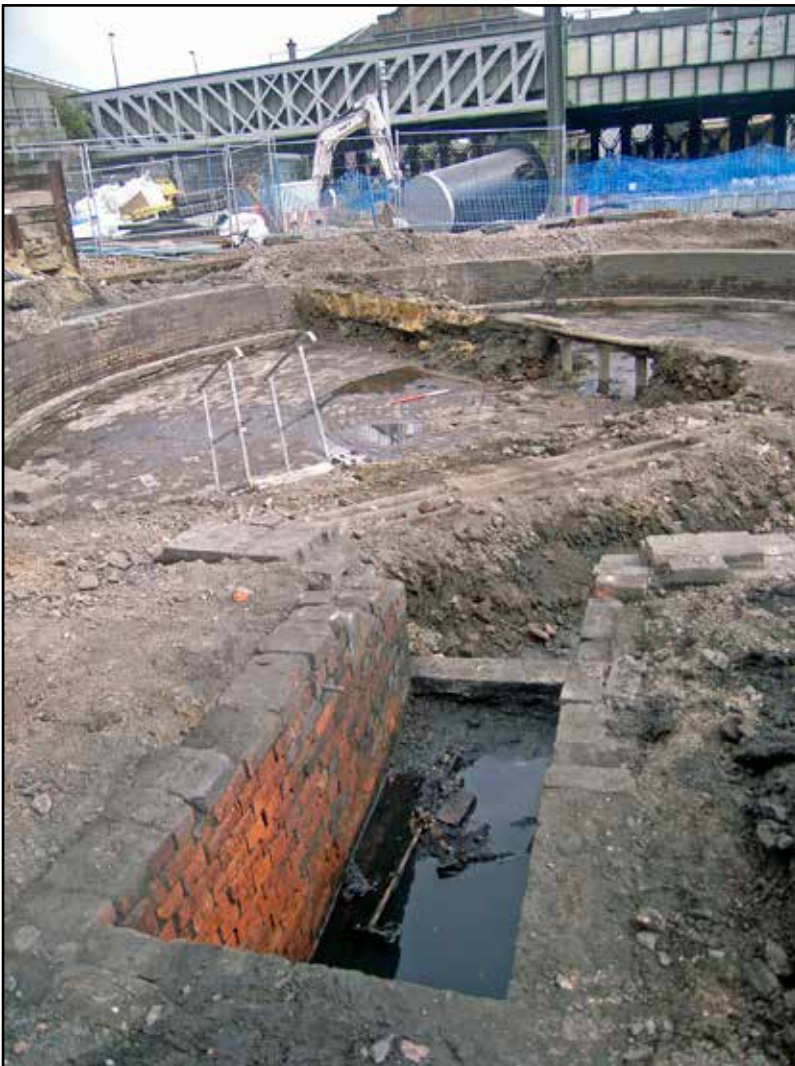
Plate 8: Engine house [8528]

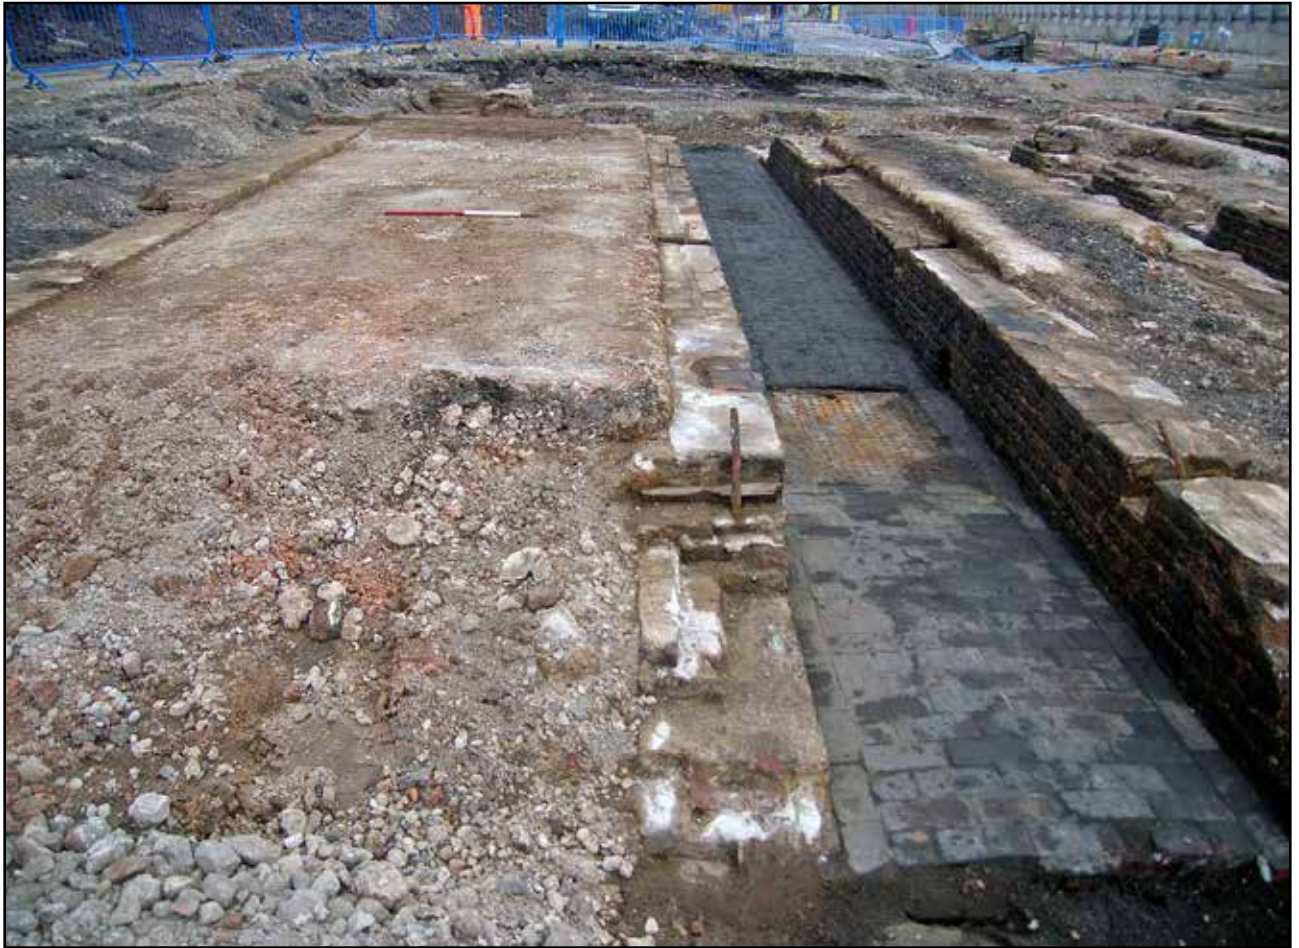
Plate 13: Western end of 1861 inspection pit showing catchment pit [8685] and sleeper cuts. The floor of shed (8681) is to the left

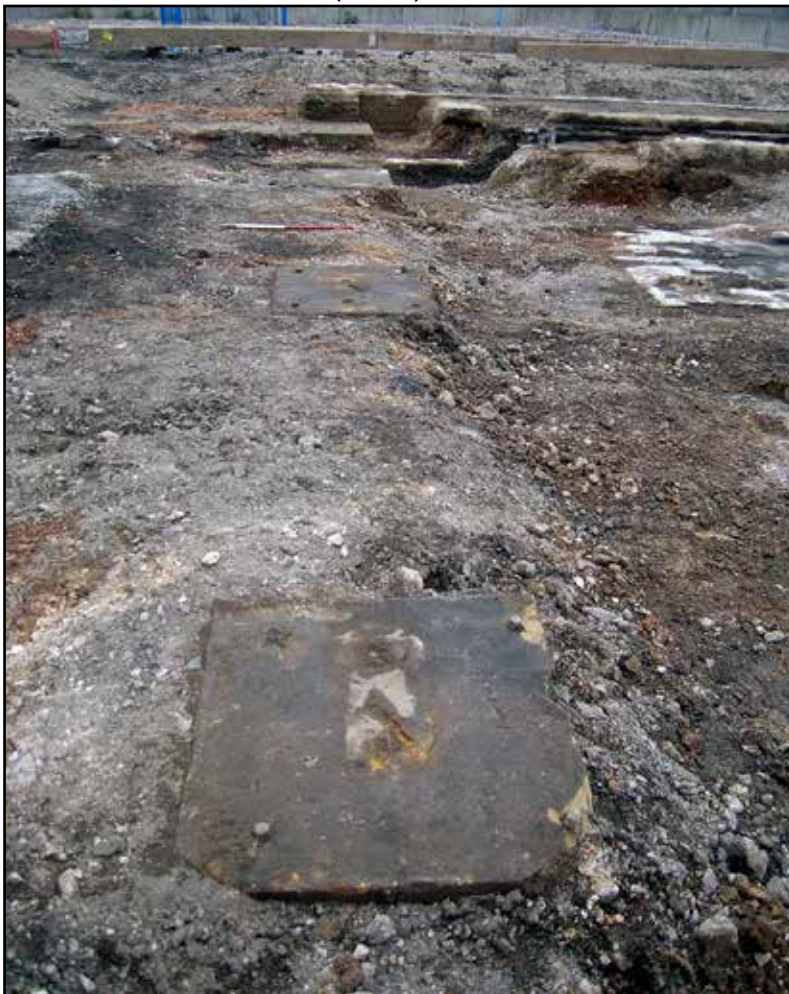
Plate 14: Eastern end of 1861 shed showing row of stone plinths for metal columns

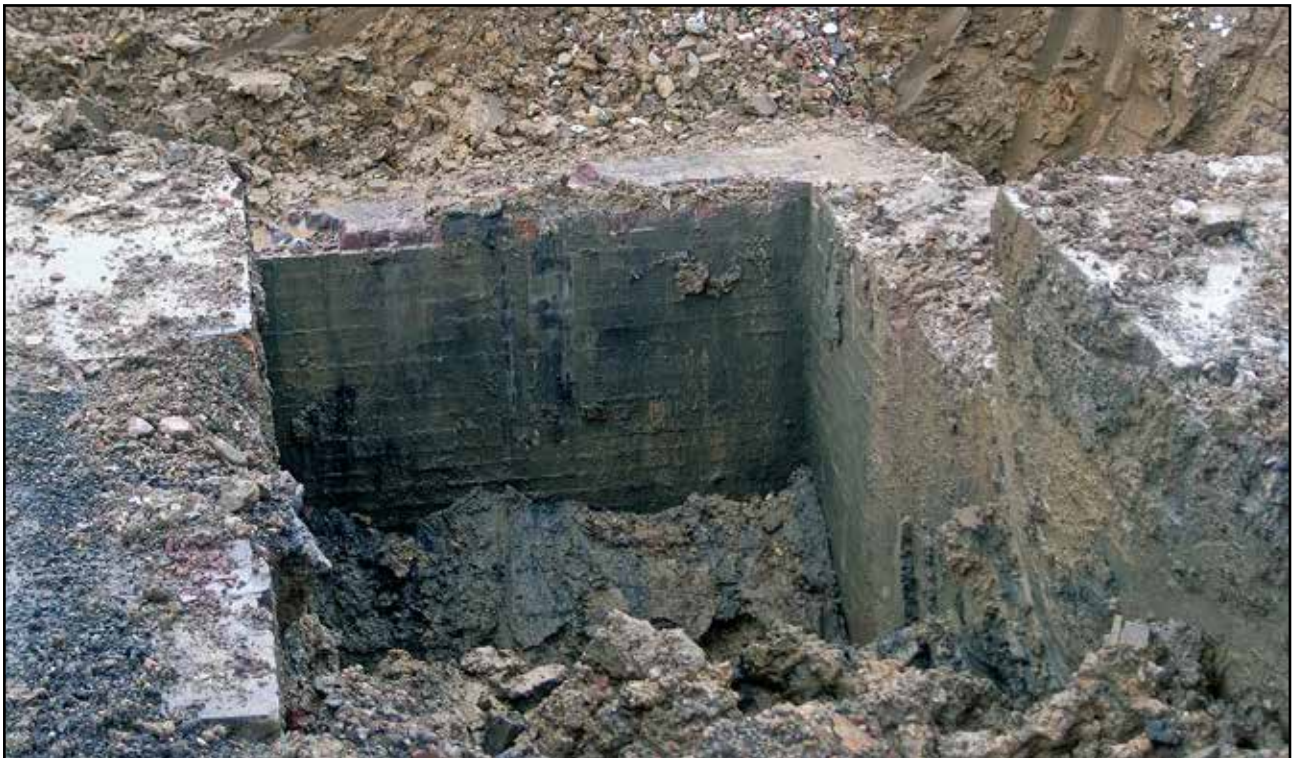
Plate 16: Brick Tank [8828] to north of 1861 shed

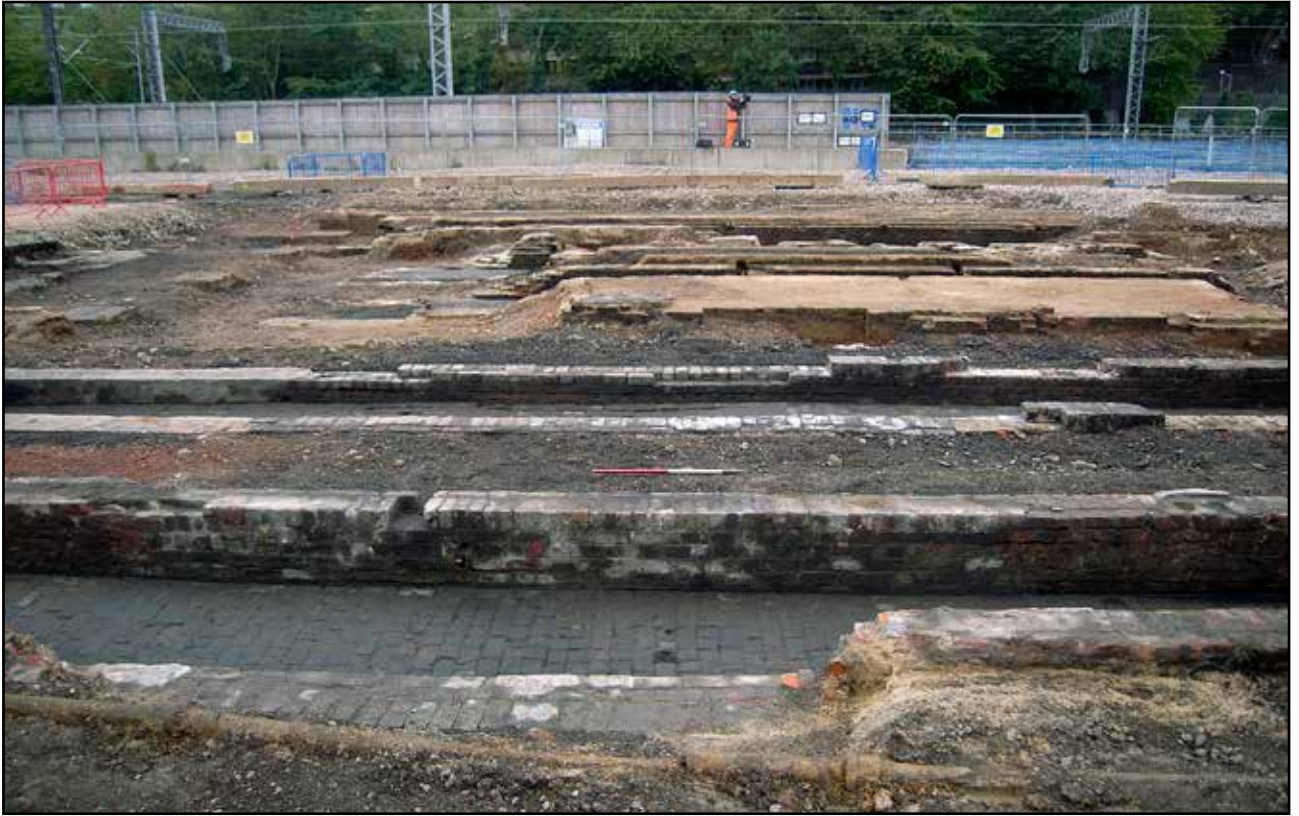
Plate 17: Inspection pits of 1861 and 1871 shed from north

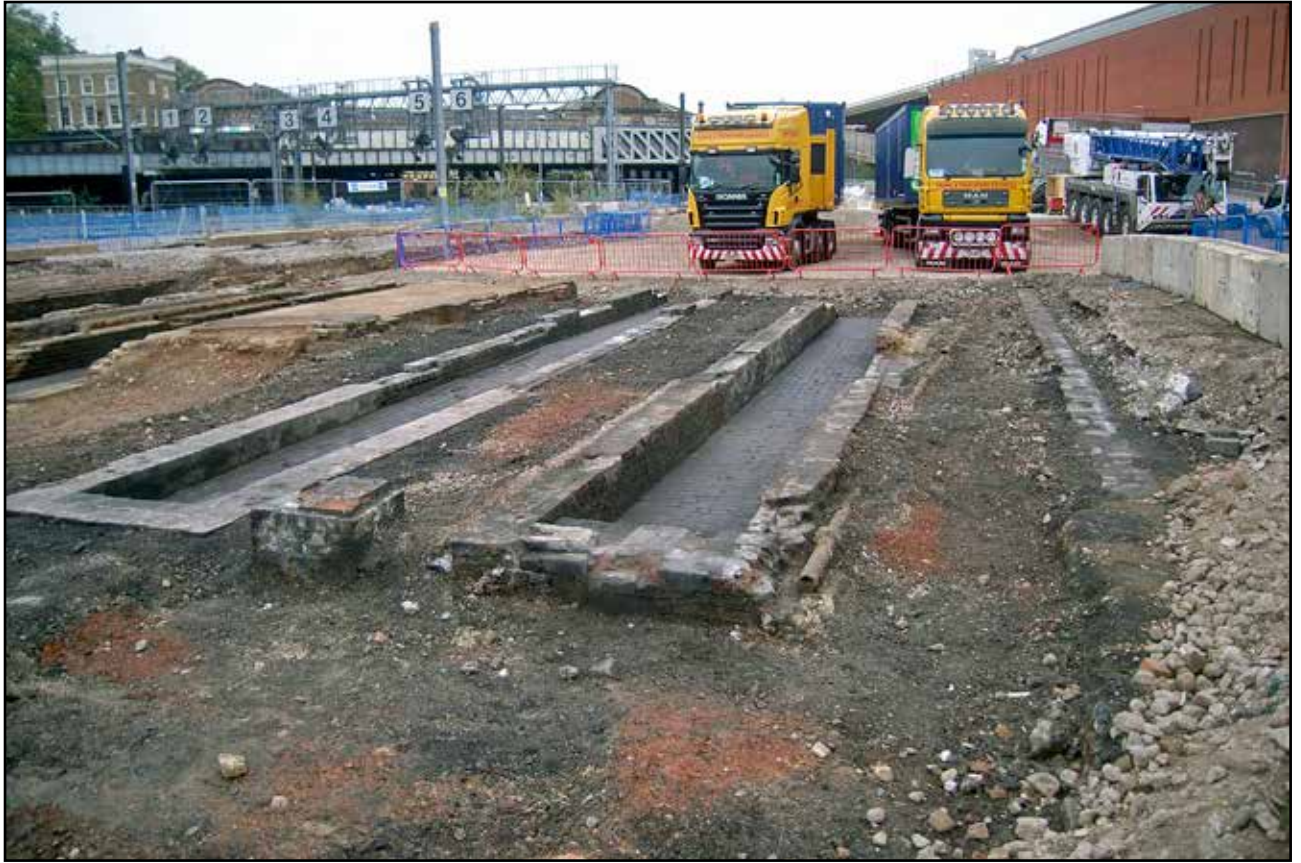
Plate 19: Inspection pits [8786] and [8785] of 1871 shed from east

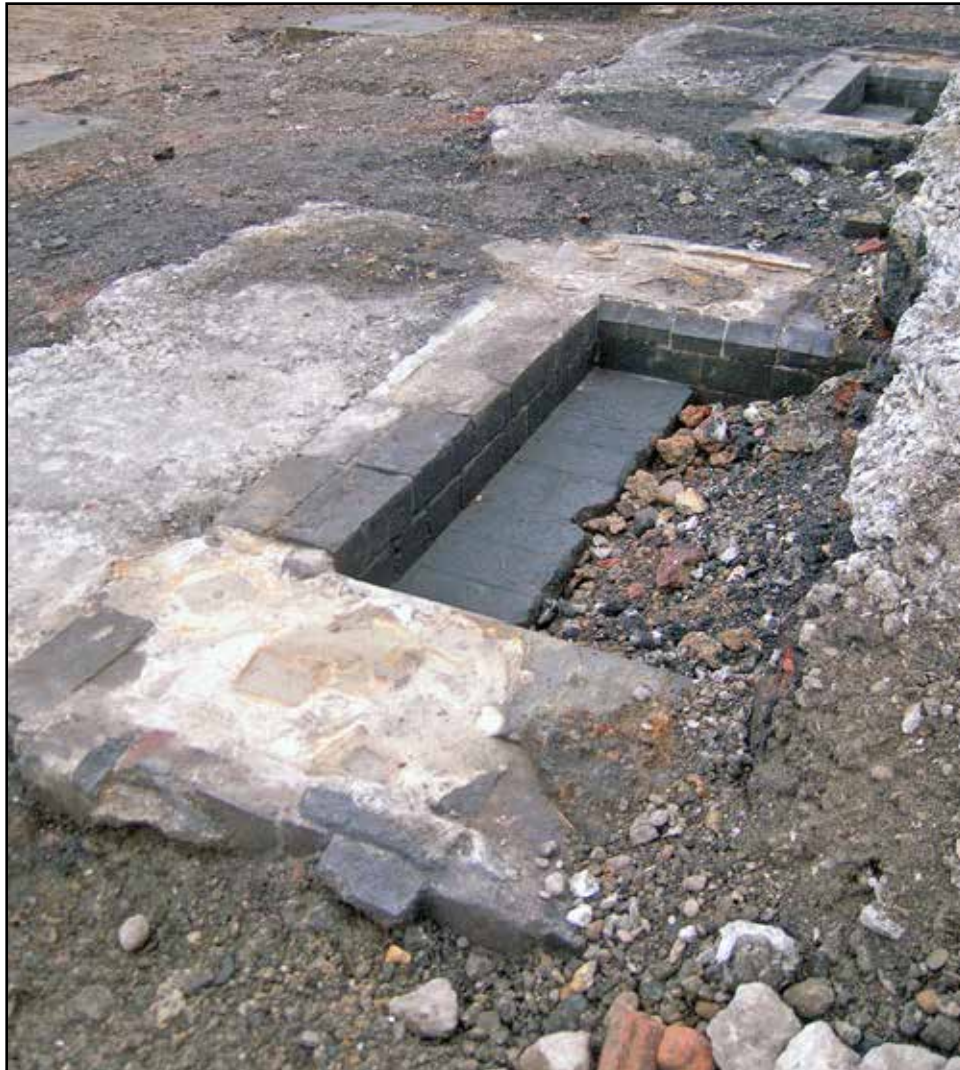
Plate 20: Western ends of external pits [8724 and 8732]

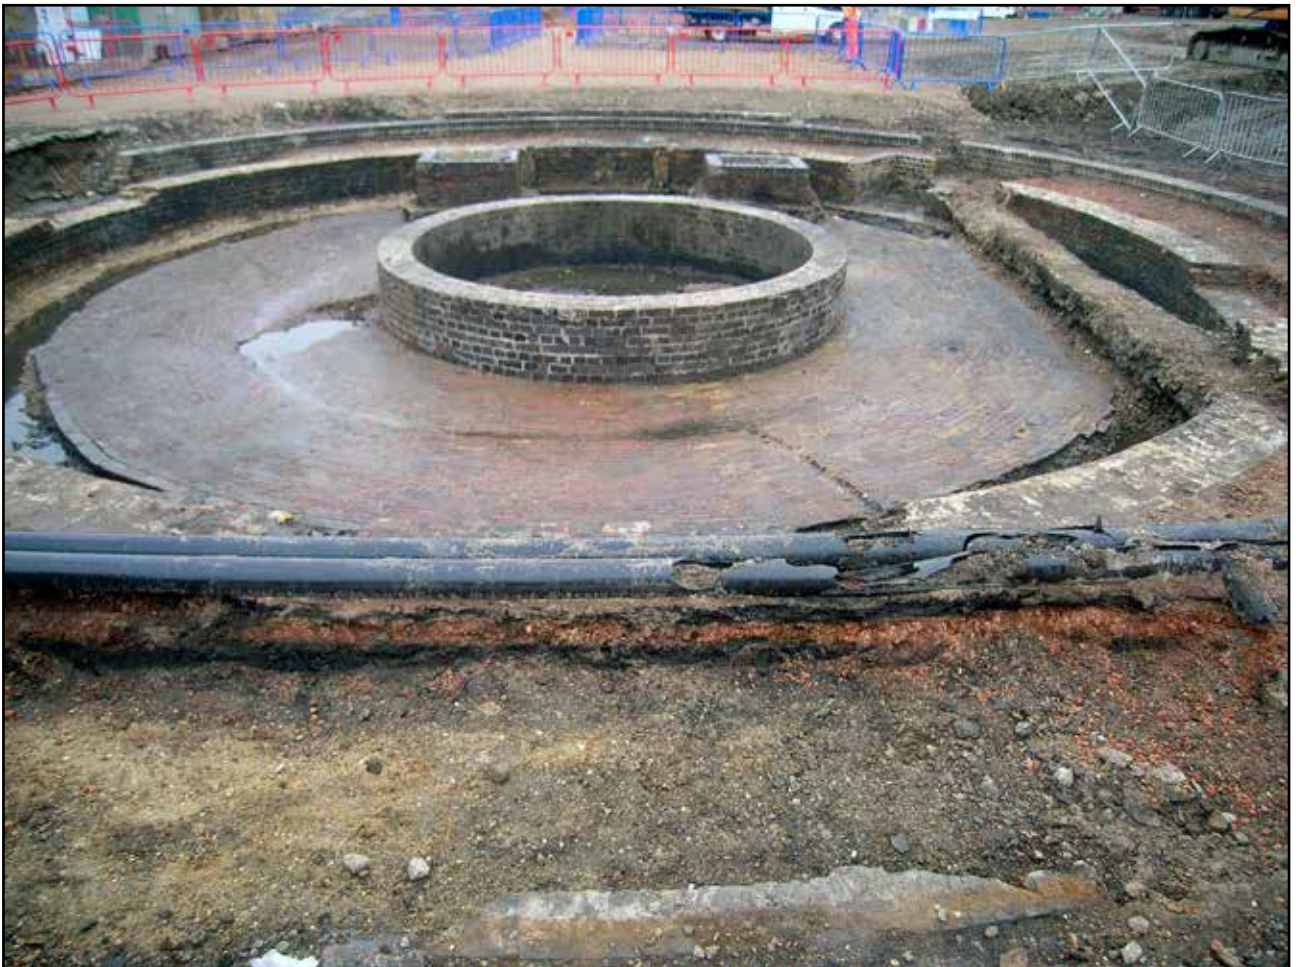
Plate 22: Turntable pit from east

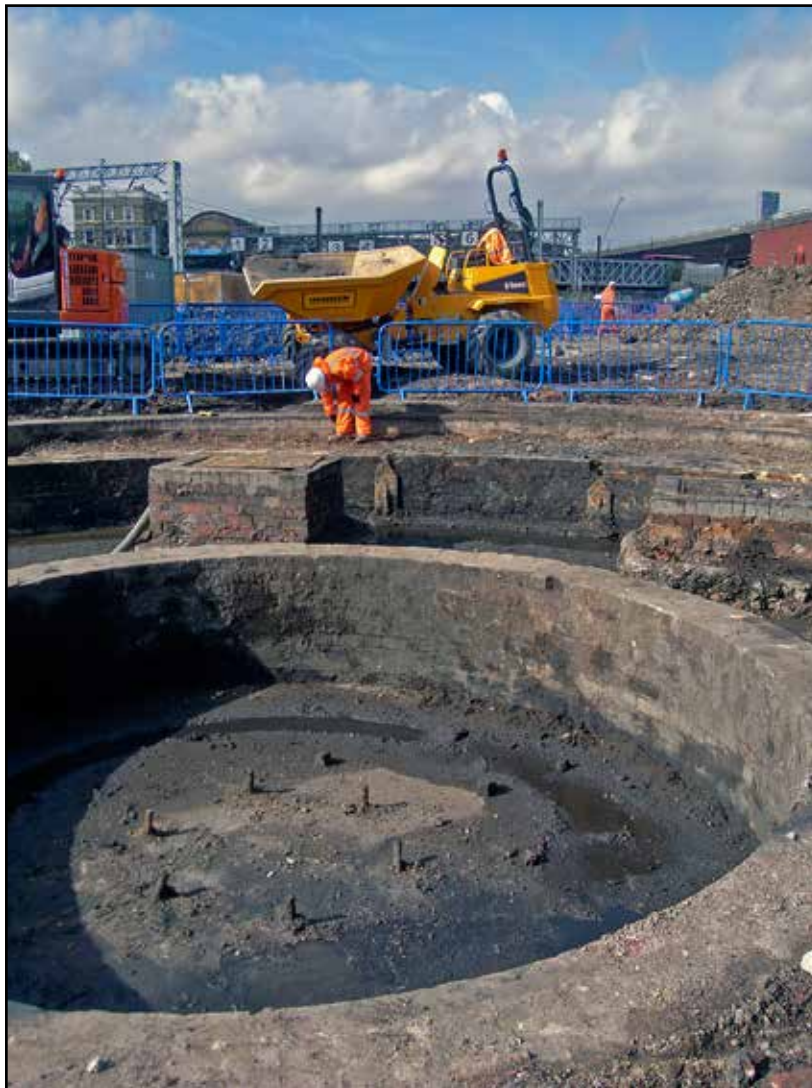
Plate 24: Centre of Turntable pit showing phase 2 wall [8747]

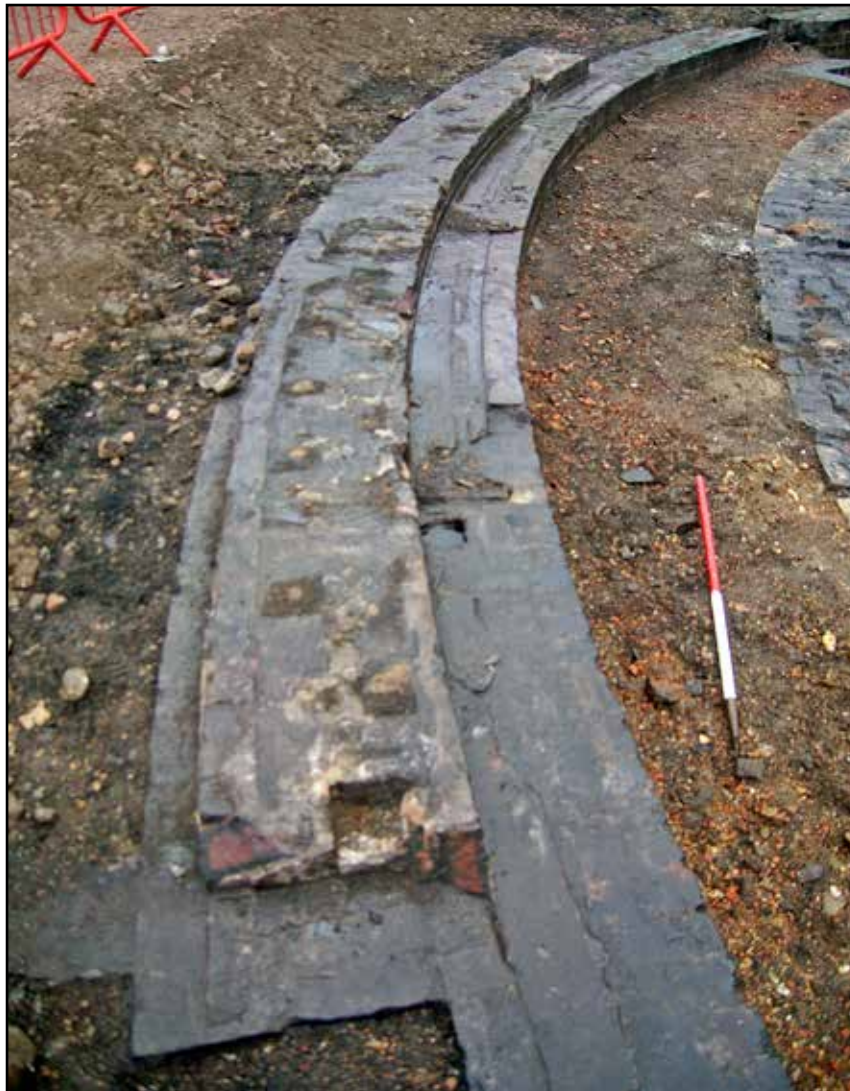
Plate 25: Outer wall [8752] of second phase of Turntable

- 6.5.8 Wall 8752 was 0.47m wide and built of blue grey engineering bricks set in a hard white mortar (See Table 6). Wall 8752 survived for most of its original height (0.6m) and comprised five courses of stretcher bond, with a single course lain on edge at its top. Monitoring of its demolition by OA/R showed that it had stepped foundations set on substantial concrete footings.

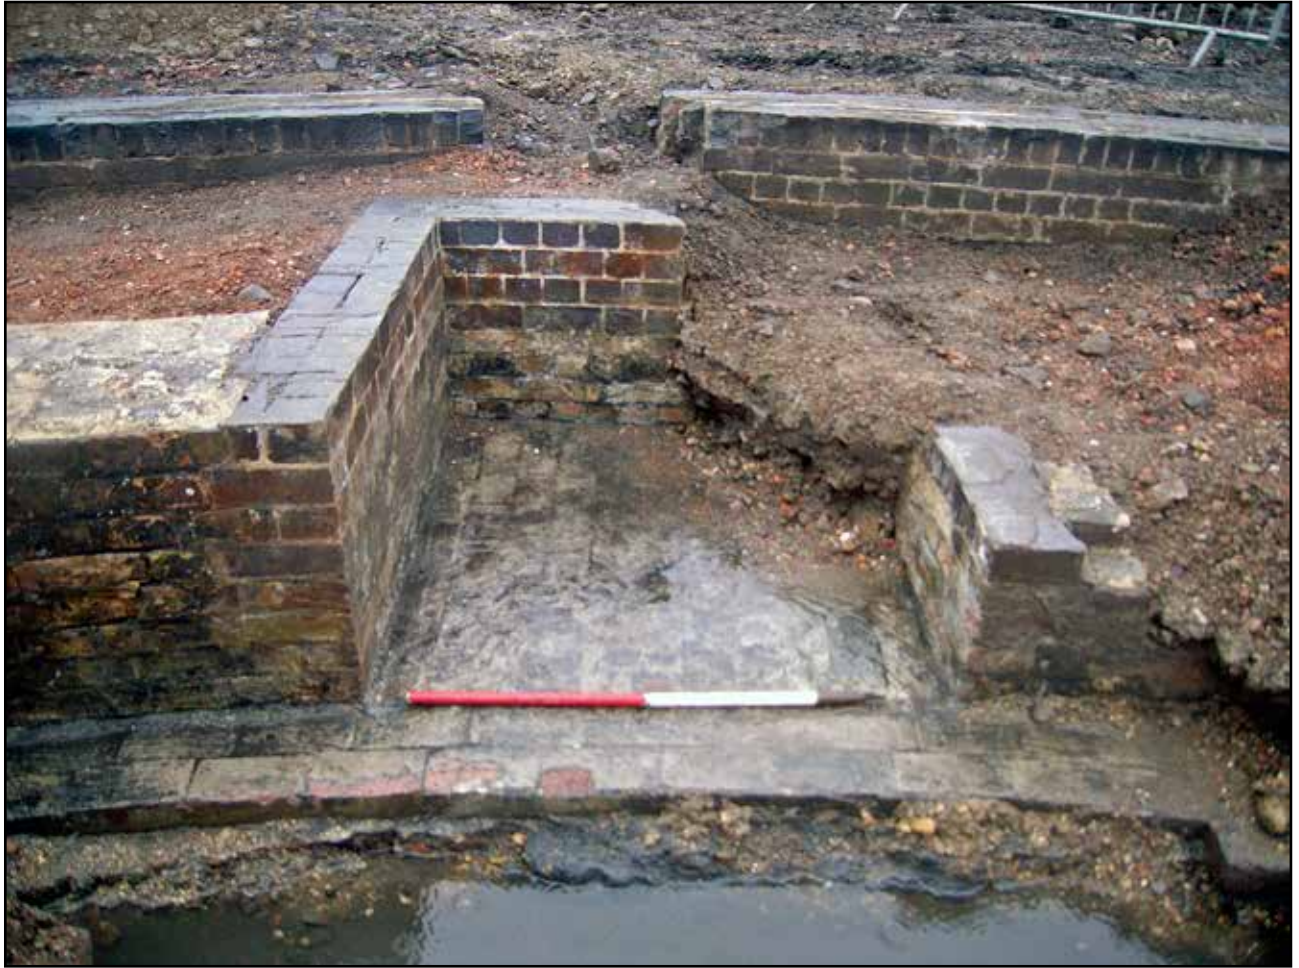
Plate 27: Motor room 8800

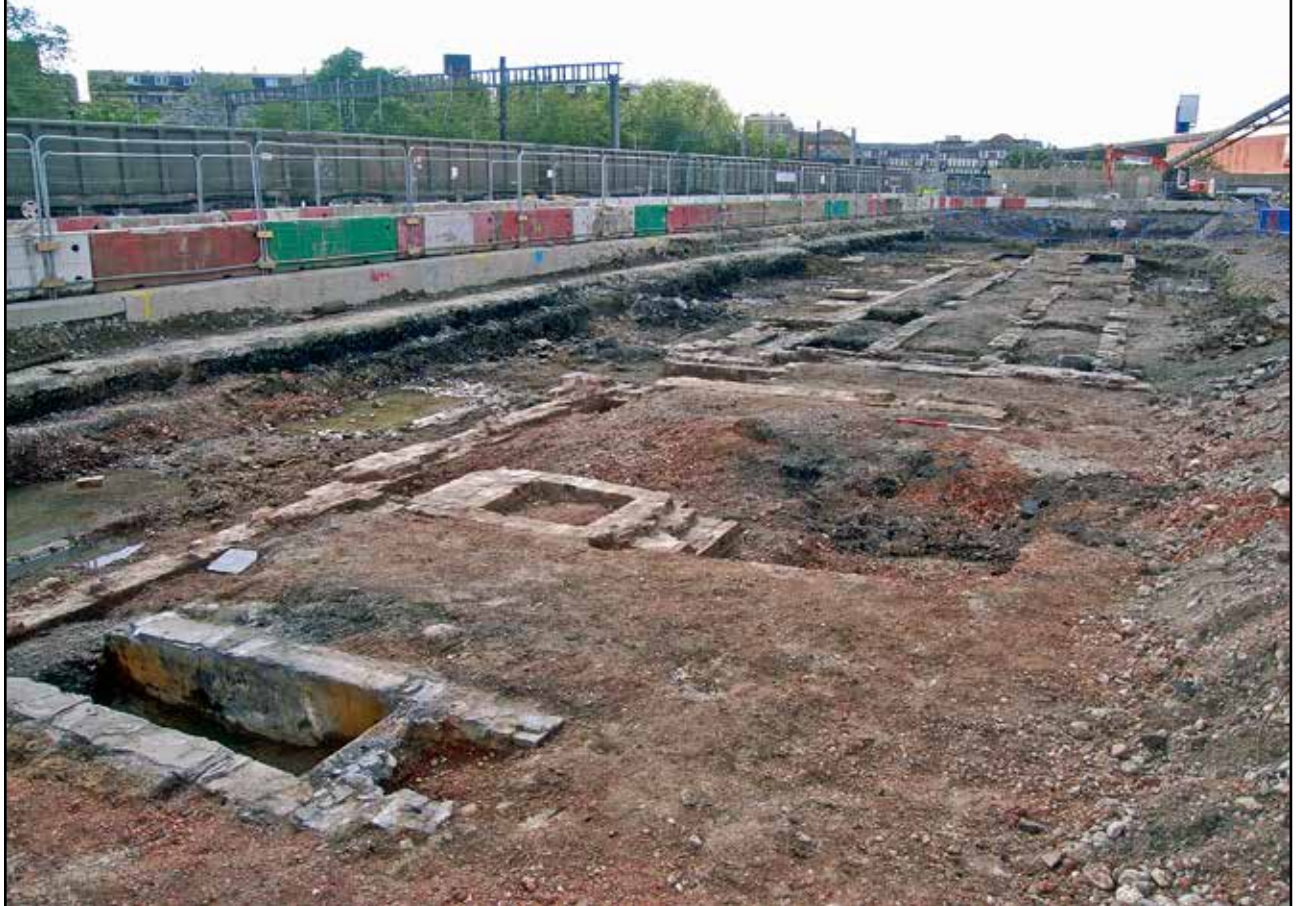
Plate 28: "Smiths shop" of 1852 Workshop showing forges base [8029] and quenching pit [8027]

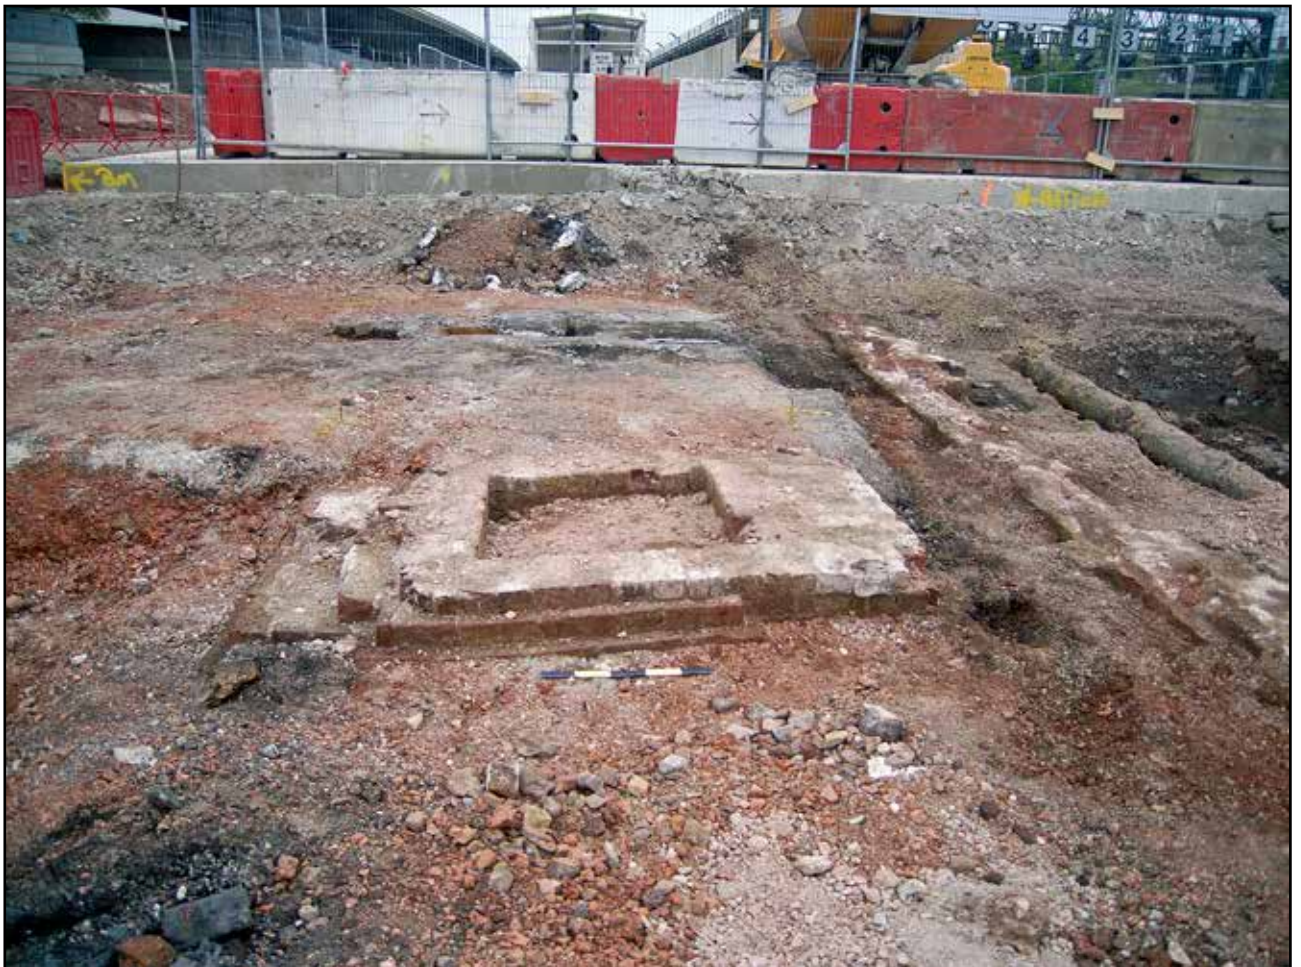
Plate 30: Forge base [8029]

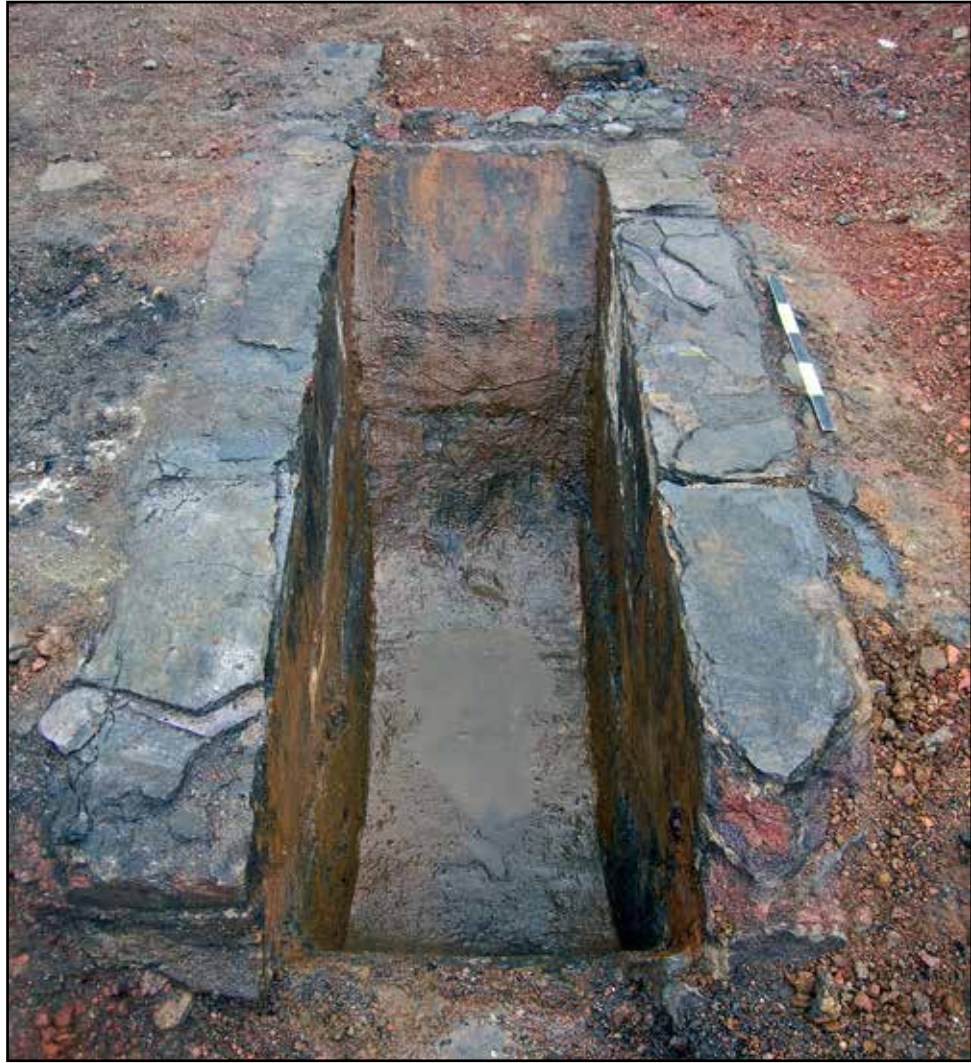
Plate 31: Quenching pit [8027]

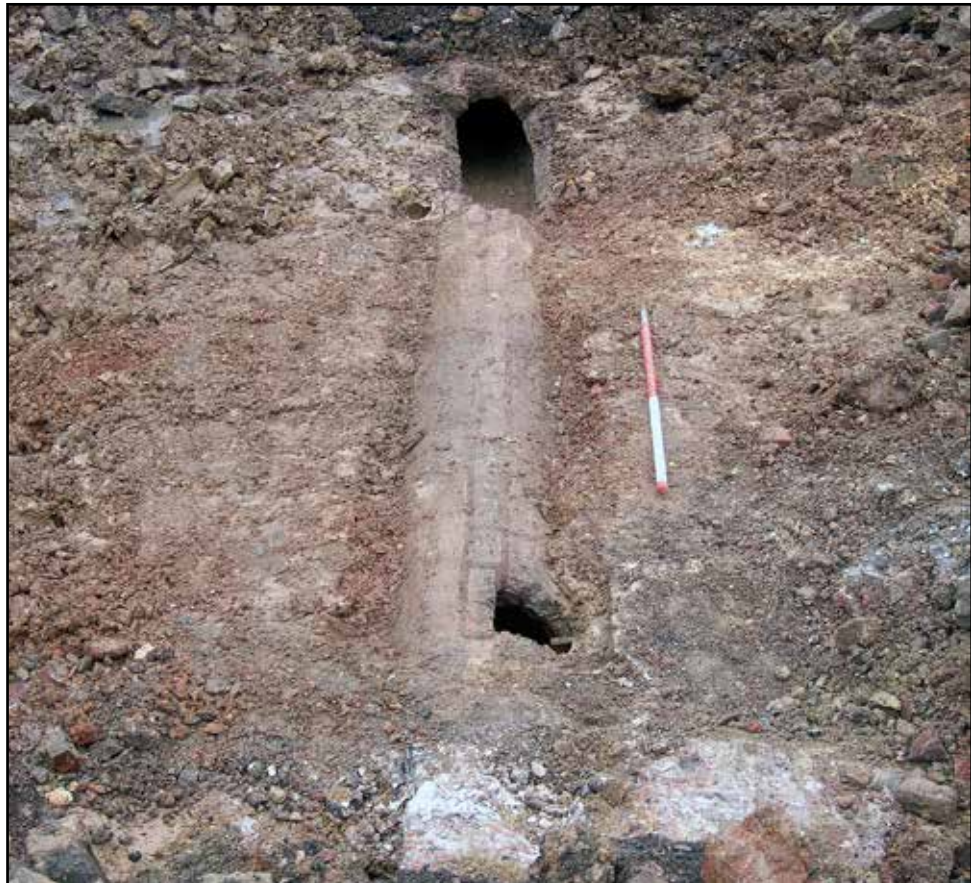
Plate 32: Conduit [8153] beneath 1852 Workshop's "Store Rooms"

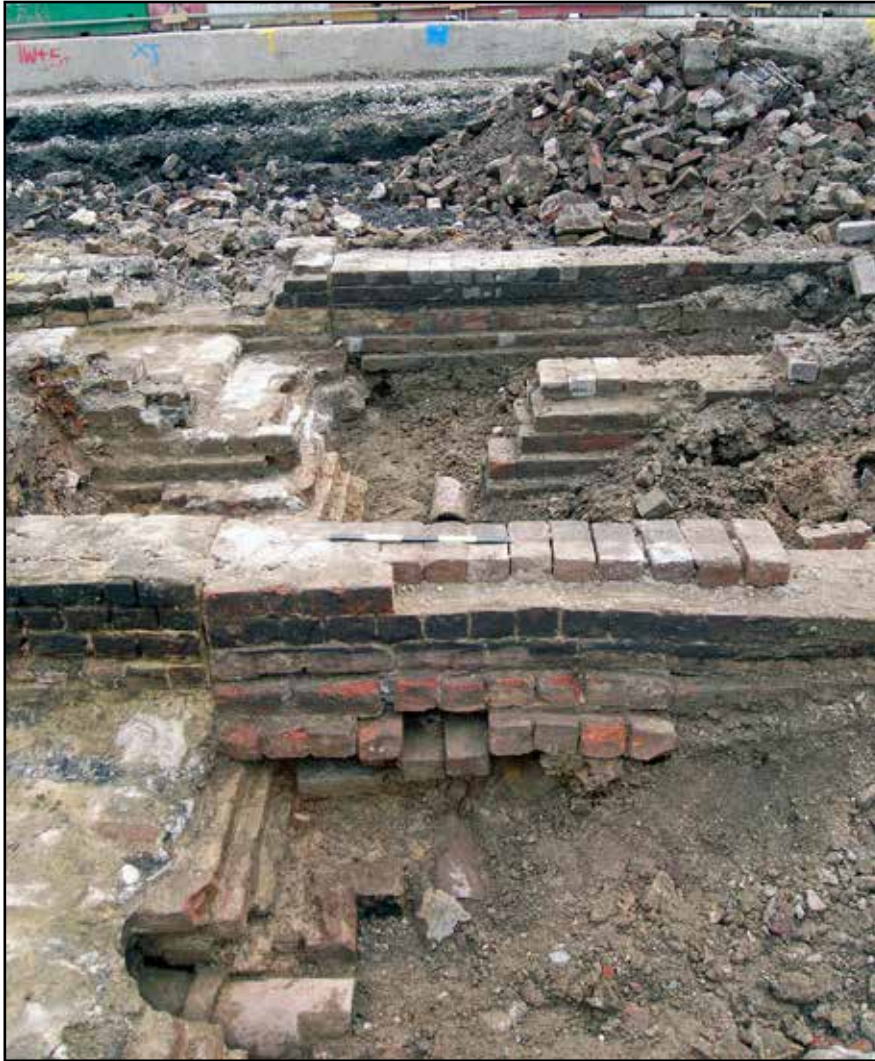
Plate 33: Former western wall of Workshop's "Stores" [8073] overlain by later inspection pits

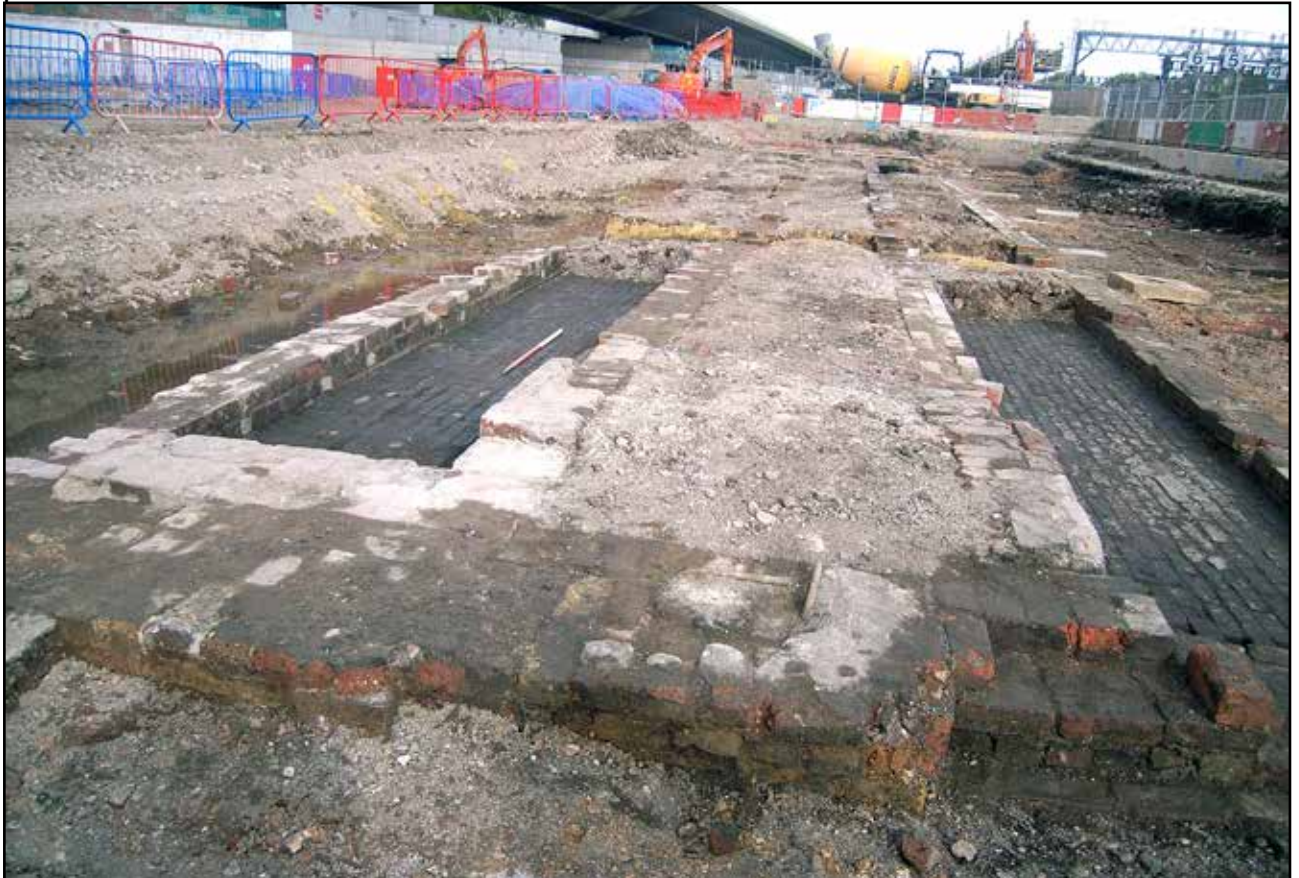
Plate 34: Inspection pits 8915 and 8916 from west

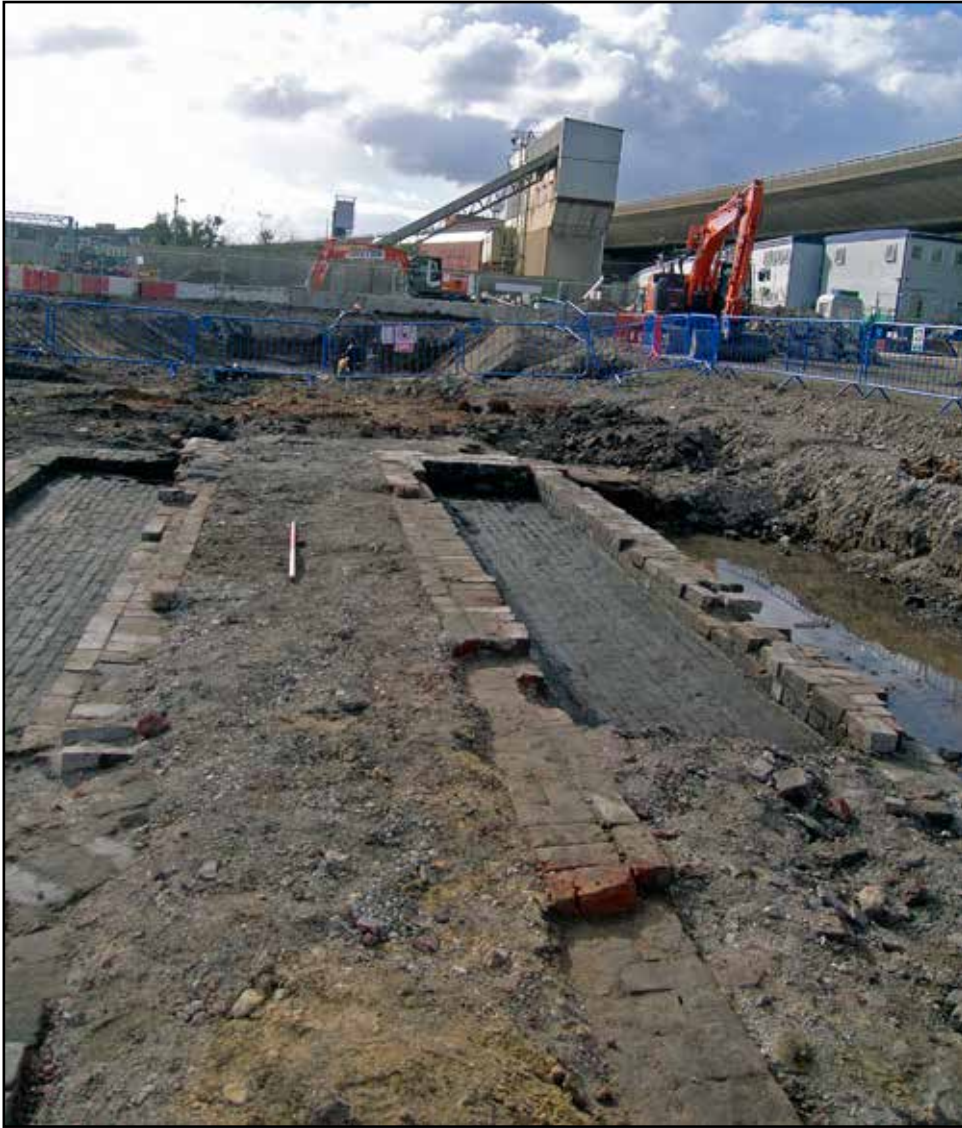
Plate 35: Inspection pits 8915 and 8916 in western extension of Workshop
