# C254 Archaeology West

## Site Code - XSI 10

Paddington New Yard, Westbourne Park, London W9

### Archaeological Fieldwork Report

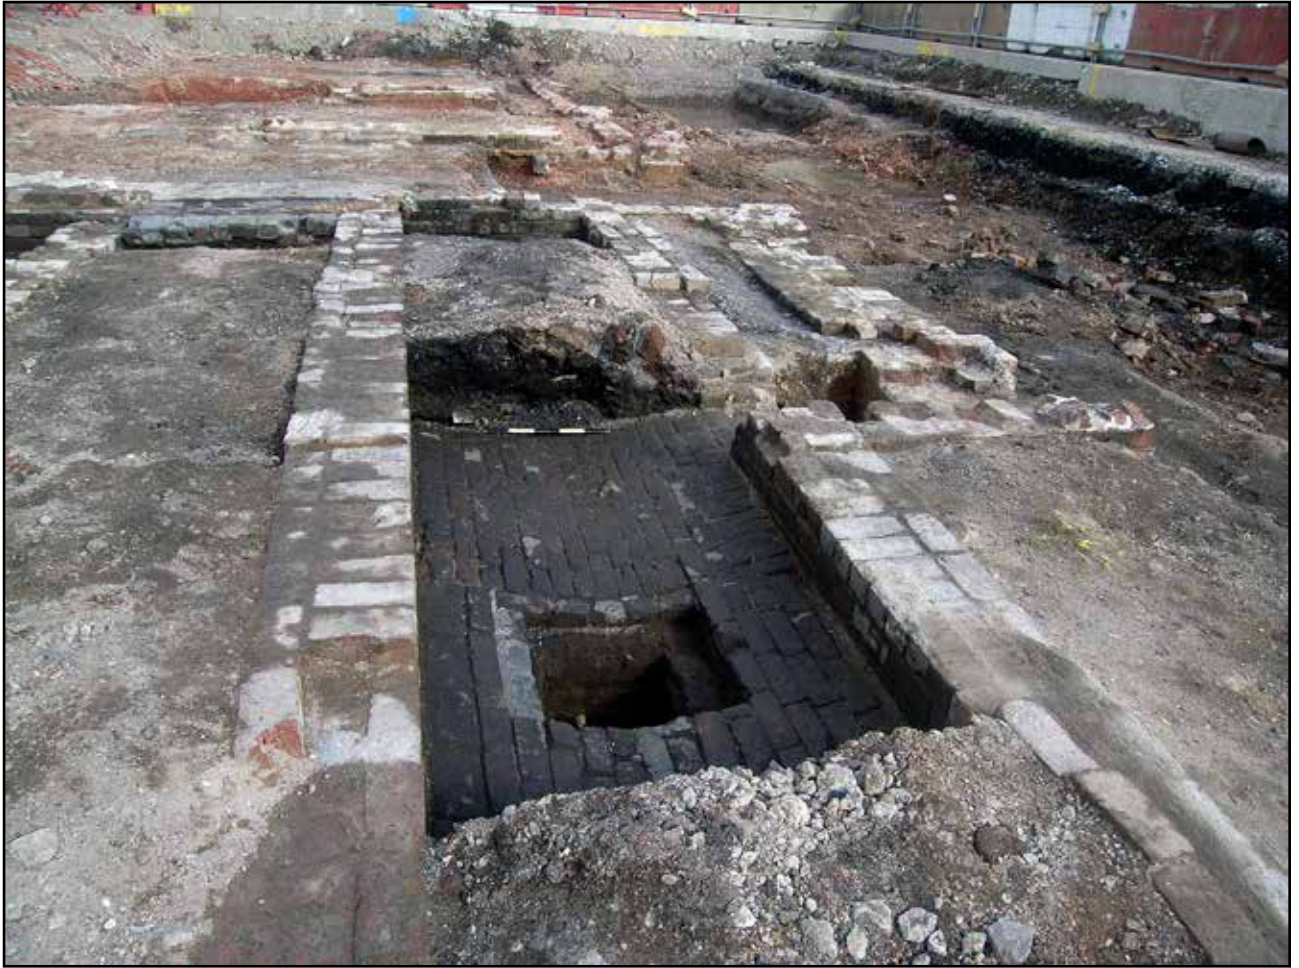
Plate 37: Catchment pit 8099 in floor of inspection pit 8916

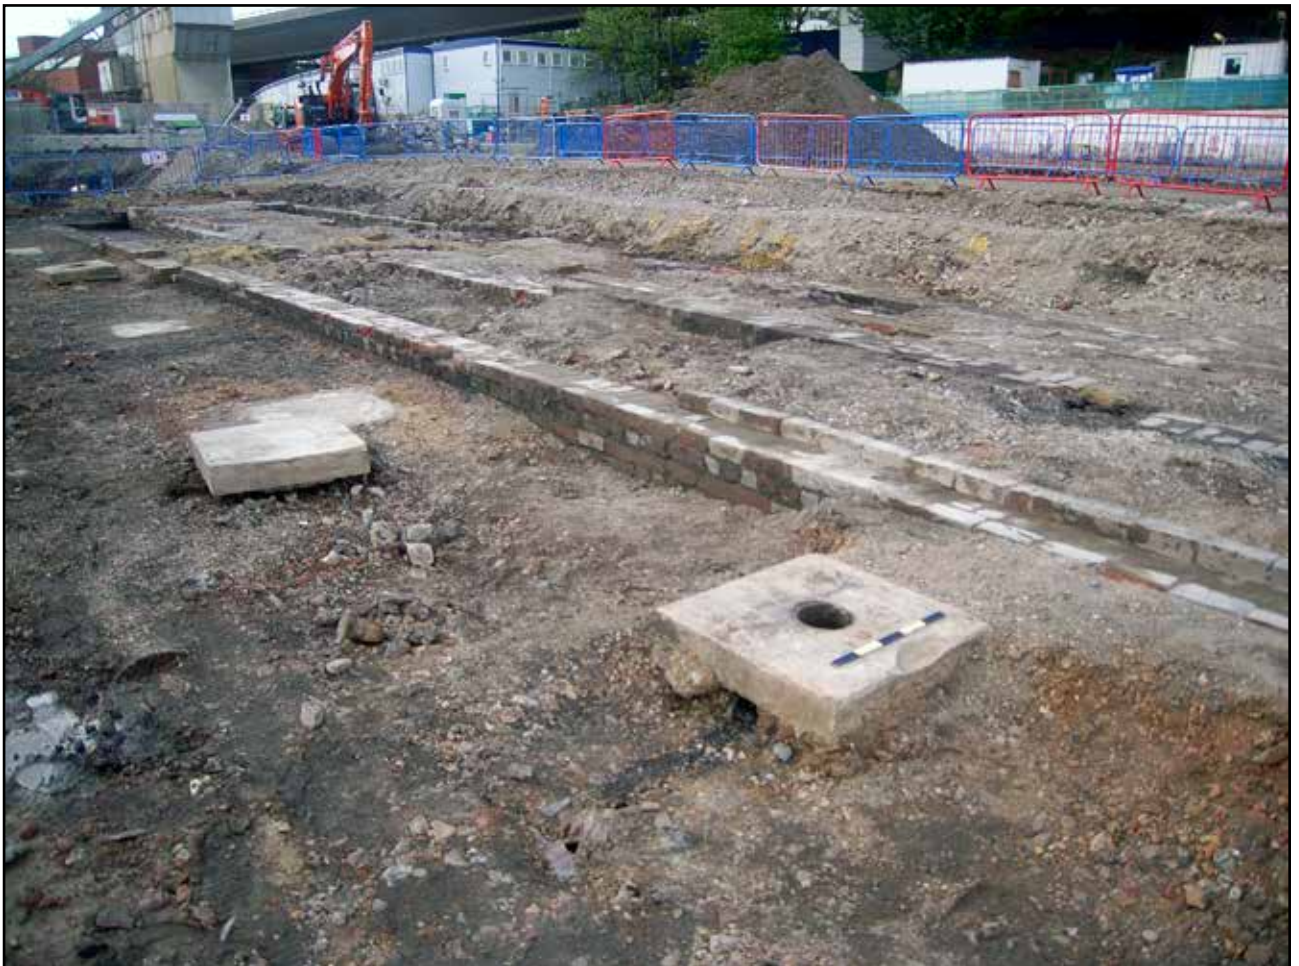
Plate 38: Stone plinths for roof supports along southern edge of western extension of Workshop

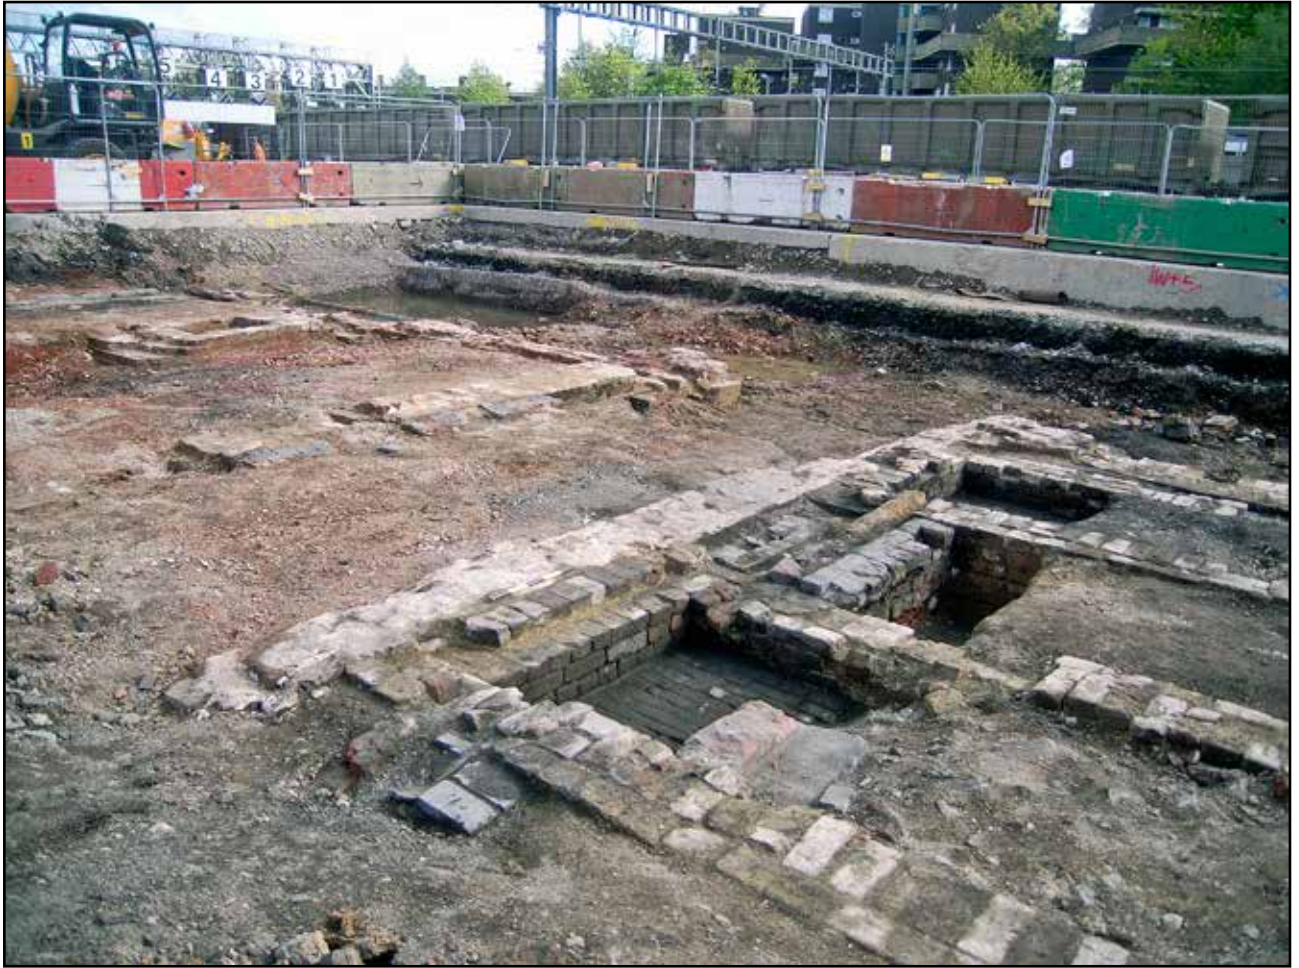
Plate 39: Inspection pits 8915 and 8916 extending into former west wing of 1852 Workshop

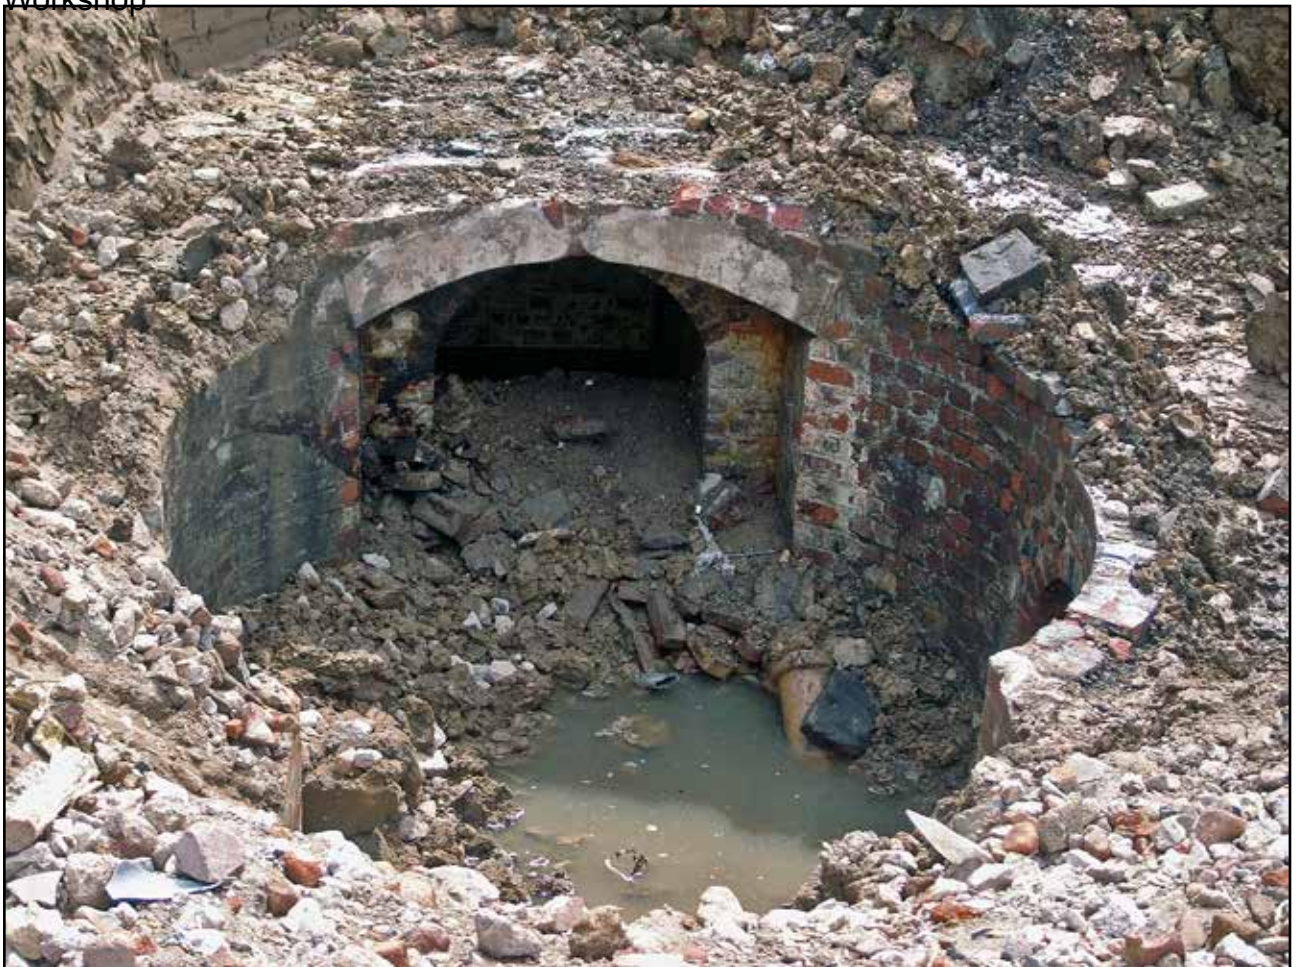
Plate 40: Upper level 8201 of shaft [8236] showing room [8211] and entrance to conduit [8213]

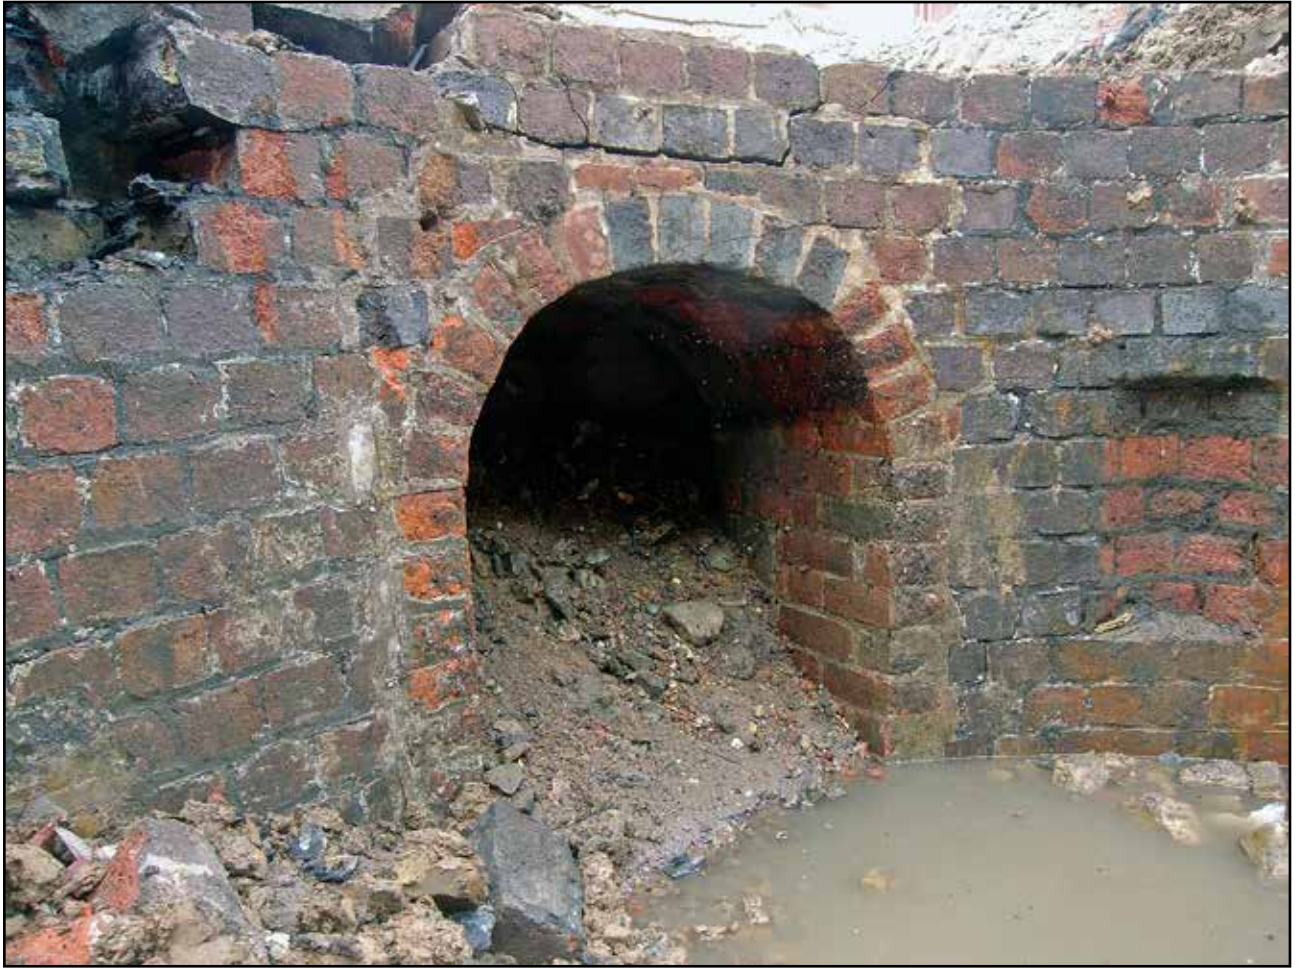
Plate 41: Base of upper level [8201] showing arched entrance to conduit [8213]

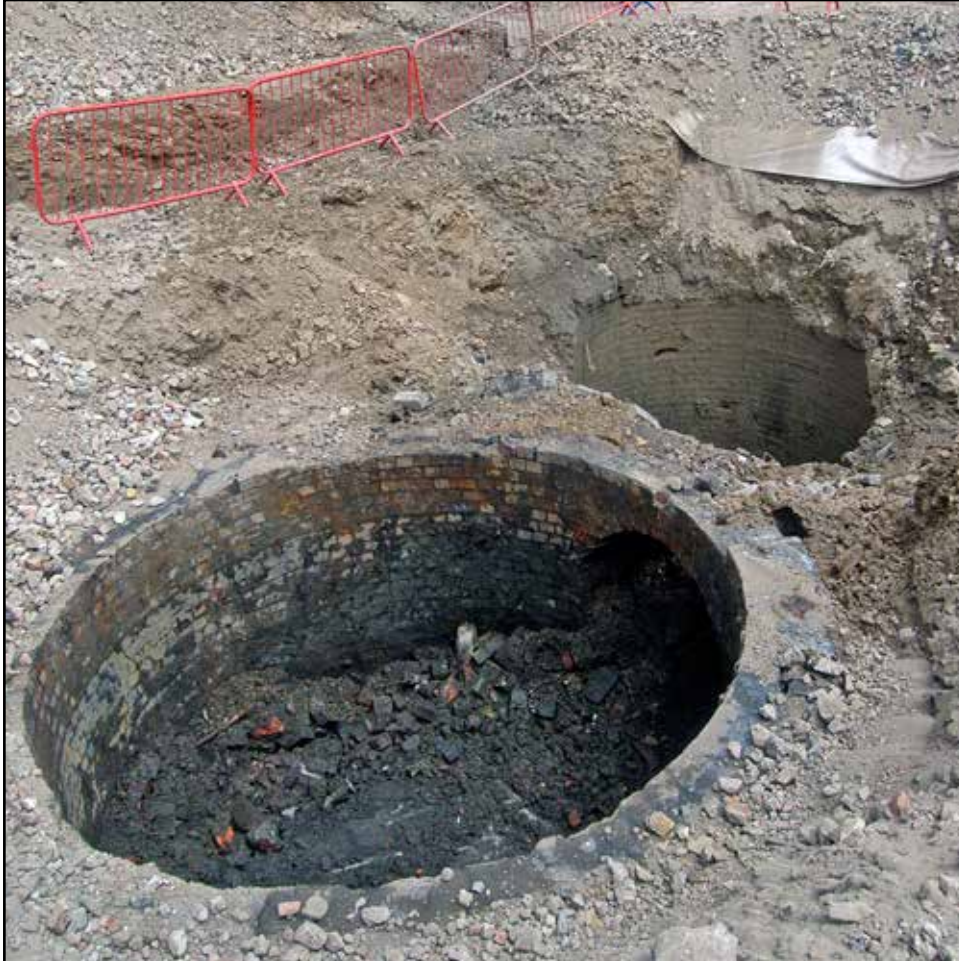
Plate 42: Shaft 8206 and lowest level [8227] of shaft [8236]

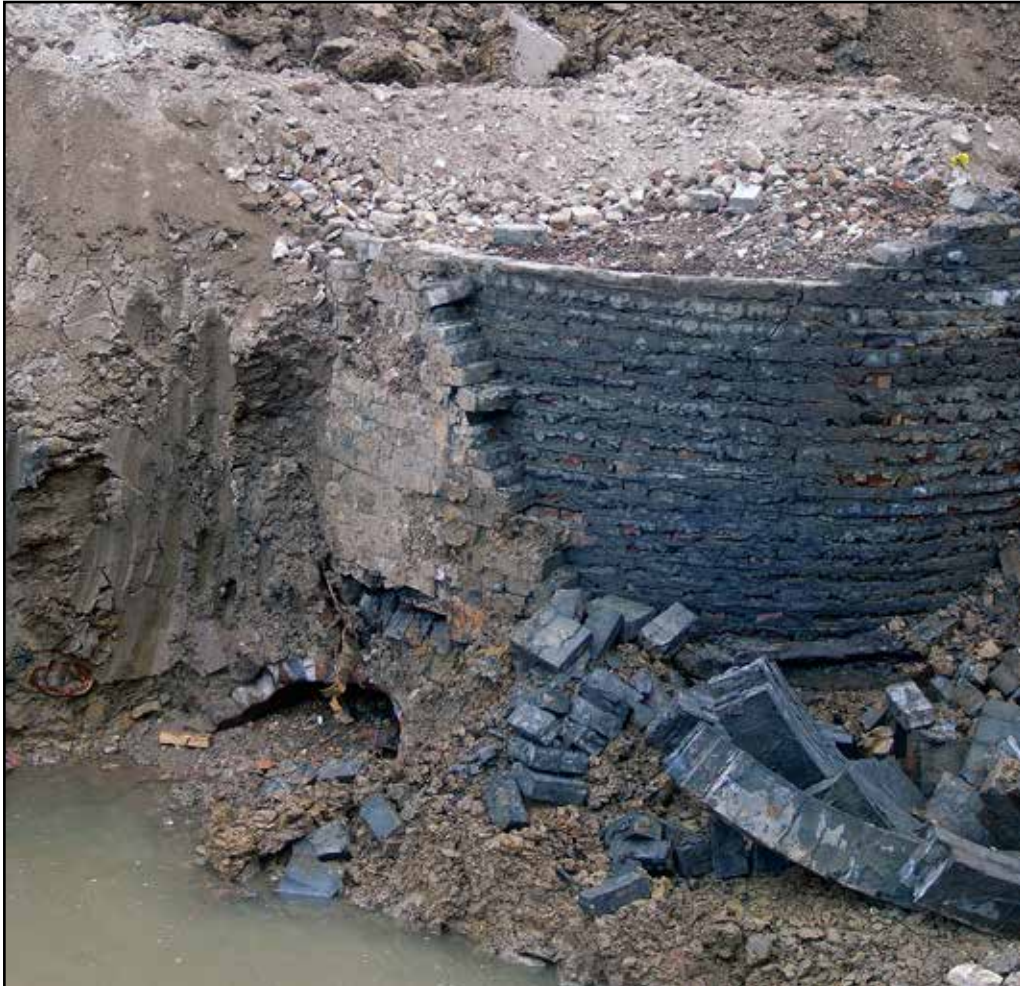
Plate 43: Shaft 8206 showing double skinned wall

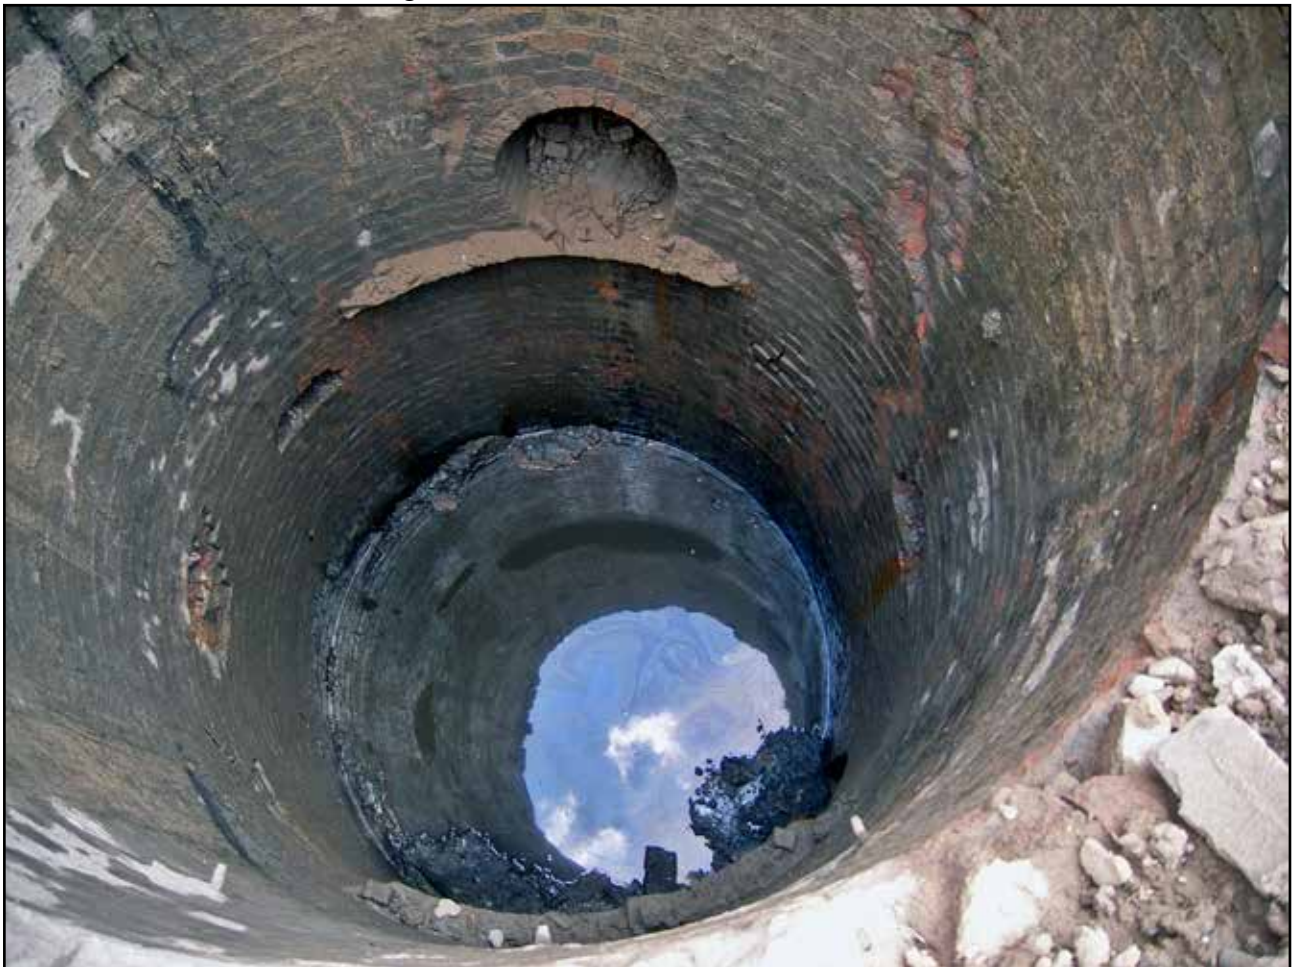
Plate 44: Base of [8227] showing entrance to [8251] and [8250]

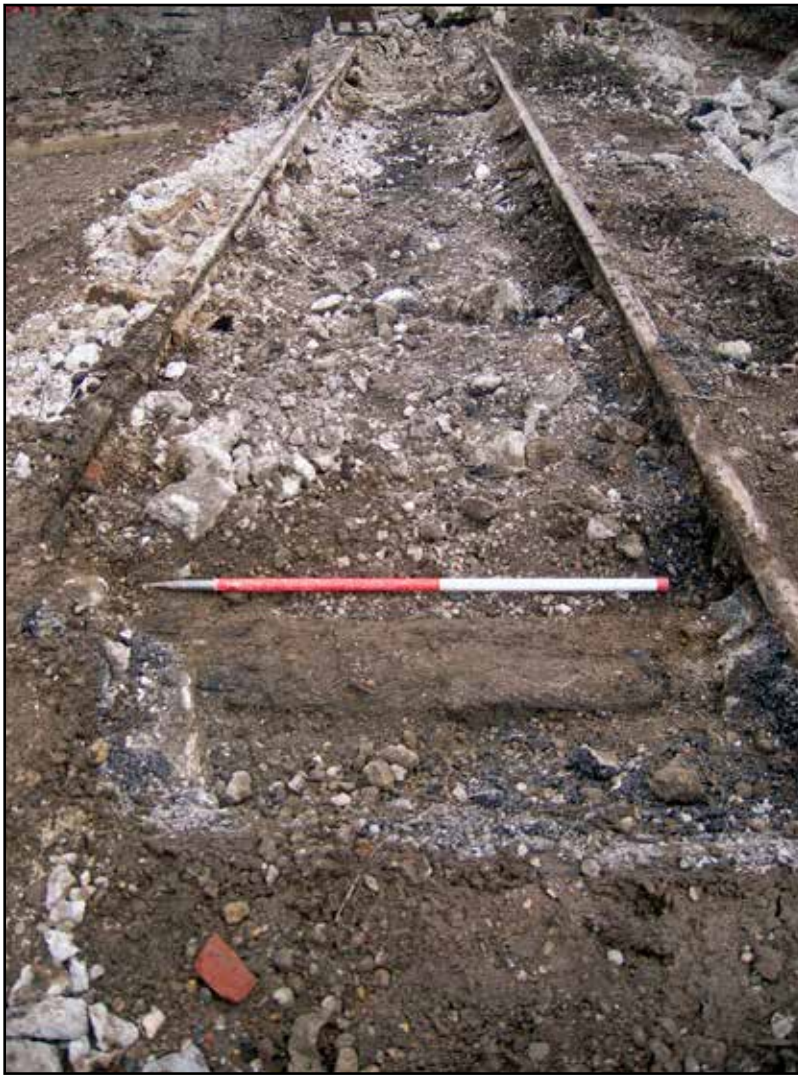
Plate 45: In situ standard gauge railway track

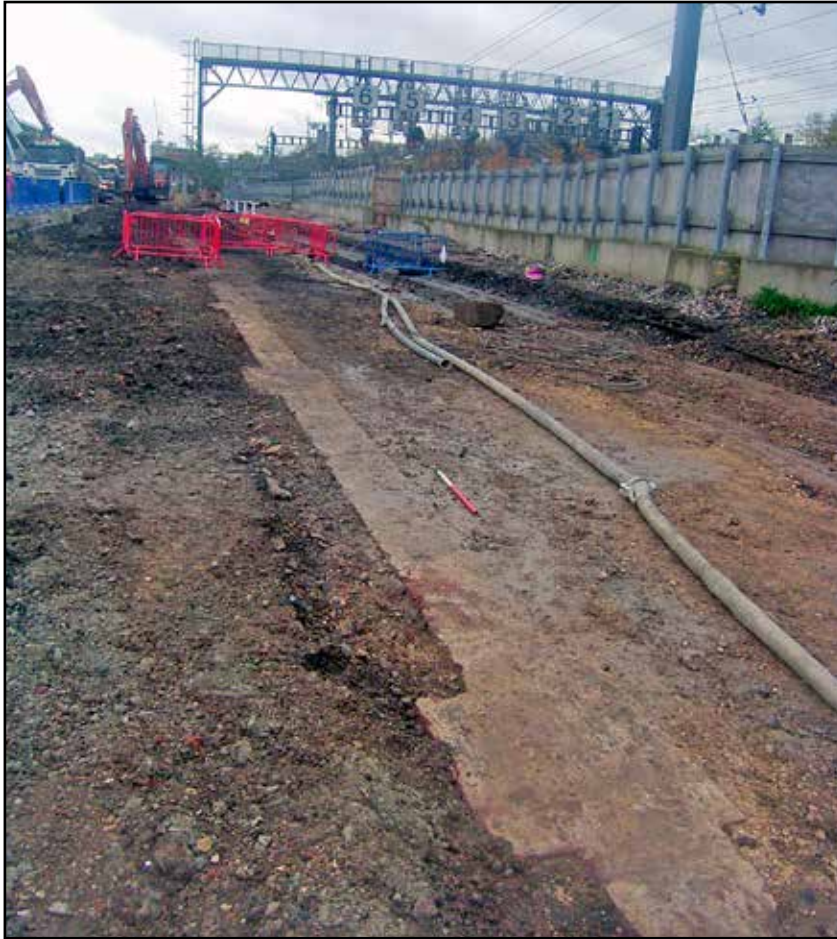
Plate 47: Northern wall of Broad gauge shed

- 6.6.2 At the northern limit of the trenches, the northern (exterior) wall (8418, 8656, 8844 and 8886) of the shed was uncovered for a total of 189.55 m (Plate: 47). This 0.42m (1ft 4 ½") thick, wall was found 0.6m below the present ground level and was built of red bricks set in a cream coloured lime mortar. A series of brick built buttress and vertical drainpipes ran along the outside of the wall.

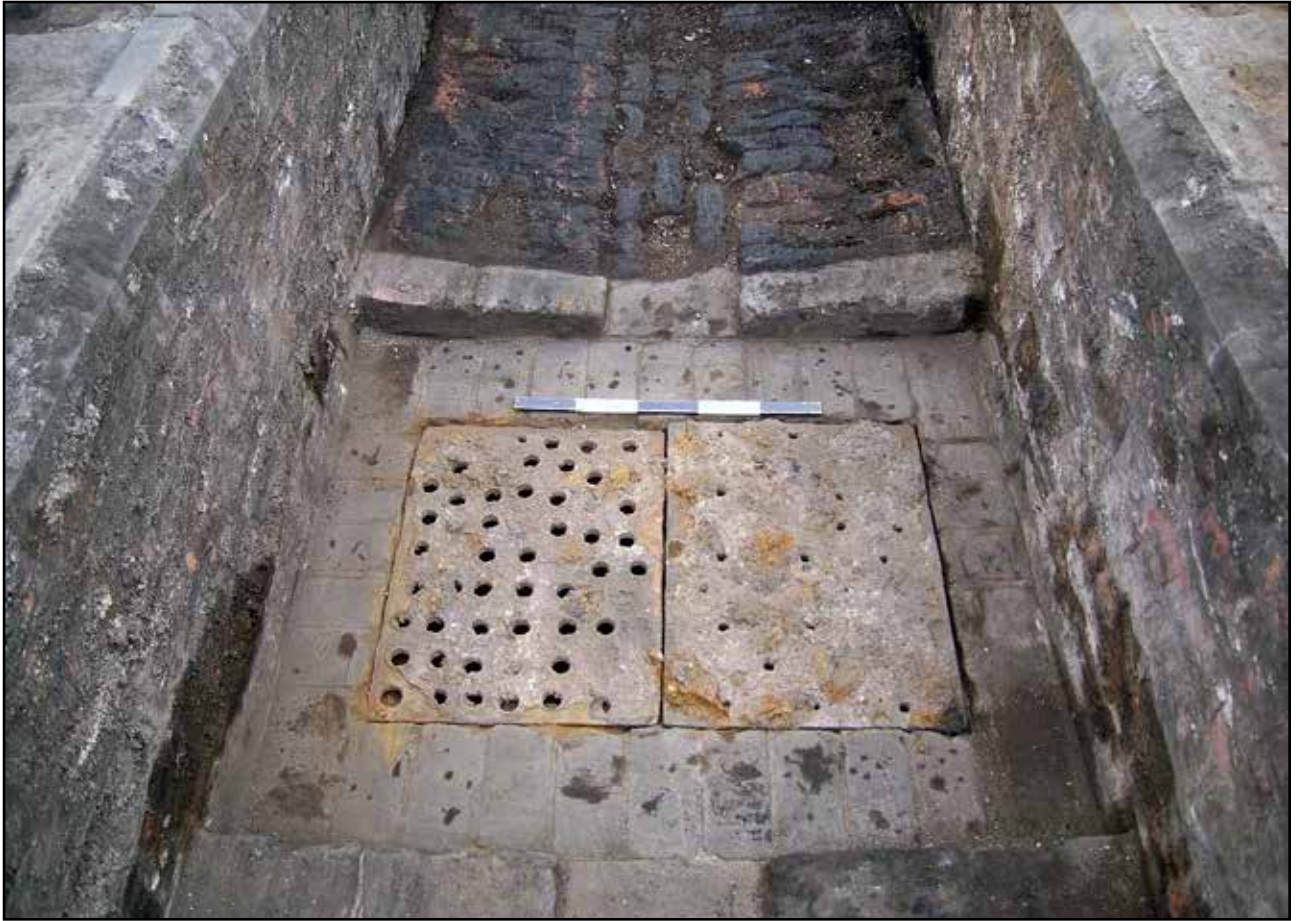
Plate 49: Catchment pit [8358] in base of inspection pit

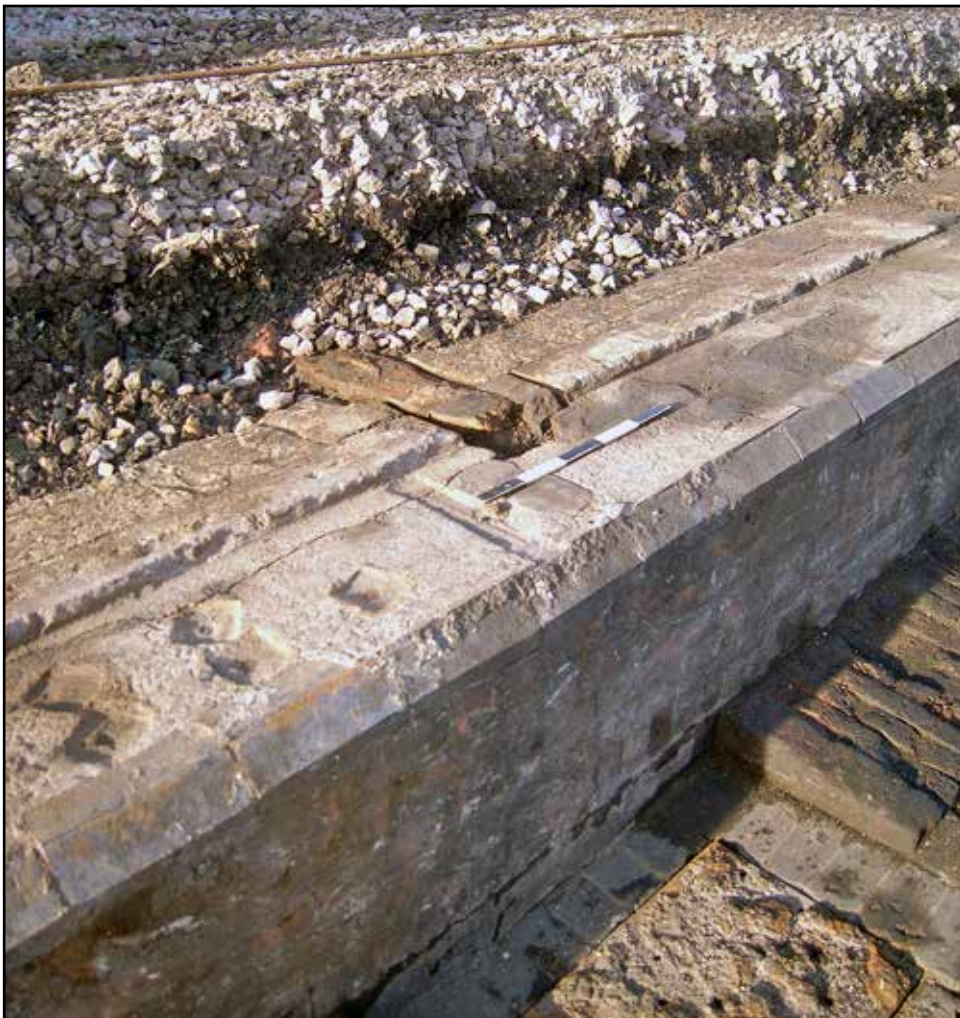
Plate 52: Detail of standard gauge pit wall showing timber sleeper and marks of screw jacks

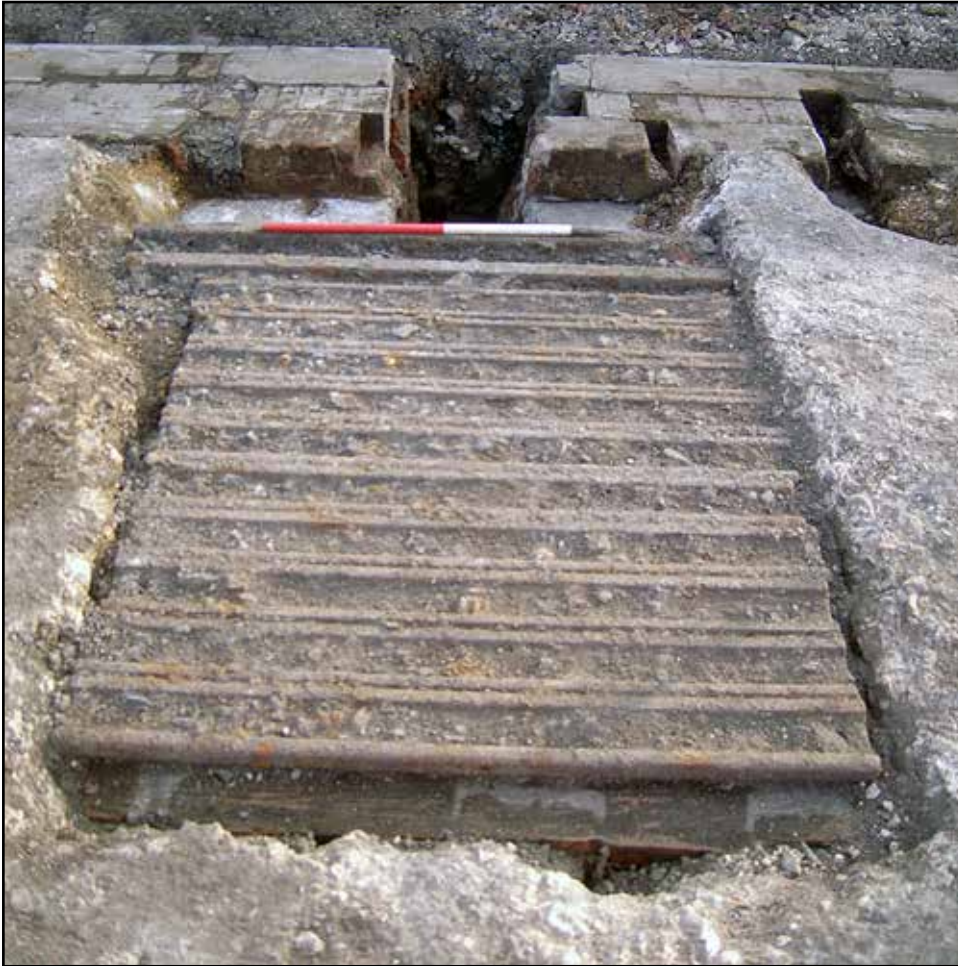
Plate 53: Access chamber [8448] into Marcon Sewer covered by sections of bridge rail [8447]

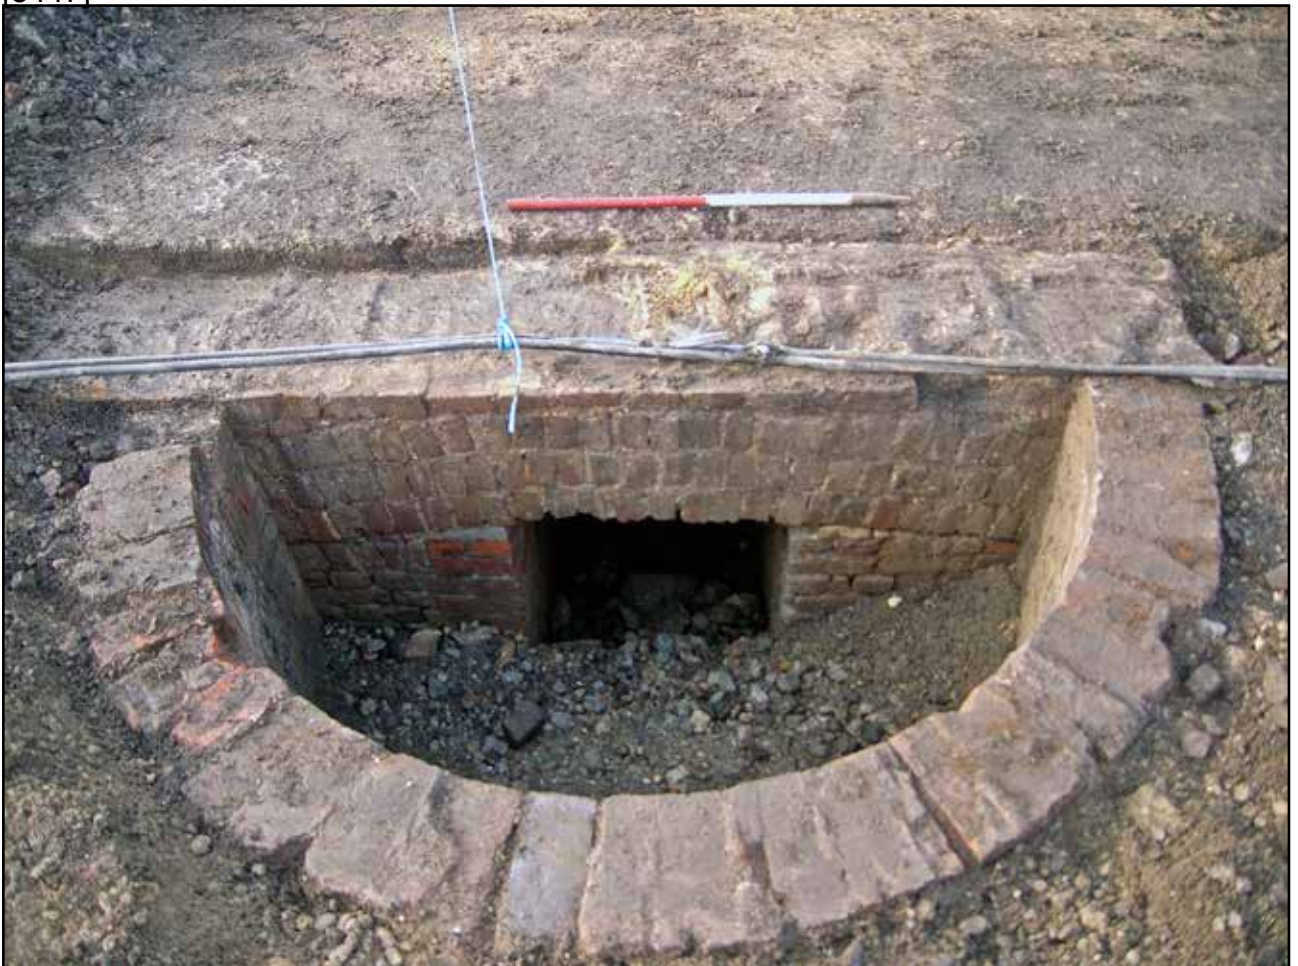
Plate 54: Semi circular inspection chamber [8854] into Marcon Sewer added to outside of northern wall of Broad gauge shed

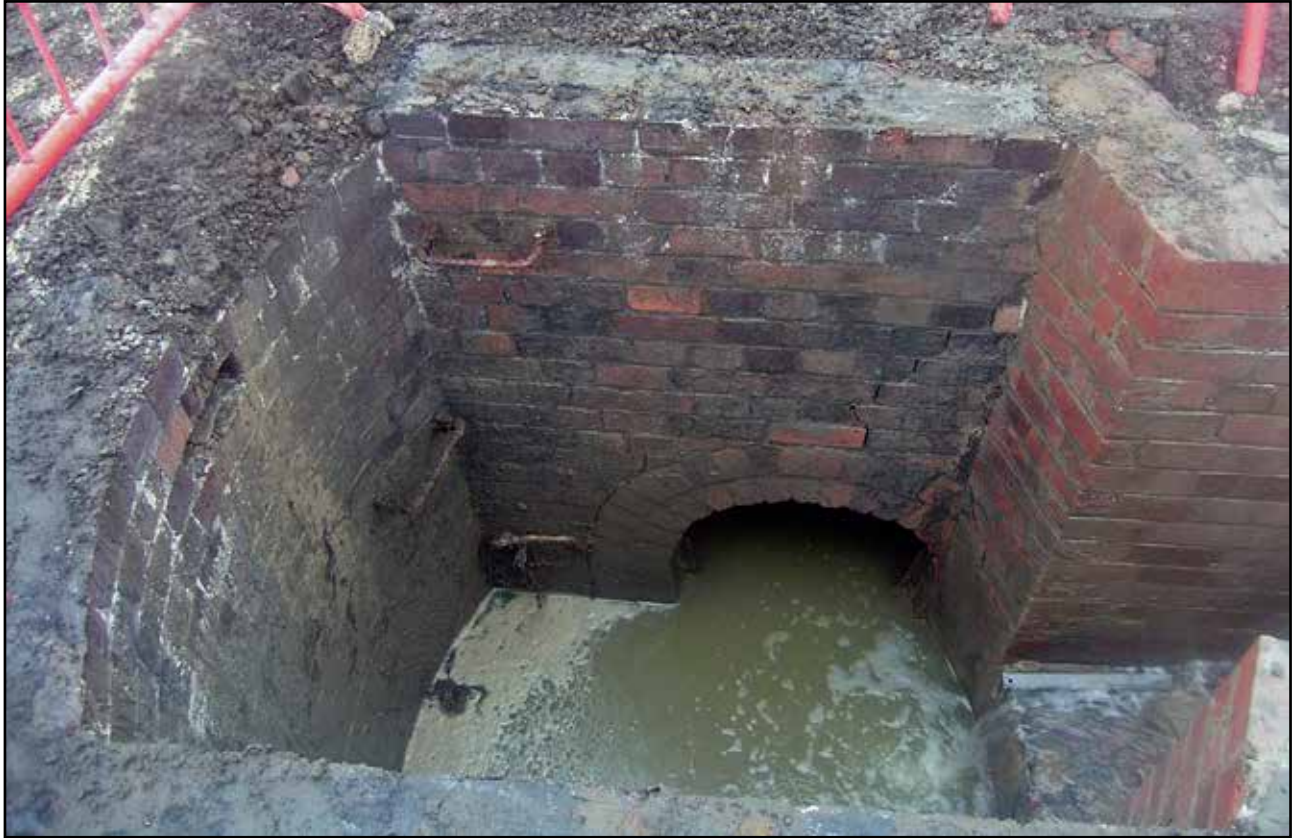
Plate 55: Access chamber [8897] and entrance to Marcon Sewer [8898]

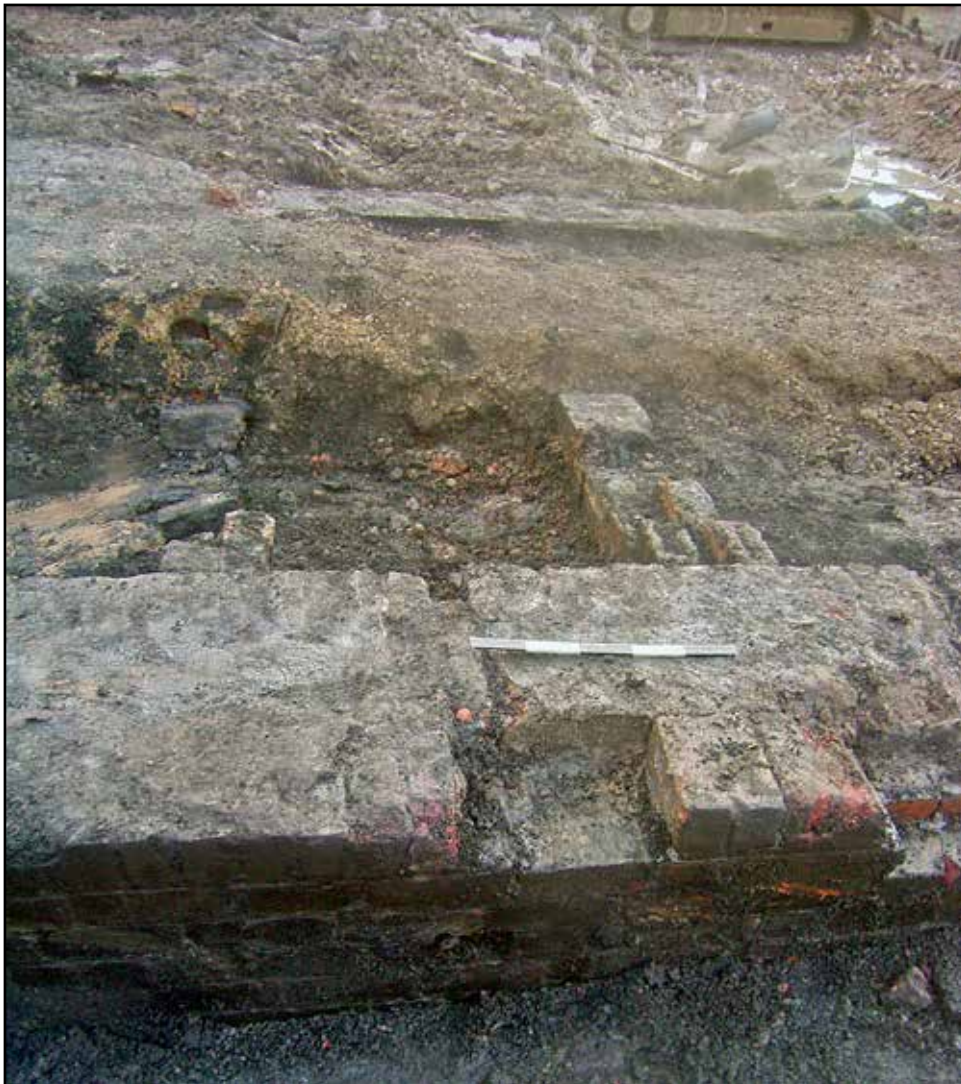
Plate 56: Southern wall of Lifting shed building [8899] and central pit

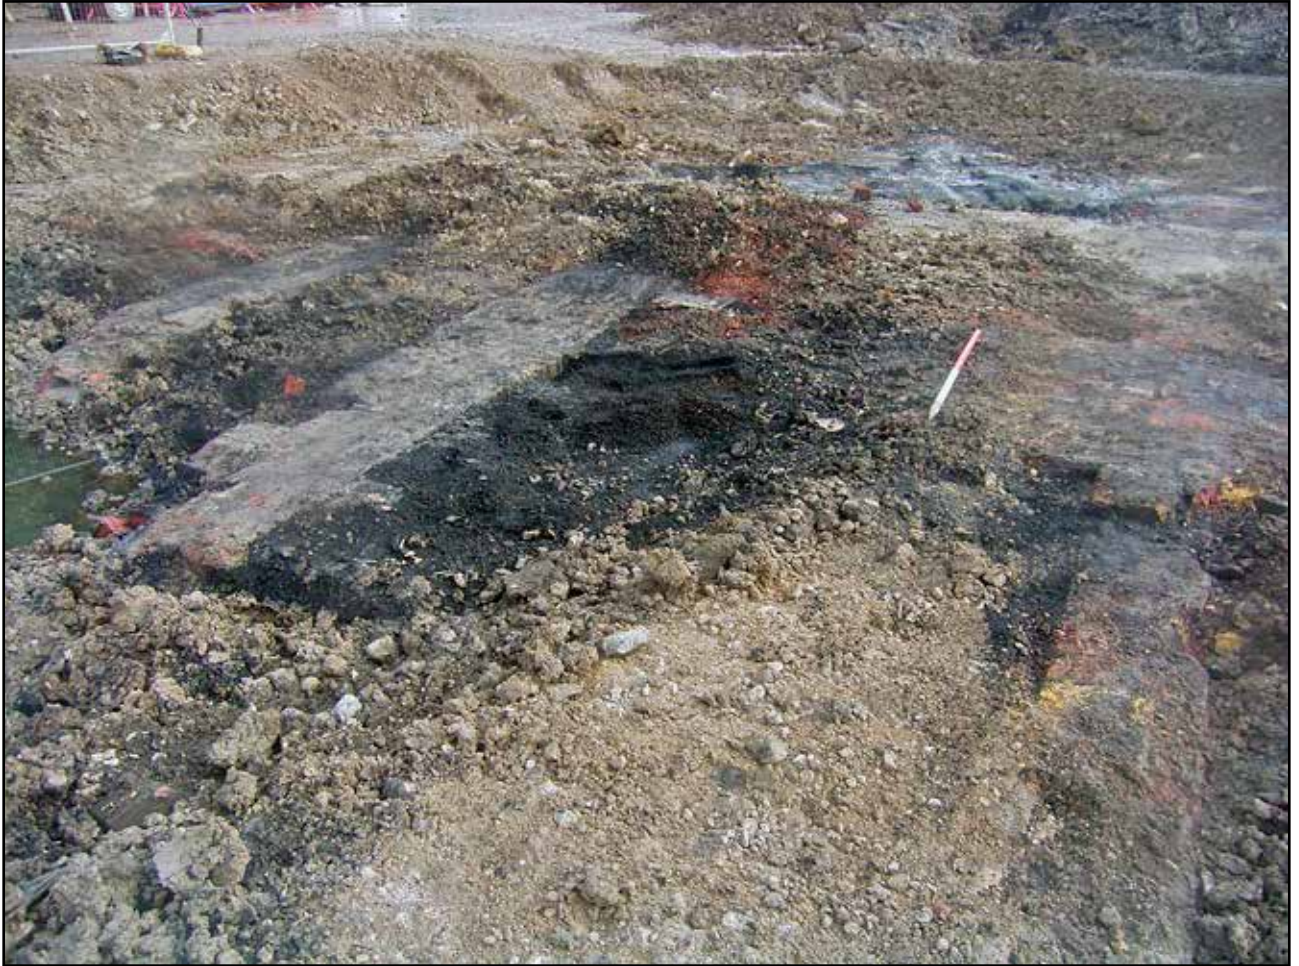
Plate 57: Central pit of Lifting shed

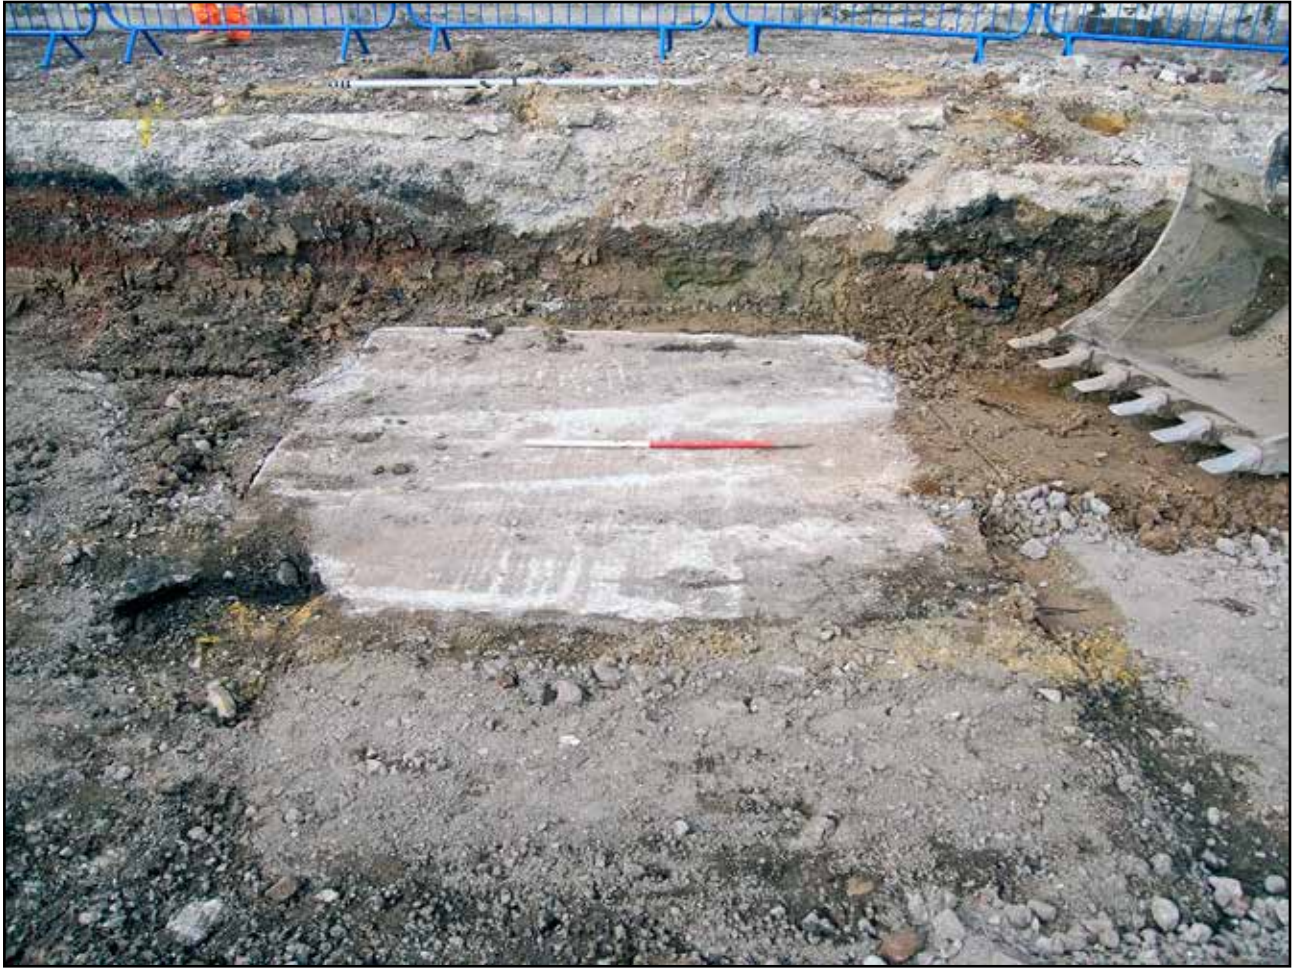
Plate 59: Concrete foundations of Alfred Road Warehouse

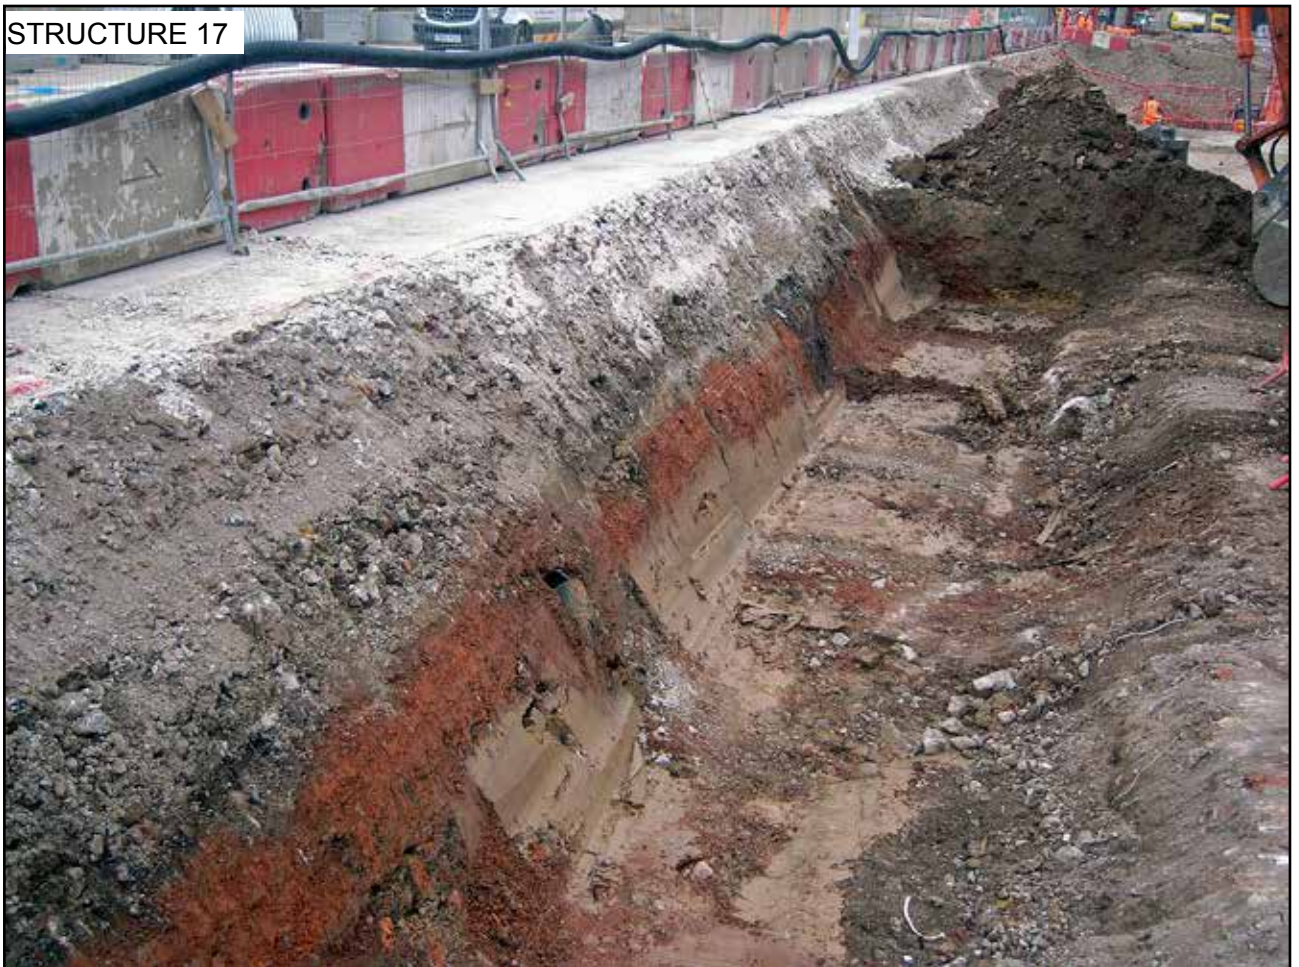
Plate 60: London Clay beneath makeup layer of crushed brick
