◀ **BEST PRACTICE** **INFORMATION** ▶

Retaining Rings

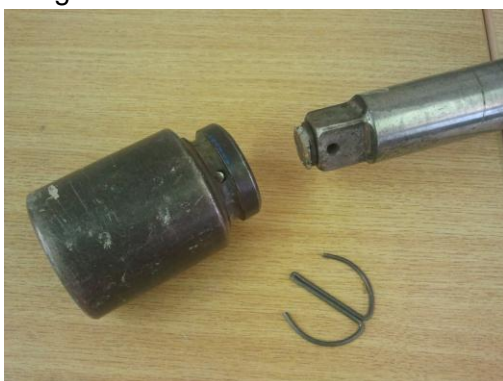
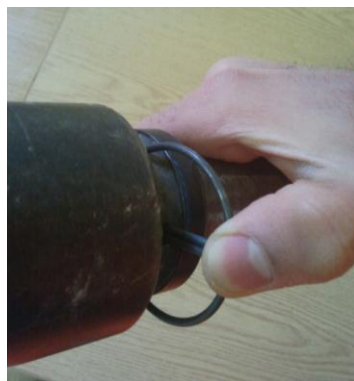
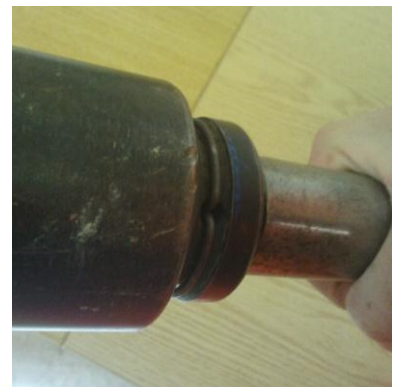
The subcontractor then provided IRIMO steel ring pins for their operatives. These attach around the base of the socket (see photographs) and prevent it from flinging off the driver attachment.

This best practice submission aims to make all aware of the method Laing O'Rourke Strabag mandated to ensure prevention of a re-occurrence where sockets cannot slip off when using mechanical aids. LORS investigated and encouraged their subcontractor to consider the use of a retaining ring pin system.

This best practice ensures the safety of anyone in the immediate area around or below the tightening of bolts on site, especially when working directly underneath the bolts or working at height.
