Western Tunnels & Caverns Project

Final Monitoring Report

TBM DRIVES ~ from Bond Street Station to Tottenham Court Road Station

CRL Document No. **C300-BFK-C4-RGN-CRT00_ST005-51016**

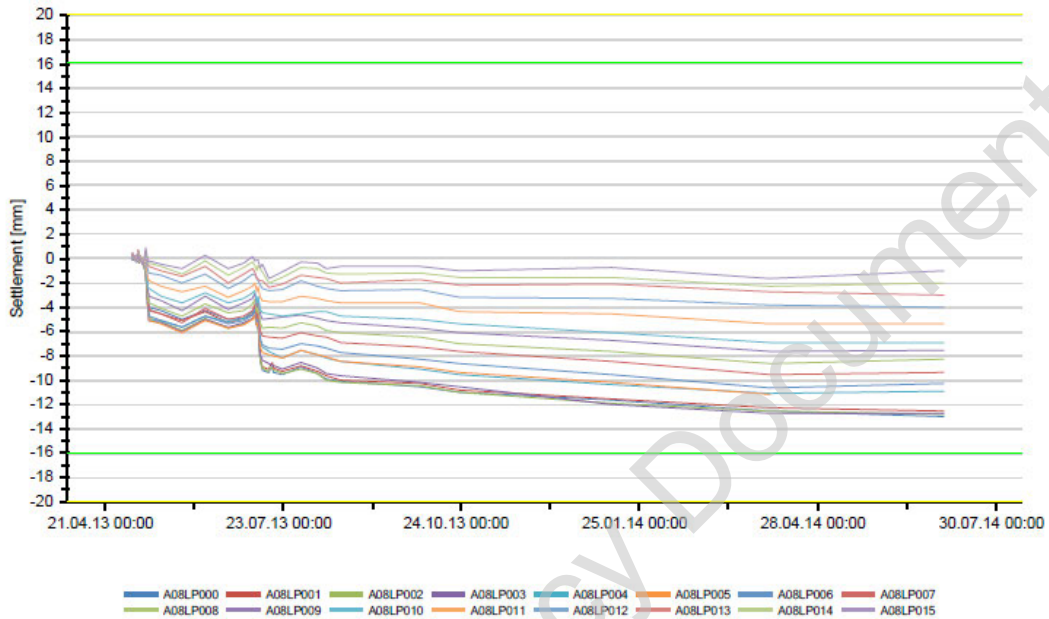
Figure 22a,b: data time-plots - comparison against settlement trigger

The PLP and BRE on and adjacent to 30 – 38 Great Marlborough Street settled up to approx. 13mm due to the C300 running tunnels excavation. The effect of the WB and EB TBMs is visible from the settlement time-plots. No settlement trigger has been breached.

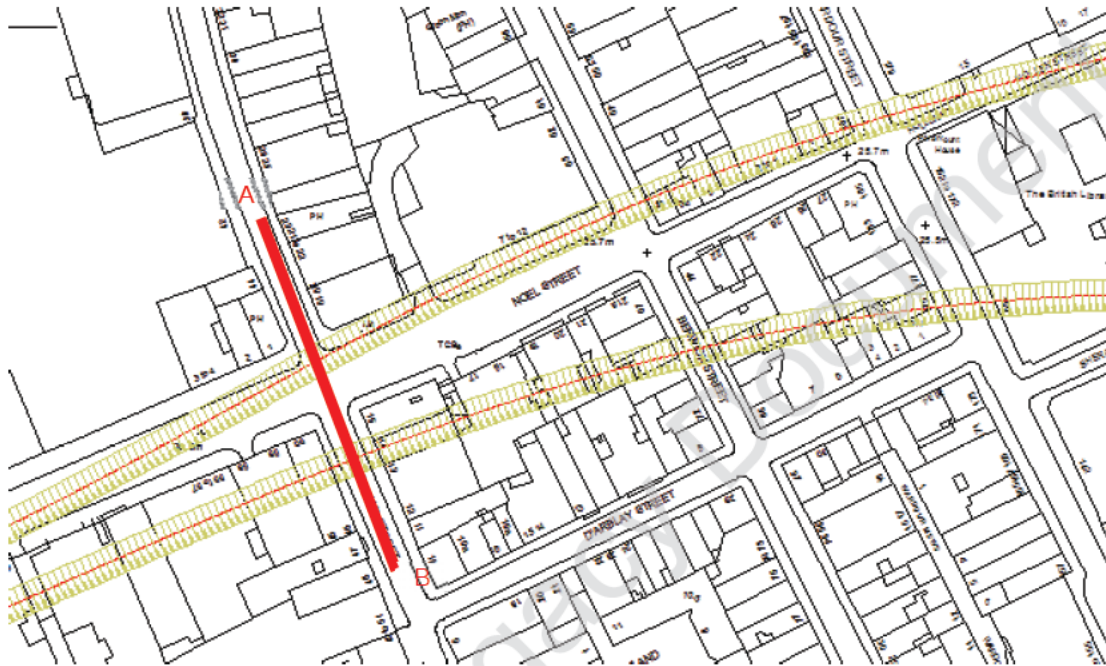
Figure 24: Location

2.9. Poland Street PLPs

The PLPs in Poland Street settled up to approx. 12mm due to the C300 running tunnels excavation. The effect of the WB and EB TBMs is visible from the settlement time-plots. Four points breached settlement green trigger.

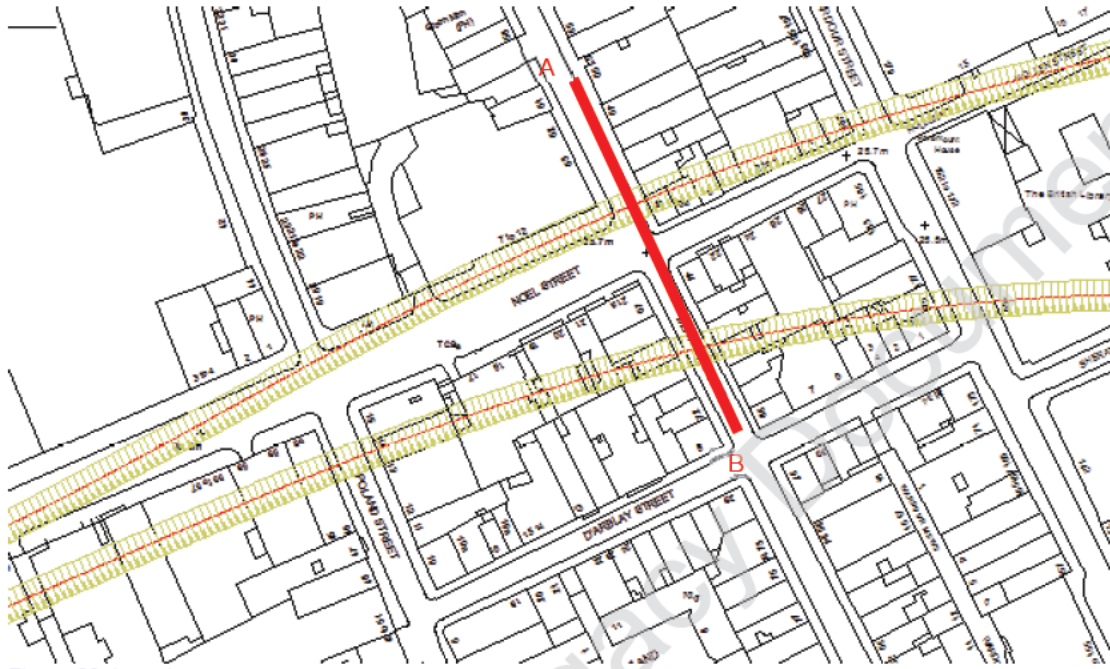
Figure 28: Location

2.10. Berwick Street PLPs

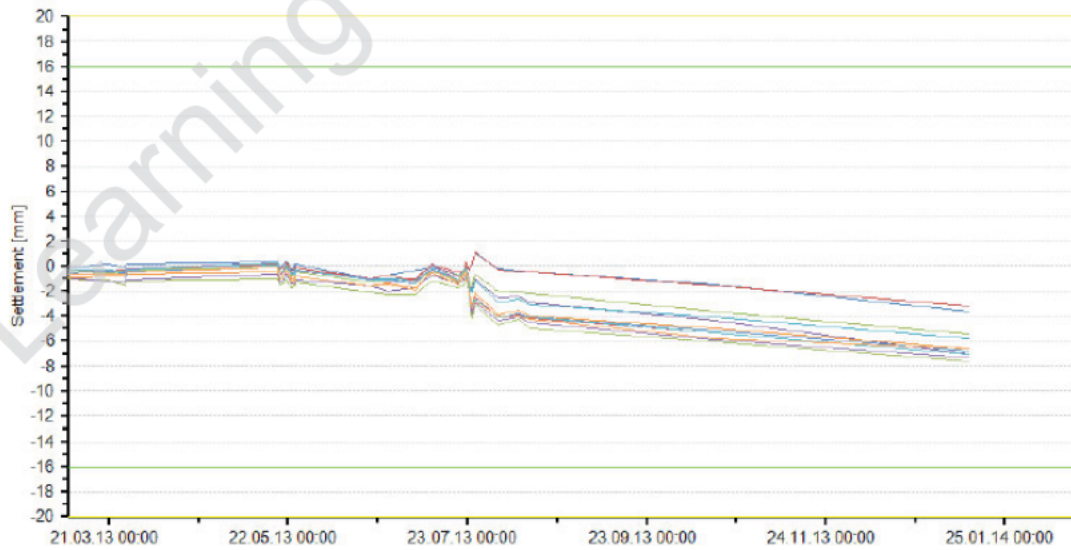
Berwick Street North PLPs

— A08LP306 — A08LP307 — A08LP308 — A08LP309 — A08LP310 — A08LP311
— A08LP312 — A08LP313 — A08LP314 — A08LP315 — A08LP316 — A08LP317

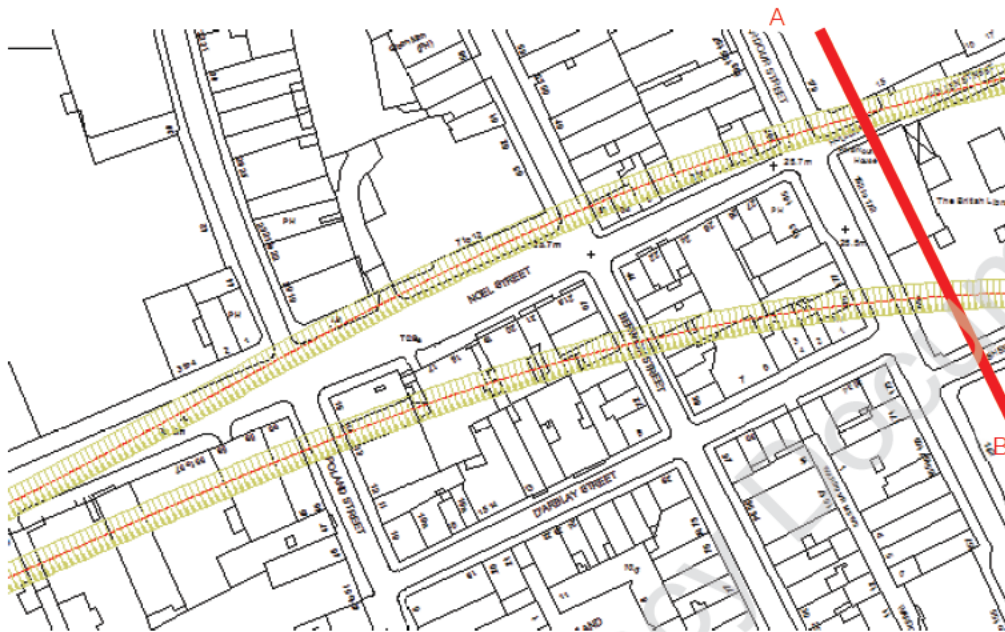
Figure 32: Location

2.11. Wardour Street PLPs
