C300/410
Western Tunnels & Caverns Project

Grouting Summary & I & M Final Report - BOS GS2

CRL Document No. **C300-BFK-C4-RGN-CRT00_ST005-51179**

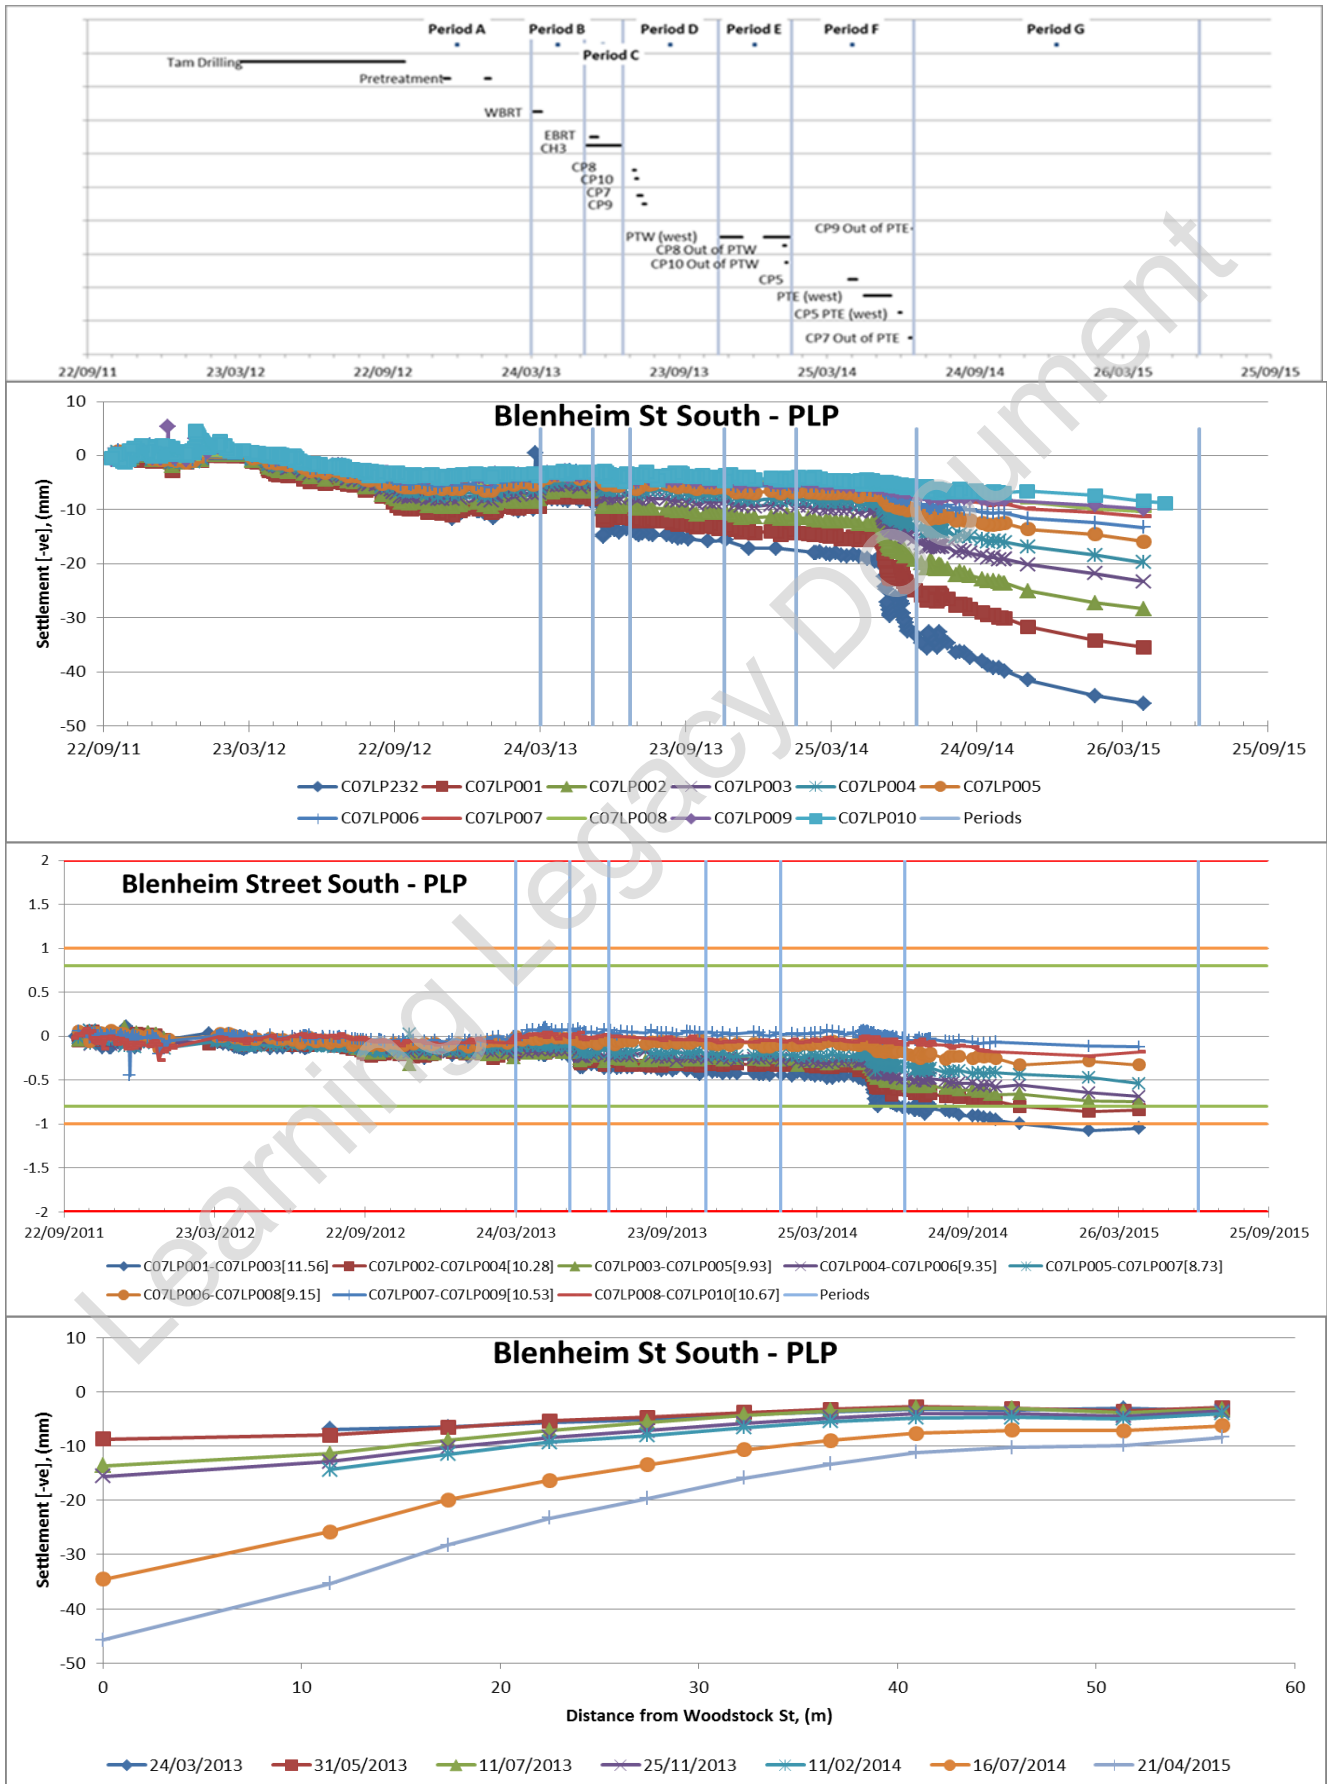
5.8. Blenheim Street - South

- The Blenheim Street south façade extends from over the PTE / CP5 junction with increasing offset towards New Bond Street and is outside the GS2 arrays from distance 40m onwards.
