Western Tunnels & Caverns Project

Grouting Summary & I&M Close-Out - TCR Grout Shaft 1

CRL Document No. **C300-BFK-C4-RGN-CRT00_ST005-51225**

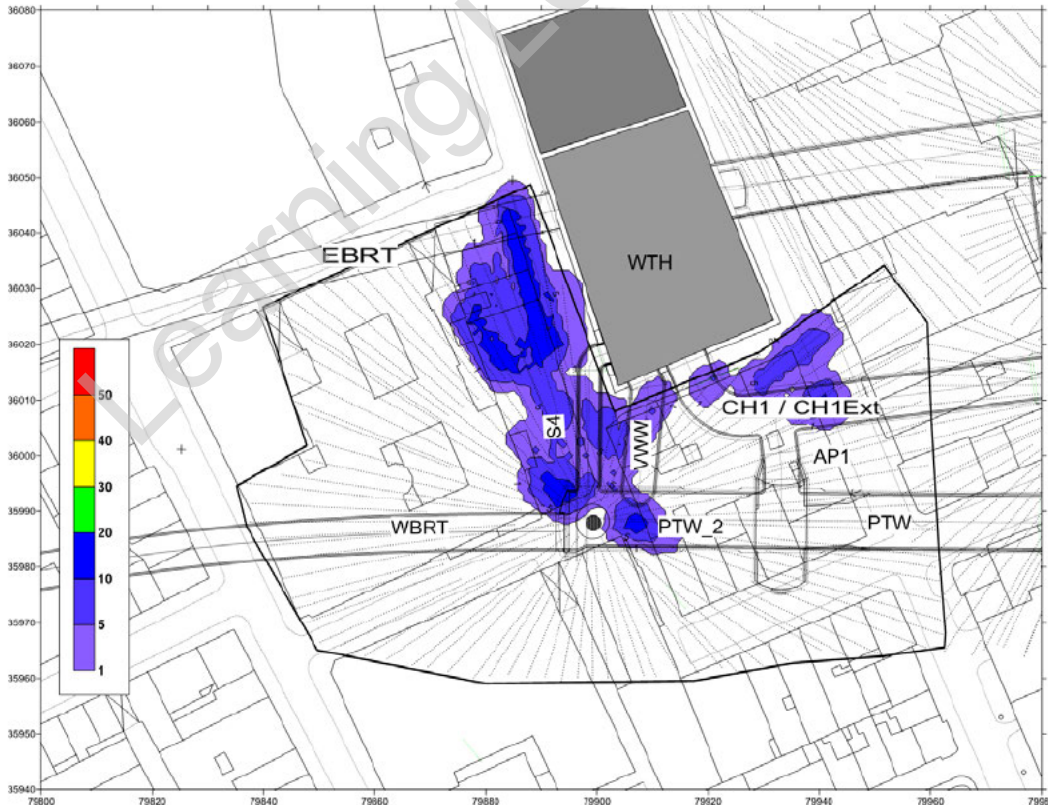
Figure 3.3.3 Period B: Distribution of grout injected from TCR GS1: Grout jacking. Grout Intensity (mm).

Figures 3.3.2 and 3.3.3 show the pre-treatment and jack grouting undertaken during the period in terms of grout Intensity: the intensity of the pre-treatment was varied to reflect the observed settlements.

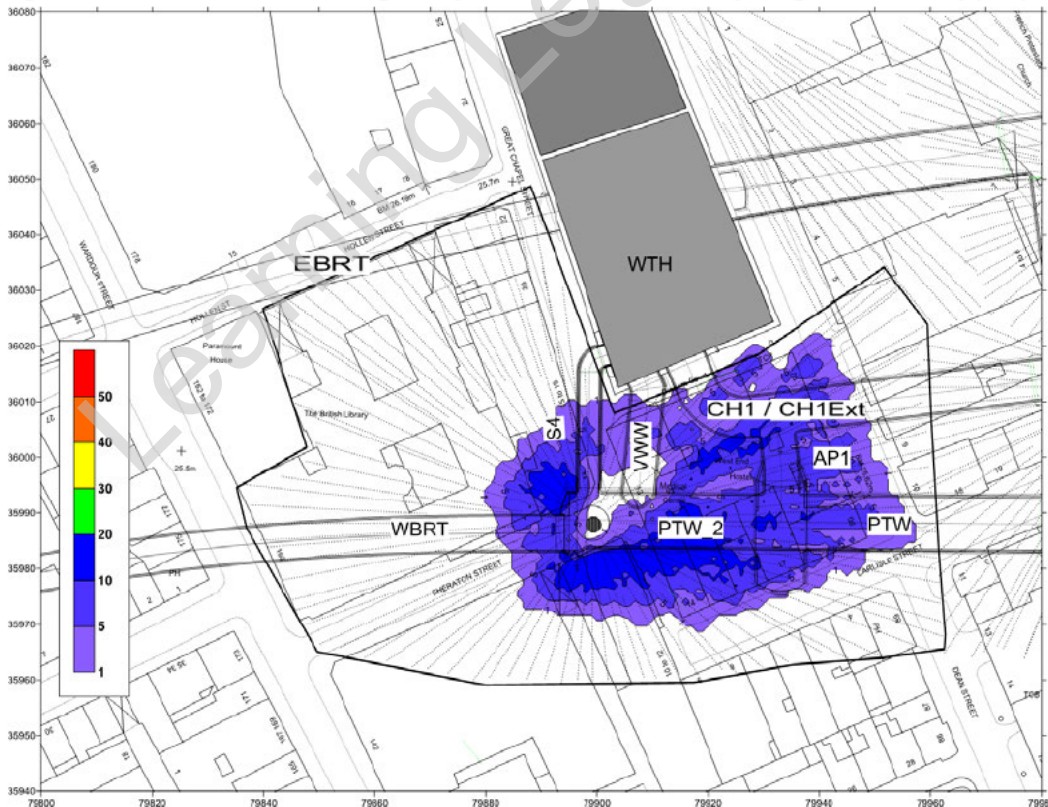
Figure 3.5.2 Period D: Distribution of grout injected from TCR GS1: Grout jacking. Grout Intensity (mm).

A grout jacking episode was undertaken following the WBRT drive which was targeted at the areas of maximum settlement as shown in Figure 3.5.2.

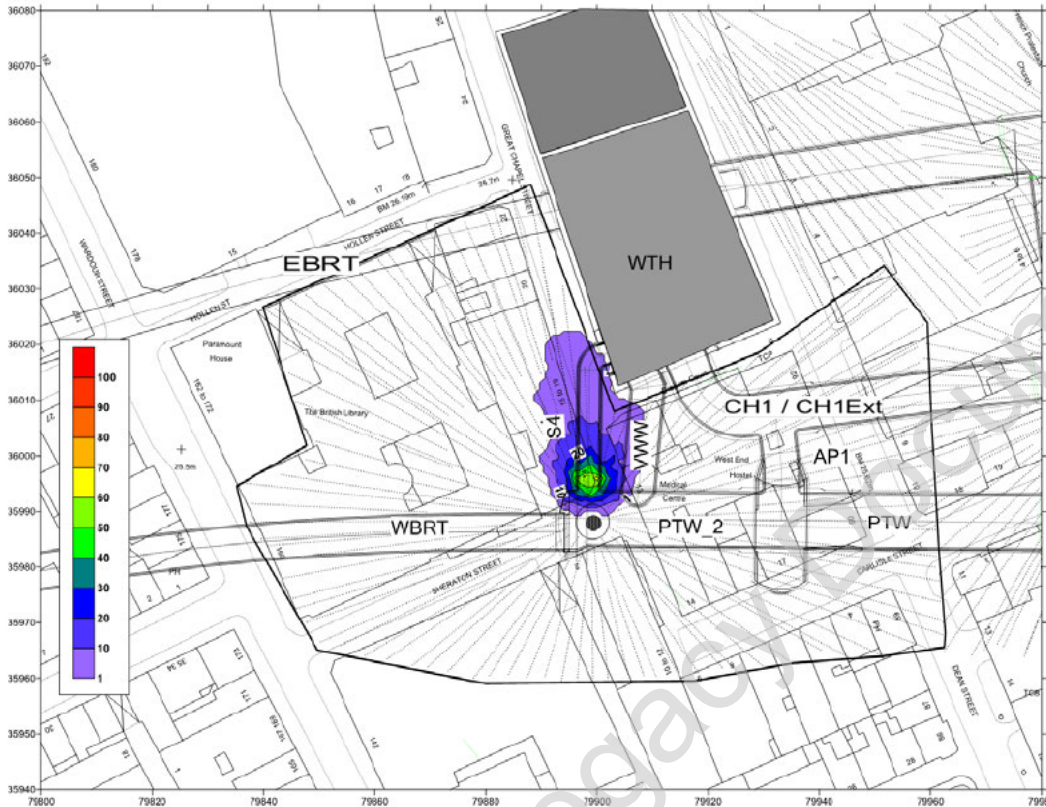
Figure 3.6.3 Period E: Distribution of grout injected from TCR GS1: Grout jacking. Grout Intensity (mm).

The concurrent grouting carried out with PTW and PTW2 (Figure 3.6.2) was successful in reducing volume loss settlement substantially. Grout jacking episodes were carried out during Period E over S4 (Figure 3.6.3), before and after its excavation due to the minor impact expected from this small diameter tunnel.

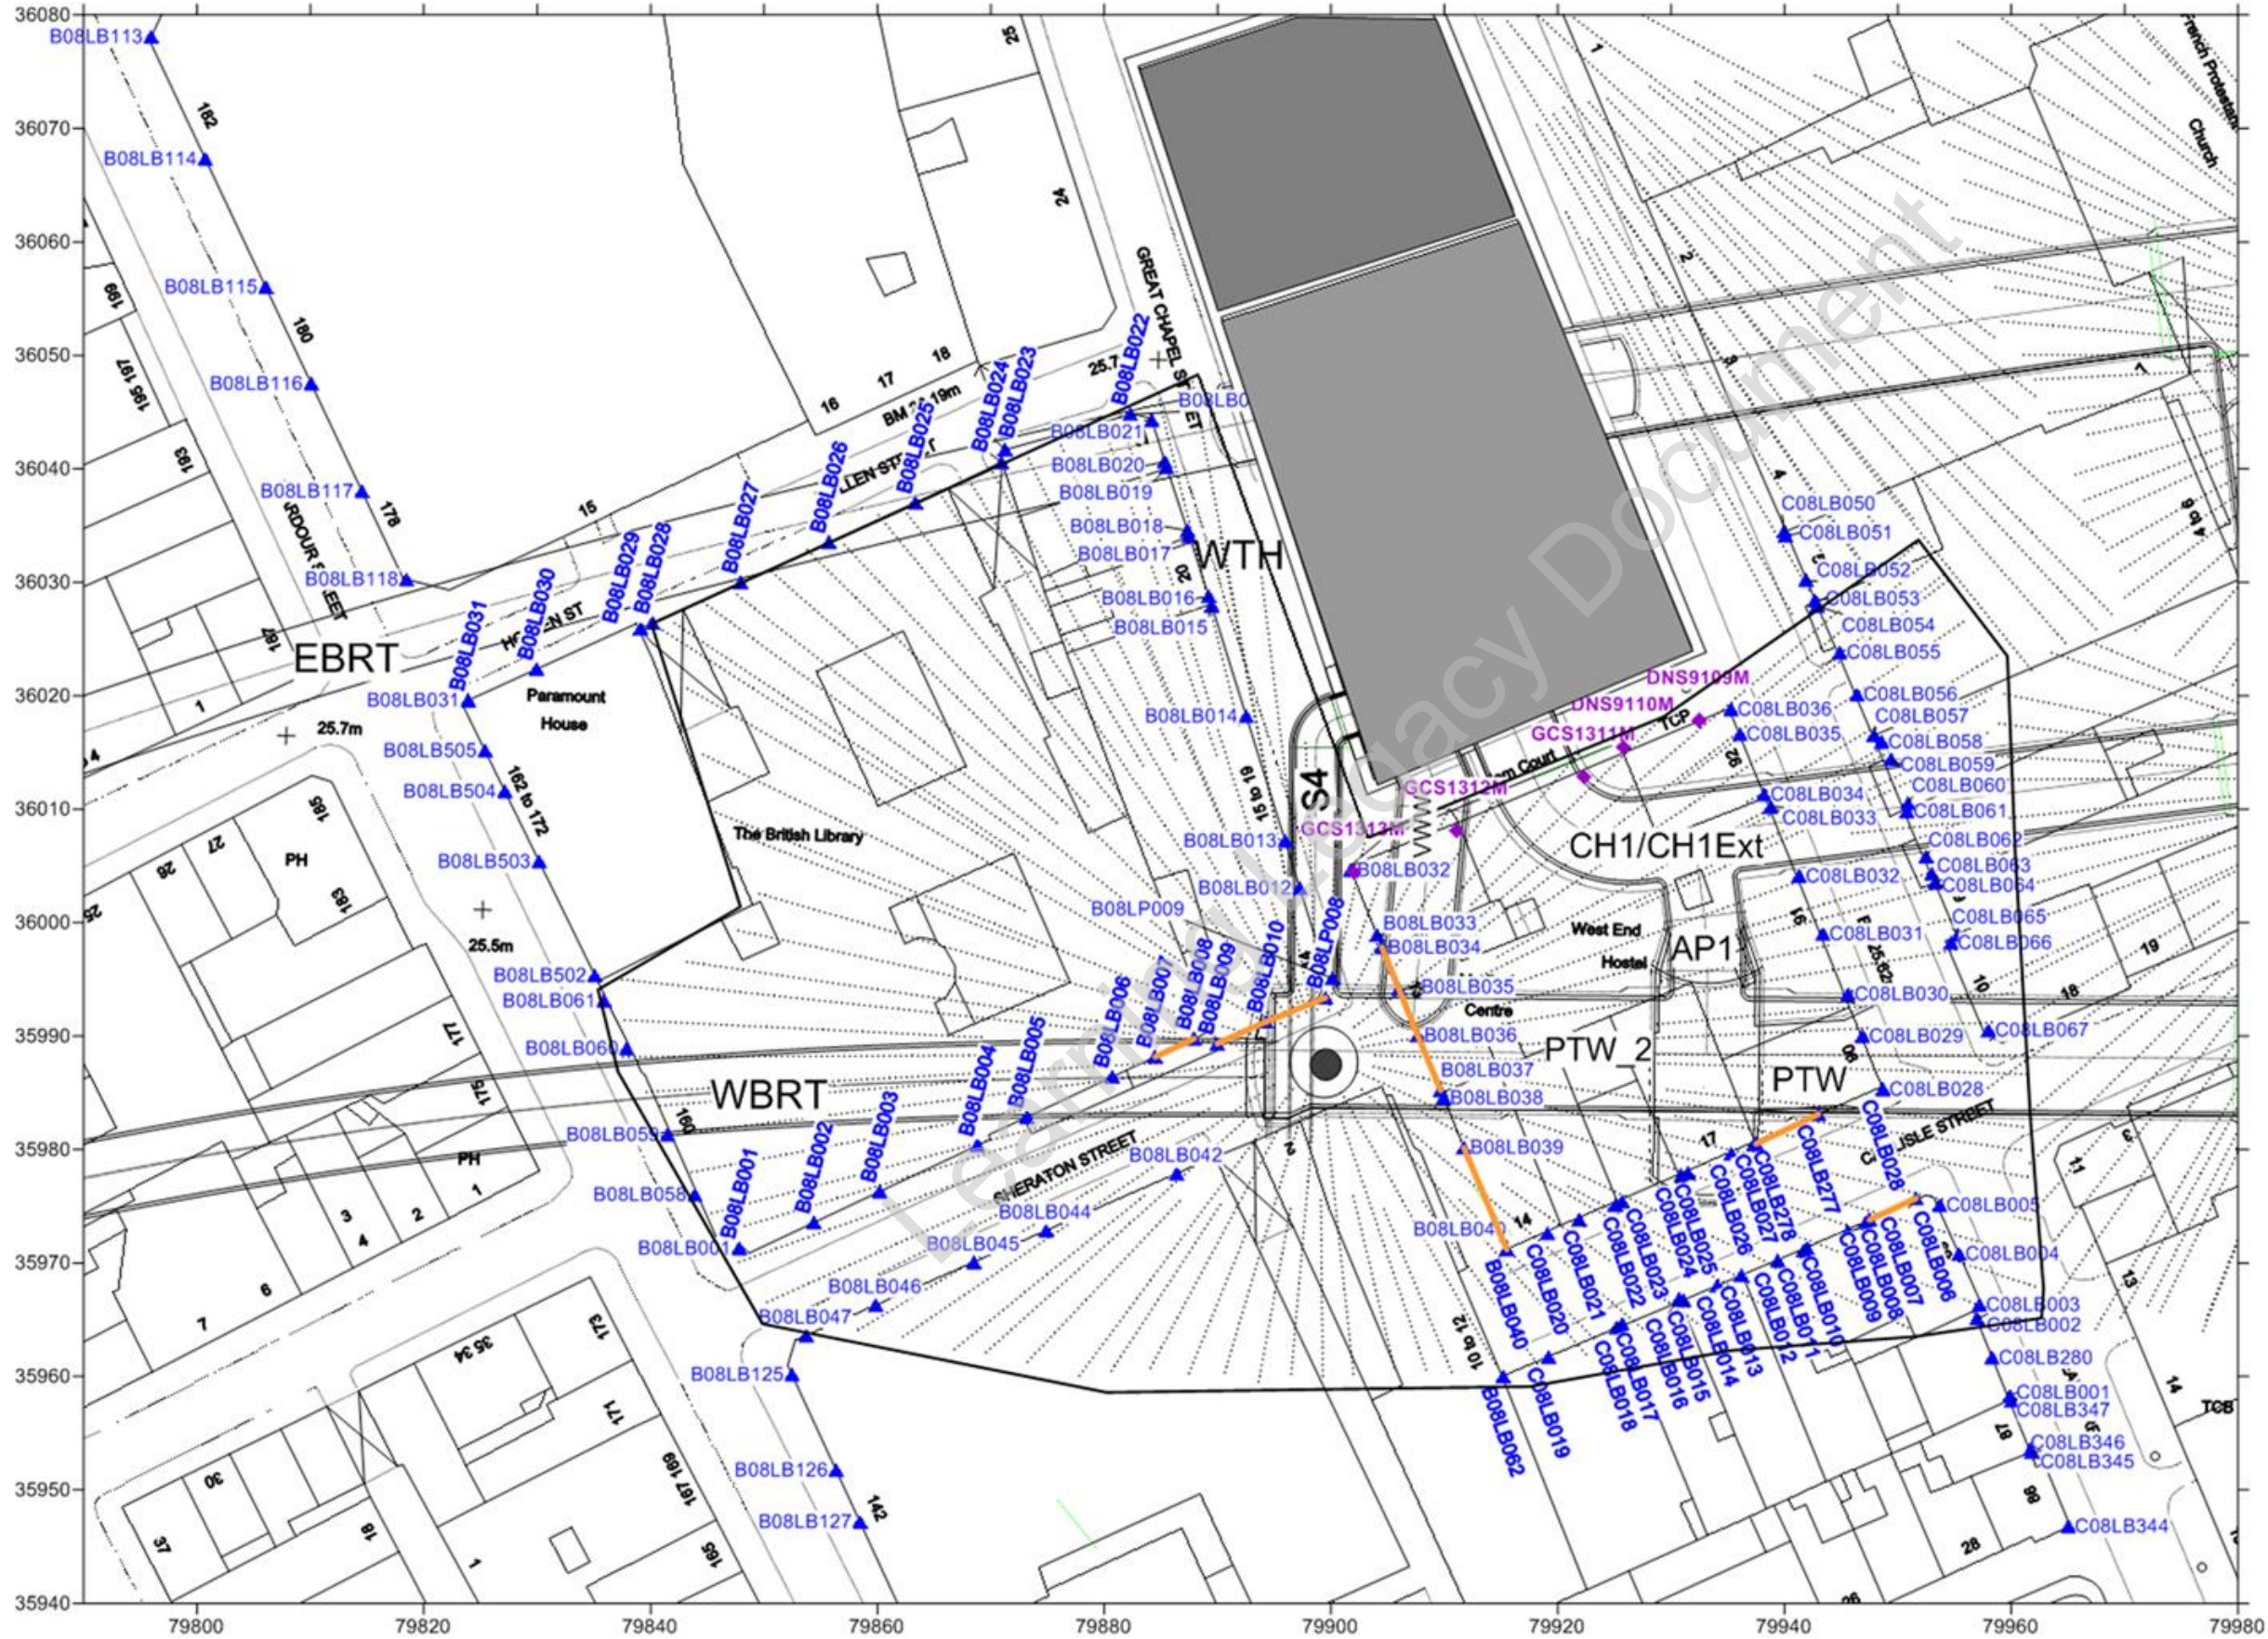
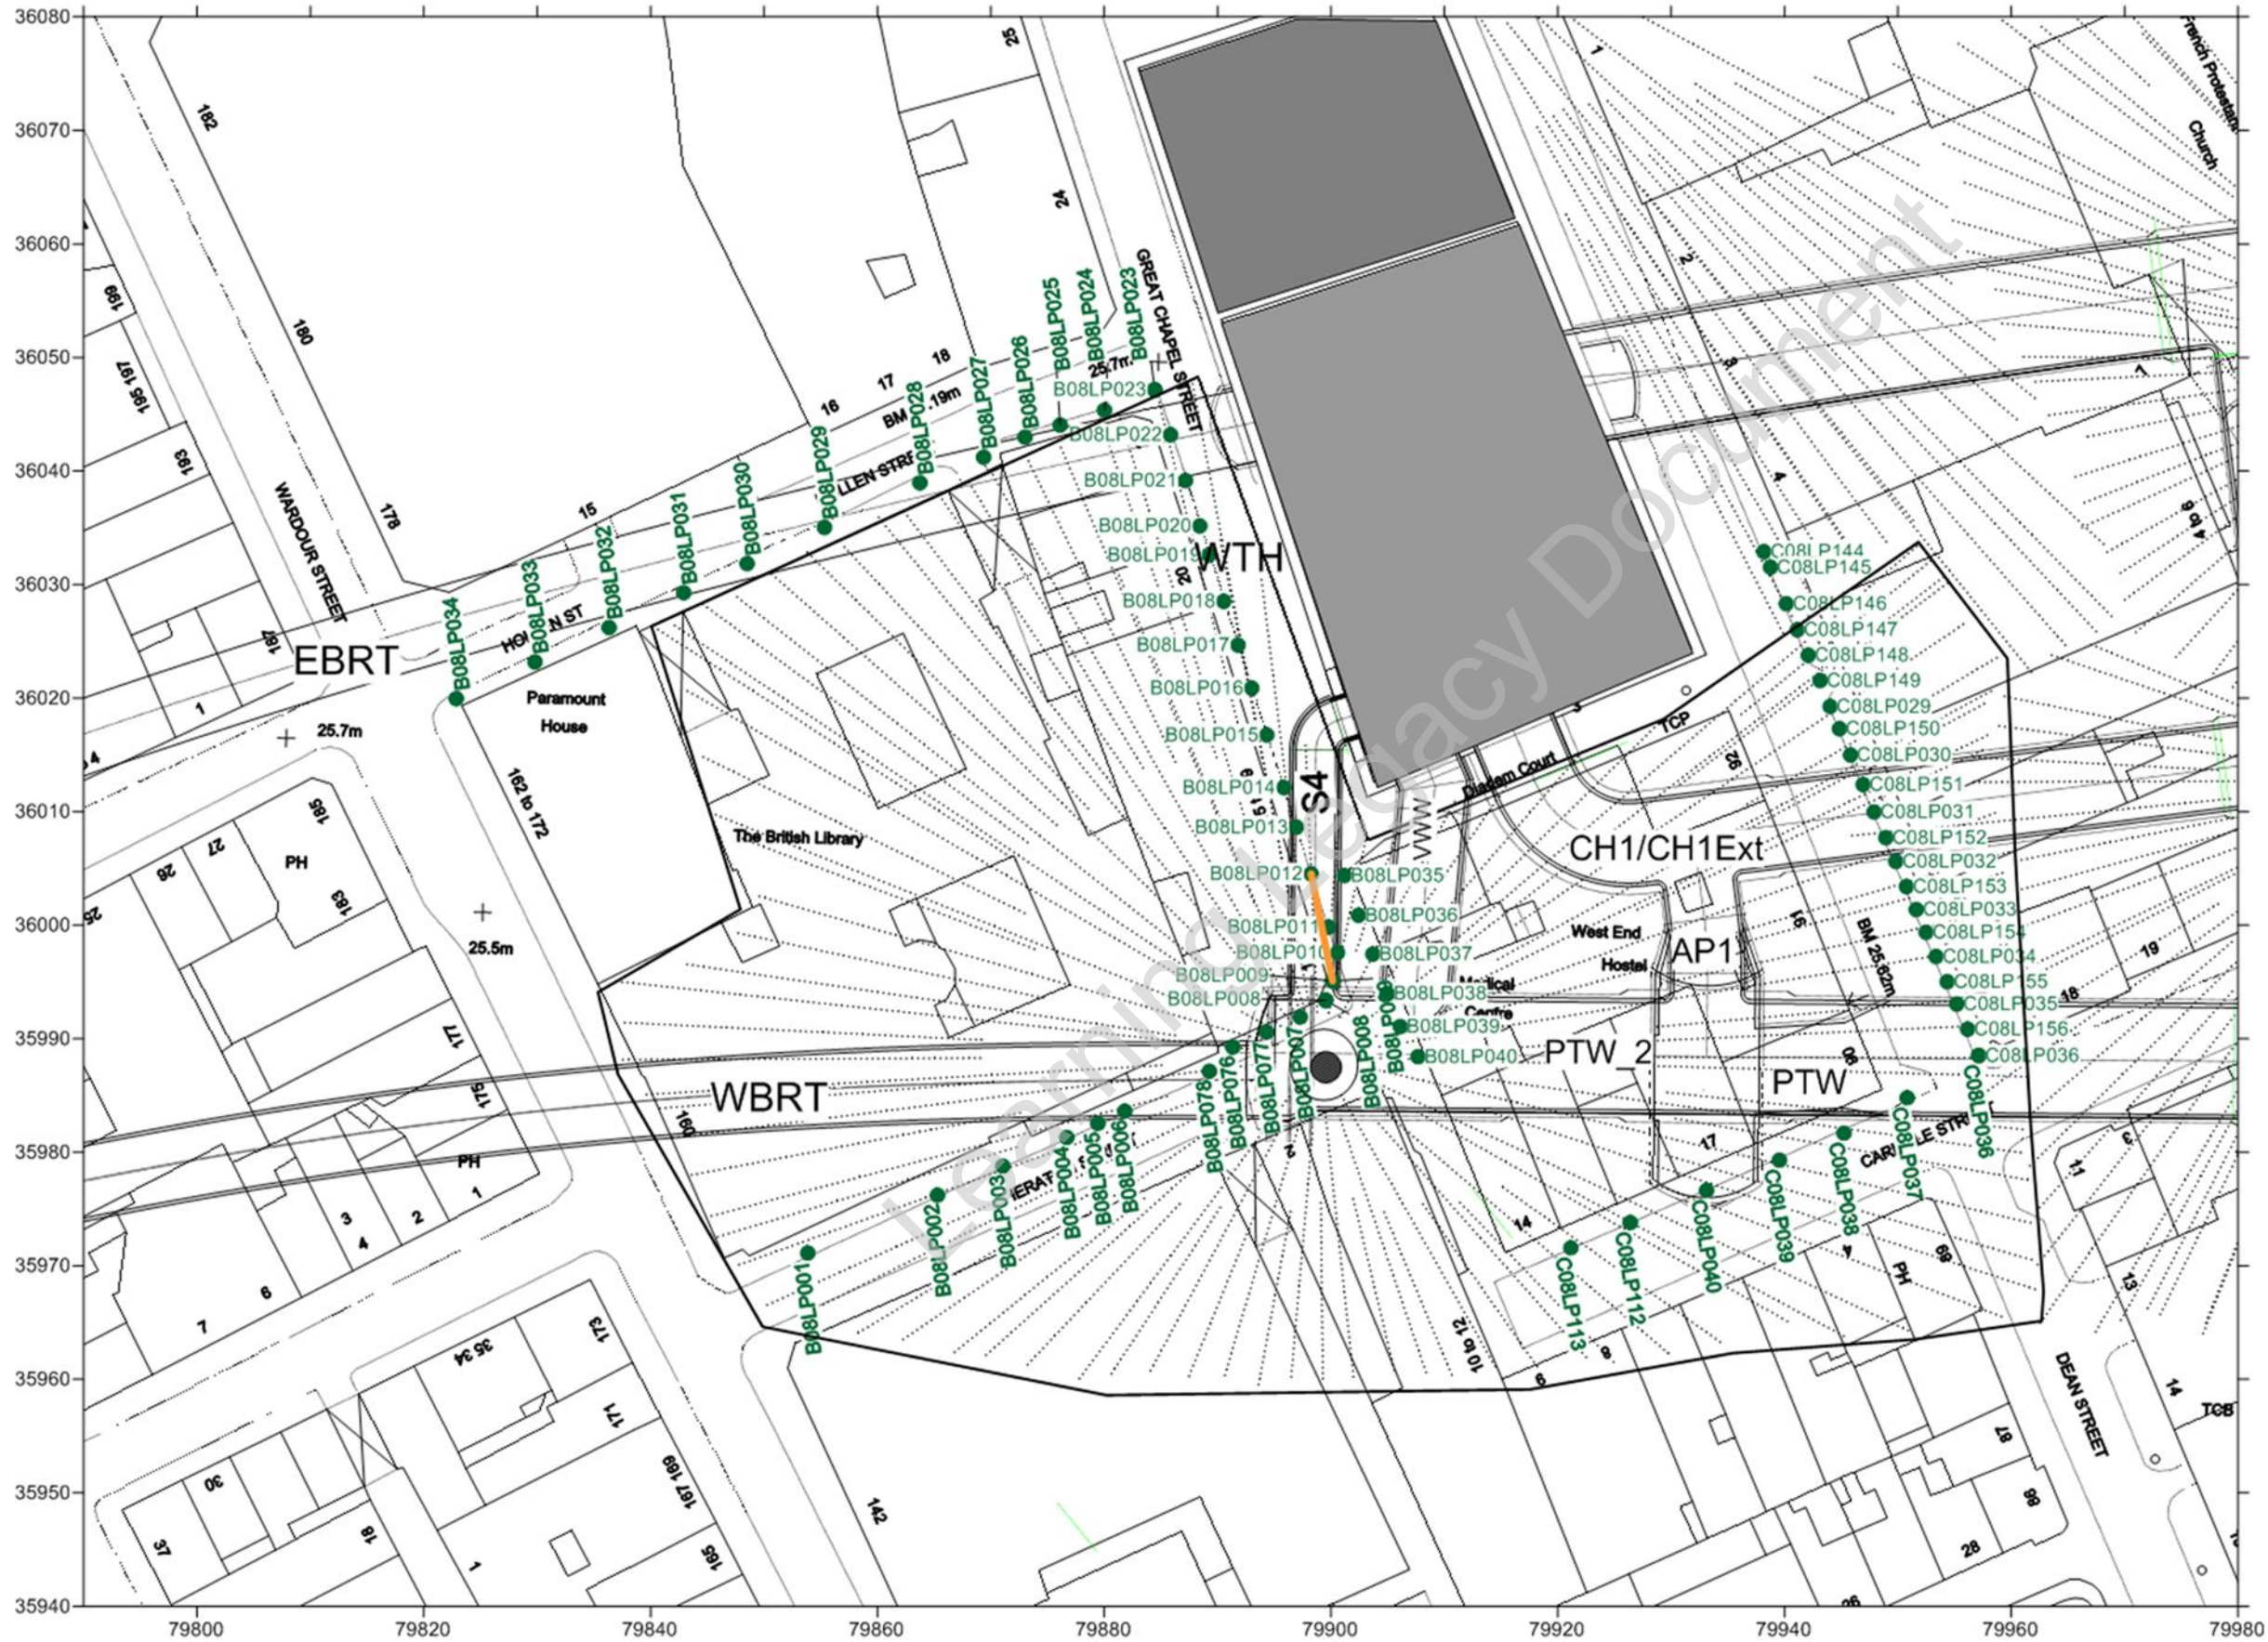
Enlarged version of Figures 4.1 and 5.1 showing location of monitoring point and slope triggers

The locations where slope triggers have been exceeded are shown for BRE monitoring of building facades. A larger version of Figure 4.1.1 is included in Appendix C. Details of trigger breaches are given in Table 4.1. By inspection, there have been no Deflection Ratio trigger breaches.
