C300/410 Western Tunnels & Caverns Project Report

Grouting Summary & I &M Final Report - TCR GS3

CRL Document No. **C300-BFK-C4-RGN-CRT00_ST005-51227**

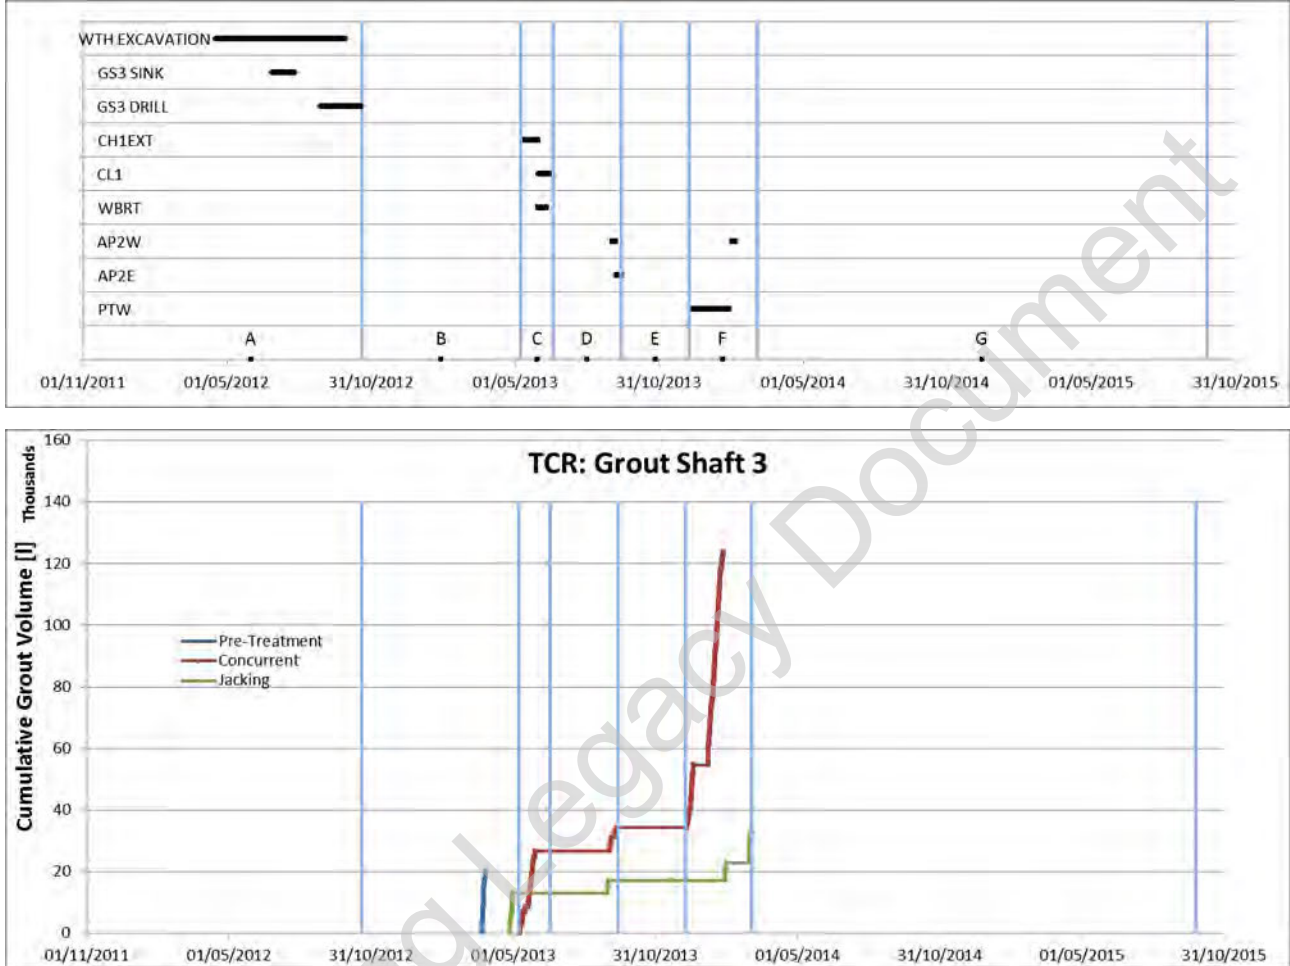
Figure 2.3.1 Volume of grout injected from TCR GS3 by grouting type.

The volume of grout injected from TCR GS3 is plotted against time on Figure 2.3.1 together with a plot of when each of the tunnels was constructed. Figure 2.3.1 shows that pre-treatment comprised approximately 20m³ injected prior to tunnelling, concurrent grouting over 120m³ and grout jacking just over 30m³. Concurrent grouting was undertaken with all tunnels except the WBRT, CL1 and the AP2W / PTW junction. A VE proposal was implemented to avoid any delays to the running tunnel drive which allowed grouting to be undertaken pre- and post- tunnelling – the volume of grout associated with this is included under grout jacking. The AP2W / PTW junction is a short length of tunnel and the extent of the exclusion zones over the tunnel face, as defined in the SCoGM, rendered concurrent grouting impractical. CL1 is a temporary tunnel below the centre of Soho Square and CRL deemed that concurrent compensation grouting was not mandatory (as per C300-CCM-01519 and C300-PMI-00434).

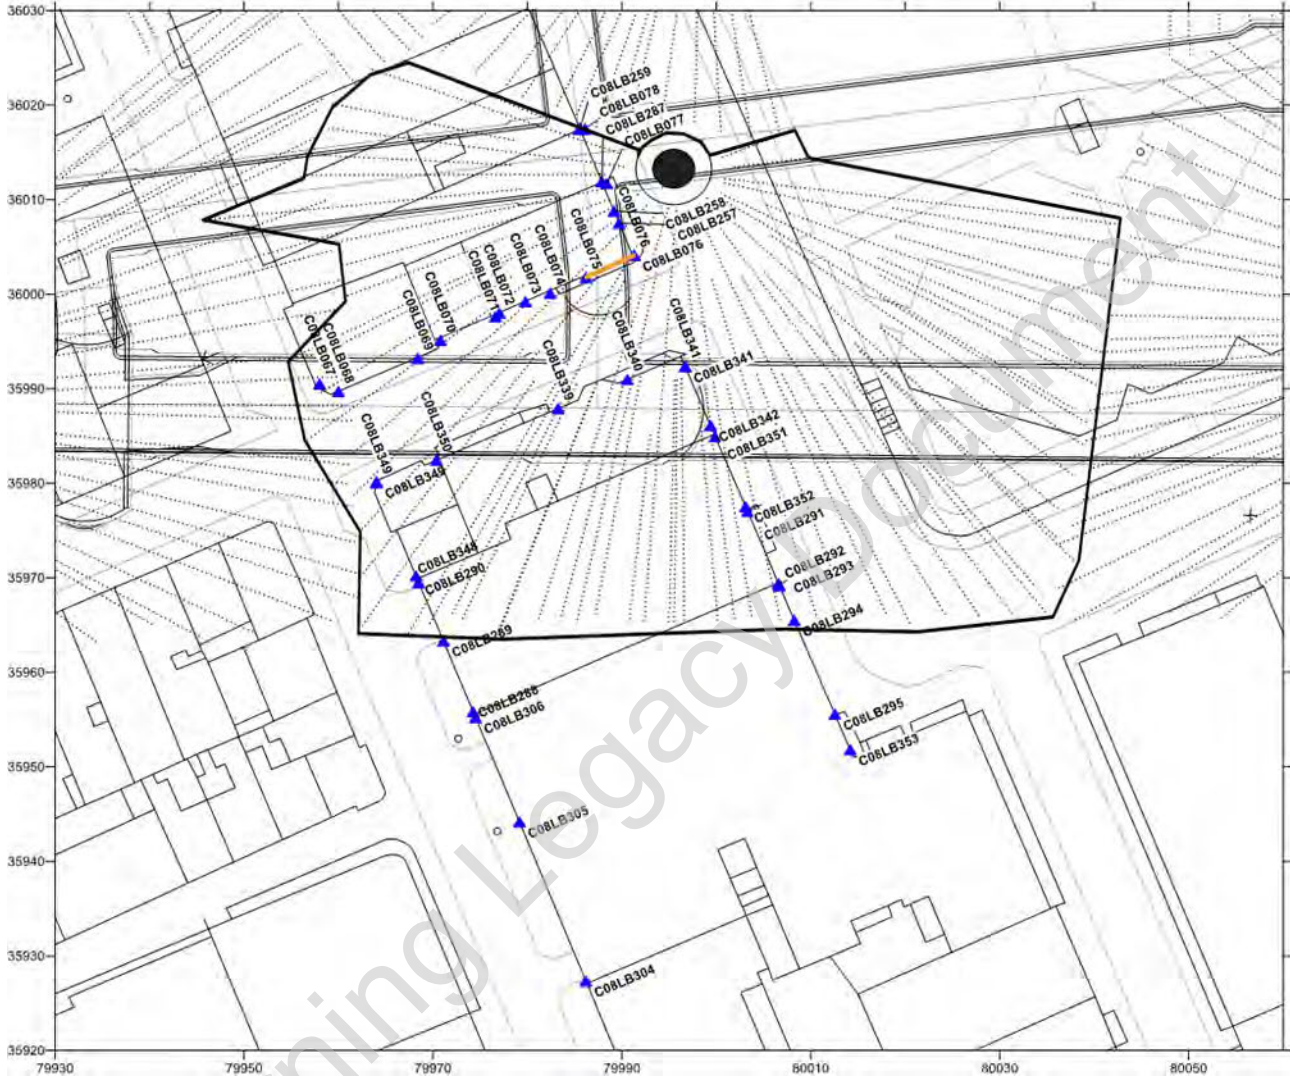
Figure 4.1.1 Locations of BREs and building slope Amber trigger.

BRE monitoring data from the facades within the footprint of GS3 are presented in the following sections, namely Carlisle Street north and south, Soho Square west and Dean Street east. The plots presented for each comprise, as appropriate:

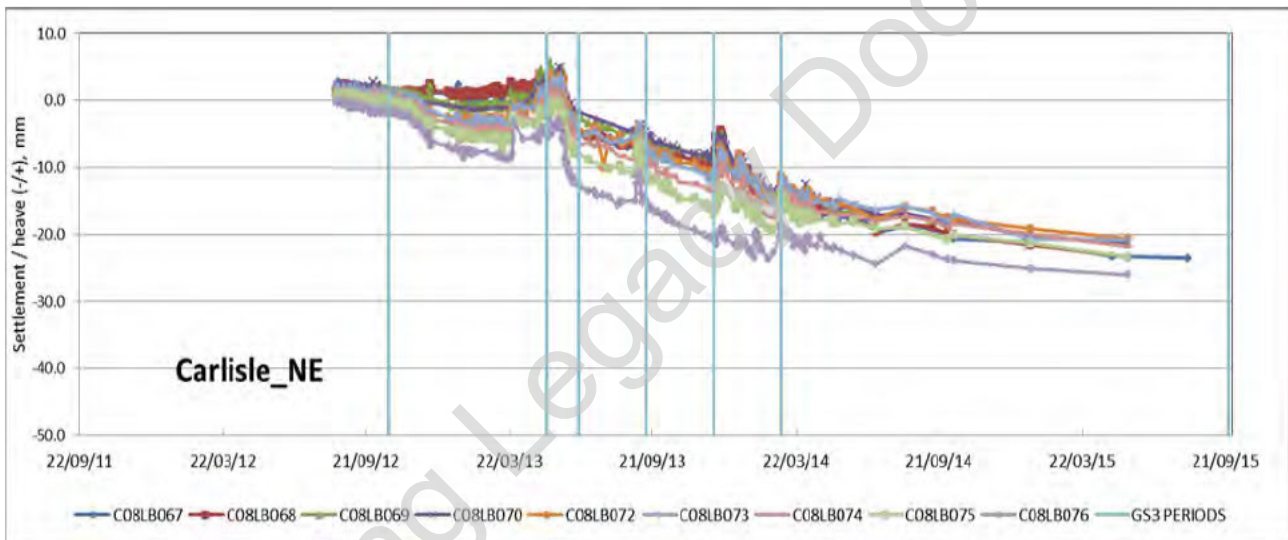
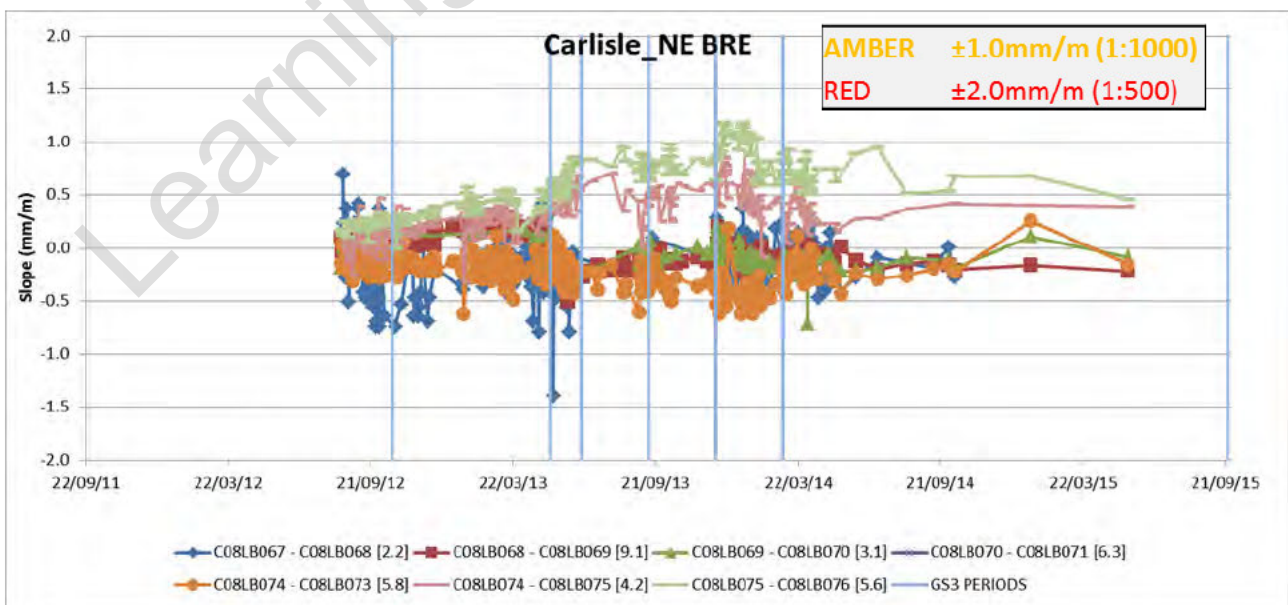
4.2. Carlisle Street North – East

- Data are presented for the BRE located on the north facade of Carlisle Street to the east of Dean Street (see GS1 report for points west of Dean Street). All points are within the plan extent of the GS3 arrays.

- The rate of post construction settlement in Period G has reduced continually with the final readings showing near stable conditions.
- Slopes were less than the Amber trigger value at the end of construction and subsequently during Period G. A transitory slope trigger occurred during the PTW enlargement between C08LB075 and C08LB076 at the corner of Soho Square, as detailed in Table 4.1.

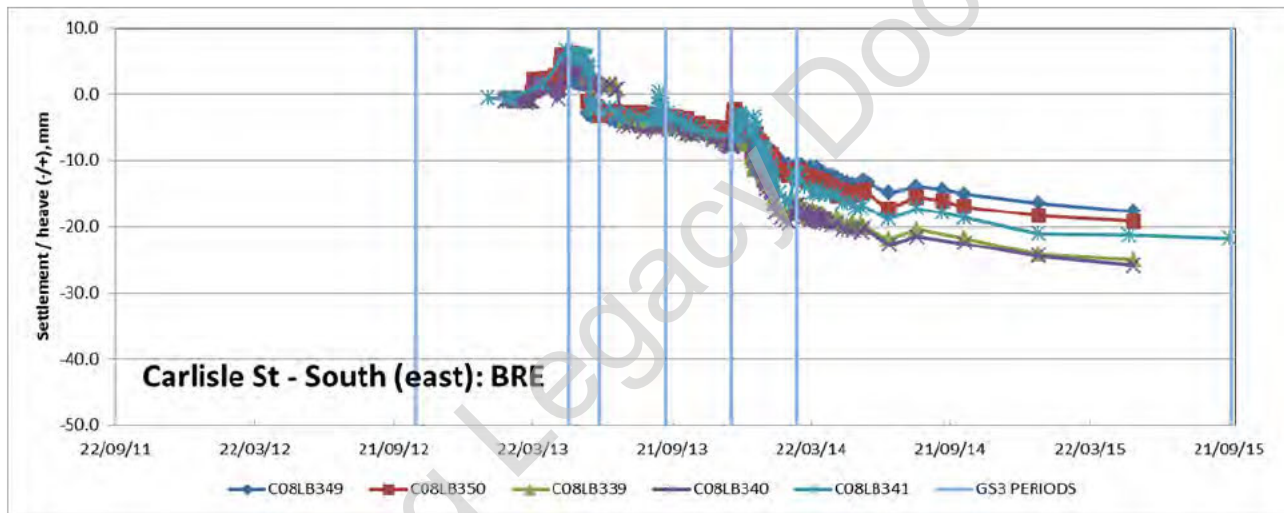
4.3. Carlisle Street South – east

- Data are presented for the BRE located on the south façade of Carlisle Street to the east of Dean Street (see GS1 report for points west of Dean Street). All points are within the plan extent of the GS3 arrays.

- The rate of post construction settlement in Period G has reduced continually with the final readings showing near stable conditions.
- Slopes were less than the Amber trigger value at the end of construction and subsequently during Period G. A single data point indicated a slope trigger during the PTW enlargement between points C08LB341 and C08LB340. Since this was not confirmed by any subsequent readings it is not included in Table 4.1.

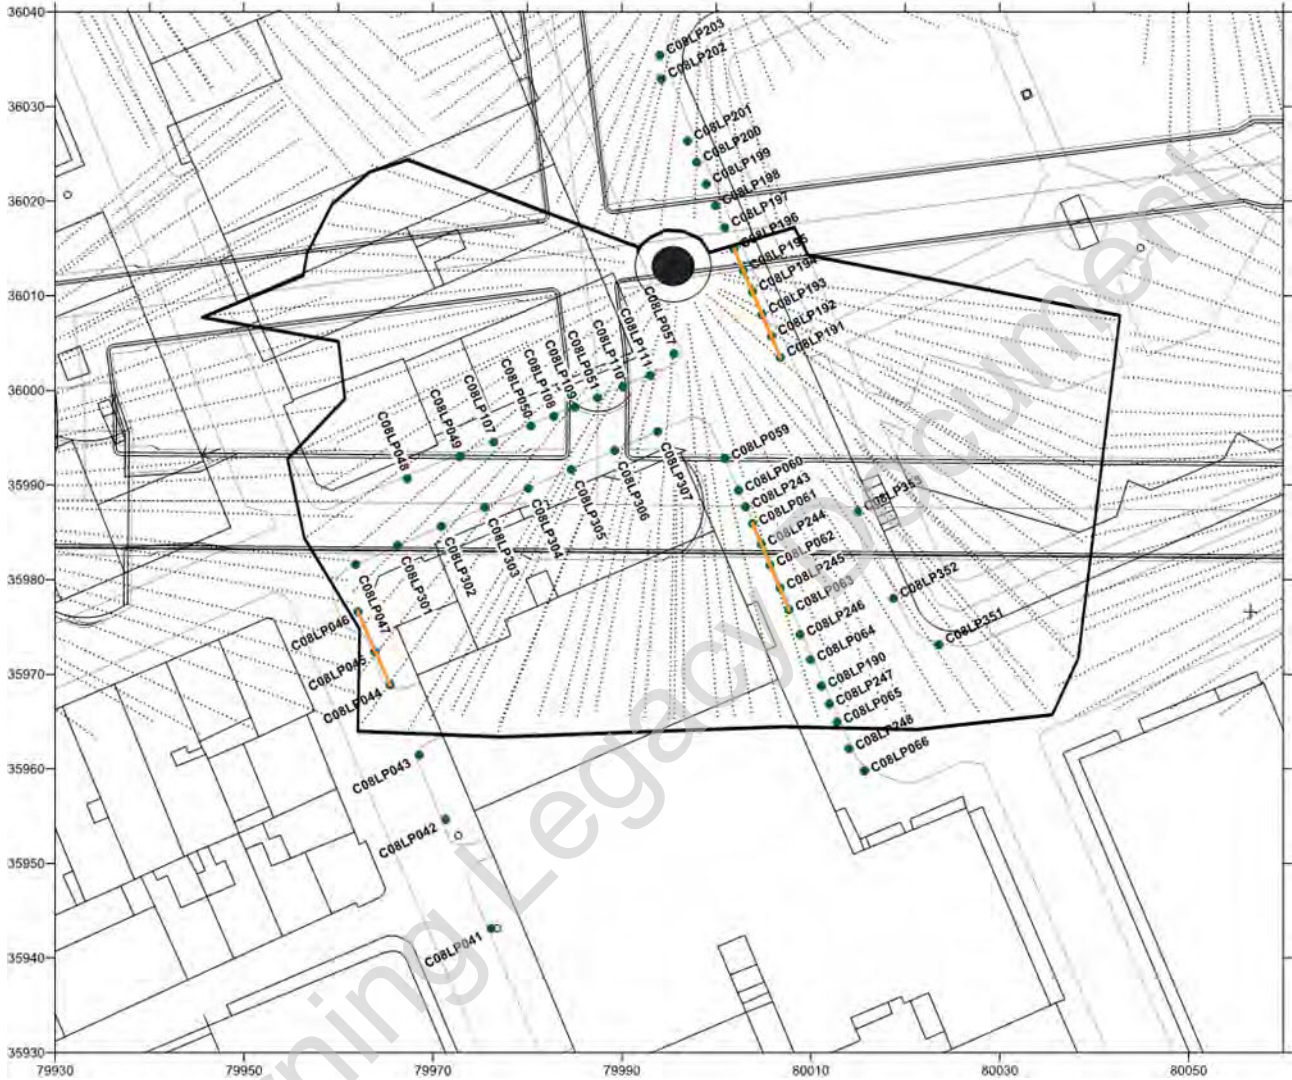
Figure 5.1.1 Location of PLP and Amber slope triggers

| Kerb Line | | Comment | Date exceeded | Maximum (mm/m) | Final (mm/m) |
|---|---|--|---|---|---|
| C08LP044 – C08LP046 | Amber | Trigger occurred 5 months after end of construction. Increased rate of settlement on point on corner kerb – probable damage to point | 08/08/14 | 1.41 | 1.41 |
