C300/410
Western Tunnels & Caverns Project

Grouting Summary & I & M Final Report - TCR GS6

CRL Document No. **C300-BFK-C4-RGN-CRT00_ST005-51230**

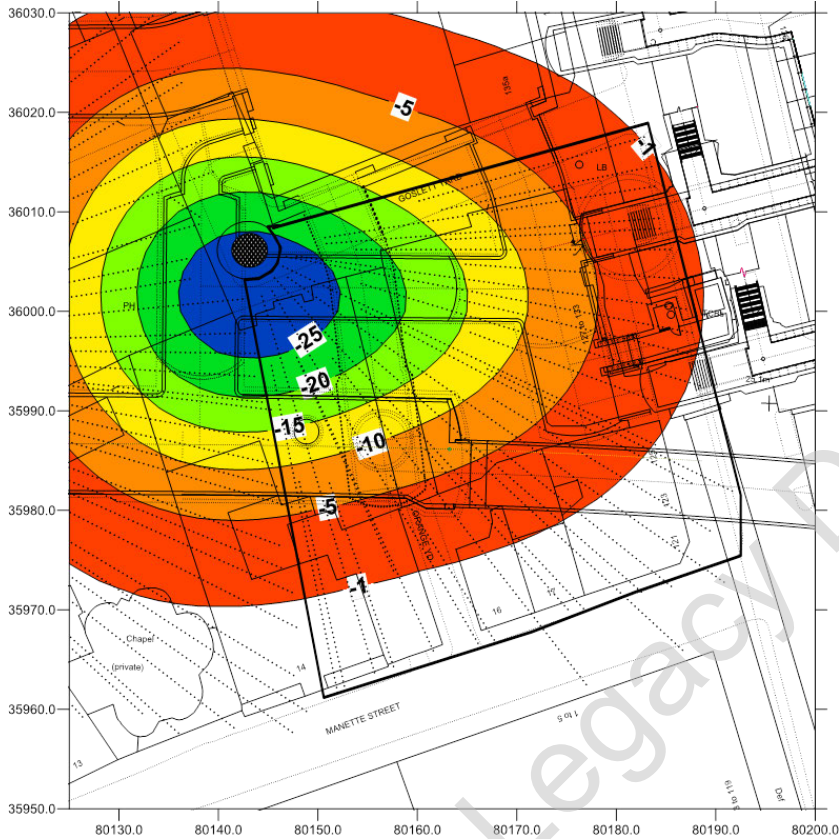
Figure 3.4.1 Period C: (a) Predicted greenfield settlement contour. (b) Change in measured settlement. (c) Total measured settlement

Figure 3.4.1(a) shows that over 25mm volume loss settlement was anticipated for AP7A and AP7B. Figure 3.4.1(b) shows the recorded settlement which has a maximum of 7.5mm over the junction between the two tunnels. The 2.5mm settlement contour encompasses the majority of the GS6 area: it is inferred that this more widespread movement is due to ongoing consolidation following the TCRSU works and the WBRT.

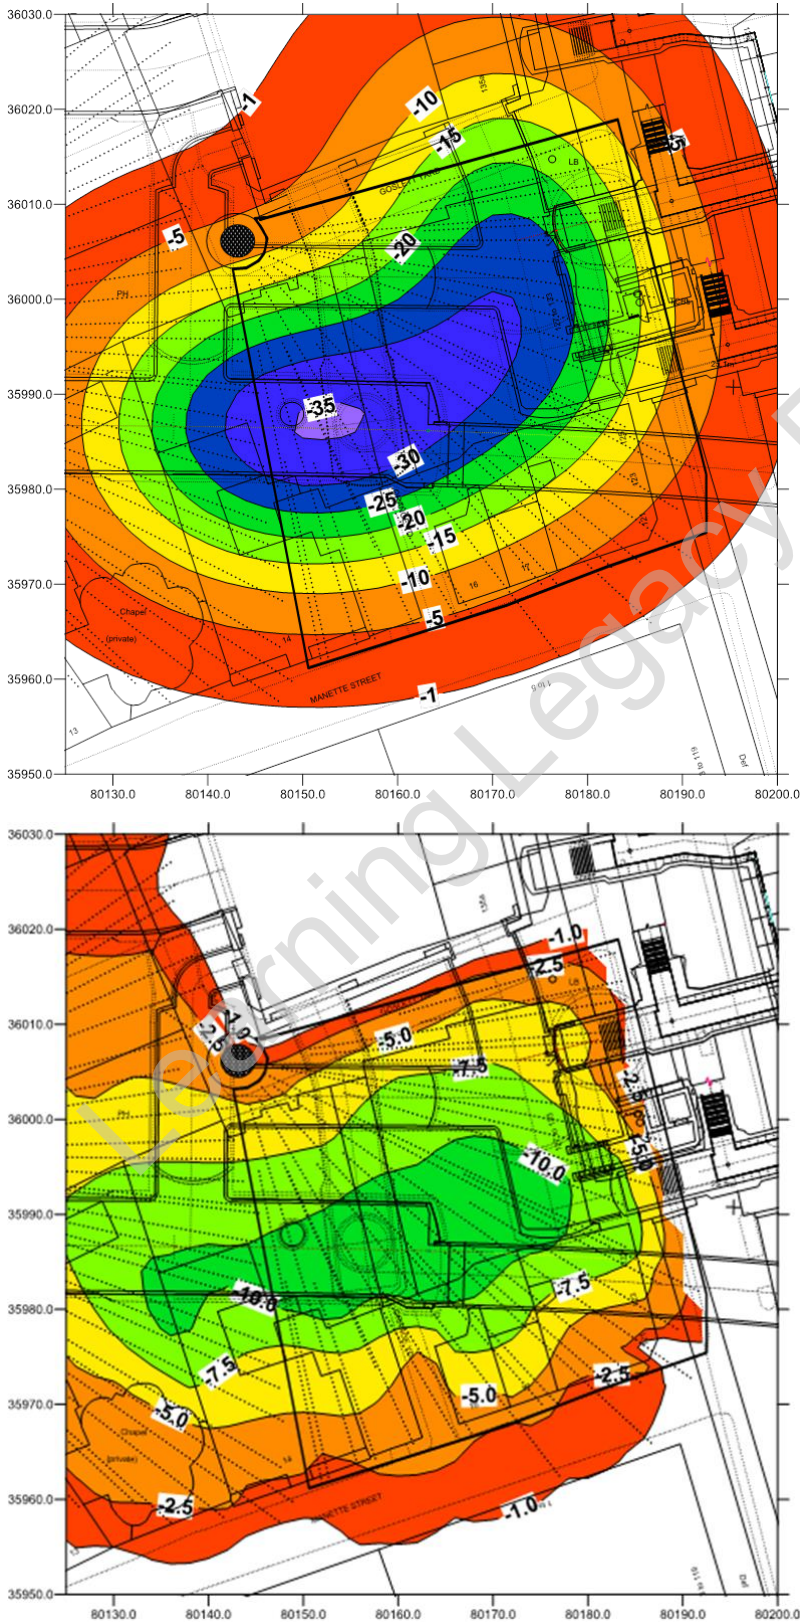
Figure 3.5.1 Period D: (a) Predicted greenfield settlement contour. (b) Change in measured settlement. (c) Total measured settlement

The volume loss settlement from construction of AP8, PTW and the associated junctions is shown in Figure 3.5.1(a) and indicates a maximum combined effect of 35mm within the area of TCR GS6. The maximum observed increase in settlement in Period D was just over 10mm (Figure 3.5.1(b)): volume loss settlement was controlled by concurrent grouting (Figure 3.5.2) and grout jacking (Figure 3.5.3).

The maximum total settlement (Figure 3.5.1(c)) increased by about 10mm, to over 40mm, with a similar pattern to that at the end of Period C.

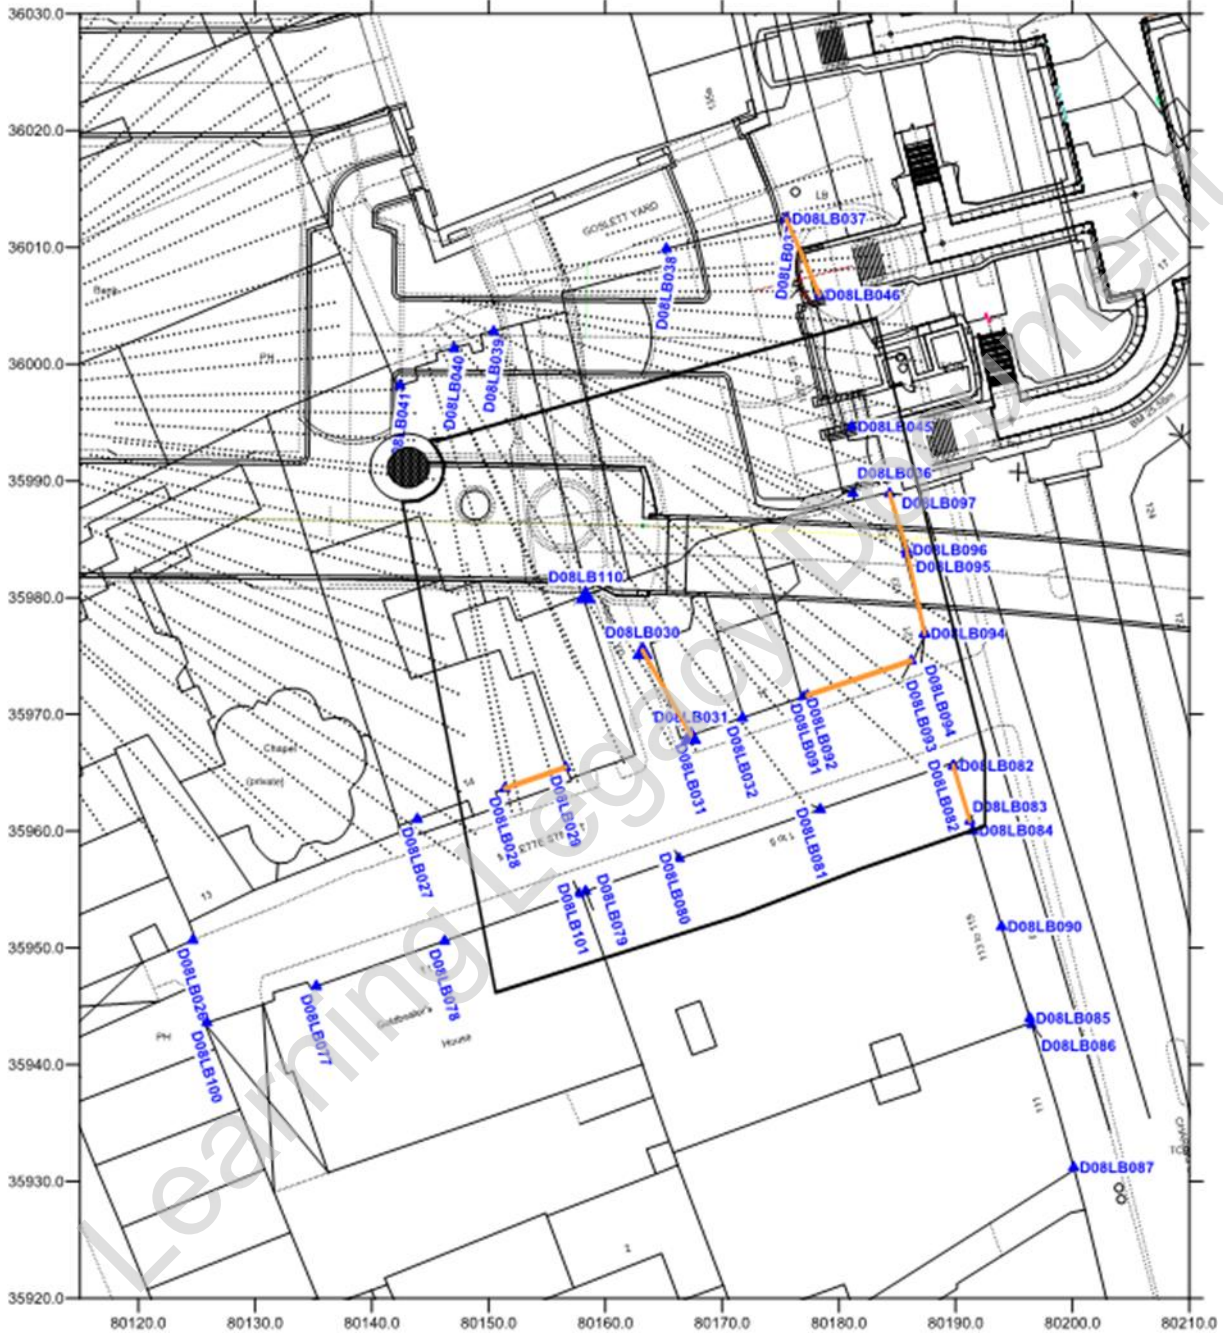
Figure 4.1. Locations of BRE building slope Amber triggers.

BUILDING FACADES		Comment	Date exceeded	Maximum (mm/m)	Final (mm/m)
Manette Street – North:					
D08LB028-D08LB029	Amber	Post construction increase - stabilised	24/07/15	1.13	1.11
D08LB092-D08LB093	Amber	Marginal - Mean 0.99mm/m over 152 readings between 18/11/13 and 24/07/15	18/11/13	1.26	0.96
Manette Street - South: NONE					
Charing Cross Road - west:					
D08LB083-D08LB082	Amber	Post construction increase - stabilised	21/10/14	1.06	1.06
D08LB094-D08LB095	Amber	Initial slope of 0.82mm/m due to TCRSU works prior to TaM drilling	10/05/13	1.82	1.79
D08LB096-D08LB097	Amber	Initial slope of 0.81mm/m due to TCRSU works prior to TaM drilling	15/04/13	1.13	0.99
D08LB046-D08LB037	-	3 isolated readings >1.0mm/m – trigger not verified	N/A	1.02	0.91
Goslett Yard - South: NONE					
Orange Yard -east					
D08LB030-D08LB031	Amber	Less than 1.1mm/m during and at the end of construction. Post construction increase - stabilised	08/07/14	1.24	1.24

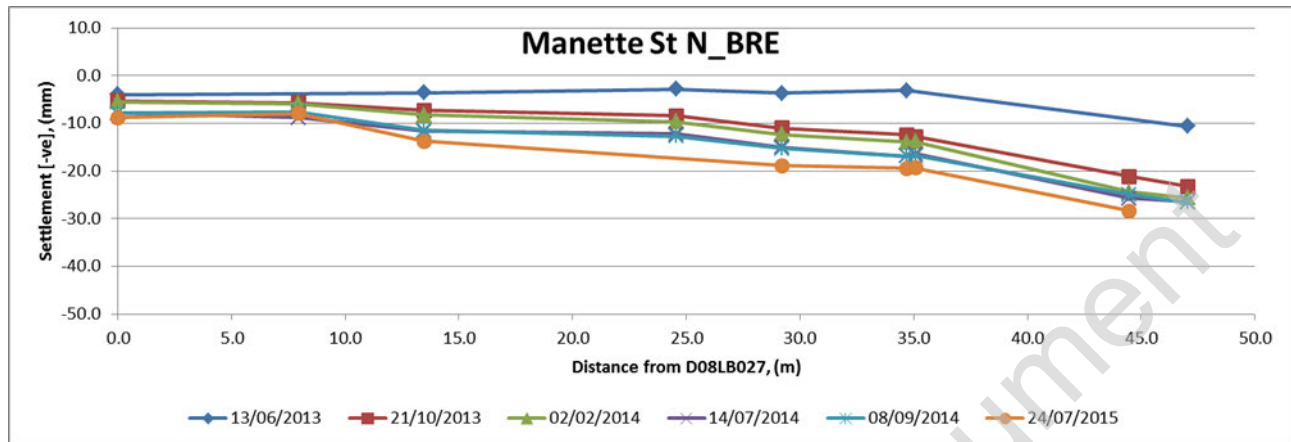
- Data are presented for the BRE located on the north facade of Manette Street as shown on Figure 4.1.
- Overall settlement was ~10mm or less at the end of Period A, primarily as a result of TCRSU works. A small net increase (~3mm) is associated with TaM drilling and subsequent pre-treatment.

- The rate of post construction settlement in Period F has reduced continually with the final readings showing near stable conditions, with ~30mm maximum settlement.

- It is noted that significant slopes (D08LB092 - D08LB093 at ~0.6mm/m and D08LB093 - D08LB094 at ~0.4mm/m) existed prior to any potential effect from BFK works, as a result of movements generated by the TCRSU works. These two slopes increased to close to the Amber trigger value following the WBRT.

- By inspection, no Deflection Ratio triggers were breached.

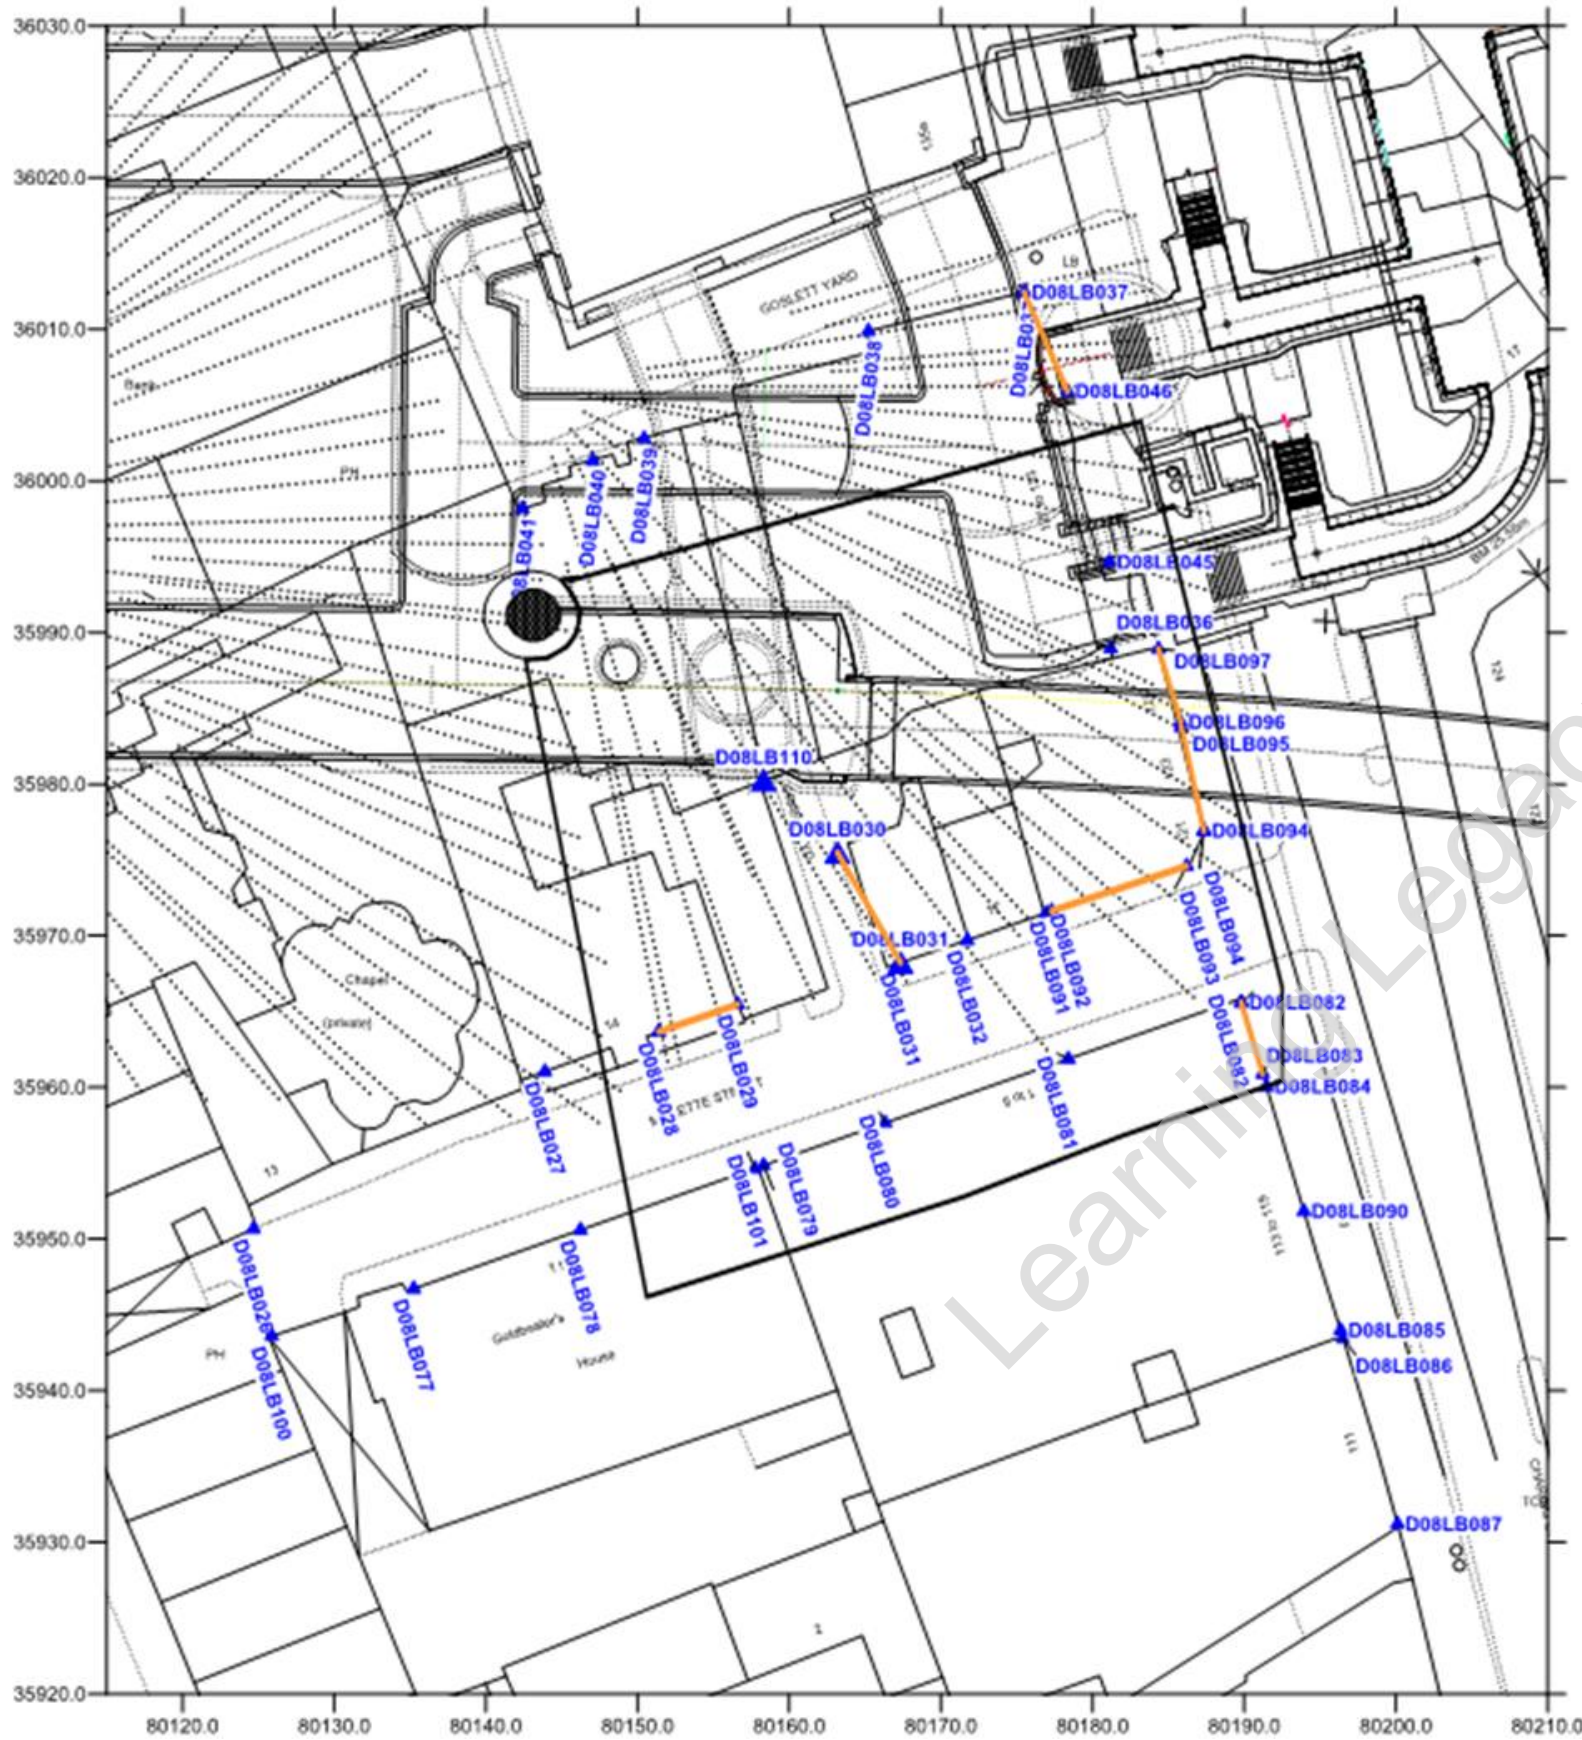
Enlarged version of Figures 4.1 and 5.1 showing location of monitoring point and slope triggers

The locations where slope triggers have been exceeded are shown for BRE monitoring of building facades on Figure 4.1. A larger version of Figure 4.1 is included in Appendix D. Details are given in Table 4.1. There have been no breaches of Deflection Ratio triggers.

- Data are presented for the BRE located on the south façade of Manette Street. None of the points are within the extent of the GS6 arrays, as shown on Figure 4.1. It is noted that the Compensation Grouting area was amended from the centre of Manette Street to the façade on the north side of the road due to an obstruction encountered during drilling for TaM installation.

- Data is presented for the BRE located on the west facade of Charing Cross Road. Only the points north of Manette Street (i.e. from distance 45m on the profile plot) are within the extent of the GS6 arrays, as shown on Figure 4.1.

- Data is presented for the BRE located on the south facade of Goslett Yard, as shown on Figure 4.1.
- Overall settlement was ~25mm at the end of Period A, primarily as a result of TCRSU works. A small net increase (~3mm) is associated with TaM drilling and subsequent pre-treatment.

- Data is presented for the BRE located around the facades of Orange Yard as shown on Figure 4.1.
- Overall settlement was ~10mm or less at the end of Period A, primarily as a result of TCRSU works, although it appears that TaM drilling also caused some settlement of these points, albeit that most of this was reversed by pre-treatment.
