Western Tunnels & Caverns Project

## Grouting Summary & I & M Final Report - TCR GS7

CRL Document No. **C300-BFK-C4-RGN-CRT00\_ST005-51231**

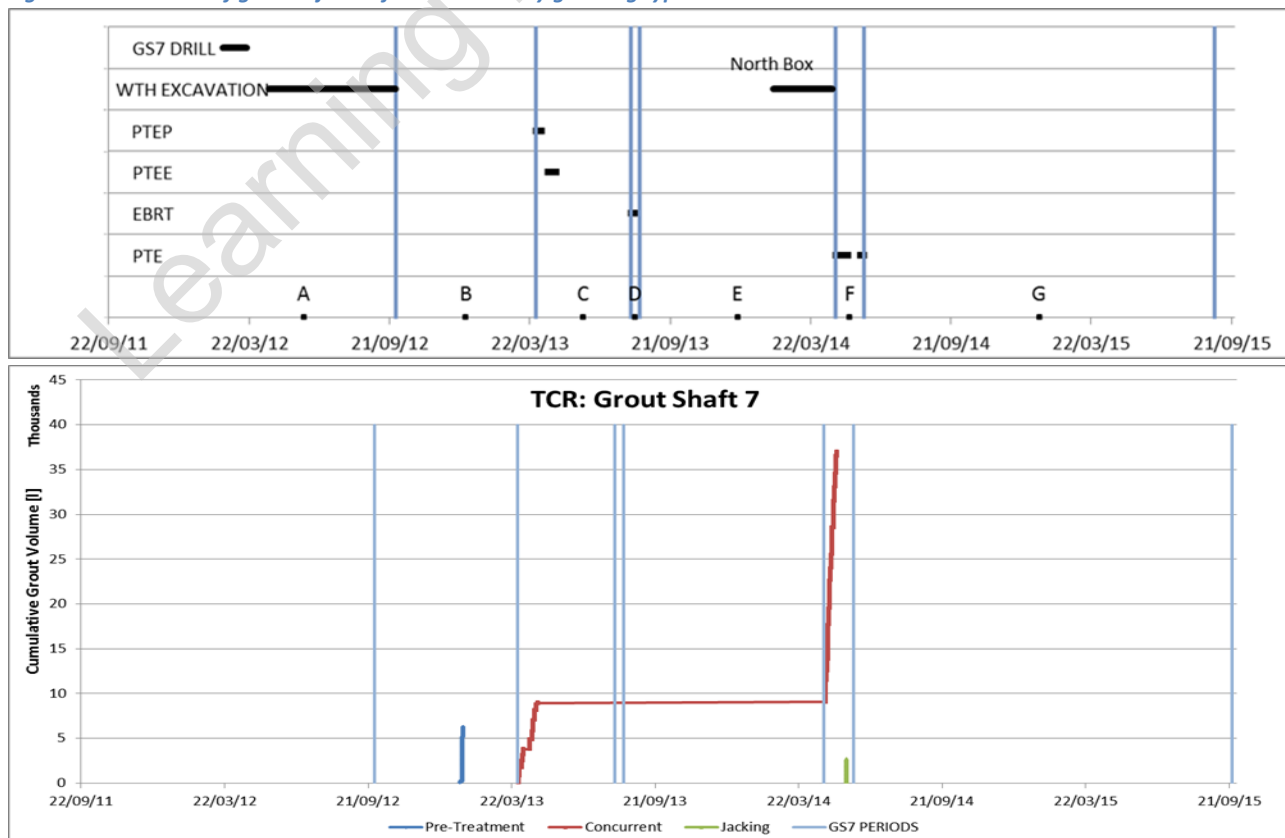
Figure 2.3.1 Volume of grout injected from TCR GS7 by grouting type

The volume of grout injected from TCR GS7 is plotted against time on Figure 2.2 together with a plot of when each of the tunnels was constructed. Figure 2.2 shows that pre-treatment comprised approximately 6m<sup>3</sup> injected prior to tunnelling, concurrent grouting 37m<sup>3</sup> and grout jacking just over 2m<sup>3</sup>.

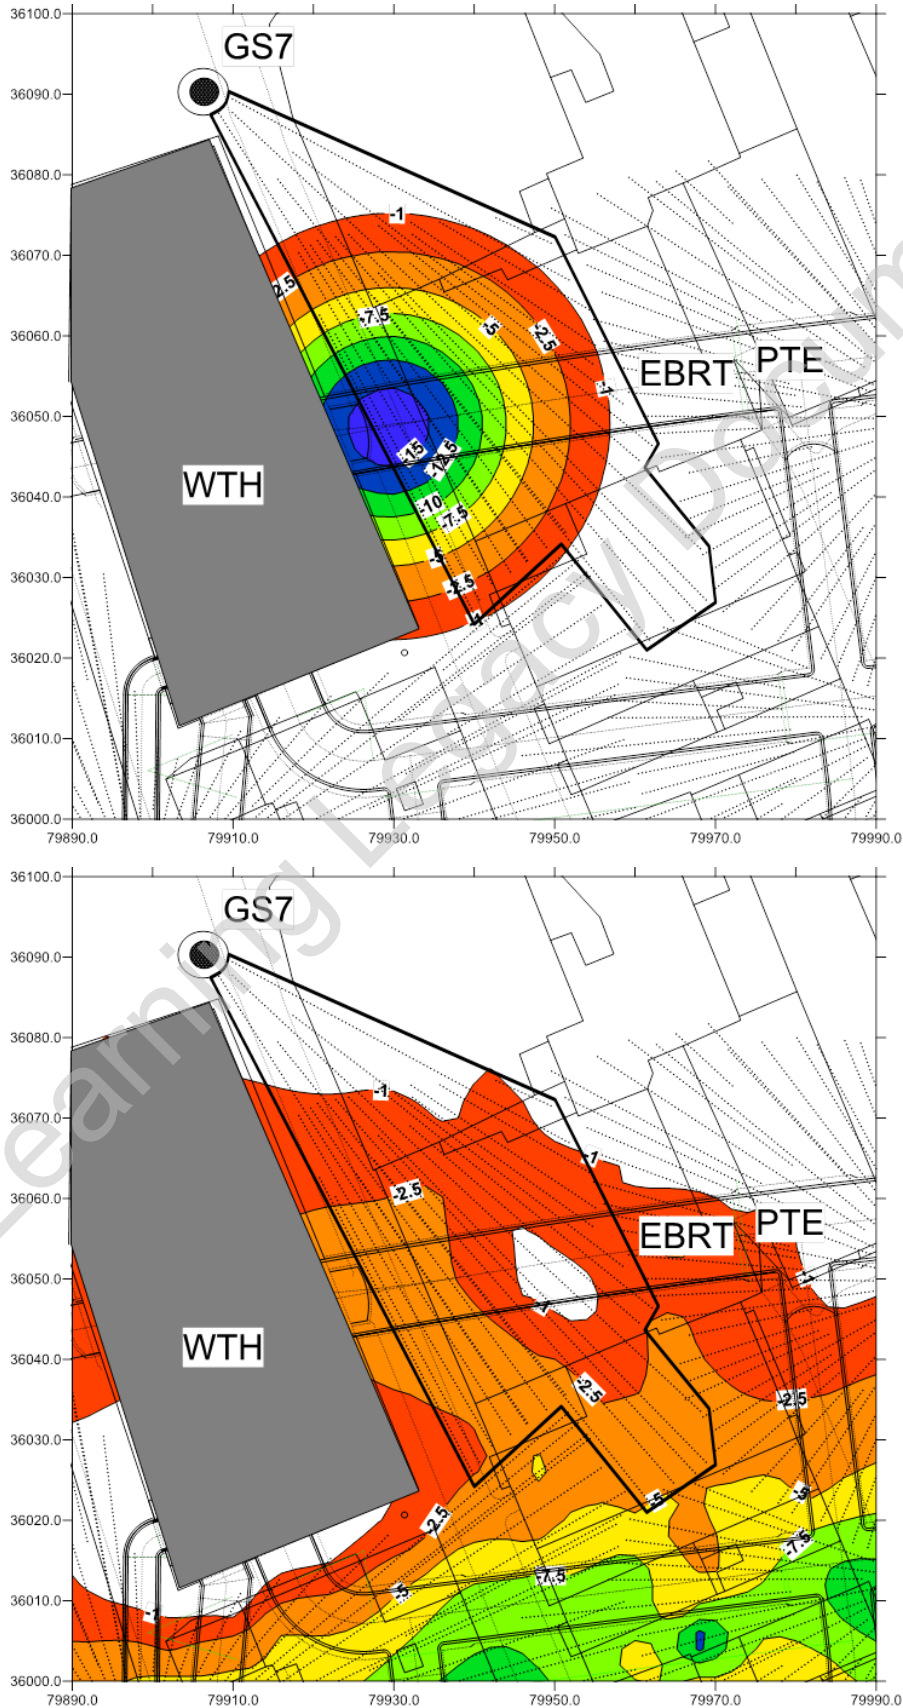
Figure 3.4.1 Period C: (a) Predicted greenfield settlement. (b) Change in measured settlement. (c) Total measured settlement

Figure 3.4.1(a) shows the predicted settlements due to tunnelling for PTEP and PTEE (max. 17mm). The measured settlements reported in Figure 3.4.1(b) are less than 5mm in the zone of influence of these tunnels. The concurrent compensation grouting carried out during Period C, as illustrated Figure 3.4.2, was effective in limiting settlement to very small values. Total settlement increased to just over 10mm (Figure 3.4.1(c)).

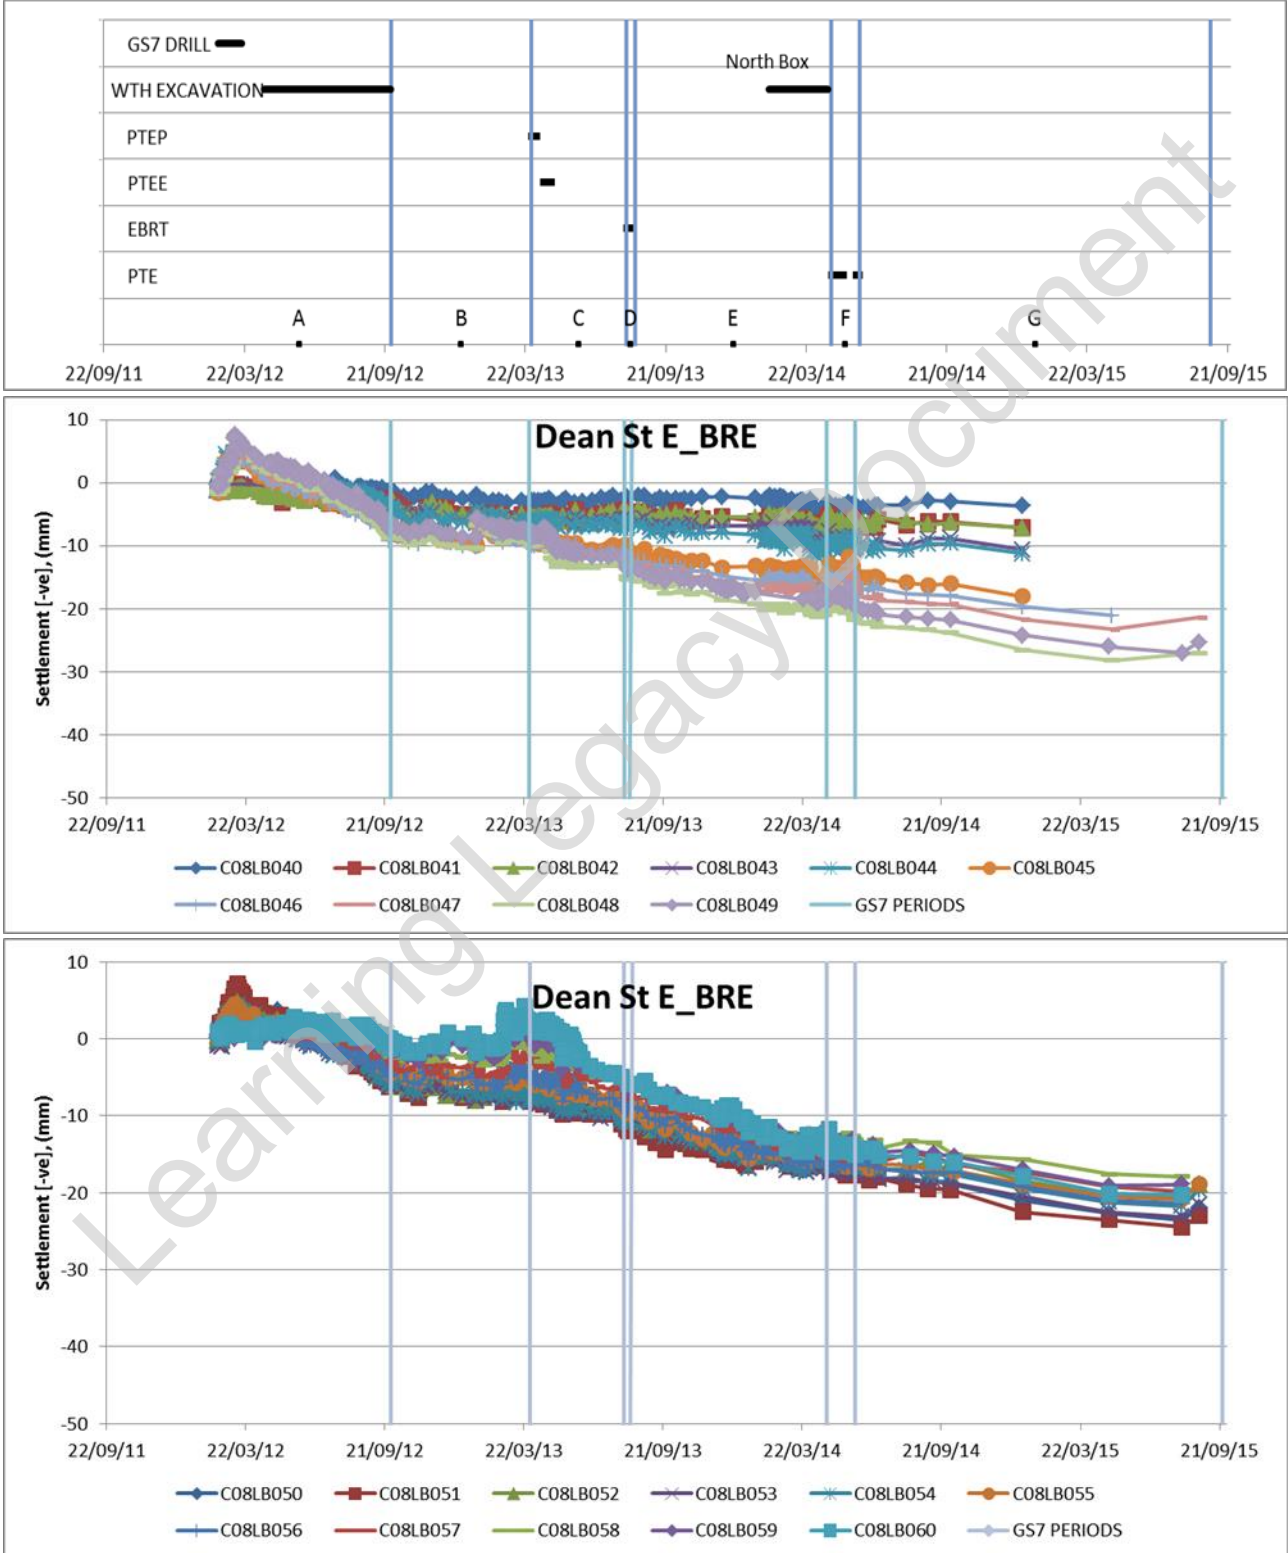
4.2. Dean Street East - North

- The northerly part of the Dean Street east façade is outside the specified compensation grouting zone although a limited number of ports were installed. The façade is within the plan extent of the GS7 array between distances 28m and 77m.

- In Period A, up to 8mm heave was generated during TaM drilling using the water flush method. Subsequent dissipation together with excavation of the WTH south box produced a settlement of less than 10mm at the end of the Period.

- The rate of post construction settlement shows a small tendency to a reducing rate to the end of Period G. It is noted that re-development of the building between 0 and 28m distance (1 Dean Street) commenced during the monitoring period and no further readings were possible on points C08LB040 - C08LB045 after January 2015.

- No Amber or Red slope triggers have been exceeded.
- The profile plot confirms that the consolidation settlement is relatively uniform over a wide area resulting in little change in slopes.

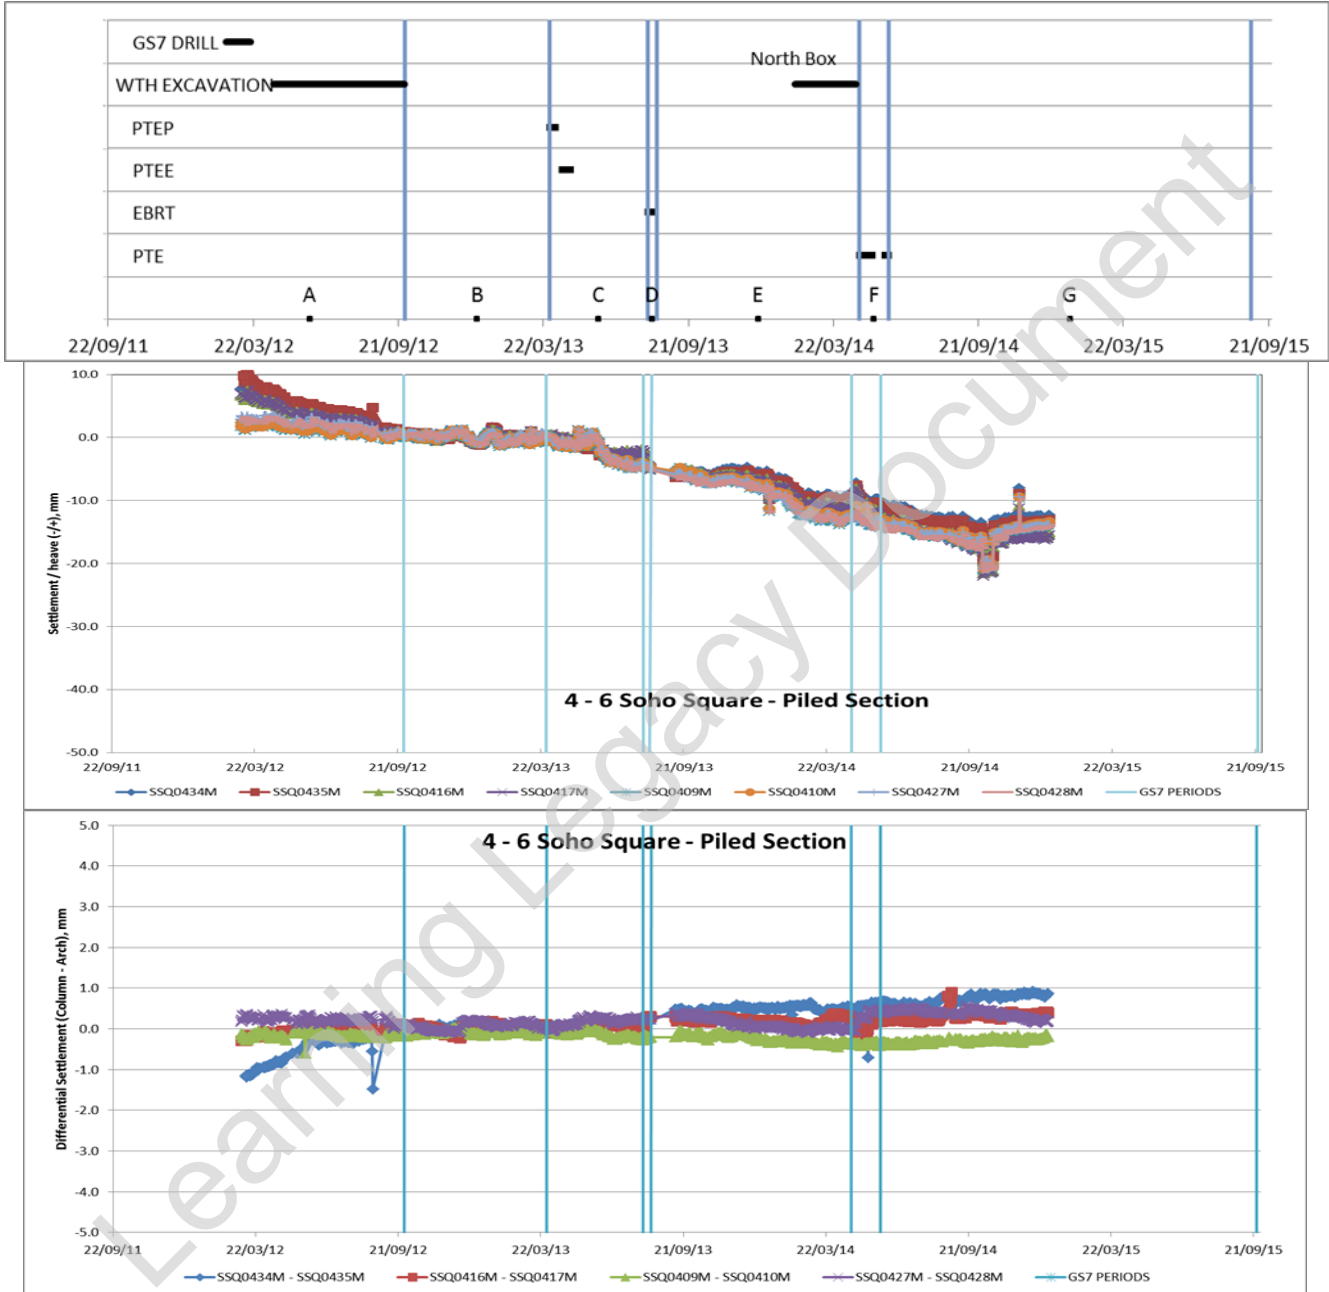
### 4.3. 4-6 Soho Square

- Data are presented from pairs of HLC from 4 locations: each pair includes one HLC on a column supported on piles and one HLC on ground bearing brickwork arches. The HLC were installed after the start of drilling (in March 2012) since the building was being refurbished. Temporary manual levelling was undertaken prior to the commissioning of the HLC and adjustments have been made based on this data.
- The only noticeable construction event related settlement occurs in Period C and is related to works outside the GS7 area (CH1Ext and CL1 excavation – see GS1 and GS2 reports). There is also an apparent increase in the rate of movement in Period E at around the time of the

WTH North Box excavation. However, given the distance of the piles from the excavation, it is considered that there is no causative link.

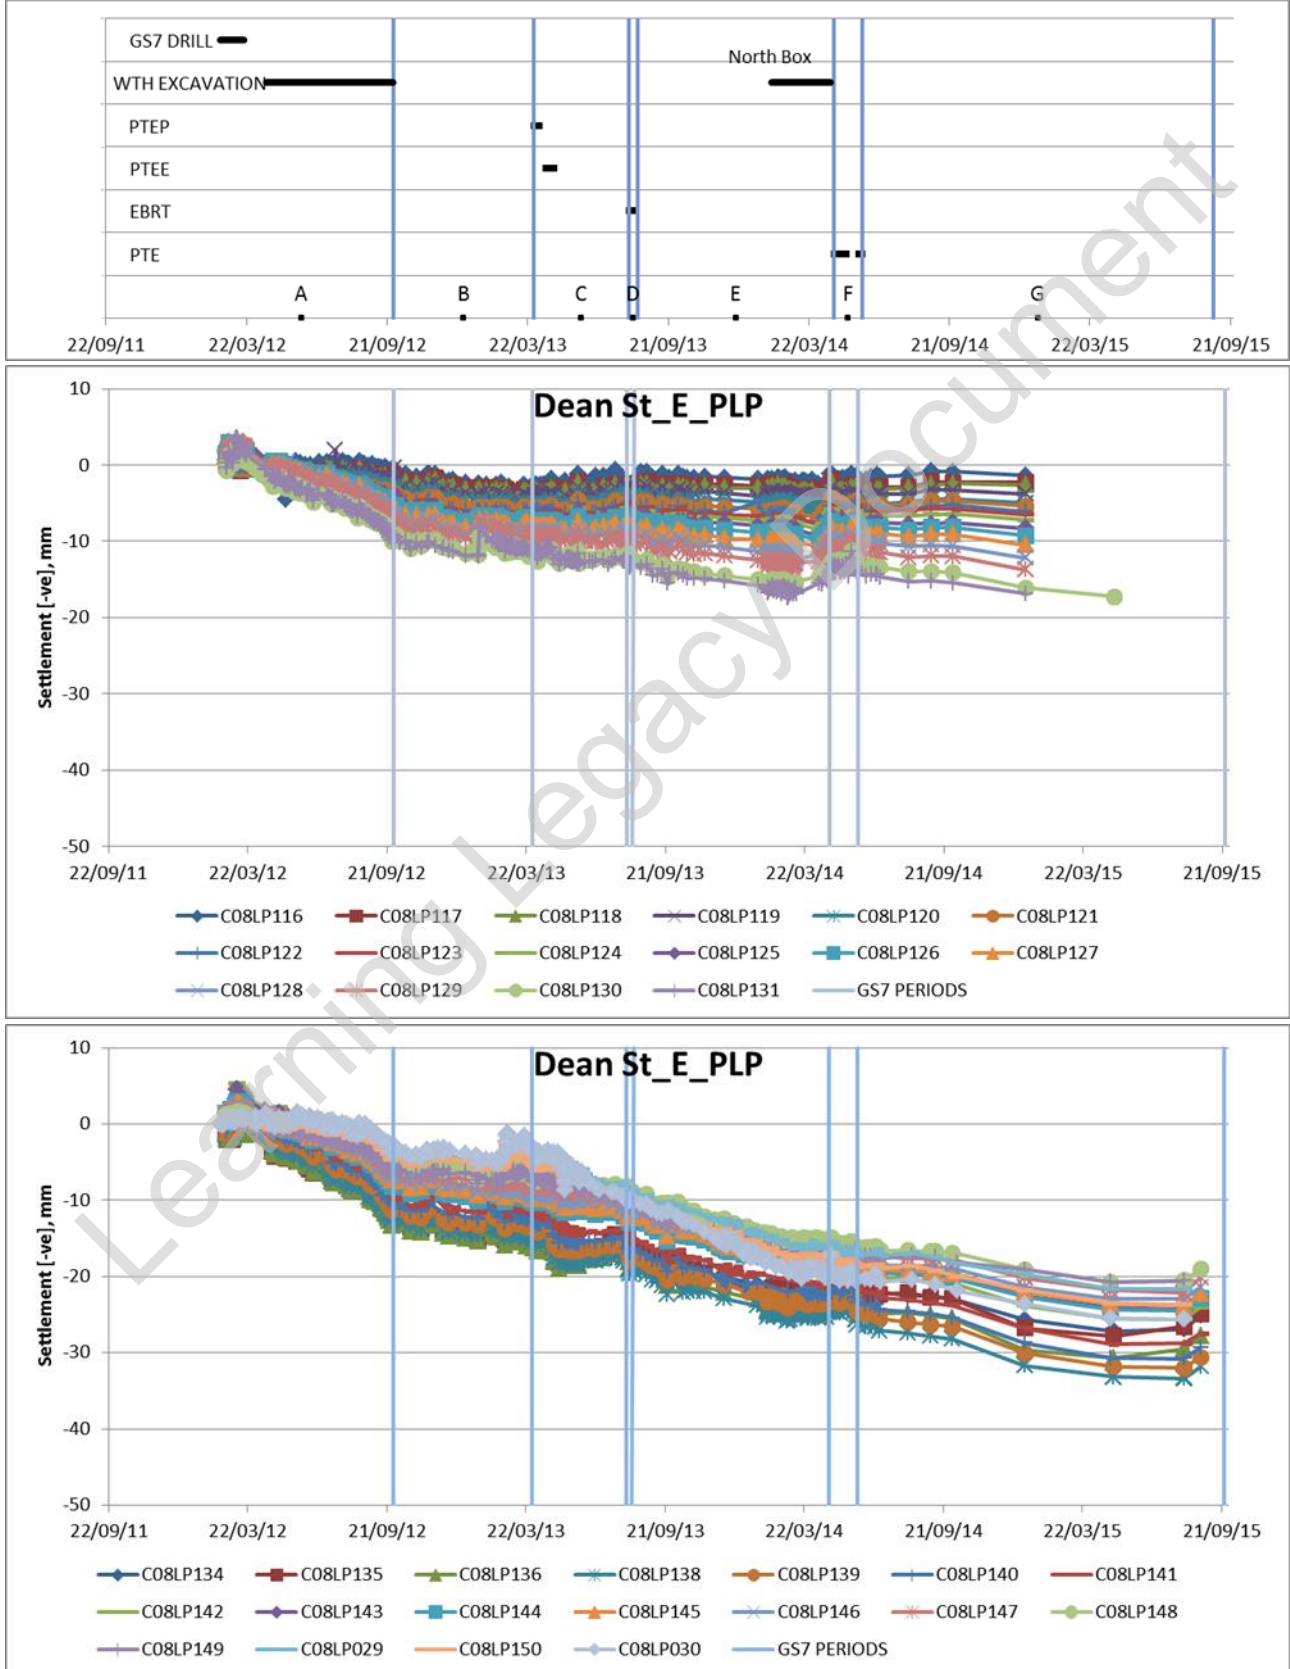
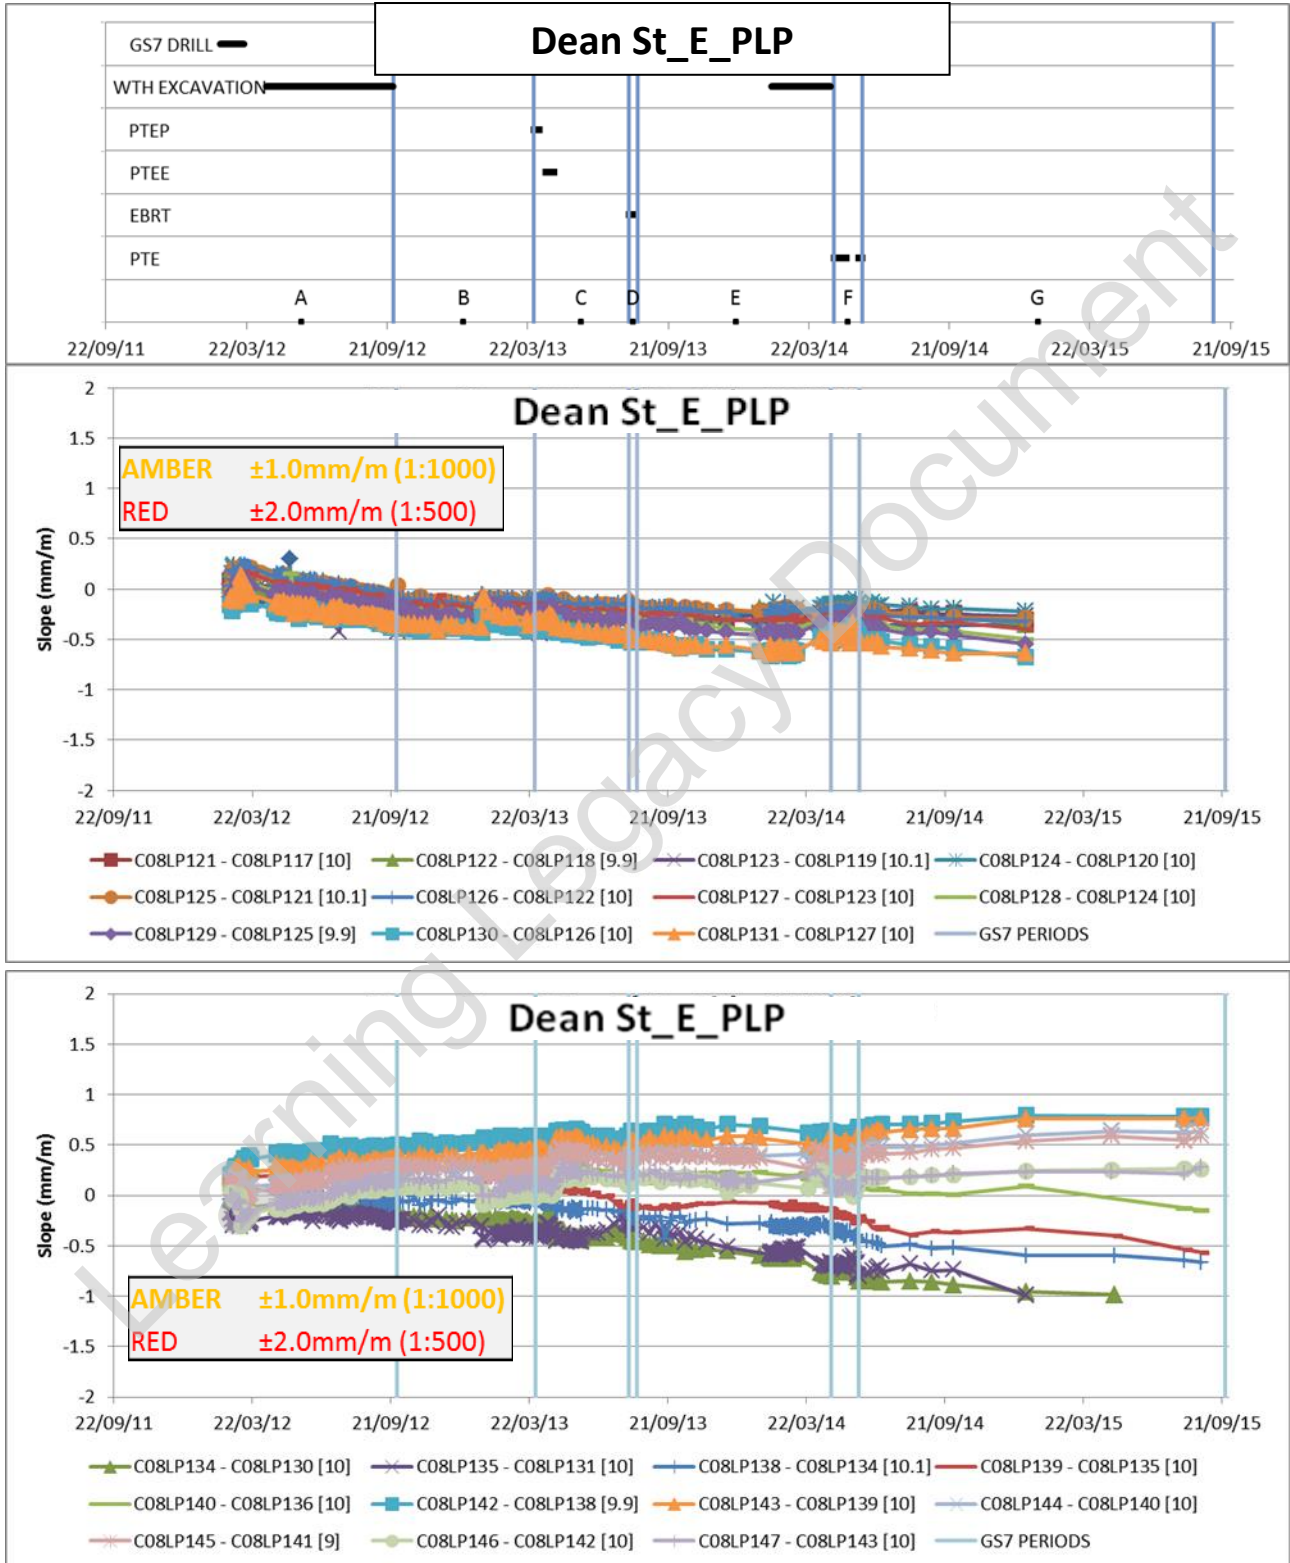
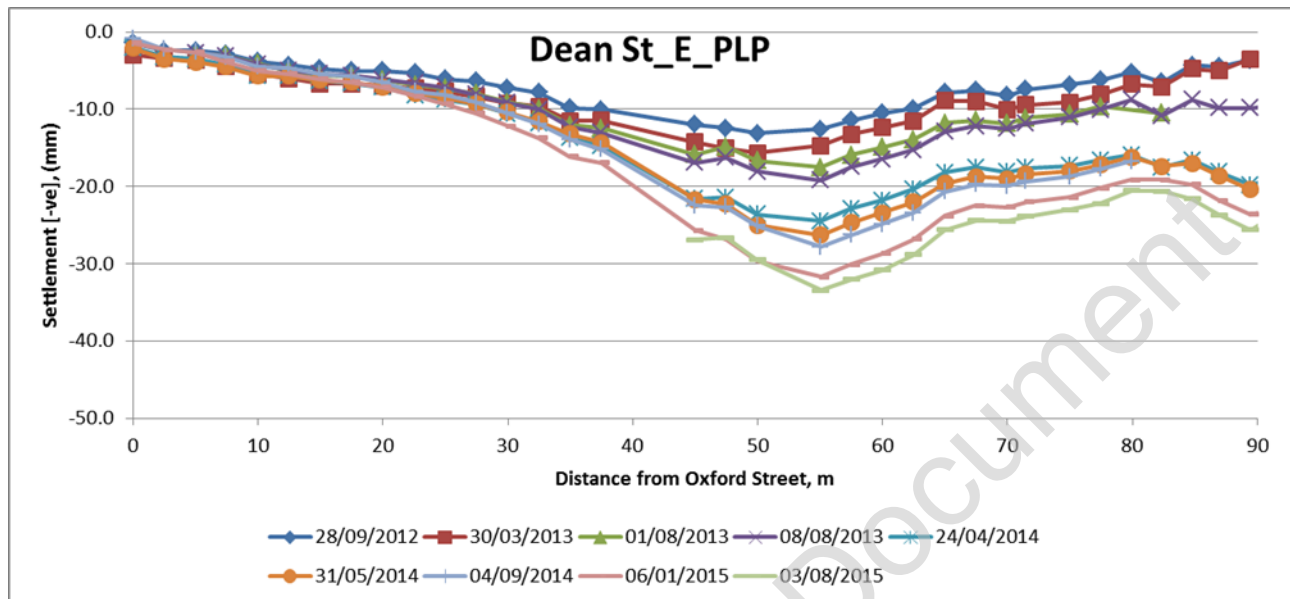
5.2. Dean Street East - north

- The northerly part of the Dean Street east kerb line is outside the specified compensation grouting zone although a limited number of ports were installed. The kerb line is within the plan extent of the GS7 array between distances 28m and 77m.<sup>1</sup>

- The rate of post construction settlement shows a small tendency to a reducing rate to the end of Period G. It is noted that re-development of the building between 0 and 28m distance (1 Dean Street) commenced during the monitoring period and no further readings were possible on points C08LP116 - C08LP129 after January 2015.

- No Amber or Red slope triggers were exceeded during construction, although a number of locations have slopes close to the Amber limit as a result of post construction movements. It is noted that C422 was constructing the permanent internal structure and removing temporary props in the WTH during this period.

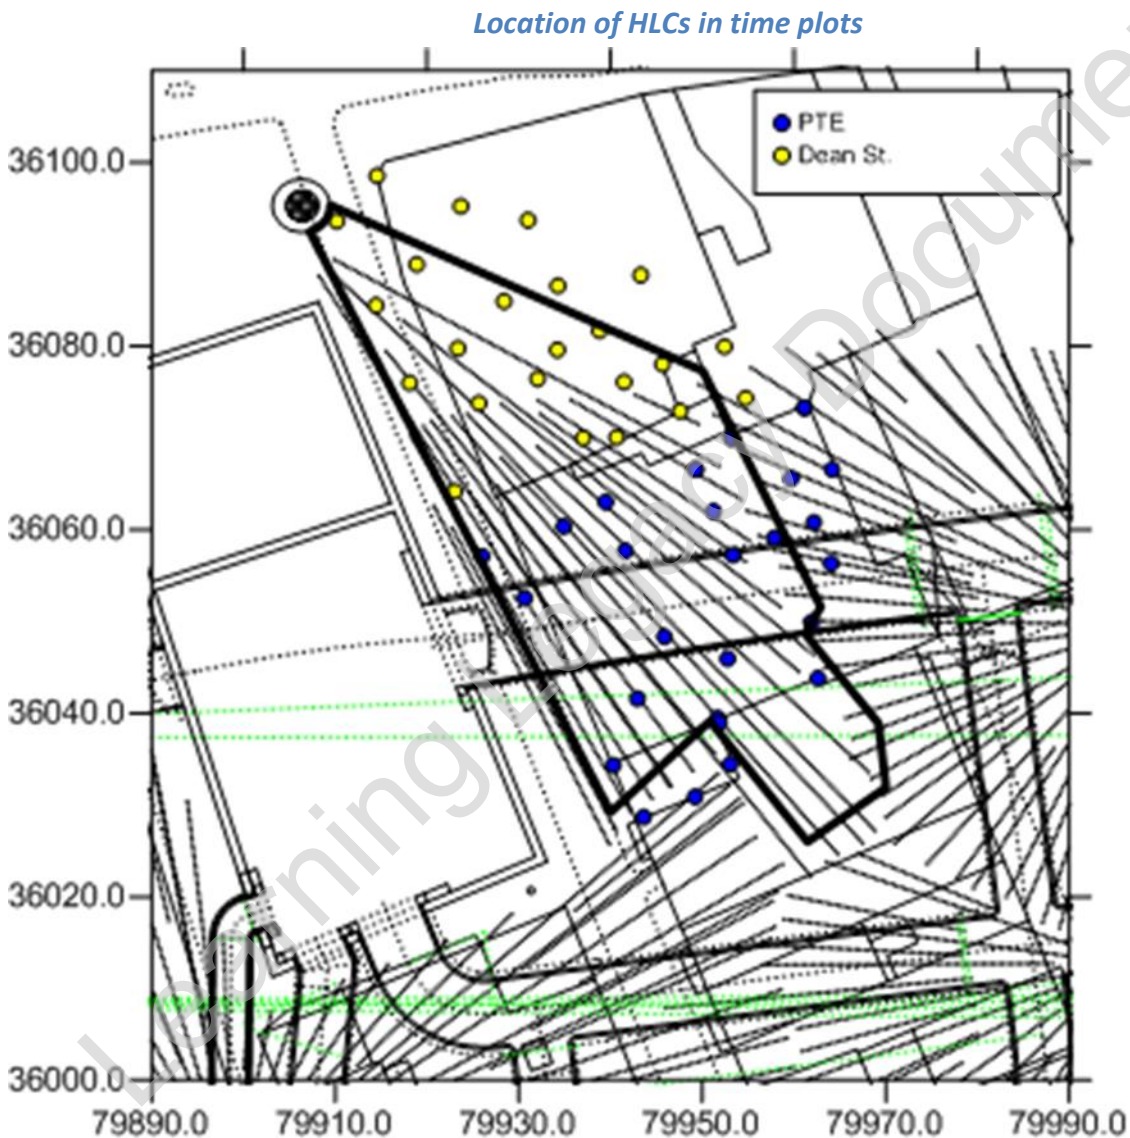
HLC were primarily used for control of compensation grouting giving data at 15 minute intervals. The system was left operational after the completion of the tunnelling to provide information on post –construction movements. Scatter observed in HLC data during December 2014 and February 2015 was due to the cessation of maintenance since this monitoring data following the completion of excavation works in May 2014 and the de-commissioning of the grout shaft from August 2014.

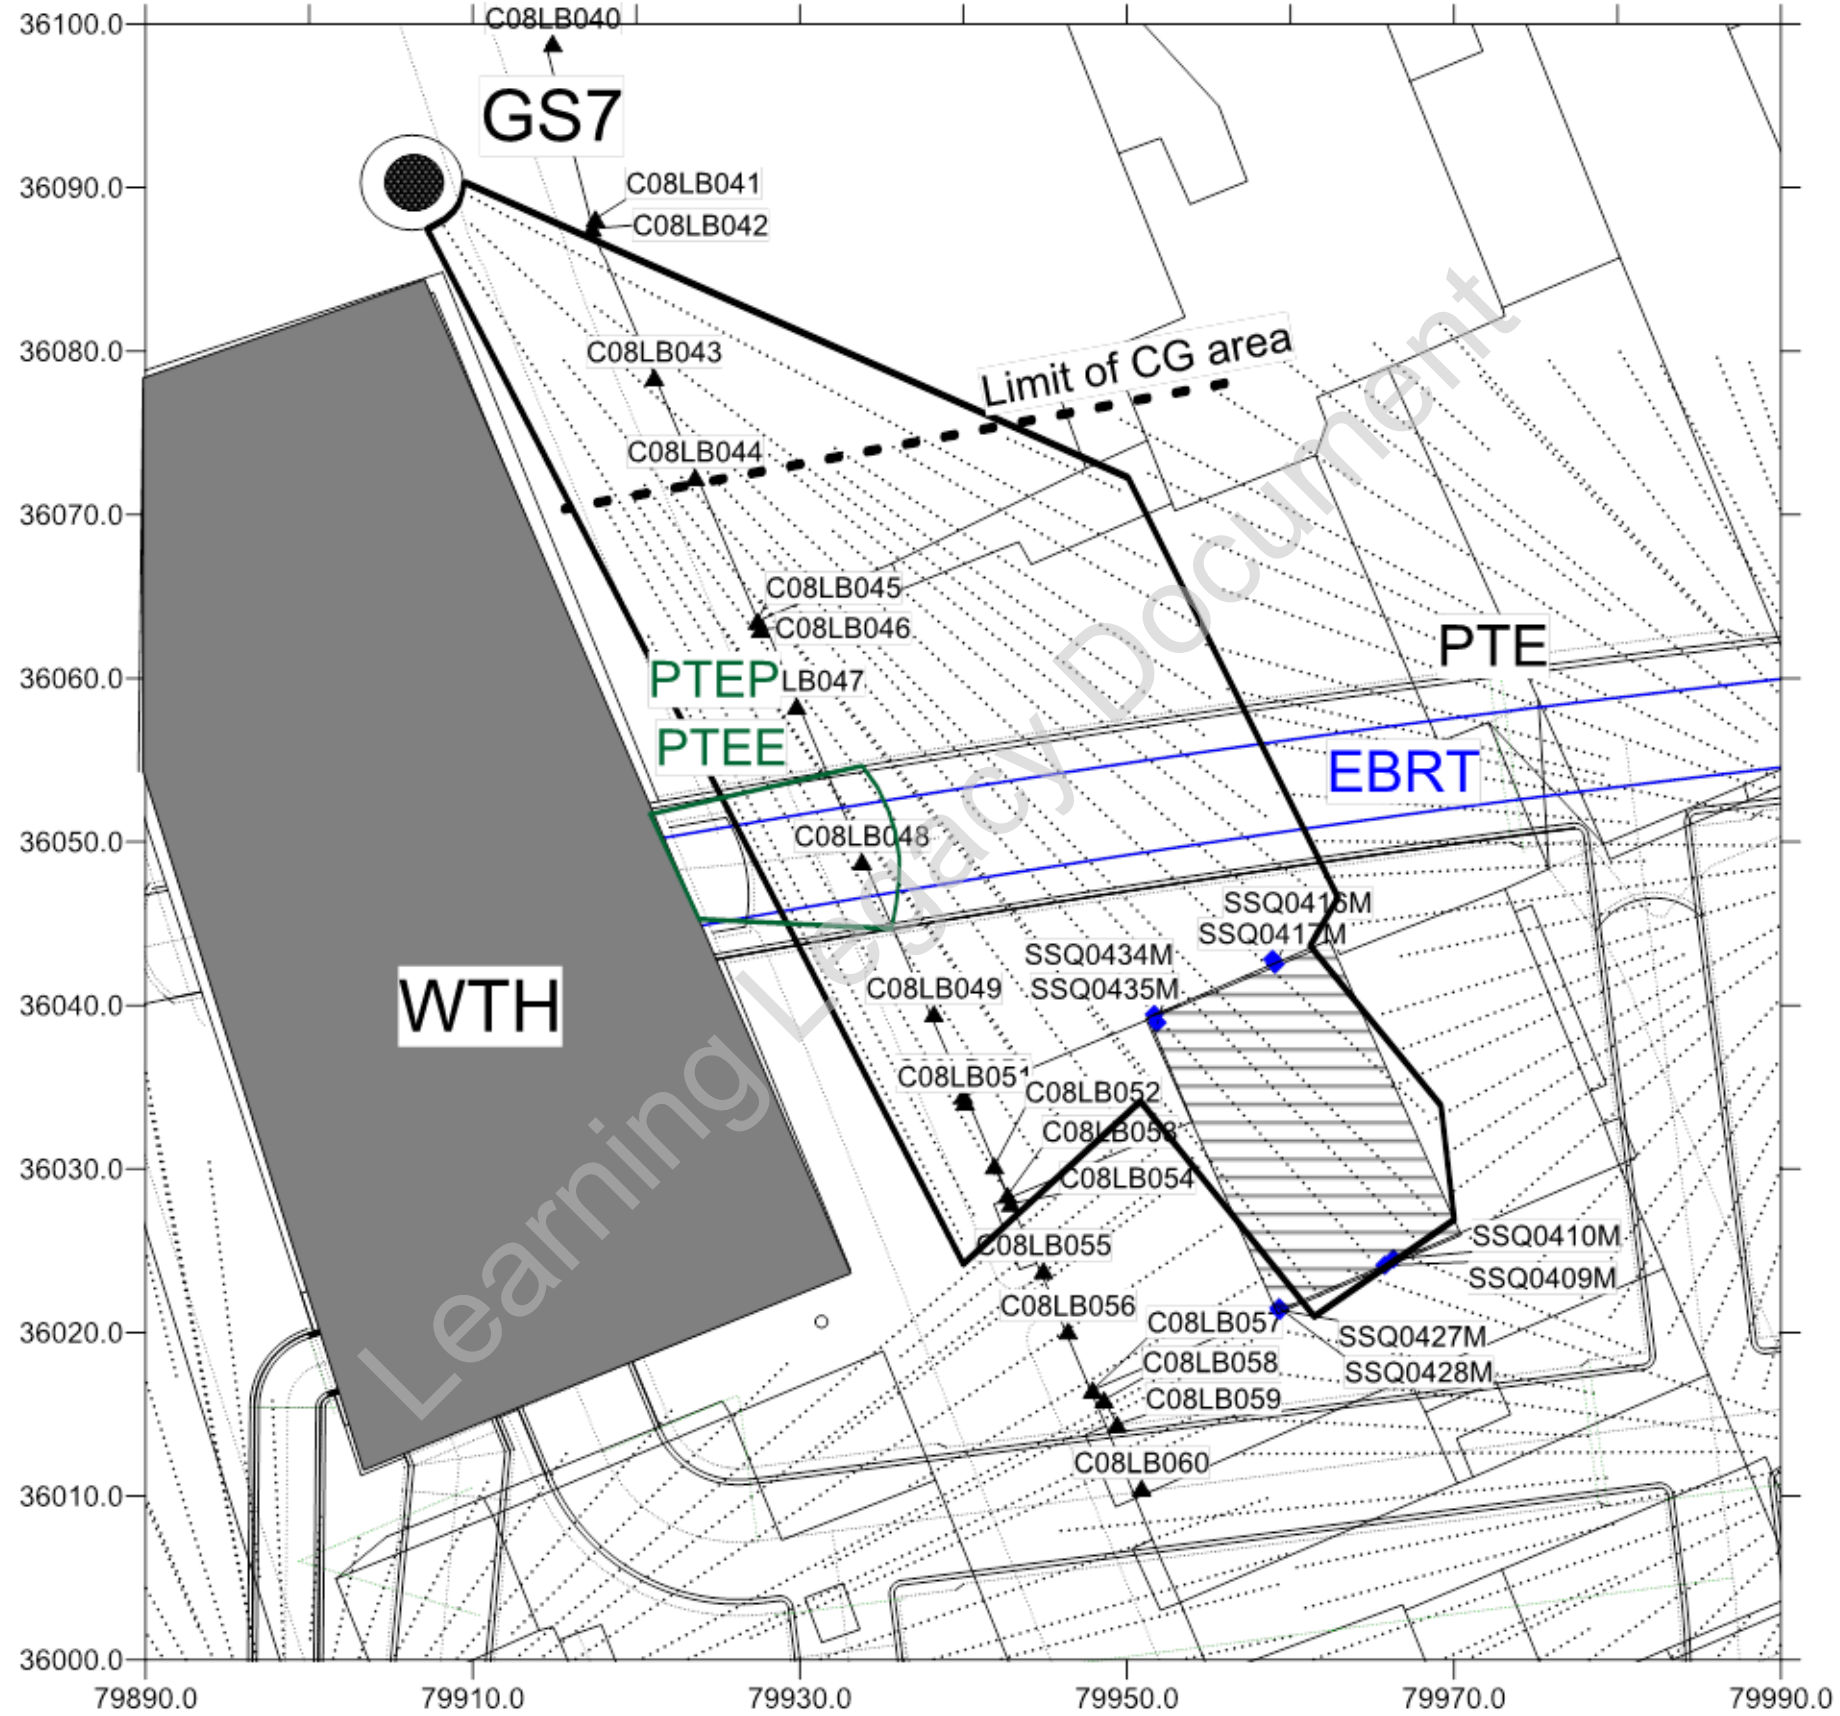
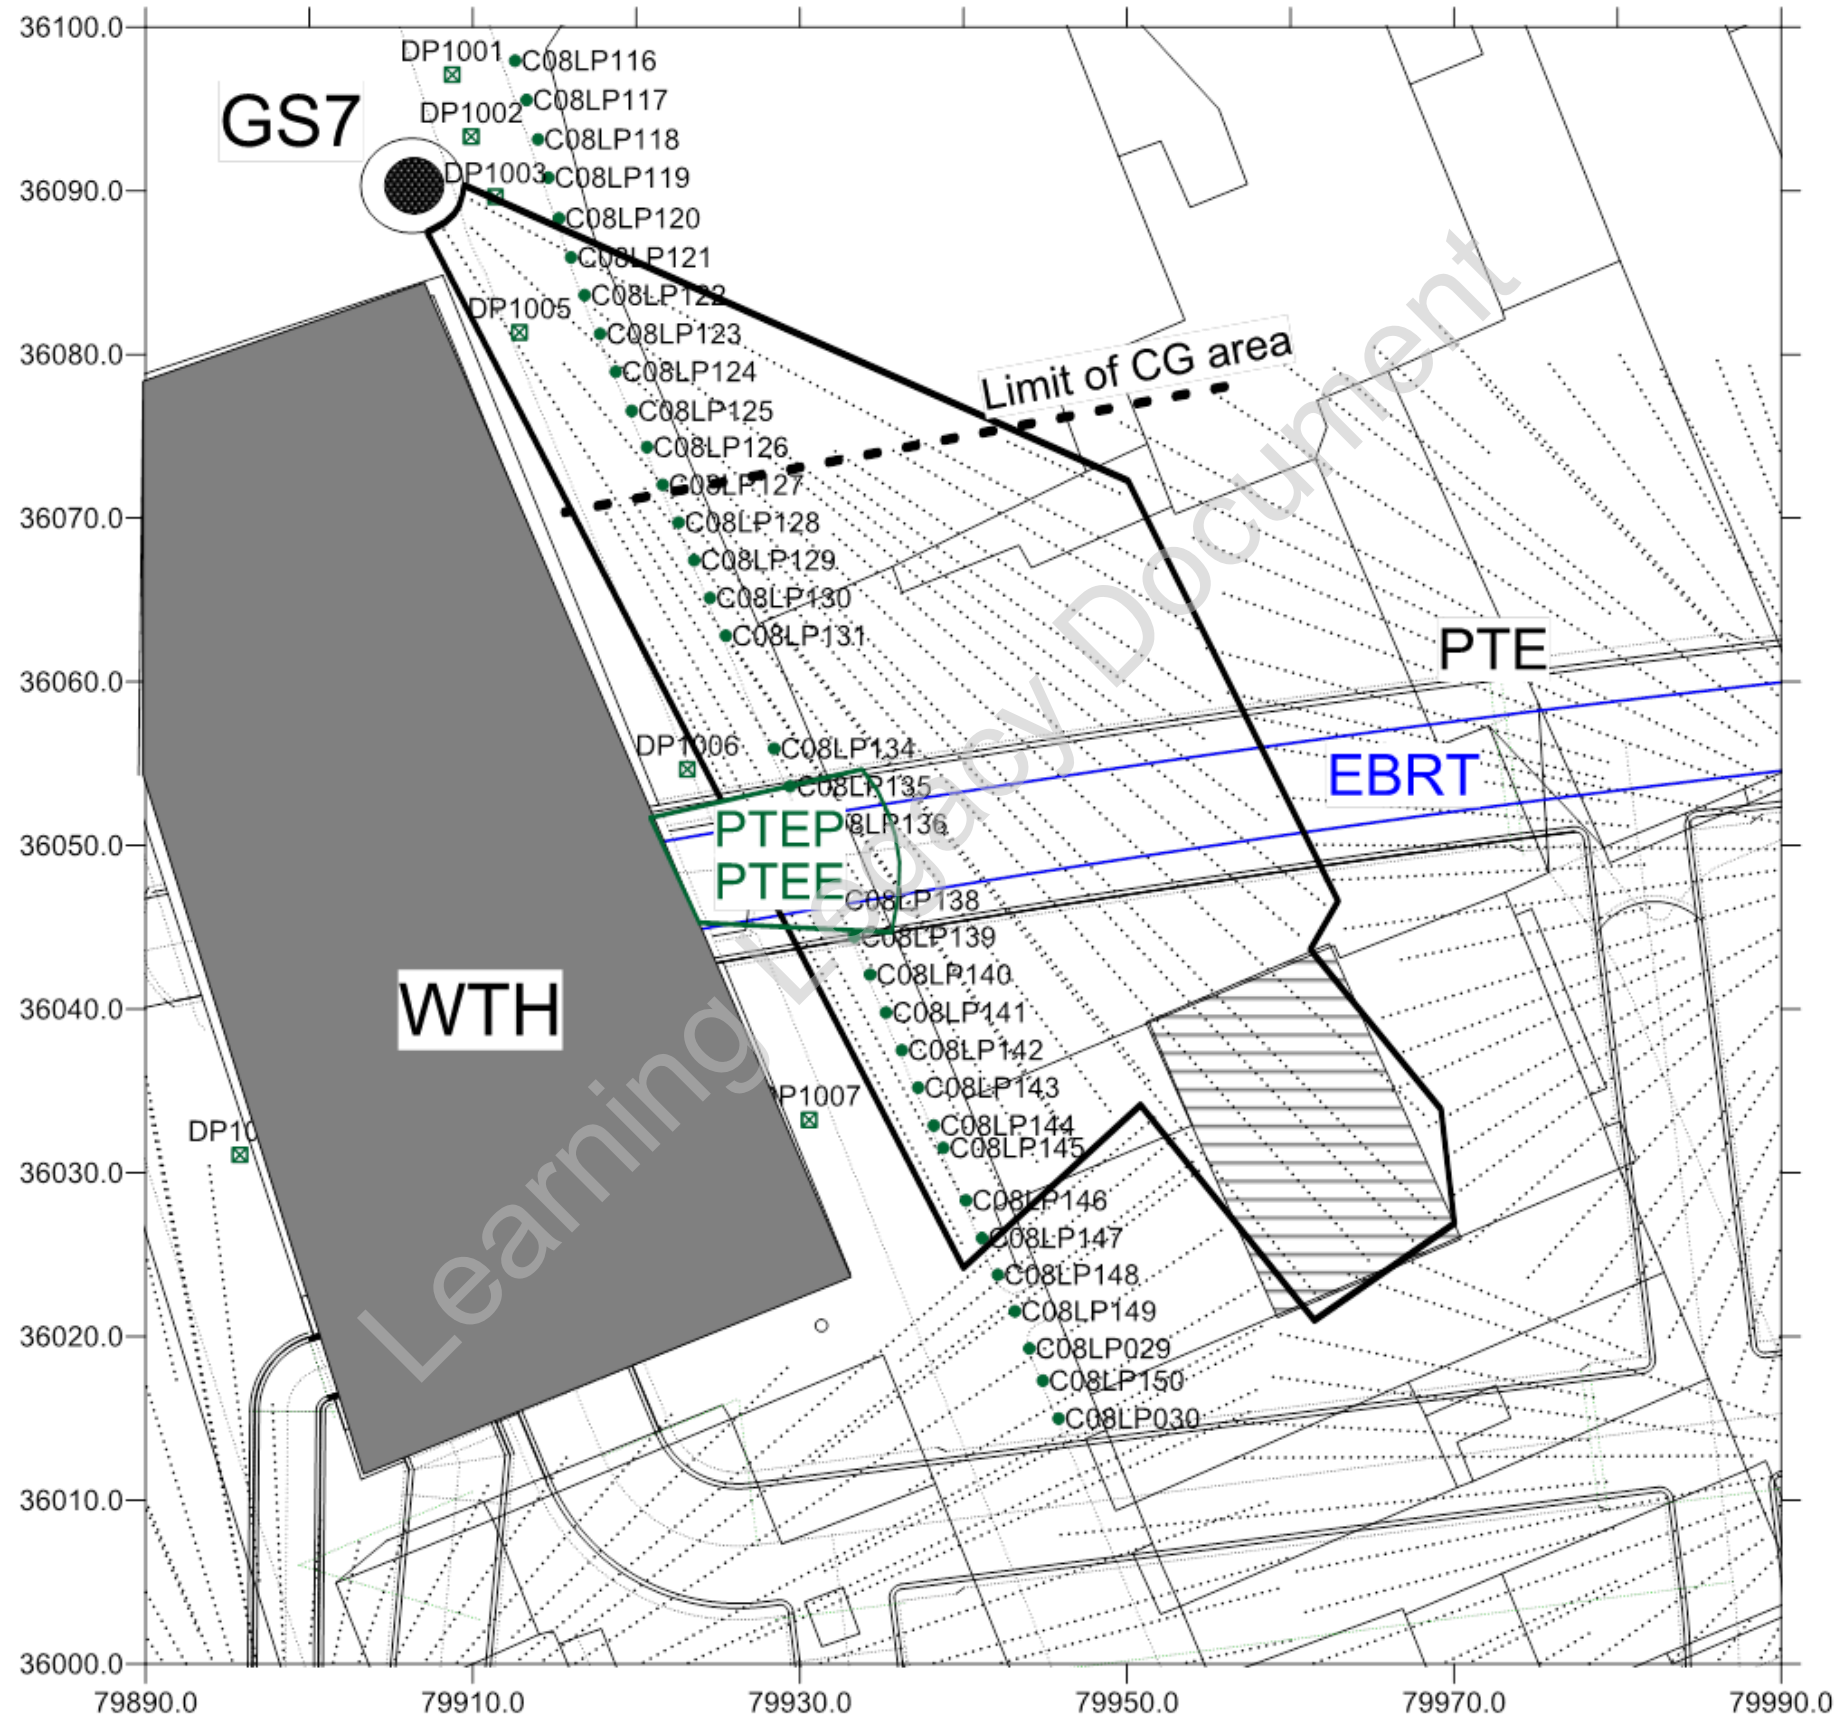
*Enlarged version of Figures 4.1 and 5.1 showing location of monitoring points*

The locations of BRE monitoring of building facades within the GS7 area are shown on Figure 4.1. A larger version of Figure 4.1 is included in Appendix C.

The TaMs installed from GS7 were extended below a partially piled section of 4-6 Soho Square, although no grouting was undertaken in this area. HLC were installed on the columns supported by piles and on the adjacent brickwork of the ground bearing arches, to record any differential movement. Selected data is presented, the locations of which are shown on Figure 4.1. All HLC data presented is based on daily means.
