### Western Tunnels & Caverns Project

# Final Monitoring Report

## Bond Street Station – Manual Monitoring

CRL Document No. **C300-BFK-C4-RGN-CRT00\_ST005-53005**

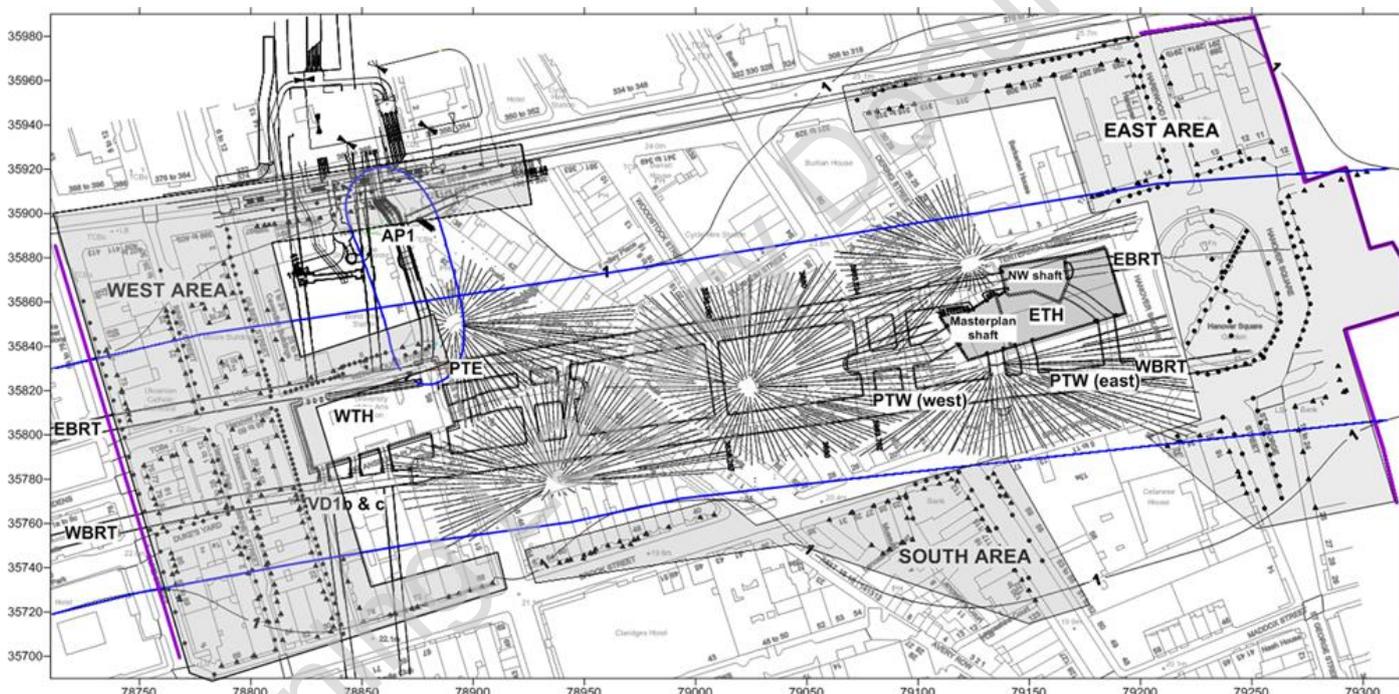
Figure 1.1 Areas from which data is presented

There are three areas not covered in the Grout Shaft Close Out reports as shown on Figure 1.1. These comprise:

1. West – Duke Street to Gilbert Street, plus Weighhouse Street, Oxford Street and Brook Street east of Gilbert Street
2. South – Area to the west of New Bond Street from Brook Street to the south
3. East – Soho Square (excluding west façade)

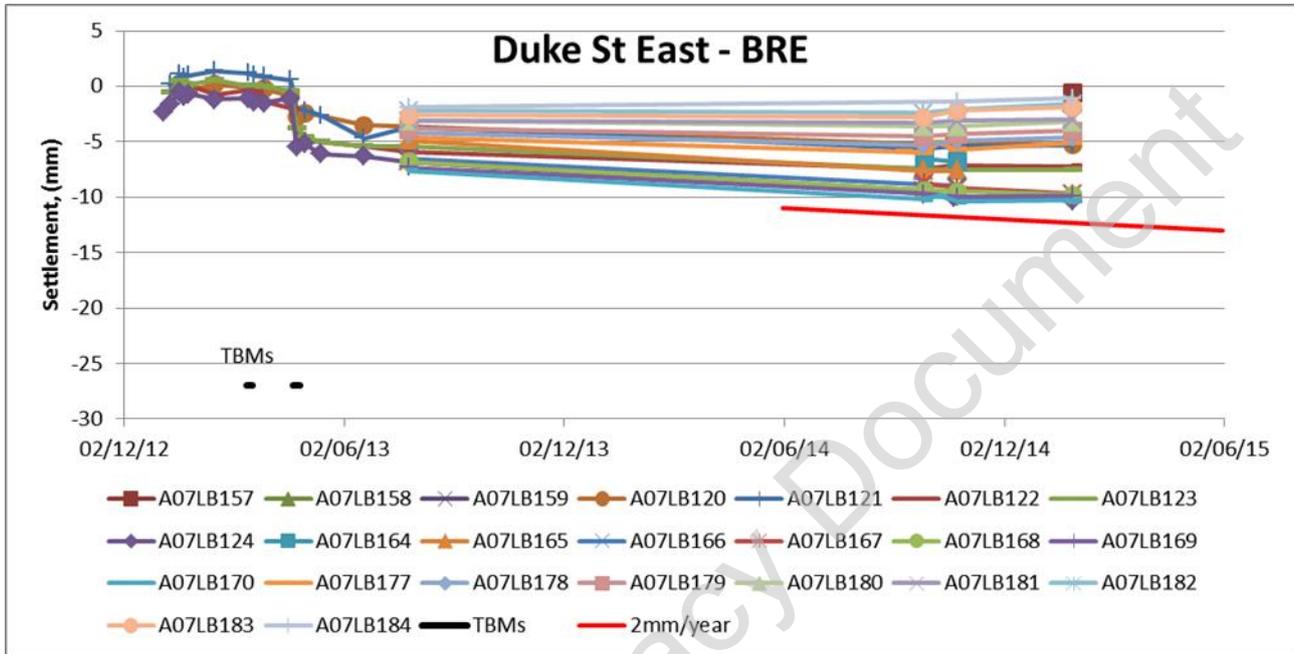
Figure 2.2: Data time-plot: comparison against 2mm/year settlement rate (long-term)

The points on the east façade of Duke Street had settled by ~5mm at the end of C300 Works. Small effects associated with the two TBM drives are visible from the settlement time-plot. Long term settlement with a potential contribution from the WTH works (C411) increased the maximum movement to 10mm.

The overall long term behaviour gives a settlement rate of less than 2mm/year. By inspection of the profile plot, no slope triggers have been exceeded. The residual risk associated with long-term settlements is considered to be negligible.

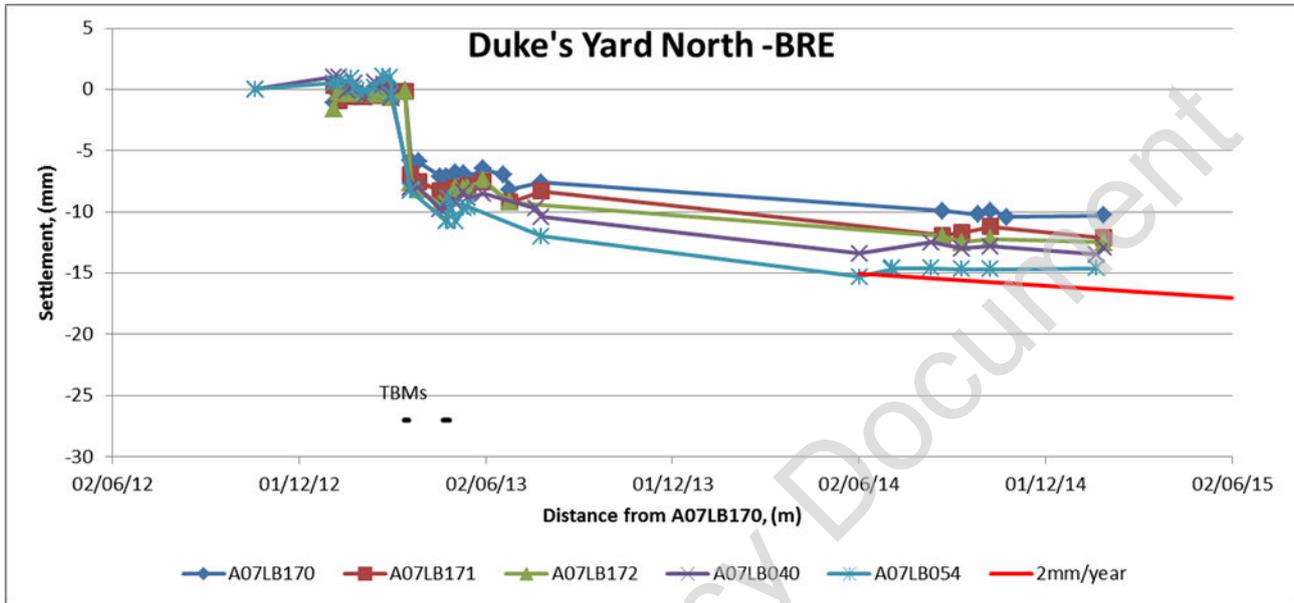
Figure 2.4: Data time-plot: comparison against 2mm/year settlement rate (long-term)

The points on the north façade of Duke's Yard had settled by ~10mm at the end of C300 Works. Small effects associated with the two TBM drives are visible from the settlement time-plot. Long term settlement with a potential contribution from the WTH works (C411) increased the maximum movement to 15mm.

The overall long term behaviour gives a settlement rate of less than 2mm/year. By inspection of the profile plot, no slope triggers have been exceeded. The residual risk associated with long-term settlements is considered to be negligible.

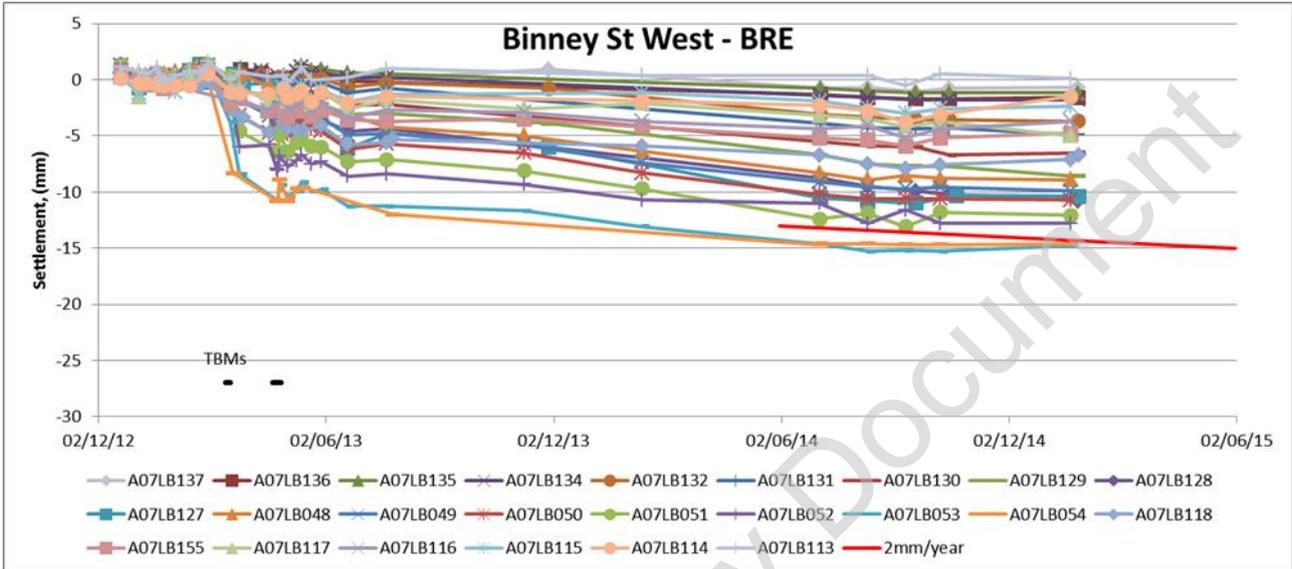
Figure 2.6: Data time-plot - comparison against 2mm/year settlement rate (long-term)

The points on the west façade of Binney Street had settled by ~10mm at the end of C300 Works. Small effects associated with the two TBM drives are visible from the settlement time-plot. Long term settlement with a potential contribution from the WTH works (C411) increased the maximum movement to 15mm.

The overall long term behaviour gives a settlement rate of 2mm/year. By inspection of the profile plot, no slope triggers have been exceeded. The residual risk associated with long-term settlements is considered to be negligible.

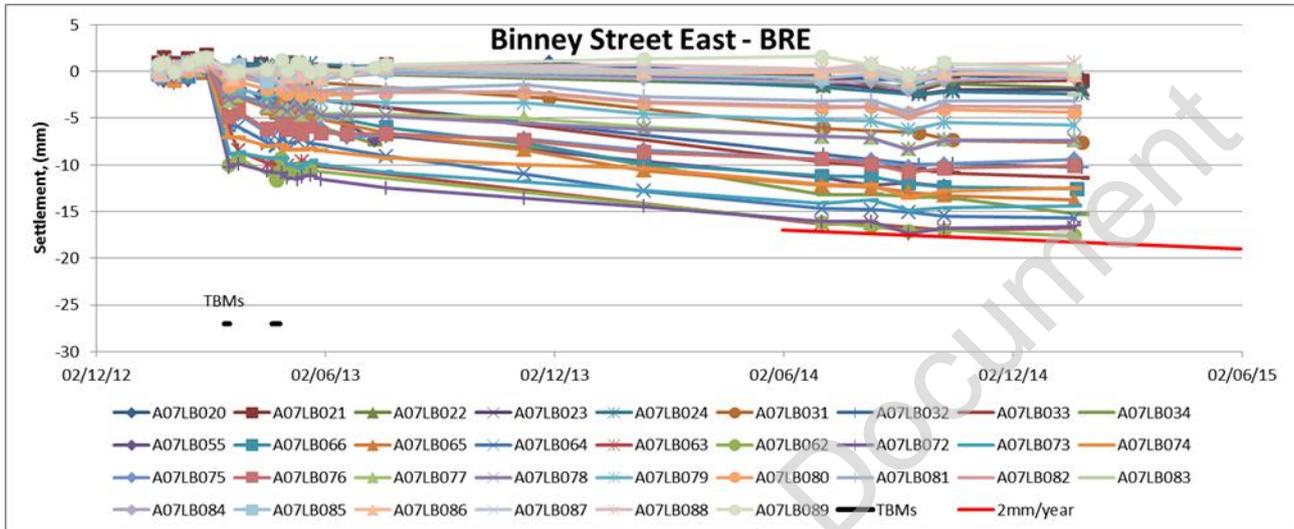
Figure 2.8: Data time-plot - comparison against 2mm/year settlement rate (long-term)

The points on the east façade of Binney Street had settled by ~12mm at the end of C300 Works. Small effects associated with the two TBM drives are visible from the settlement time-plot. Long term settlement with a potential contribution from the WTH works (C411) increased the maximum movement to 17mm.

The overall long term behaviour gives a settlement rate of 2mm/year. By inspection of the profile plot, no slope triggers have been exceeded. The residual risk associated with long-term settlements is considered to be negligible.

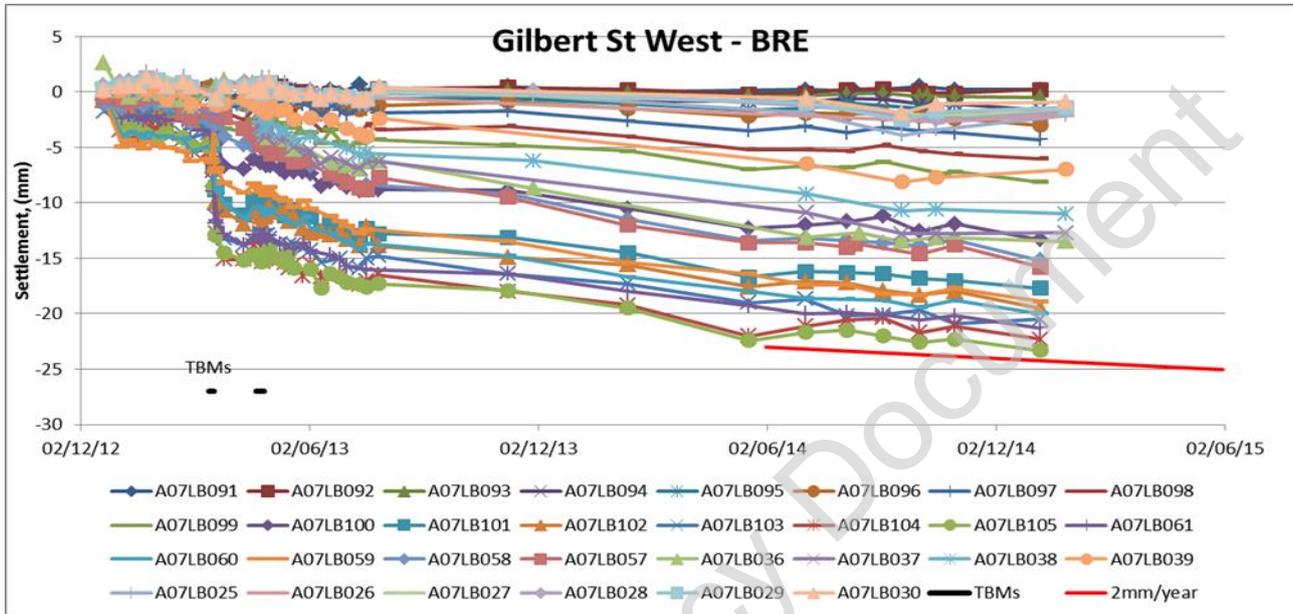
Figure 2.10: Data time-plot - comparison against 2mm/year settlement rate (long-term)

The points on the west façade of Gilbert Street had settled by up to 5mm prior to BFK works. Settlement increased by ~10mm due to the TBM drives. Small effects associated with the two TBM drives are visible from the settlement time-plot. Long term settlement with a potential contribution from the WTH works (C411) increased the maximum movement to 24mm.

The overall long term behaviour gives a settlement rate of 2mm/year. The maximum slope recorded is less than 0.8mm/m: no slope triggers have been exceeded. The residual risk associated with long-term settlements is considered to be negligible.

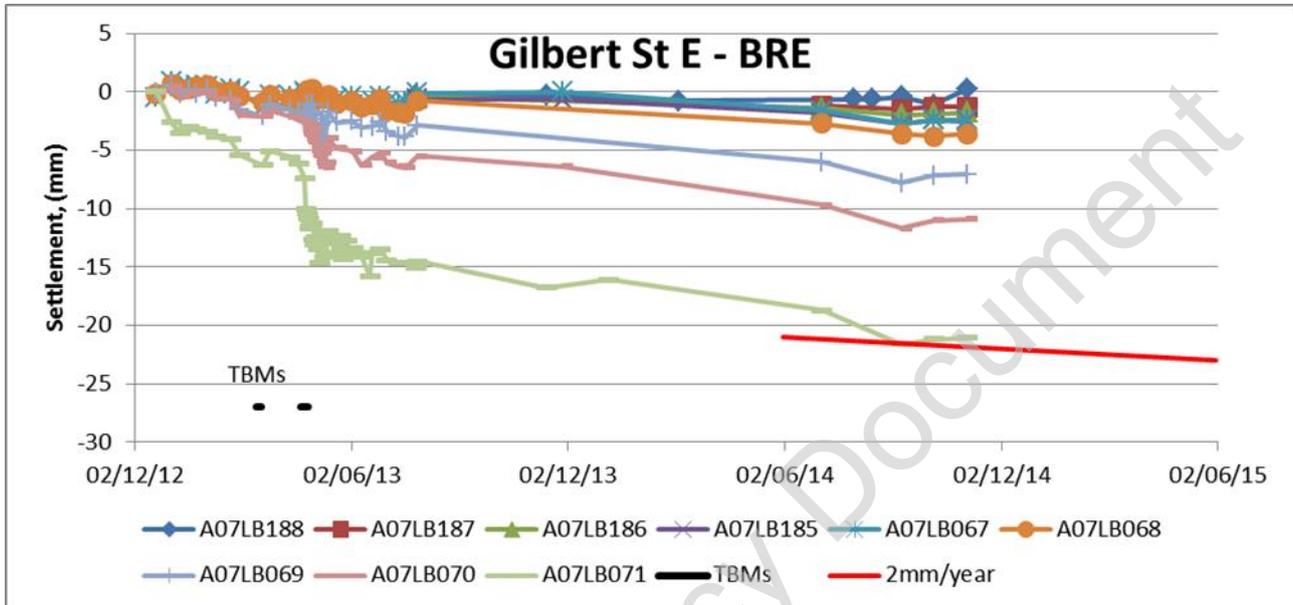
Figure 2.12: Data time-plot - comparison against 2mm/year settlement rate (long-term)

The points on the east façade of Gilbert Street (north of Weighhouse Street) had settled by up to 5mm prior to BFK works. Settlement increased by ~10mm due to the EBRT TBM drive. Long term settlement with a potential contribution from the WTH works (C411) increased the maximum movement to 22mm.

The overall long term behaviour gives a settlement rate of 2mm/year. The maximum slope recorded is 0.9mm/m: no slope triggers have been exceeded. The residual risk associated with long-term settlements is considered to be negligible.

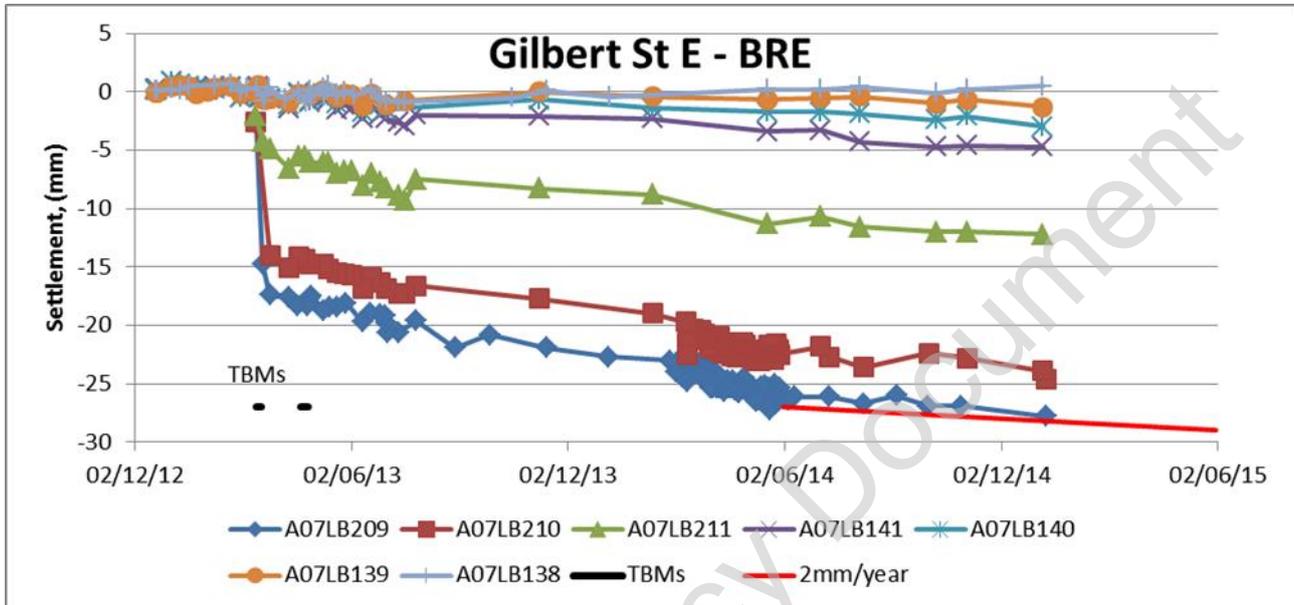
Figure 2.14 Data time-plot - comparison against 2mm/year settlement rate (long-term)

The points on the east façade of Gilbert Street (south of St. Anselm’s Place) settled up to 18mm due to the first C300 WB running tunnel excavation. There is no visible effect from the second, EB, TBM on the settlement time-plot. A small impact (<5mm) from construction of vent tunnel VD1c is evident in May 2014.

Long term settlement with a potential contribution from the WTH works (C411) increased to 28mm at a rate of about 2mm/year. The maximum slope is around 0.9mm/m: no slope triggers have been exceeded. The residual risk associated with long-term settlements is considered to be negligible.

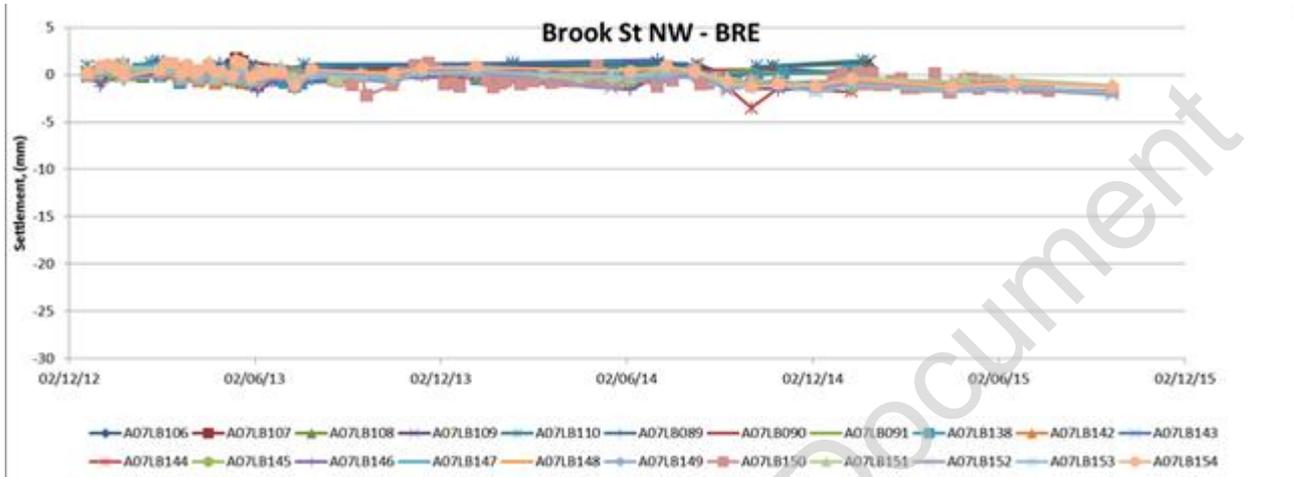
Figure 2.16: Data time-plot - comparison against 2mm/year settlement rate (long-term)

The points on the façade on north side of Brook Street show negligible impact (<5mm) from C300 works. The overall long term rate of settlement is less than 2mm/year. The residual risk associated with long-term settlements is considered to be negligible.

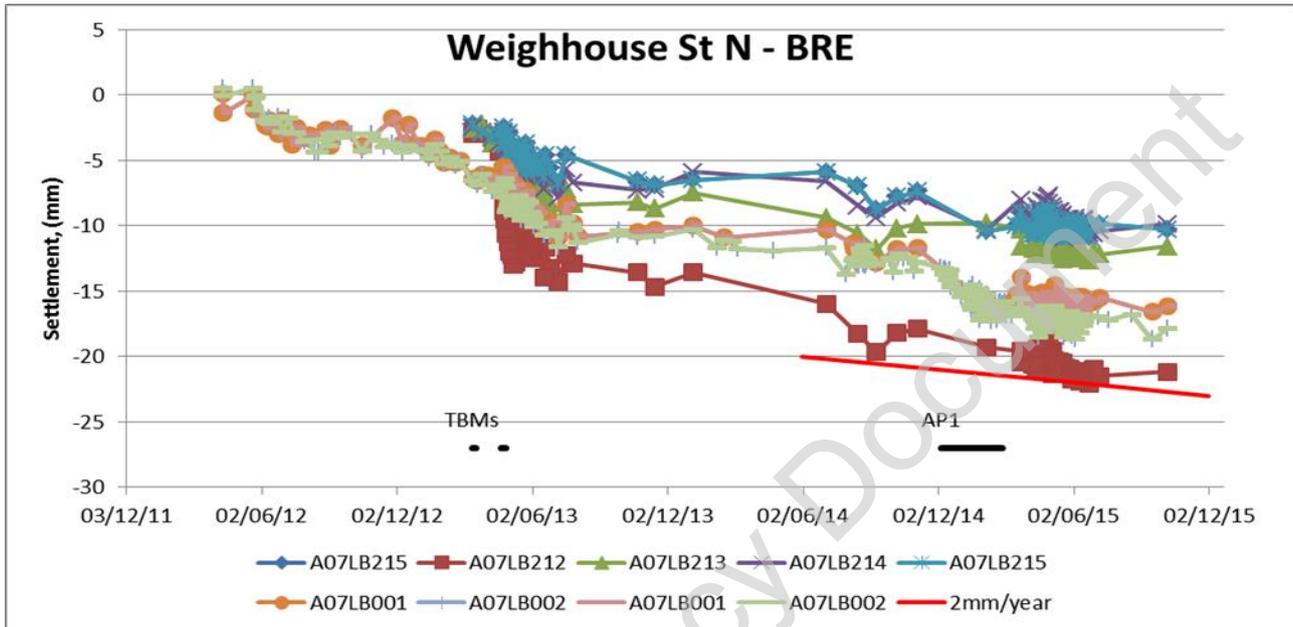
Figure 2.18: Data time-plot - comparison against 2mm/year settlement rate (long-term)

The points on the north side of Weighhouse Street (to the east of Gilbert Street) had up to 6mm settlement prior to C300 works. The maximum settlement following the two TBM drives was about 13mm. Long term settlement, with a potential contribution from the WTH works (C411), increased to a maximum of 21mm. A small effect from AP1 is shown in December 2014.

The overall long term rate of settlement is about 2mm/year. The maximum slope is around 0.9mm/m: no slope triggers have been exceeded. The residual risk associated with long-term settlements is considered to be negligible.

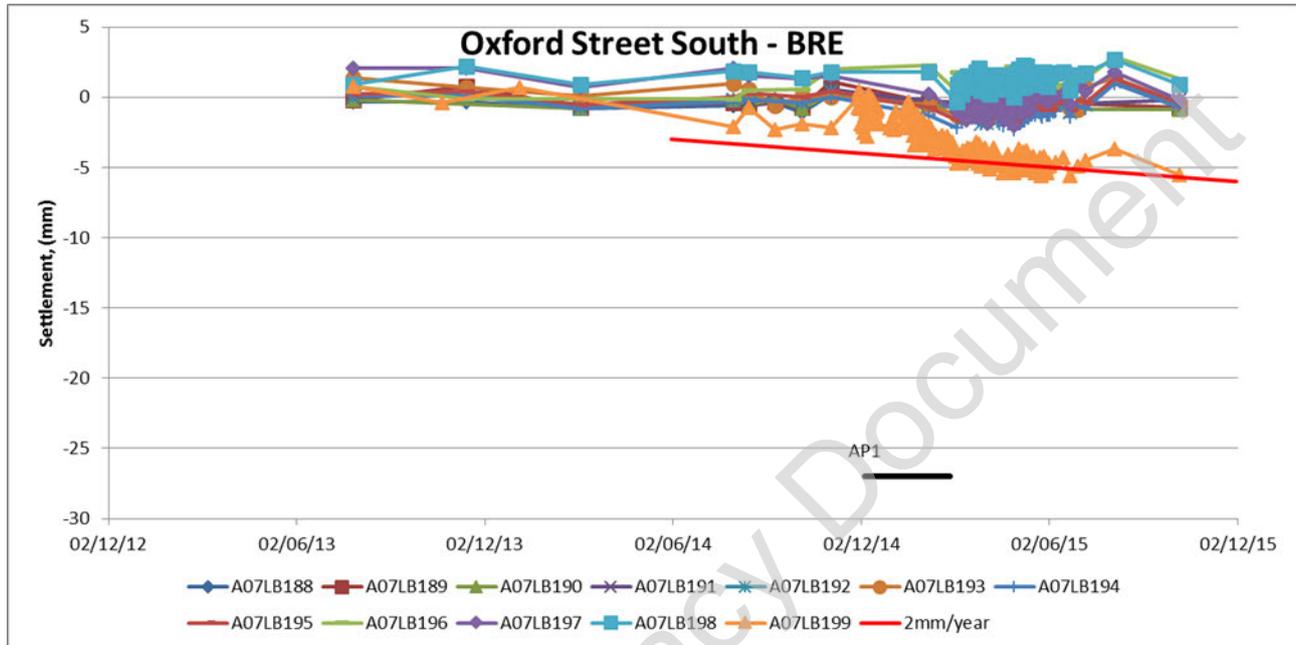
Figure 2.20: Data time-plot - comparison against 2mm/year settlement rate (long-term)

The points on the south side of Oxford Street (to the east of Davies Street) showed settlement of up to 5mm due to construction of AP1 in January 2015.

The overall long term rate of settlement is less than 2mm/year. The maximum slope is around 0.6mm/m: no slope triggers have been exceeded. The residual risk associated with long-term settlements is considered to be negligible.

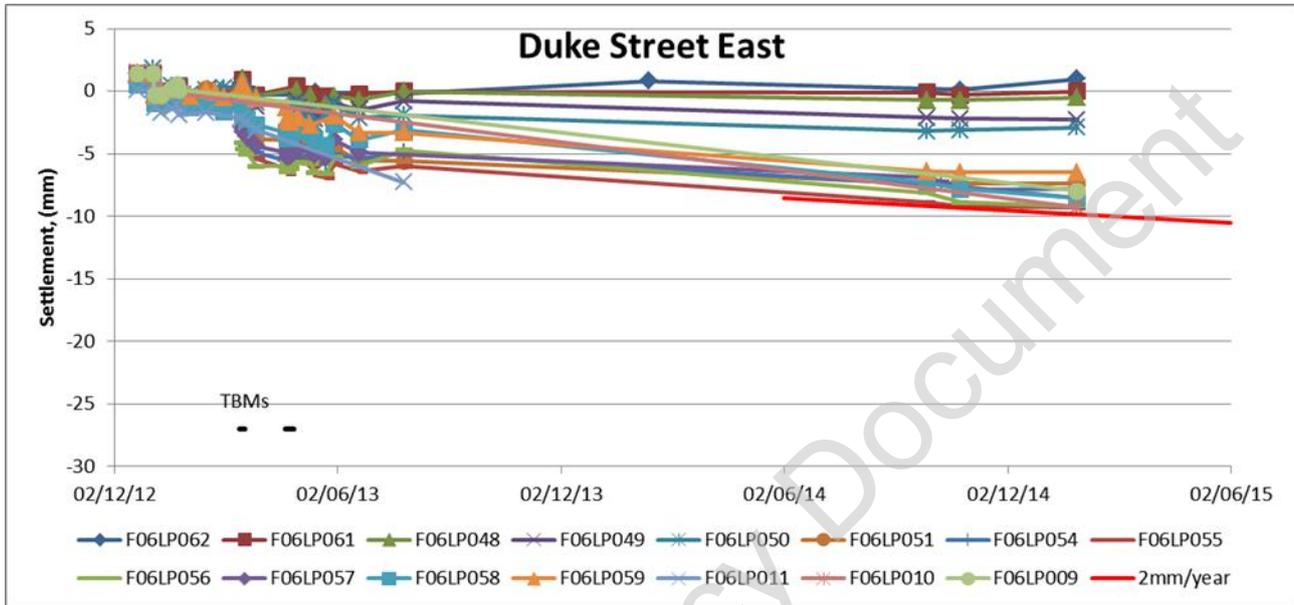
Figure 3.2: Data time-plot - comparison against 2mm/year settlement rate (long-term)

The points on the east kerbline of Duke Street had settled by ~7mm at the end of C300 Works. Small effects associated with the two TBM drives are visible from the settlement time-plot. Long term settlement with a potential contribution from the WTH works (C411) increased the maximum movement to 10mm.

The overall long term behaviour gives a settlement rate of around 2mm/year. By inspection of the profile plot, no slope triggers have been exceeded. The residual risk associated with long-term settlements is considered to be negligible.

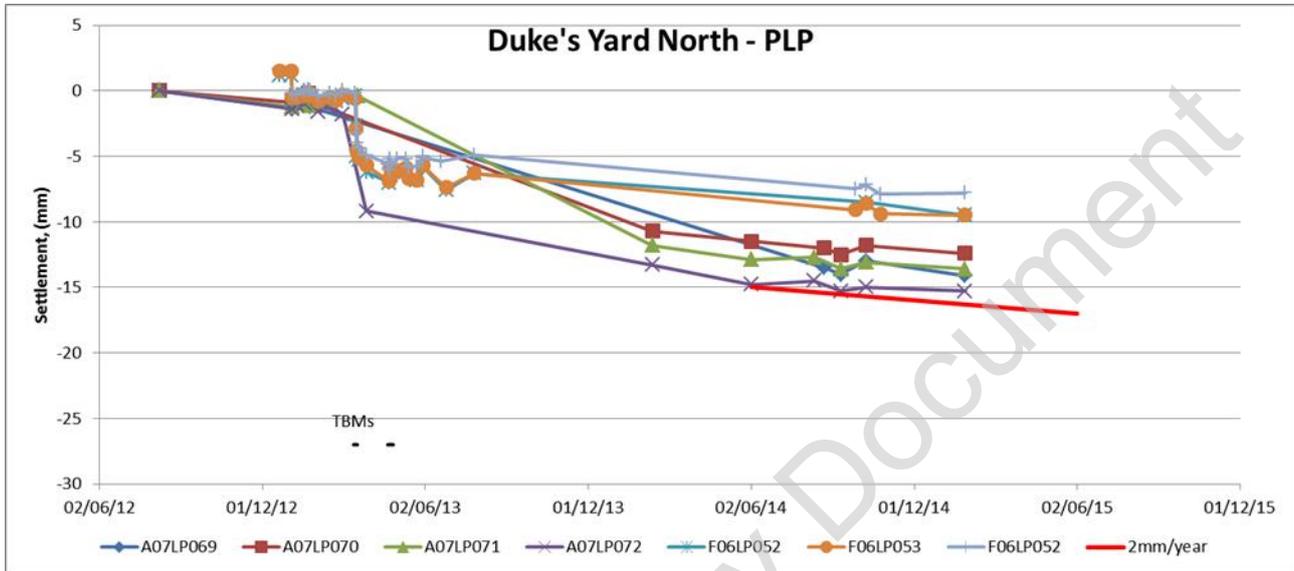
Figure 3.4: Data time-plot - comparison against 2mm/year settlement rate (long-term)

The points on the north kerbline of Duke's Yard had settled by ~10mm at the end of C300 Works. Small effects associated with the two TBM drives are visible from the settlement time-plot. Long term settlement with a potential contribution from the WTH works (C411) increased the maximum movement to 15mm.

The overall long term behaviour gives a settlement rate of less than 2mm/year. By inspection of the profile plot, no slope triggers have been exceeded. The residual risk associated with long-term settlements is considered to be negligible.

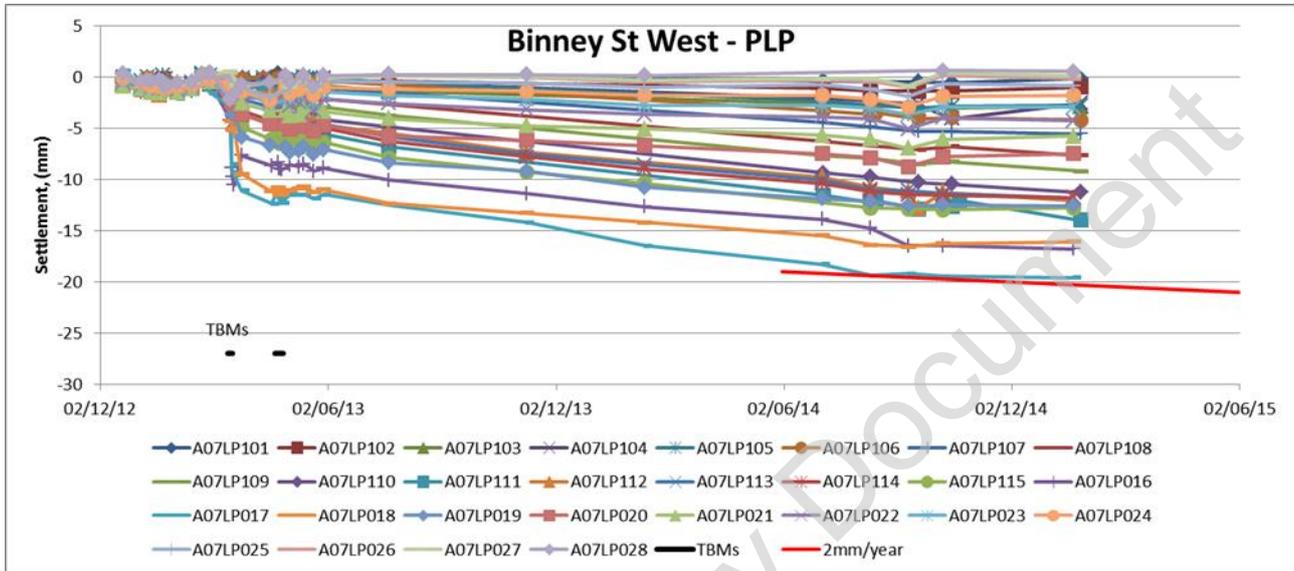
Figure 3.6: Data time-plot - comparison against 2mm/year settlement rate (long-term)

The points on the kerbline on west side of Binney Street settled by up to 12mm during the TBM drives. Long term settlement, with a potential contribution from the WTH works (C411), increased the maximum movement to 20mm. The maximum slope over ~10m was 0.7mm/m. No slope trigger levels have been exceeded

The overall long term rate of settlement is less than 2mm/year. The residual risk associated with long-term settlements is considered to be negligible.

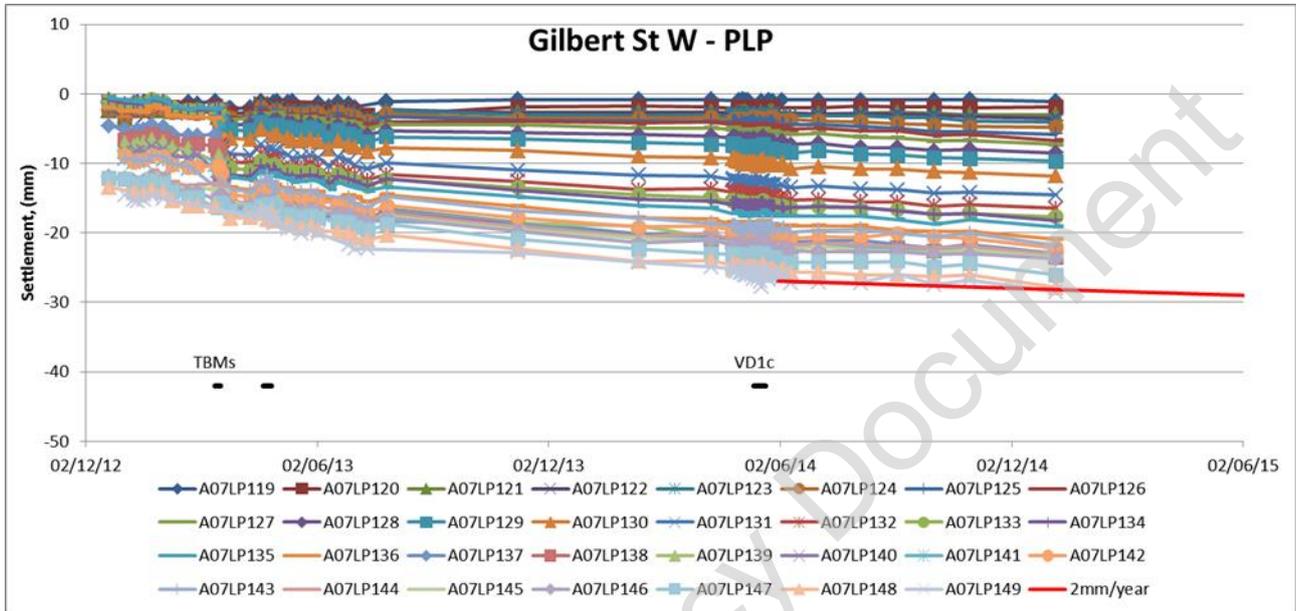
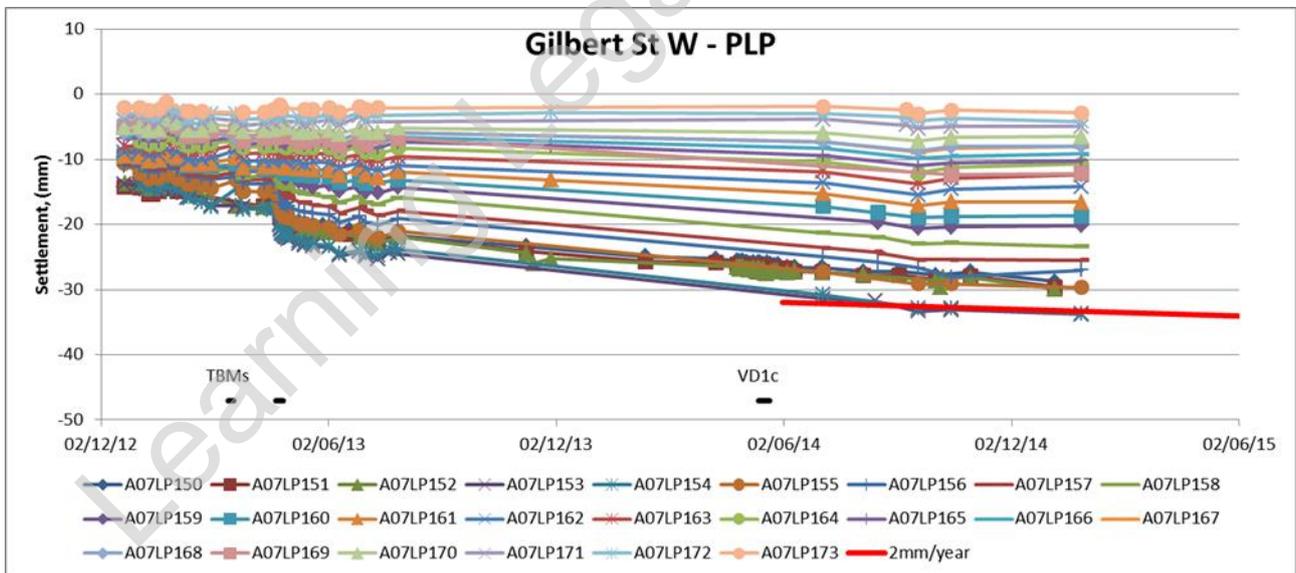
Figure 3.8 Data time-plot - comparison against 2mm/year settlement rate (long-term)

The points on the kerbline on west side of Gilbert Street settled by up to 15mm prior to the TBM drives. The maximum settlement immediately after the drives was 23mm. The excavation of VD1c in May 2014 had no noticeable effect. Long term settlement, with a potential contribution from the WTH works (C411), increased the maximum movement to 34mm. The maximum slope is 1.0mm/m at the Amber trigger level. By inspection of the profile plot, no deflection ratio triggers have been breached.

The final long term rate of settlement is about 2mm/year. The residual risk associated with long-term settlements is considered to be negligible.

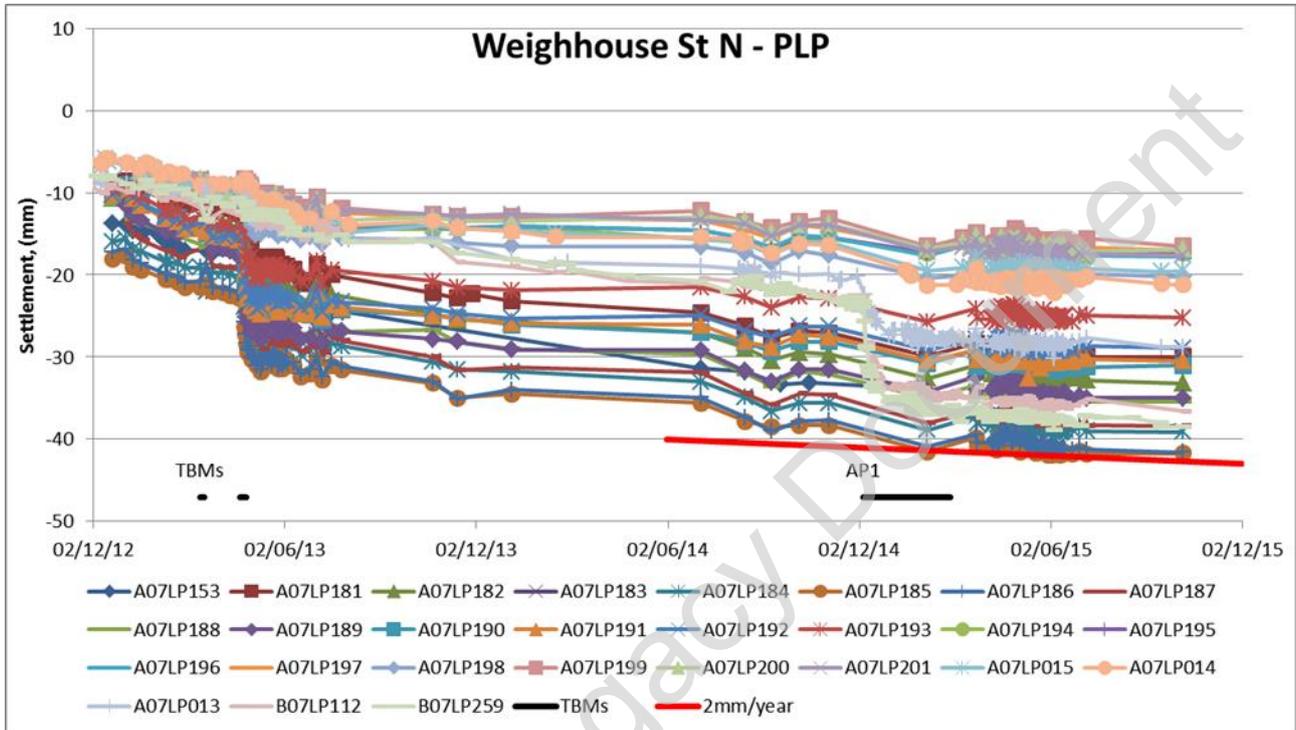
Figure 3.11 Data time-plot - comparison against 2mm/year settlement rate (long-term)

The points on the kerbline on north side of Weighouse Street settled by up to 20mm prior to the TBM drives. The maximum settlement immediately after the drives was 32mm. The excavation of AP1 in December 2014 / January 2015 increased the settlement on three points at the east end of the profile (A07LP013, B07LP112, B07LP259) by up to 15mm giving a maximum of ~36mm at this location. Slopes in excess of 1mm/m have

been recorded at the west and east ends of the profile, however the greatest slope is in the central section (distances 28m to 38m) where a value of  $\sim 1.5\text{mm/m}$  was recorded. It is noted that the location of the monitoring points changes from the kerbline to the building line at this location, which may contribute to the different responses measured.

Long term settlement, with a potential contribution from the WTH works (C411), increased the maximum movement on the profile to 41mm.

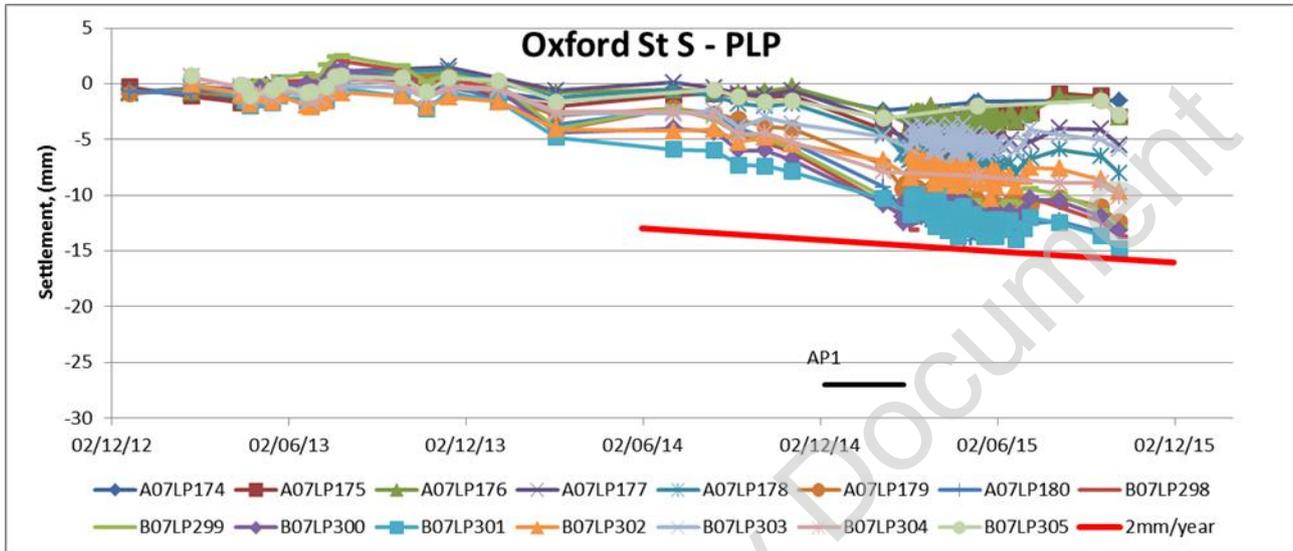
Figure 3.13 Data time-plot - comparison against 2mm/year settlement rate (long-term)

The points on the kerblines on the south side of Oxford Street settled by up to 8mm prior to the construction of AP1. The excavation of AP1 in December 2014 / January 2015 increased settlement by up to 7mm, giving a maximum settlement of 13mm. A minor post-construction settlement occurred (to 15mm maximum), however, the rate of settlement appeared to be increasing at the termination of monitoring. It is assumed that this was associated with works by the LU Station Upgrade project.

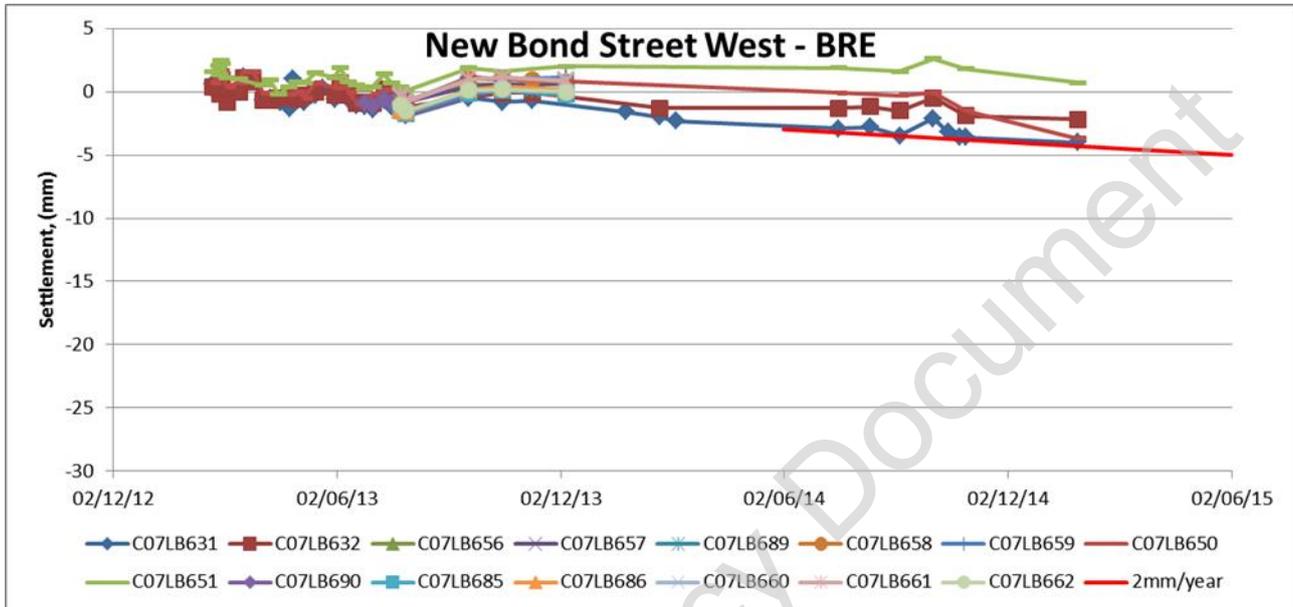
Figure 4.2 Data time-plot - comparison against 2mm/year settlement rate (long-term)

The points on the west façade of New Bond Street, south of Brook Street, had settled by less than 5mm at the end of C300 monitoring. These points are located outside the zone of influence of C300 works and it is concluded that the movements are due to C411 ETH works with a potential contribution from long term settlement following the construction of PTW in late 2013 / early 2014.

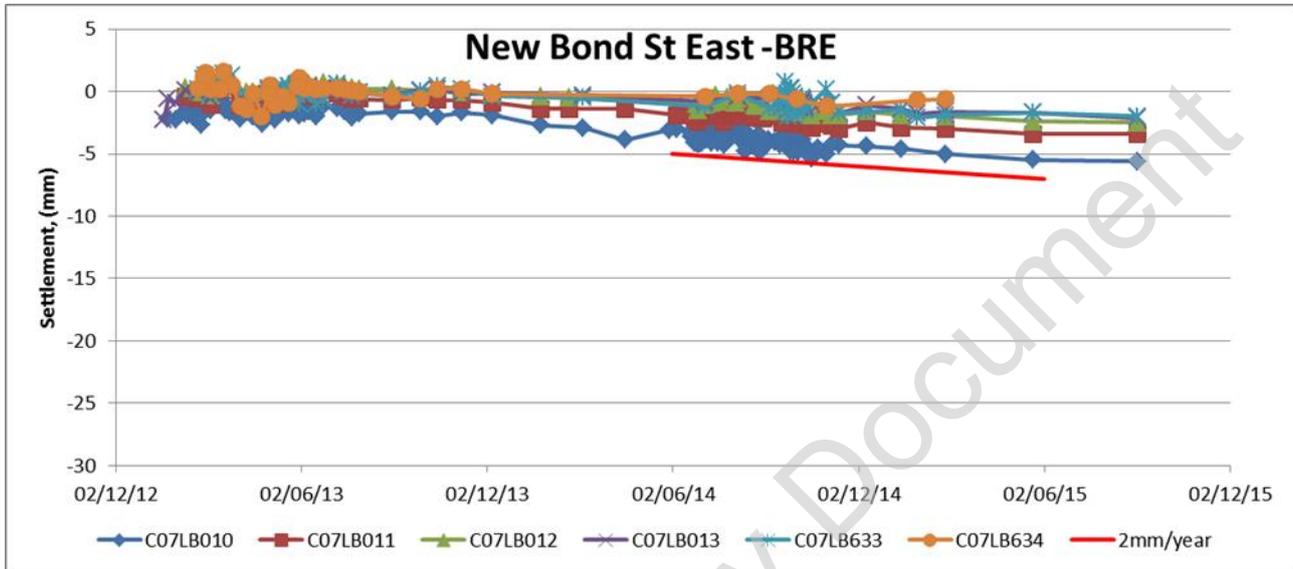
Figure 4.3 Data time-plot - comparison against 2mm/year settlement rate (long-term)

The points on the east façade of New Bond Street, south of Brook Street, had settled by less than 6mm at the end of C300 monitoring. These points are located outside the zone of influence of C300 works and it is concluded that the movements are due to C411 ETH works with a potential contribution from long term settlement following the construction of PTW in late 2013 / early 2014.

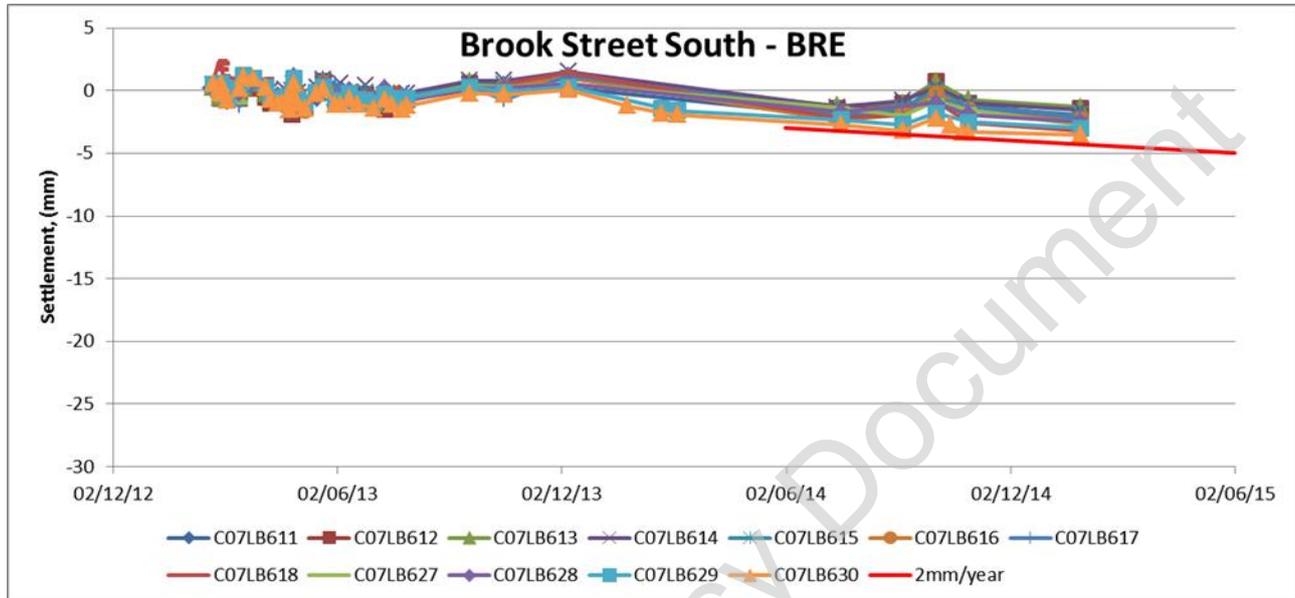
Figure 4.4 Data time-plot - comparison against 2mm/year settlement rate (long-term)

The points on the south façade of Brook Street, west of New Bond Street, had settled by less than 5mm at the end of C300 monitoring. These points are located outside the zone of influence of C300 works and it is concluded that the movements are due to C411 ETH works with a potential contribution from long term settlement following the construction of PTW in late 2013 / early 2014.

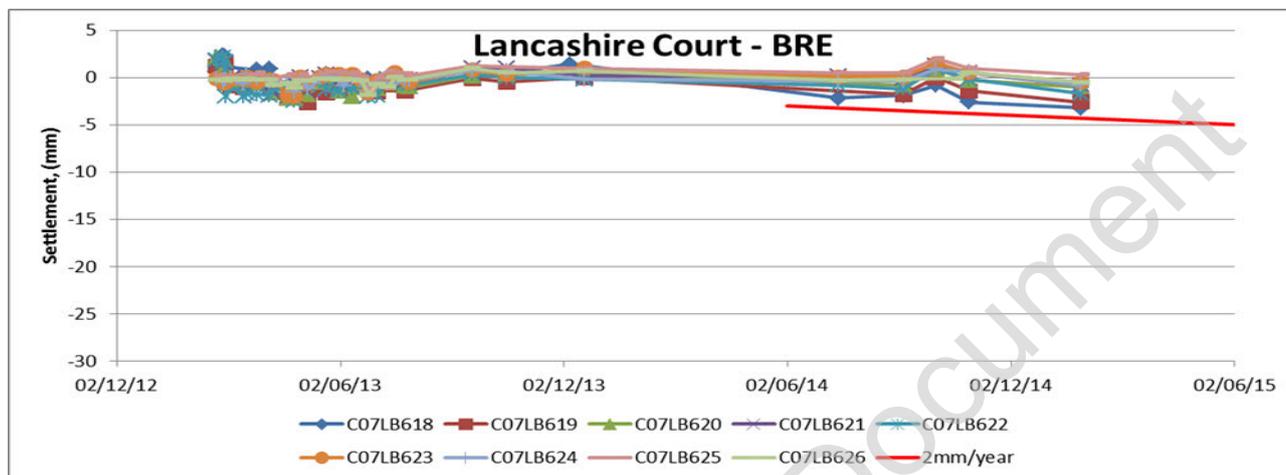
Figure 4.5 Data time-plot - comparison against 2mm/year settlement rate (long-term)

The points on the façades around Lancashire Court had settled by less than 5mm at the end of C300 monitoring. These points are located outside the zone of influence of C300 works and it is concluded that the movements are due to C411 ETH works with a potential contribution from long term settlement following the construction of PTW in late 2013 / early 2014.

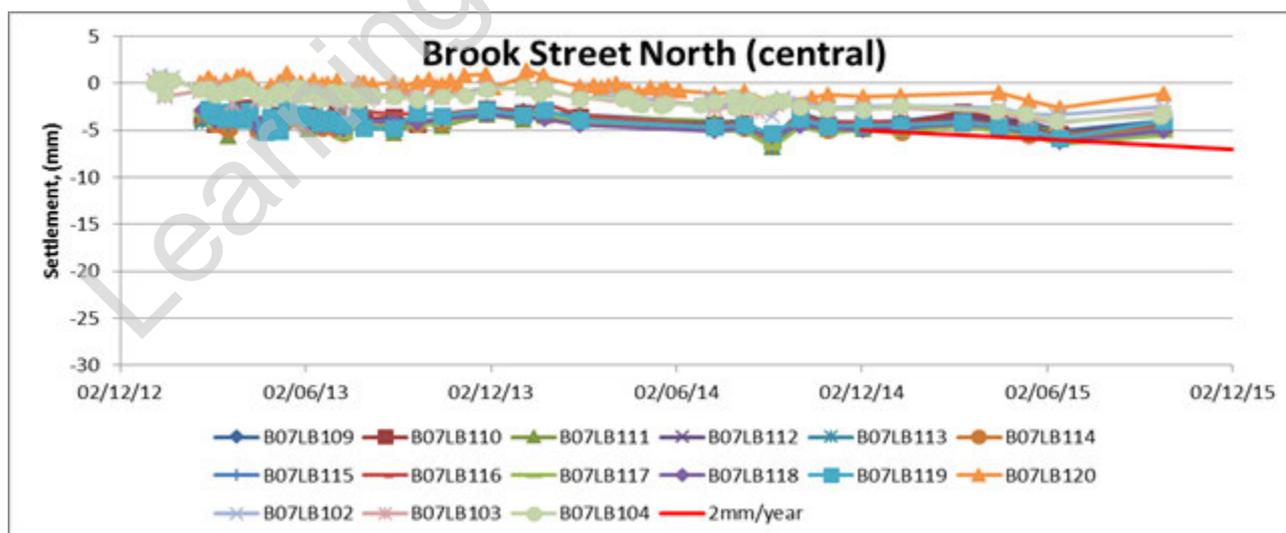
The points on the façades along the north side of Brook Street between Davies Street and South Molton Lane had settled by about 5mm at the end of C300 monitoring. These points are located outside the 1mm greenfield settlement contour works and settlement has not significantly increased during or following C300 works.

The overall long term behaviour gives a settlement rate of less than 2mm/year. The residual risk associated with long-term settlements is considered to be negligible.

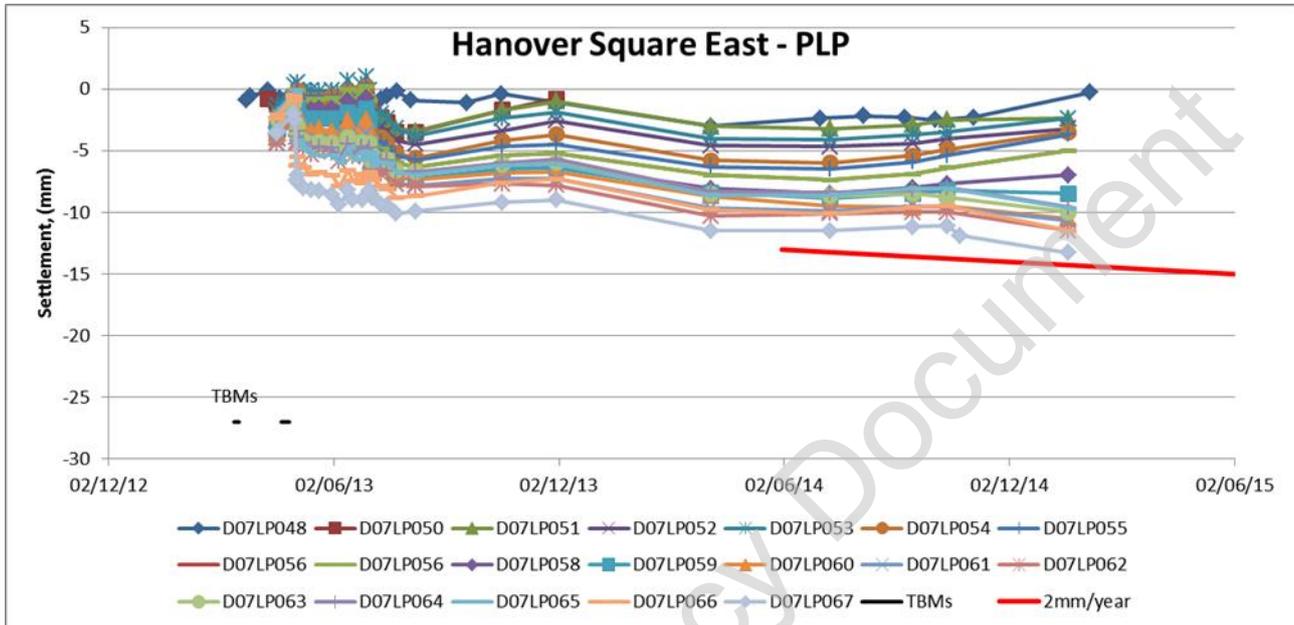
Figure 7.4 Data time-plot

The points on the east outer kerblines of Hanover Square show low impact (~8mm) from C300 works. The overall long term rate of settlement was about 2mm/year, giving a maximum settlement of 14mm at the termination of monitoring. It is noted that most of the points were destroyed due to a re-development on the corner of Hanover Square and Princes Street. The residual risk associated with long-term settlements is considered to be negligible.
