### Western Tunnels & Caverns Project

# Final Monitoring Report

## Bond Street Station – Manual Monitoring

CRL Document No. **C300-BFK-C4-RGN-CRT00\_ST005-53005**

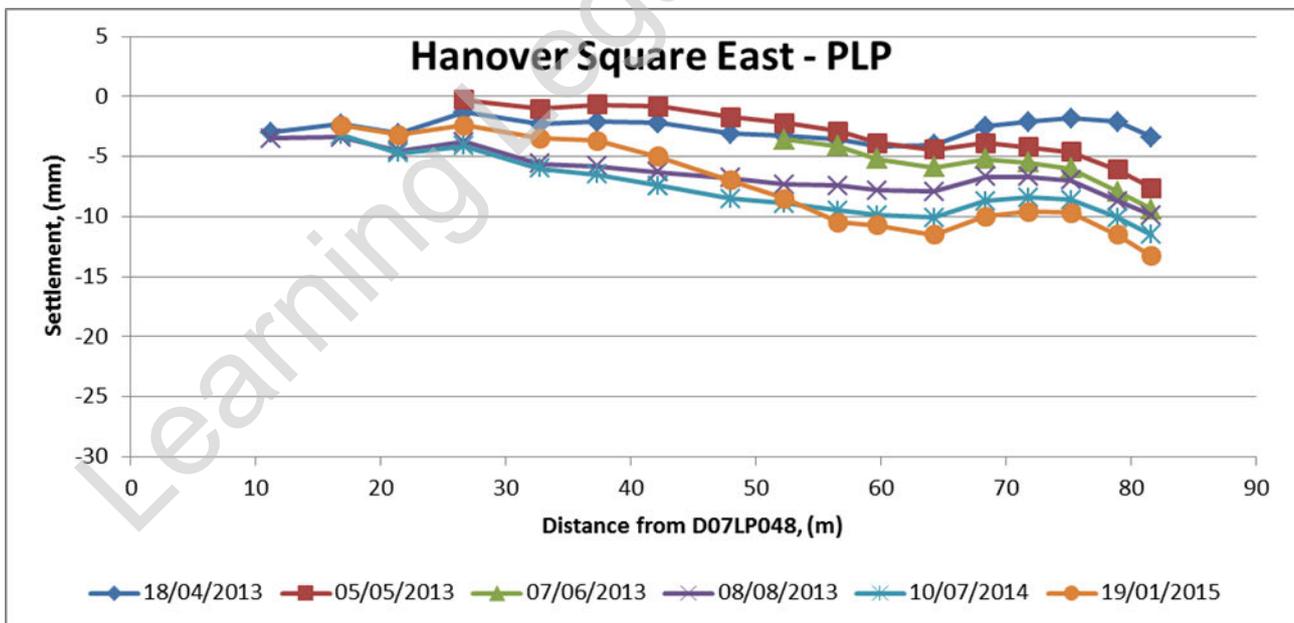
Figure 7.5: Profile Plot: Hanover Square East kerblines

The points on the east outer kerblines of Hanover Square show low impact (~8mm) from C300 works. The overall long term rate of settlement was about 2mm/year, giving a maximum settlement of 14mm at the termination of monitoring. It is noted that most of the points were destroyed due to a re-development on the corner of Hanover Square and Princes Street. The residual risk associated with long-term settlements is considered to be negligible.

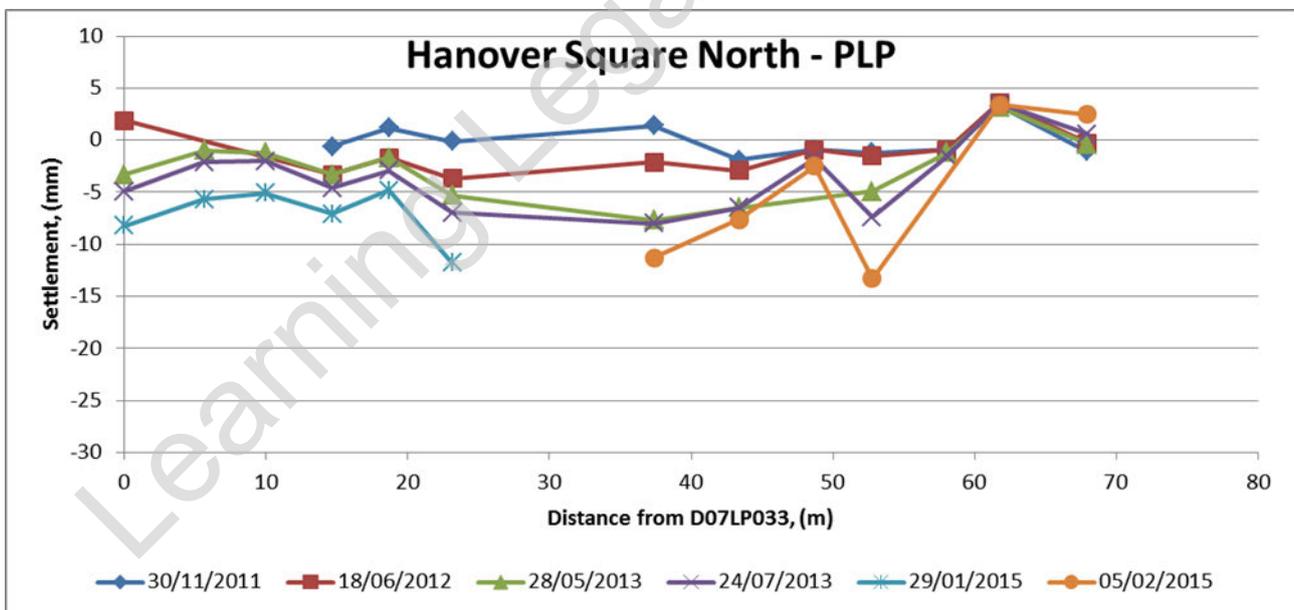
Figure 7.7 Profile Plot: Hanover Square North kerblines

It is noted that there were a number of re-developments ongoing around the east and north of Hanover Square and the form of the settlement profile plot showing localised peaks suggests that some damage to the kerbs may have occurred due to construction traffic.

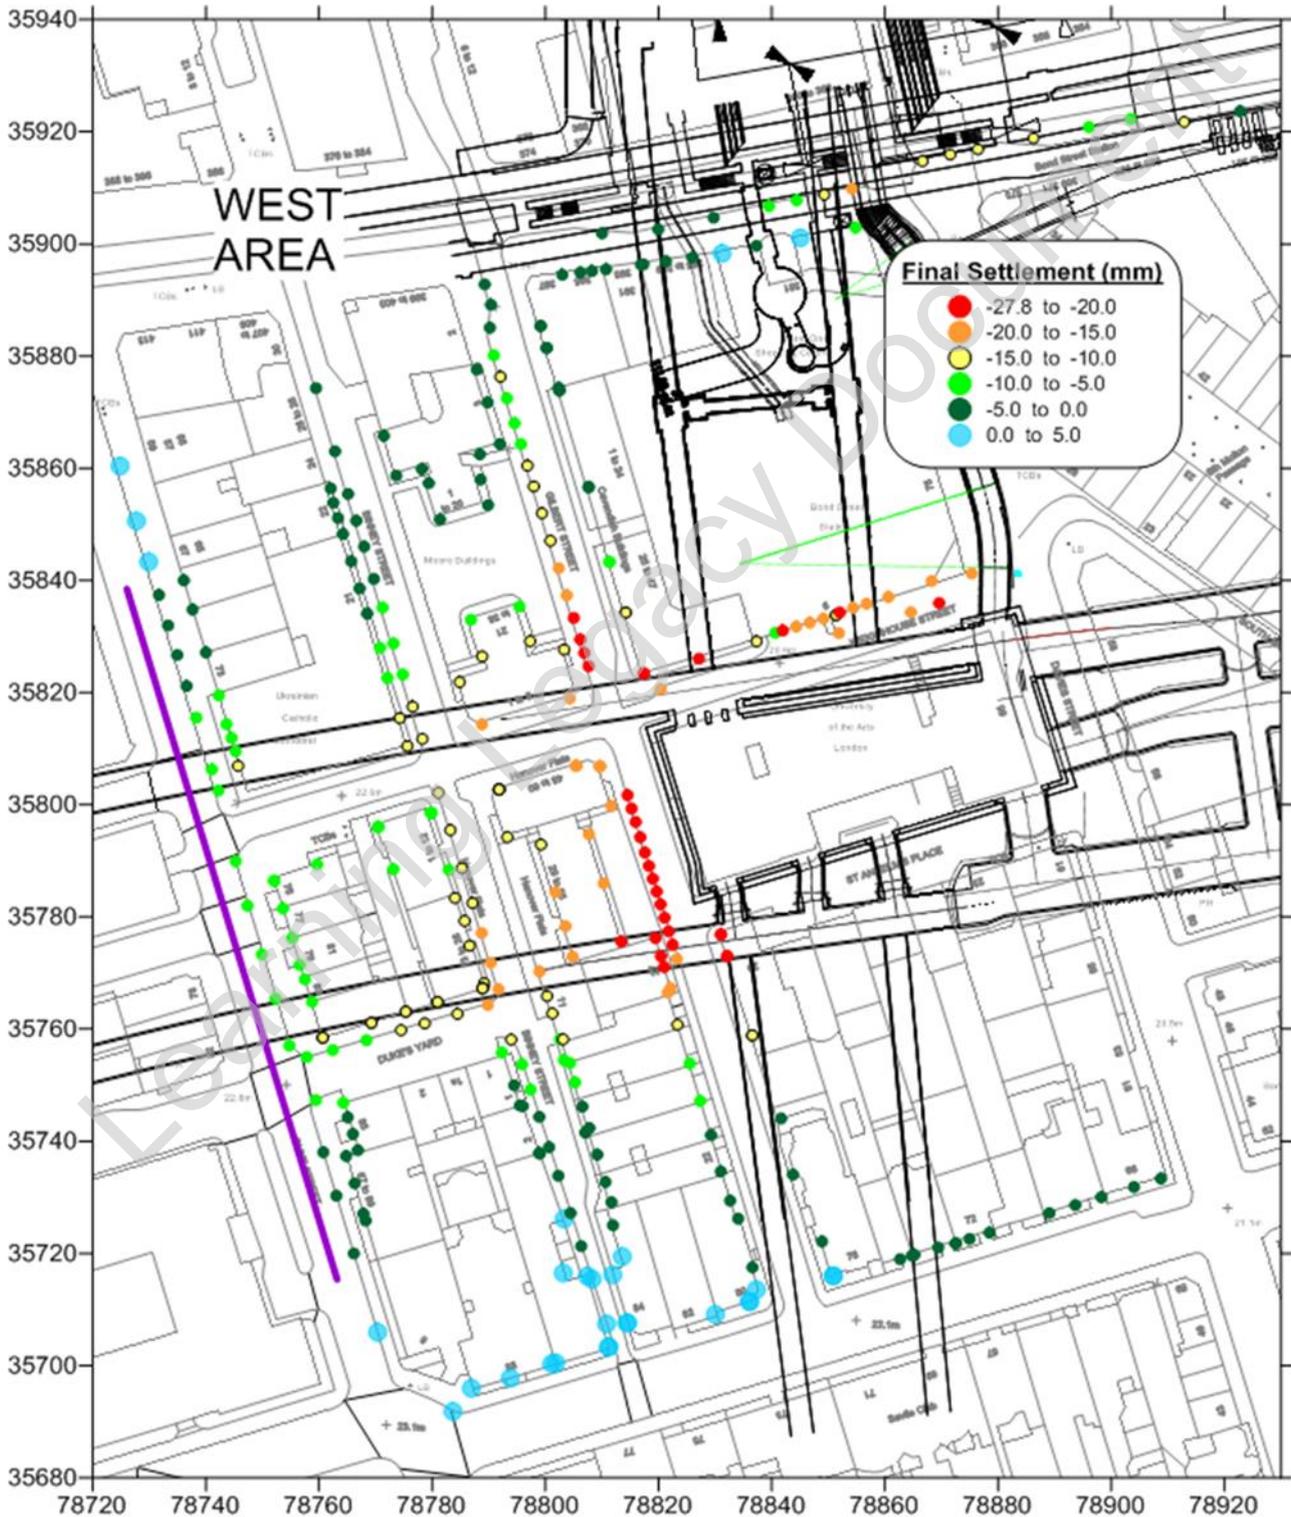
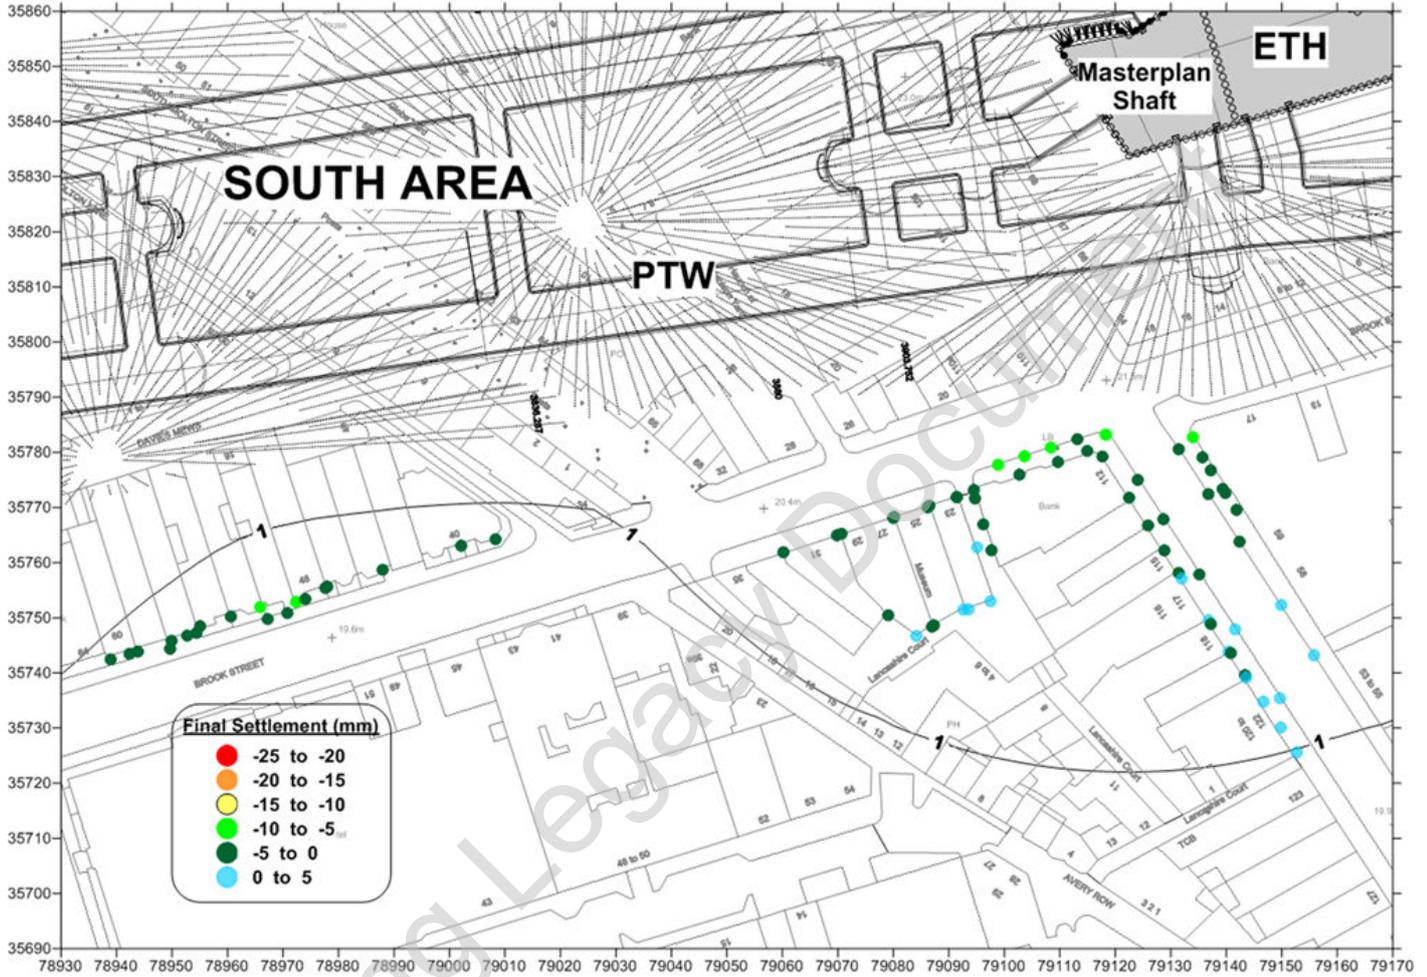
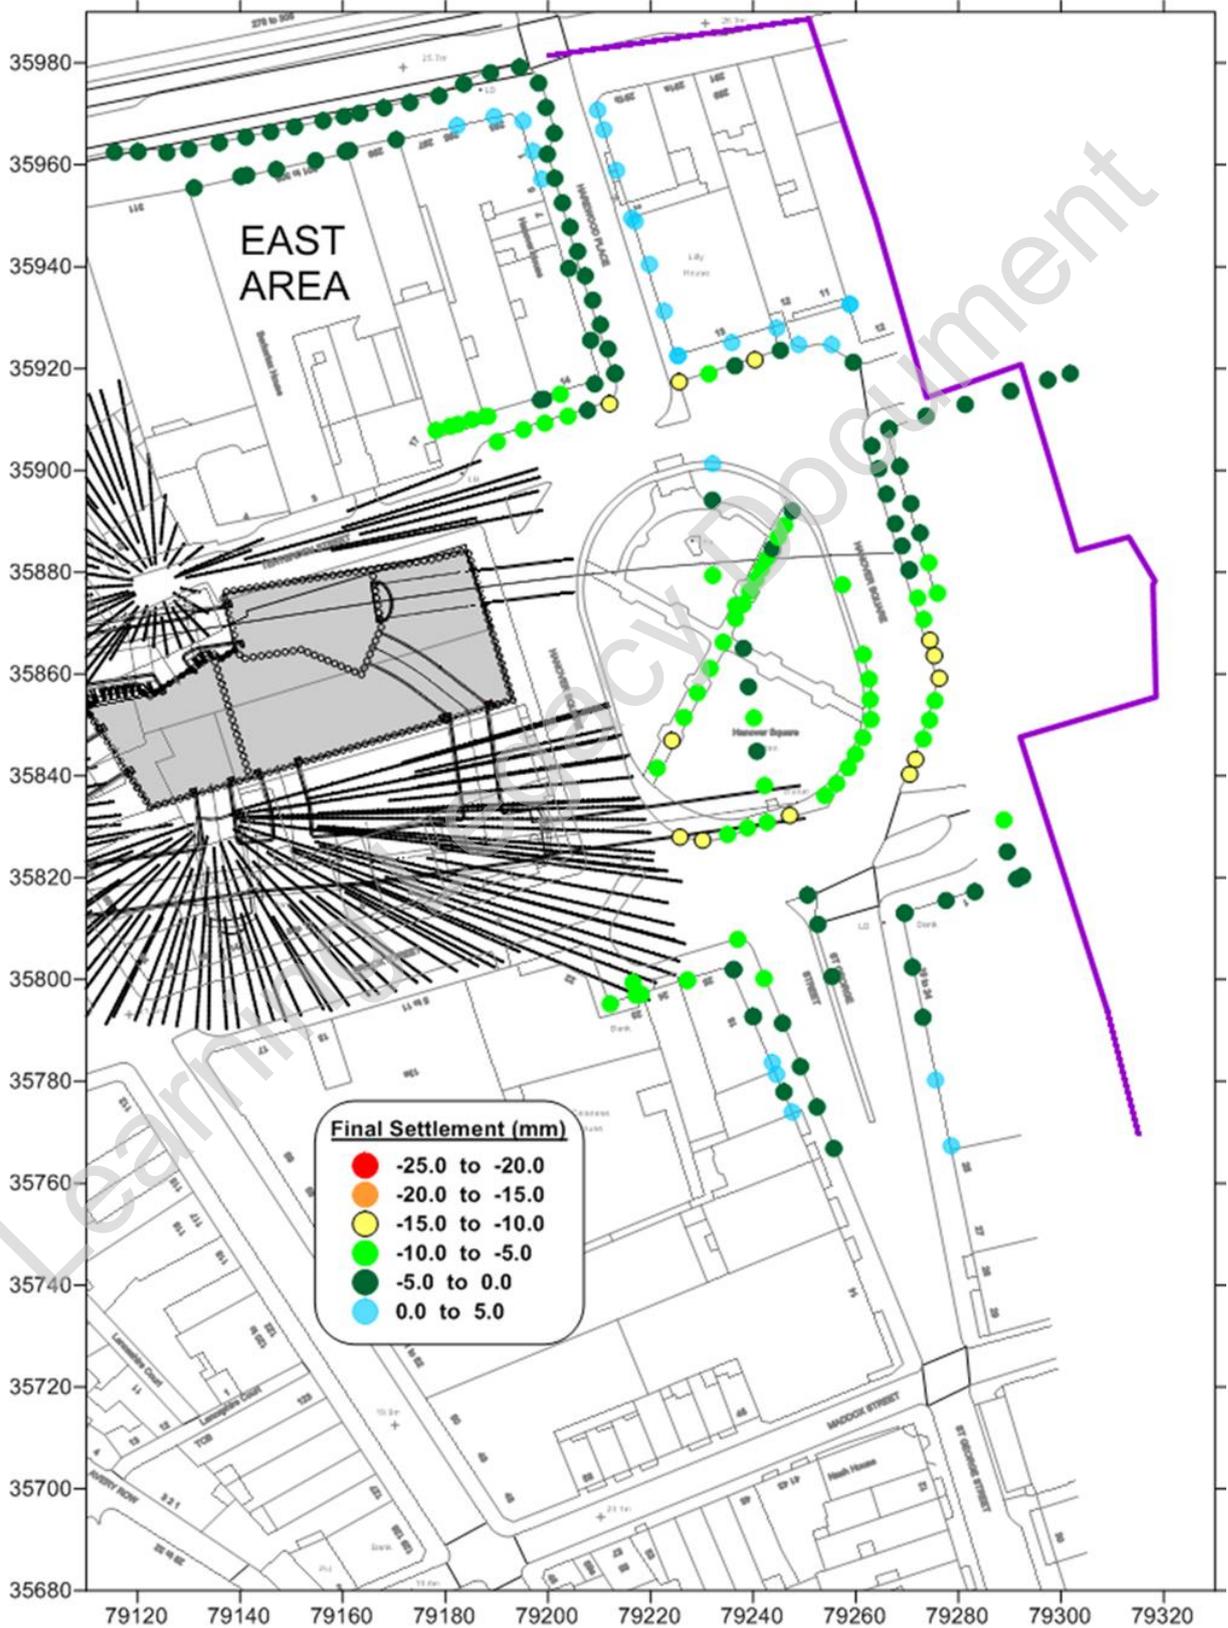
## Appendix 1. Final Settlement Distribution

Only data for points with readings within 90 days of the termination of monitoring are included.
